Your Ref: Mini Clubman  
(chassis number WMWJZ520X02L19279)  
Our Ref : CI/TP21000563/D

12 January 2021

**INSPECTION REPORT OF AN UNREGISTERD MINI CLUBMAN MOTOR CAR  
WITH CHASSIS NUMBER WMWJZ520X02L19279**

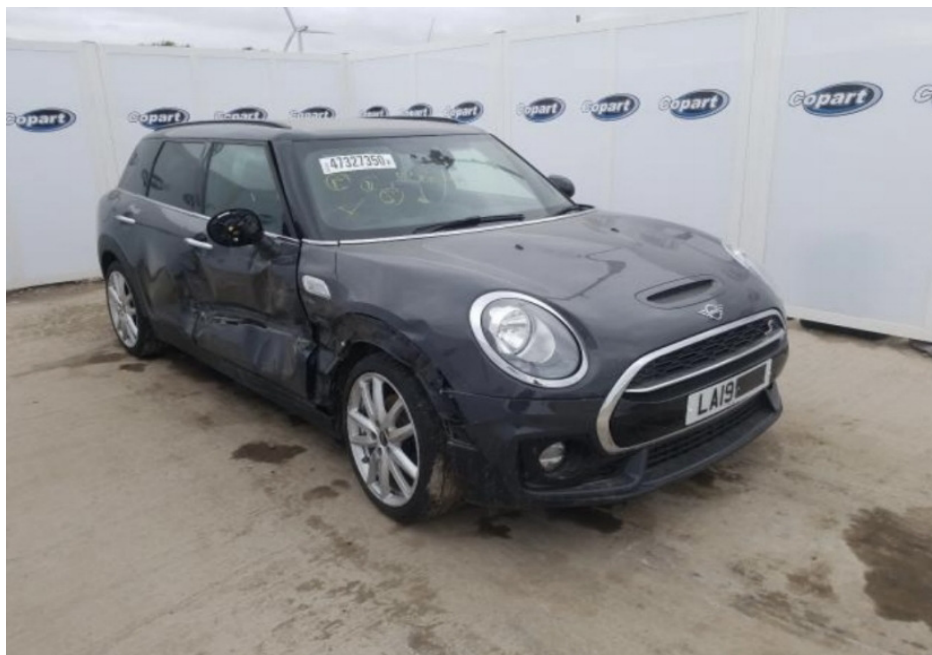
3. From the photographs provided to me, it was observed that the Motor Car had sustained damages along its right side portion. Body parts damaged include the front bumper, front bonnet, front right fender, front right wheel arc garnish, front right door, right side wing mirror, right side rocker panel garnish and rear right door amongst others.
4. No physical damage was observed to other areas of the Motor Car. The airbags of the Motor Car were also not activated as seen from the photographs that were provided to me. See photo 1 – 4 below.

**Photo 1** shows the front right body of the Motor Car (photograph provided to me). The Motor Car was observed to have sustained damage along its right side portion. The front bumper, front bonnet, front right fender, front right wheel arc garnish, front right door and right side wing mirror were amongst the body parts that were observed to have been damaged.

22. The body parts along the right side portion of the Motor Car were visually examined and it was noted that the repair/restoration works carried out to the damaged area of the Motor Car (refer to photograph 1 & 2 above) were reasonably adequate and in order.

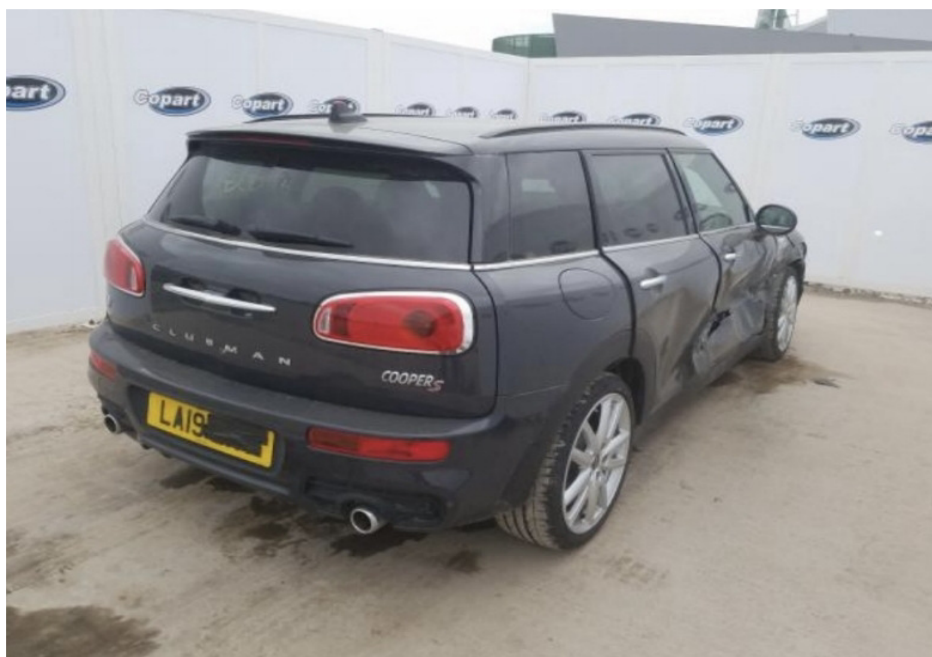
**Photo 2** shows the rear right body of the Motor Car (photograph provided to me). The Motor Car was observed to have sustained damage along its right side portion. The front right door, rear right door and right side rocker panel garnish were amongst the body parts that were observed to have been damaged.

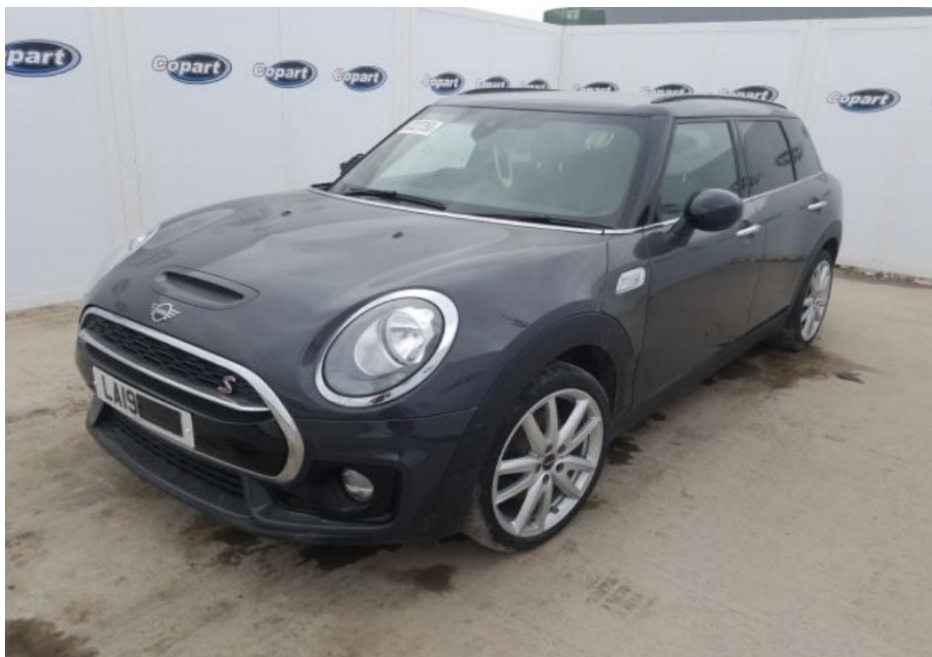
**Photo 3** shows the front left body of the Motor Car (photograph provided to me). Apart for the right side portion, there was no physical damage seen to other areas of the Motor Car.

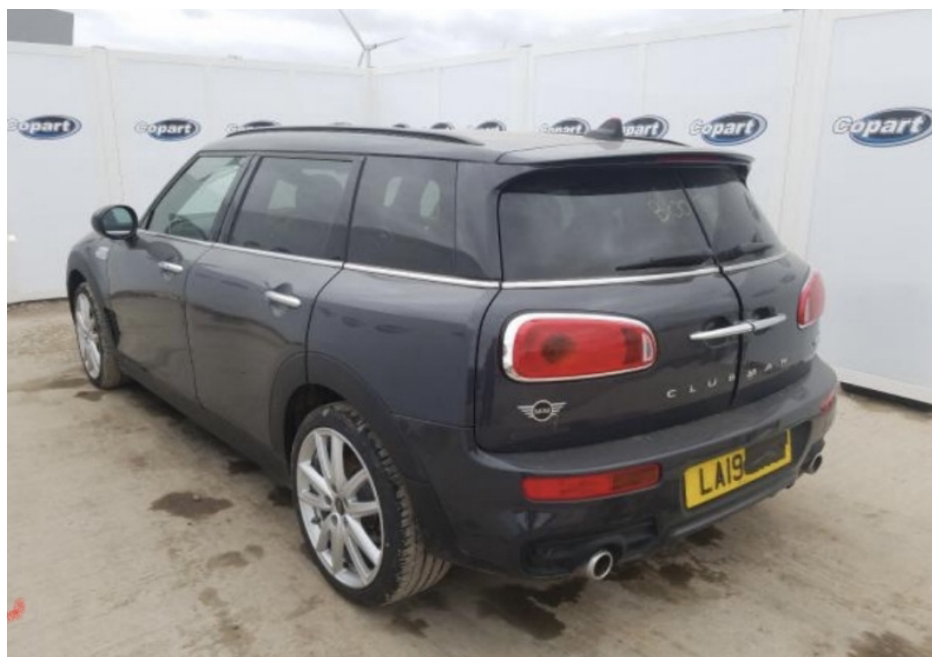
**Photo 4** shows the rear left body of the Motor Car (photograph provided to me). Apart for the right side portion, there was no physical damage seen to other areas of the Motor Car.

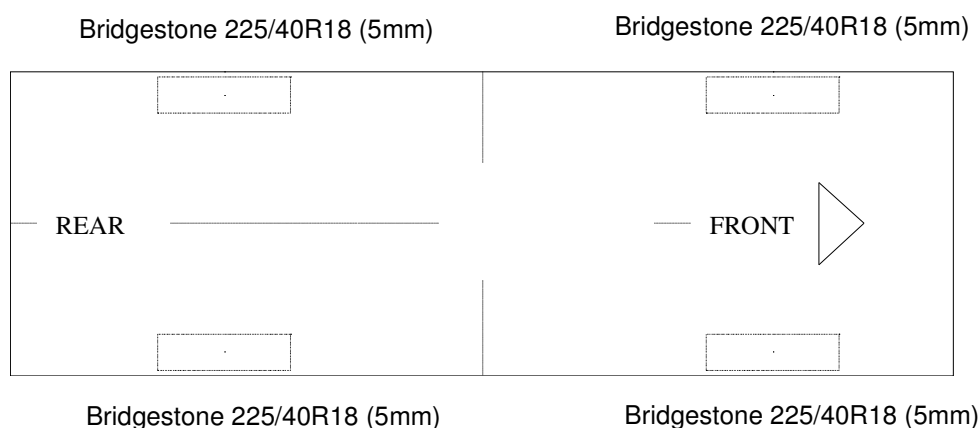
8. It was fitted with 18inch sport wheel rims that were wrapped with tyres that were observed to be of serviceable condition. The tyres were also sufficiently inflated for vehicular operation. The tyre brand, tyre size and approximate remaining tread depth of the 4 tyres of the Motor Car were recorded as follows: -

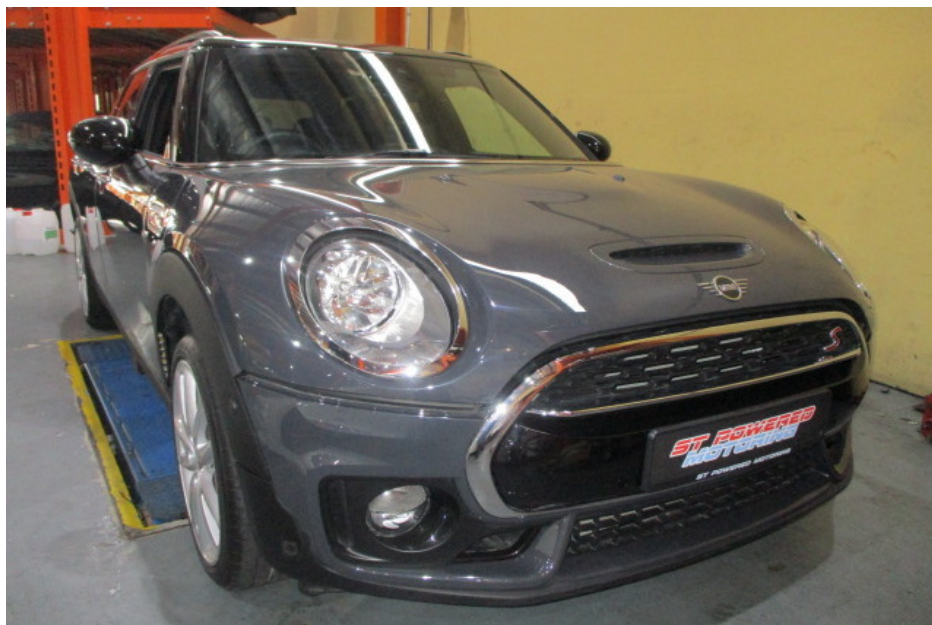
**Photo 5** shows a general view of the front right body of the Motor Car at the time of my inspection. The Motor Car was observed to be in a relatively good general condition with no loose exterior fittings observed. The body parts along the right side portion of the Motor Car were visually examined and it was observed that the repair/restoration works carried out to the damaged area of the Motor Car (refer to photograph 1 & 2 above) were reasonably adequate and in order.

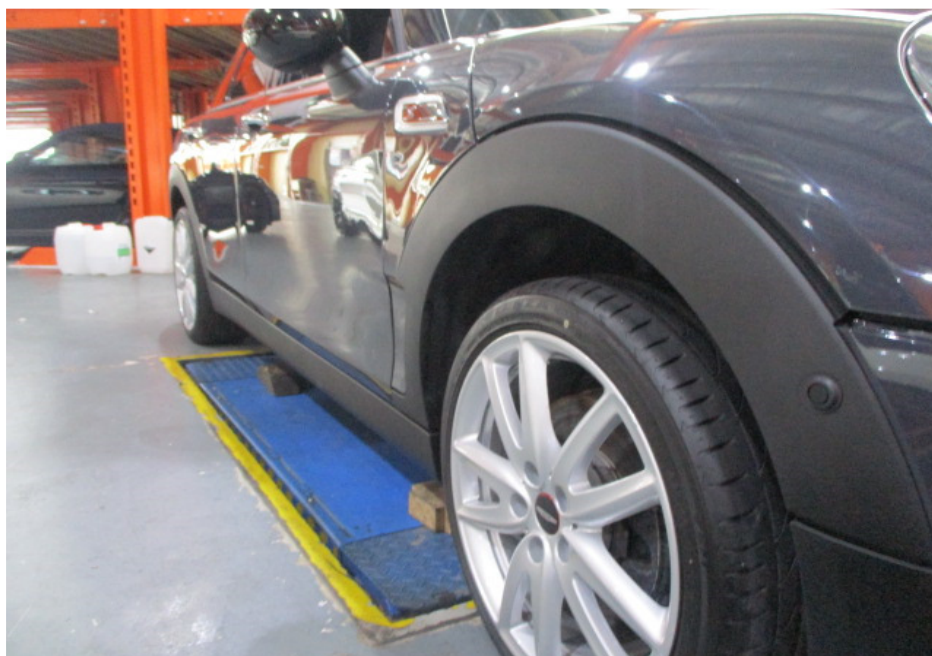
**Photo 6** shows a closer view of the front bonnet, front right fender and front right wheel arc garnish of the Motor Car at the time of my inspection. The body parts along the right side portion of the Motor Car were visually examined and it was observed that the repair/restoration works carried out to the damaged area of the Motor Car (refer to photograph 1 & 2 above) were reasonably adequate and in order.

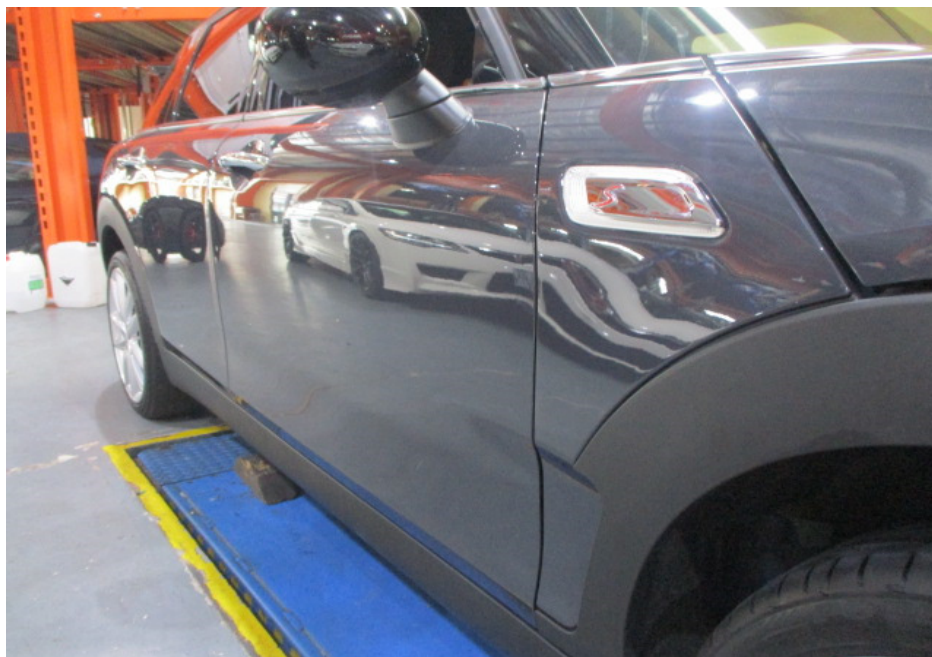
**Photo 7** shows a closer view of the front bonnet, front right fender, front right door, right side rocker panel garnish and right side wing mirror of the Motor Car at the time of my inspection. The body parts along the right side portion of the Motor Car were visually examined and it was observed that the repair/restoration works carried out to the damaged area of the Motor Car (refer to photograph 1 & 2 above) were reasonably adequate and in order.

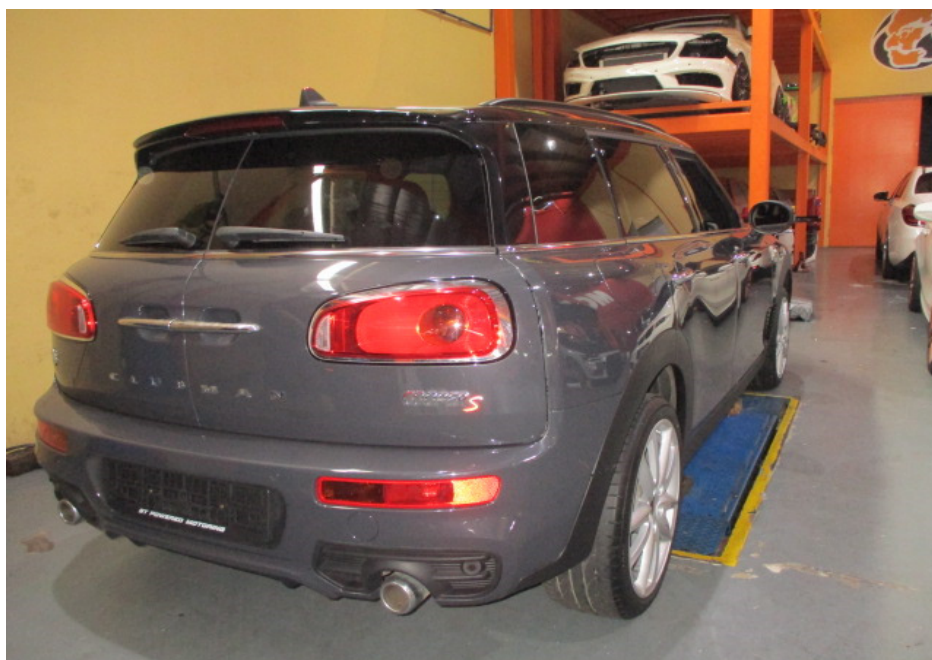
**Photo 8** shows a general view of the rear right body of the Motor Car at the time of my inspection. The Motor Car was observed to be in a relatively good general condition with no loose exterior fittings observed. The mileage of the Motor Car recorded at the time of my inspection was 11,881km.

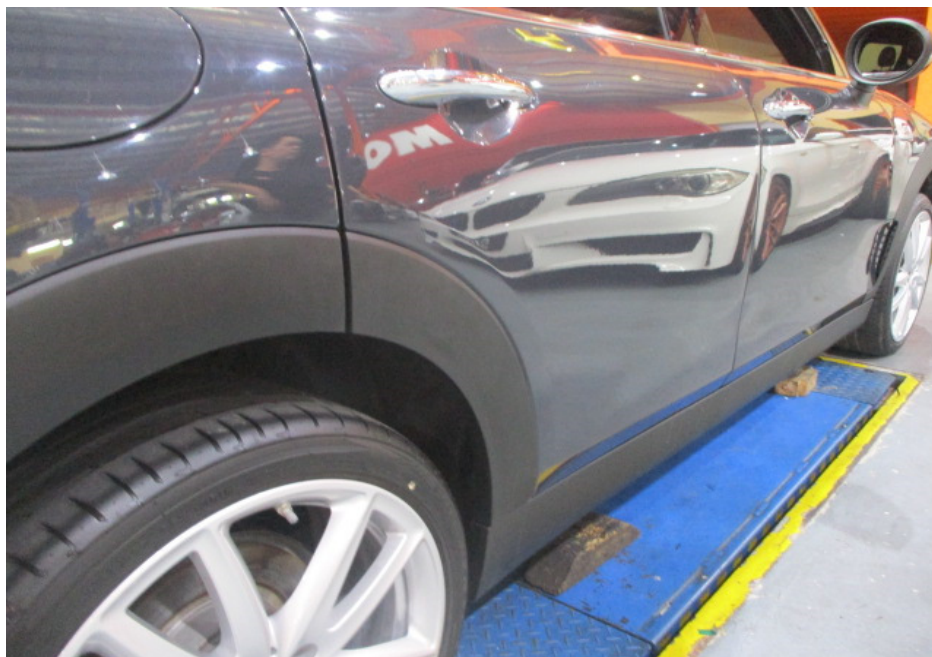
**Photo 9** shows a closer view of the rear right door and right side rocker panel garnish of the Motor Car at the time of my inspection. The body parts along the right side portion of the Motor Car were visually examined and it was observed that the repair/restoration works carried out to the damaged area of the Motor Car (refer to photograph 1 & 2 above) were reasonably adequate and in order.

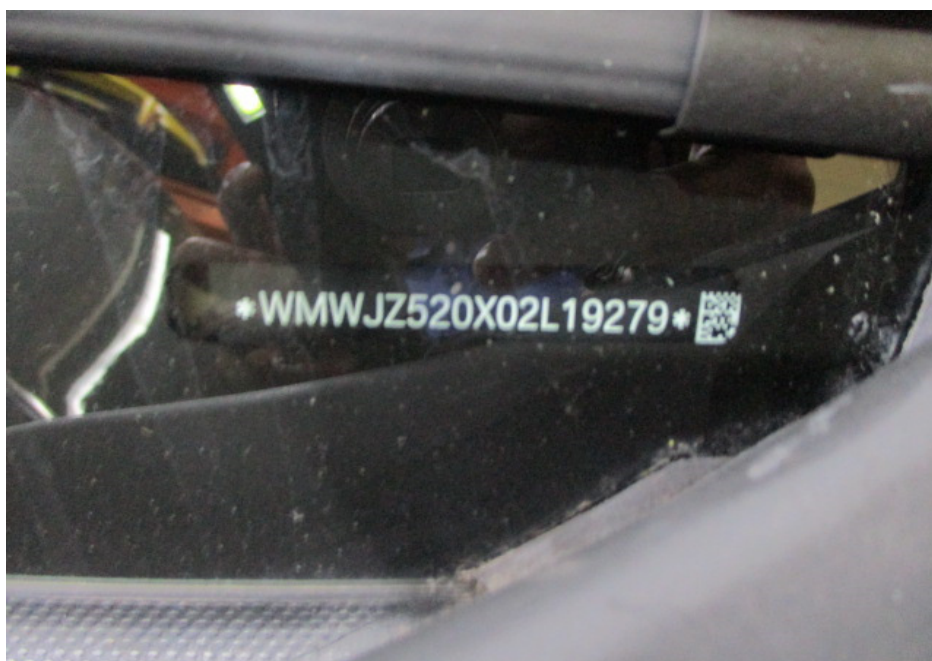
**Photo 10** shows the chassis number of the Motor Car. The chassis number recorded was WMWJZ520X02L19279.

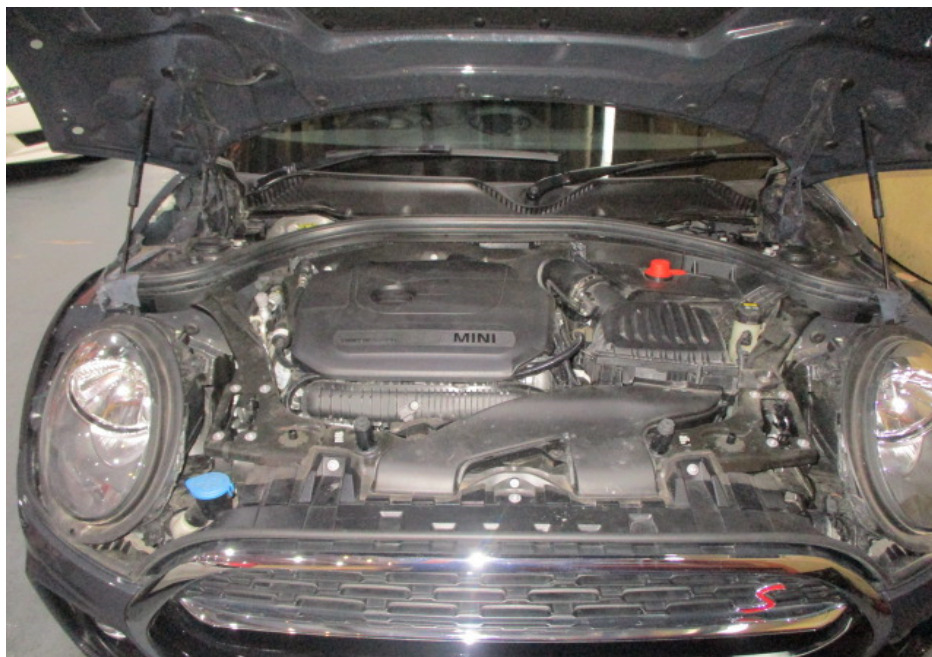
14. My examination of the engine compartment of the Motor Car revealed that the various parts and components inside the engine compartment were all intact and properly fitted. The engine oil, brake fluid and engine coolant were all found to be of sufficient level for operating purposes. Visually, there was also no contamination found to these fluids.
15. My checks on the underside of the Motor Car revealed no sign(s) or indication(s) of fluid leakage and/or fluid stain(s). The engine block and automatic transmission assembly were both secured properly. All undercarriage components of the Motor Car were also observed to be intact and secured in an appropriate manner.

**Photo 11** shows a general view of the engine compartment of the Motor Car at the time of my inspection. The various parts and components inside the engine compartment were all observed to be intact and properly fitted. There was also no sign(s) or indication(s) of fluid leak and/or fluid stain found inside the engine compartment.

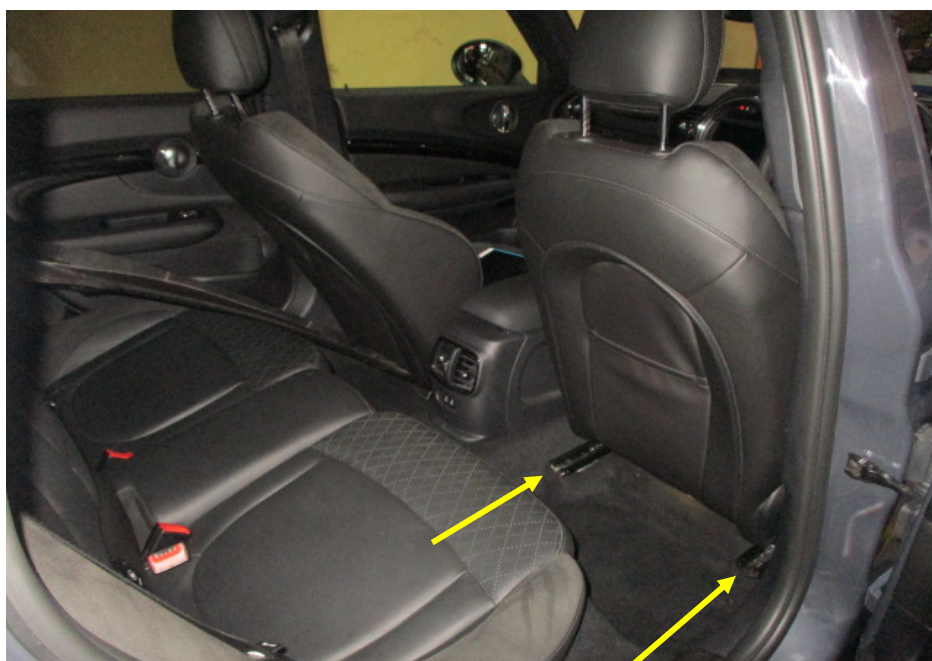
12. The seats of the Motor Car were found to be secured to the floorboard of the Motor Car via seat rails bolted onto the floorboard. Retractable seat belt reels and pre-tensioners were fitted on all seats of the Motor Car. The seat belts were tested and were able to be fastened securely into the respective pre-tensioners that were fixed to the side of all the seats.

**Photo 12** shows the seats of the Motor Car, which were secured via seat rails (arrowed) to the floorboard. All the seats of the Motor Car were fitted with a retractable seat belt reel and pre-tensioner. The seat belts were tested and were able to be fastened into the respective pre-tensions that were fitted on the side of each individual seat.

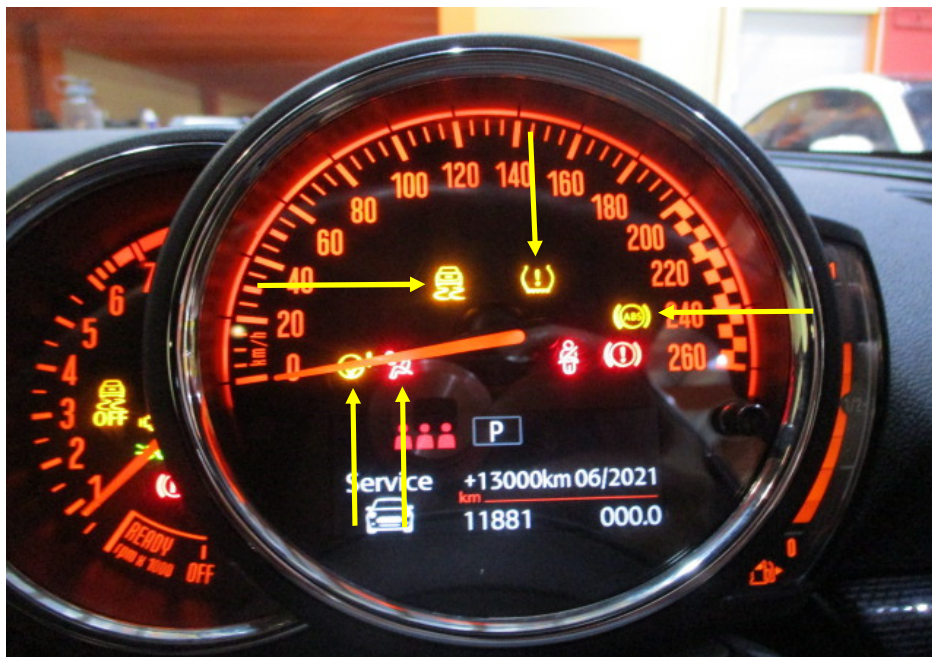
**Photo 13** shows the warning lights for the various electronic safety features appearing on the instrument panel of the Motor Car during its self-test when the engine is cranked, in particular the ABS, SRS, PAS, TPM and DSC lights (arrowed).

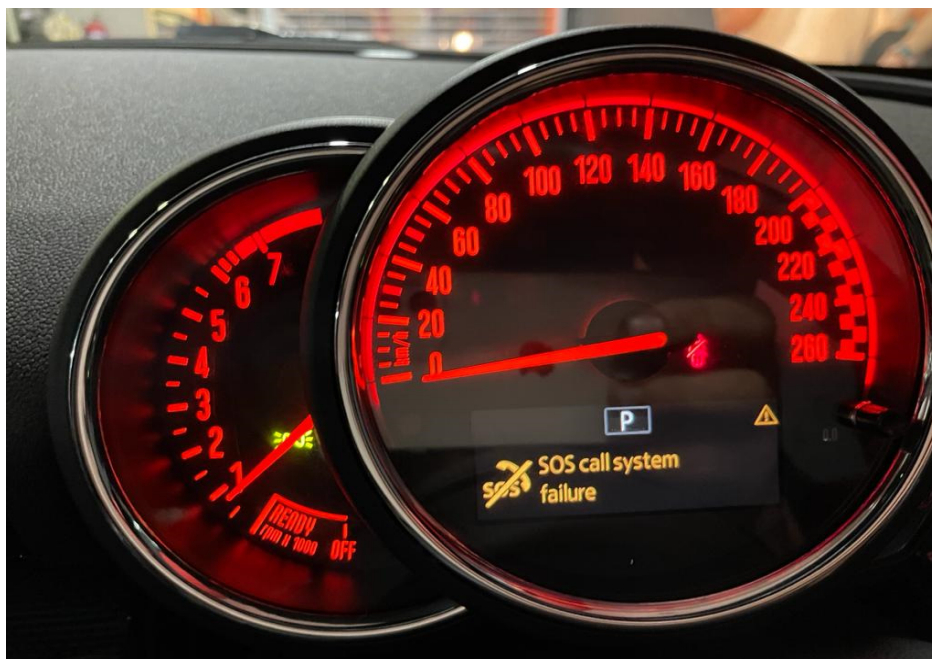
13. The Motor Car's automatic self-test of the functionality of its various electronic safety features like the Anti-Lock Brake System (ABS), Supplemental Restraint System (SRS), Power Assisted Steering (PAS), Tyre Pressure Monitor (TPM) and Dynamic Stability Control (DSC) during cranking of the engine had indicated that these electronic systems were in working condition. This was determined from the respective warning lights disappearing from the instrument panel after the self-test.

**Photo 14** shows the respective warning lights no longer illuminated, indicating that there is no fault detected to the ABS, SRS, PAS, TPM and DSC systems of the Motor Car during the self-test. These electronic systems were hence in working condition at the time of my inspection.

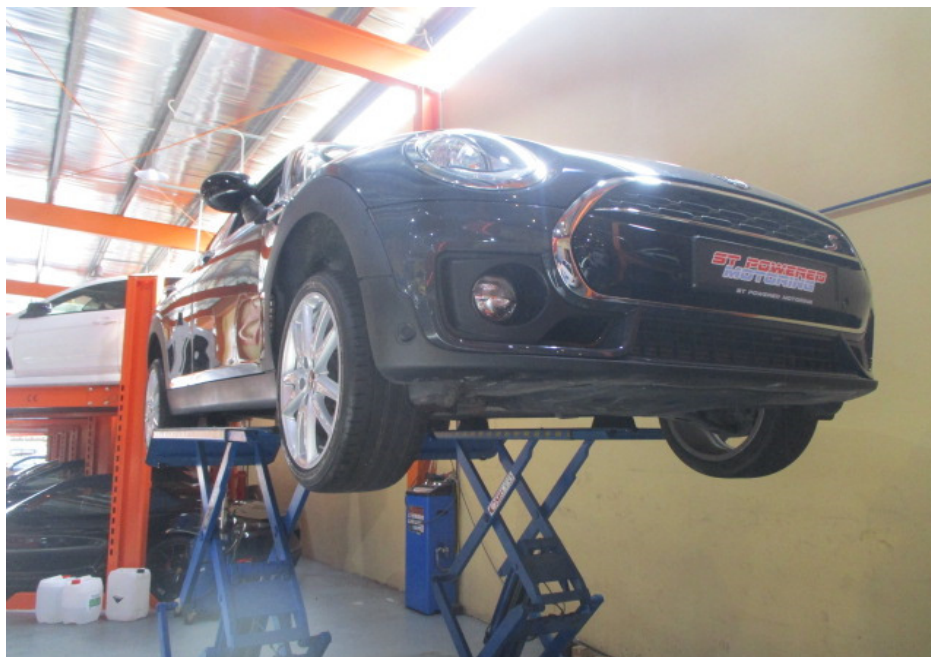
**Photo 15** shows the Motor Car hoisted up for checks on its undercarriage. There was no sign(s) or indication(s) of fluid leakage and/or fluid stain(s) on the underside of the Motor Car. The undercarriage components of the Motor Car were also all observed to be intact and secured in an appropriate manner.

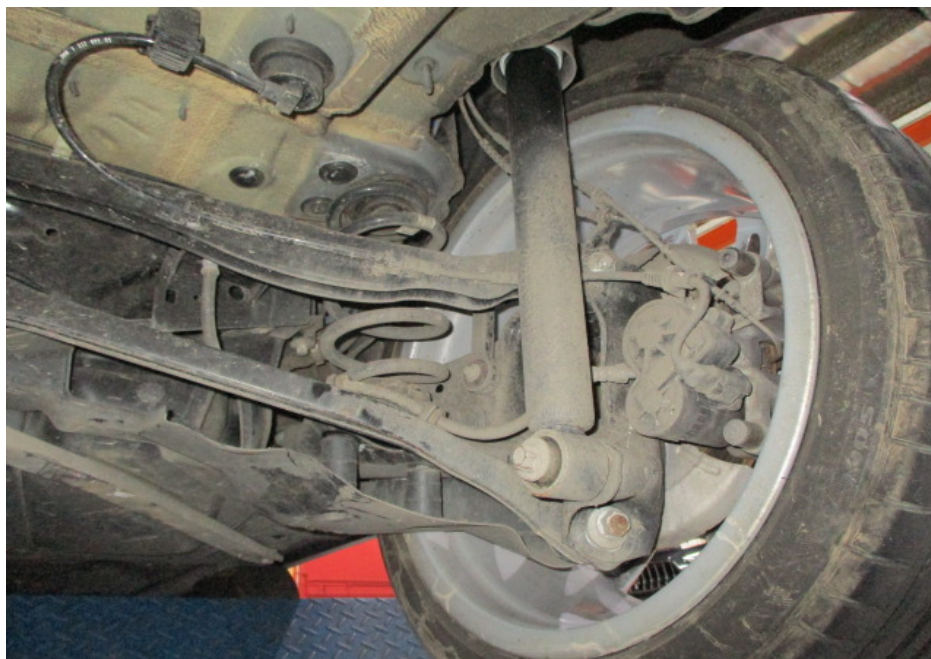
**Photo 16** shows a general view of the control arms and linkages at the rear right wheel of the Motor Car. I did not observe any fluid leak and/or fluid stain on the underside of the Motor Car. All of the Motor Car's undercarriage components were observed to be intact and secured in an appropriate manner.

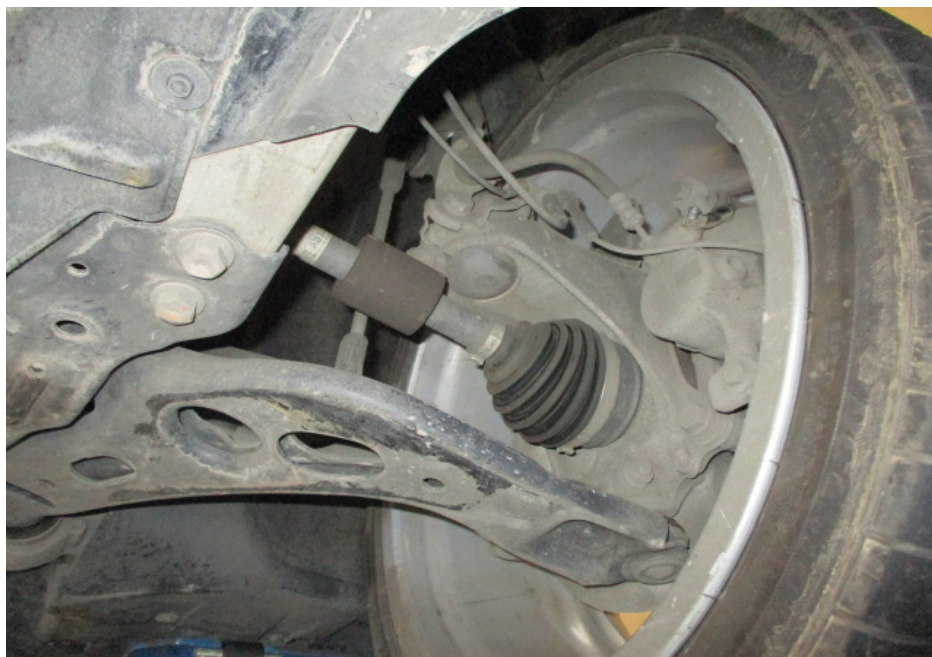
**Photo 17** shows the various undercarriage components at the front left wheel of the Motor Car. The mechanical components, control arms and linkages were all found to be intact and secured in an appropriate manner.

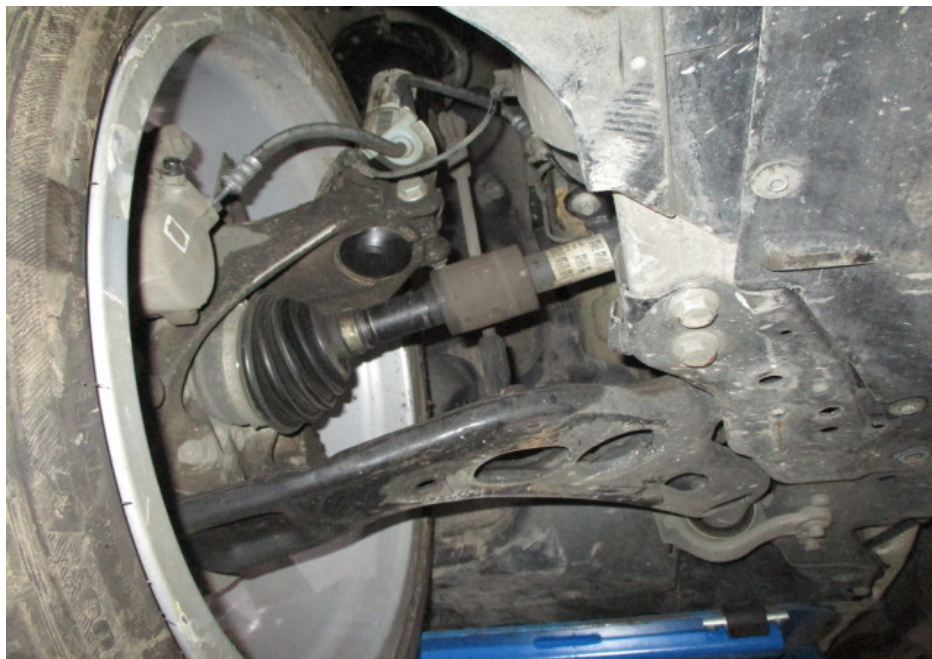
**Photo 18** shows the various undercarriage components at the front right wheel of the Motor Car. The mechanical components, control arms and linkages were all found to be intact and secured in an appropriate manner. I also did not observe any fluid leak and/or fluid stain on the underside of the Motor Car.

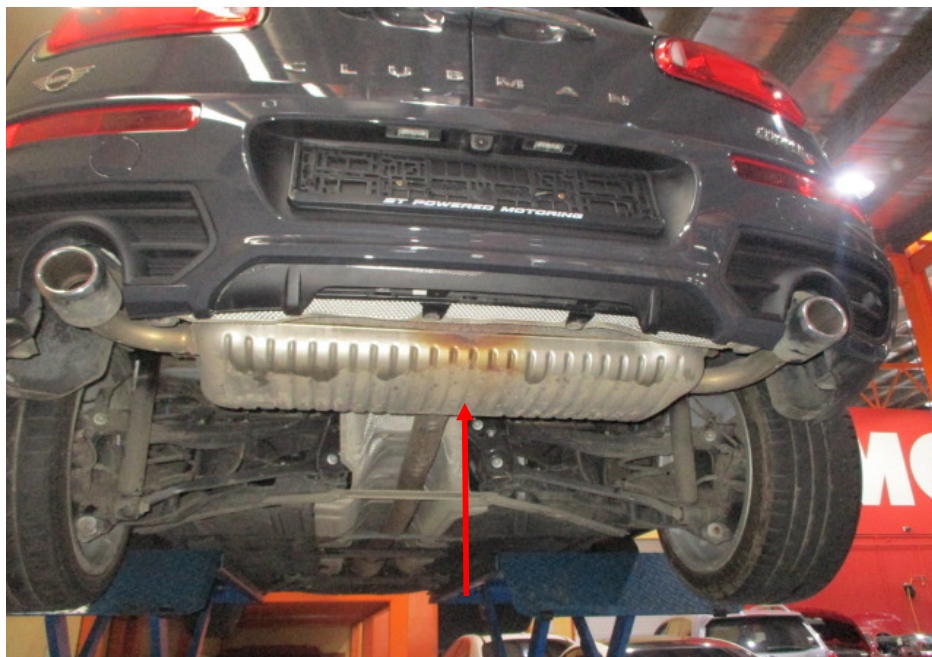
**Photo 19** shows the Motor Car's rear muffler (arrowed). My examination of the Motor Car's exhaust system revealed no sign(s) or indication(s) of any cut or weld marks along its exhaust pipes and on its catalytic converter.

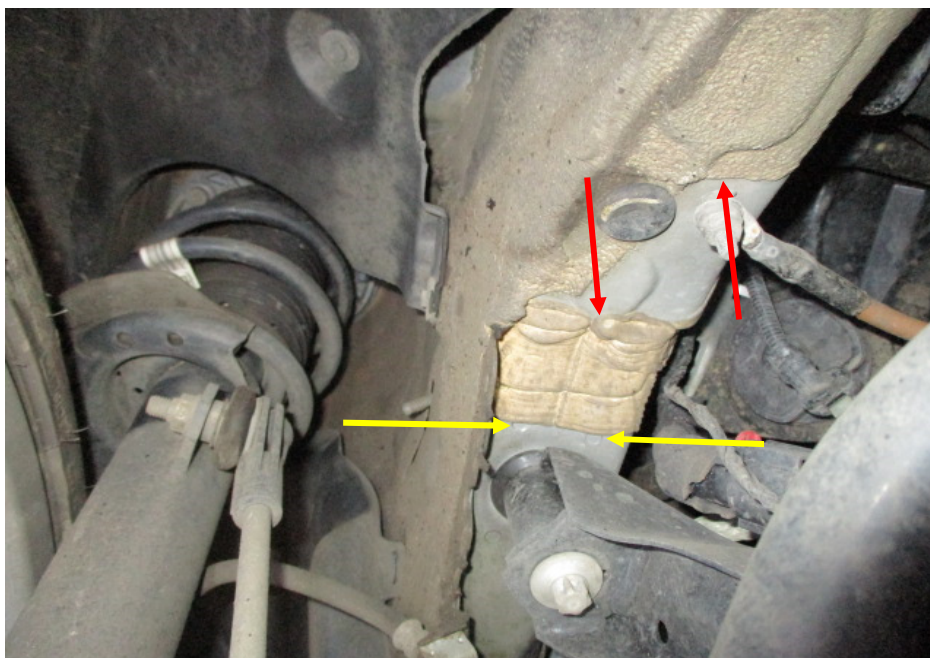
11. Visually, I did not find any weld marks, other than the original spot weld marks, on the chassis/structural body of the Motor Car. The original factory sealant at the joints along the chassis/structural body was also untouched, again indicating that no replacement of the chassis/structural body was carried out; and that the chassis/structural body was originally fitted.

**Photo 20** shows the chassis/structural body at the underside front left of the Motor Car. I did not find any weld marks other than original spot weld marks (yellow arrow) on the chassis/structural body of the Motor Car. The original factory sealant (red arrow) at the joints along the chassis/structural body was untouched, indicating no work was done on the chassis/structural body of the Motor Car and that the chassis/structural body was originally fitted.

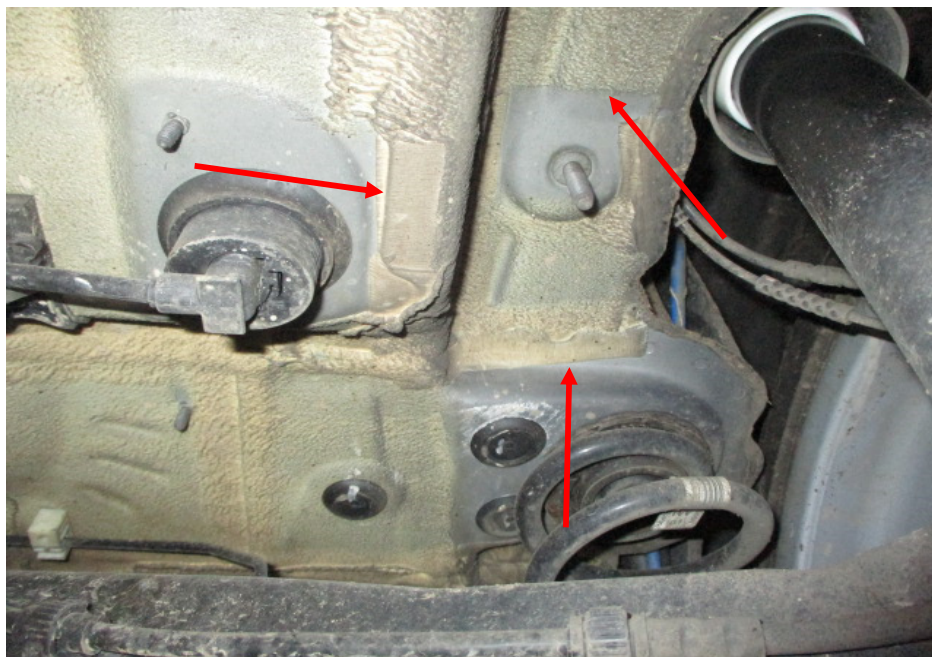
**Photo 21** shows the chassis/structural body at the underside rear right of the Motor Car. The original factory sealant (arrowed) at the joints along the chassis/structural body was observed to be untouched. In general, I had found no work was carried out on the chassis/structural body of the Motor Car. The chassis/structural body of the Motor Car was originally fitted.

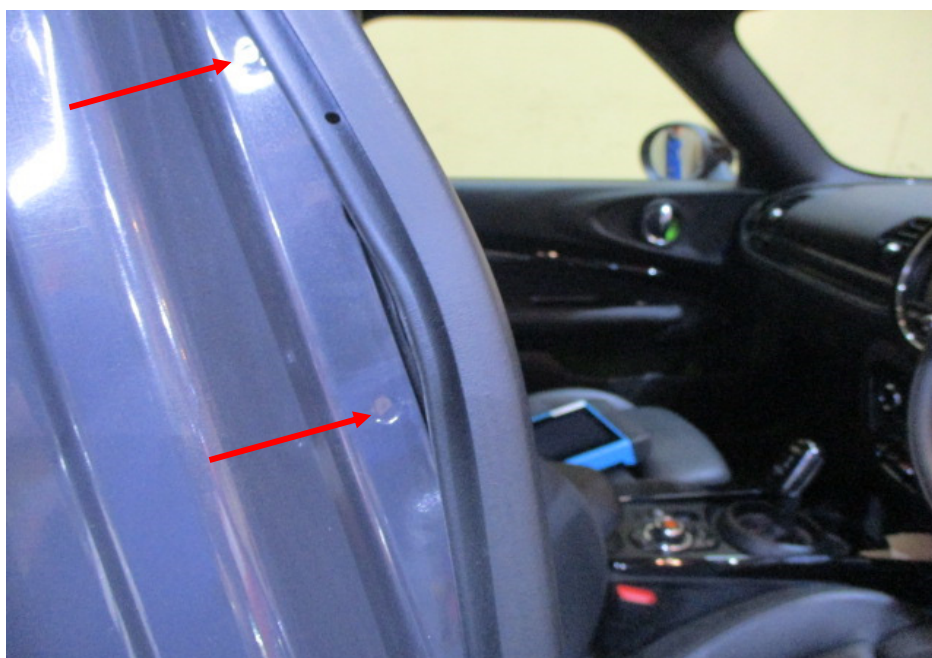
**Photo 22** shows the right side "B" pillar of the Motor Car. I did not find any weld marks other than original spot weld marks (arrowed) on the right side "B" pillar of the Motor Car which, indicates that there was no re-welding works carried out. In general, I had found all the non-detachable body panels of the Motor Car to be originally fitted at the time of my inspection.

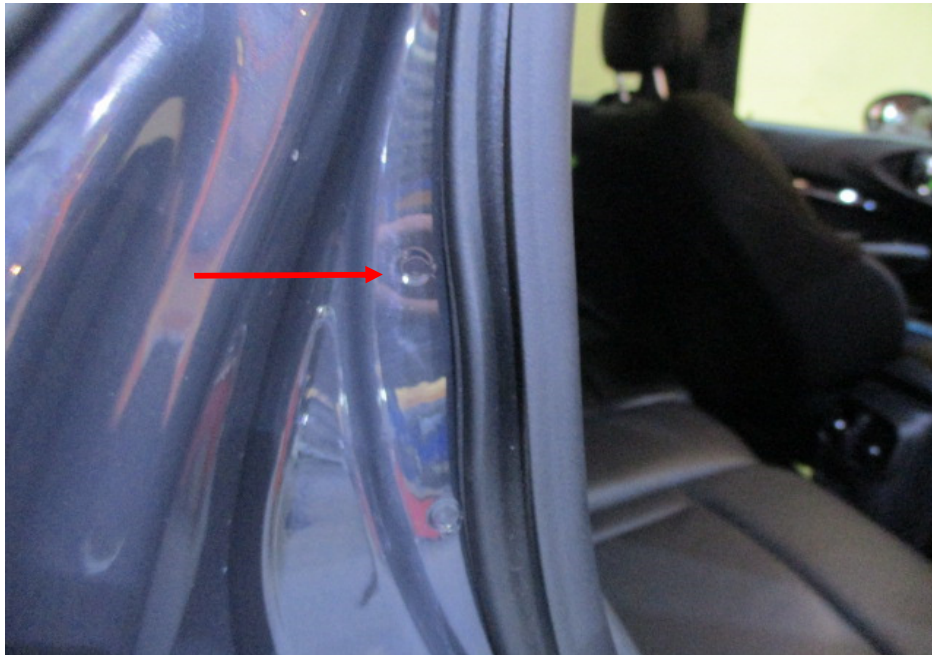
**Photo 23** shows the right side "C" pillar of the Motor Car. I did not find any weld marks other than original spot weld marks (arrowed) on the right side "C" pillar of the Motor Car which, indicates that there was no re-welding works carried out. In general, I had found all the non-detachable body panels of the Motor Car to be originally fitted at the time of my inspection.
