Your Ref: G0071989  
Our Ref : CI/AVI21000611/P

12<sup>th</sup> January 2021

**TECHNICAL INVESTIGATION REPORT OF FIRE INCIDENT INVOLVING THE  
INSURED VEHICLE SKB 88G ON 6<sup>th</sup> January 2021**

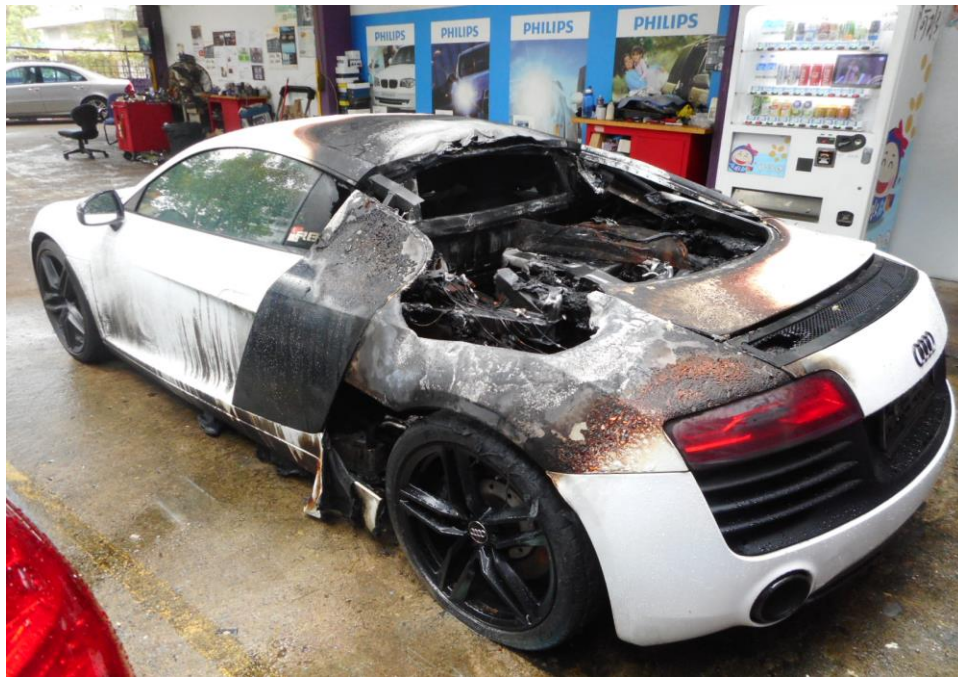
**Photo 1** shows the left and rear portion of the Insured Vehicle, which was observed to be affected by the fire.

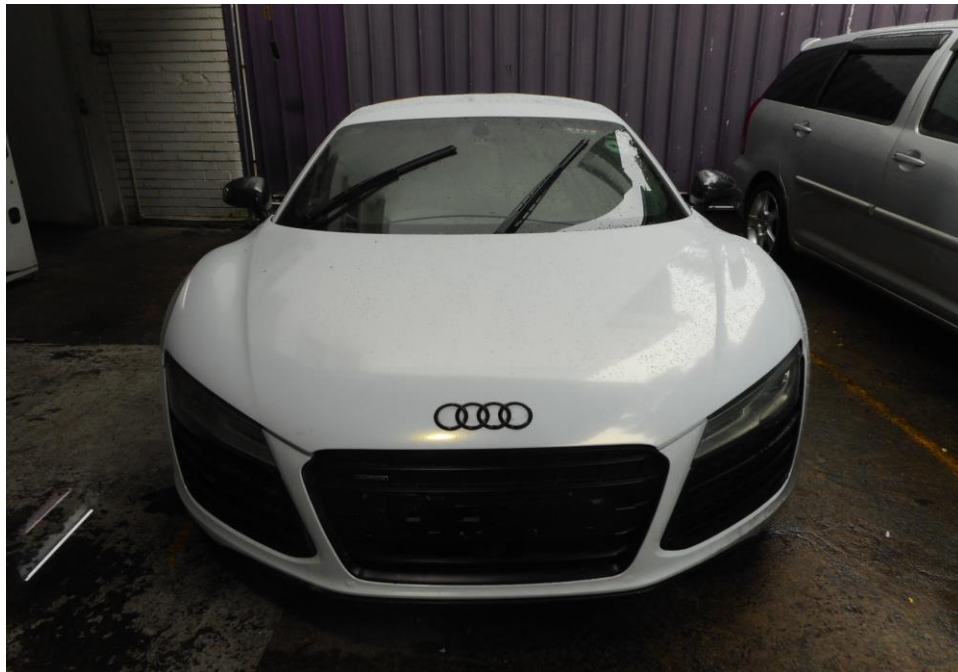
**Photo 2** shows the right body of the Insured Vehicle, which was observed to be unaffected by the fire.

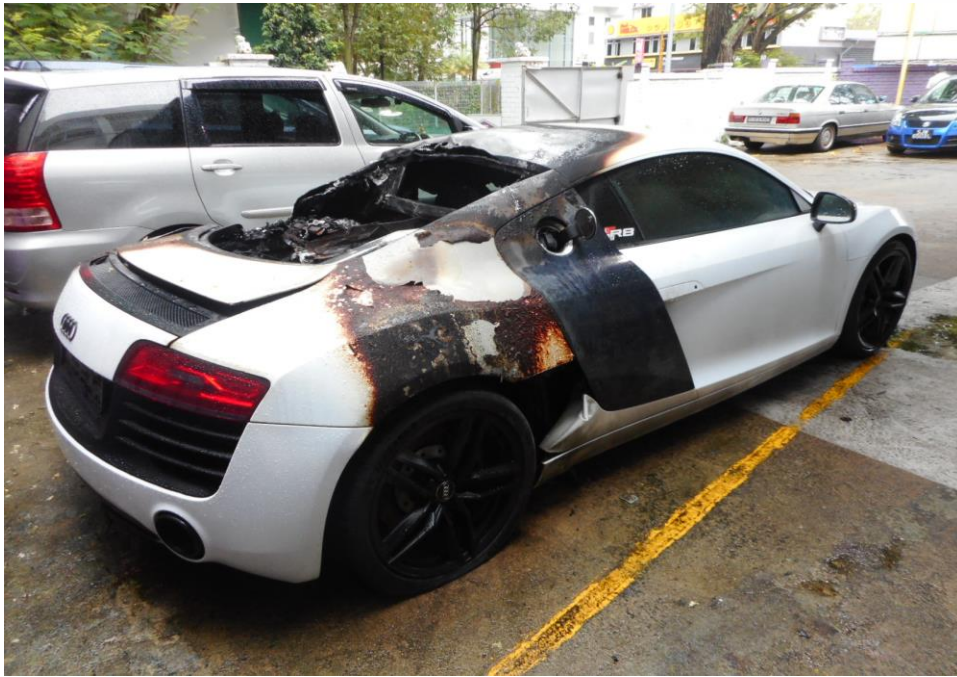
**Photo 3** shows the right body of the Insured Vehicle, which was observed to be affected by the fire.

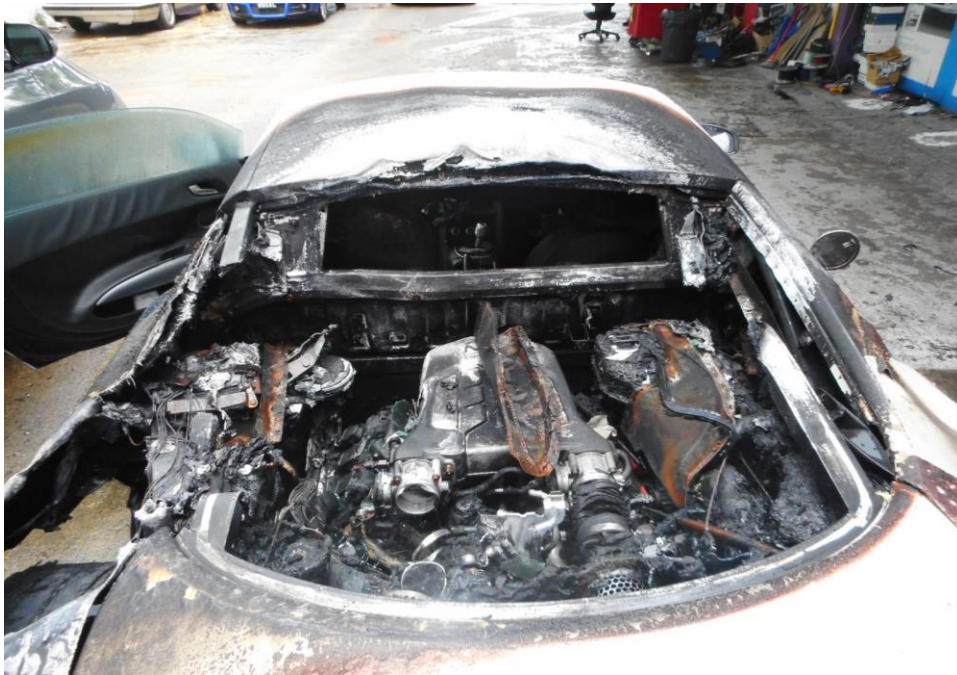
**Photo 4** shows the general view of the engine compartment of the Insured Vehicle at the time of our inspection. The Insured Vehicle was observed to have sustained severe fire damage. Its engine cover and engine compartment was completely burnt. Rust had accumulated around the engine compartment of the Insured Vehicle as a result of exposure to environmental condition for a period of time.

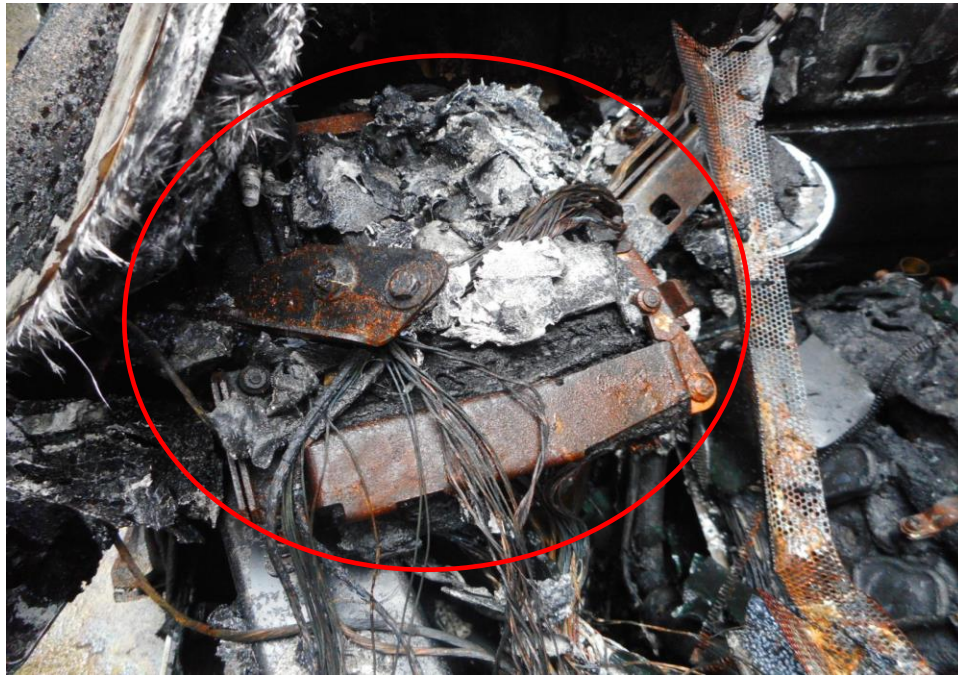
**Photo 5** shows the engine compartment of the Insured Vehicle at the time of our inspection. The engine ecu (circled) was observed to be severely burnt. Most of the parts inside the engine compartment were found to be burnt and/or melted as a result of the fire.

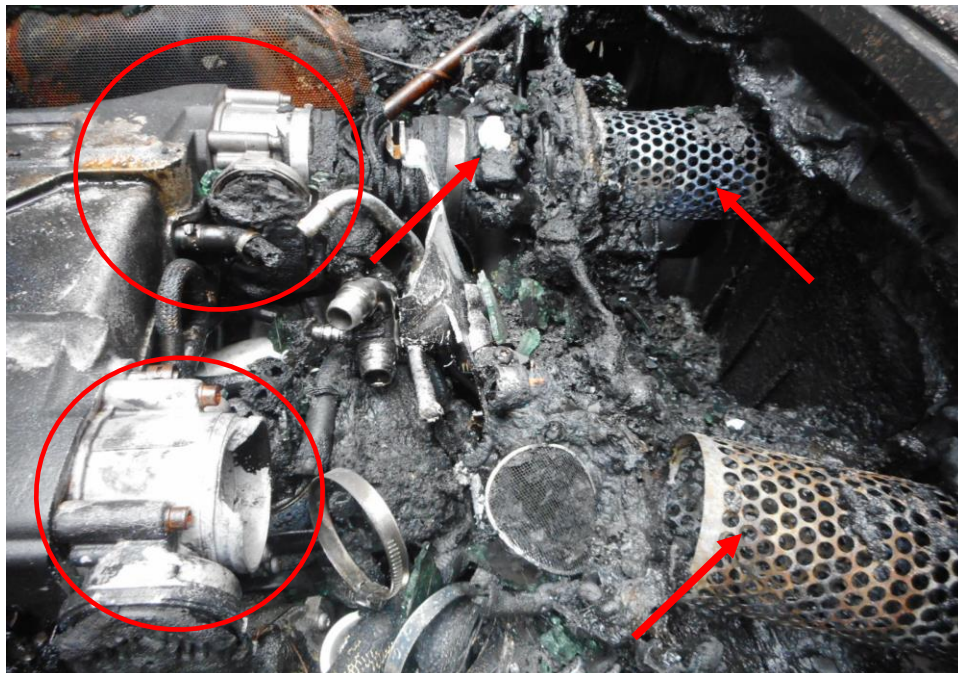
**Photo 6** shows the engine compartment of the Insured Vehicle at the time of our inspection. The throttle body (circled) and various air hoses (arrowed) was observed to be burnt and/or melted as a result of the fire.

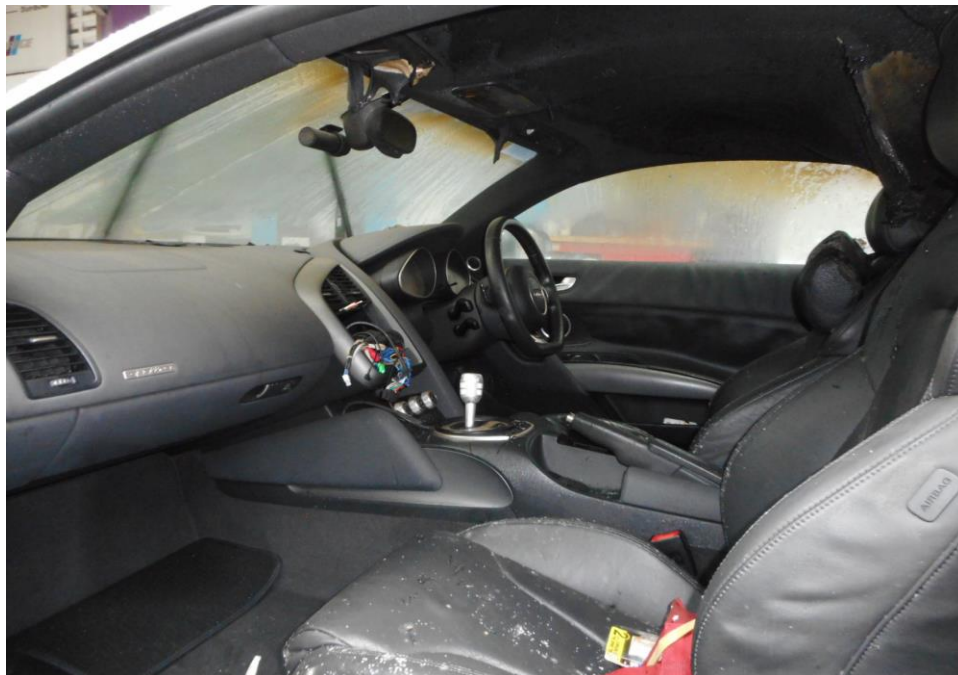
**Photo 7** shows the interior view from the right side of the Insured Vehicle at the time of our inspection. The interior fittings of the Insured Vehicle were observed to suffer smoke and heat damage as a result of the fire.

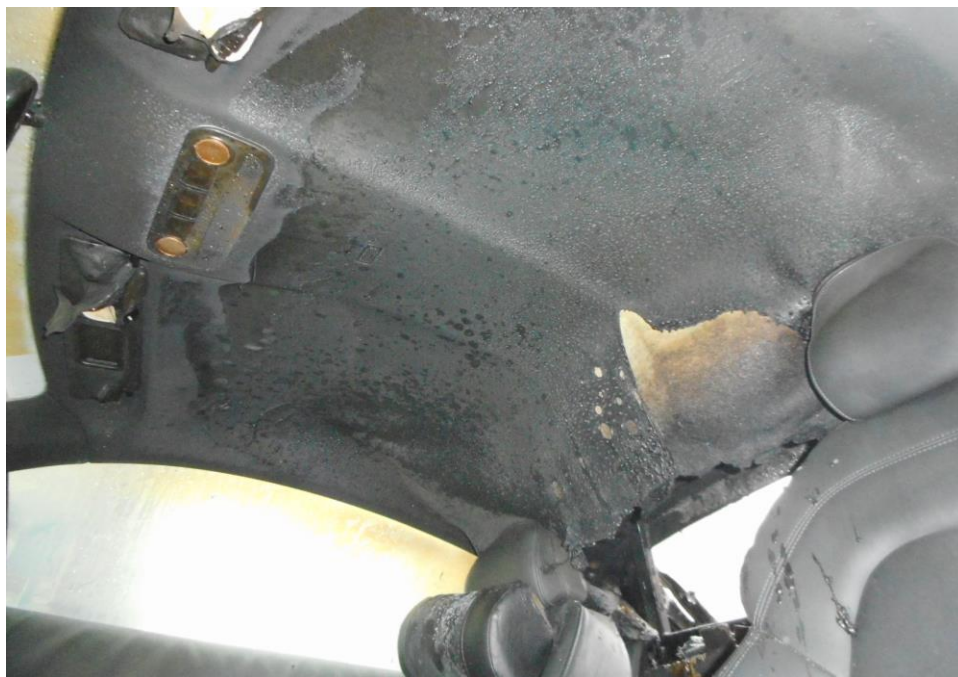
**Photo 8** shows the close up interior view from the left side of the Insured Vehicle at the time of our inspection. The rear sight glass, rear seat compartment fittings and the seats material of the Insured Vehicle were observed to suffer smoke and heat damage as a result of the fire.

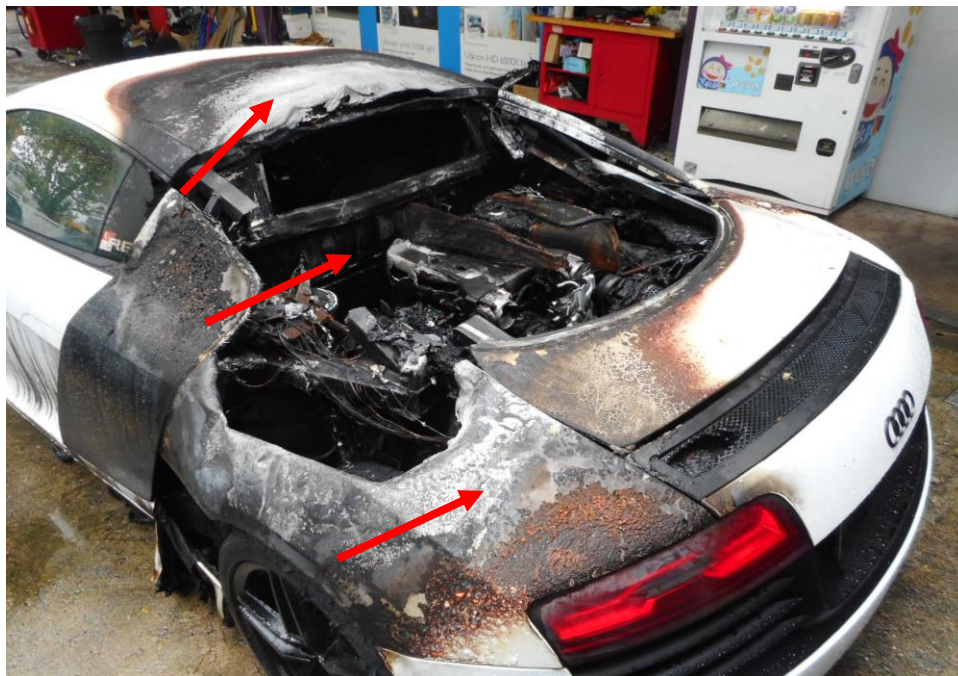
18. For this particular case, the fire appears to have originated from the middle portion of the engine compartment of the Insured Vehicle. This can be determined from the burn pattern of the various components in the engine compartment, which were observed to have been partly melted and burn from the high heat intensity and the high heat intensity burn marks (whitish burn marks) found on the metal parts around the Insured Vehicle. Rust had also developed on these metal parts.

19. The whitish burn marks are a result of exposure to prolonged heat intensity. Rust would normally start to develop around these areas soon after a fire as prolonged exposure to high heat intensity usually causes steel/metal material body parts to be exposed to natural environmental condition. The rust that had developed on the metal body is an indication that roof portion of the Insured Vehicle had sustained exposure to prolonged high heat intensity. See photos 9 & 10 below.

**Photo 10** shows the roof and the surrounding of the middle portion (arrowed) of the Insured Vehicle at the time of our inspection. The high heat intensity burn marks (whitish burn marks) and rust that had development found on the exterior surface of the roof metal body and the surrounding area indicates that the fire had originated from the engine compartment of the Insured Vehicle.

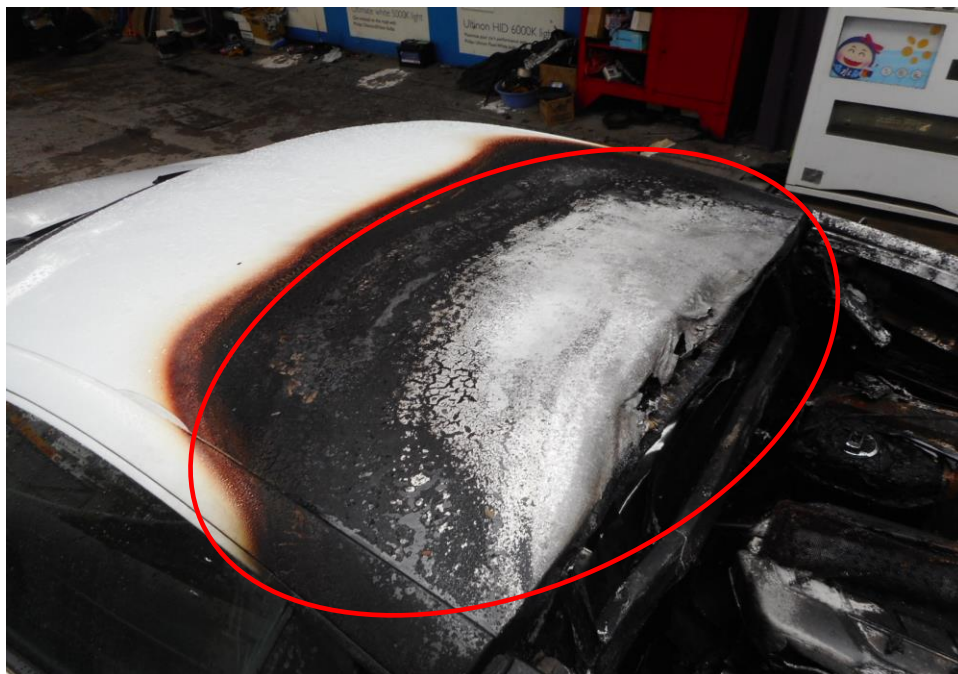
**Photo 11** shows the roof and the surrounding of the middle portion (circled) of the Insured Vehicle at the time of our inspection. The high heat intensity burn marks (whitish burn marks) and rust that had development found on the exterior surface of the roof metal body and the surrounding area indicates that the fire had originated from the engine compartment of the Insured Vehicle.

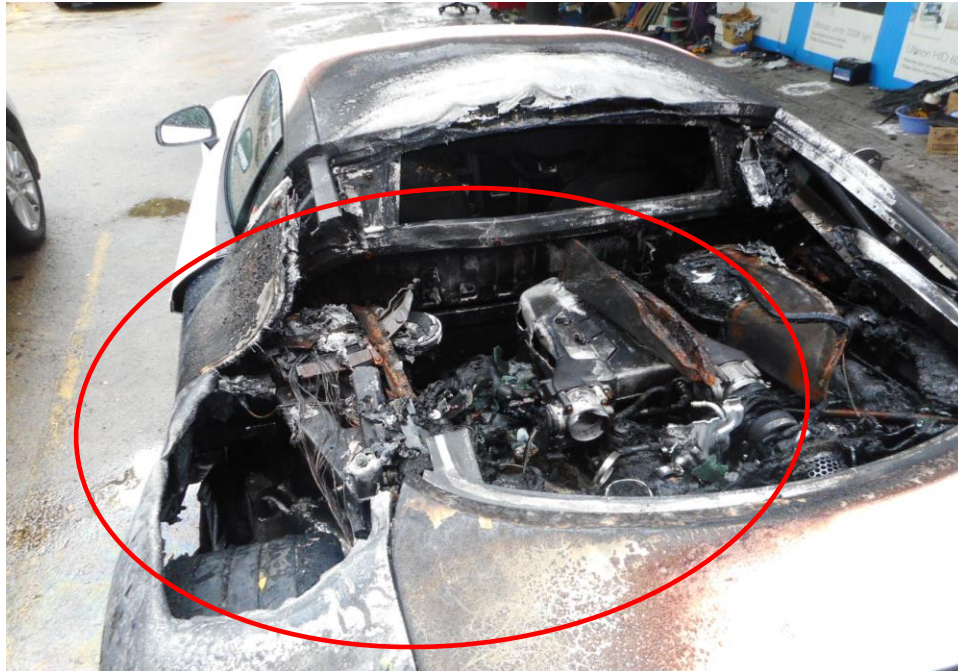
20. Upon closer examination of the engine compartment of the Insured Vehicle which was where the fire had started, we observed that the burn damage was more severe to the rear left side of the engine compartment, we had found high heat intensity burn marks (whitish burn marks), rust development and the fire had burn a hole through the rear left body panel of the Insured Vehicle. Components along this area are part of the fuel systems.

**Photo 12** shows the general view of the rear left engine compartment portion of the Insured Vehicle where the fire had likely started. The engine cover and the surrounding area had whitish burn marks due to high heat intensity burn on the Insured vehicle (circled)

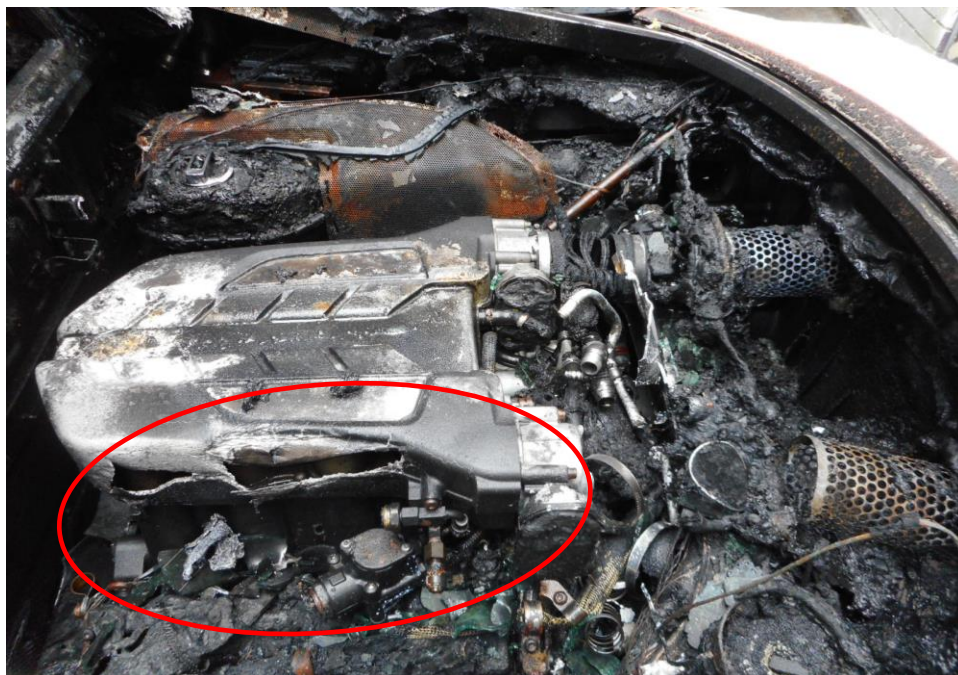
**Photo 13** shows the close up view of the rear left engine compartment portion of the Insured Vehicle where the fire had likely started. The engine cover and the surrounding area had whitish burn marks due to high heat intensity burn on the Insured vehicle (circled)

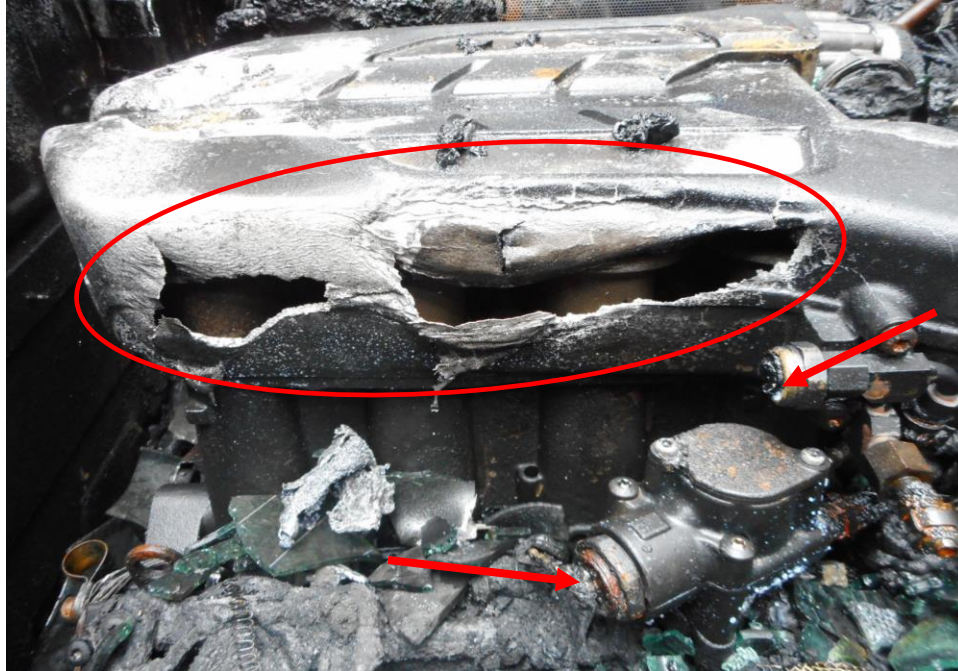
21. The left throttle body, high pressure fuel pump and broken fuel hoses were found around the area. This items were originally fitted from manufacturer all there is fuel running through this components as it is all part of the fuel system.

22. During the inspection we noticed strong fuel smell emitting from the Insured Vehicle would suggest that there was fuel leakage and noticed broken fuel hoses and the spilled fuel from the fuel hoses had come into contact with hot surface of the running engine compartments, which had caused the fire to be started and the fire spread around the engine compartment of the Insured Vehicle. This physical evidence would then appear to suggest that the cause of fire to the Insured Vehicle could have possibly been due to fluid contact onto hot surfaces. See photos 12 - 15 below.

**Photo 14** shows the close up view of the left rear engine compartment area where the fire had likely started and spread around the engine compartment. Observed was a broken fuel hose (red arrow) from the high pressure fuel pump which had likely caused a fuel leakage onto and around the hot surface of the running engine components which was likely the cause of fire. The fire's high heat intensity burn from this area had also resulted in whitish burn marks and cracks to the engine cover) (red circle) of the Insured Vehicle.

27. Since engine overheating and electrical in nature were both unlikely the cause of fire, the most probable cause would then be the leakage of fluid, which was also what we had observed between the broken fuel hose and the running hot surface of the engine components that may cause a fire to be ignited on Insured Vehicle. The leaked fluid comes into contact with hot surfaces; such the heated engine components would possibly have been at a sufficient temperature that could result in leaked fluid to self-ignite and started burning of materials in the engine compartments of the Insured Vehicle which had caused the fire at the engine of the Insured Vehicle.

29. Having investigated and technically analysed the damages of burnt nature to the Insured Vehicle, we are of the view that the cause of fire to the Insured Vehicle was of leakage of fluid which contacted on to hot surface that caused the self-ignition of fire. For this particular case, the fire had originated from the engine compartment area between the broken fuel hoses and the engine components, somewhere around the engine's rear left portion of the Insured Vehicle.

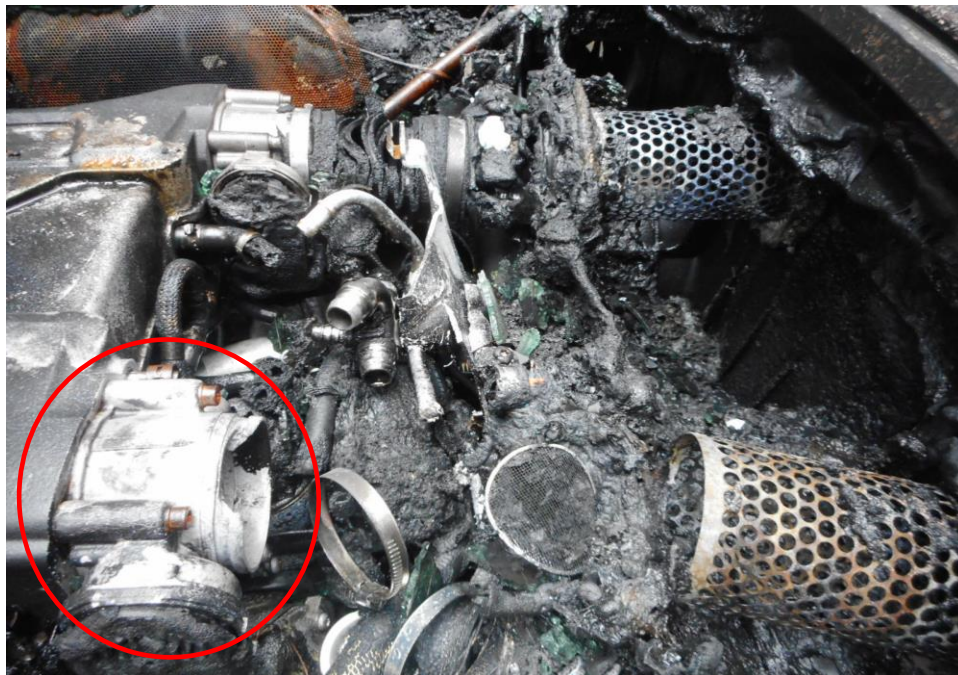
**Photo 15** shows the close up view of the engine compartment portion of the Insured Vehicle where the fire had likely started. The throttle body and the surrounding areas was observed to have sustained whitish burn marks due to high heat intensity burn (circled) this was caused by the fuel leakage from the fuel hoses that come into contact with the hot running engine surfaces that had ignited the fire and was spread around the surrounding areas.

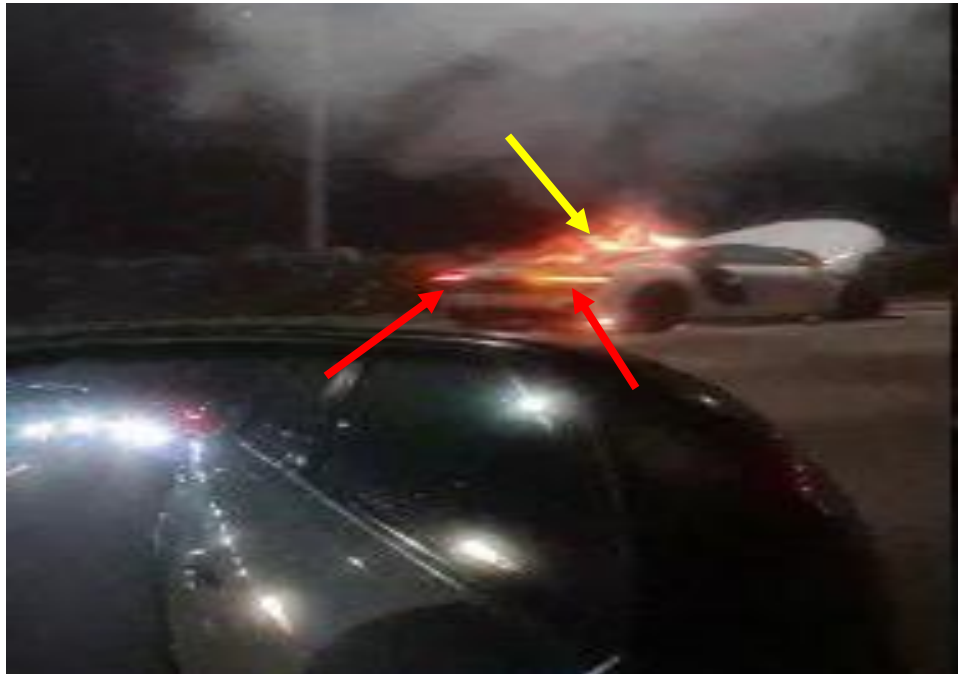
23. During the course of our investigations, we were able to obtain coloured photographs showing the Insured Vehicle and the scene photos of the fire incident at the incident location. These were provided to us by Mr Gan.
24. Our examination of these photographs revealed that the fire had started from the the engine compartment located in the middle of the Insured Vehicle. The photographs had also showed the Insured Vehicle on fire and similar extent of damage and burn pattern to the Insured Vehicle as per what we had observed during our physical inspection of the Insured Vehicle. Apart from the aforesaid, there was no further notable information that could be gathered from these photographs. See photos 16 below which were provided to us by Mr Gan.

**Photo 16** From the photograph, it shows the smoke and flames engulfing the middle engine compartment of the Insured Vehicle (yellow arrow) and the lighting system of the Insured Vehicle was still functioning during the fire (red arrow).

26. Fire due to an electrical short circuit to the Insured Vehicle was unlikely as no greenish residue were observed on the burnt wirings, except for a few stretch of wiring harness that was slightly melted due to the heat from the burning area of the engine compartment portion of the Insured Vehicle. Furthermore, several lighting system were still functioning during the fire.
