## Estimated Labour Charges for Accident Vehicle. SLA 1587 U

### Material List for Accident Vehicle Regn No. SLA 1587 U

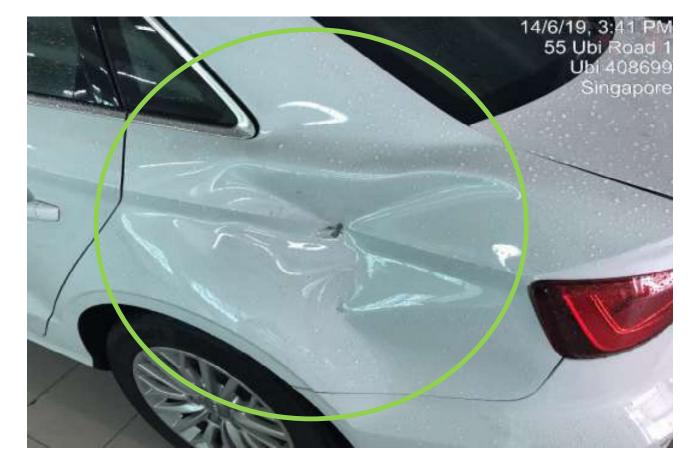
Photo 7 LHR FENDER BENT

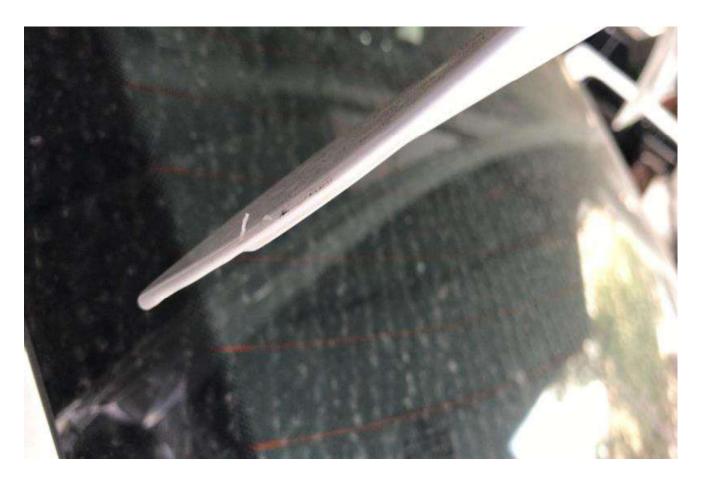
Photo 15 REAR BOOTLID PANEL CUT/SCRATCHED - REPAIR

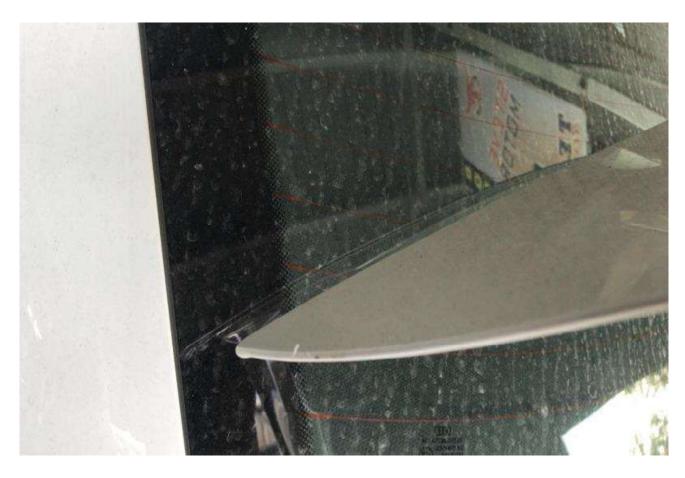
Photo 16 REAR BOOTLID PANEL CUT/SCRATCHED - REPAIR
