LKK Auto Consultants Pte Ltd

Ref: CC4/LPC21000650/Kpa3q2

ADJUSTMENT ON REPAIR COST FOR VEHICLE NO. SMU 1265G

PHOTOGRAPHS FOR VEHICLE NO. SMU 1265G

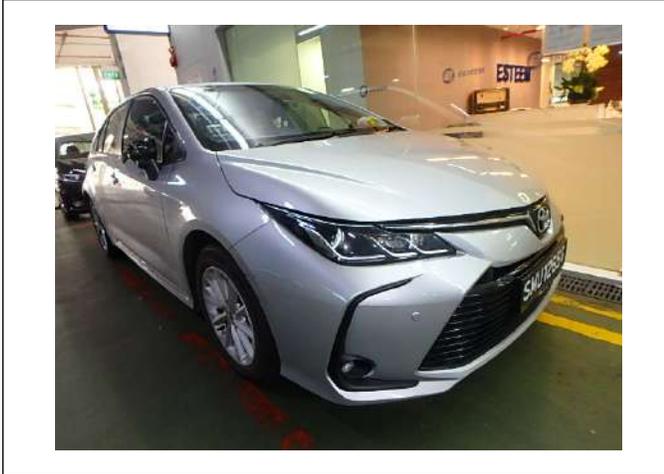
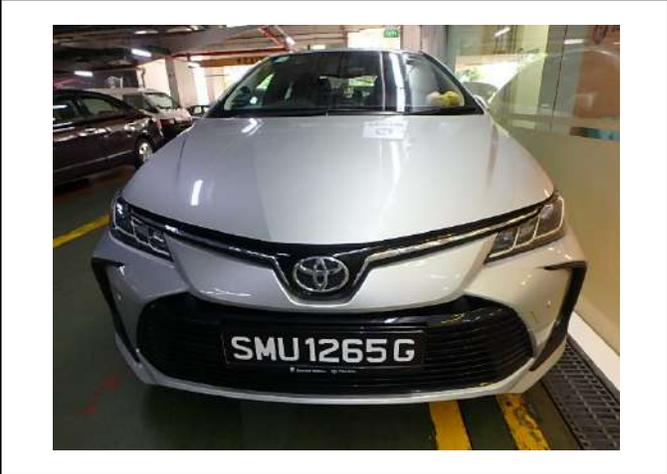
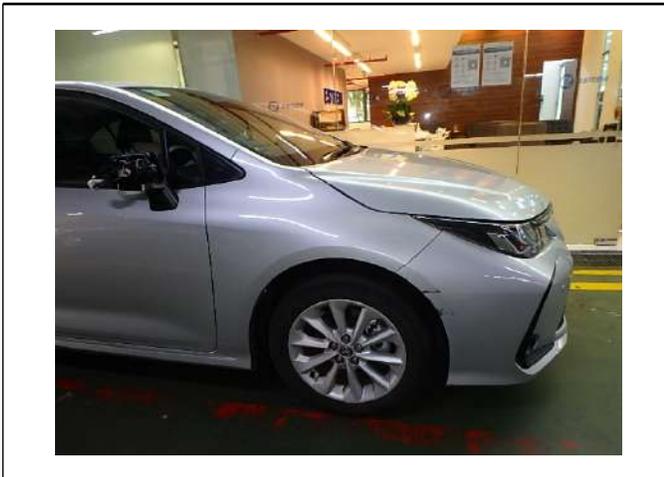
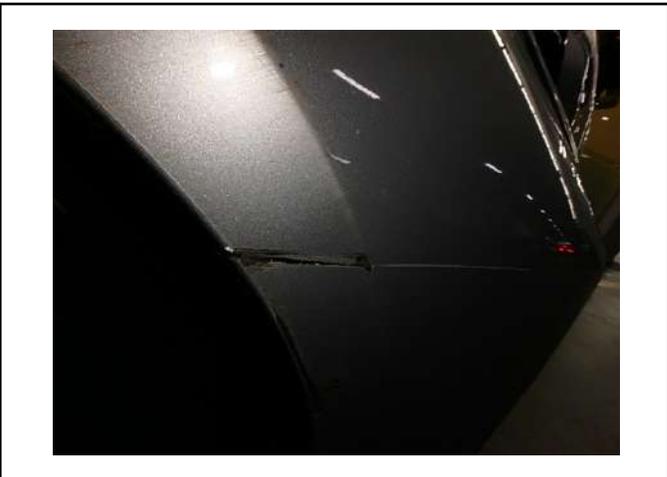
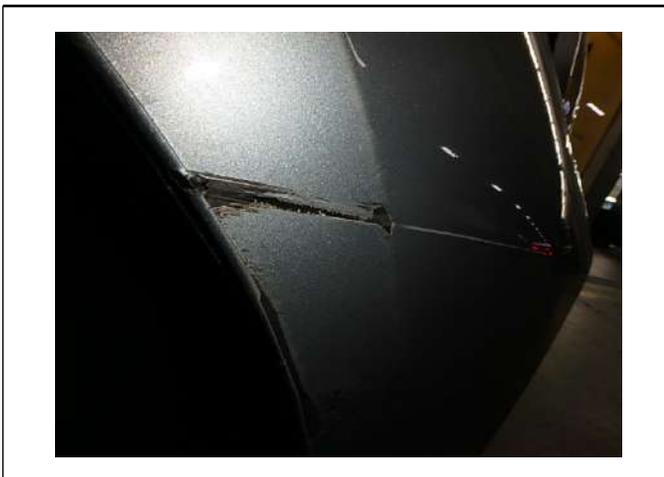
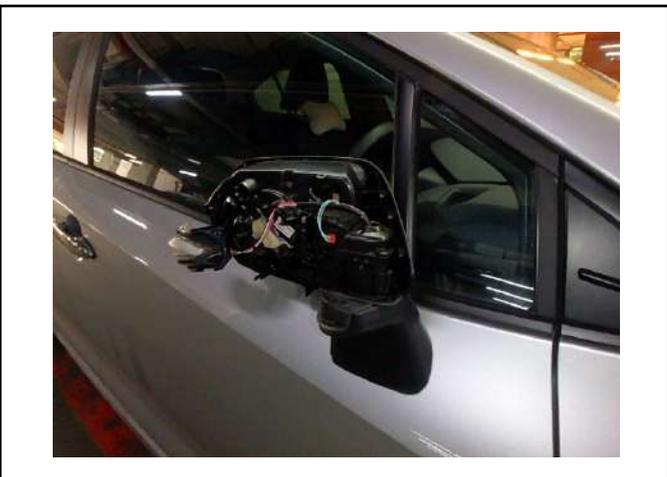
INSPECTION

THE VEHICLE SUSTAINED DAMAGES AT THE O/S FRONT PORTION.
DAMAGES SEE DETAILS.
