Vehicle No. GBJ 1972L  
Insured Veh. YN 7527G  
Claim No. 20/21/21/VC05/024135  
Policy No. Z20VC05006070  
Accident Date 12/01/2021  
Inspection Date 15/01/2021

## ADJUSTMENT ON REPAIR COST FOR VEHICLE NO. GBJ 1972L

### PHOTOGRAPHS FOR VEHICLE NO. GBJ 1972L

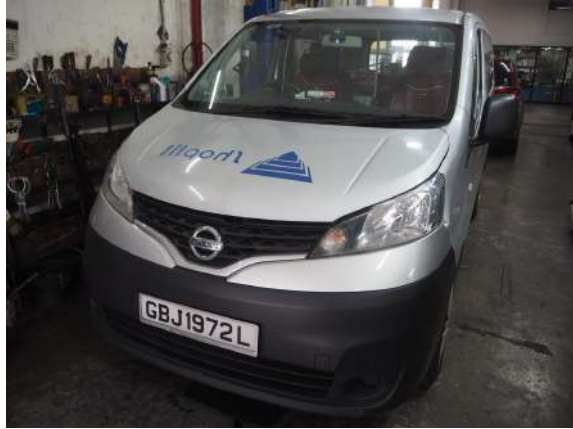
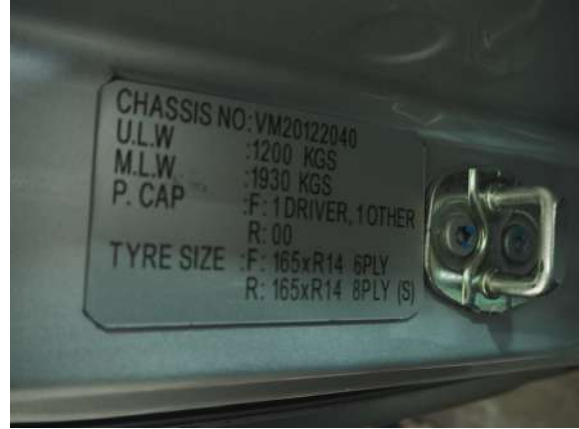
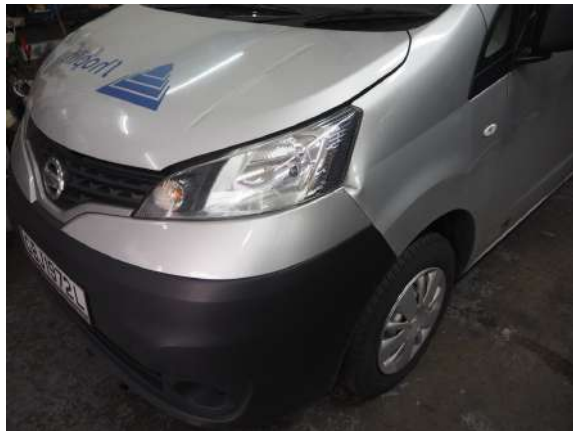
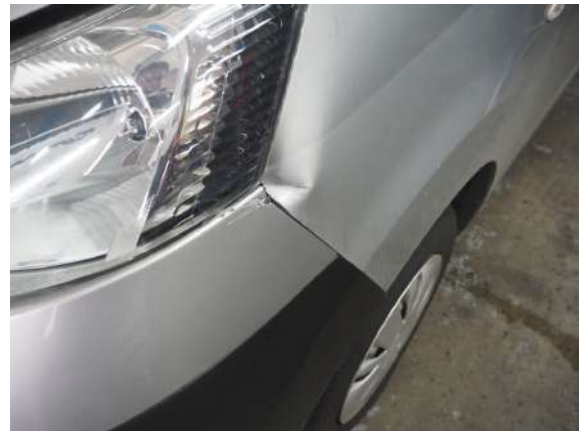
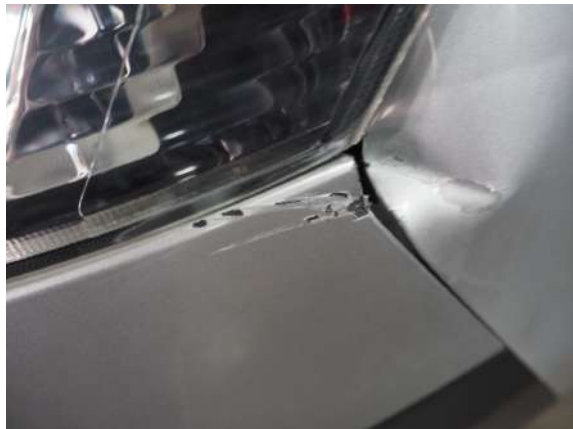
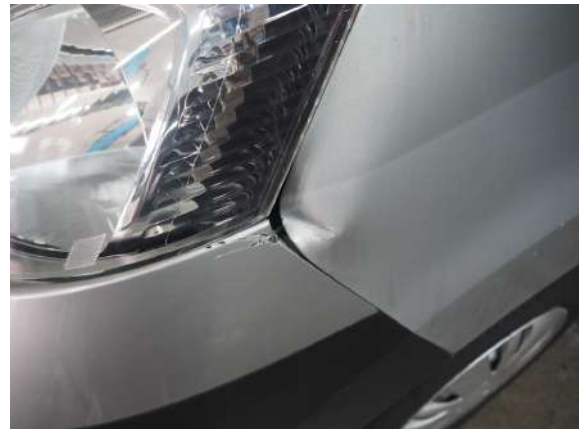
### INSPECTION

| Affiliated to Federation Internationale Des Experts En Automobile | | | | |
|---|---|---|---|--|
| THE VEHICLE SUSTAINED DAMAGES AT THE FRONT N/S PORTION.<br>DAMAGES SEE DETAILS. | | | | |

| Qty | Description of Parts | Condition | Estimate By Workshop (\$) | Our Adjusted (\$) |
|---|---|---|---|---|
| 1 | FRONT HEADLAMP L/H (N) | CUT | 477.60 | 477.60 |
| 1 | FRONT HEADLAMP LOWER GARNISH (N) | DEFORMED | 352.35 | 352.35 |
| 1 | FRONT BUMPER (N) | CUT | 573.60 | 573.60 |
| 1 | FRONT FENDER L/H (N) | DENTED | 540.10 | 540.10 |

| Qty | Description of Parts | Condition | Estimate By Workshop (\$) | Our Adjusted (\$) |
|---|---|---|---|---|
| | <b>RECOMMENDED COST OF LUMP SUM REPAIRS<br/>(TO ITS PRE-ACCIDENT CONDITION)</b> | | | <b>1,900.00</b> |
