VEHICLE INSPECTION REPORT

PARTICULARS OF DAMAGED VEHICLE

Registration Number	: SMR1608S	Odometer Reading	: 86520 Km
Make/Model	: Mercedes Benz B180	Radio/Cassette/CD	: Fitted
Year of Manuf/Reg	: 2019	Air Conditioner	: Fitted
Engine Number	: Hidden from view	View Mirrors	: Fitted-o/s & n/s
Chassis Frame Number	: WDD2462462422J261505	Seat Belts	: Fitted-front & rear only
Class/Type	: Passenger [SUV]	Other Accessories	: Fitted
Colour	: White	(Specify)	: Fitted

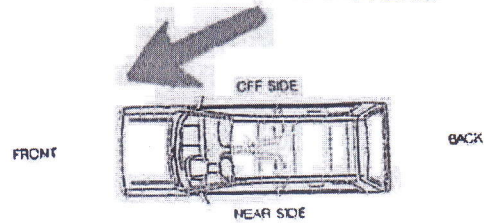
Damages sustained were consistent with the subject vehicle being involved in a collision with another vehicle and the impact was delivered onto the o/s front of vehicle. Apparently, the o/s front wheel was struck upon, thus misaligning its wheel camber/geometry.

Damages sustained were the front bumper assembly, o/s front fender & its inner panel dented/buckled/headlamp panel o/s thrust inwards / buckled etc.
