Your Ref: BMW M5  
(chassis number WBSJF02090GA03157)  
Our Ref : CI/TP21001019/D

21 January 2021

**INSPECTION REPORT OF AN UNREGISTERD BMW M5 MOTOR CAR WITH  
CHASSIS NUMBER WBSJF02090GA03157**

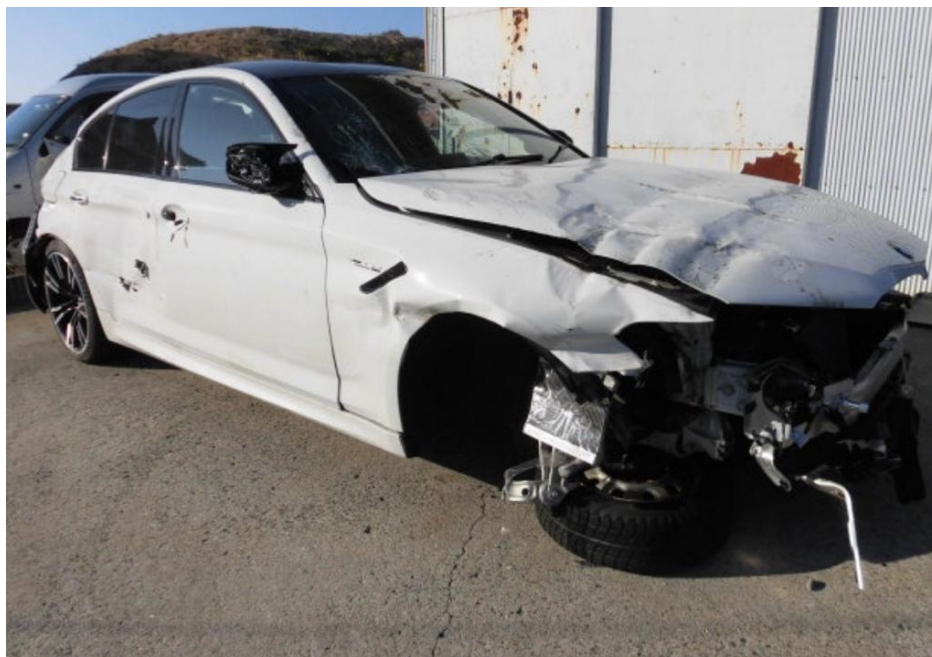
**Photo 1** shows the front right body of the Motor Car prior to any repairs being carried out (photograph provided to me). The Motor Car was observed to have sustained damages at its frontal portion and along its right side portion. The front right wheel rim was observed to be dislodged, which would suggest that the front right undercarriage parts of the Motor Car were also damaged.

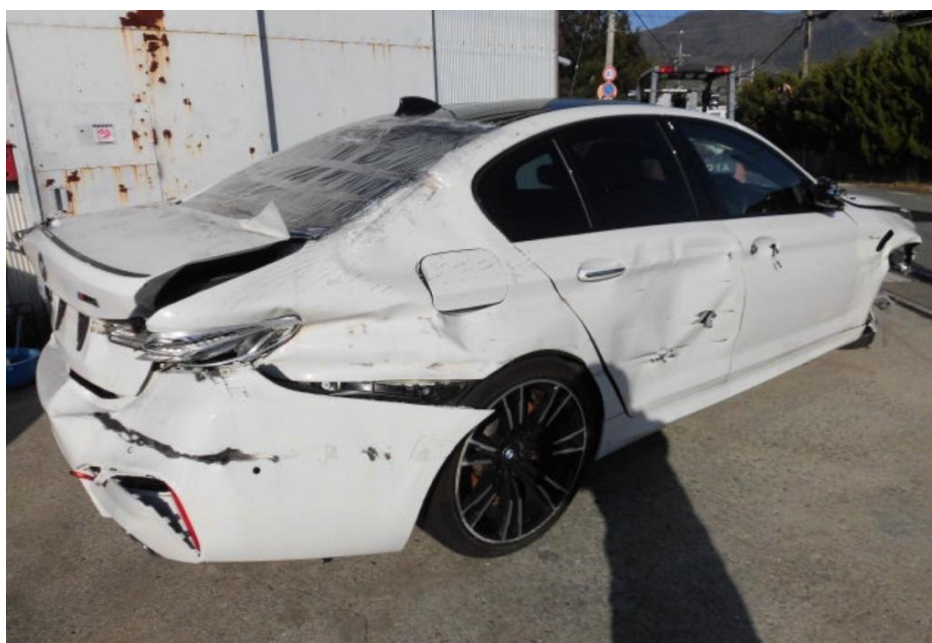
**Photo 2** shows the rear right body of the Motor Car prior to any repairs being carried out (photograph provided to me). Apart for the frontal portion, the Motor Car had also sustained damage at its rear portion and along its right side portion. The rear windscreen of the Motor Car was also observed to be shattered. Body parts damaged include the rear bumper, rear bootlid, rear right fender and rear right door amongst others.

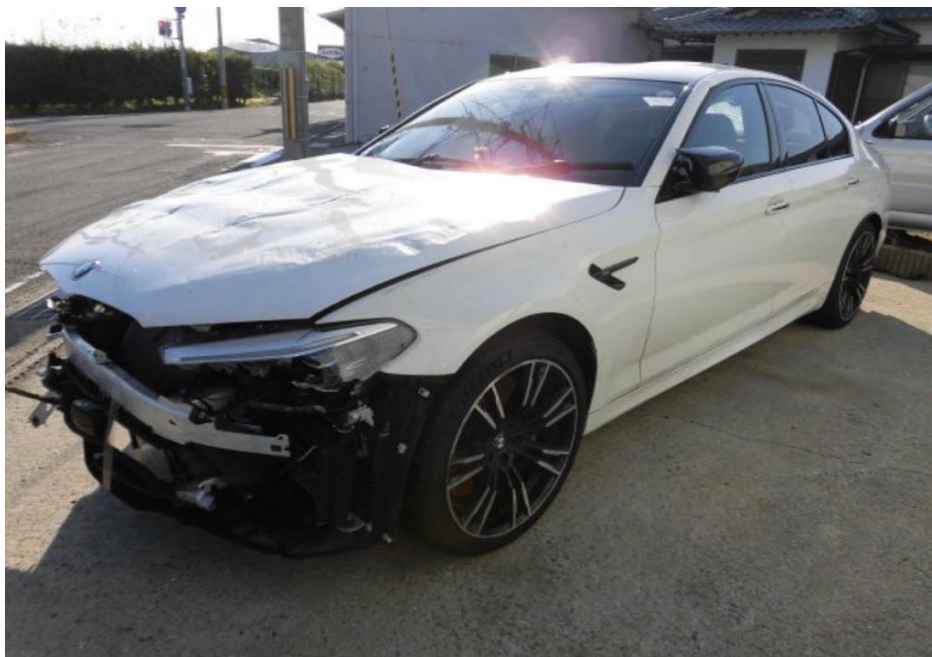
**Photo 3** shows the front left body of the Motor Car prior to any repairs being carried out (photograph provided to me). The front bumper and all its related parts and attachments, front bonnet, front left headlamp, front bumper reinforcement and front grilles were amongst the body parts that were observed to have been damaged at the Motor Car's frontal portion. The left side portion of the Motor Car was unaffected as seen from the photographs that were provided to me.

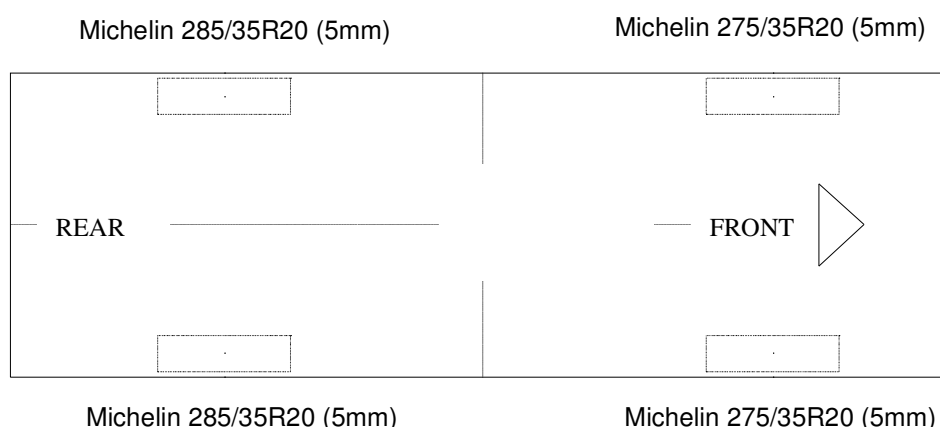
8. It was fitted with 20inch sport wheel rims that were wrapped with tyres that were observed to be of serviceable condition. The tyres were also sufficiently inflated for vehicular operation. The tyre brand, tyre size and approximate remaining tread depth of the 4 tyres of the Motor Car were recorded as follows: -

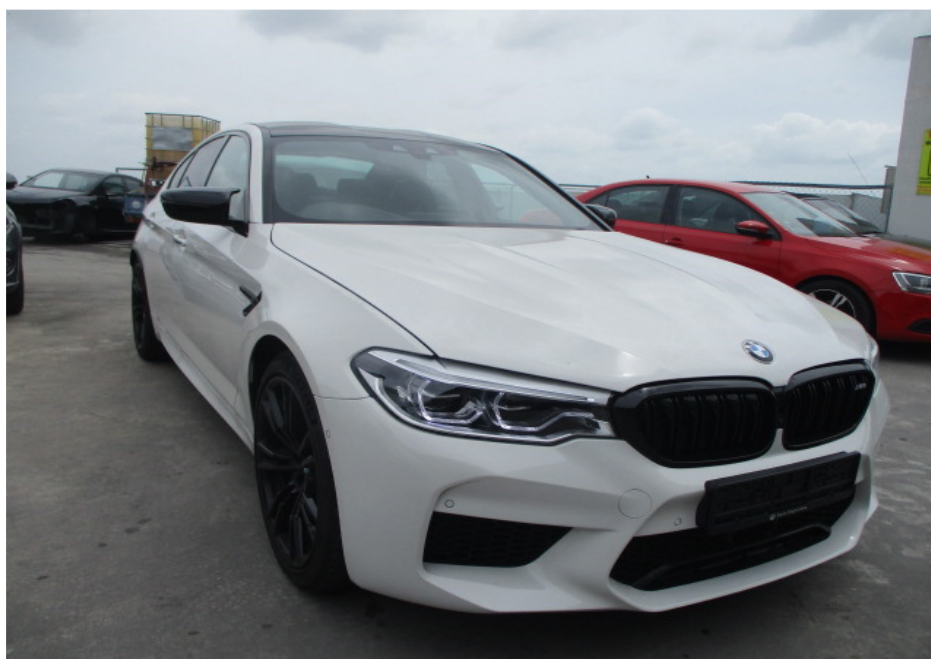
**Photo 4** shows a general view of the front right body of the Motor Car at the time of my inspection. The Motor Car was observed to be in a relatively good general condition with no loose exterior fittings observed. The body parts at the frontal portion of the Motor Car like the front bumper, front grilles, front headlamps and front bonnet, were visually examined and it was observed that the repair/restoration works carried out to the damaged area of the Motor Car (refer to photograph 1 – 3 above) were reasonably adequate and in order.

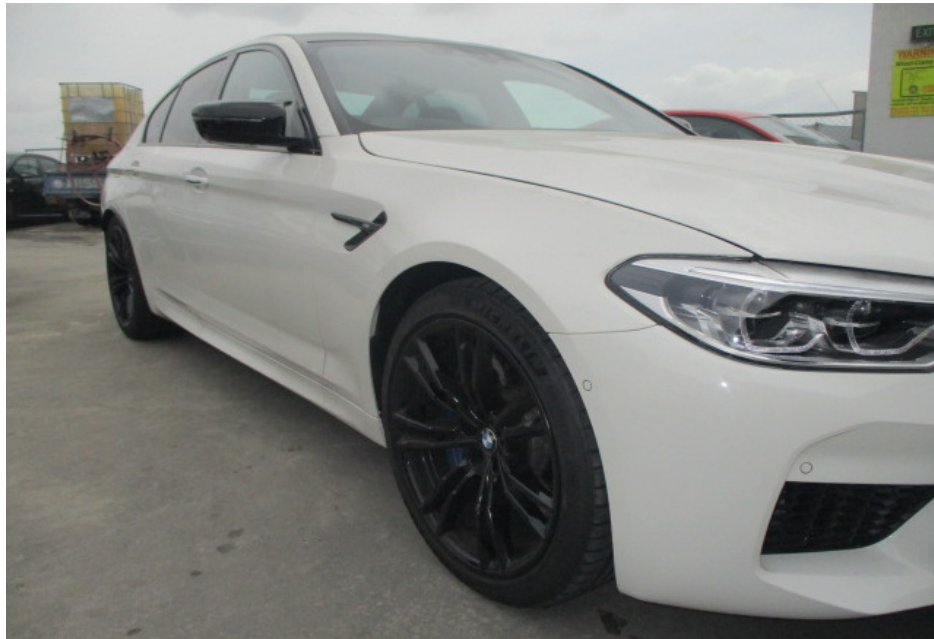
**Photo 5** shows a closer view of the front bumper, front bonnet, front right headlamp, front right fender, front right wheel, front right door and right side wing mirror of the Motor Car at the time of my inspection. The body parts at the frontal portion and right side portion of the Motor Car were visually examined and it was observed that the repair/restoration works carried out to the damaged area of the Motor Car (refer to photograph 1 – 3 above) were reasonably adequate and in order.

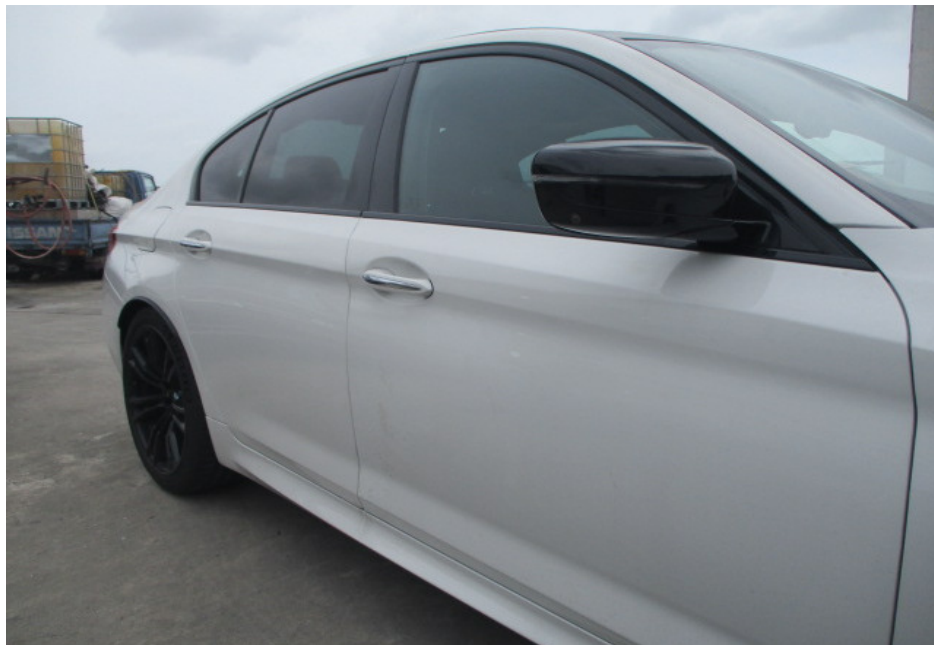
**Photo 6** shows a closer view of the front right door, rear right door and right side wing mirror of the Motor Car. The body parts along the right side portion of the Motor Car were visually examined and it was observed that the repair/restoration works carried out to the damaged area of the Motor Car (refer to photograph 1 – 3 above) were reasonably adequate and in order.

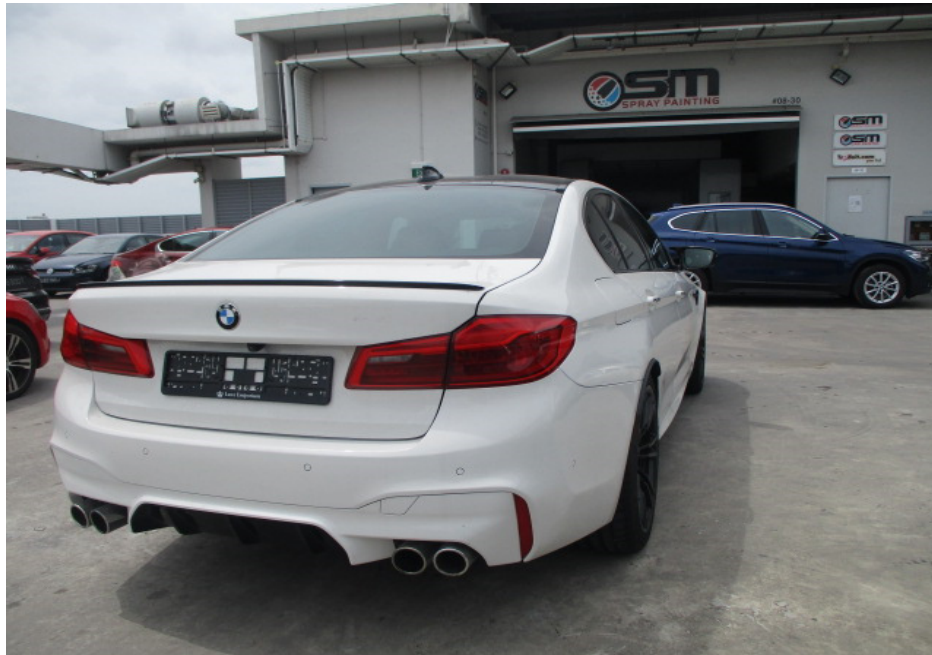
**Photo 7** shows a general view of the rear right body of the Motor Car at the time of my inspection. The Motor Car was observed to be in a relatively good general condition with no loose exterior fittings observed. The body parts at the rear portion of the Motor Car, like the rear bumper, rear bootlid, rear taillamps and rear bootlid lamps, were visually examined and it was observed that the repair/restoration works carried out to the damaged area of the Motor Car (refer to photograph 1 – 3 above) were reasonably adequate and in order.

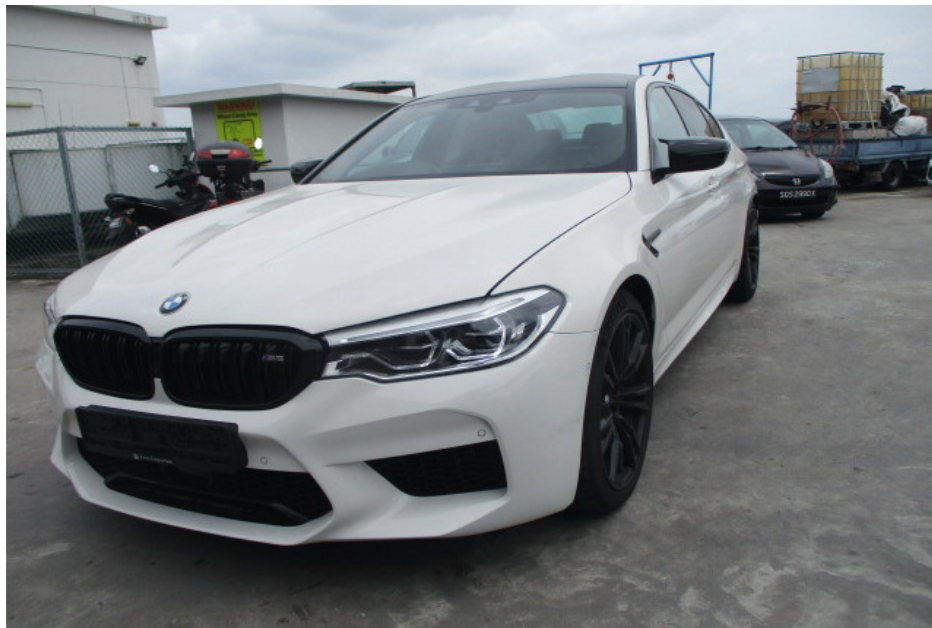
**Photo 8** shows a general view of the front left body of the Motor Car at the time of my inspection. The Motor Car was observed to be in a relatively good general condition with no loose exterior fittings observed. The mileage of the Motor Car recorded at the time of my inspection was 5,215km.

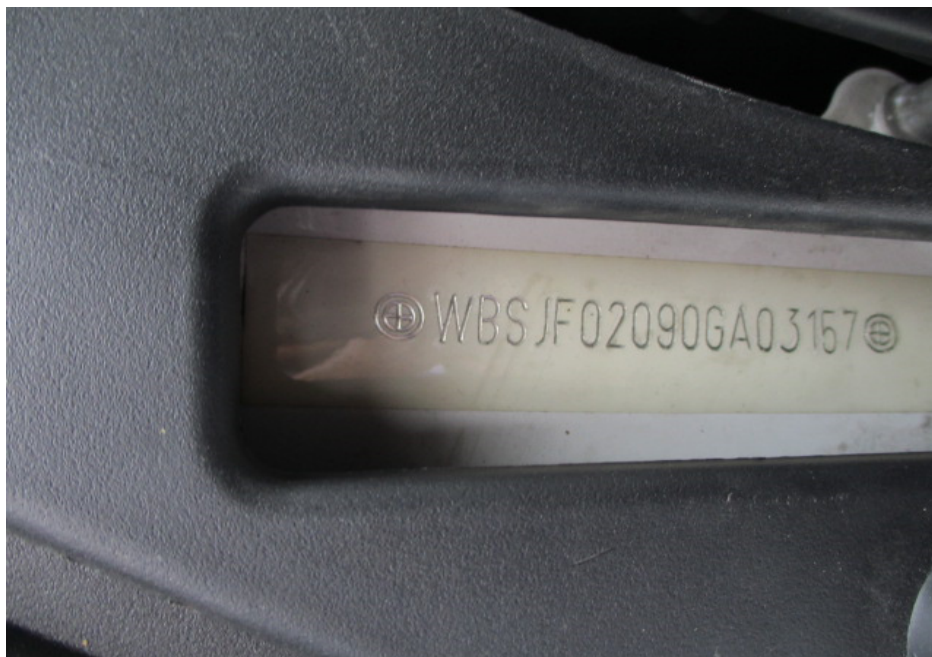
**Photo 9** shows the chassis number of the Motor Car. The chassis number recorded was WBSJF02090GA03157.

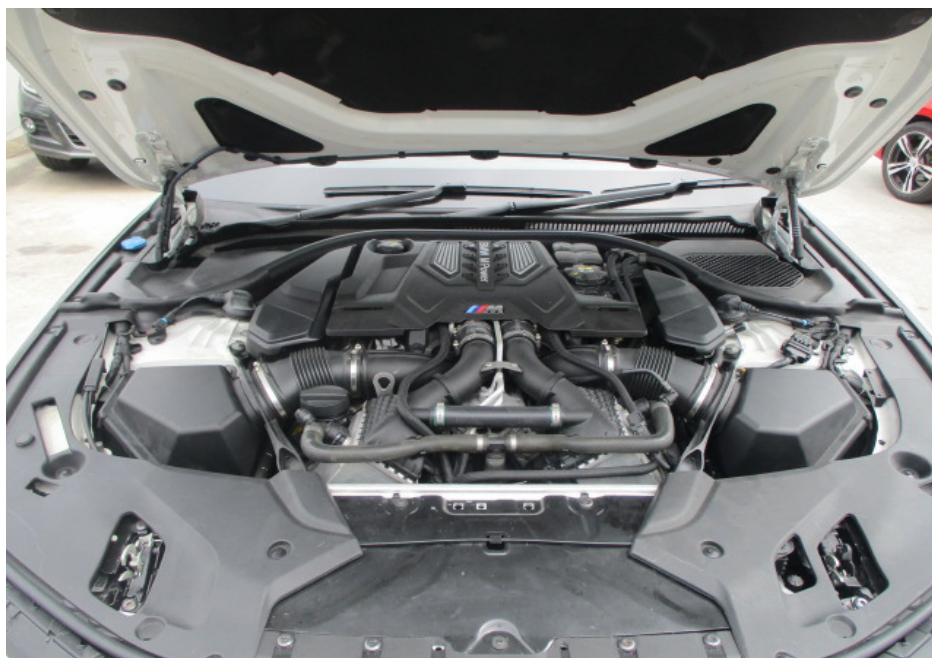
14. My examination of the engine compartment of the Motor Car revealed that the various parts and components inside the engine compartment were all intact and properly fitted. The engine oil, brake fluid and engine coolant were all found to be of sufficient level for operating purposes. Visually, there was also no contamination found to these fluids.
15. My checks on the underside of the Motor Car revealed no sign(s) or indication(s) of fluid leakage and/or fluid stain(s). The engine block and automatic transmission assembly were both secured properly. All undercarriage components of the Motor Car were also observed to be intact and secured in an appropriate manner.

**Photo 10** shows a general view of the engine compartment of the Motor Car at the time of my inspection. The various parts and components inside the engine compartment were all observed to be intact and properly fitted. There was also no sign(s) or indication(s) of fluid leak and/or fluid stain found inside the engine compartment.

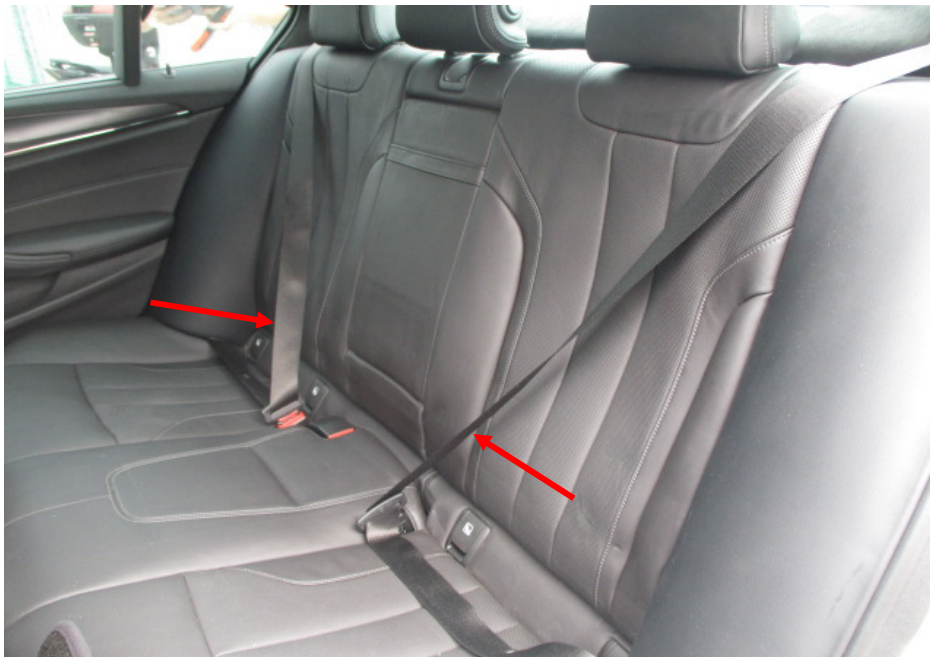
**Photo 11** shows the rear seats of the Motor Car. All the seats of the Motor Car were secured via seat rails to the floorboard. They were also fitted with a retractable seat belt reel and a pre-tensioner. The seat belts (arrowed) were tested and were able to be fastened into the respective pre-tensions that were fitted on the side of each individual seat.

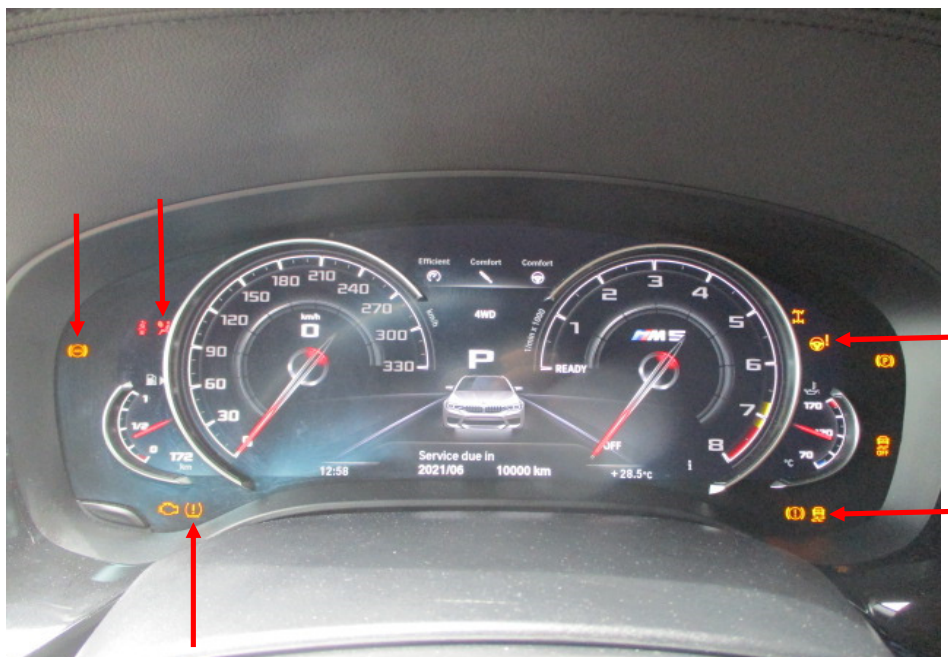
**Photo 12** shows the warning lights for the various electronic safety features appearing on the instrument panel of the Motor Car during its self-test when the engine is cranked, in particular the ABS, SRS, IAS, TPM and DSC lights (arrowed).

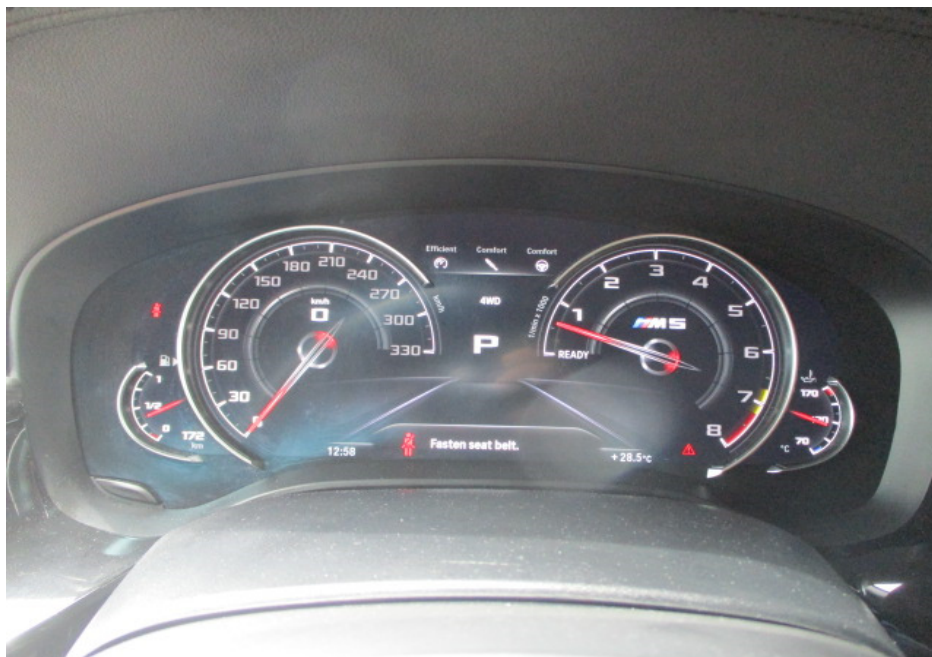
**Photo 13** shows the respective warning lights no longer illuminated, indicating that there is no fault detected to the ABS, SRS, IAS, TPM and DSC systems of the Motor Car during the self-test. These electronic systems were hence in working condition at the time of my inspection.

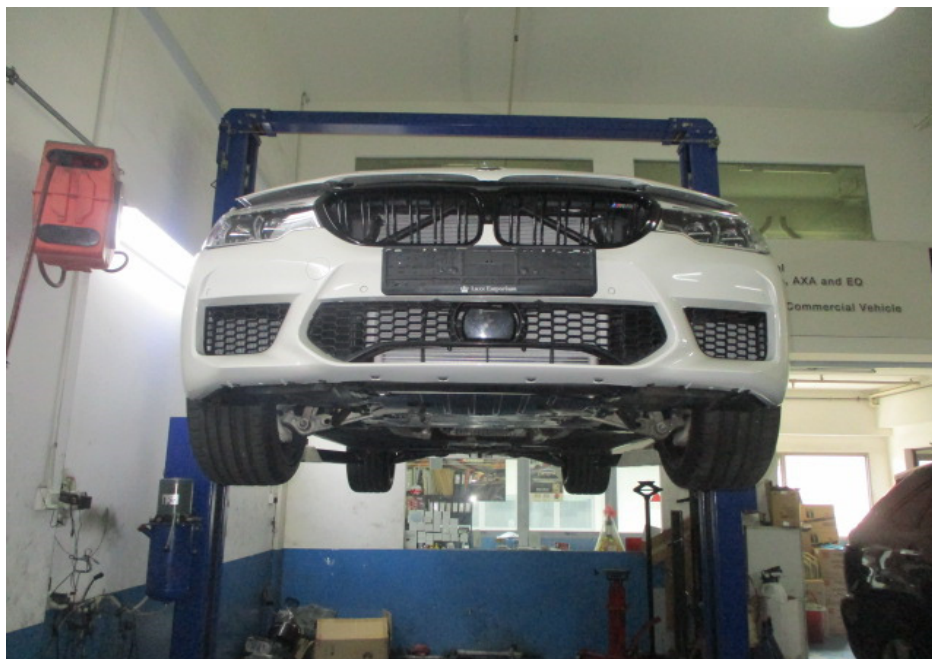
**Photo 14** shows the Motor Car hoisted up for checks on its undercarriage. There was no sign(s) or indication(s) of fluid leakage and/or fluid stain(s) on the underside of the Motor Car. The undercarriage components of the Motor Car were also all observed to be intact and secured in an appropriate manner.

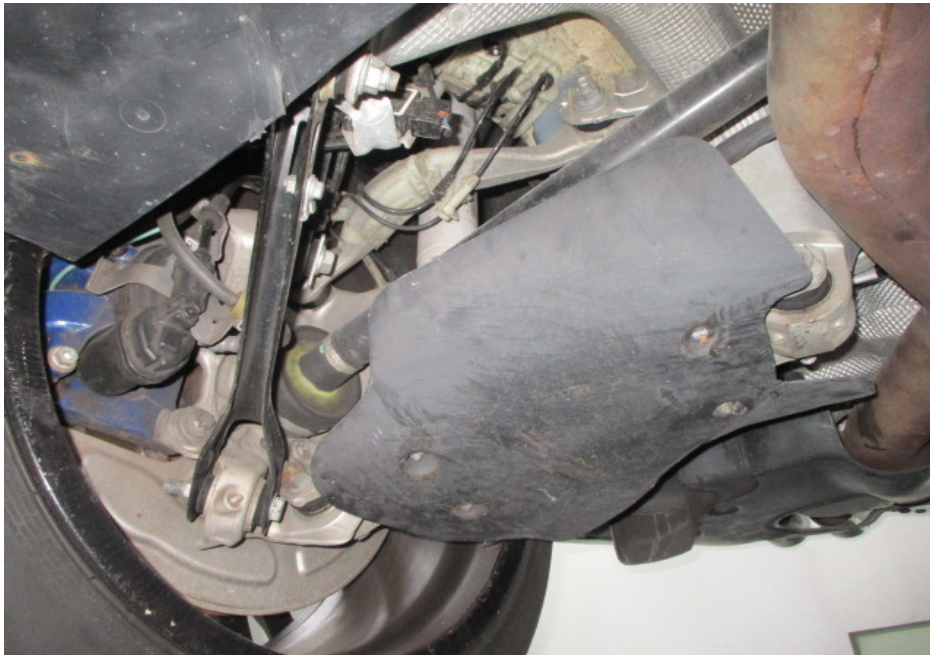
**Photo 15** shows a general view of the control arms and linkages at the rear right wheel of the Motor Car. I did not observe any fluid leak and/or fluid stain on the underside of the Motor Car. All of the Motor Car's undercarriage components were observed to be intact and secured in an appropriate manner.

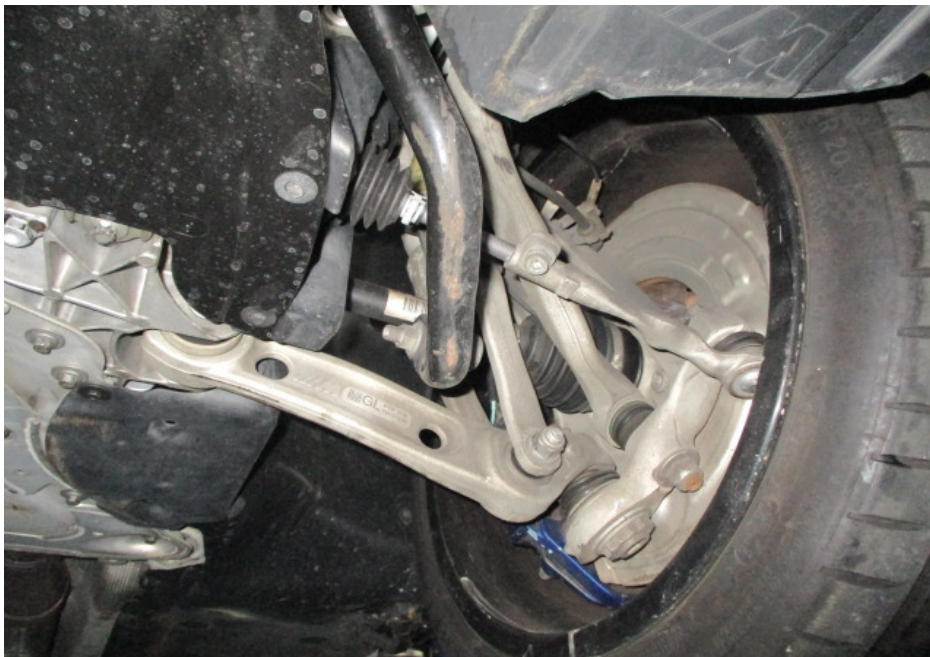
**Photo 16** shows the various undercarriage components at the front left wheel of the Motor Car. The mechanical components, control arms and linkages were all found to be intact and secured in an appropriate manner.

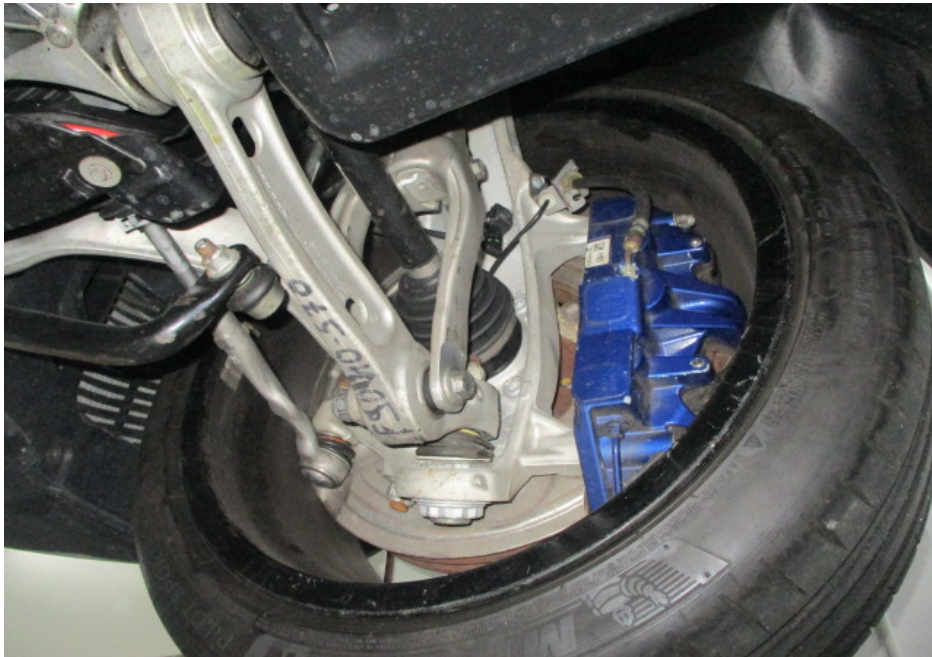
**Photo 17** shows the various undercarriage components at the front right wheel of the Motor Car. The mechanical components, control arms and linkages were all found to be intact and secured in an appropriate manner. I did not observe any fluid leak and/or fluid stain on the underside of the Motor Car.

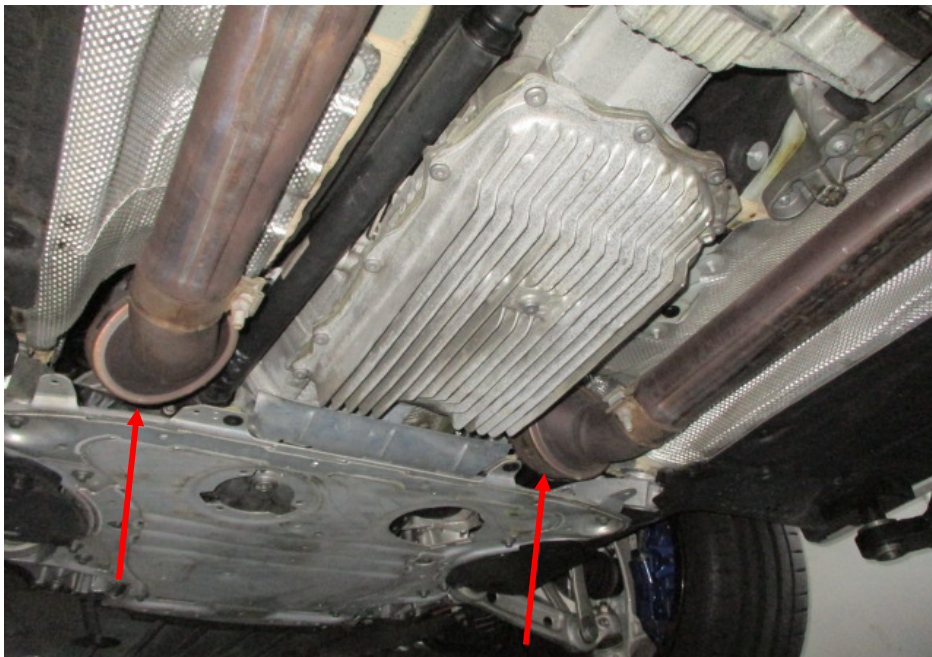
**Photo 18** shows the Motor Car's catalytic converters (arrowed). My examination of the Motor Car's exhaust system revealed no sign(s) or indication(s) of any cut or weld marks along its exhaust pipes and on its rear mufflers.

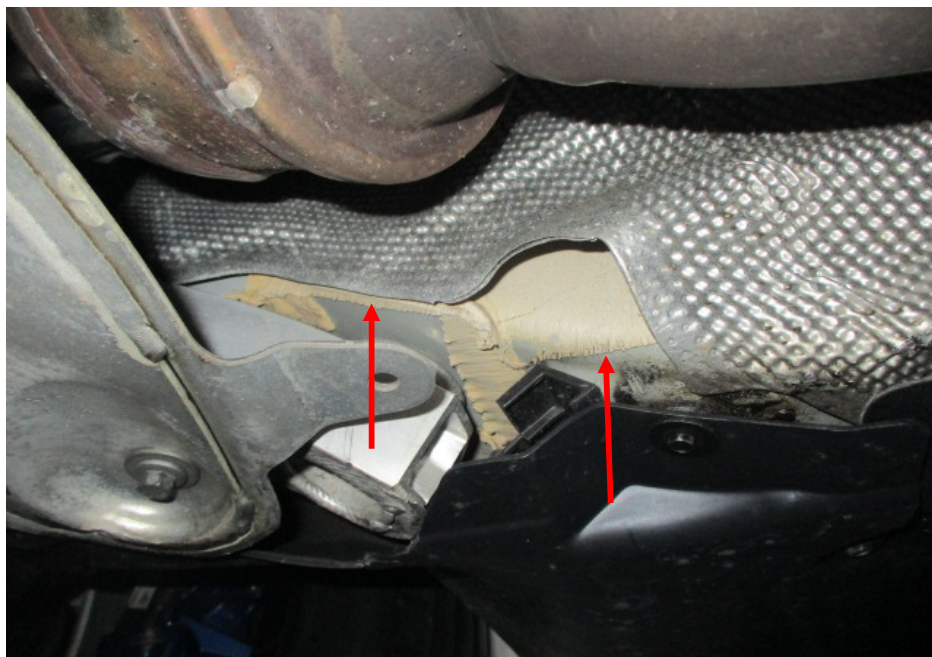
**Photo 19** shows the chassis/structural body at the underside front right of the Motor Car. In general, I had found the original factory sealant (arrowed) at the joints along the chassis/structural body to be untouched, indicating no work was done on the chassis/structural body of the Motor Car and that the chassis/structural body was originally fitted.

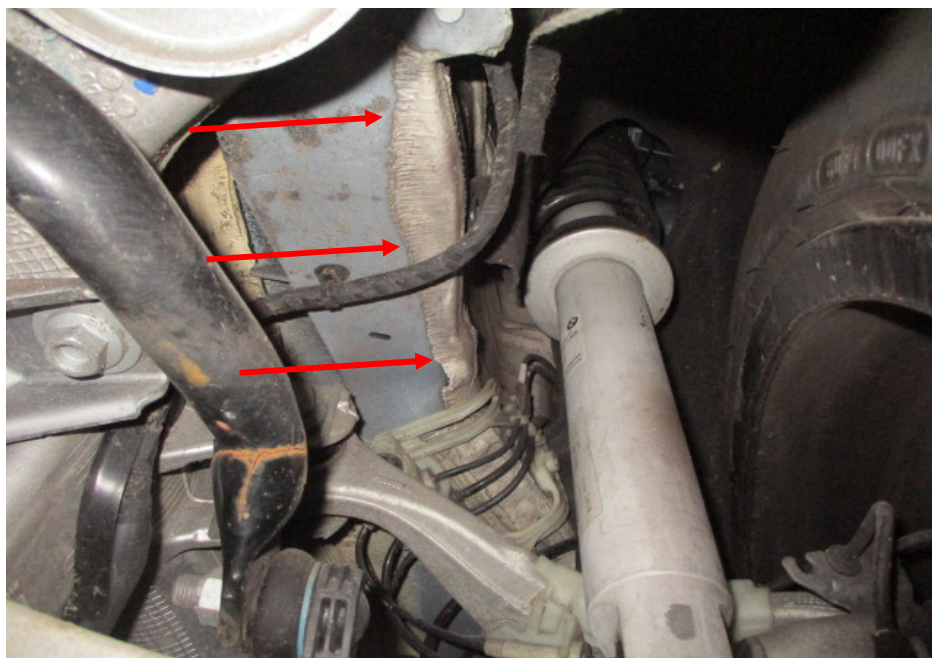
**Photo 20** shows the chassis/structural body at the underside rear right of the Motor Car. Visually, I did not find any weld marks other than original spot weld marks on the chassis/structural body of the Motor Car. The original factory sealant (arrowed) at the joints along the chassis/structural body was also untouched, indicating no work was done on the chassis/structural body of the Motor Car and that the chassis/structural body was originally fitted.

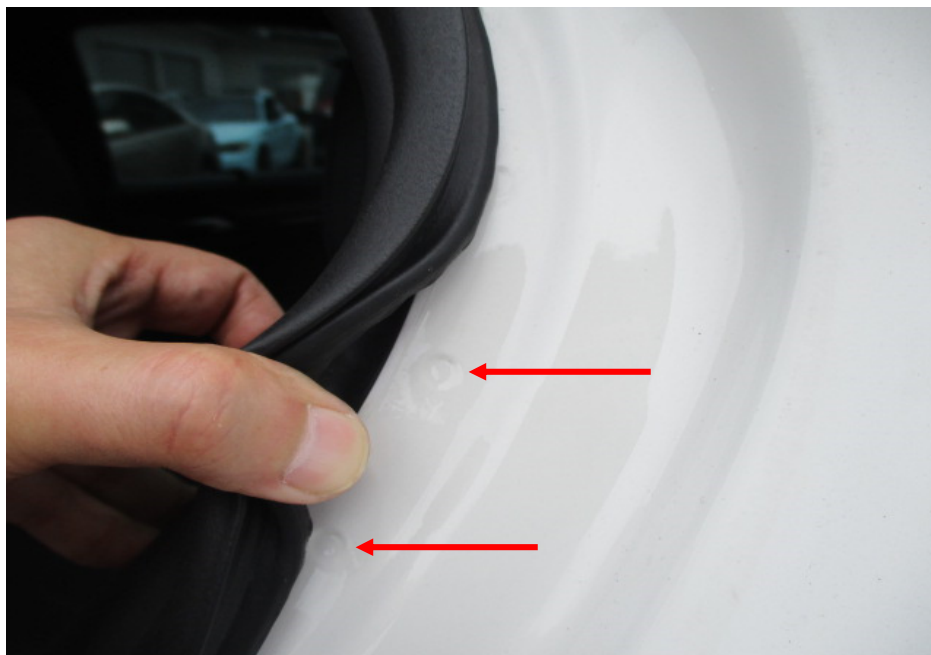
**Photo 21** shows the rear left "C" pillar of the Motor Car. I did not find any weld marks other than original spot weld marks (arrowed) on the rear left "C" pillar of the Motor Car. In general, I had found all the non-detachable body panels of the Motor Car to be originally fitted except for the rear right fender, which was found to be replaced (refer to photograph 22 below).

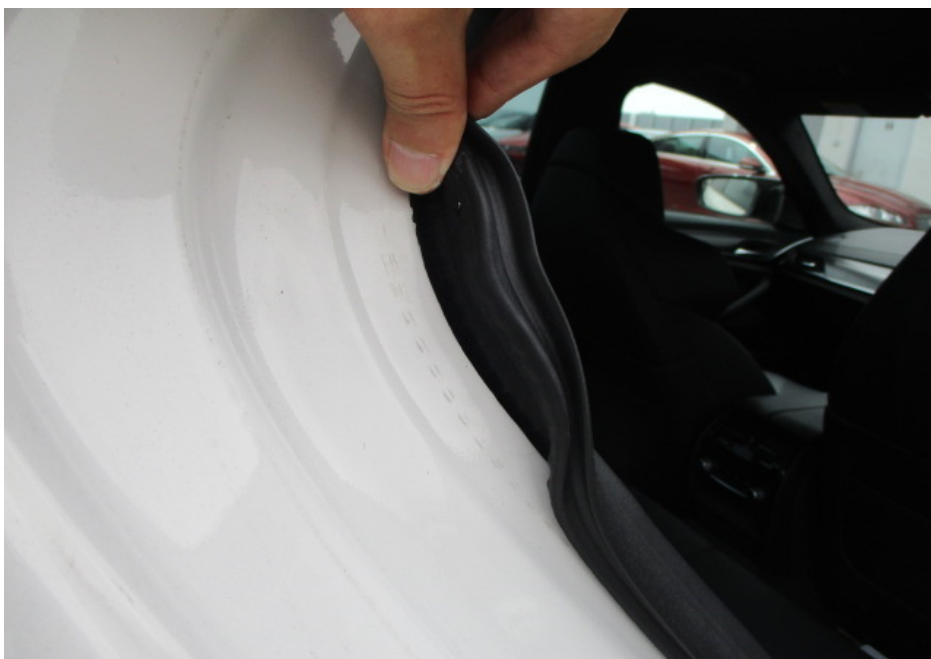
9. The detachable body panels of the Motor Car like the front fenders, front bumper, rear bumper, doors, bonnet and rear bootlid amongst others were all found to be fitted securely.
10. Checks on the non-detachable body panels like the rear fenders, floorboard, roof panel, pillars and rocker panels amongst others, revealed that these body panels were spot welded onto the chassis/structural body of the Motor Car. The original factory sealant at the joints of the non-detachable body panels was all untouched indicating no replacement of the non-detachable body panels was carried out; and that these body panels were all originally fitted except for the rear right fender, which was found to be replaced (refer to photograph 22 below).

**Photo 22** shows the right side "C" pillar of the Motor Car. I did not find any original weld marks at the right side "C" pillar of the Motor Car, indicating that the rear right fender of the Motor Car was replaced. The lack of original weld marks seen was due to replacement work when the replaced rear right fender was re-welded onto the Motor Car and smoothen for re-spraying work.

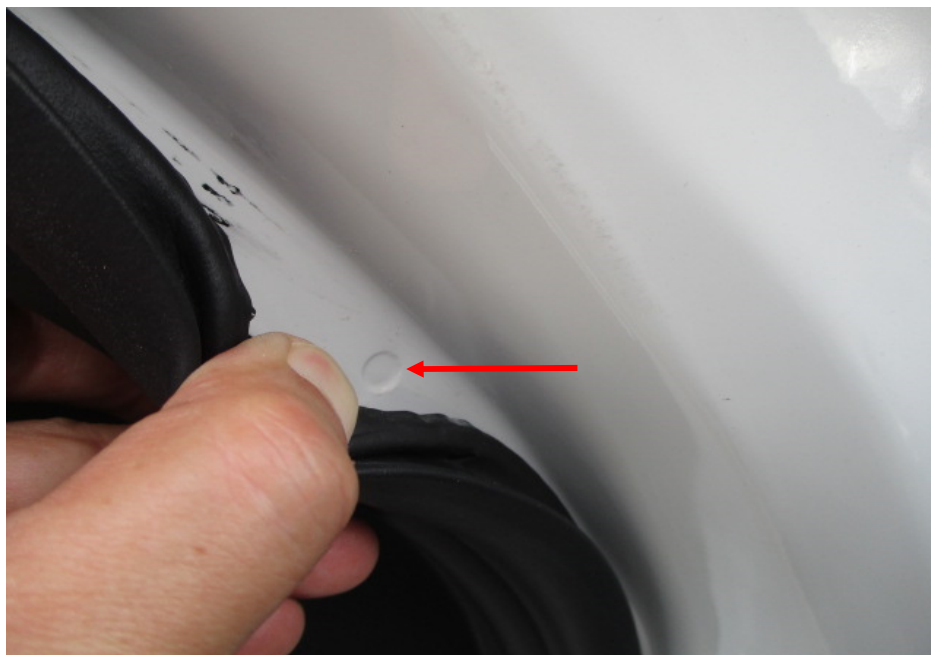
**Photo 23** shows the front right "A" pillar of the Motor Car. I did not find any weld marks other than original spot weld marks (arrowed) on the front right "A" pillar of the Motor Car. In general, I had found all the non-detachable body panels of the Motor Car to be originally fitted except for the rear right fender, which was found to be replaced (refer to photograph 22 below).
