Our Reference : KAAS/TA/6133/9114/TP/10.20
Date : 07 January 2021

VEHICLE APPRAISAL REPORT

Registration No.	: YP 9114R	Chassis Frame No.	: JALFRR907J7000125
Make / Model	: Isuzu FRR90SUQA-C AMT	Engine No. (Logcard)	: 4HK1718740
Year of Manufacture/Reg	: 2018	Odometer Reading	: 123,284 KM
Colour	: Yellow		
Class / Type	: Truck

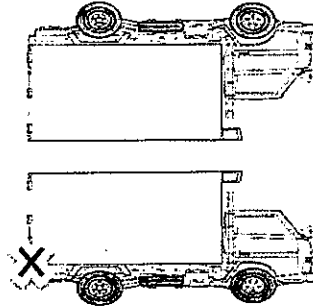
Damages sustained were consistent with the subject vehicle being involved in a collision with another vehicle and the impact was delivered **Diagonally to the RH Rear from left to right; rear to front;** portion of the vehicle.

The general area of damages is at the **RH Rear portion**
(Please refer to the parts list and photographs as attached for more information)

The estimated repair costs submitted by Messrs **R&S Engineering Works Pte Ltd** is \$ **4,360.00** .
We have adjusted the cost to \$ **3,750.00** and the repairer has agreed to undertake the repairs at a
Contract Lump Sum of \$ 3,000.00 to a acceptable quality and standards.
However, we have not given authorization and instruction to the repairer to proceed with the repairs.
