**PROPERTY DAMAGES CLAIMS AS A RESULT OF A ROAD TRAFFIC ACCIDENT INVOLVING
MOTOR VEHICLES NO. VBK5018 AND SML3333C ALONG AYE TOWARDS CITY ON 02.12.2020.**

Re : Third Party Claim For Vehicle Registration No. VBK5018

VEHICLE INSPECTION REPORT

Registration no. : VBK5018
 Our reference : UAM21.01.04-PT-STP-CSM-VBK5018

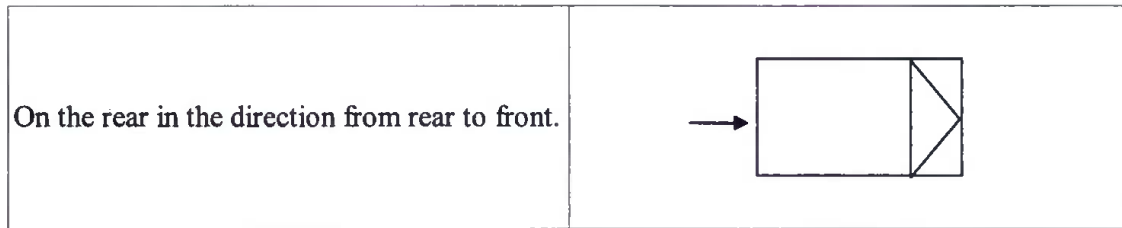
POINT OF IMPACT

The impact of the collision has damaged / affected the bootlid, taillamps, rear bumper, rear end panel and etc...
