VEHICLE INSPECTION REPORT

Our ref. : UAM21.01.04-PT-STP-CSM-VBK5018

Registration no.	: VBK5018	Odometer	: 37073 km
Make / Model	: Volkswagen Passat TSI Trendline (CI	Chassis no.	: PPVZZZ3CZHL000372
Regn. date	: 2018	Engine no.	: T.B.A
Body colour	: Black	Engine cap.	: 1798 cc

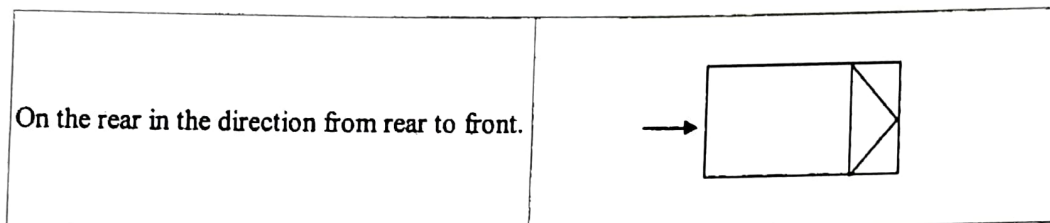
POINT OF IMPACT

The impact of the collision has damaged / affected the bootlid, taillamps, rear bumper, rear end panel and etc...
