Your Ref: BMW M5  
(chassis number WBSJF02090CE23752)  
Our Ref : CI/TP21001114/D

22 January 2021

**INSPECTION REPORT OF AN UNREGISTERD BMW M5 MOTOR CAR WITH  
CHASSIS NUMBER WBSJF02090CE23752**

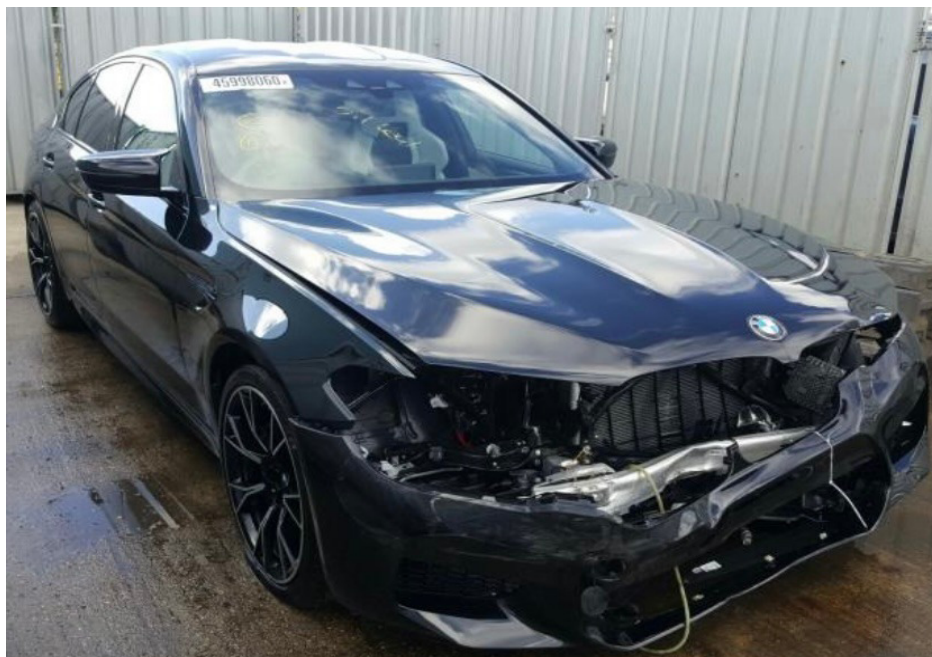
3. From the photographs provided to me, it was observed that the Motor Car had sustained damages at its frontal portion. Body parts damaged at the frontal portion include the front bumper, front bumper centre lower grille, front headlamps, front grilles, front bumper reinforcement, front brace panel, radiator air guide, aircon condenser, front bonnet and front left fender amongst others.
4. No physical damage was observed to other areas of the Motor Car. The airbags of the Motor Car were also not activated as seen from the photographs that were provided to me. See photo 1 – 4 below.

**Photo 1** shows the front right body of the Motor Car (photograph provided to me). The Motor Car was observed to have sustained damage at its frontal portion. The front bumper, front right headlamp, front grilles, front bumper reinforcement and front bonnet were amongst the body parts that were observed to have been damaged.

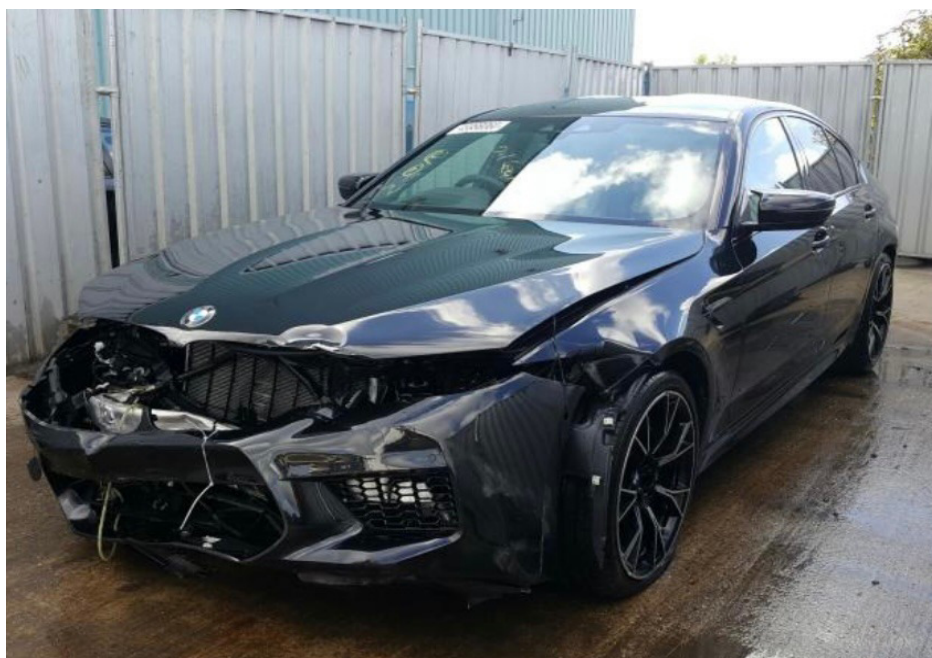
**Photo 2** shows the front left body of the Motor Car (photograph provided to me). The Motor Car was observed to have sustained damage at its frontal portion. The front bumper, front left headlamp, front grilles, front bumper centre lower grille, front brace panel, aircon condenser, front left fender and front bonnet were amongst the body parts that were observed to have been damaged.

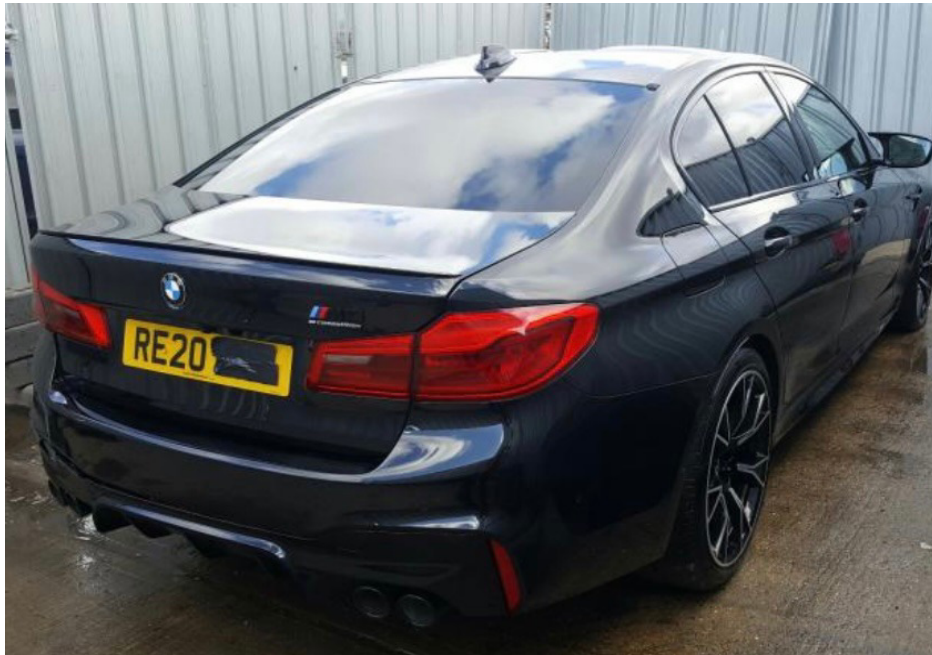
**Photo 3** shows the rear right body of the Motor Car (photograph provided to me). Apart for the frontal portion, there was no physical damage seen to other areas of the Motor Car.

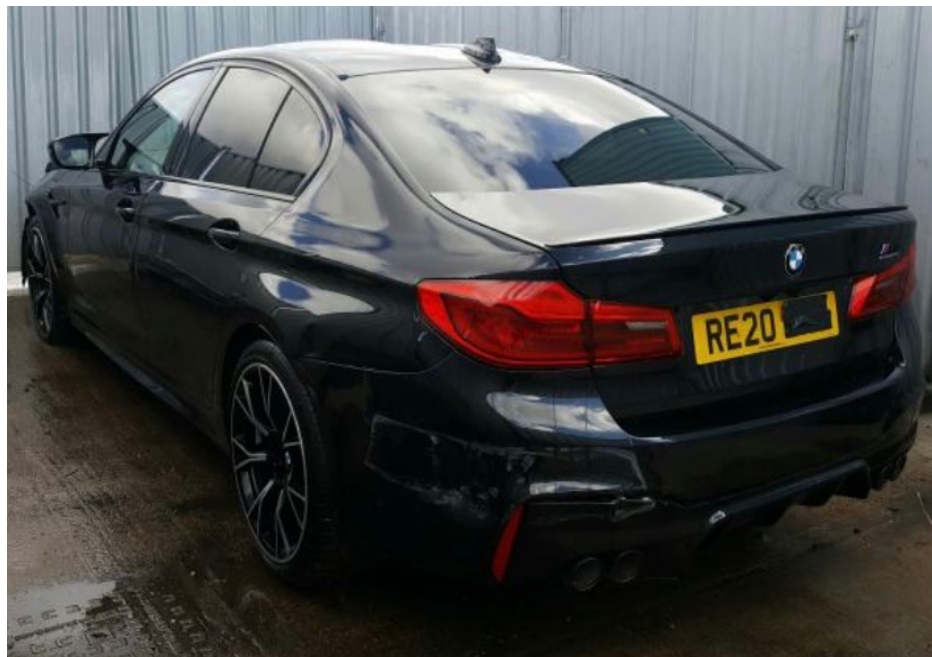
**Photo 4** shows the rear left body of the Motor Car (photograph provided to me). Apart for the frontal portion, there was no physical damage seen to other areas of the Motor Car.

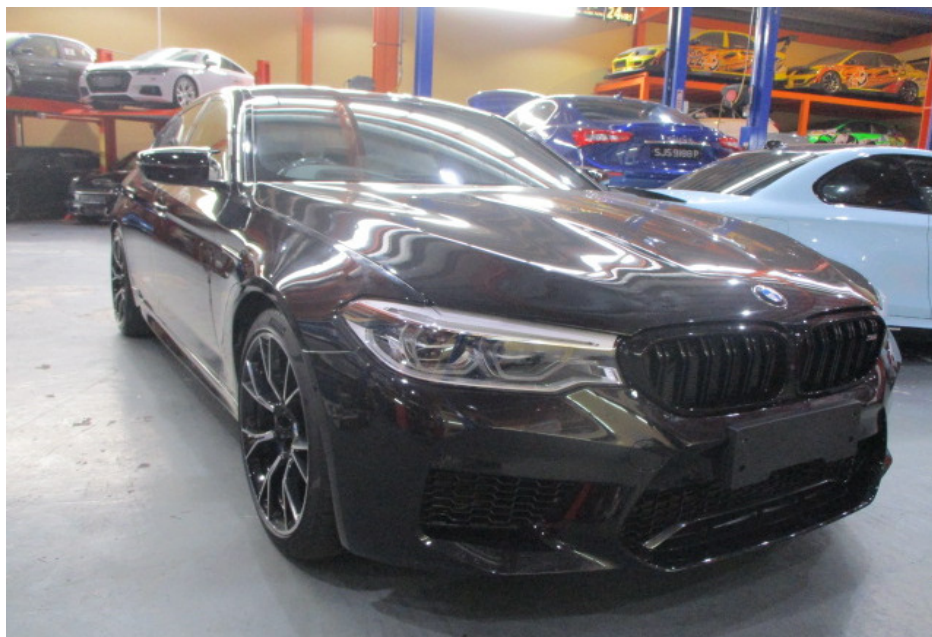
**Photo 5** shows a general view of the front right body of the Motor Car at the time of my inspection. The Motor Car was observed to be in a relatively good general condition with no loose exterior fittings observed. The body parts at the frontal portion of the Motor Car were visually examined and it was observed that the repair/restoration works carried out to the damaged area of the Motor Car (refer to photograph 1 & 2 above) were reasonably adequate and in order.

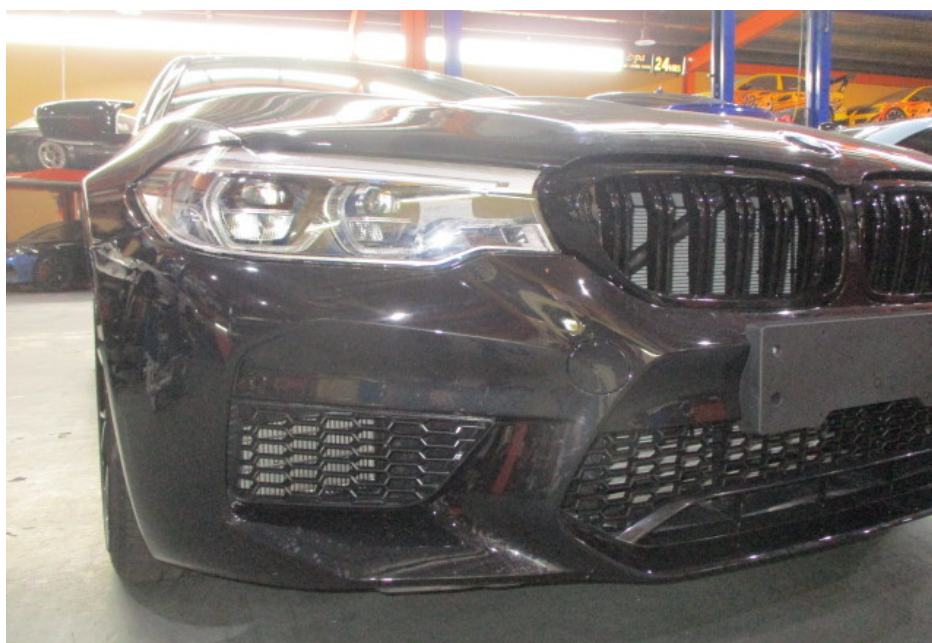
**Photo 6** shows a closer view of the front bumper, front right headlamp, front bonnet and front grilles of the Motor Car at the time of my inspection. The body parts at the frontal portion of the Motor Car were visually examined and it was observed that the repair/restoration works carried out to the damaged area of the Motor Car (refer to photograph 1 & 2 above) were reasonably adequate and in order.

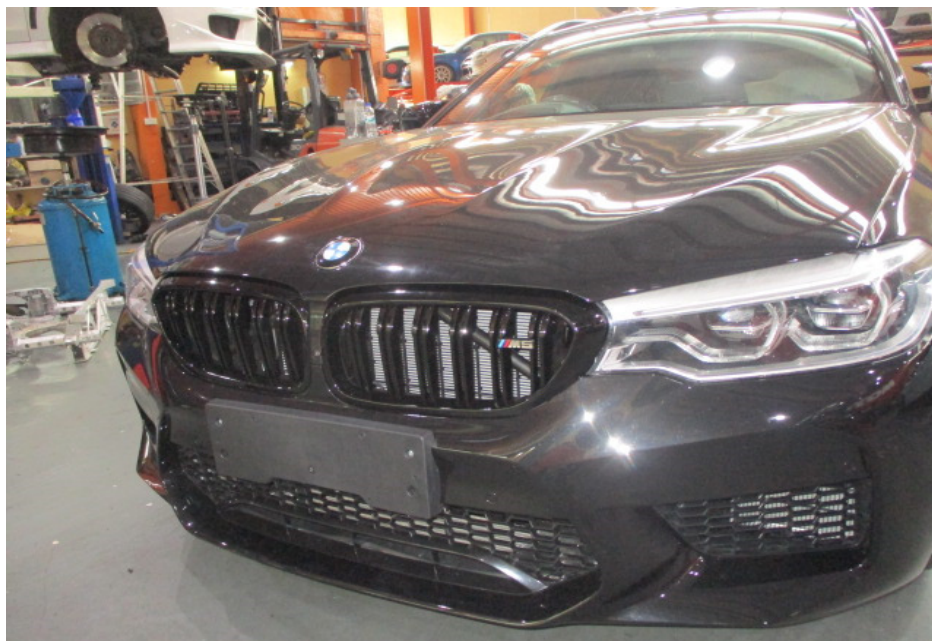
**Photo 7** shows a closer view of the front bumper, front left headlamp, front bonnet and front grilles of the Motor Car at the time of my inspection. The body parts at the frontal portion of the Motor Car were visually examined and it was observed that the repair/restoration works carried out to the damaged area of the Motor Car (refer to photograph 1 & 2 above) were reasonably adequate and in order.

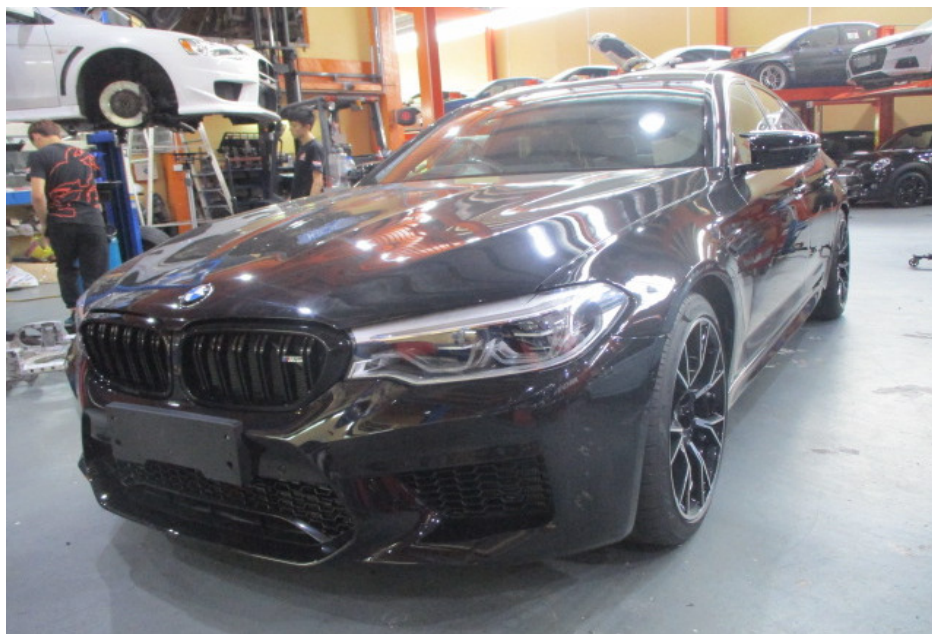
**Photo 8** shows a general view of the front left body of the Motor Car at the time of my inspection. The Motor Car was observed to be in a relatively good general condition with no loose exterior fittings observed. The body parts at the frontal portion of the Motor Car were visually examined and it was observed that the repair/restoration works carried out to the damaged area of the Motor Car (refer to photograph 1 & 2 above) were reasonably adequate and in order.

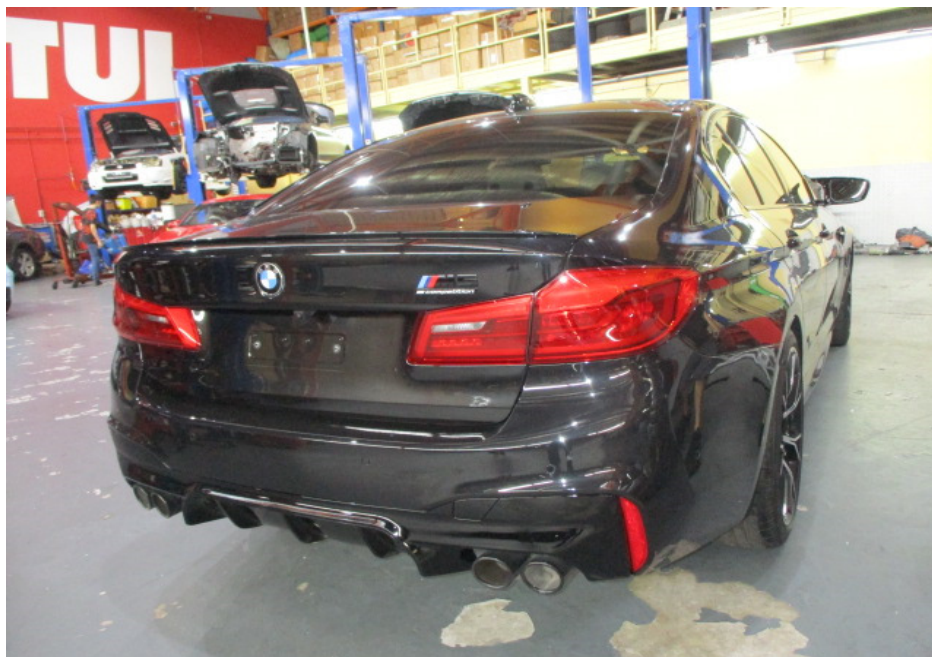
**Photo 9** shows a general view of the rear right body of the Motor Car at the time of my inspection. The Motor Car was observed to be in a relatively good general condition with no loose exterior fittings observed. The mileage of the Motor Car recorded at the time of my inspection was 2,195km.

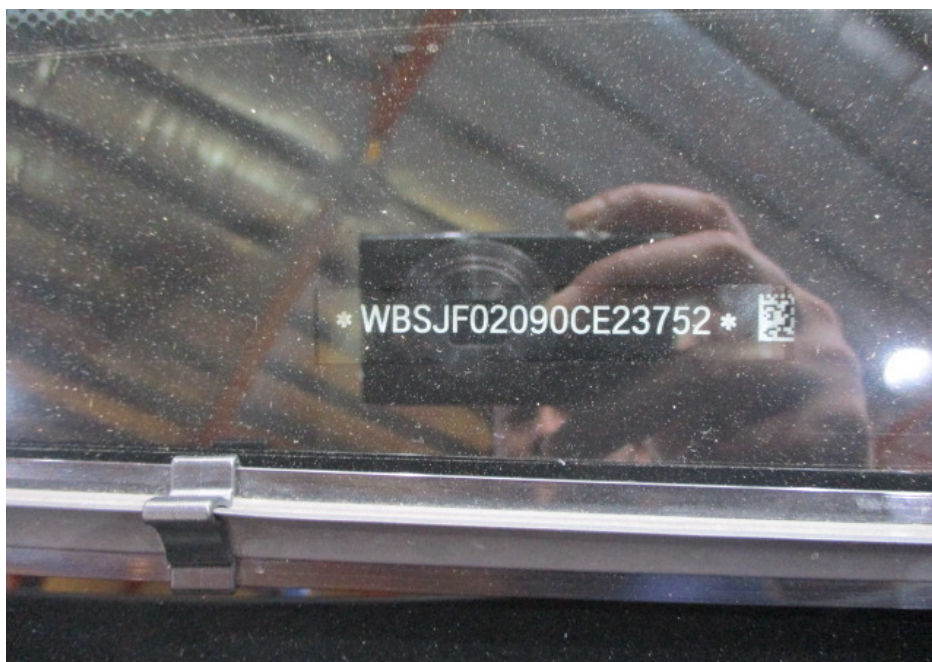
**Photo 10** shows the chassis number of the Motor Car. The chassis number recorded was WBSJF02090CE23752.

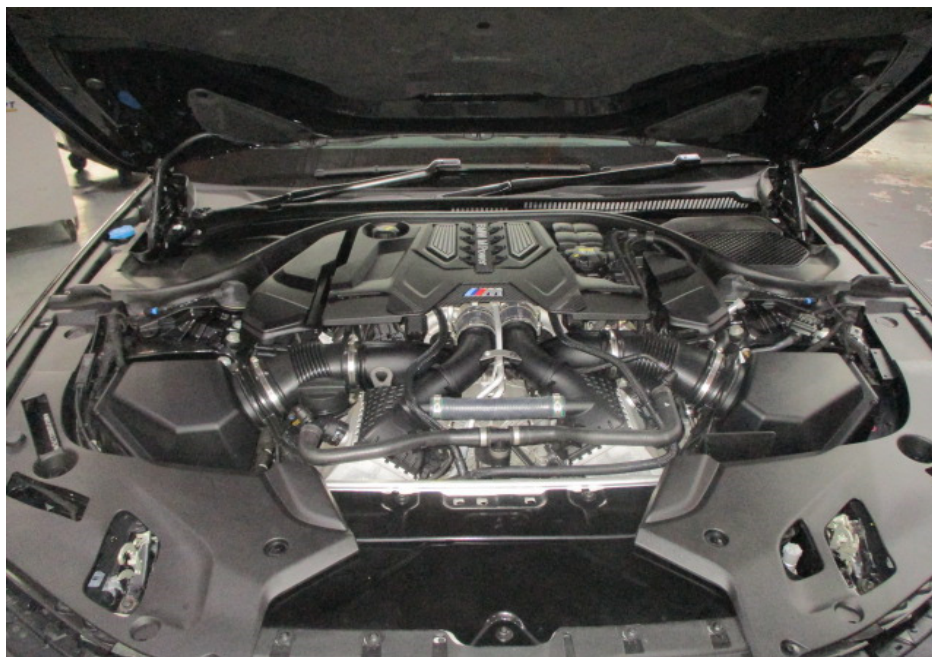
**Photo 11** shows a general view of the engine compartment of the Motor Car at the time of my inspection. The various parts and components inside the engine compartment were all observed to be intact and properly fitted. There was also no sign(s) or indication(s) of fluid leak and/or fluid stain found inside the engine compartment.

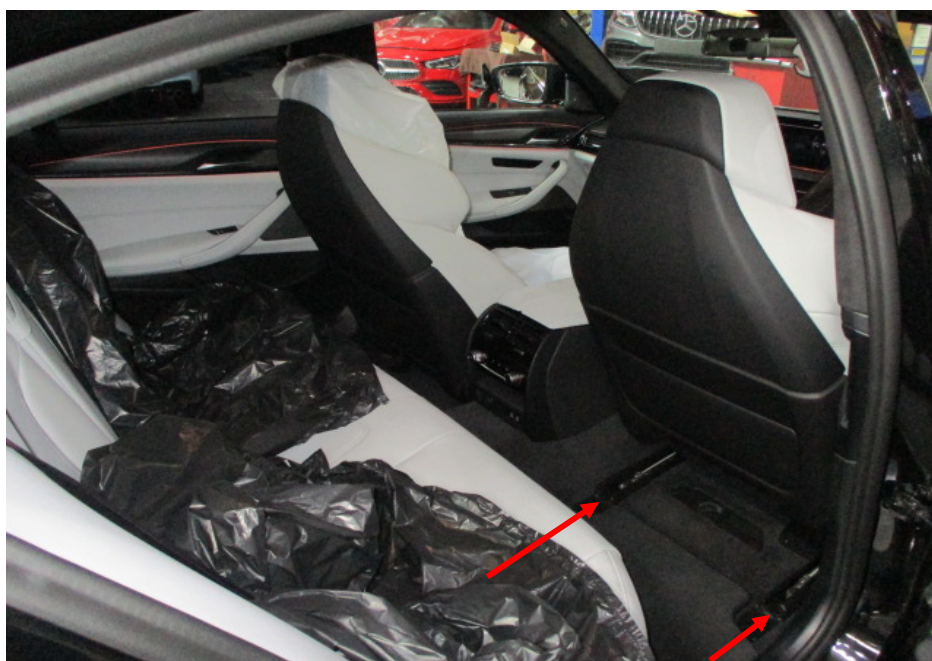
**Photo 12** shows the seats of the Motor Car, which were secured via seat rails (arrowed) to the floorboard. All the seats of the Motor Car were fitted with a retractable seat belt reel and pre-tensioner. The seat belts were tested and were able to be fastened into the respective pre-tensions that were fitted on the side of each individual seat.

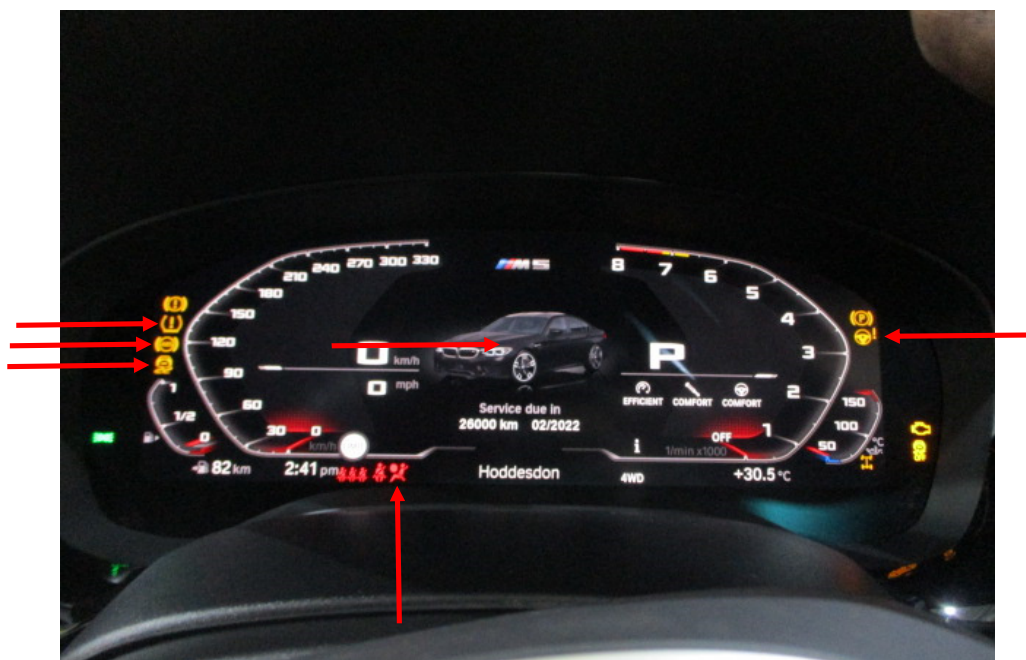
**Photo 13** shows the warning lights for the various electronic safety features appearing on the instrument panel of the Motor Car during its self-test when the engine is cranked, in particular the ABS, SRS, IAS, TPM and DSC lights (arrowed).

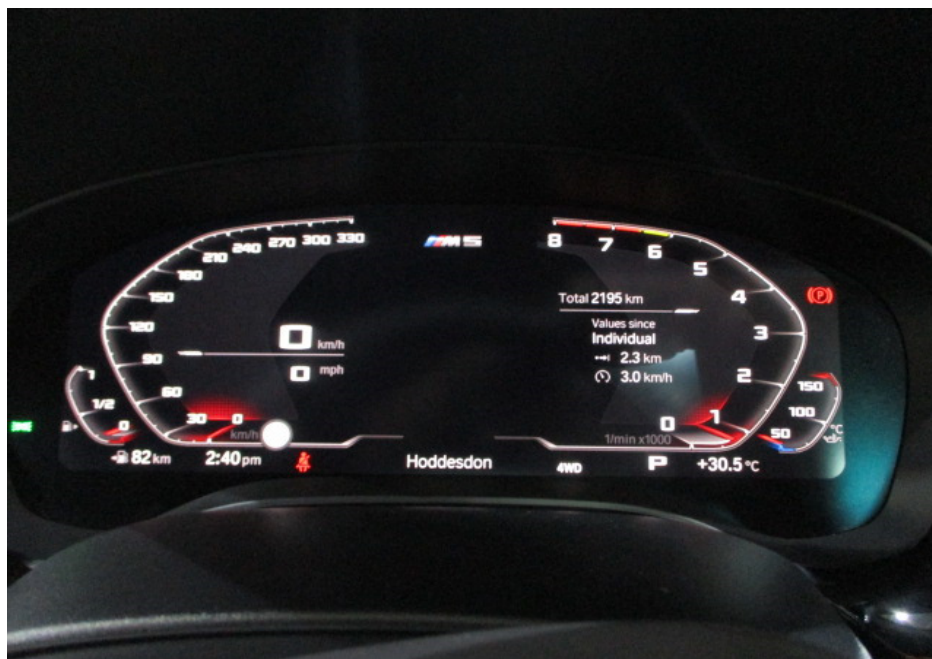
**Photo 14** shows the respective warning lights no longer illuminated, indicating that there is no fault detected to the ABS, SRS, IAS, TPM and DSC systems of the Motor Car during the self-test. These electronic systems were hence in working condition at the time of my inspection.

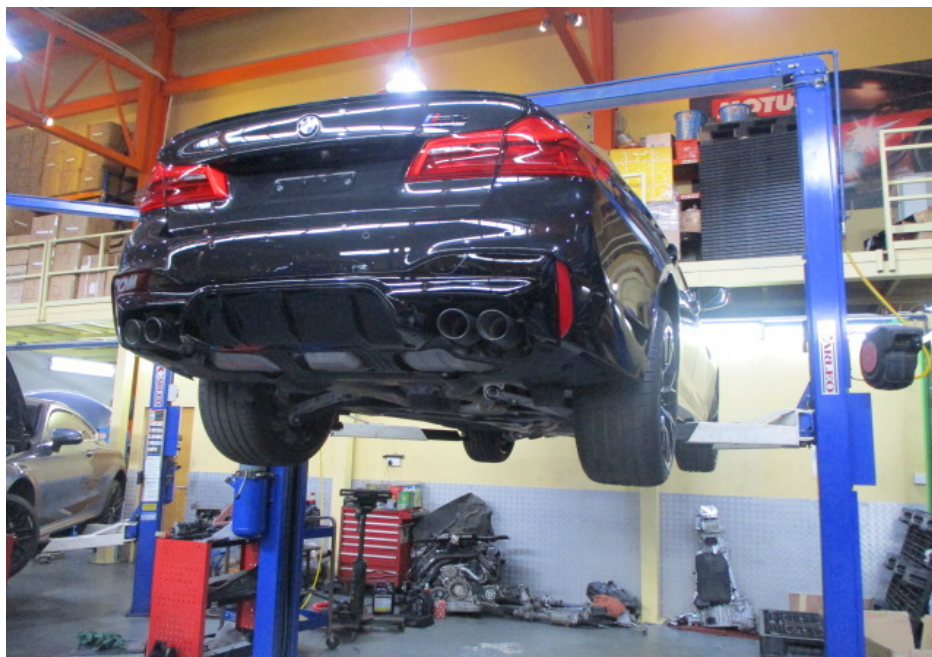
**Photo 15** shows the Motor Car hoisted up for checks on its undercarriage. There was no sign(s) or indication(s) of fluid leakage and/or fluid stain(s) on the underside of the Motor Car. The undercarriage components of the Motor Car were also all observed to be intact and secured in an appropriate manner.

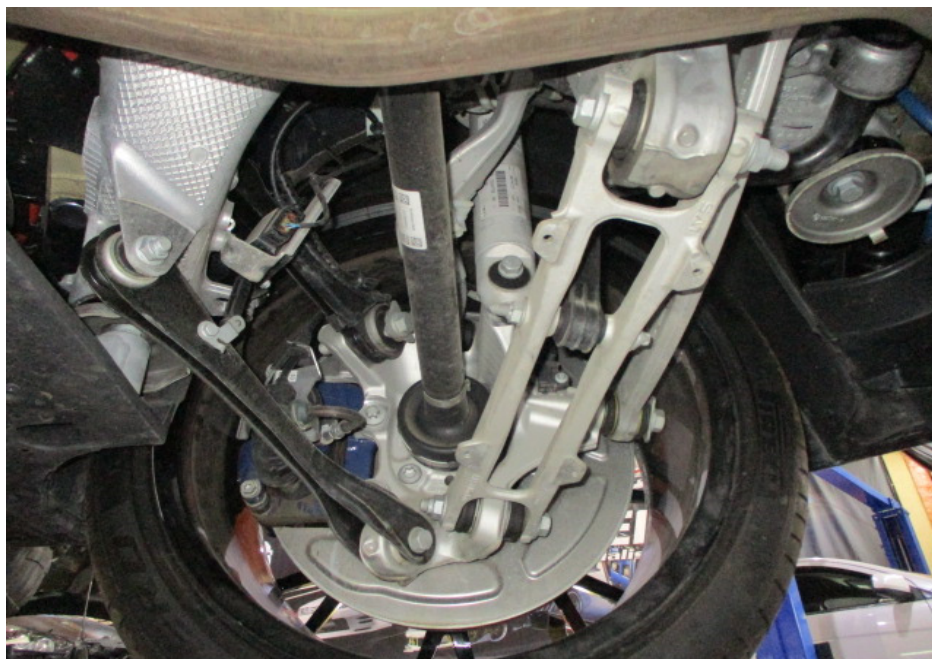
**Photo 16** shows a general view of the control arms and linkages at the rear right wheel of the Motor Car. I did not observe any fluid leak and/or fluid stain on the underside of the Motor Car. All of the Motor Car's undercarriage components were observed to be intact and secured in an appropriate manner.

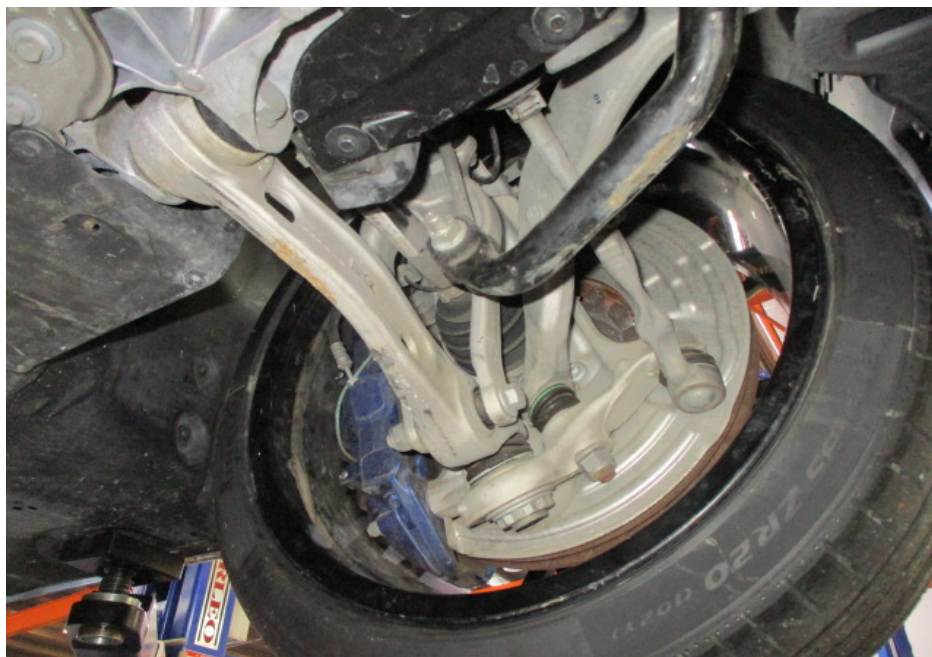
**Photo 17** shows the various undercarriage components at the front left wheel of the Motor Car. The mechanical components, control arms and linkages were all found to be intact and secured in an appropriate manner.

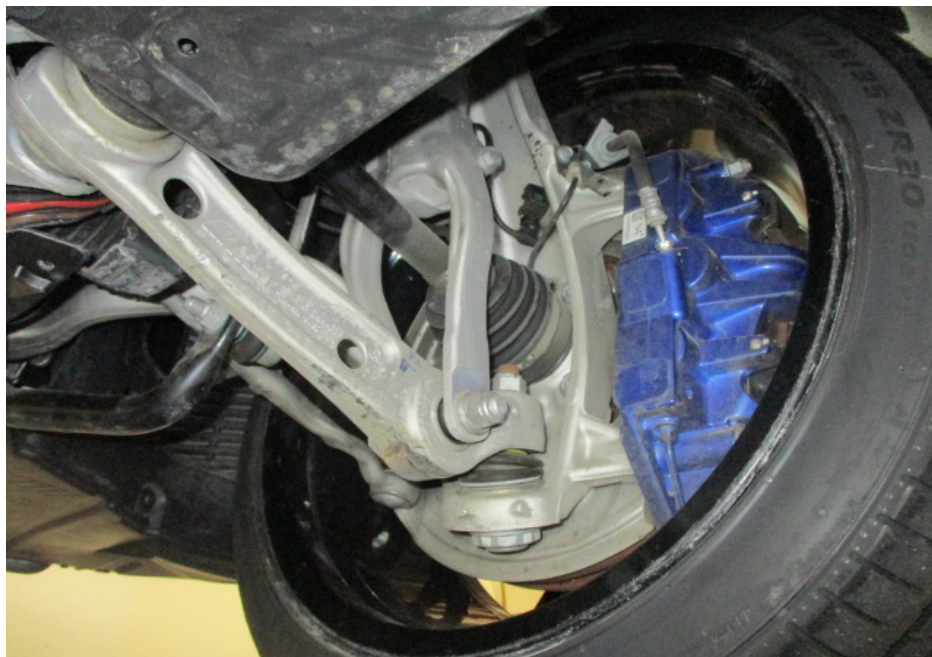
**Photo 18** shows the various undercarriage components at the front right wheel of the Motor Car. The mechanical components, control arms and linkages were all found to be intact and secured in an appropriate manner. I also did not observe any fluid leak and/or fluid stain on the underside of the Motor Car.

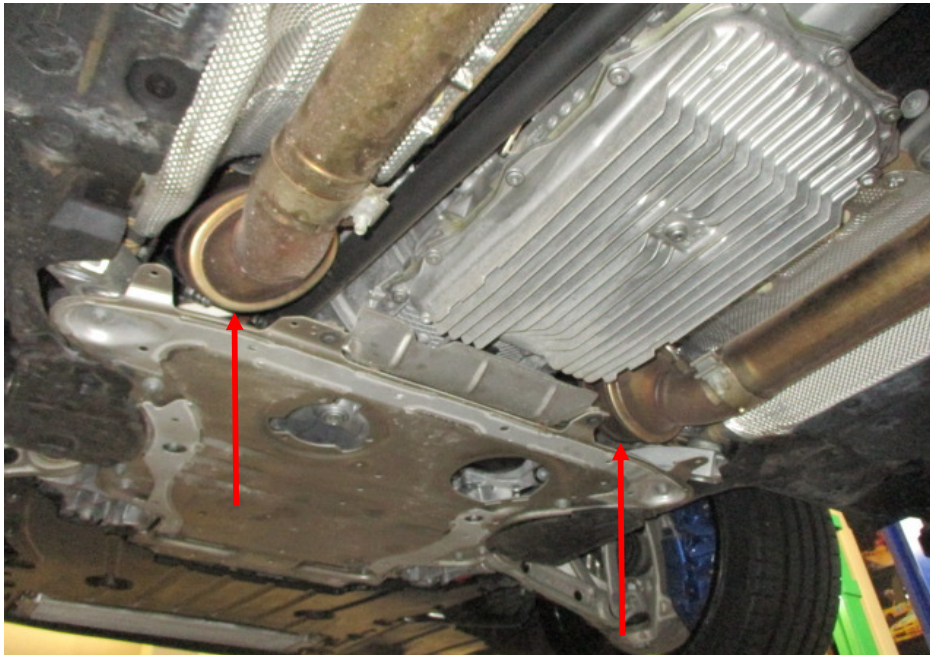
**Photo 19** shows the Motor Car's catalytic converters (arrowed). My examination of the Motor Car's exhaust system revealed no sign(s) or indication(s) of any cut or weld marks along its exhaust pipes and on its rear mufflers.

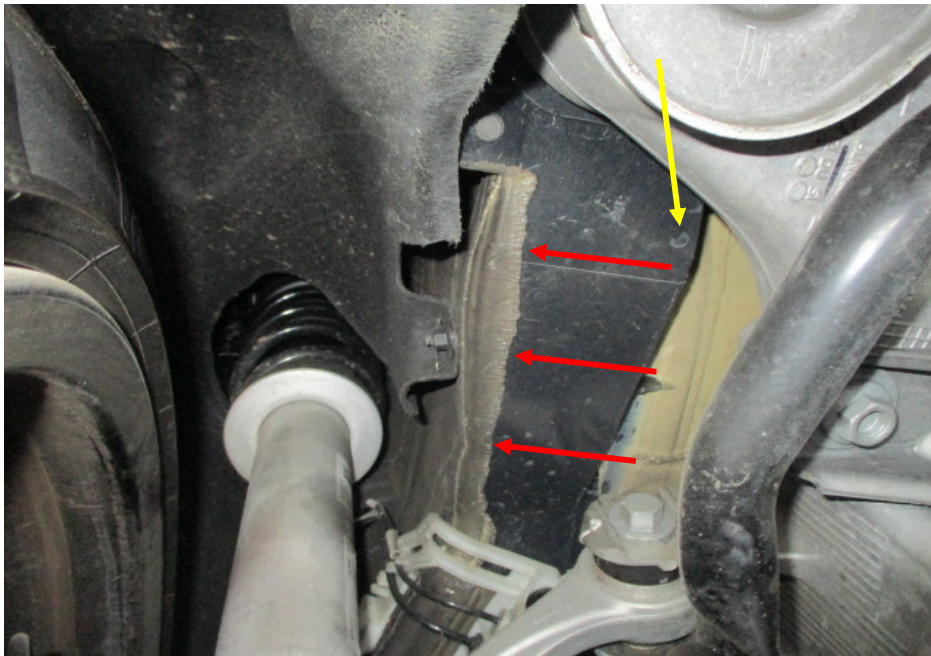
**Photo 20** shows the chassis/structural body at the underside rear left of the Motor Car. I did not find any weld marks other than original spot weld marks (yellow arrow) on the chassis/structural body of the Motor Car. The original factory sealant (red arrow) at the joints along the chassis/structural body was untouched, indicating no work was done on the chassis/structural body of the Motor Car and that the chassis/structural body was originally fitted.

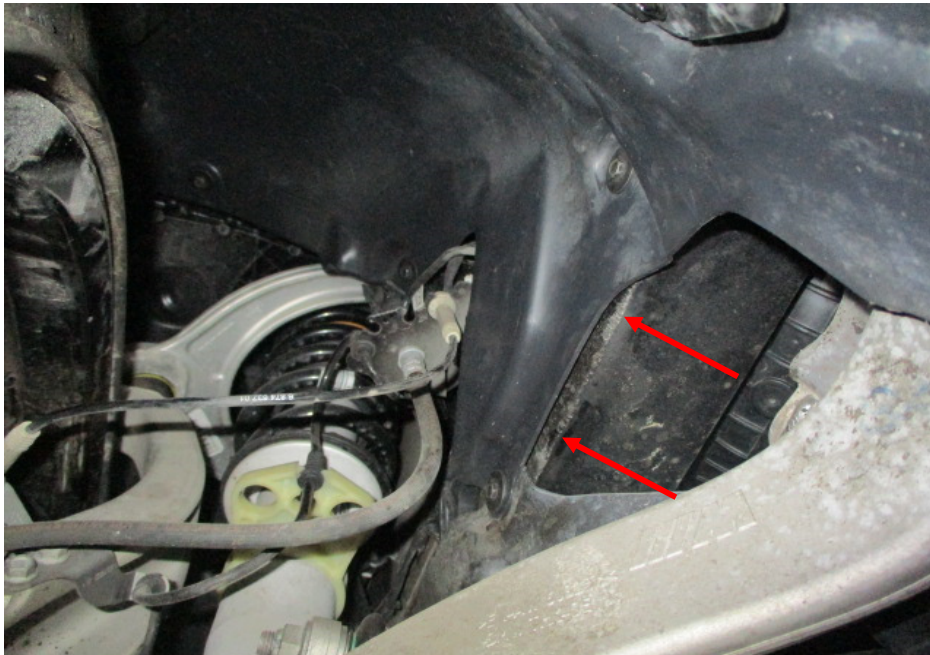
**Photo 21** shows the chassis/structural body at the underside front right of the Motor Car. The original factory sealant (arrowed) at the joints along the chassis/structural body was observed to be untouched. In general, I had found no work was carried out on the chassis/structural body of the Motor Car. The chassis/structural body of the Motor Car was originally fitted.

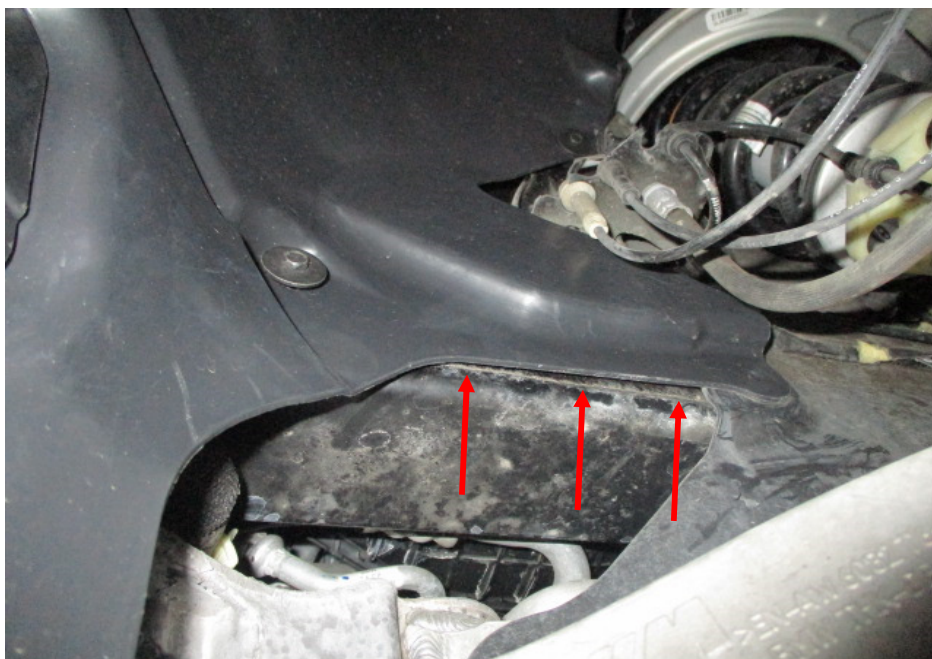
**Photo 22** shows the chassis/structural body at the underside front left of the Motor Car. The original factory sealant (arrowed) at the joints along the chassis/structural body was observed to be untouched. In general, I had found no work was carried out on the chassis/structural body of the Motor Car. The chassis/structural body of the Motor Car was originally fitted.

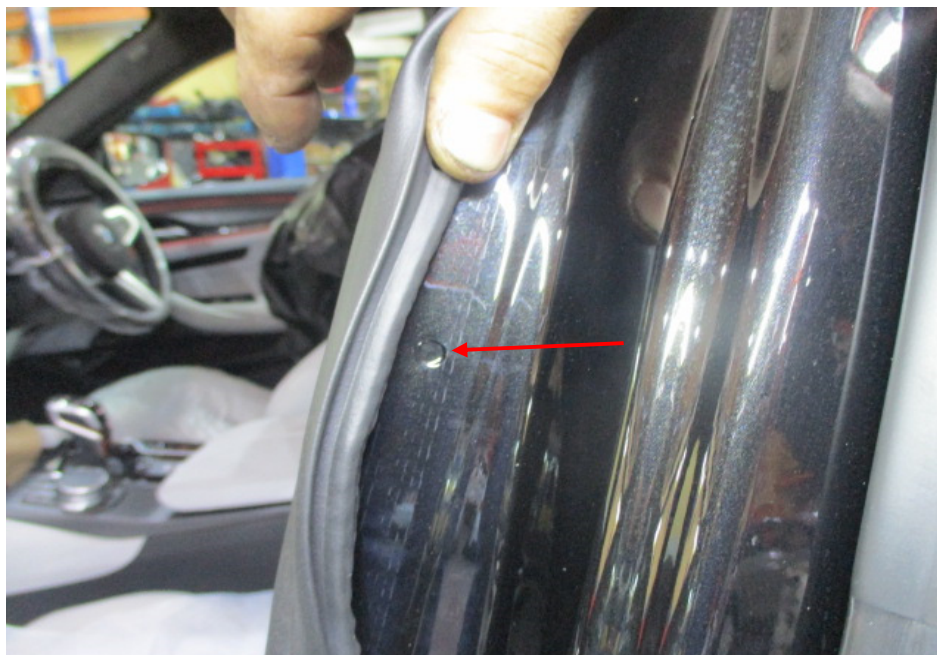
**Photo 23** shows the left side "B" pillar of the Motor Car. I did not find any weld marks other than original spot weld marks (arrowed) on the left side "B" pillar of the Motor Car which, indicates that there was no re-welding works carried out. In general, I had found all the non-detachable body panels of the Motor Car to be originally fitted at the time of my inspection.
