Your Ref: Maserati Ghibli  
(chassis number ZAMXS57C001260100)  
Our Ref : CI/TP21001115/D

02 February 2021

**INSPECTION REPORT OF AN UNREGISTERD MASERATI Ghibli MOTOR CAR WITH CHASSIS NUMBER ZAMXS57C001260100**

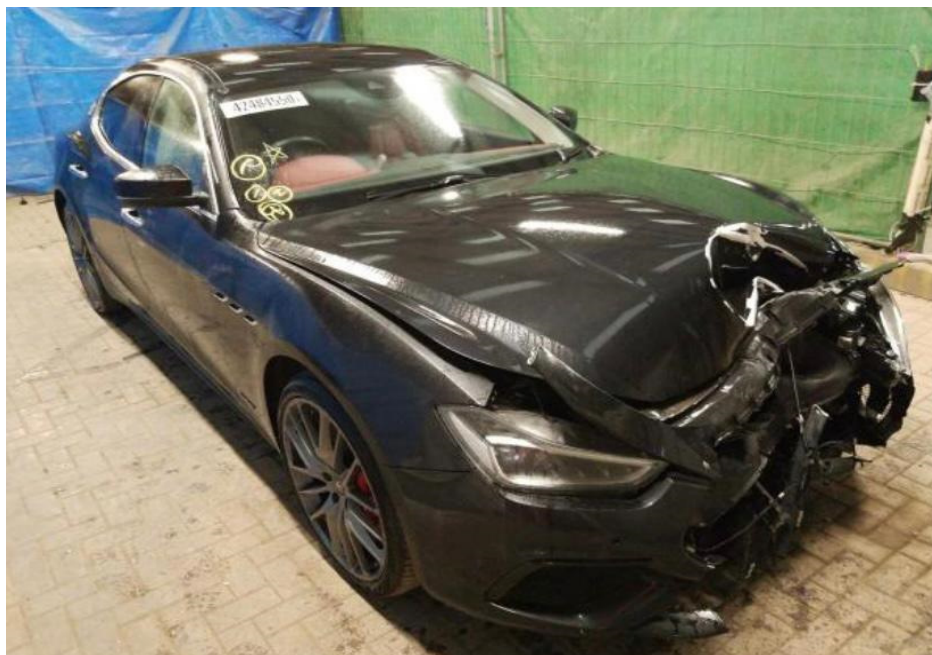
**Photo 1** shows the front right body of the Motor Car (photograph provided to me). The Motor Car was observed to have sustained damage at its frontal portion. The front bumper, front right headlamp, front radiator grille, front bumper centre lower grille and front bonnet were amongst the body parts that were observed to have been damaged.

22. The body parts at the frontal portion of the Motor Car were visually examined and it was noted that the repair/restoration works carried out to the damaged area of the Motor Car (refer to photograph 1 & 2 above) were reasonably adequate and in order.

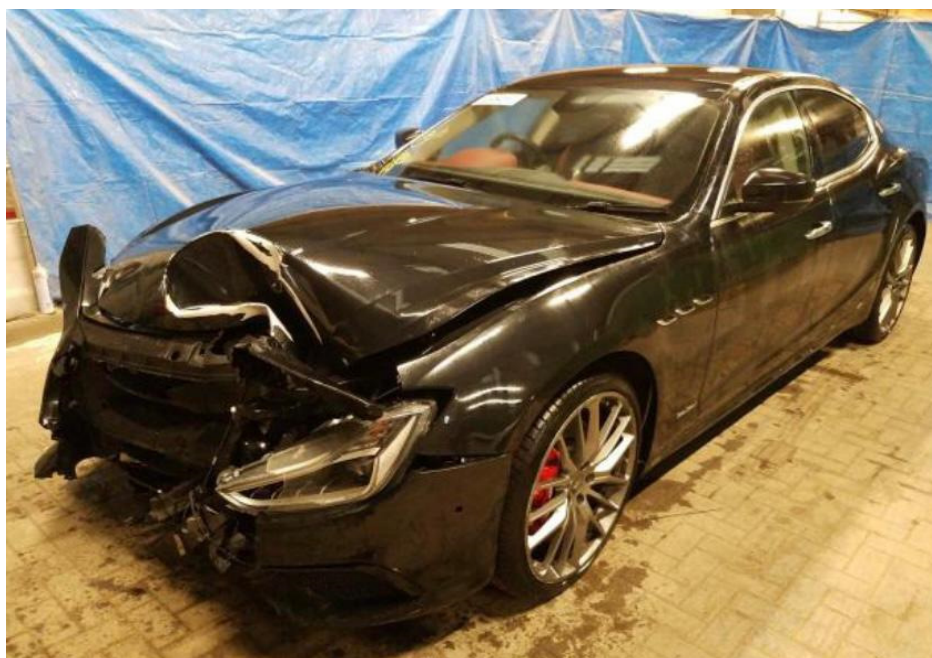
**Photo 2** shows the front left body of the Motor Car (photograph provided to me). The Motor Car was observed to have sustained damage at its frontal portion. The front bumper, front left headlamp, front radiator grille, front bumper centre lower grille, front left fender and front bonnet were amongst the body parts that were observed to have been damaged.

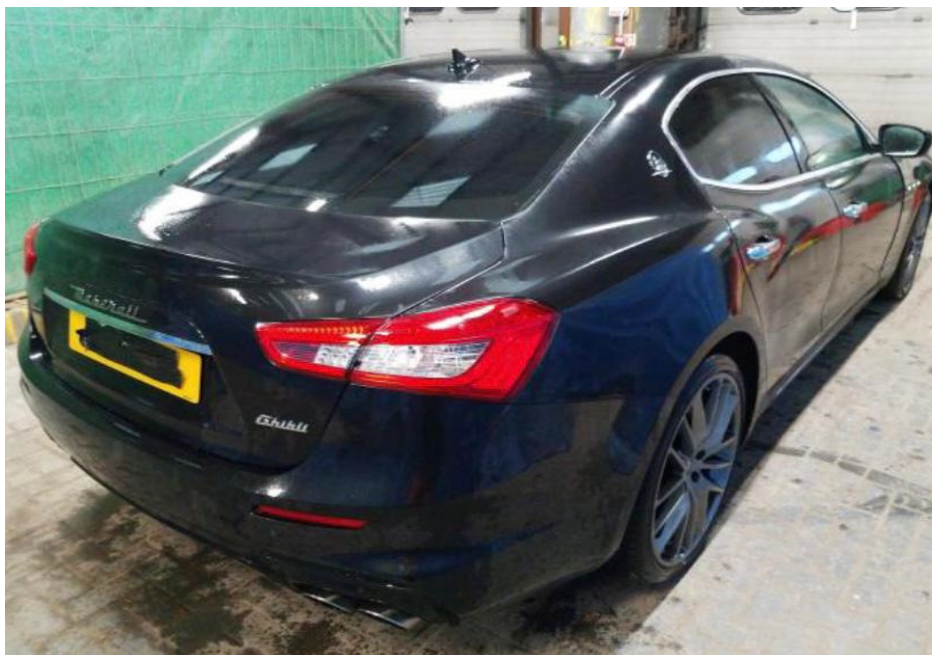
**Photo 3** shows the rear right body of the Motor Car (photograph provided to me). Apart for the frontal portion, there was no physical damage seen to other areas of the Motor Car.

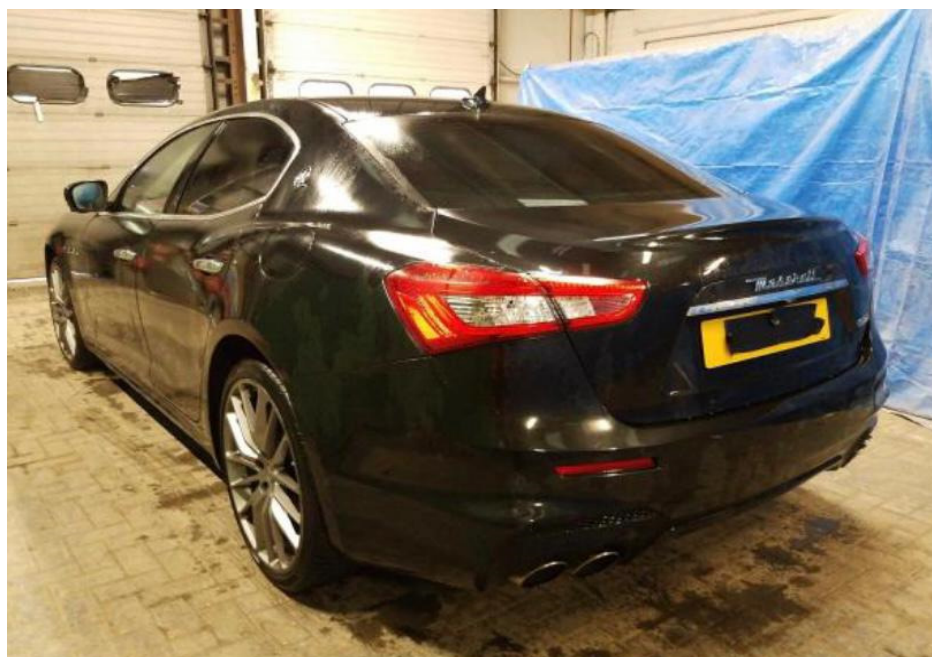
**Photo 4** shows the rear left body of the Motor Car (photograph provided to me). Apart for the frontal portion, there was no physical damage seen to other areas of the Motor Car.

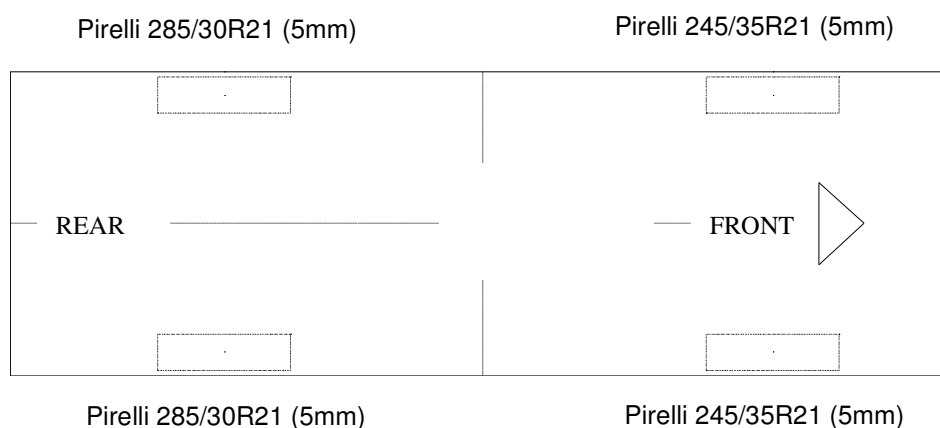
8. It was fitted with 21inch sport wheel rims that were wrapped with tyres that were observed to be of serviceable condition. The tyres were also sufficiently inflated for vehicular operation. The tyre brand, tyre size and approximate remaining tread depth of the 4 tyres of the Motor Car were recorded as follows: -

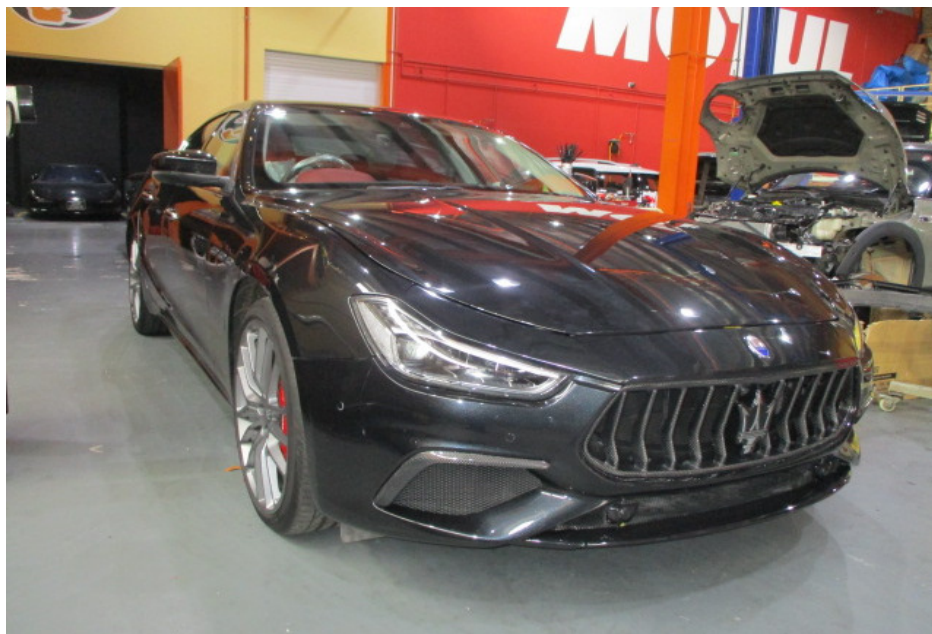
**Photo 5** shows a general view of the front right body of the Motor Car at the time of my inspection. The Motor Car was observed to be in a relatively good general condition with no loose exterior fittings observed. The body parts at the frontal portion of the Motor Car were visually examined and it was observed that the repair/restoration works carried out to the damaged area of the Motor Car (refer to photograph 1 & 2 above) were reasonably adequate and in order.

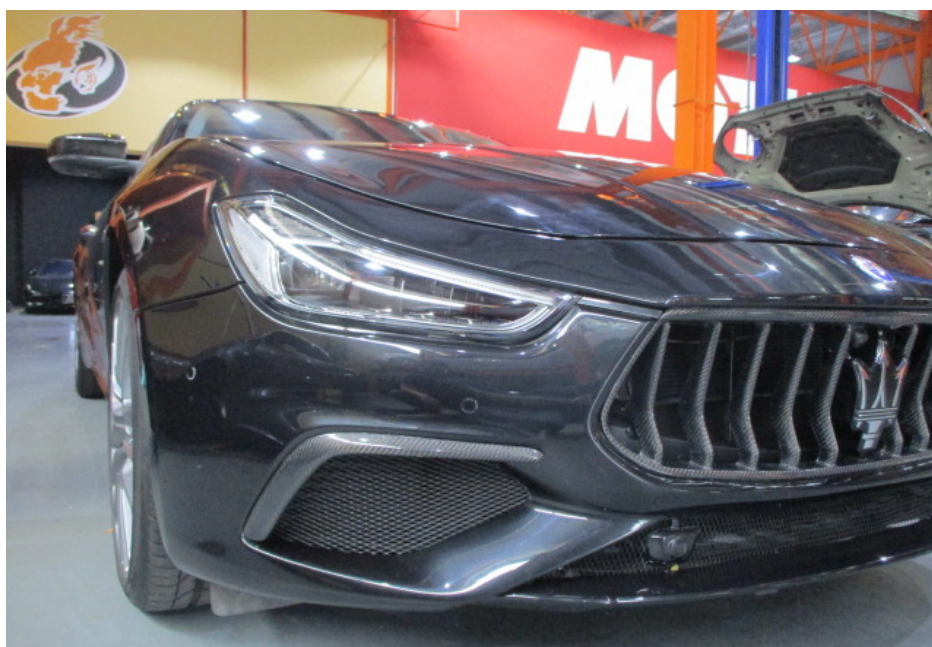
**Photo 6** shows a closer view of the front bumper, front right headlamp, front bonnet and front radiator grille of the Motor Car at the time of my inspection. The body parts at the frontal portion of the Motor Car were visually examined and it was observed that the repair/restoration works carried out to the damaged area of the Motor Car (refer to photograph 1 & 2 above) were reasonably adequate and in order.

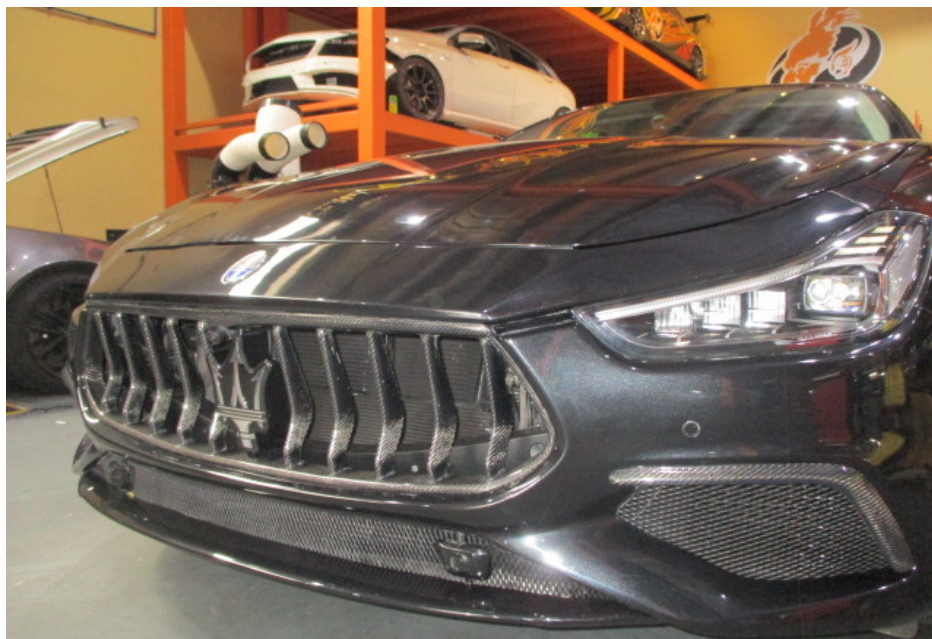
**Photo 7** shows a closer view of the front bumper, front left headlamp, front bonnet and front bumper centre lower grille of the Motor Car at the time of my inspection. The body parts at the frontal portion of the Motor Car were visually examined and it was observed that the repair/restoration works carried out to the damaged area of the Motor Car (refer to photograph 1 & 2 above) were reasonably adequate and in order.

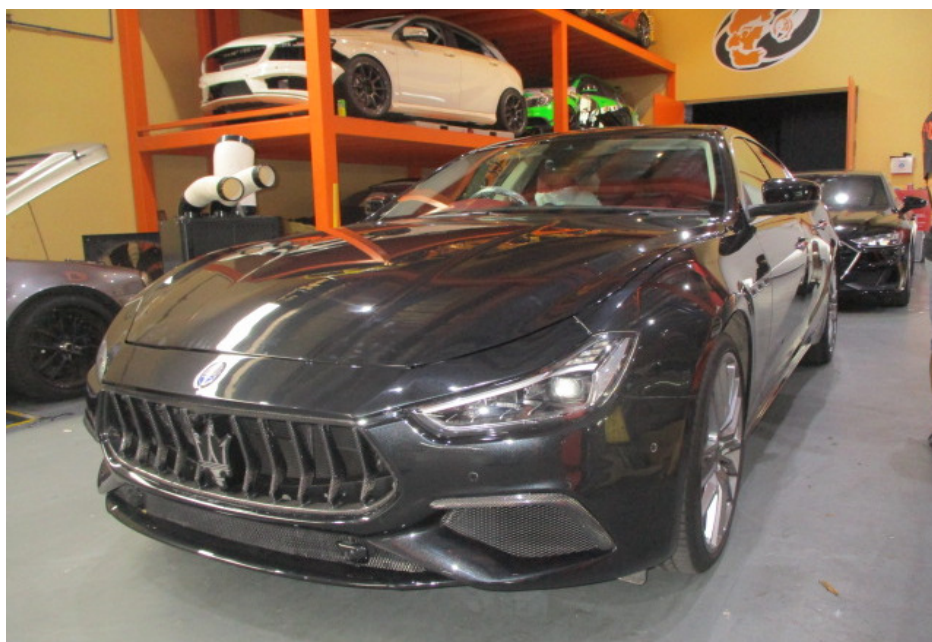
**Photo 8** shows a general view of the front left body of the Motor Car at the time of my inspection. The Motor Car was observed to be in a relatively good general condition with no loose exterior fittings observed. The body parts at the frontal portion of the Motor Car were visually examined and it was observed that the repair/restoration works carried out to the damaged area of the Motor Car (refer to photograph 1 & 2 above) were reasonably adequate and in order.

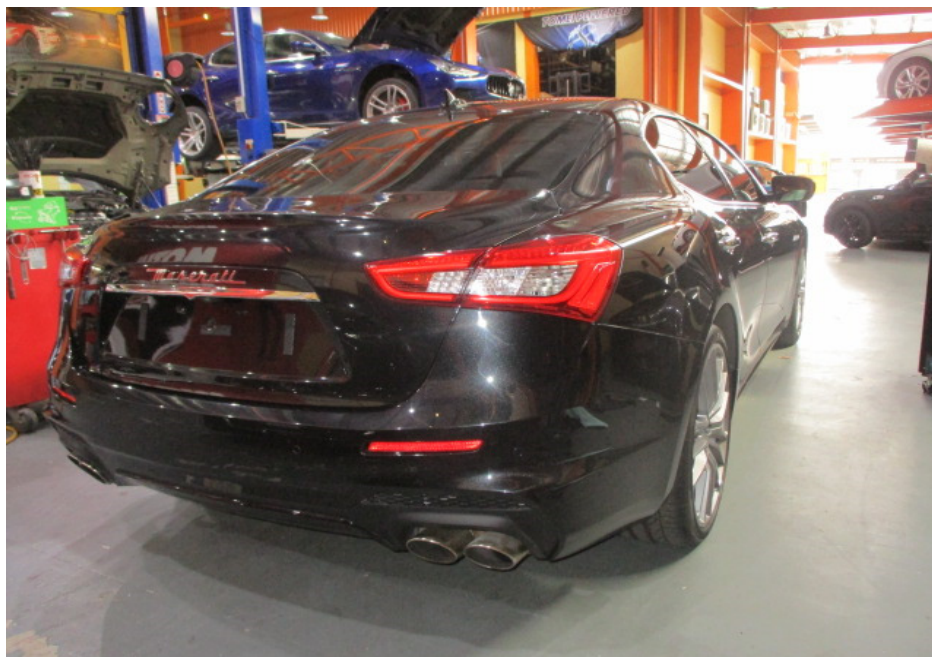
**Photo 9** shows a general view of the rear right body of the Motor Car at the time of my inspection. The Motor Car was observed to be in a relatively good general condition with no loose exterior fittings observed. The mileage of the Motor Car recorded at the time of my inspection was 34,728km.

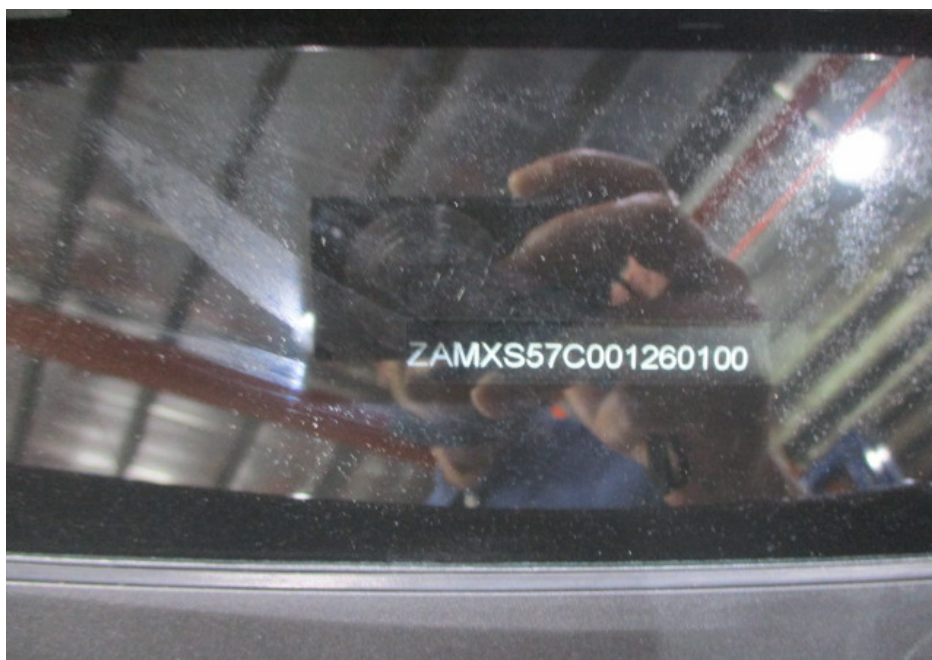
**Photo 10** shows the chassis number of the Motor Car. The chassis number recorded was ZAMXS57C001260100.

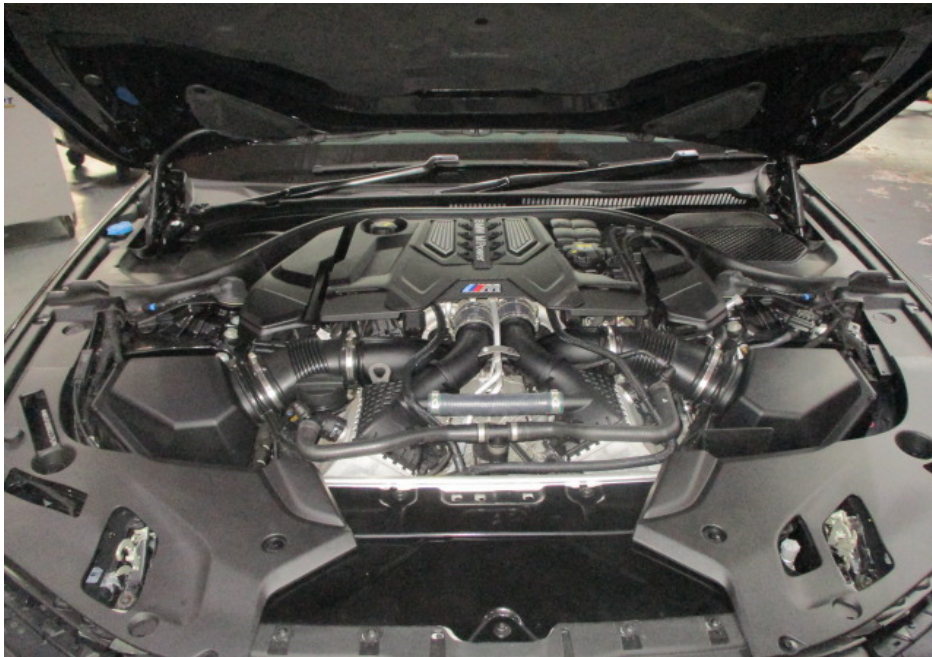
**Photo 11** shows a general view of the engine compartment of the Motor Car at the time of my inspection. The various parts and components inside the engine compartment were all observed to be intact and properly fitted. There was also no sign(s) or indication(s) of fluid leak and/or fluid stain found inside the engine compartment.

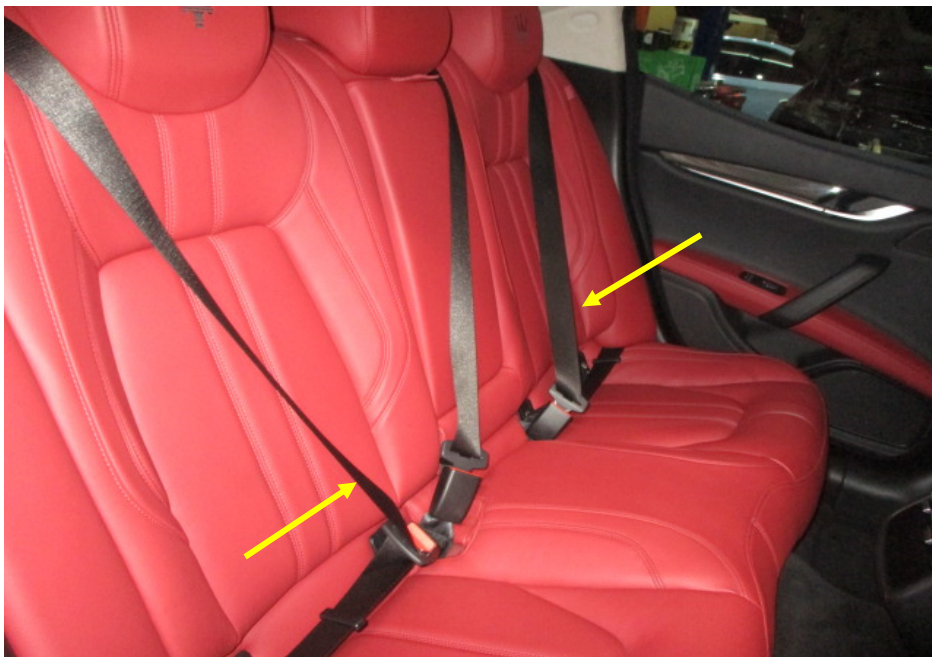
**Photo 12** shows the rear seats of the Motor Car. All the seats of the Motor Car were secured via seat rails to the floorboard. They were also fitted with a retractable seat belt reel and a pre-tensioner. The seat belts (arrowed) were tested and were able to be fastened into the respective pre-tensions that were fitted on the side of each individual seat.

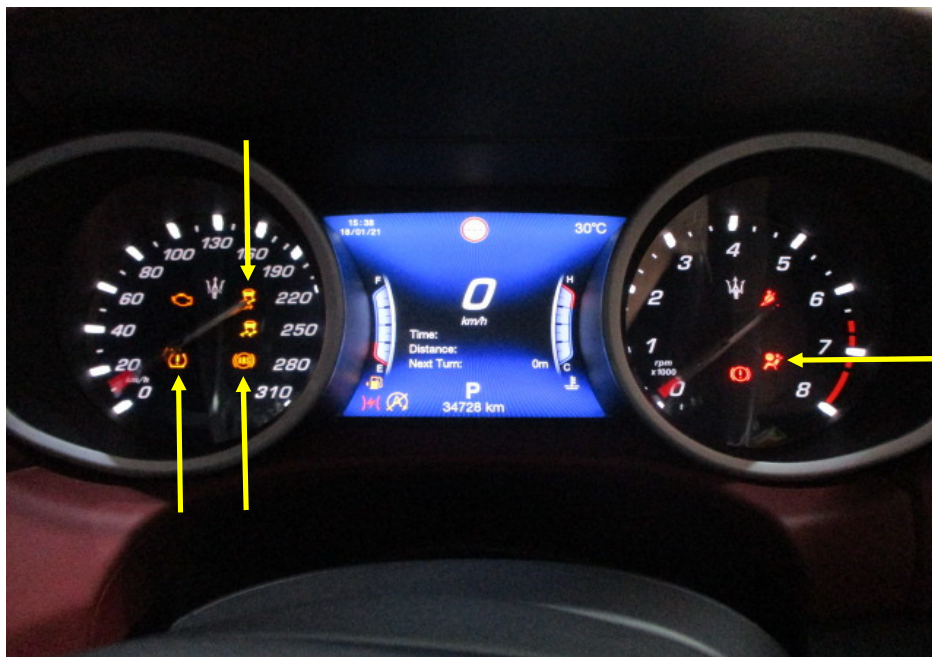
**Photo 13** shows the warning lights for the various electronic safety features appearing on the instrument panel of the Motor Car during its self-test when the engine is cranked, in particular the ABS, SRS, TPM and TC lights (arrowed).

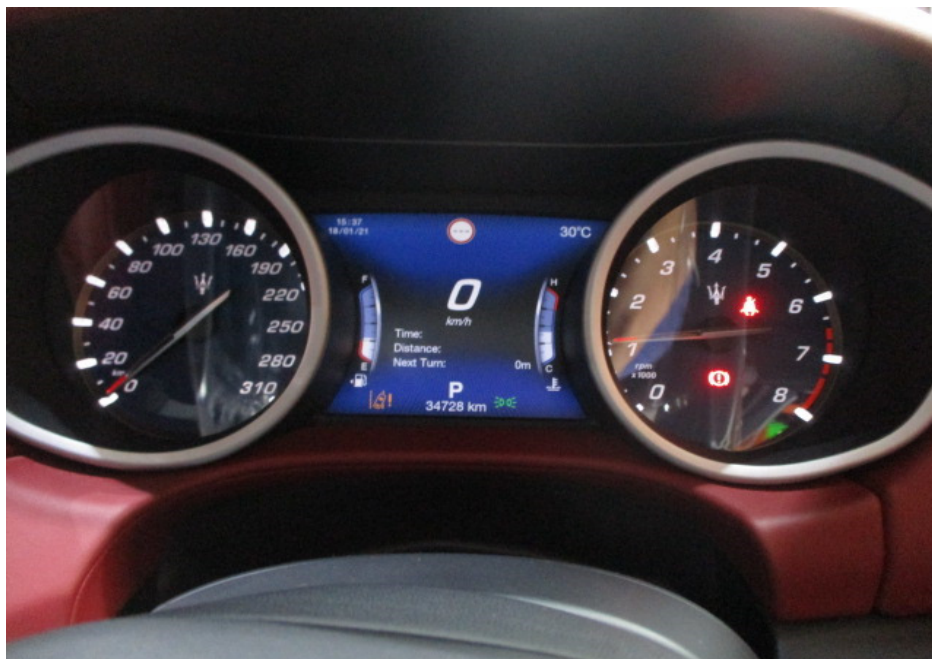
**Photo 14** shows the respective warning lights no longer illuminated, indicating that there is no fault detected to the ABS, SRS, TPM and TC systems of the Motor Car during the self-test. These electronic systems were hence in working condition at the time of my inspection.

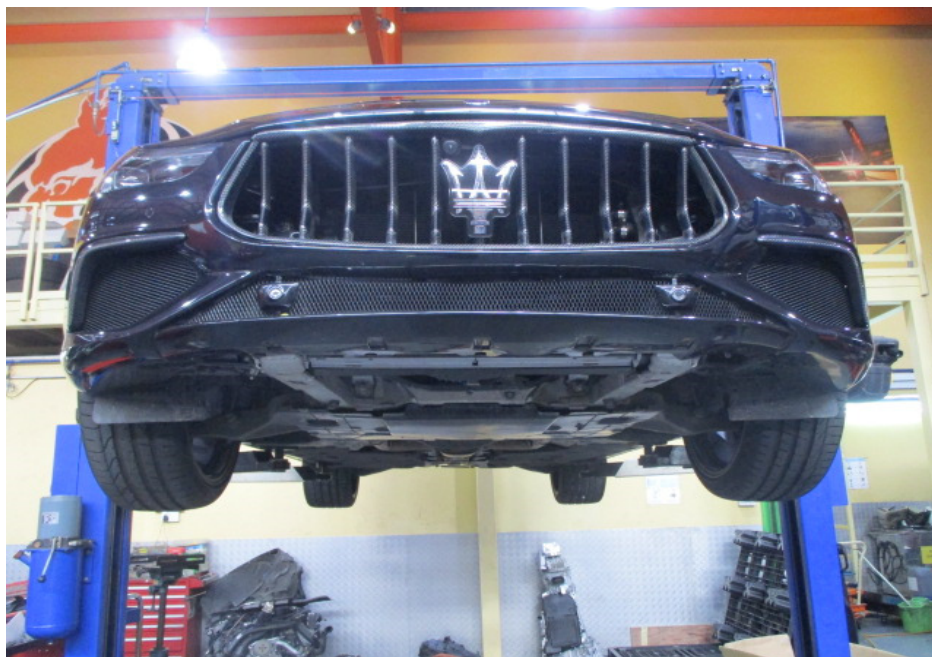
**Photo 15** shows the Motor Car hoisted up for checks on its undercarriage. There was no sign(s) or indication(s) of fluid leakage and/or fluid stain(s) on the underside of the Motor Car. The undercarriage components of the Motor Car were also all observed to be intact and secured in an appropriate manner.

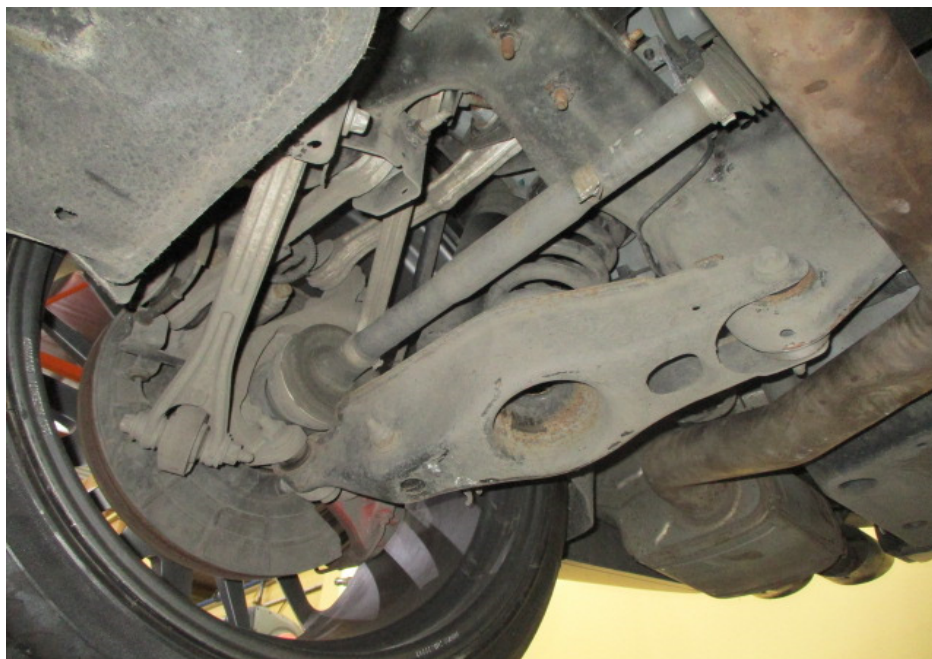
**Photo 16** shows a general view of the control arms and linkages at the rear right wheel of the Motor Car. I did not observe any fluid leak and/or fluid stain on the underside of the Motor Car. All of the Motor Car's undercarriage components were observed to be intact and secured in an appropriate manner.

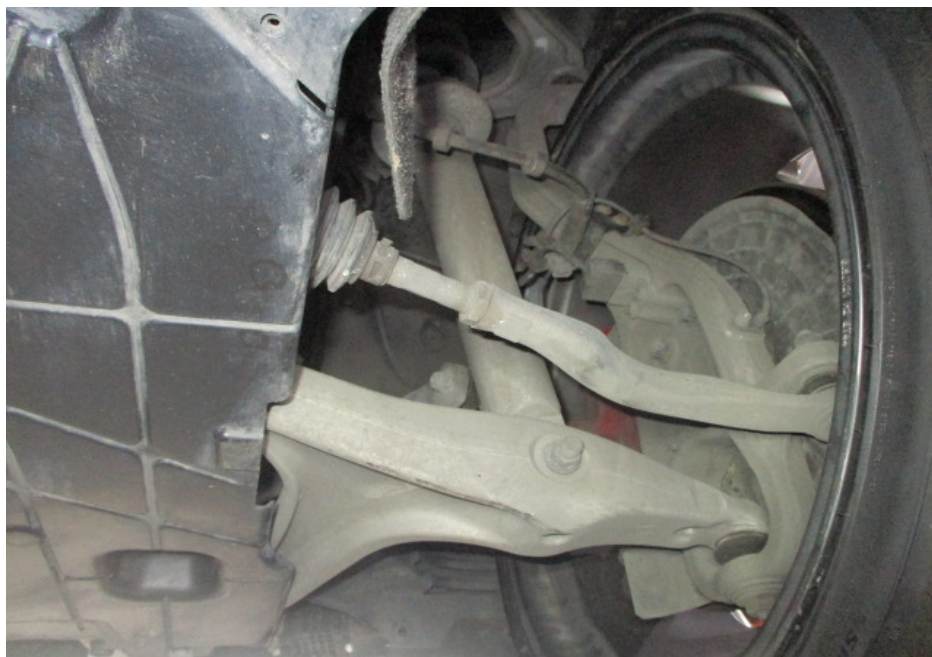
**Photo 17** shows the various undercarriage components at the front right wheel of the Motor Car. The mechanical components, control arms and linkages were all found to be intact and secured in an appropriate manner.

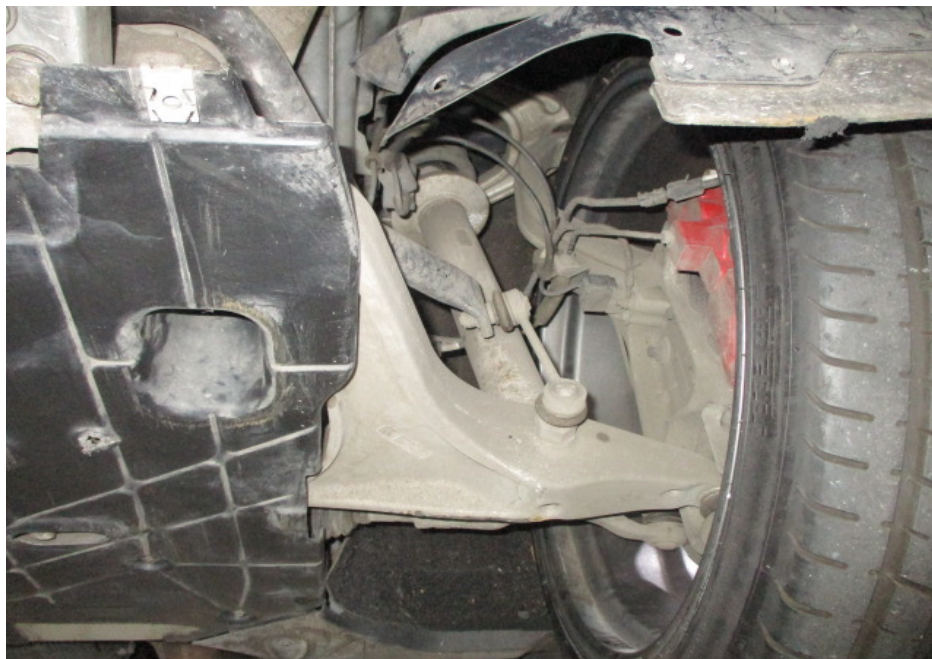
**Photo 18** shows the various undercarriage components at the front left wheel of the Motor Car. The mechanical components, control arms and linkages were all found to be intact and secured in an appropriate manner. I also did not observe any fluid leak and/or fluid stain on the underside of the Motor Car.

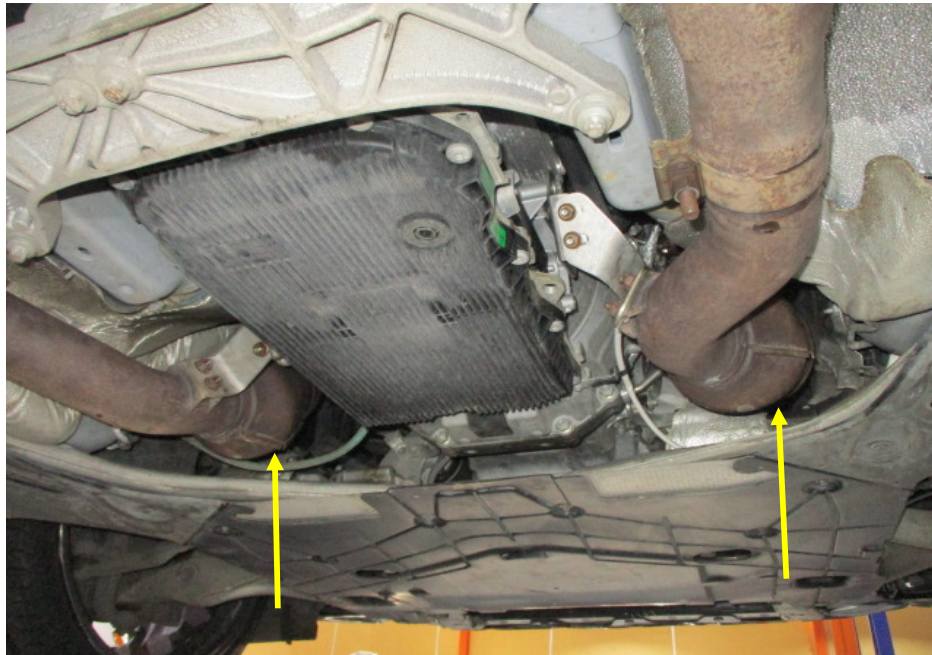
**Photo 19** shows the Motor Car's catalytic converters (arrowed). My examination of the Motor Car's exhaust system revealed no sign(s) or indication(s) of any cut or weld marks along its exhaust pipes and on its rear mufflers.

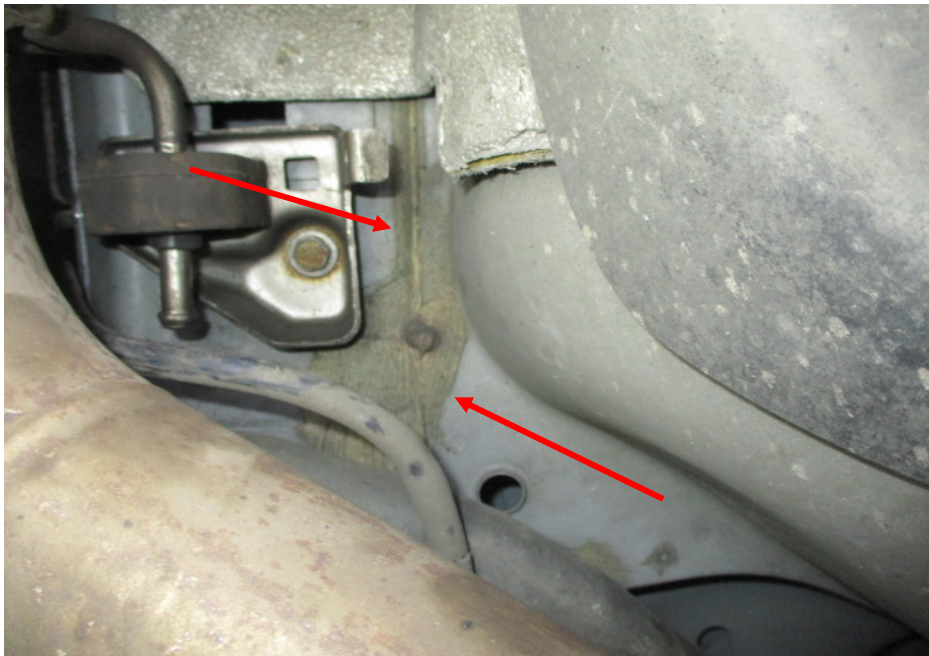
**Photo 20** shows the floorboard at the underside rear left of the Motor Car. The original factory sealant (arrowed) at the joints along the non-detachable body panels were untouched, indicating no work was done on the non-detachable body panels of the Motor Car; and that these body panels were originally fitted. In general, I had found all the non-detachable body panels of the Motor Car to be originally fitted at the time of my inspection.

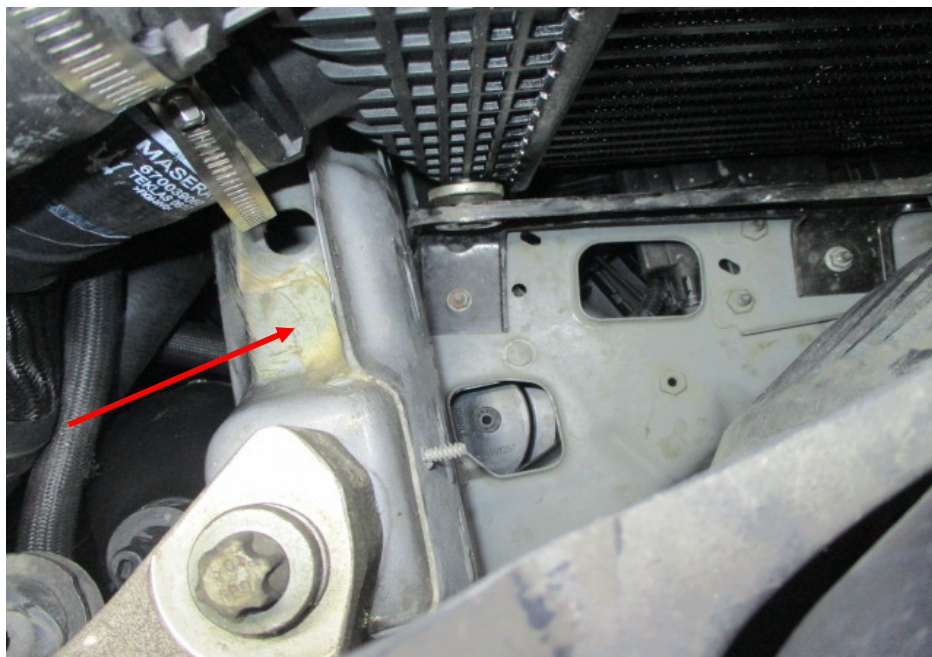
**Photo 21** shows the chassis/structural body at the underside front left of the Motor Car. The original factory sealant (arrowed) at the joints along the chassis/structural body was observed to be untouched. In general, I had found no work was carried out on the chassis/structural body of the Motor Car. The chassis/structural body of the Motor Car was originally fitted.

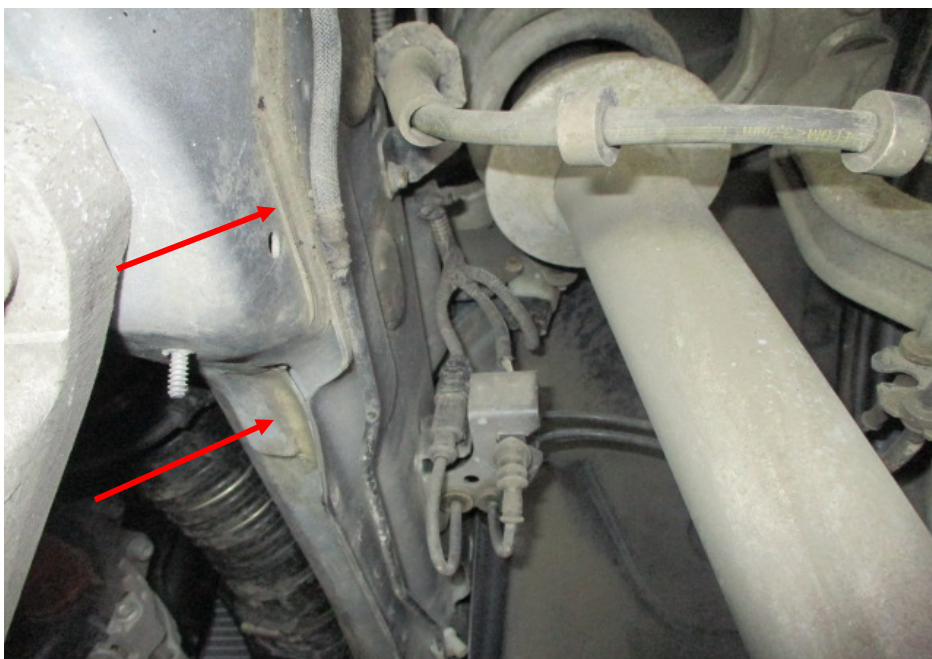
**Photo 22** shows the chassis/structural body at the underside front right of the Motor Car. The original factory sealant (arrowed) at the joints along the chassis/structural body was observed to be untouched. In general, I had found no work was carried out on the chassis/structural body of the Motor Car. The chassis/structural body of the Motor Car was originally fitted.

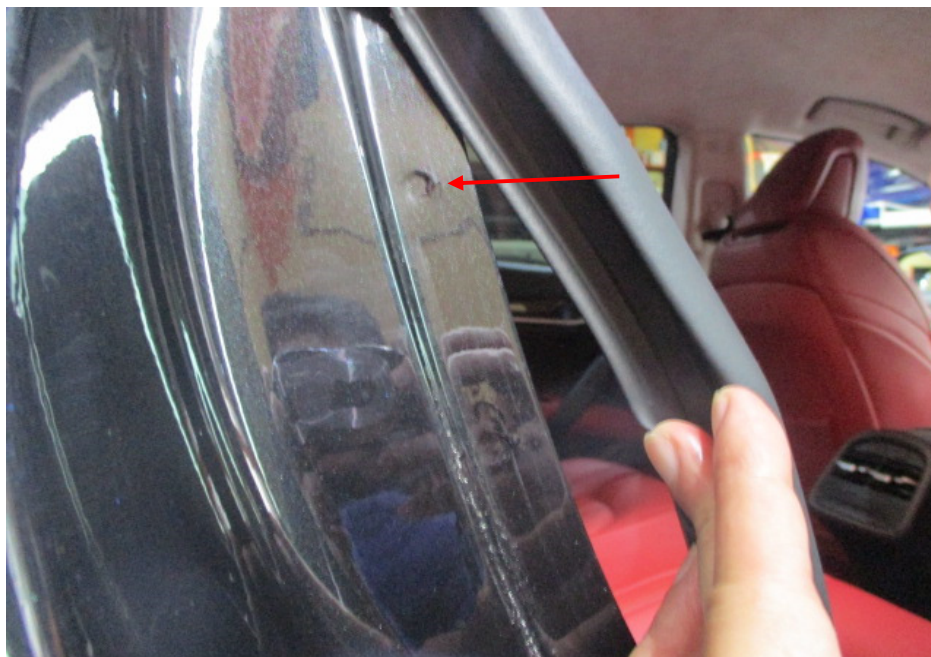
**Photo 23** shows the right side "C" pillar of the Motor Car. I did not find any weld marks other than original spot weld marks (arrowed) on the right side "C" pillar of the Motor Car which, indicates that there was no re-welding works carried out. In general, I had found all the non-detachable body panels of the Motor Car to be originally fitted at the time of my inspection.
