Your Ref: Mercedes Benz C300 Coupe  
(chassis number WDD2053832F898653)  
Our Ref : CI/TP21001117/D

16 February 2021

**INSPECTION REPORT OF AN UNREGISTERD MERCEDES BENZ C300  
COUPE MOTOR CAR WITH CHASSIS NUMBER WDD2053832F898653**

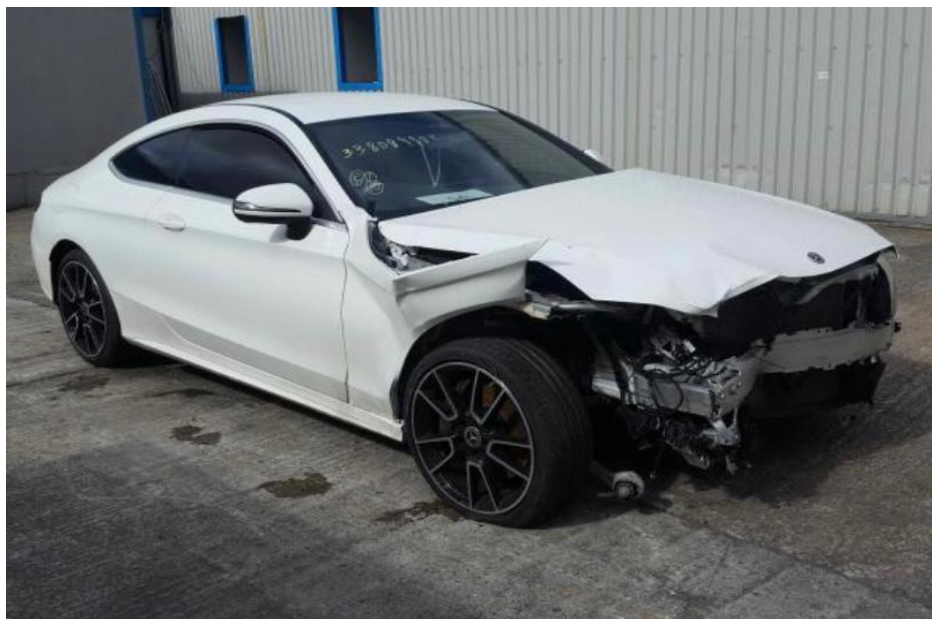
3. From the photographs provided to me, it was observed that the Motor Car had sustained damages at its frontal portion. Body parts damaged include the front bumper and all its related parts and attachments, front bumper reinforcement, front radiator grille, front headlamps, front bonnet, front bonnet lock, front bonnet hinges, front support panel and front right fender amongst others.
4. The orientation of the front right wheel and front left wheel, as seen from the photographs, indicates to me that the front right undercarriage parts of the Motor Car were also damaged. The airbags of the Motor Car were not deployed. See photo 1 – 4 below.

**Photo 1** shows the front right body of the Motor Car (photograph provided to me). The Motor Car was observed to have sustained damage at its frontal portion. The front bumper and all its related parts and attachments, front bonnet, front right fender and front right headlamp were amongst the body parts that were observed to have been damaged. The front right wheel and front left wheel (refer to photograph 2 below) were orientated in different directions, which suggests to me that the front right undercarriage parts of the Motor Car were also damaged.

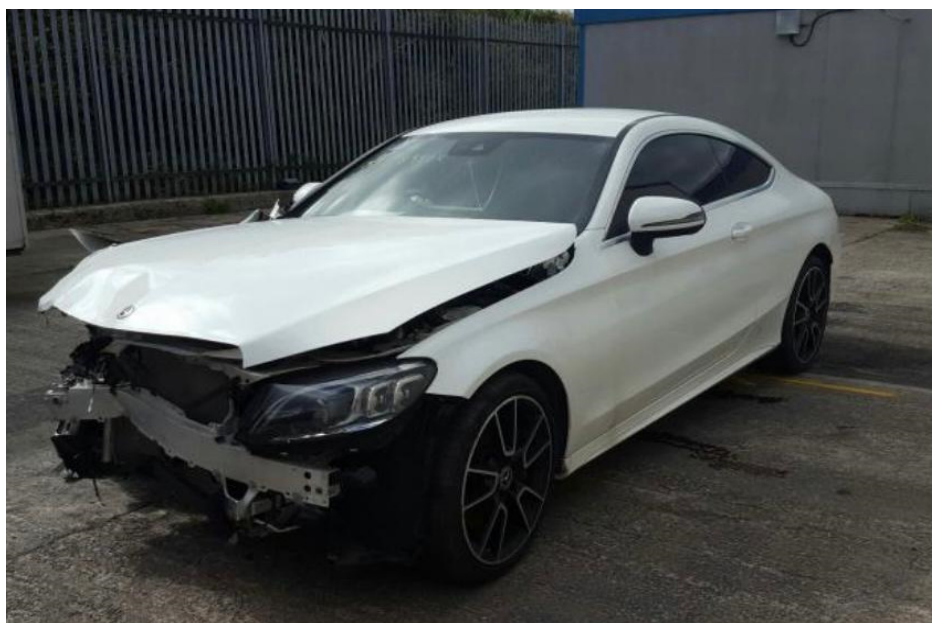
**Photo 2** shows the front left body of the Motor Car (photograph provided to me). The front left wheel was orientated straight as compared to the front right wheel, which was orientated slightly to the left (refer to photograph 1 above). This would indicate to me that there was damage to the front right undercarriage parts of the Motor Car, given that the front left portion of the Motor Car was seen to be undamaged.

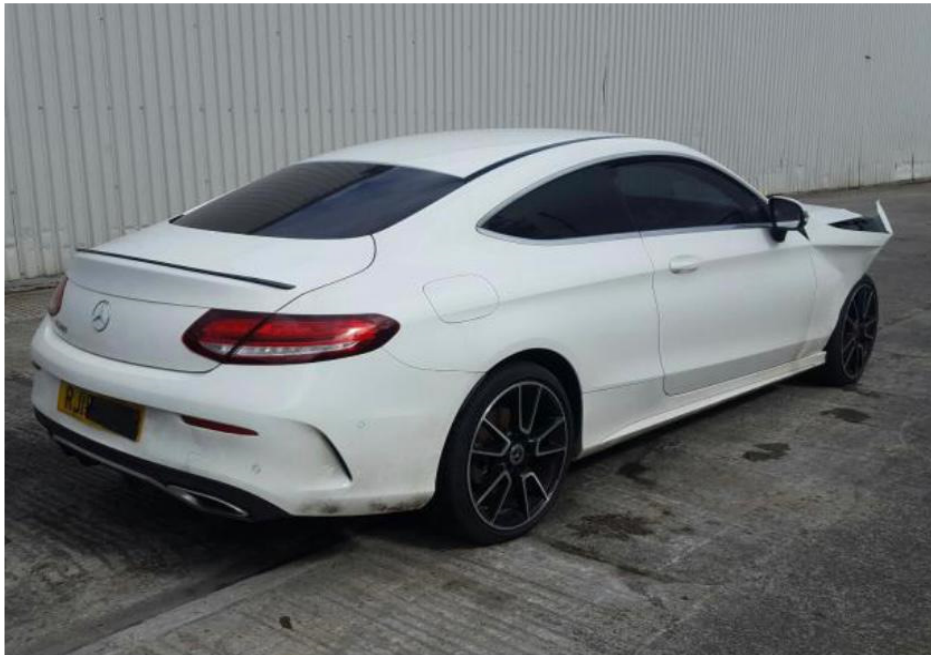
**Photo 3** shows the rear right body of the Motor Car (photograph provided to me). Apart for the frontal portion, there was no physical damage seen to other areas of the Motor Car.

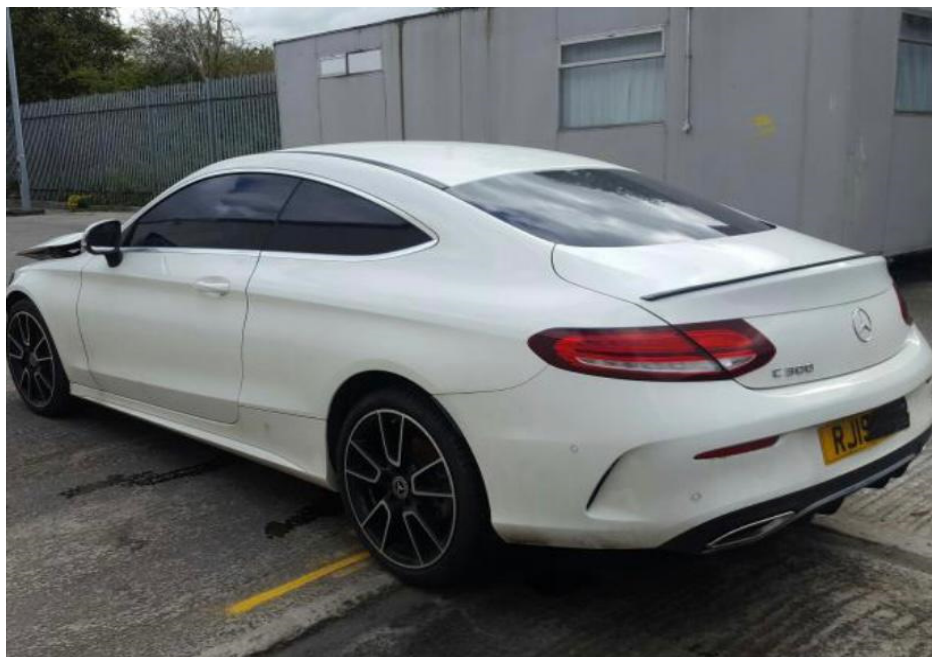
**Photo 4** shows the rear left body of the Motor Car (photograph provided to me). Apart for the frontal portion, there was no physical damage seen to other areas of the Motor Car.

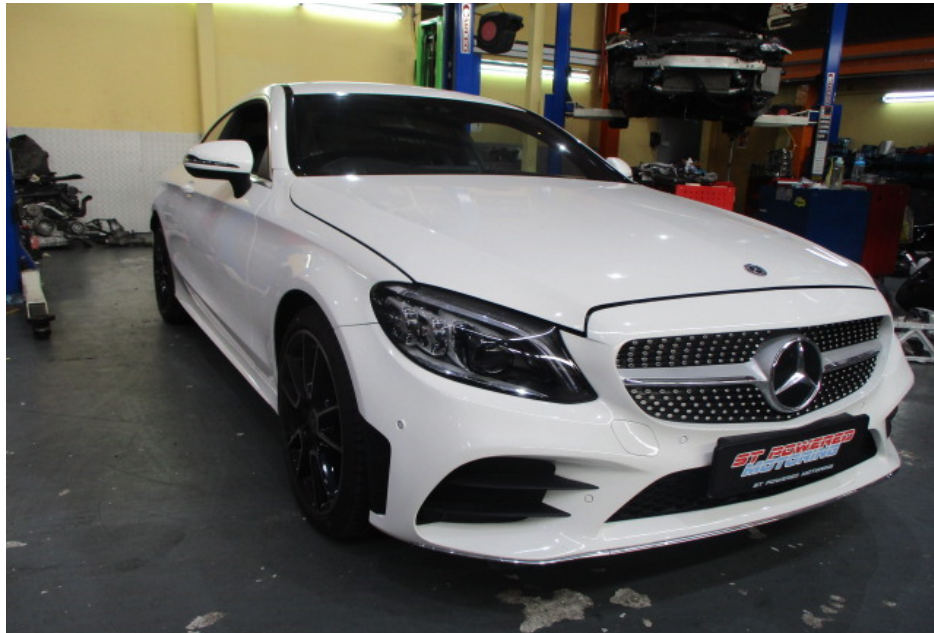
22. The body parts at the frontal portion of the Motor Car were visually examined and it was noted that the repair/restoration works carried out to the damaged area of the Motor Car (refer to photograph 1 & 2 above) were reasonably adequate and in order.

**Photo 5** shows a general view of the front right body of the Motor Car at the time of my inspection. The Motor Car was observed to be in a relatively good general condition with no loose exterior fittings observed. The body parts at the frontal portion of the Motor Car were visually examined and it was observed that the repair/restoration works carried out to the damaged area of the Motor Car (refer to photograph 1 & 2 above) were reasonably adequate and in order.

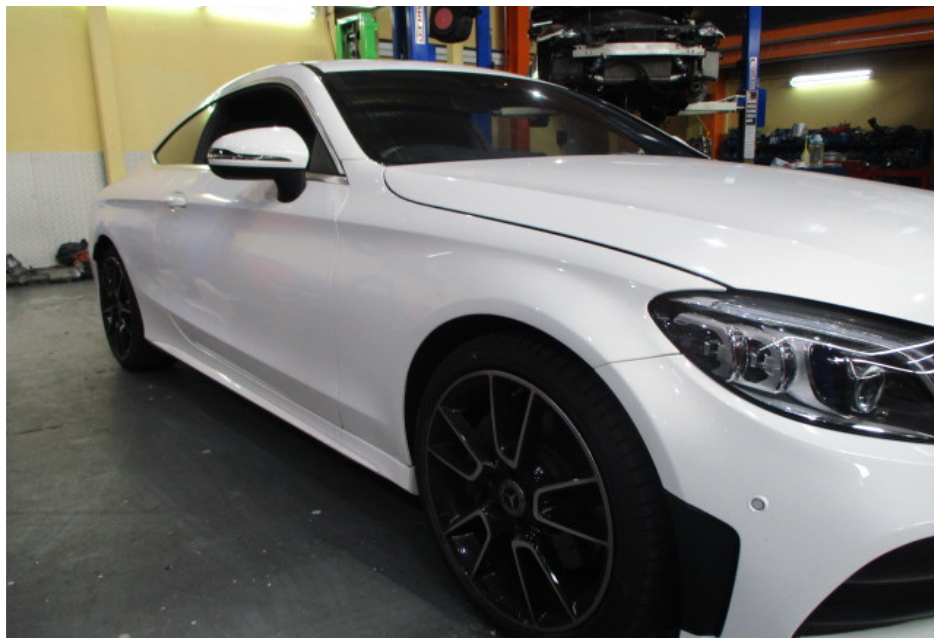
**Photo 6** shows a closer view of the front bumper, front right headlamp, front bonnet and front right fender of the Motor Car at the time of my inspection. The body parts at the frontal portion of the Motor Car were visually examined and it was observed that the repair/restoration works carried out to the damaged area of the Motor Car (refer to photograph 1 & 2 above) were reasonably adequate and in order.

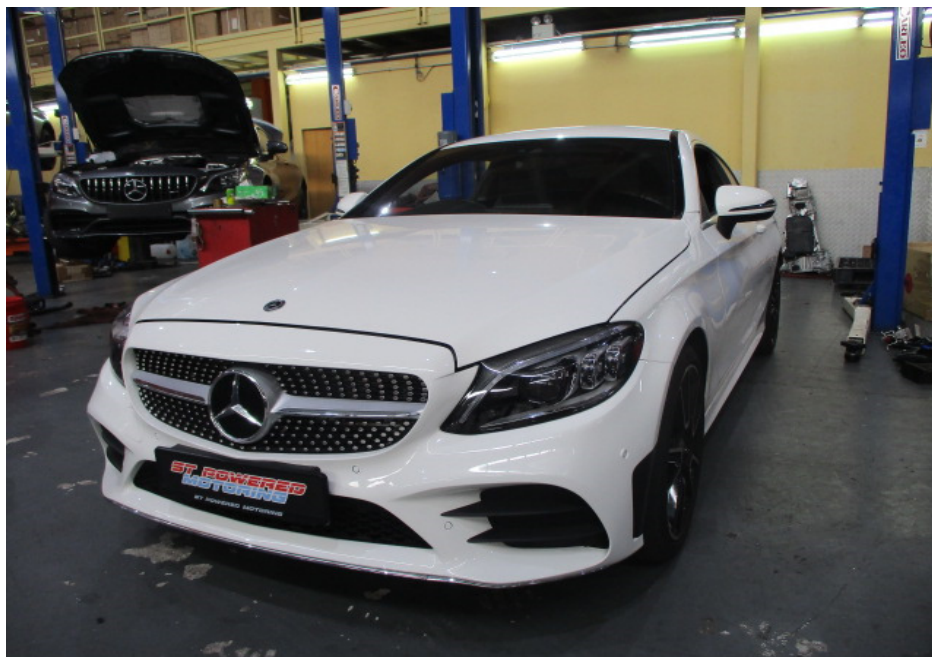
**Photo 7** shows a general view of the front left body of the Motor Car at the time of my inspection. The Motor Car was observed to be in a relatively good general condition with no loose exterior fittings observed. The body parts at the frontal portion of the Motor Car were visually examined and it was observed that the repair/restoration works carried out to the damaged area of the Motor Car (refer to photograph 1 & 2 above) were reasonably adequate and in order.

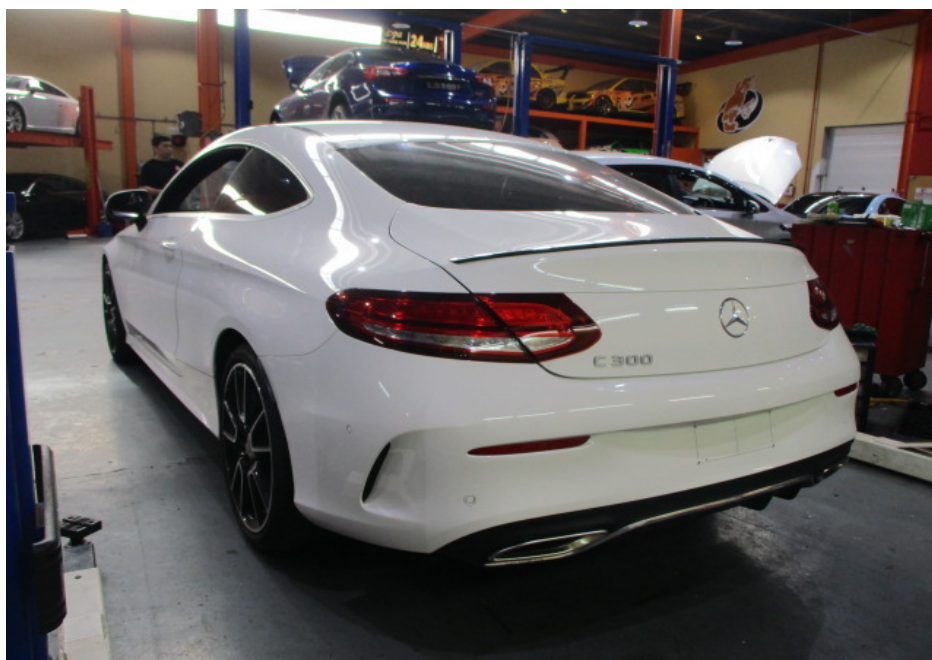
**Photo 8** shows a general view of the rear left body of the Motor Car at the time of my inspection. The Motor Car was observed to be in a relatively good general condition with no loose exterior fittings observed. The mileage of the Motor Car recorded at the time of my inspection was 13,972km.

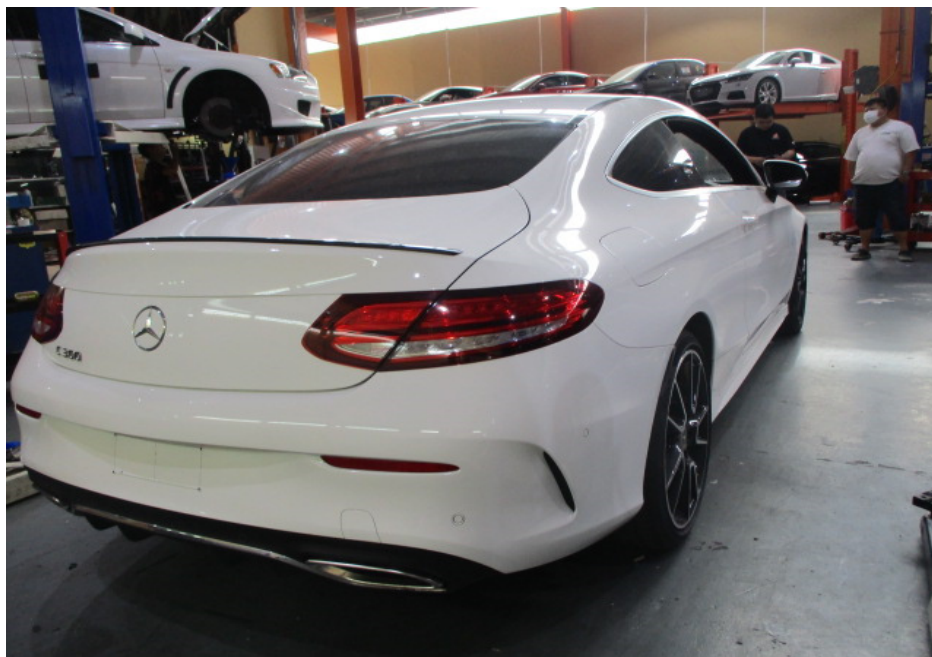
**Photo 9** shows a general view of the rear right body of the Motor Car at the time of my inspection. The Motor Car was observed to be in a relatively good general condition with no loose exterior fittings observed. The mileage of the Motor Car recorded at the time of my inspection was 13,972km.

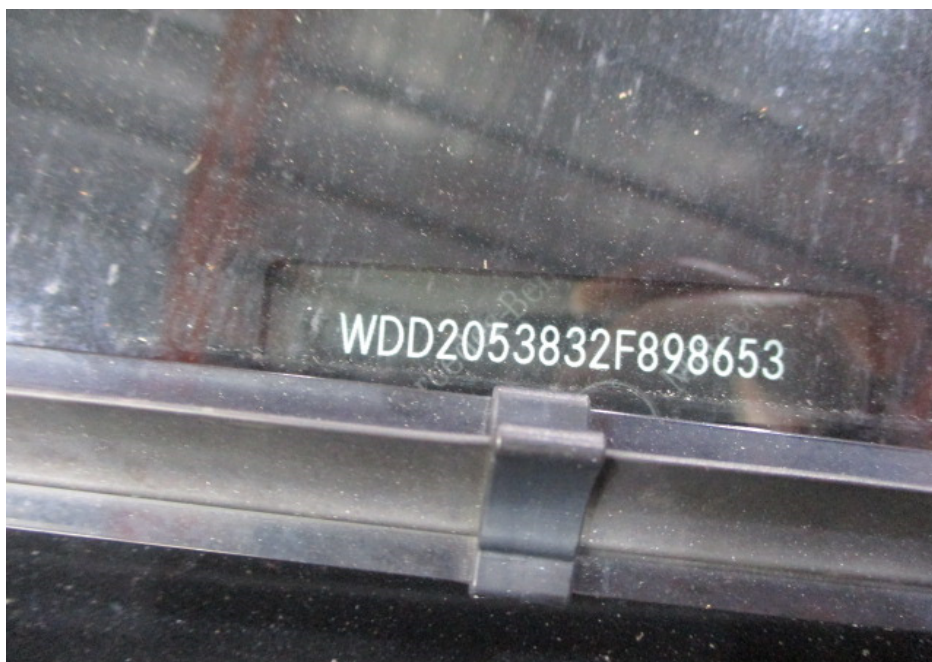
**Photo 10** shows the chassis number of the Motor Car. The chassis number recorded was WDD2053832F898653.

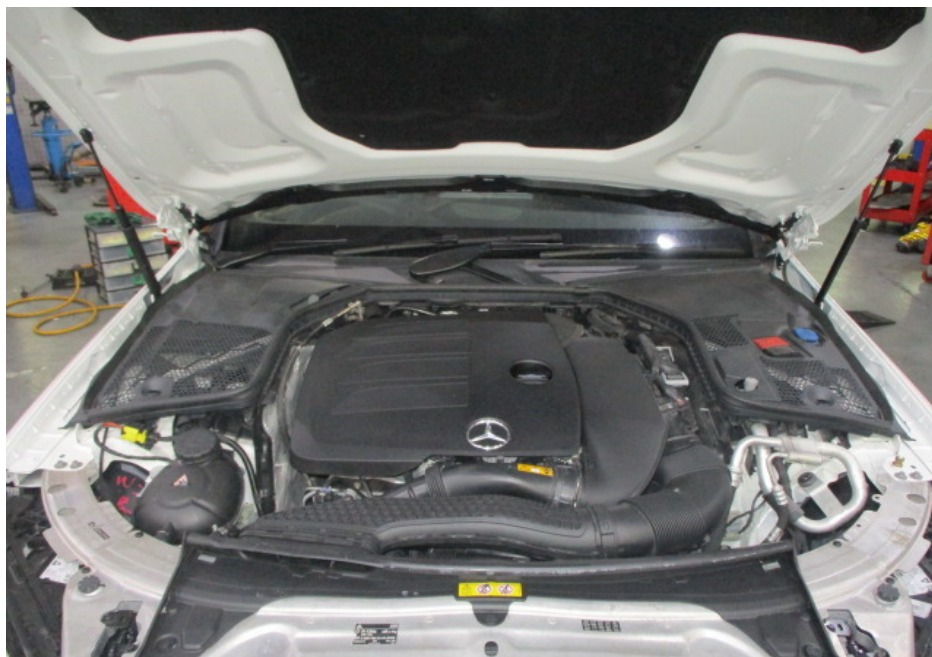
**Photo 11** shows a general view of the engine compartment of the Motor Car at the time of my inspection. The various parts and components inside the engine compartment were all observed to be intact and properly fitted. There was also no sign(s) or indication(s) of fluid leak and/or fluid stain found inside the engine compartment.

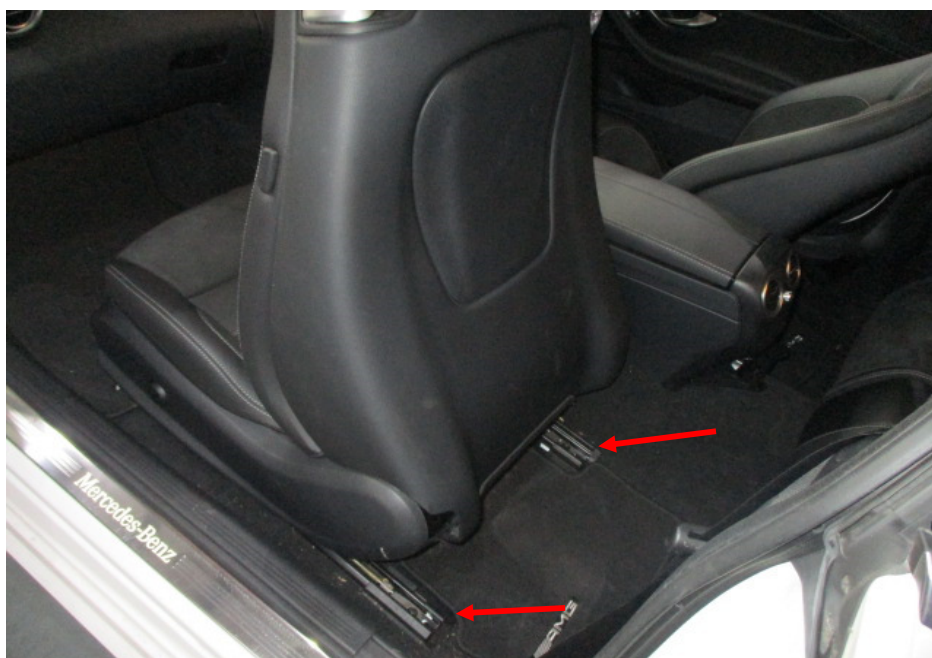
**Photo 12** shows the front left seat of the Motor Car. All the seats of the Motor Car were secured via seat rails (arrowed) to the floorboard and were fitted with a retractable seat belt reel and pre-tensioner. The seat belts were tested and were able to be fastened into the respective pre-tensions that were fitted on the side of each individual seat.

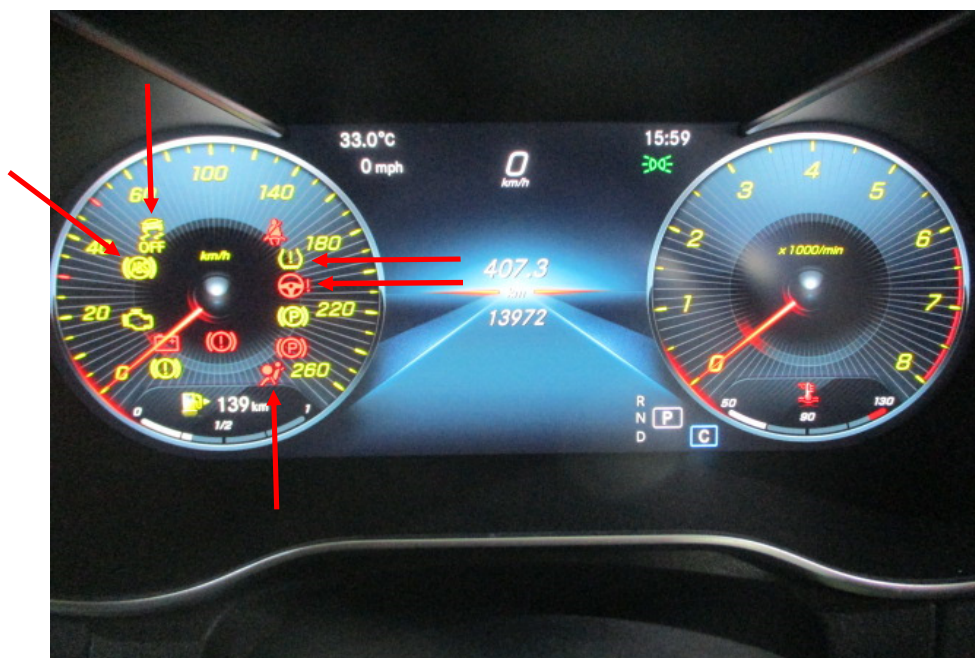
**Photo 13** shows the warning lights for the various electronic safety features appearing on the instrument panel of the Motor Car during its self-test when the engine is cranked, in particular the ABS, SRS, EPS, TPM and TCS lights (arrowed).

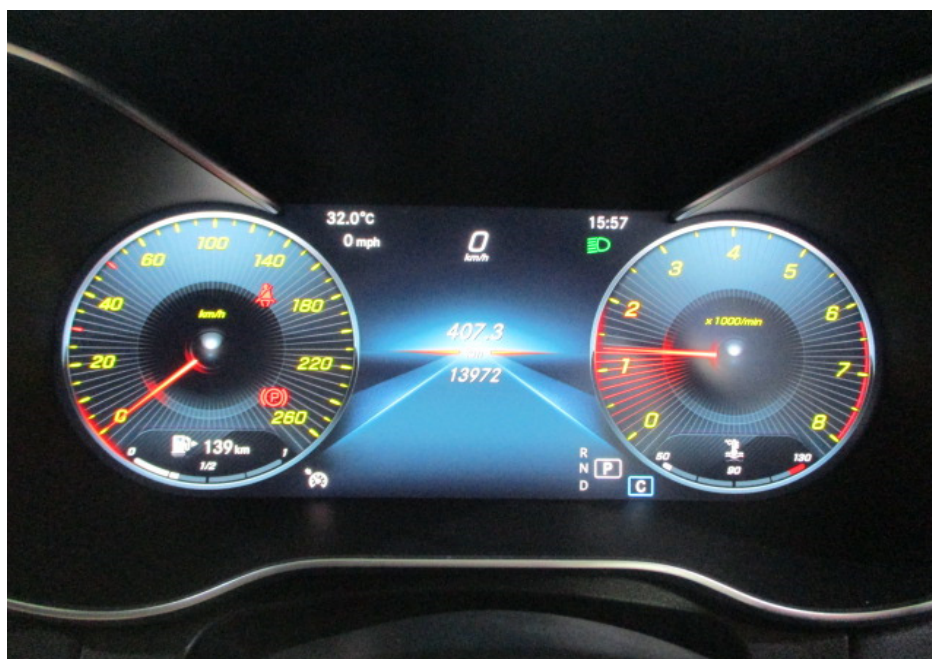
**Photo 14** shows the respective warning lights no longer illuminated, indicating that there is no fault detected to the ABS, SRS, EPS, TPM and TCS systems of the Motor Car during the self-test. These electronic systems were hence in working condition at the time of my inspection.

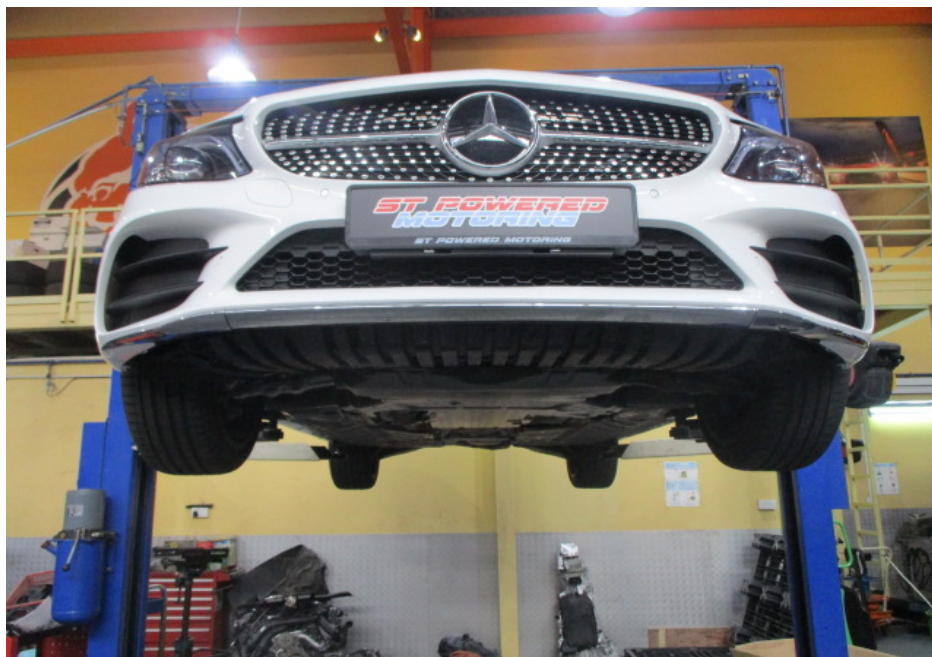
**Photo 15** shows the Motor Car hoisted up for checks on its undercarriage. There was no sign(s) or indication(s) of fluid leakage and/or fluid stain(s) on the underside of the Motor Car. The undercarriage components of the Motor Car were also all observed to be intact and secured in an appropriate manner.

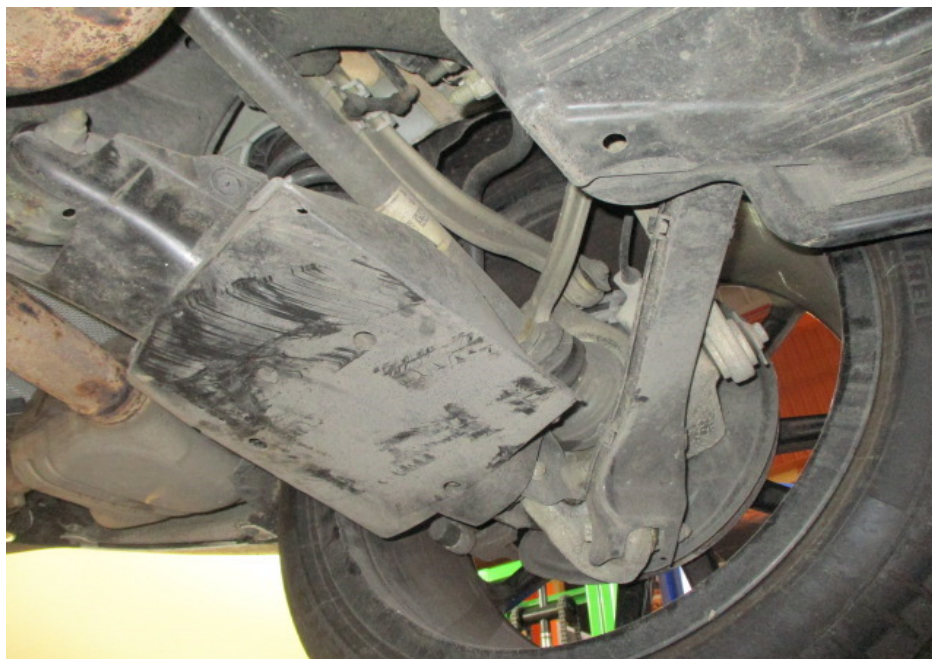
**Photo 16** shows a general view of the control arms and linkages at the rear left wheel of the Motor Car. I did not observe any fluid leak and/or fluid stain on the underside of the Motor Car. All of the Motor Car's undercarriage components were observed to be intact and secured in an appropriate manner.

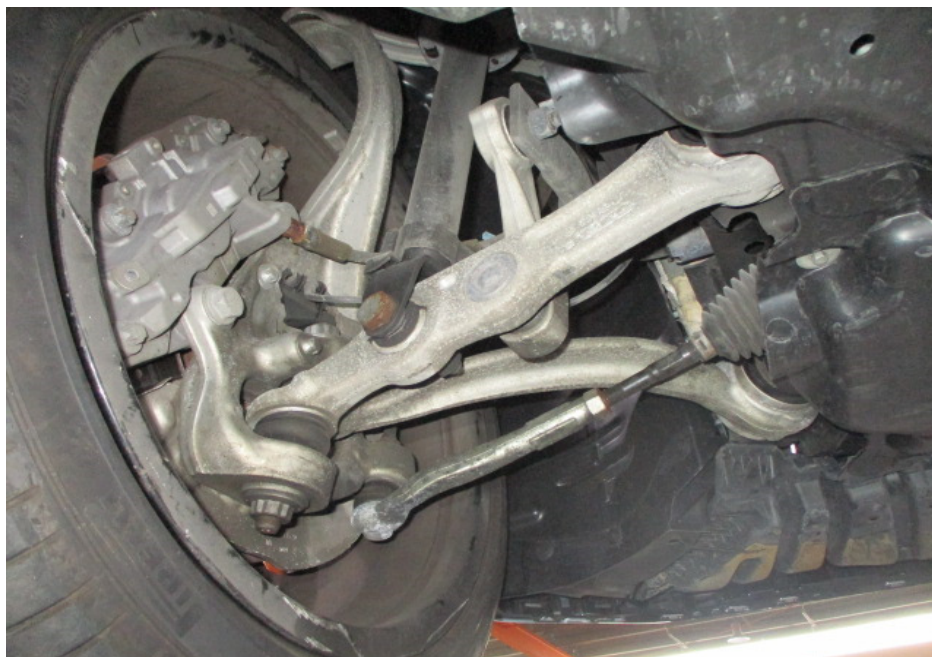
**Photo 17** shows the various undercarriage components at the front left wheel of the Motor Car. The mechanical components, control arms and linkages were all found to be intact and secured in an appropriate manner.

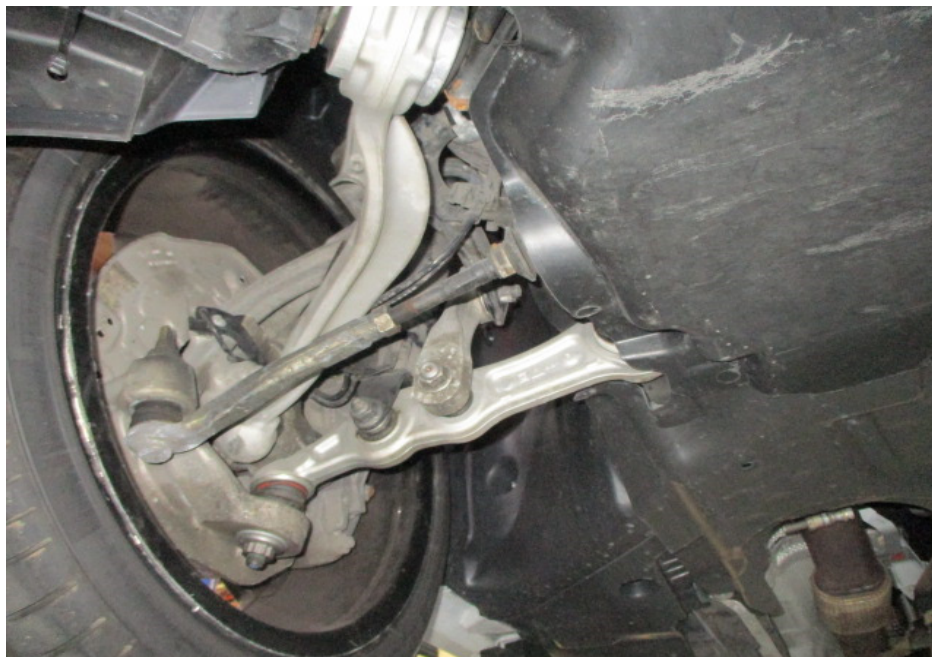
**Photo 18** shows the various undercarriage components at the front right wheel of the Motor Car. The mechanical components, control arms and linkages were all found to be intact and secured in an appropriate manner. I also did not observe any fluid leak and/or fluid stain on the underside of the Motor Car.

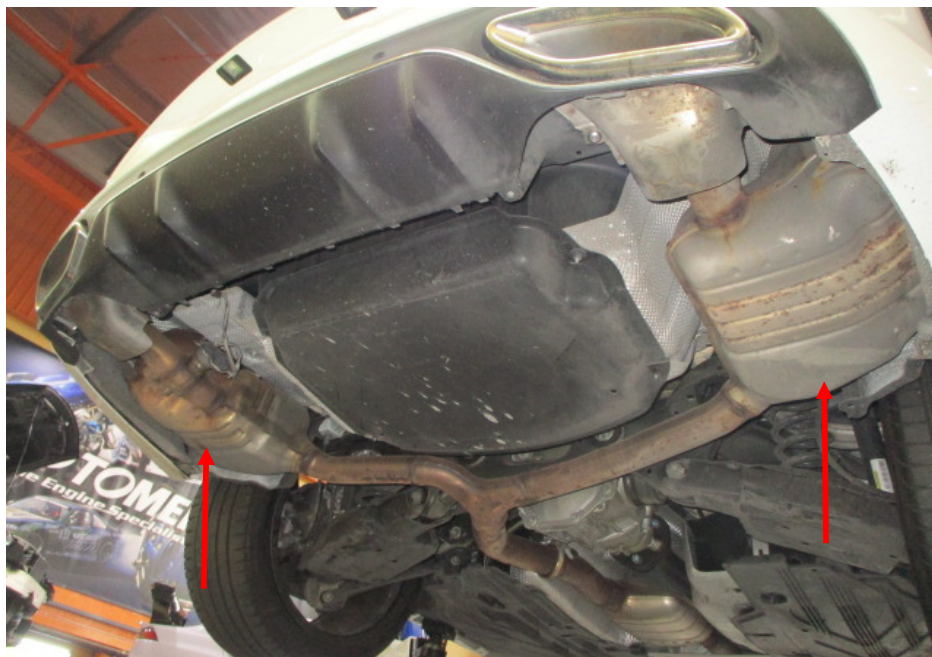
**Photo 19** shows the Motor Car's rear mufflers (arrowed). My examination of the Motor Car's exhaust system revealed no sign(s) or indication(s) of any cut or weld marks along its exhaust pipes and on its catalytic converter.

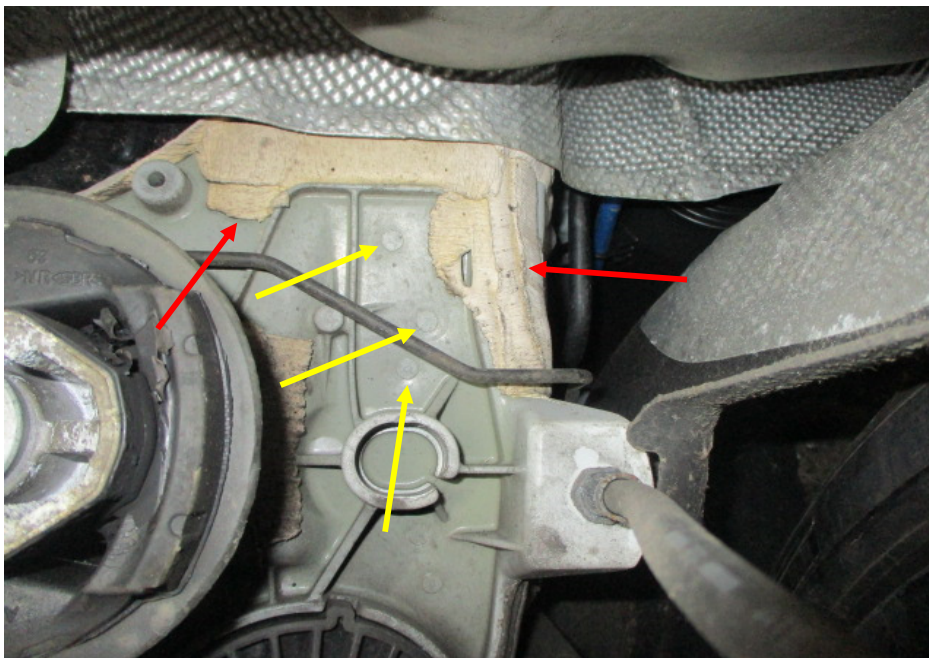
**Photo 20** shows the chassis/structural body at the underside rear right of the Motor Car. I did not find any weld marks other than original spot weld marks (yellow arrow) on the chassis/structural body of the Motor Car. The original factory sealant (red arrow) at the joints along the chassis/structural body was untouched, indicating no work was done on the chassis/structural body of the Motor Car and that the chassis/structural body was originally fitted.

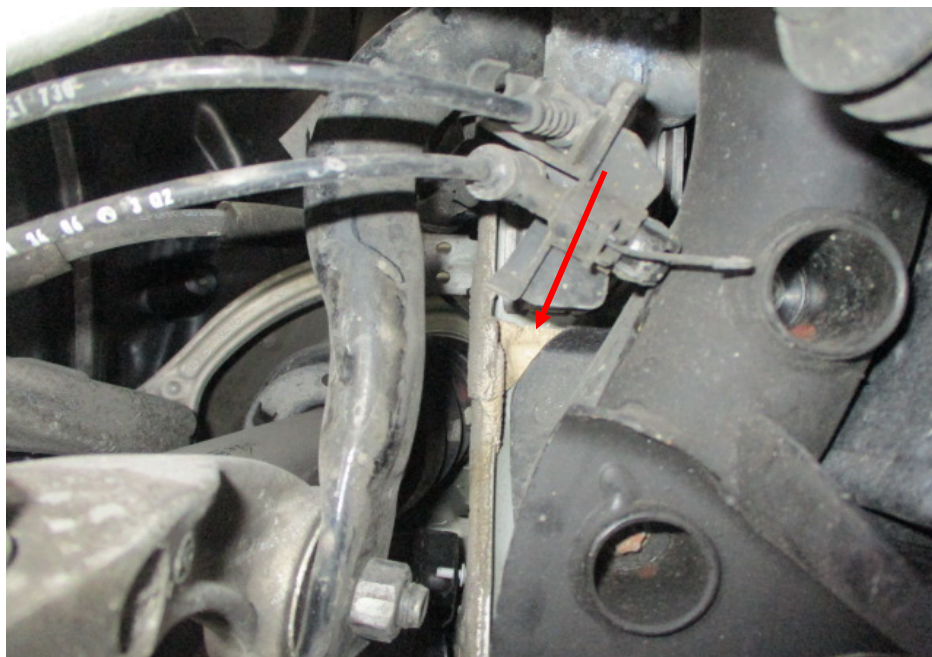
**Photo 21** shows the chassis/structural body at the underside front right of the Motor Car. The original factory sealant (arrowed) at the joints along the chassis/structural body was observed to be untouched. In general, I had found no work was carried out on the chassis/structural body of the Motor Car. The chassis/structural body of the Motor Car was originally fitted.

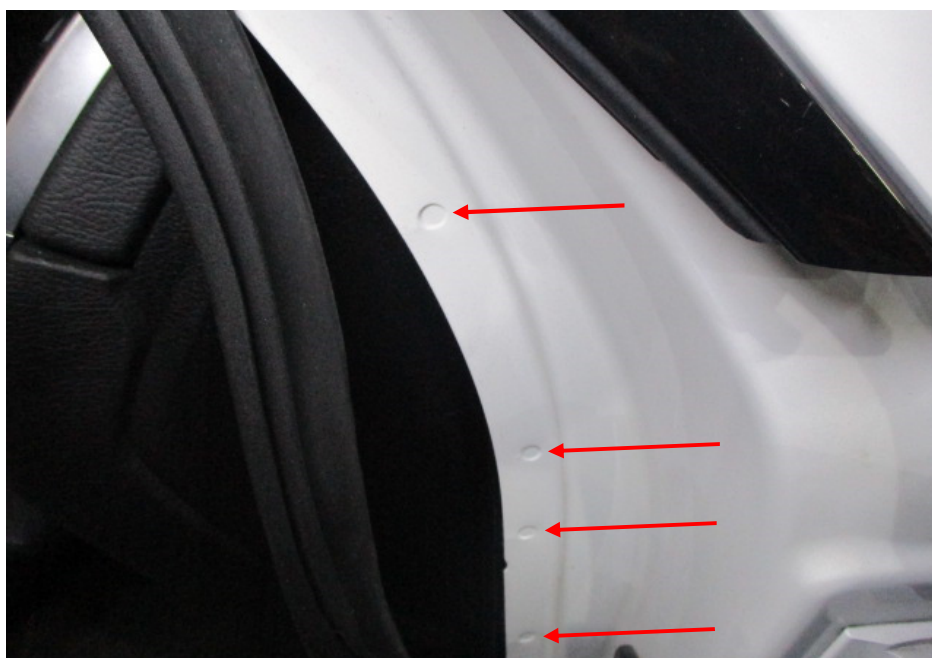
**Photo 22** shows the right side "A" pillar of the Motor Car. I did not find any weld marks other than original spot weld marks (arrowed) on the right side "A" pillar of the Motor Car which, indicates that there was no re-welding works carried out. In general, I had found all the non-detachable body panels of the Motor Car to be originally fitted at the time of my inspection.

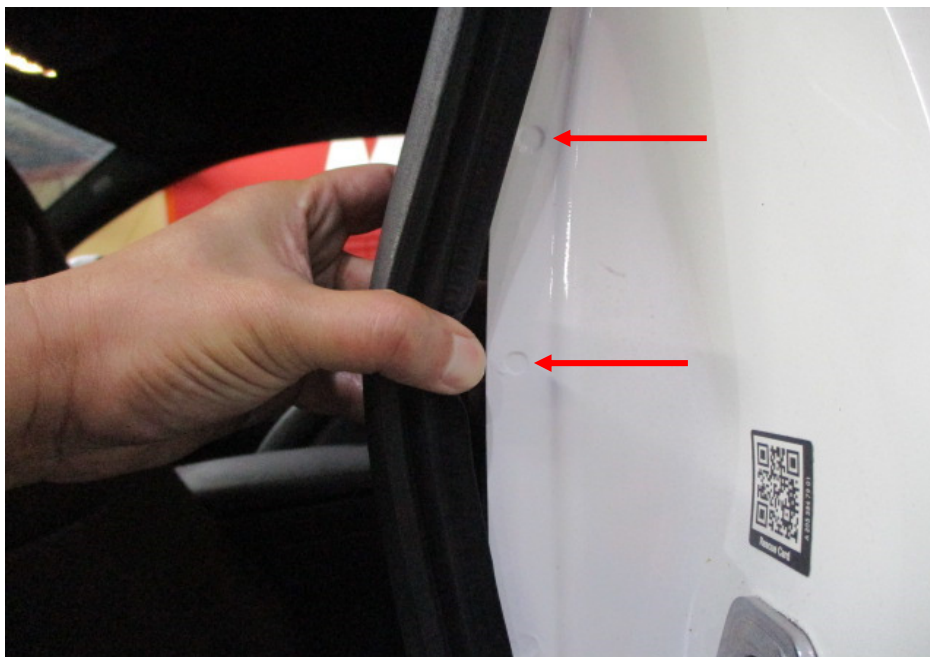
**Photo 23** shows the left rear body panel of the Motor Car. I did not find any weld marks other than original spot weld marks (arrowed) on the left rear body panel of the Motor Car which, indicates that there was no re-welding works carried out. In general, I had found all the non-detachable body panels of the Motor Car to be originally fitted at the time of my inspection.
