Your Ref: Mercedes Benz CLA 250  
(chassis number WDD1183472N001461)  
Our Ref : CI/TP21001118/D

23 January 2021

**INSPECTION REPORT OF AN UNREGISTERD MERCEDES BENZ CLA 250  
MOTOR CAR WITH CHASSIS NUMBER WDD1183472N001461**

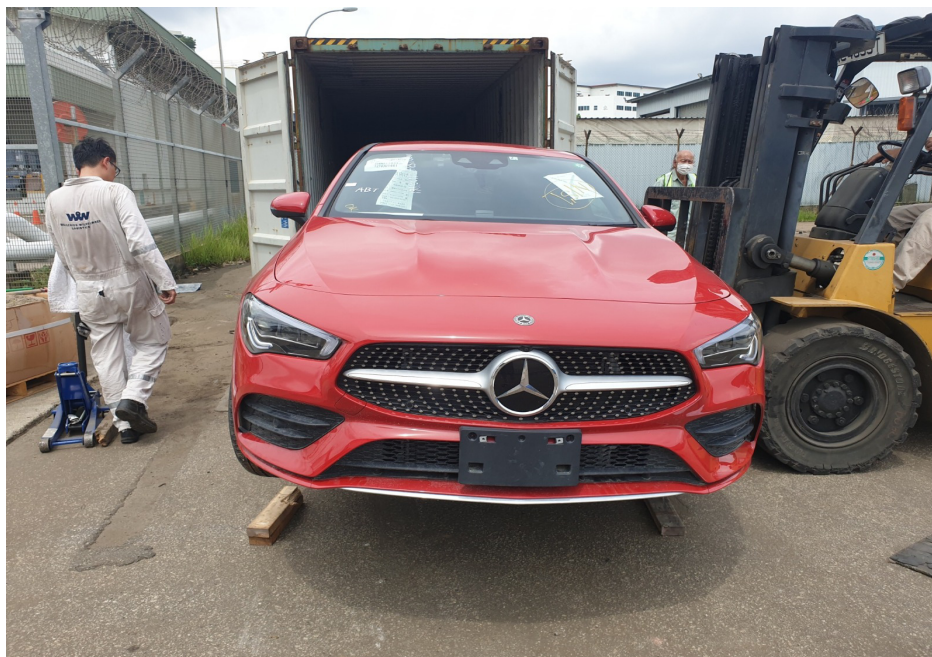
**Photo 1** shows the frontal body of the Motor Car (photograph provided to me). There was no physical damage seen to the Motor Car from the photographs that were provided to me.

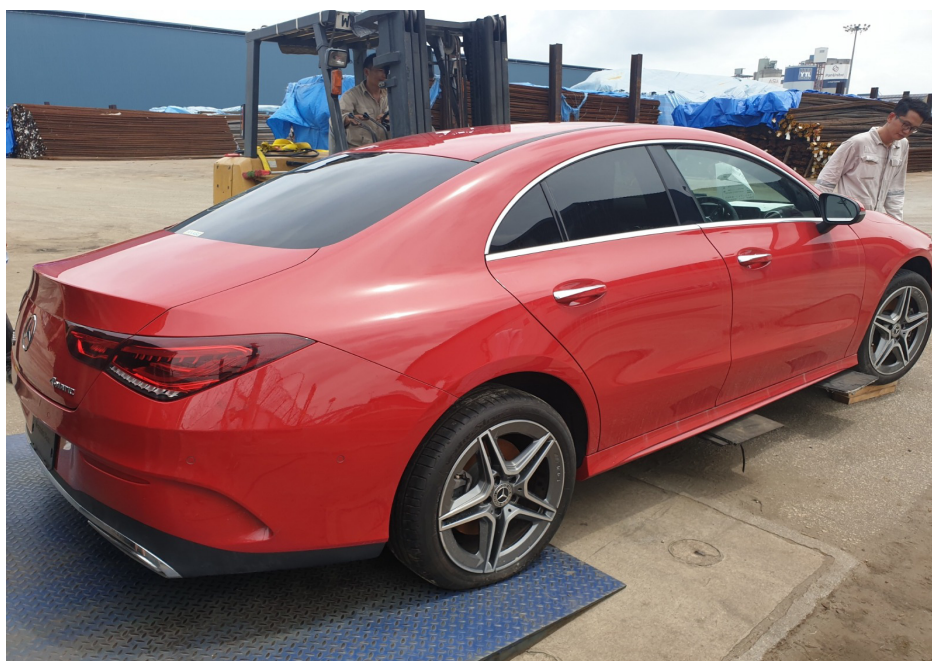
**Photo 2** shows the rear right body of the Motor Car (photograph provided to me). There was no physical damage seen to the Motor Car from the photographs that were provided to me.

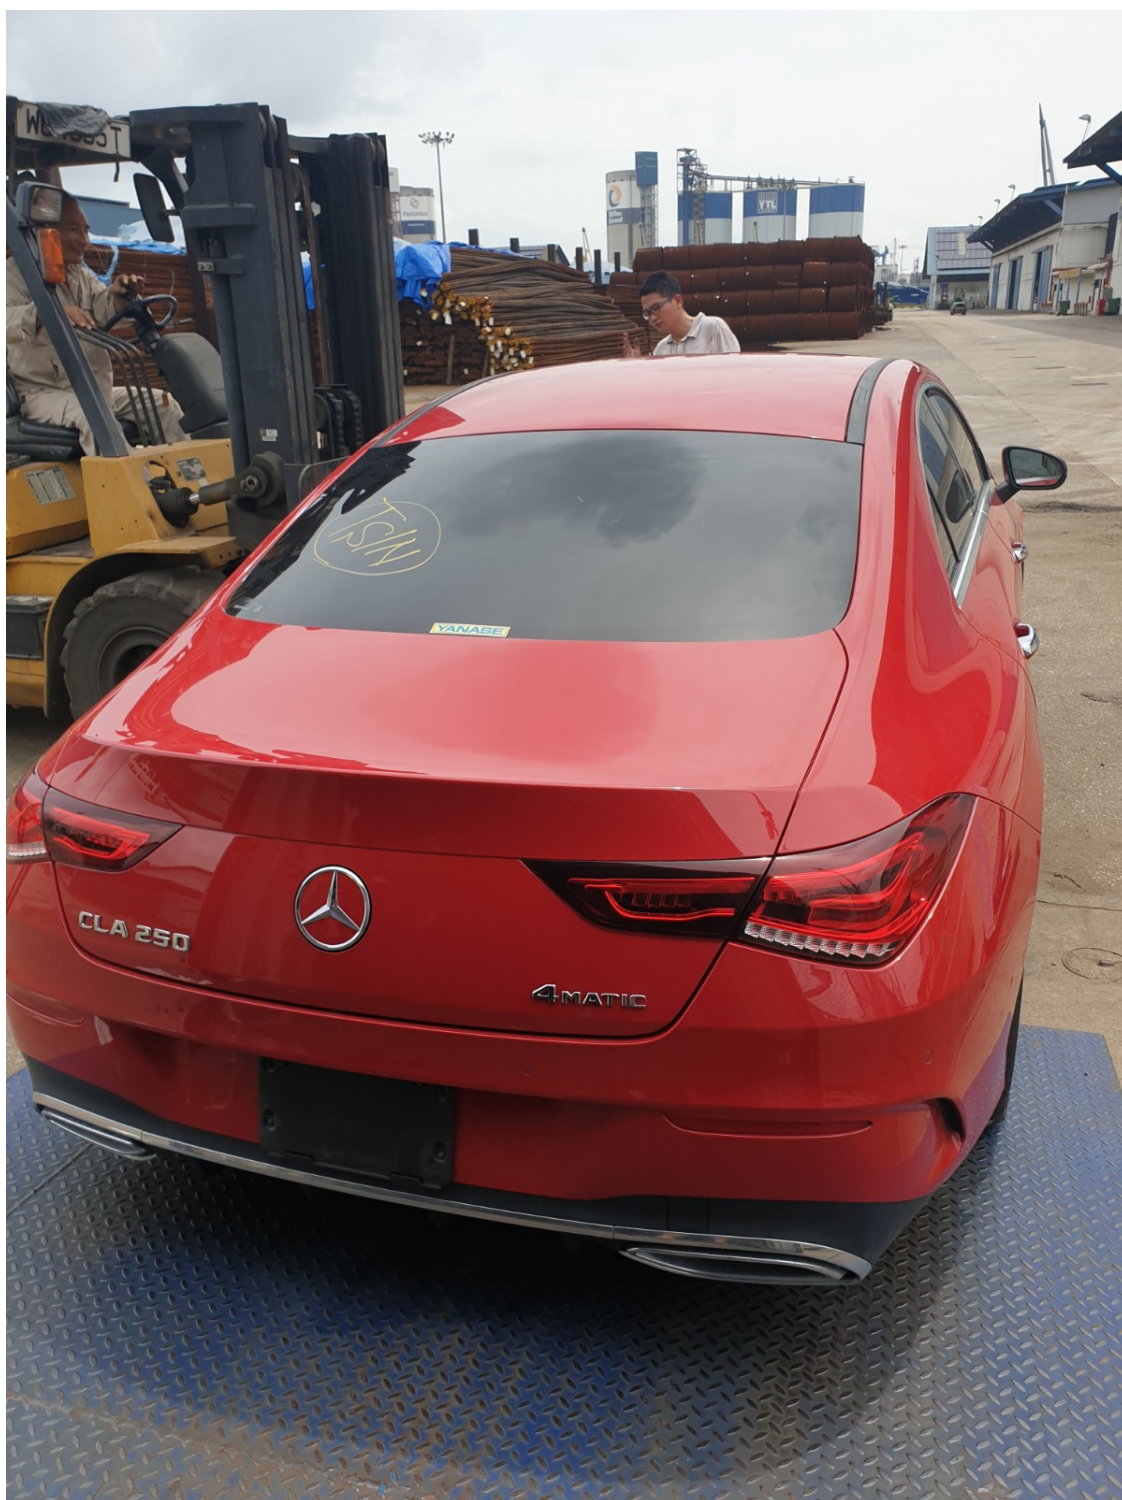
**Photo 3** shows the rear body of the Motor Car (photograph provided to me). There was no physical damage seen to the Motor Car from the photographs that were provided to me.

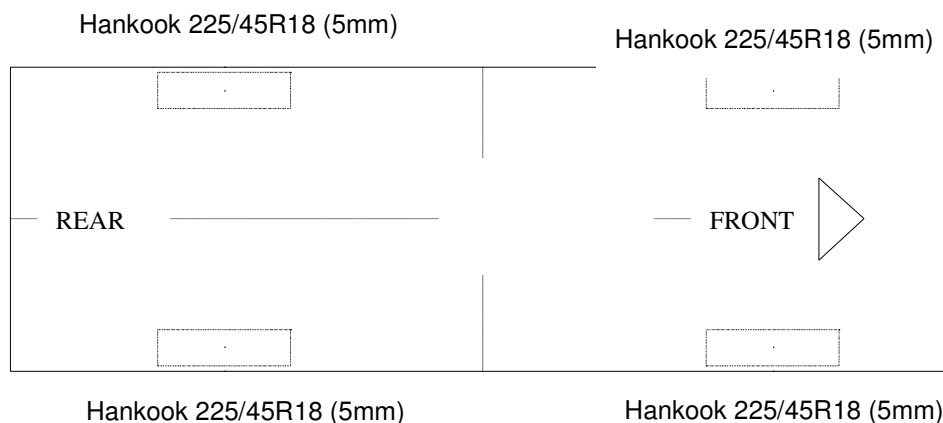
7. It was fitted with 18inch sport wheel rims that were wrapped with tyres that were observed to be of serviceable condition. The tyres were also sufficiently inflated for vehicular operation. The tyre brand, tyre size and approximate remaining tread depth of the 4 tyres of the Motor Car were recorded as follows: -

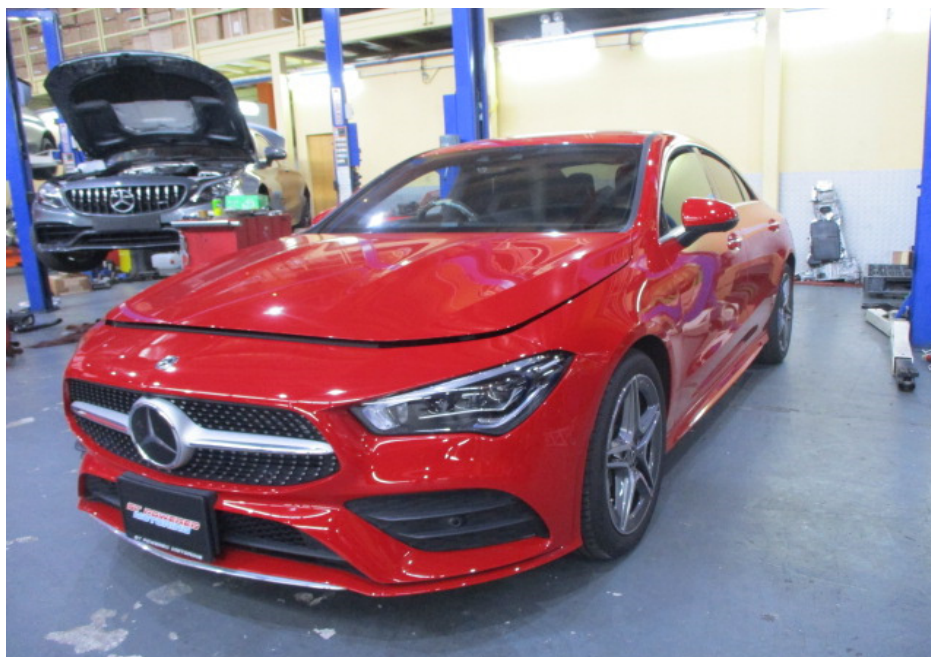
**Photo 4** shows a general view of the front left body of the Motor Car at the time of my inspection. The Motor Car was observed to be in a relatively good general condition with no loose exterior fittings observed. The mileage of the Motor Car recorded at the time of my inspection was 2,273km.

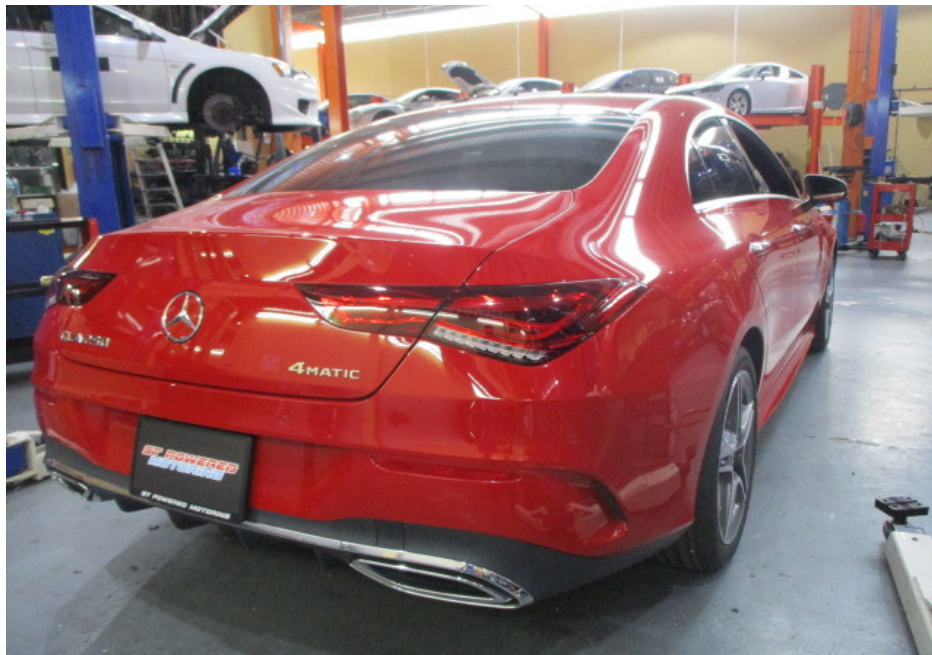
**Photo 5** shows a general view of the rear right body of the Motor Car at the time of my inspection. The Motor Car was observed to be in a relatively good general condition with no loose exterior fittings observed. The mileage of the Motor Car recorded at the time of my inspection was 2,273km.

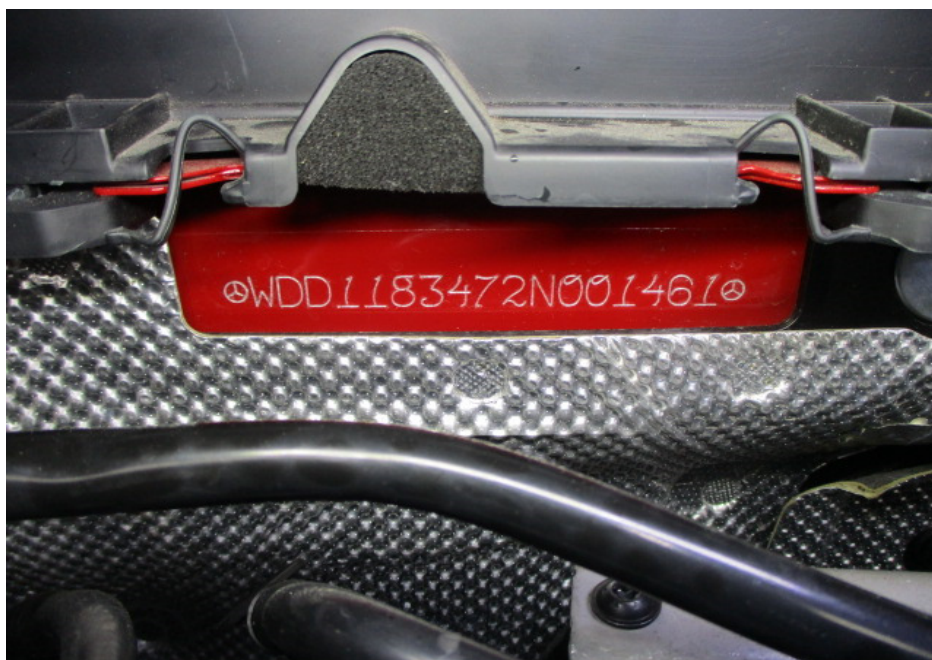
**Photo 6** shows the chassis number of the Motor Car. The chassis number recorded was WDD1183472N001461.

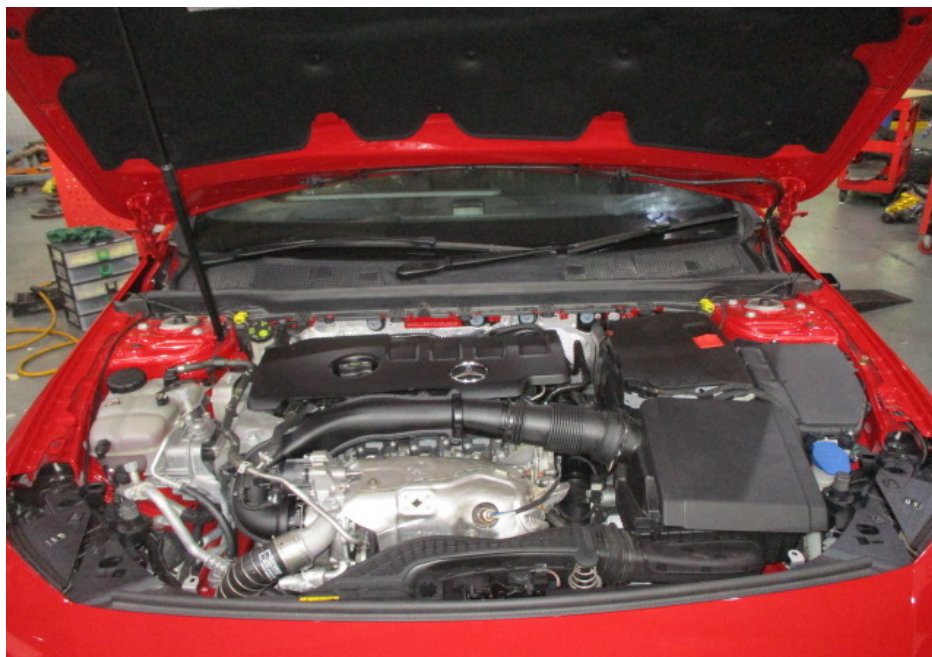
13. My examination of the engine compartment of the Motor Car revealed that the various parts and components inside the engine compartment were all intact and properly fitted. The engine oil, brake fluid and engine coolant were all found to be of sufficient level for operating purposes. Visually, there was also no contamination found to these fluids.

**Photo 7** shows a general view of the engine compartment of the Motor Car at the time of my inspection. The various parts and components inside the engine compartment were all observed to be intact and properly fitted. There was also no sign(s) or indication(s) of fluid leak and/or fluid stain found inside the engine compartment.

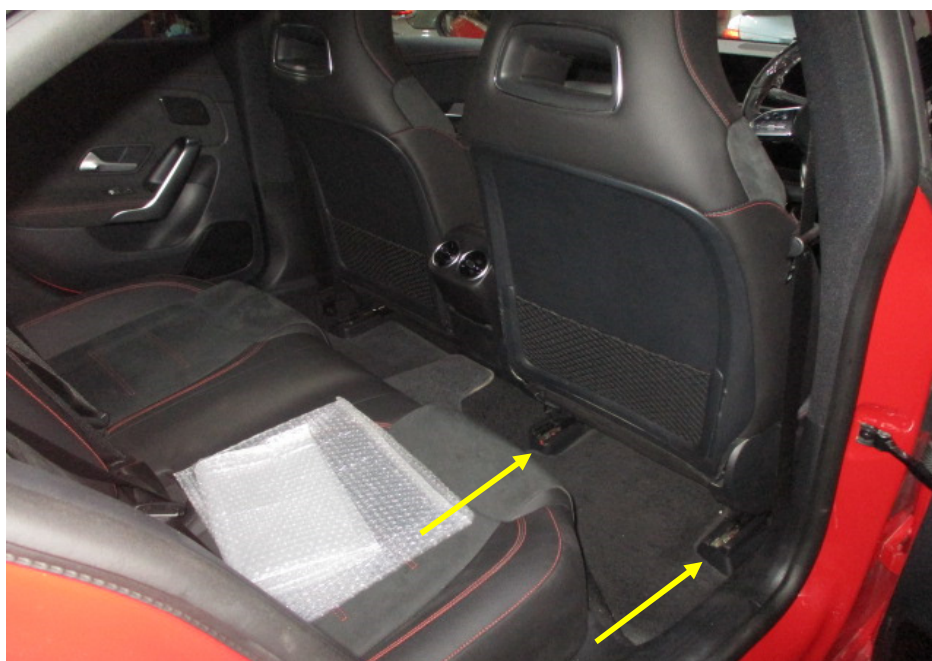
11. The seats of the Motor Car were found to be secured to the floorboard of the Motor Car via seat rails bolted onto the floorboard. Retractable seat belt reels and pre-tensioners were fitted on all seats of the Motor Car. The seat belt reels were tested and were able to be fastened securely into the respective pre-tensioners that were fixed to the side of all the seats.

**Photo 8** shows the seats of the Motor Car, which were secured via seat rails (arrowed) to the floorboard. All the seats of the Motor Car were fitted with a retractable seat belt reel and pre-tensioner. The seat belts were tested and able to be fastened into the respective pre-tensions that were fitted on the side of each individual seat.

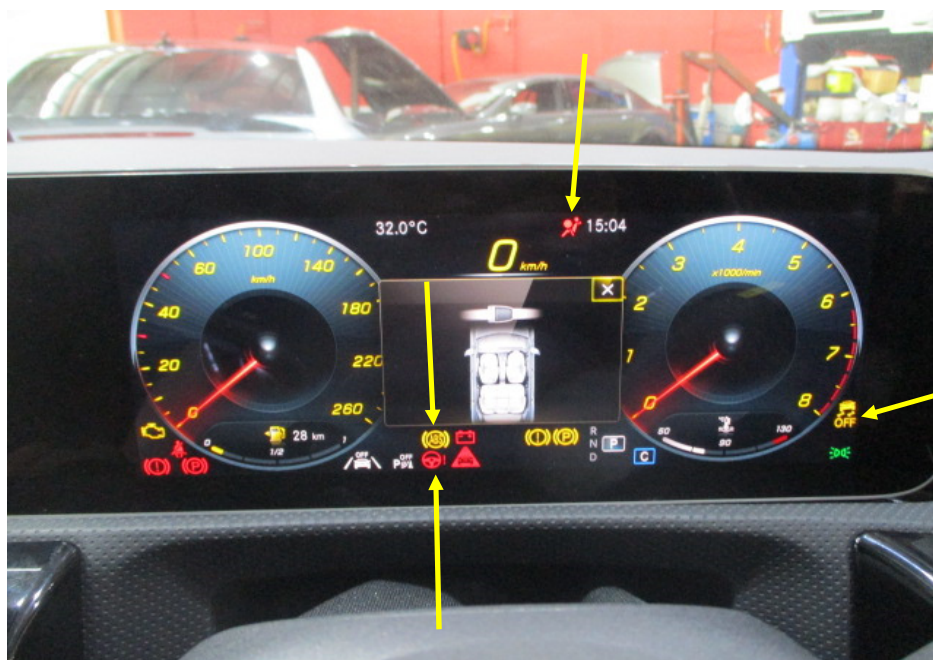
**Photo 9** shows the warning lights for the various electronic safety features appearing on the instrument panel of the Motor Car during its self-test when the engine is cranked, in particular the ABS, SRS, EPS and TCS lights (arrowed).

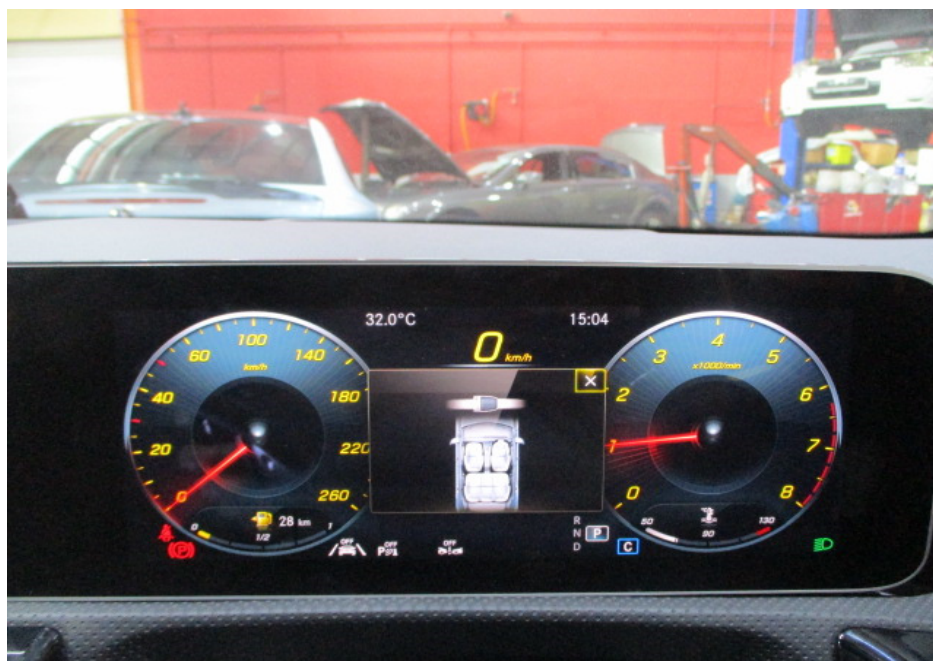
12. The Motor Car's automatic self-test of the functionality of its various electronic safety features like the Anti-Brake Lock System (ABS), Supplemental Restraint System (SRS), Electric Power Steering (EPS) and Traction Control System (TCS) during cranking of the engine had indicated that these electronic systems were in working condition. This was determined from the respective warning lights disappearing from the instrument panel after the self-test.

**Photo 10** shows the respective warning lights no longer illuminated, indicating that there is no fault detected to the ABS, SRS, EPS and TCS systems of the Motor Car during the self-test. These electronic systems were hence in working condition at the time of my inspection.

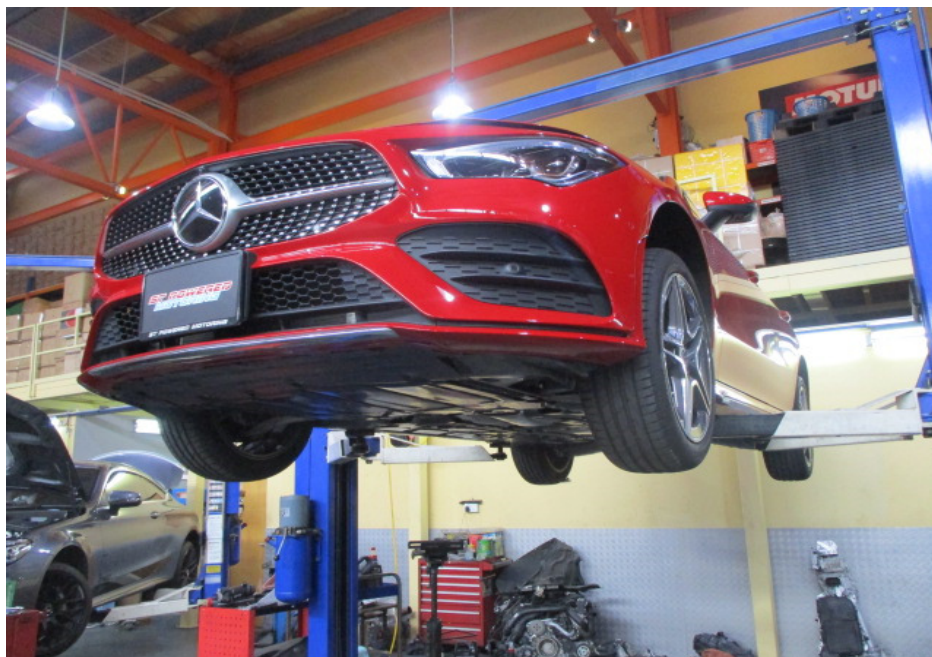
14. My checks on the underside of the Motor Car revealed no sign(s) or indication(s) of fluid leakage and/or fluid stain(s). The engine block and automatic transmission assembly were both secured properly. All undercarriage components of the Motor Car were also observed to be intact and secured in an appropriate manner.

**Photo 11** shows the Motor Car hoisted up for checks on its undercarriage. There was no sign(s) or indication(s) of fluid leakage and/or fluid stain(s) on the underside of the Motor Car. The undercarriage components of the Motor Car were also all observed to be intact and secured in an appropriate manner.

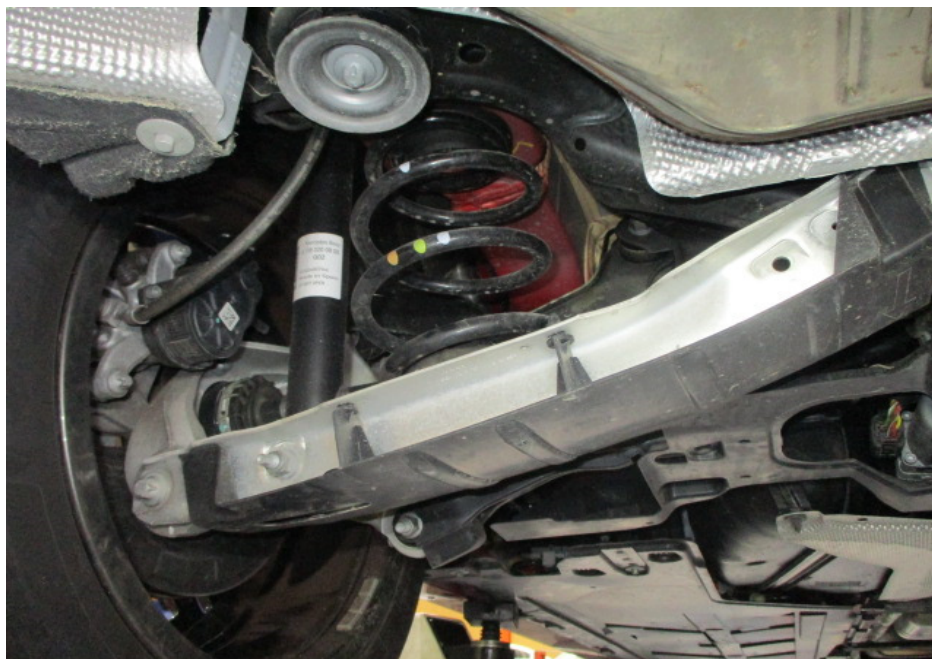
**Photo 12** shows a general view of the control arms and linkages at the rear left wheel of the Motor Car. I did not observe any fluid leak and/or fluid stain on the underside of the Motor Car. All of the Motor Car's undercarriage components were observed to be intact and secured in an appropriate manner.

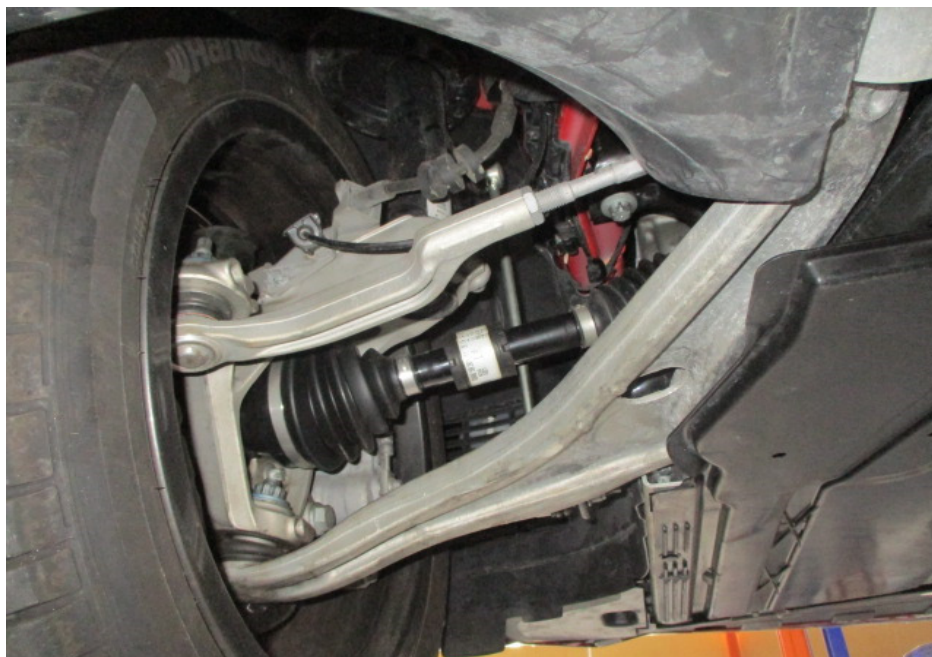
**Photo 13** shows the various undercarriage components at the front left wheel of the Motor Car. The mechanical components, control arms and linkages were all found to be intact and secured in an appropriate manner.

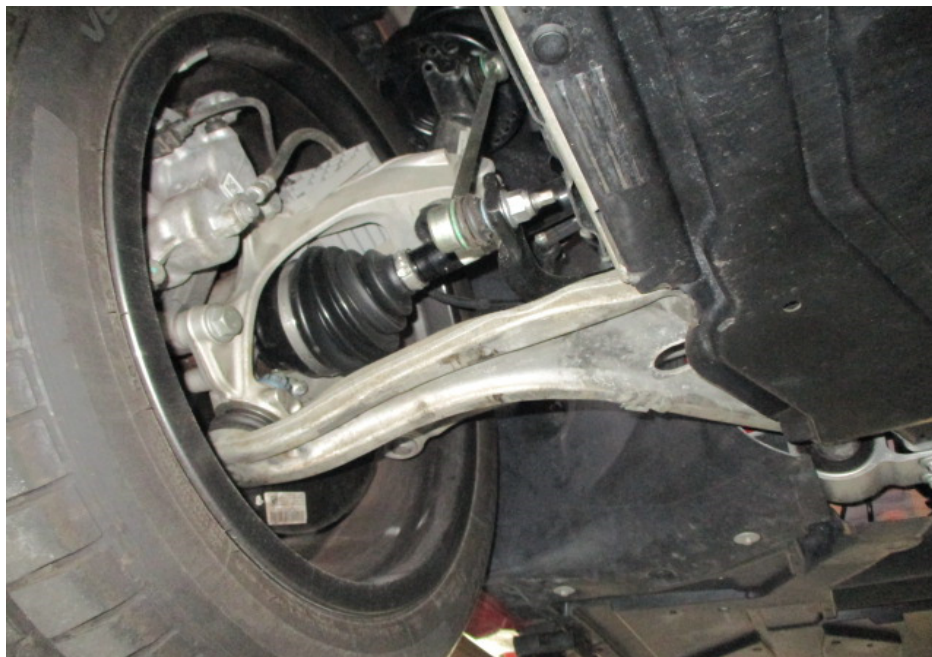
**Photo 14** shows the various undercarriage components at the front right wheel of the Motor Car. The mechanical components, control arms and linkages were all found to be intact and secured in an appropriate manner. I also did not observe any fluid leak and/or fluid stain on the underside of the Motor Car.

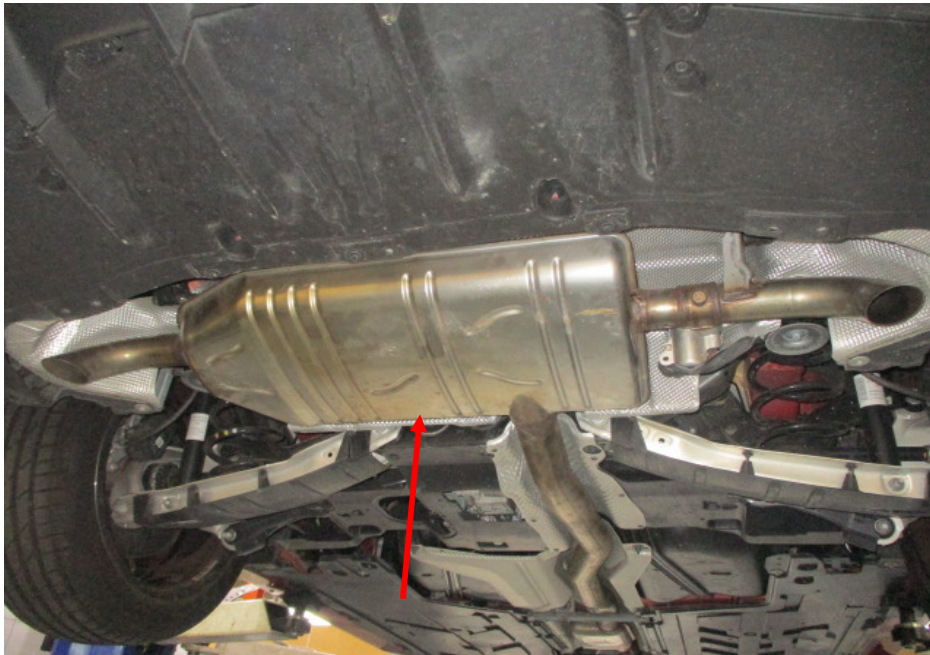
**Photo 15** shows the Motor Car's rear muffler (arrowed). My examination of the Motor Car's exhaust system revealed no sign(s) or indication(s) of any cut or weld marks along its exhaust pipes and on its catalytic converter.

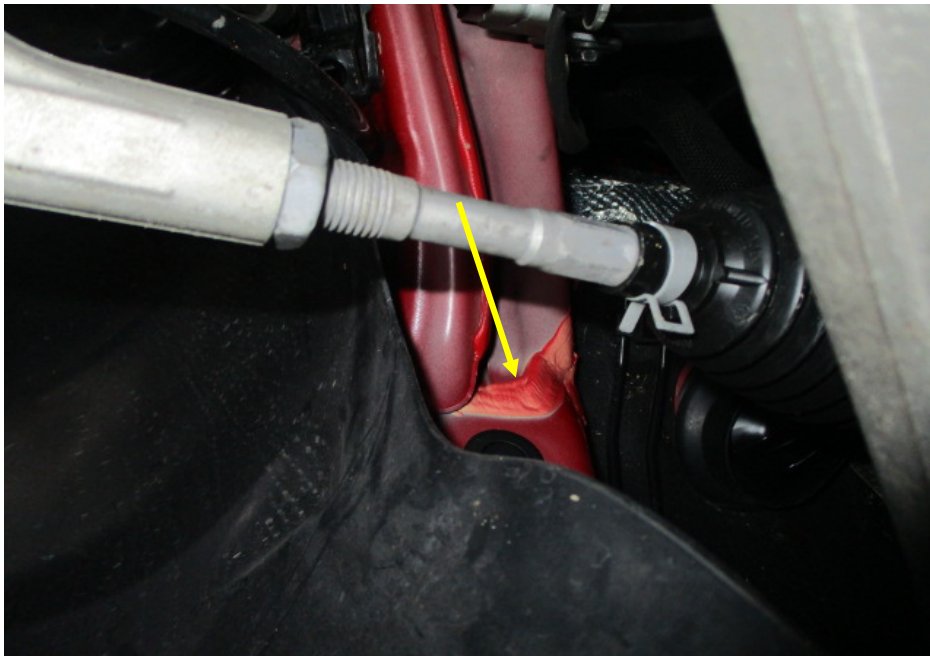
10. Visually, I did not find any weld marks, other than the original spot weld marks, on the chassis/structural body of the Motor Car. The original factory sealant at the joints along the chassis/structural body was also untouched, again indicating that no replacement of the chassis/structural body was carried out; and that the chassis/structural body was originally fitted.

**Photo 16** shows the chassis/structural body at the underside front right of the Motor Car. I did not find any weld marks other than original spot weld marks on the chassis/structural body of the Motor Car. The original factory sealant (arrowed) at the joints along the chassis/structural body was untouched, indicating no work was done on the chassis/structural body of the Motor Car and that the chassis/structural body was originally fitted.

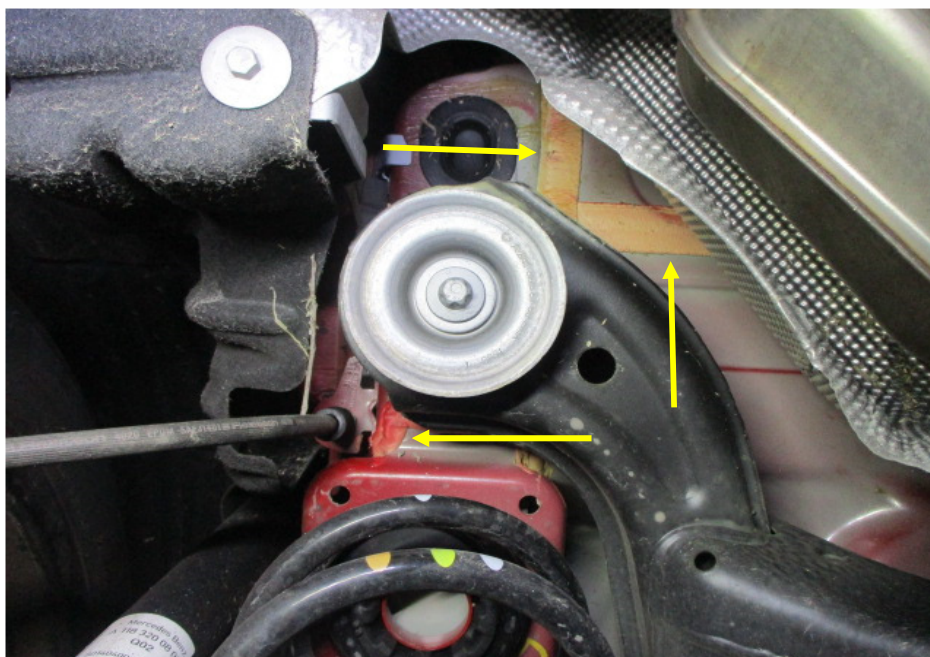
**Photo 17** shows the chassis/structural body at the underside rear left of the Motor Car. The original factory sealant (arrowed) at the joints along the chassis/structural body was observed to be untouched. In general, I had found no work was carried out on the chassis/structural body of the Motor Car. The chassis/structural body of the Motor Car was originally fitted.

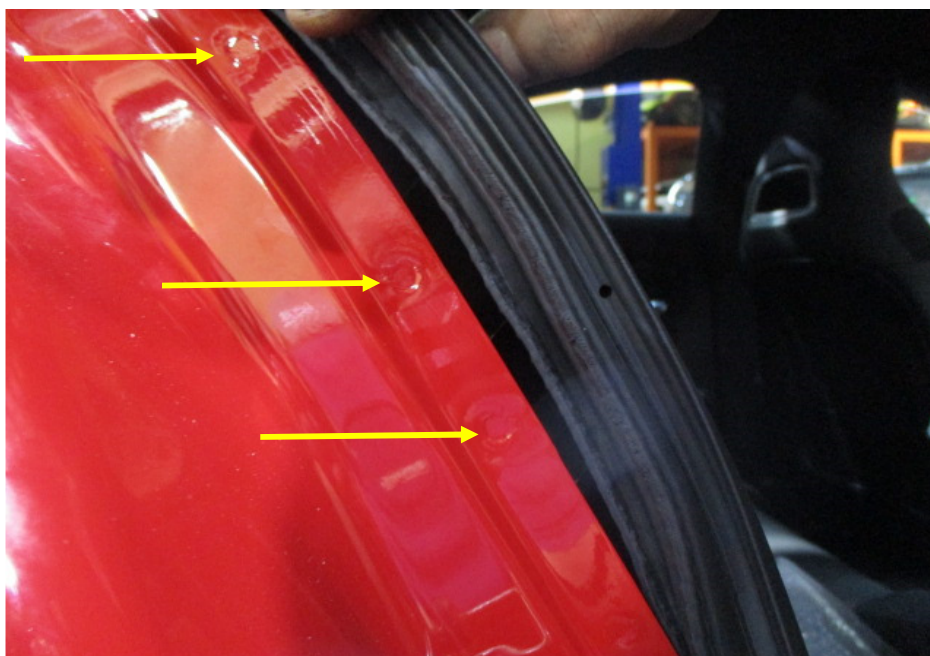
9. Checks on the non-detachable body panels like the rear fenders, floorboard, roof panel, pillars and rocker panels amongst others, revealed that these body panels were spot welded onto the chassis/structural body of the Motor Car. The original factory sealant at the joints of the non-detachable body panels was all untouched indicating no replacement of the non-detachable body panels was carried out; and that these body panels were all originally fitted.

**Photo 18** shows the right side "C" pillar of the Motor Car. I did not find any weld marks other than original spot weld marks (arrowed) on the right side "C" pillar of the Motor Car, which indicates that there was no re-welding works carried out. In general, I had found all the non-detachable body panels of the Motor Car to be originally fitted at the time of my inspection.

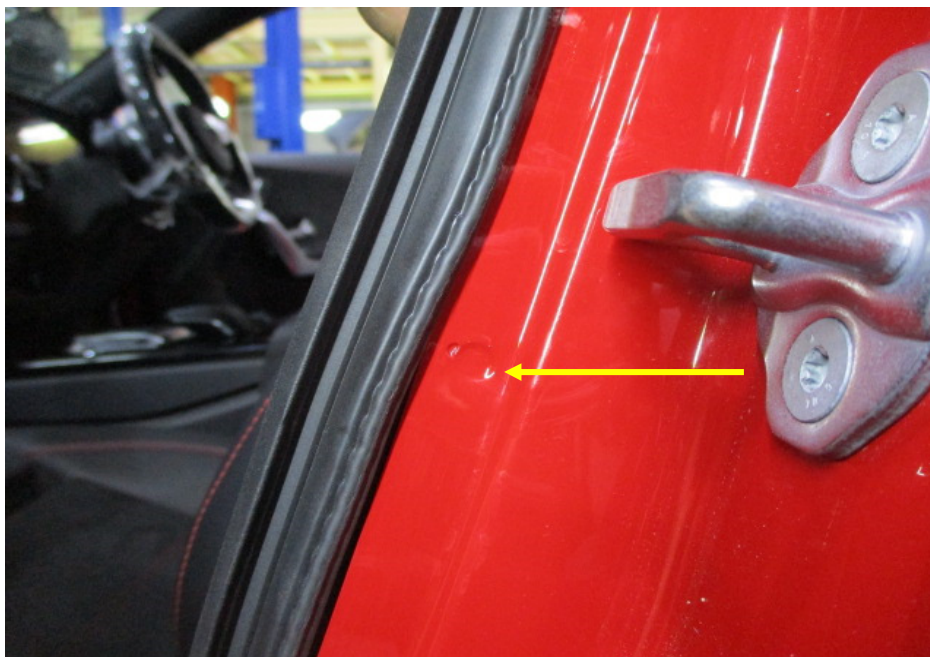
**Photo 19** shows the left side "B" pillar of the Motor Car. I did not find any weld marks other than original spot weld marks (arrowed) on the left side "B" pillar of the Motor Car, which indicates that there was no re-welding works carried out. In general, I had found all the non-detachable body panels of the Motor Car to be originally fitted at the time of my inspection.
