Your Ref: Mini Copper S  
(chassis number WMWXR520702L71138)  
Our Ref : CI/TP21001119/D

**INSPECTION REPORT OF AN UNREGISTERD MINI COPPER S MOTOR CAR  
WITH CHASSIS NUMBER WMWXR520702L71138**

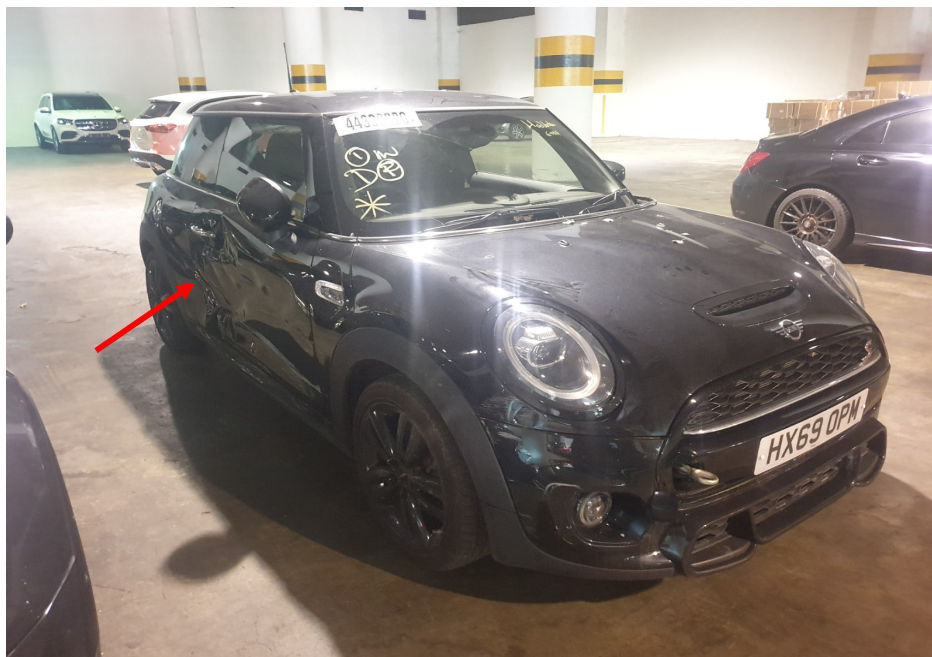
3. From the photographs provided to me, it was observed that the Motor Car had sustained damages at its right side centre portion. Body parts damaged include the front right door, right side rocker panel garnish and rear right body panel amongst others.
4. No physical damage was observed to other areas of the Motor Car. The airbags of the Motor Car were also not activated as seen from the photographs that were provided to me. See photo 1 – 4 below.

**Photo 1** shows the front right body of the Motor Car (photograph provided to me). The Motor Car was observed to have sustained damage at its right side centre portion (arrowed). The front right door, right side rocker panel garnish and rear right body panel were amongst the body parts that were observed to have been damaged.

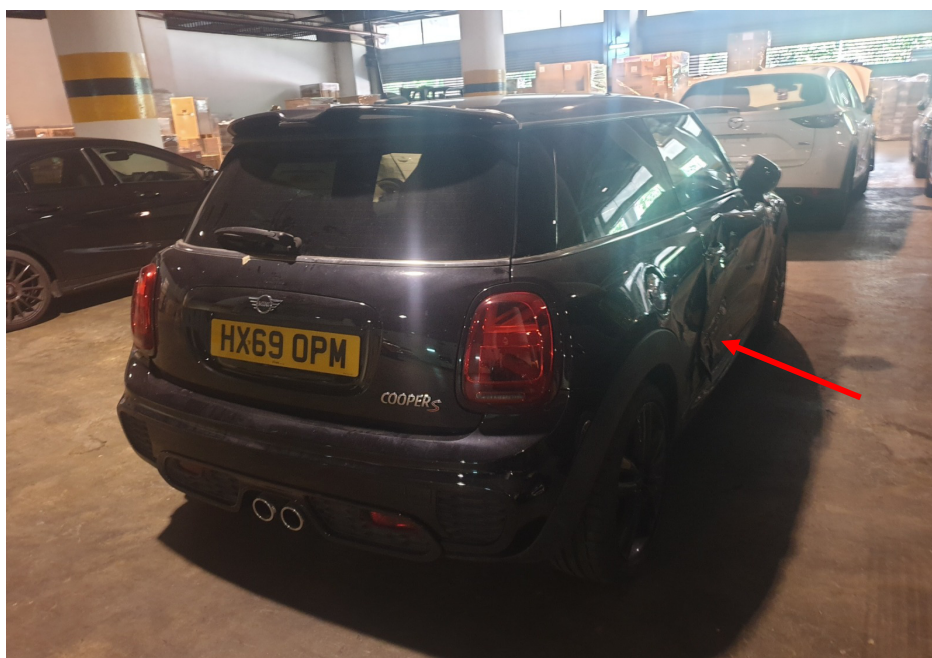
**Photo 2** shows the rear right body of the Motor Car (photograph provided to me). The Motor Car was observed to have sustained damage at its right side centre portion (arrowed). The front right door, right side rocker panel garnish and rear right body panel were amongst the body parts that were observed to have been damaged.

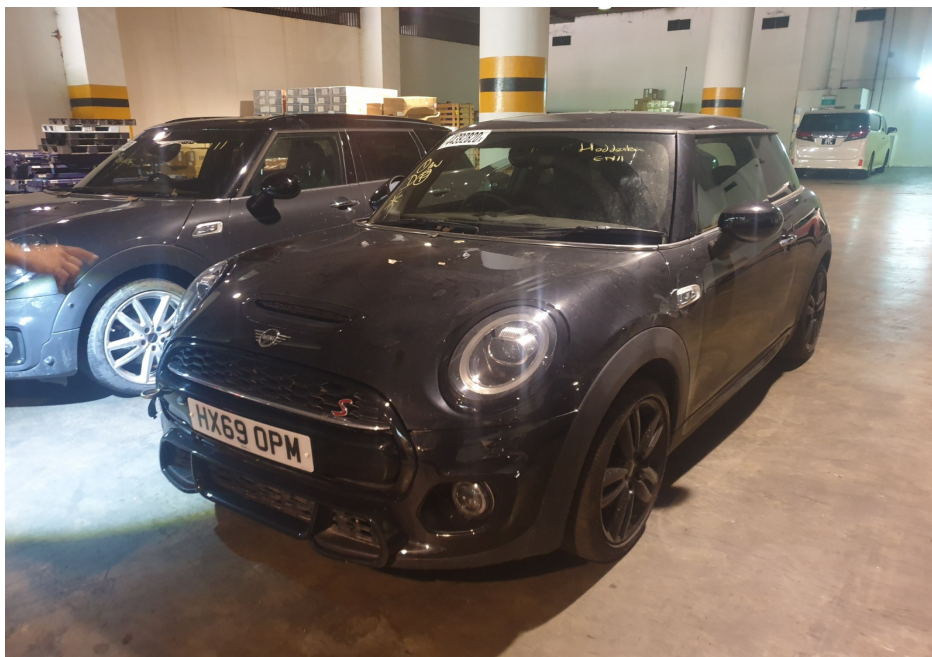
**Photo 3** shows the front left body of the Motor Car (photograph provided to me). Apart for the right side centre portion, there was no physical damage seen to other areas of the Motor Car.

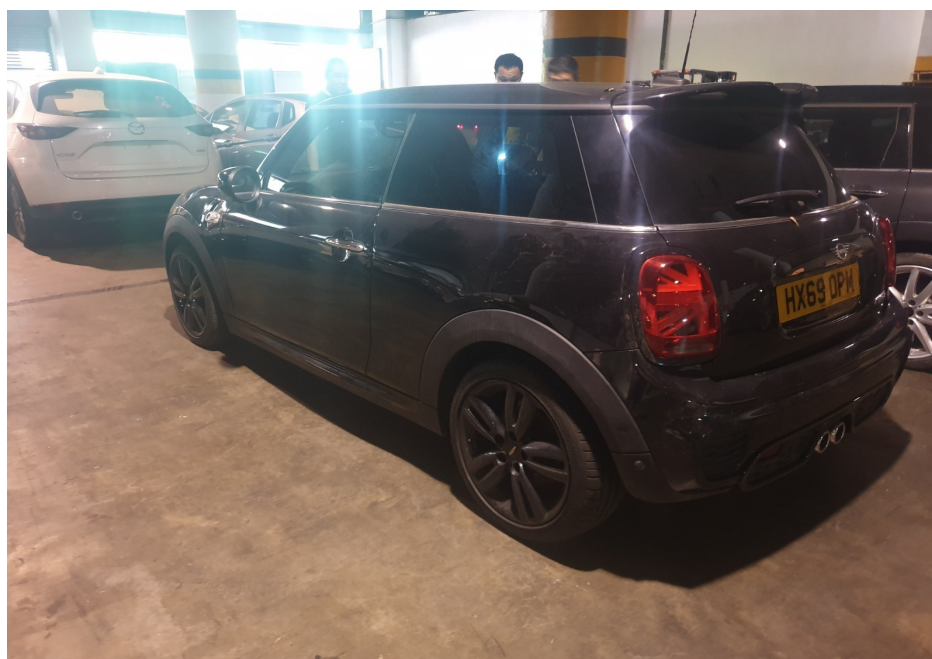
**Photo 4** shows the rear left body of the Motor Car (photograph provided to me). Apart for the right side centre portion, there was no physical damage seen to other areas of the Motor Car.

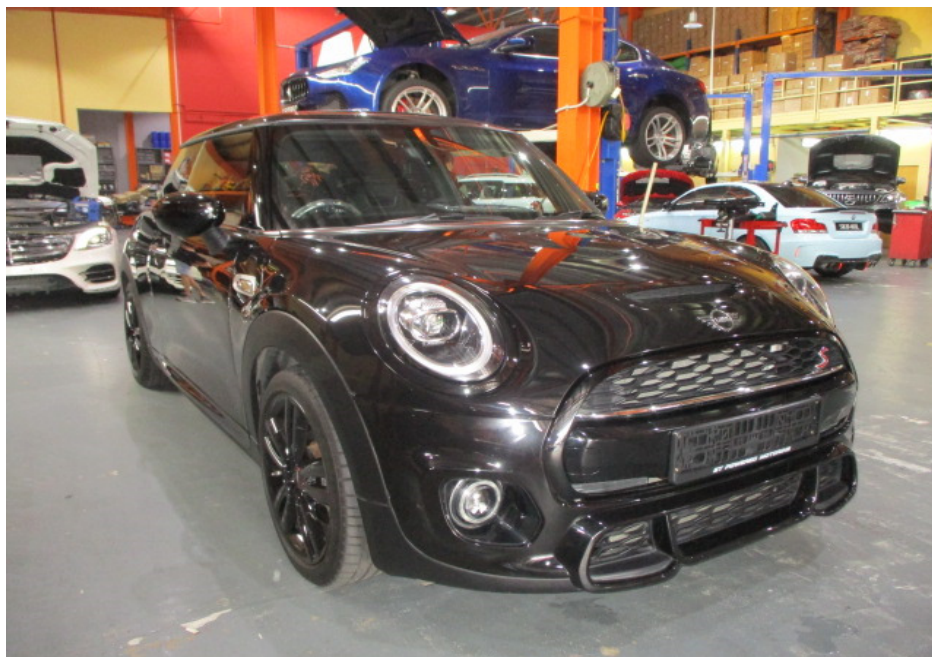
**Photo 5** shows a general view of the front right body of the Motor Car at the time of my inspection. The Motor Car was observed to be in a relatively good general condition with no loose exterior fittings observed. The body parts at the right side centre portion of the Motor Car were visually examined and it was observed that the repair/restoration works carried out to the damaged area of the Motor Car (refer to photograph 1 & 2 above) were reasonably adequate and in order.

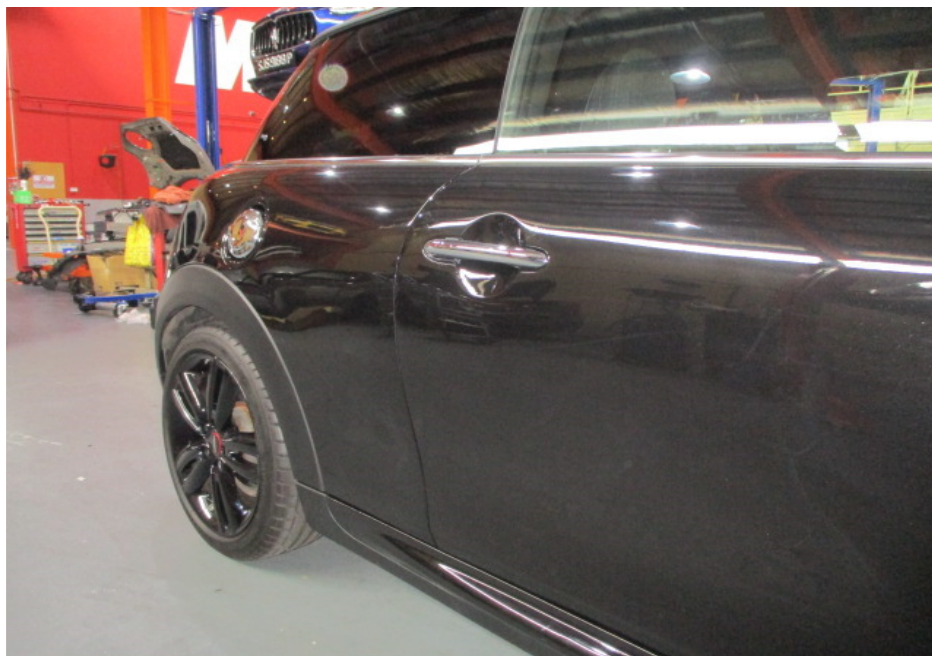
22. The body parts at the right side centre portion of the Motor Car were visually examined and it was noted that the repair/restoration works carried out to the damaged area of the Motor Car (refer to photograph 1 & 2 above) were reasonably adequate and in order.

**Photo 6** shows a closer view of the front right door, rear right body panel and right side rocker panel garnish of the Motor Car. The body parts at the right side centre portion of the Motor Car were visually examined and it was observed that the repair/restoration works carried out to the damaged area of the Motor Car (refer to photograph 1 & 2 above) were reasonably adequate and in order.

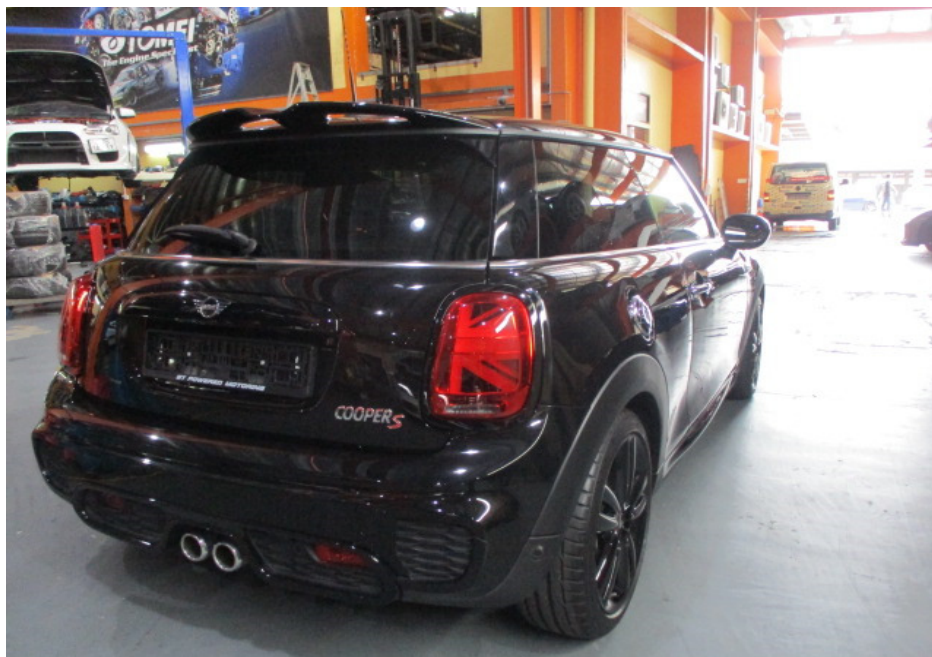
**Photo 7** shows a general view of the rear right body of the Motor Car at the time of my inspection. The Motor Car was observed to be in a relatively good general condition with no loose exterior fittings observed. The body parts at the right side centre portion of the Motor Car were visually examined and it was observed that the repair/restoration works carried out to the damaged area of the Motor Car (refer to photograph 1 & 2 above) were reasonably adequate and in order.

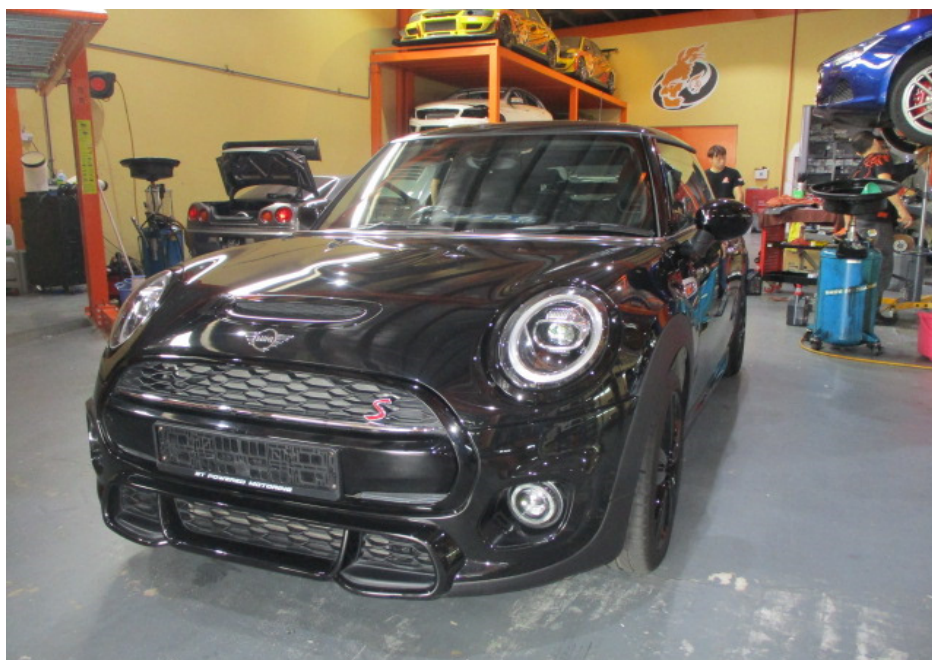
**Photo 8** shows a general view of the front left body of the Motor Car at the time of my inspection. The Motor Car was observed to be in a relatively good general condition with no loose exterior fittings observed. The mileage of the Motor Car recorded at the time of my inspection was 10,267km.

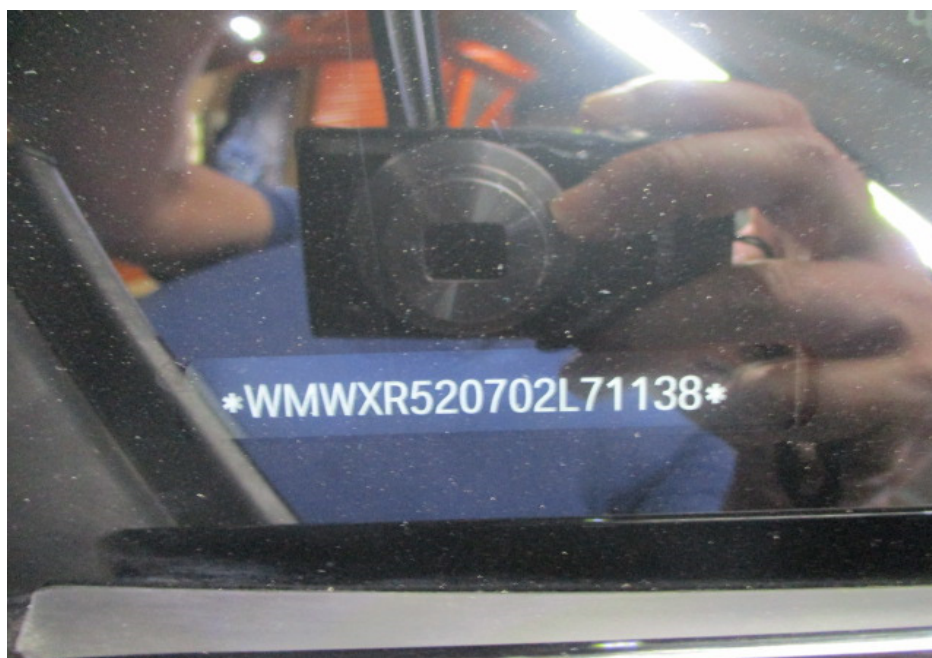
**Photo 9** shows the chassis number of the Motor Car. The chassis number recorded was WMWXR520702L71138.

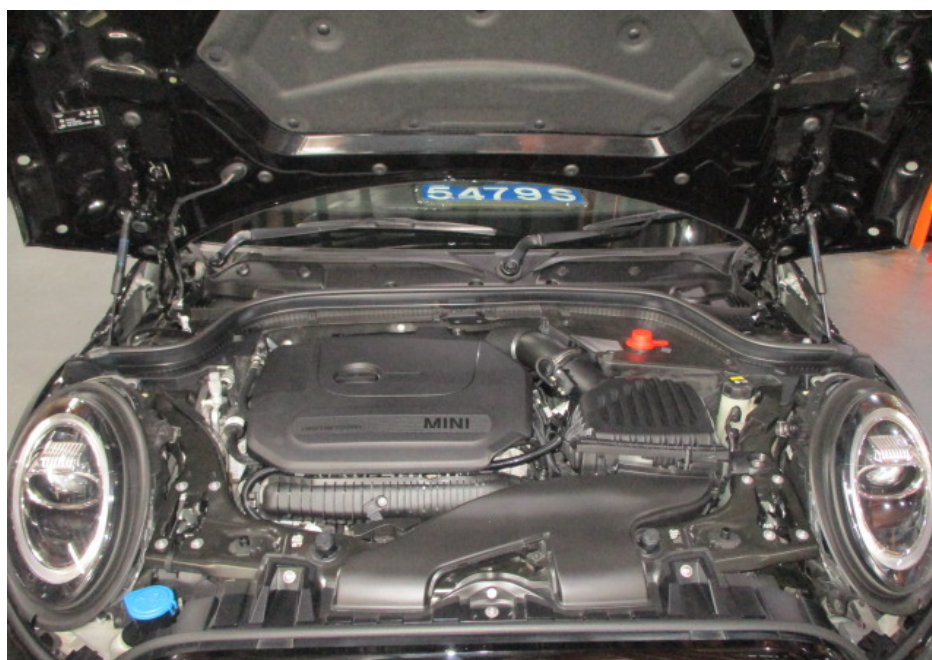
**Photo 10** shows a general view of the engine compartment of the Motor Car at the time of my inspection. The various parts and components inside the engine compartment were all observed to be intact and properly fitted. There was also no sign(s) or indication(s) of fluid leak and/or fluid stain found inside the engine compartment.

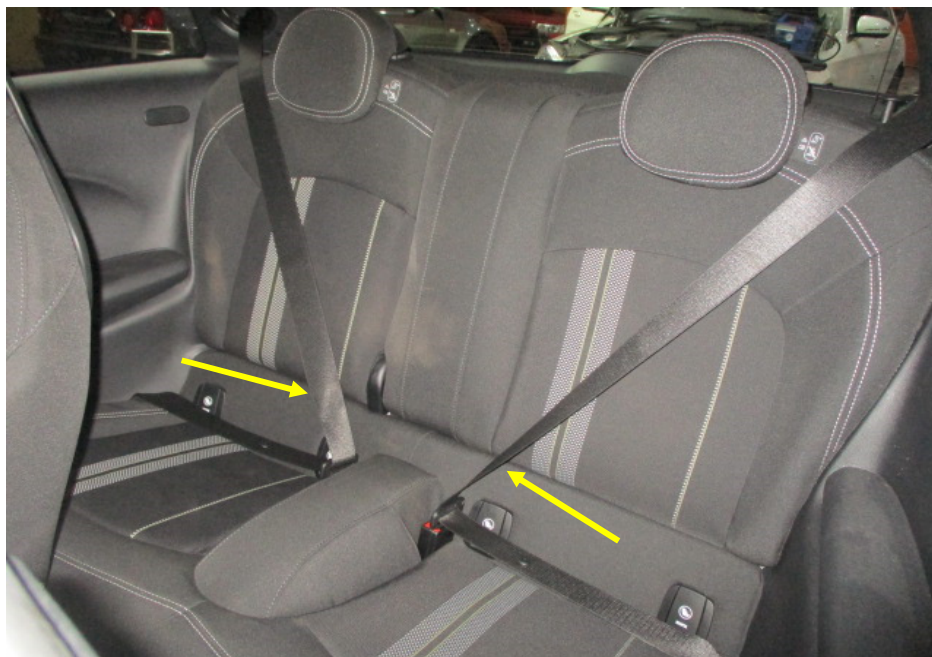
**Photo 11** shows the rear seats of the Motor Car. All the seats of the Motor Car were secured via seat rails to the floorboard. They were also fitted with a retractable seat belt reel and a pre-tensioner. The seat belts (arrowed) were tested and were able to be fastened into the respective pre-tensions that were fitted on the side of each individual seat.

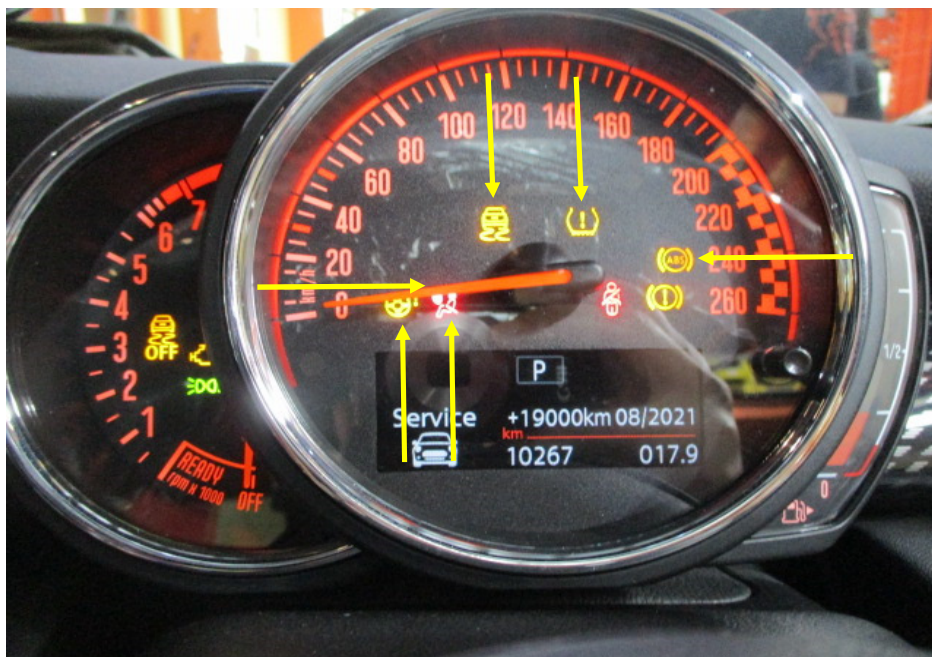
**Photo 12** shows the warning lights for the various electronic safety features appearing on the instrument panel of the Motor Car during its self-test when the engine is cranked, in particular the ABS, SRS, PAS, TPM and DSC lights (arrowed).

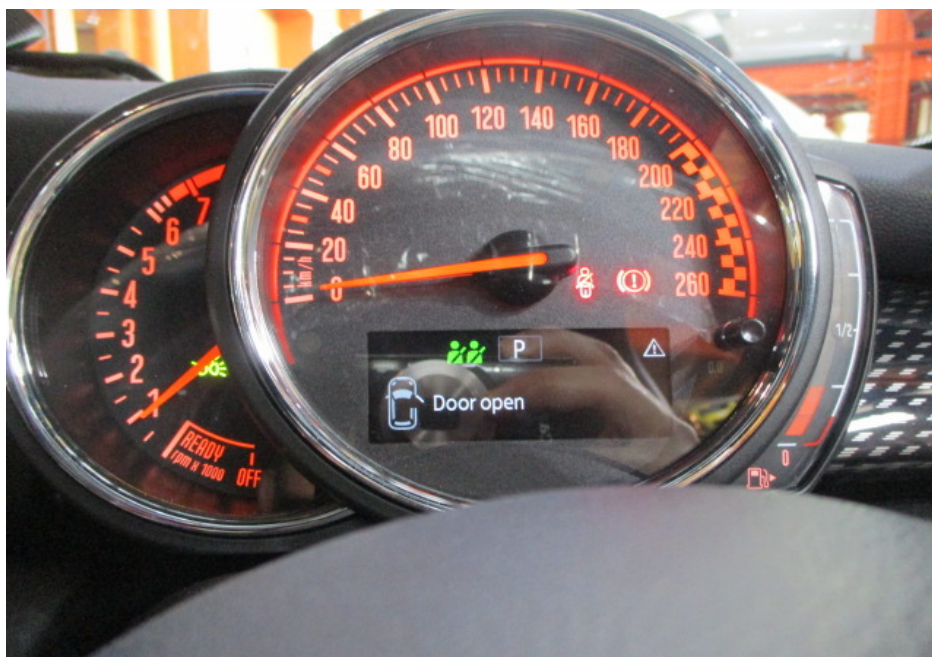
**Photo 13** shows the respective warning lights no longer illuminated, indicating that there is no fault detected to the ABS, SRS, PAS, TPM and DSC systems of the Motor Car during the self-test. These electronic systems were hence in working condition at the time of my inspection.

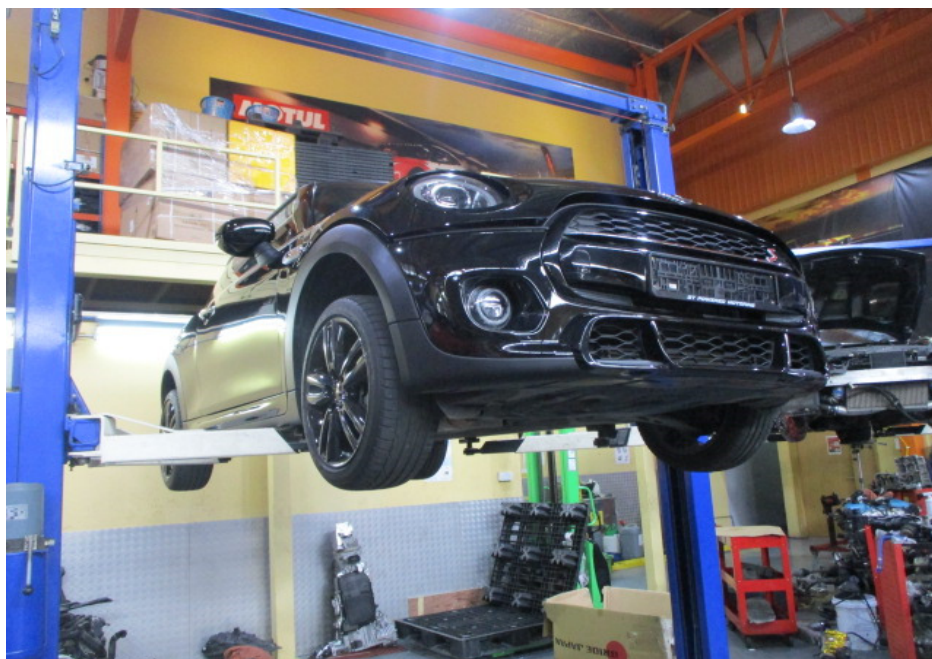
**Photo 14** shows the Motor Car hoisted up for checks on its undercarriage. There was no sign(s) or indication(s) of fluid leakage and/or fluid stain(s) on the underside of the Motor Car. The undercarriage components of the Motor Car were also all observed to be intact and secured in an appropriate manner.

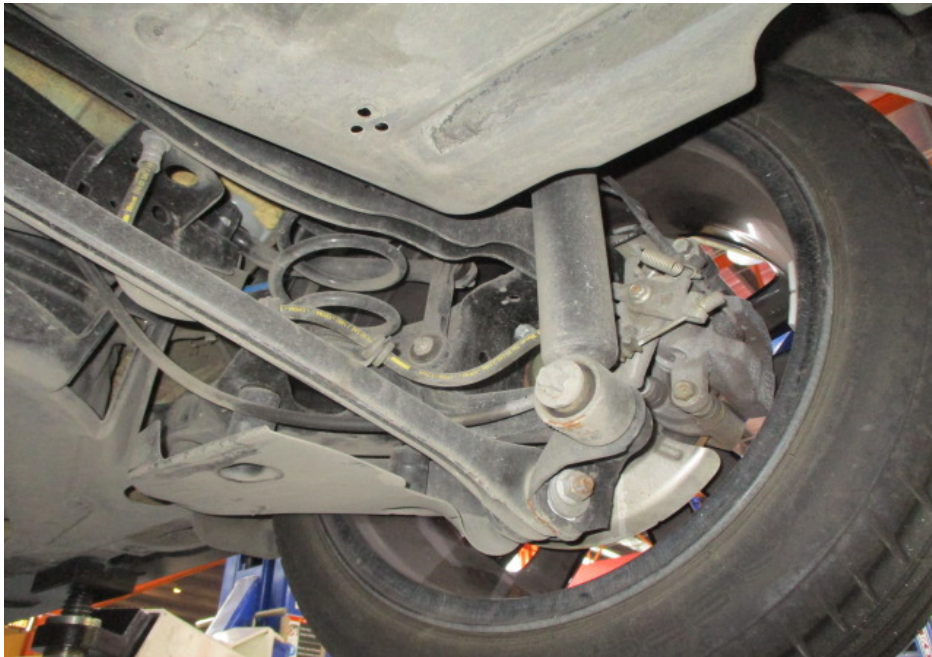
**Photo 15** shows a general view of the control arms and linkages at the rear right wheel of the Motor Car. I did not observe any fluid leak and/or fluid stain on the underside of the Motor Car. All of the Motor Car's undercarriage components were observed to be intact and secured in an appropriate manner.

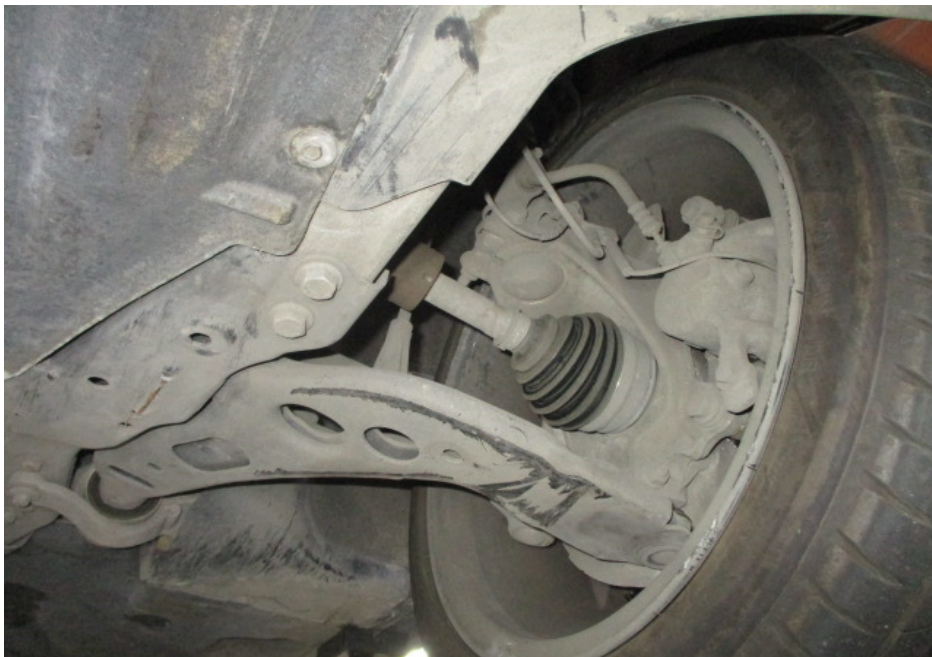
**Photo 16** shows the various undercarriage components at the front left wheel of the Motor Car. The mechanical components, control arms and linkages were all found to be intact and secured in an appropriate manner.

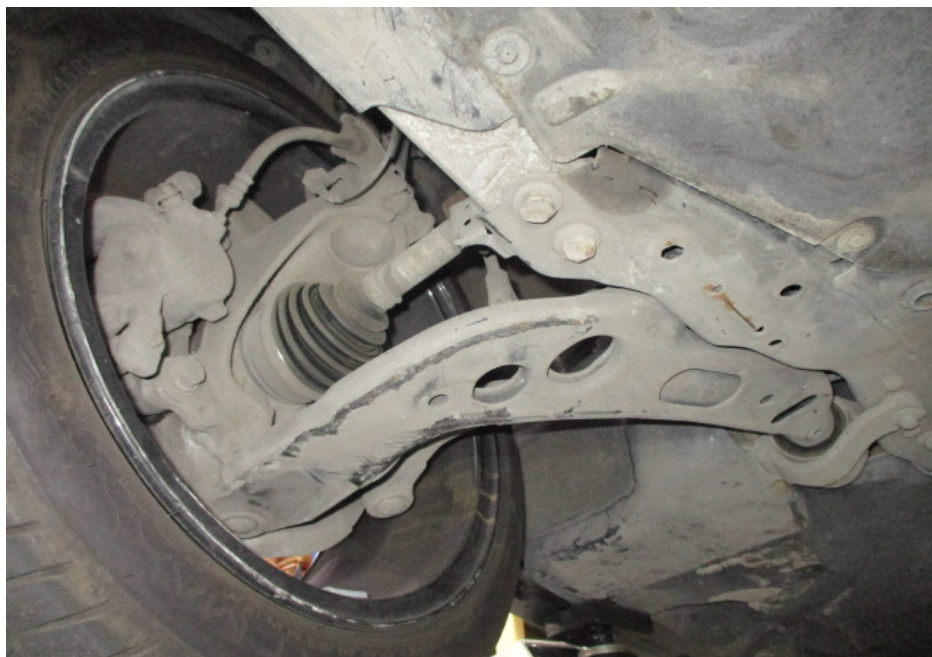
**Photo 17** shows the various undercarriage components at the front right wheel of the Motor Car. The mechanical components, control arms and linkages were all found to be intact and secured in an appropriate manner. I also did not observe any fluid leak and/or fluid stain on the underside of the Motor Car.

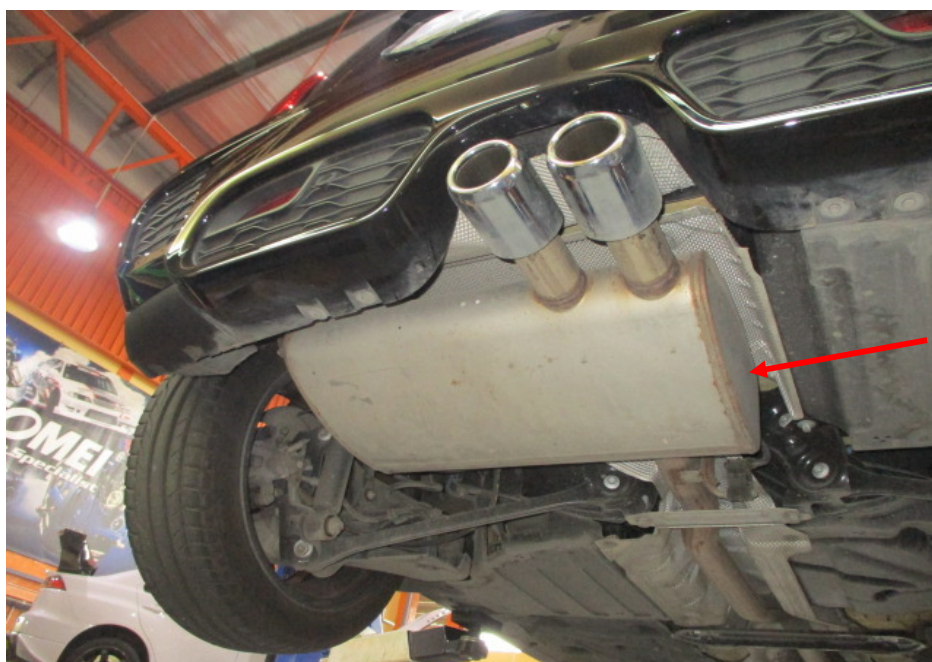
**Photo 18** shows the Motor Car's rear muffler (arrowed). My examination of the Motor Car's exhaust system revealed no sign(s) or indication(s) of any cut or weld marks along its exhaust pipes and on its catalytic converter.

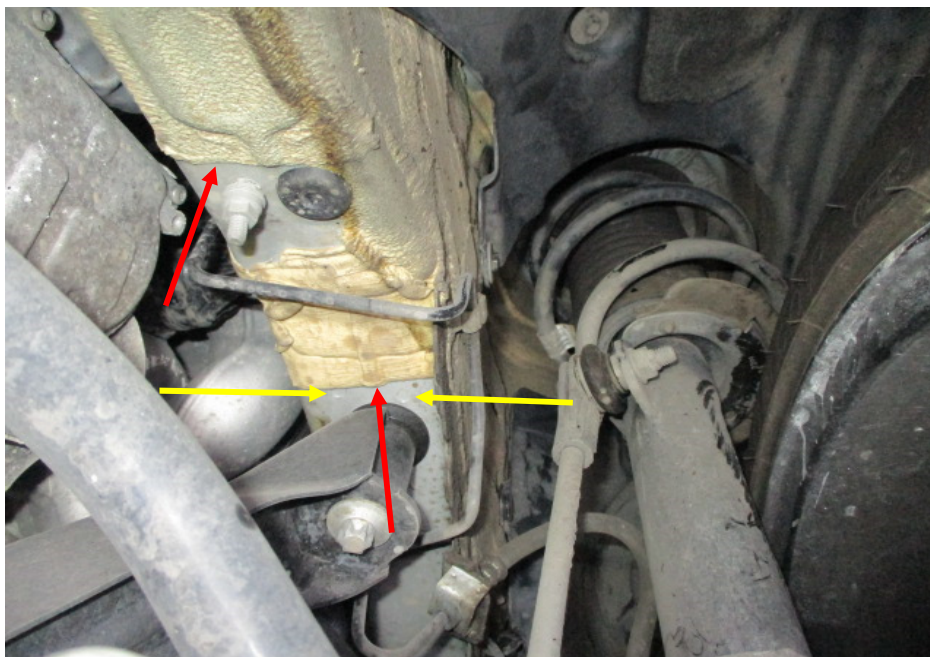
**Photo 19** shows the chassis/structural body at the underside front right of the Motor Car. I did not find any weld marks other than original spot weld marks (yellow arrow) on the chassis/structural body of the Motor Car. The original factory sealant (red arrow) at the joints along the chassis/structural body was untouched, indicating no work was done on the chassis/structural body of the Motor Car and that the chassis/structural body was originally fitted.

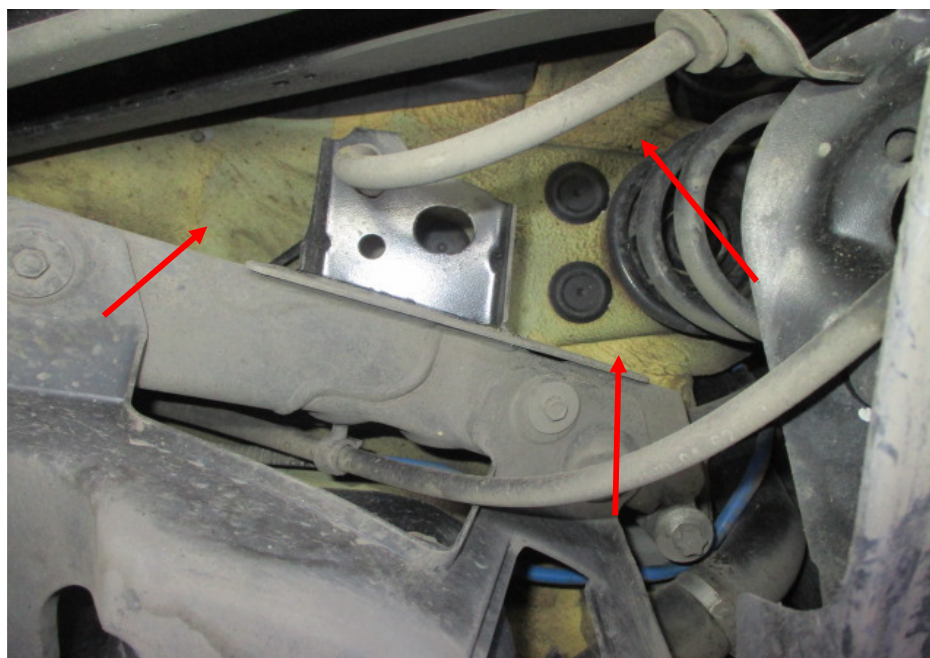
**Photo 20** shows the chassis/structural body at the underside rear right of the Motor Car. The original factory sealant (arrowed) at the joints along the chassis/structural body was observed to be untouched. In general, I had found no work was carried out on the chassis/structural body of the Motor Car. The chassis/structural body of the Motor Car was originally fitted.

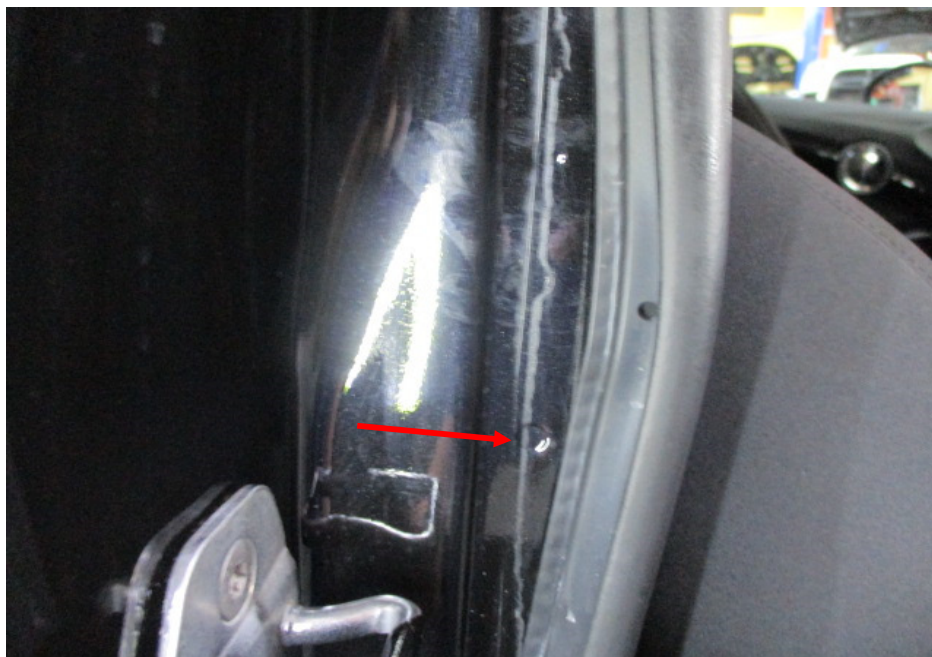
**Photo 21** shows the rear right body panel of the Motor Car. I did not find any weld marks other than original spot weld marks (arrowed) on the rear right body panel of the Motor Car which, indicates that there was no re-welding works carried out. In general, I had found all the non-detachable body panels of the Motor Car to be originally fitted at the time of my inspection.
