Your Ref : M607023
Our Ref : CI/MSG21001142/N

31 March 2021

**AUTOMOBILE TECHNICAL INVESTIGATION REPORT OF ACCIDENT
INVOLVING GBA 7106D AND SMF 1834T ON 25 SEPTEMBER 2019**

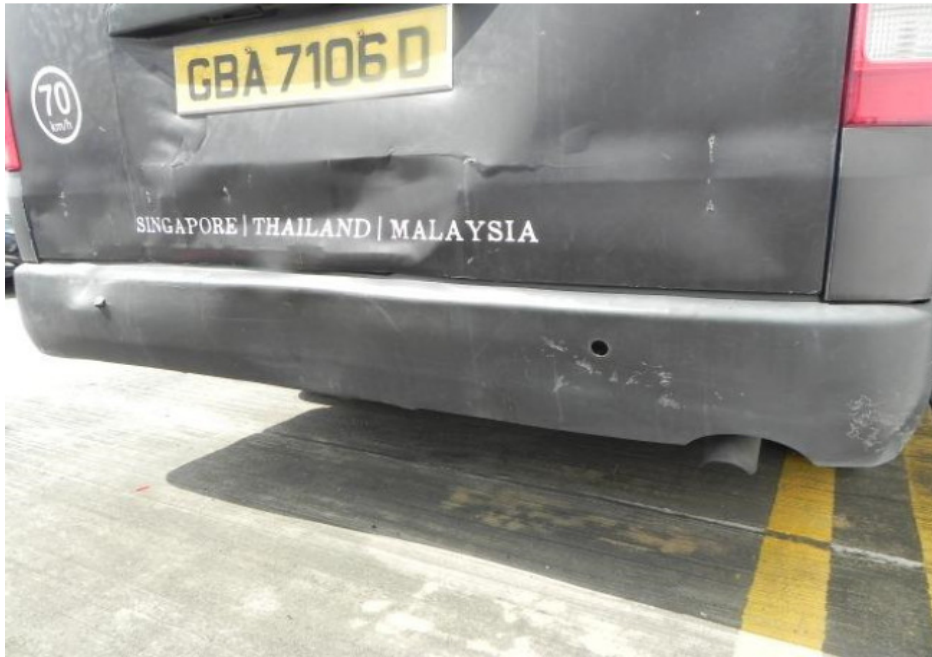
Photo 2 shows a closer view of the damages observed on the rear bumper and tail gate of the Toyota.

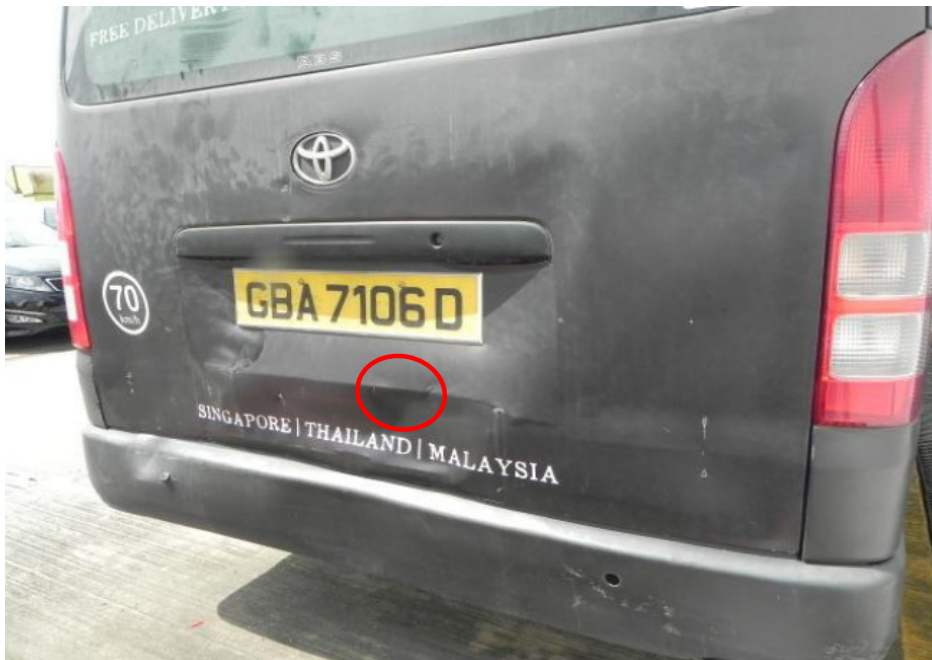
Photo 4 shows a horizontal indentation found below the rear number plate of the Toyota (circled).

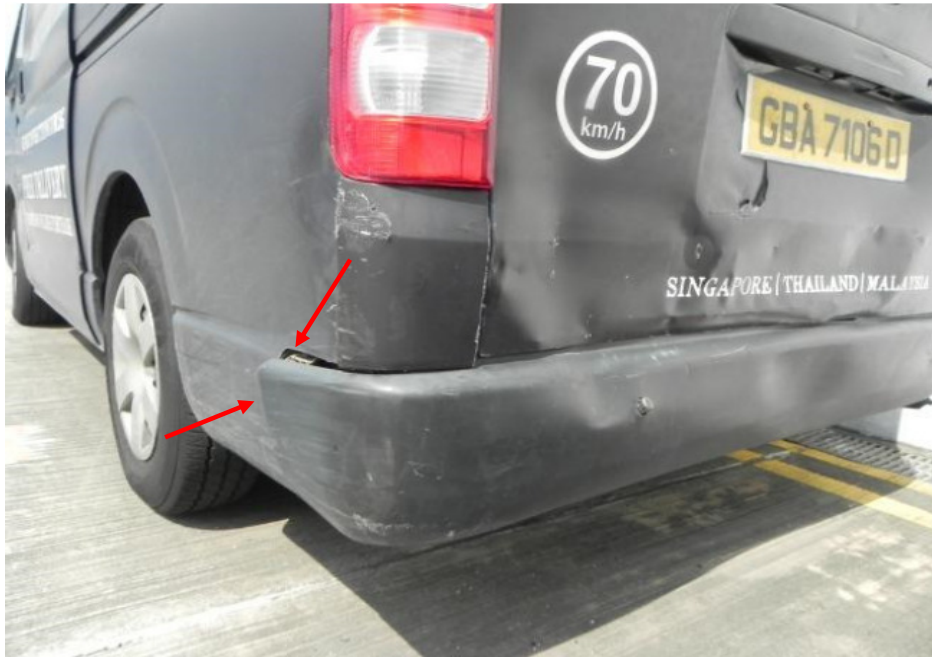
Photo 6 shows a closer view of the left corner edge of the rear bumper of the Toyota. We observed a dislodgement of the left corner edge of the rear bumper of the Toyota (arrowed).

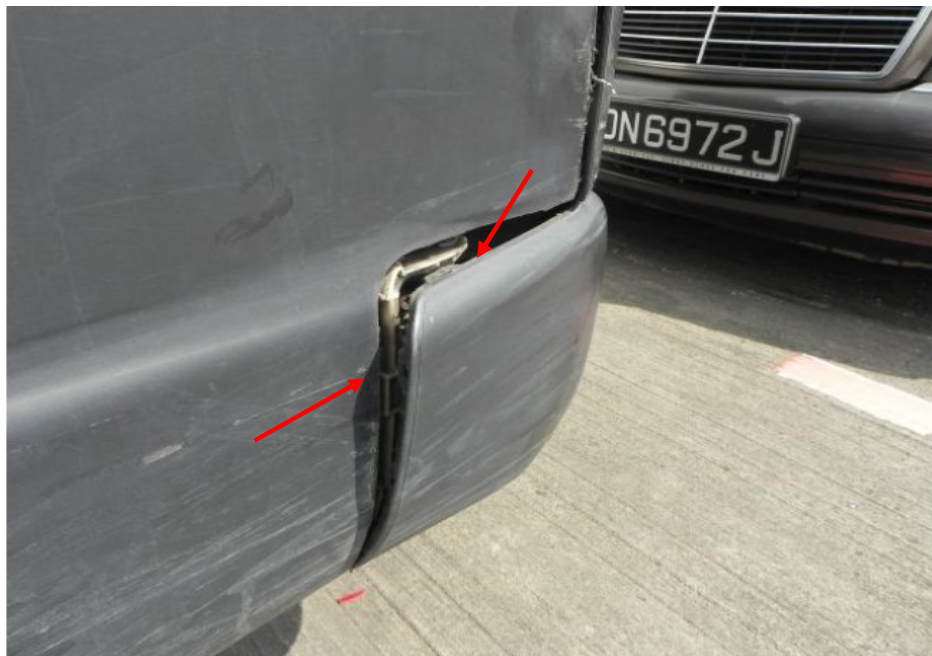
Photo 7 shows a close up view of the dislodgement observed at the left corner edge of the rear bumper of the Toyota (arrowed).

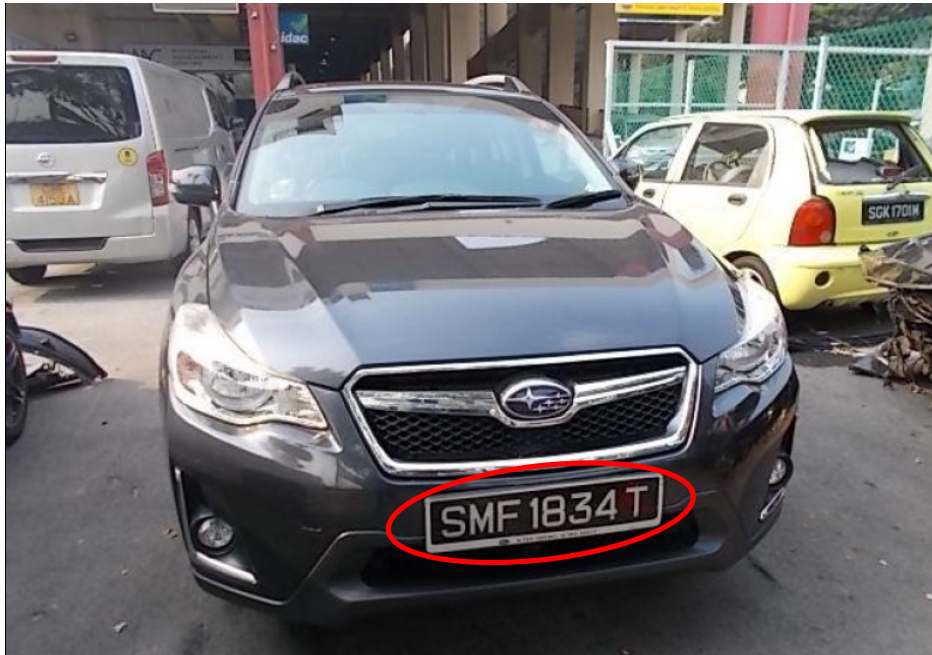
12. From the photographs contained in the Singapore Accident Statement of the Subaru, which was taken about 1 day after the accident, we note that the Subaru had sustained an impact onto its front portion. Examination of the photographs taken at the time of accident reporting showed the Subaru had sustained damages to its front number plate. See photos 8 – 11 below.

Photo 8 shows the general view of the front of the Subaru at the time of reporting, which was 1 day after the accident. The damage to the Subaru was observed to be confined to its front number plate. The front number plate appears to be cracked (circled).

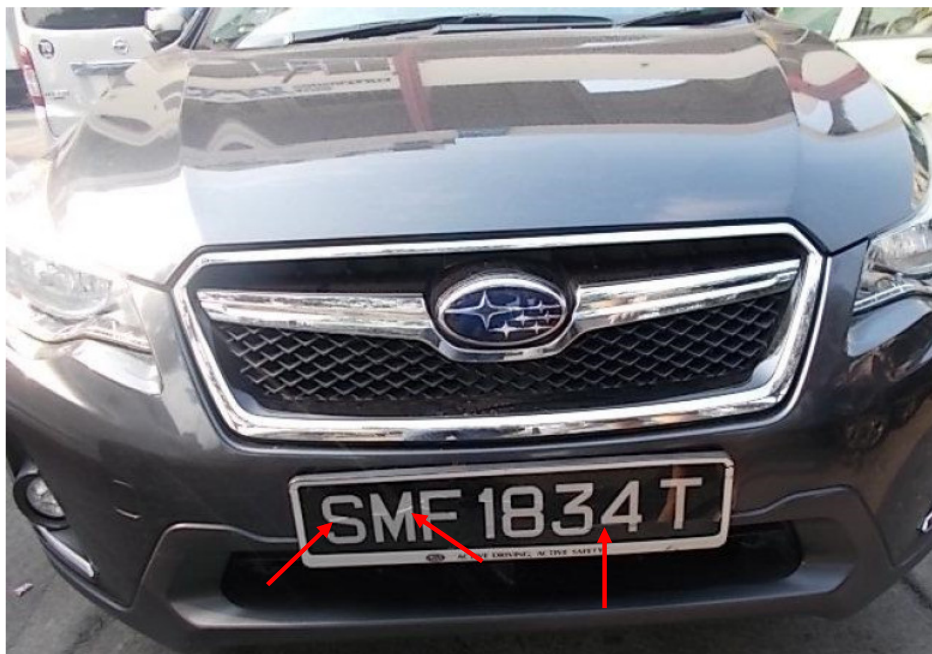
Photo 9 shows a closer view of the cracked front number plate of the Subaru at the time of reporting, which was 1 day after the accident (red arrows).

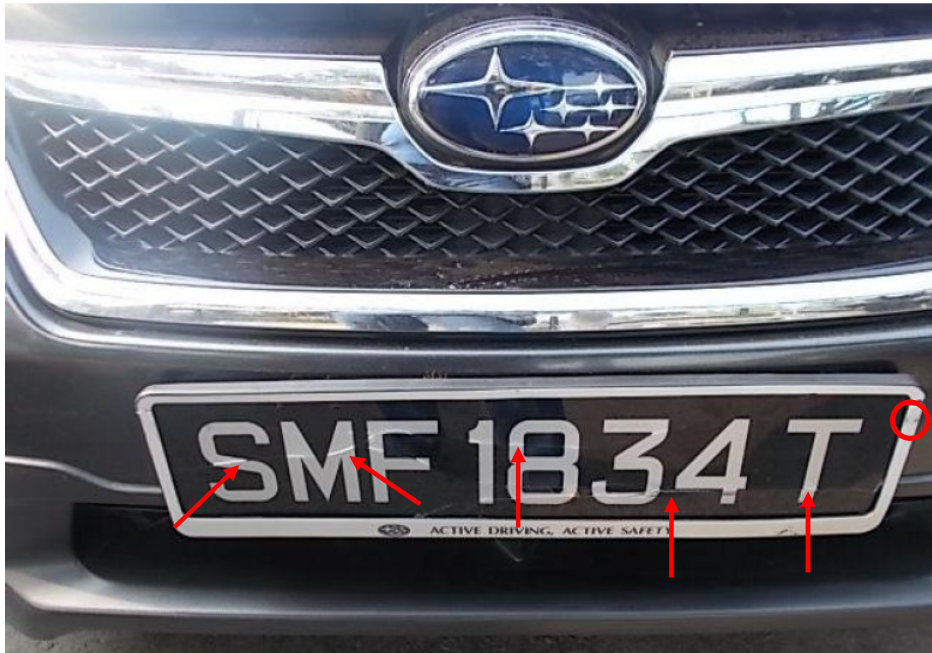
Photo 10 shows a close up view of the cracked front number plate of the Subaru (red arrows). Upon closer examination, we also observed scuff marks on the left corner of the front number plate frame (circled).

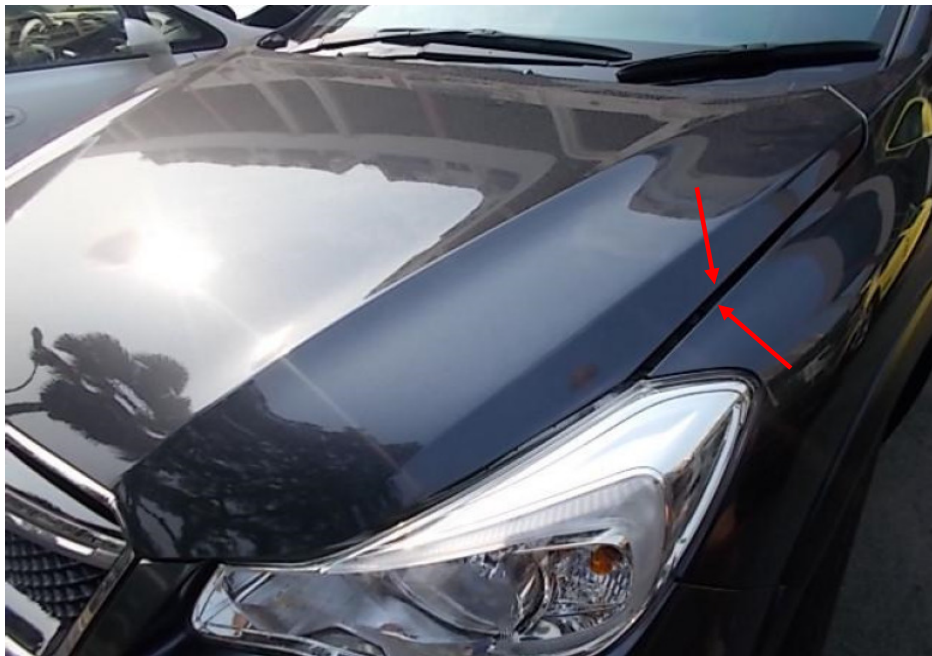
Photo 11 shows a closer view of the left corner edge of the front bonnet and left front fender of the Subaru. We observed that there was a slight misalignment at the corner edges (red arrows) which indicates there was damage to the front bonnet of the Subaru.

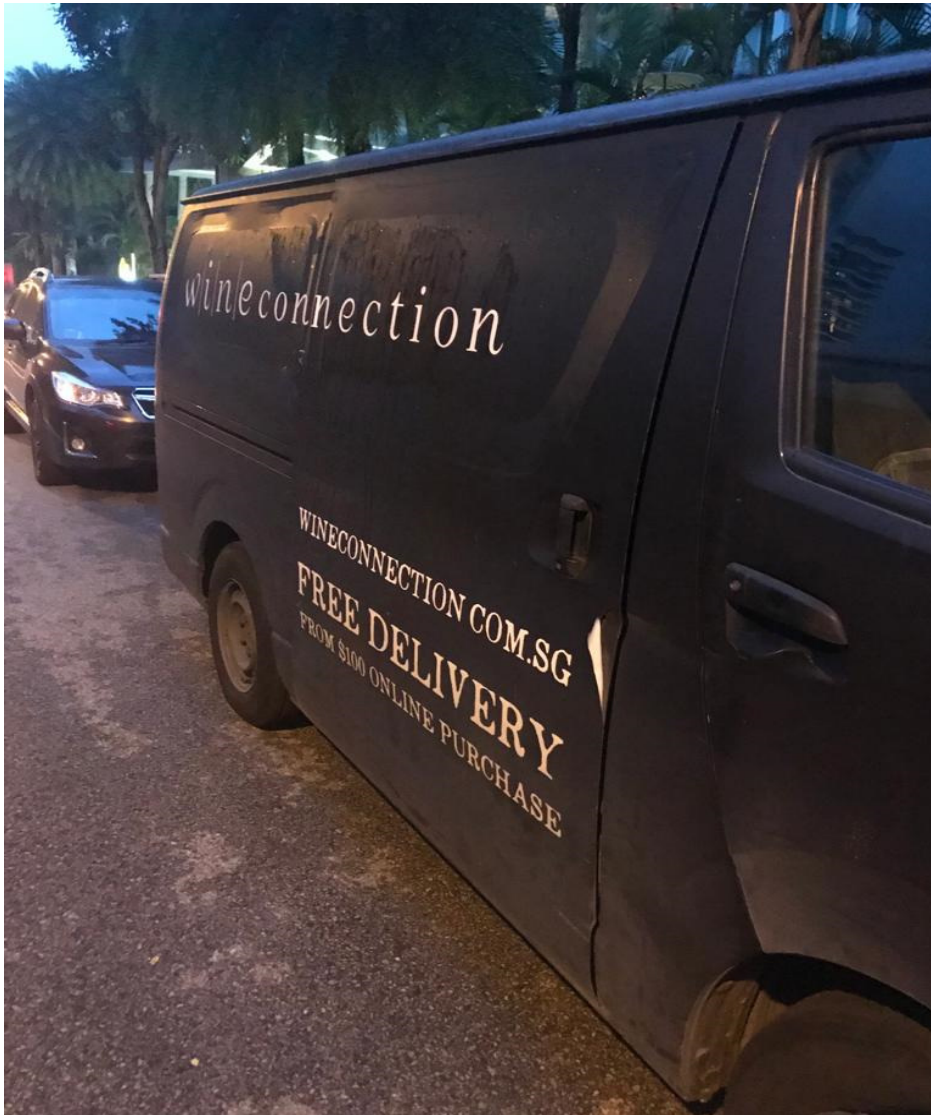
13. For this case, we were able to obtain several photographs taken at the accident scene by Mr Cole. It shows the position of the Involved Motor Vehicles at the accident location. The Subaru was observed to be directly behind the rear of the Toyota. Upon closer examination of these photographs, we observed a dent on the left portion of the Toyota's rear bumper. We also found a horizontal indentation which resembled the top centre portion of the Subaru's front grille. We observed cracks on the Subaru's front number plate and a slight misalignment of the front bonnet and left front fender of the Subaru.

Photo 12 shows the position of the Involved Motor Vehicles at the accident location. The Subaru was observed to be directly behind the rear of the Toyota.

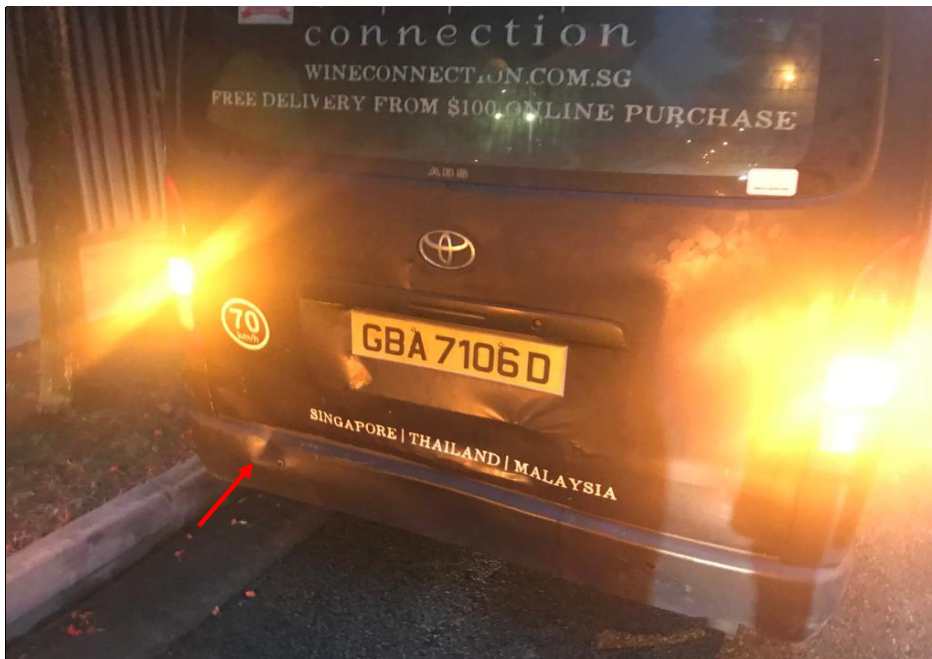
Photo 13 shows a closer view of the rear portion of the Toyota post- accident. Upon closer examination, we observed a dent on the left portion of the Toyota's rear bumper (arrowed).

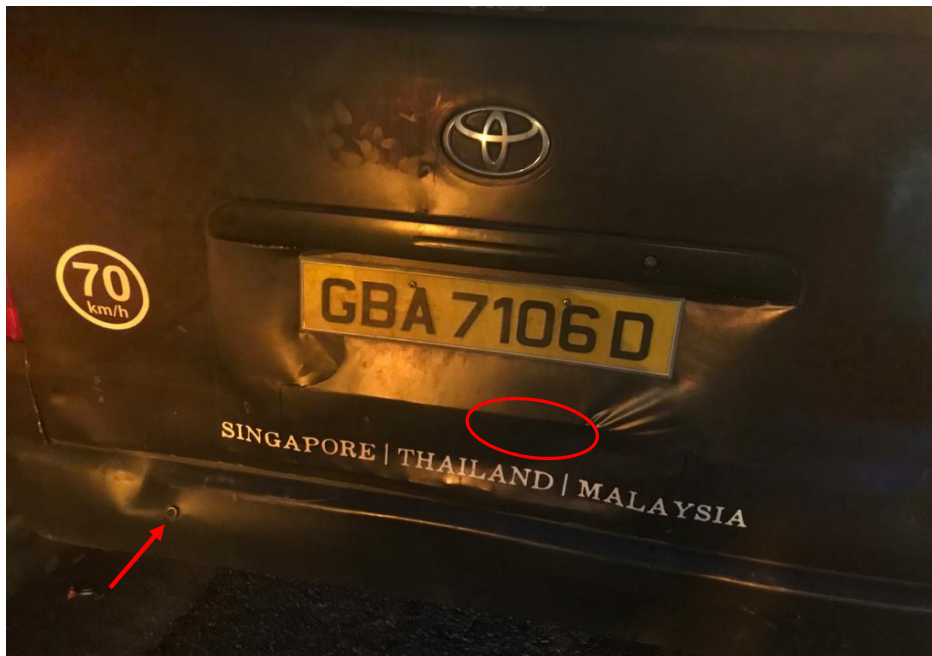
14. It would appear that the damage to the Subaru that could possibly which indicates there was damage to the front bonnet of the Subaru. have been a result of contact with the rear of the Toyota was the front number plate and front grille of the Subaru. This is also taking into consideration that the rear bumper is the most protruded body part at the rear of the Toyota where in the event of any contact, it will be the first body part that will come into contact with the front number plate of the Subaru. See photos 12 - 16 below.

Photo 14 shows a close up view of the rear portion of the Toyota post- accident. Upon closer examination, we also observed the dislodged reverse sensor on the left portion of the Toyota's rear bumper (arrowed) as well as a horizontal indentation which resembled the top centre portion of the Subaru's front grille (circled).

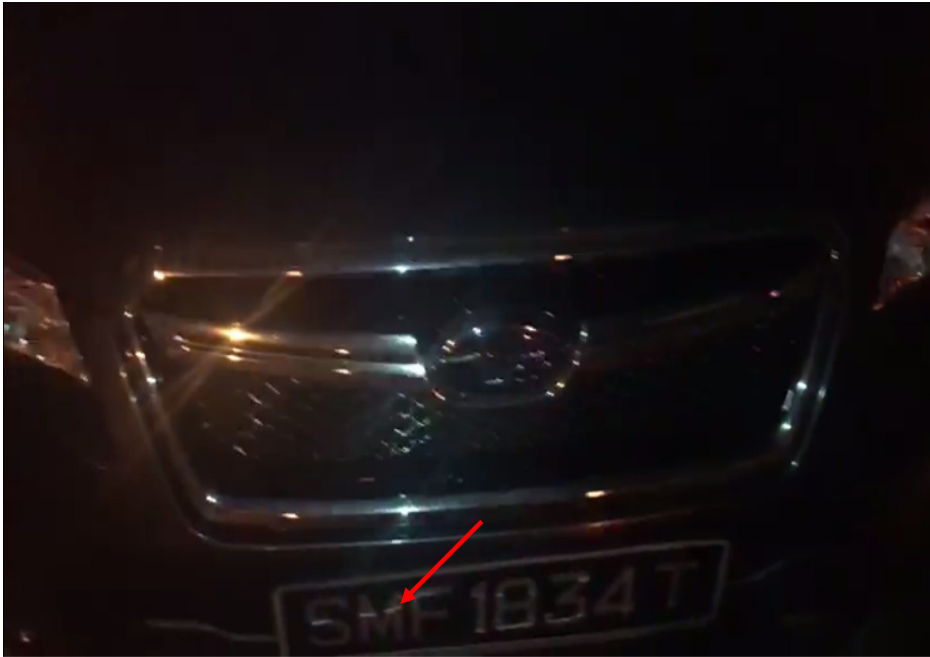
Photo 15 shows a close up view of the cracked front number plate of the Subaru post- accident (arrowed).

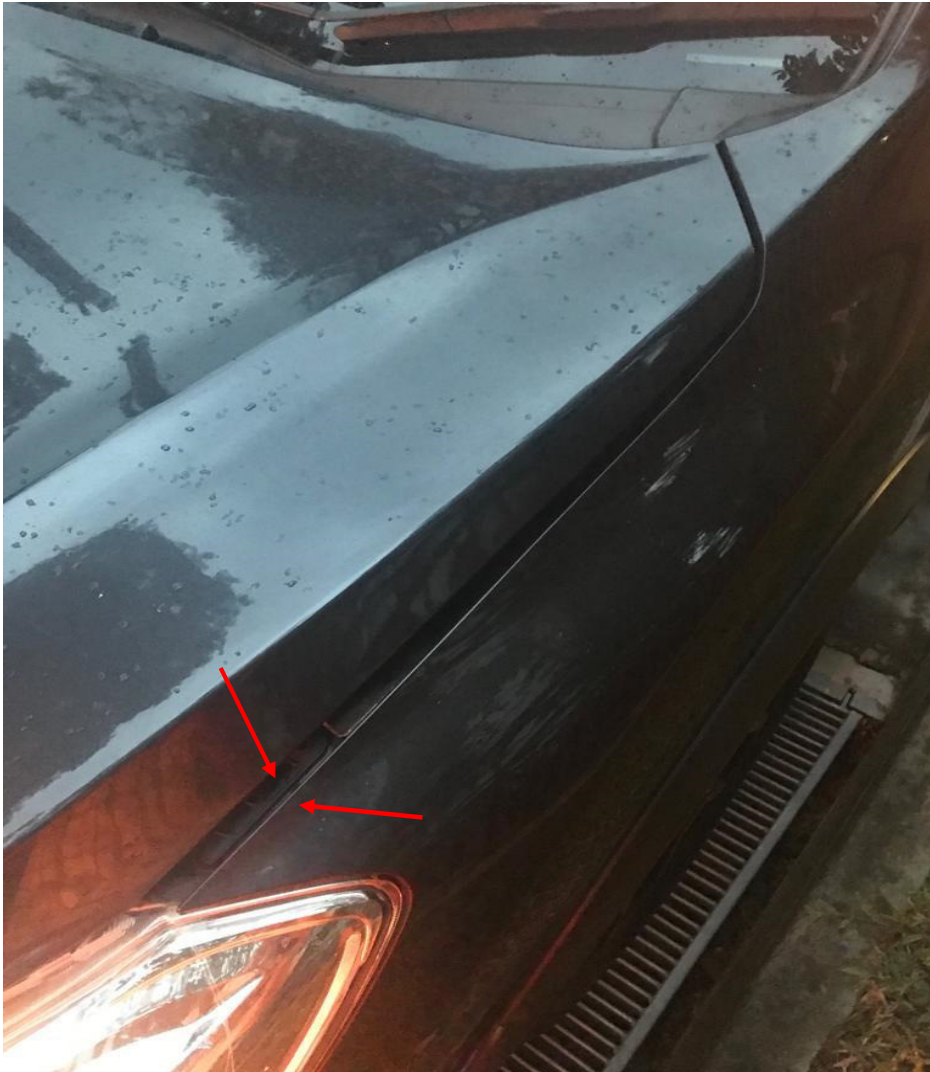
Photo 16 shows the slight misalignment of the front bonnet and left front fender of the Subaru post- accident (arrowed) which indicates there was damage to the front bonnet of the Subaru.

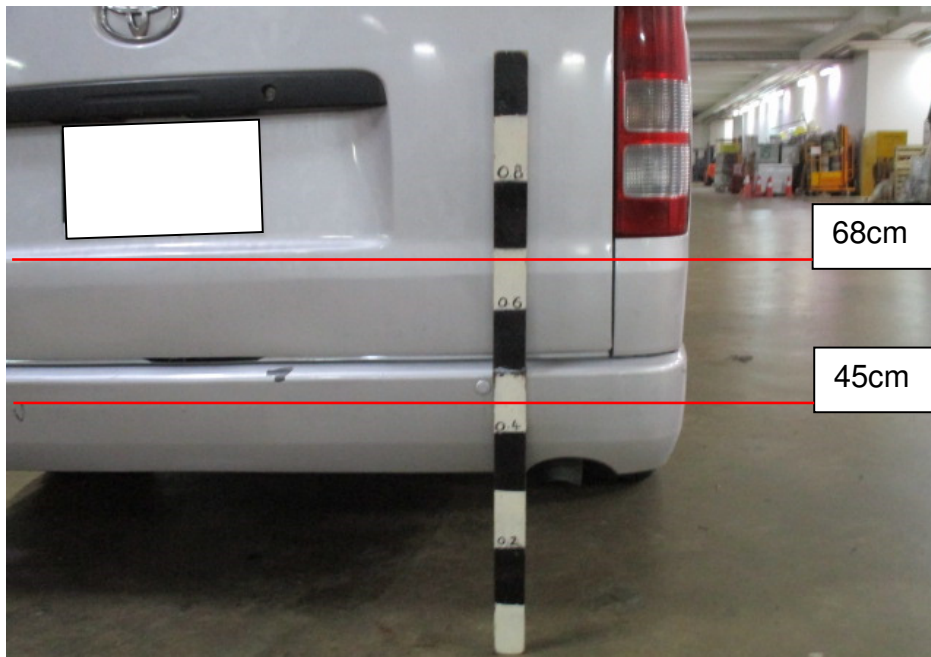
Photo 17 shows the height measurement being conducted on the rear portion of the Toyota (using a similar make and model). The height range above ground level of the damages found on the Toyota, was measured to be approximately between 45cm to 68cm.

- a) The height range above ground level of the damages found on the Toyota, was measured to be approximately between 45cm to 68cm;
- b) the height range above ground level of the damages found on the front number plate and front number plate frame of the Subaru, was measured to be approximately between 46cm to 58cm;
- c) the body part at the height of 68cm above ground level was the top centre portion of the Subaru's front grille, which corresponds to the horizontal indentation found on the Toyota's tail gate.
