Your Ref : M607023
Our Ref : CI/MSG21001142/N

**AUTOMOBILE TECHNICAL INVESTIGATION REPORT OF ACCIDENT
INVOLVING GBA 7106D AND SMF 1834T ON 25 SEPTEMBER 2019**

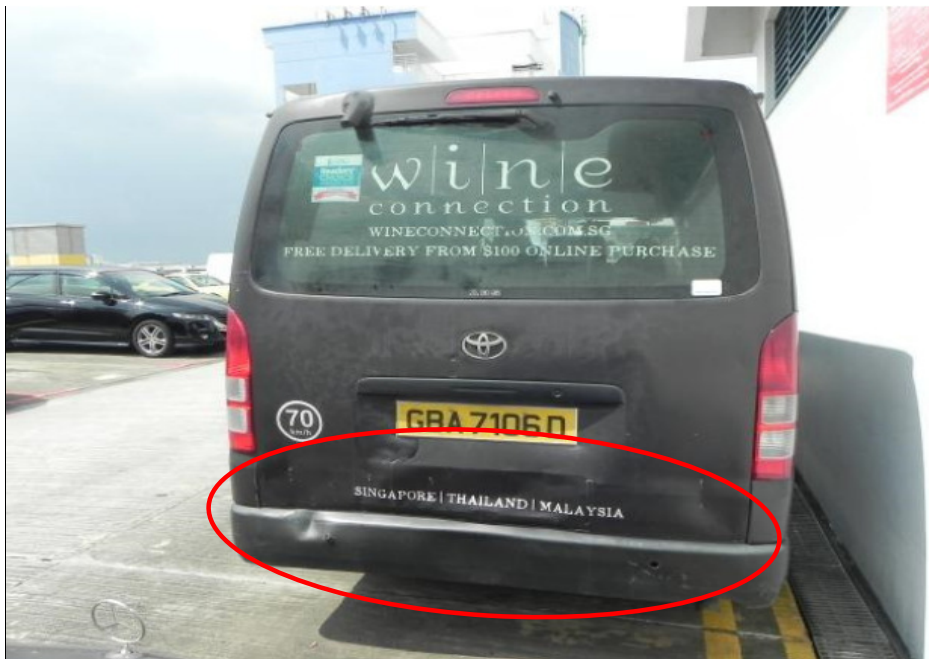
Photo 1 shows the general view of the rear portion of the Toyota at the time of the Pre- Repair Survey conducted by STA Inspection Pte. Ltd. The damage to the Toyota was observed to be confined to the rear bumper and tail gate (circled).

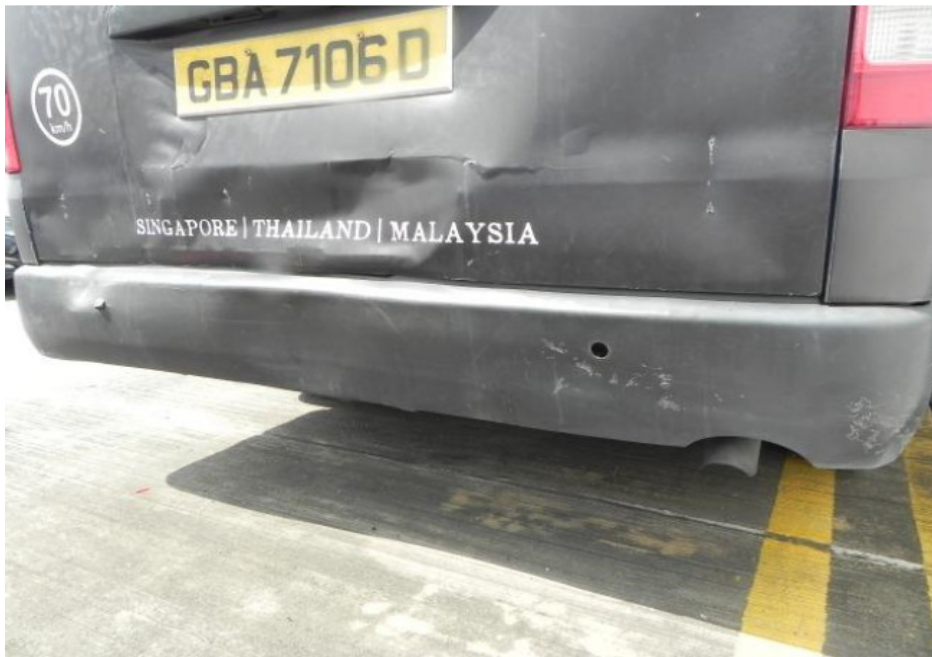
Photo 2 shows a closer view of the damages observed on the rear bumper and tail gate of the Toyota.

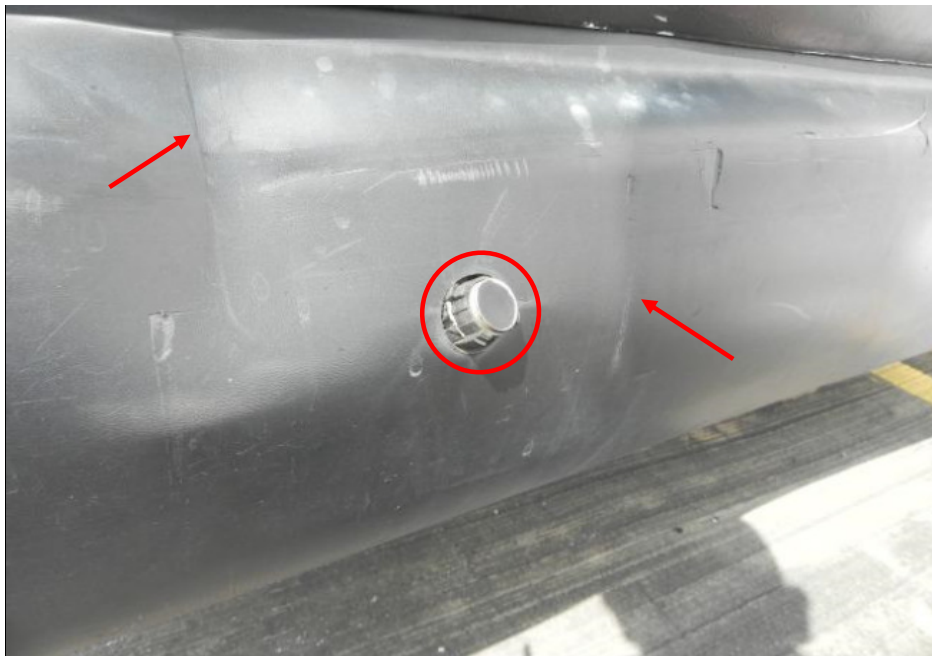
8. We observed vertical indentations and a dislodged reverse sensor on the left portion of the Toyota's rear bumper. We also found a horizontal indentation below the rear number plate of the Toyota. Upon closer examination, we observed a dislodgement of the left corner edge of the rear bumper of the Toyota. See photos 1 - 7 below.

Photo 3 shows a close up view of the vertical indentations (arrowed) and dislodged reverse sensor (circled) found on the left portion of the Toyota's rear bumper.

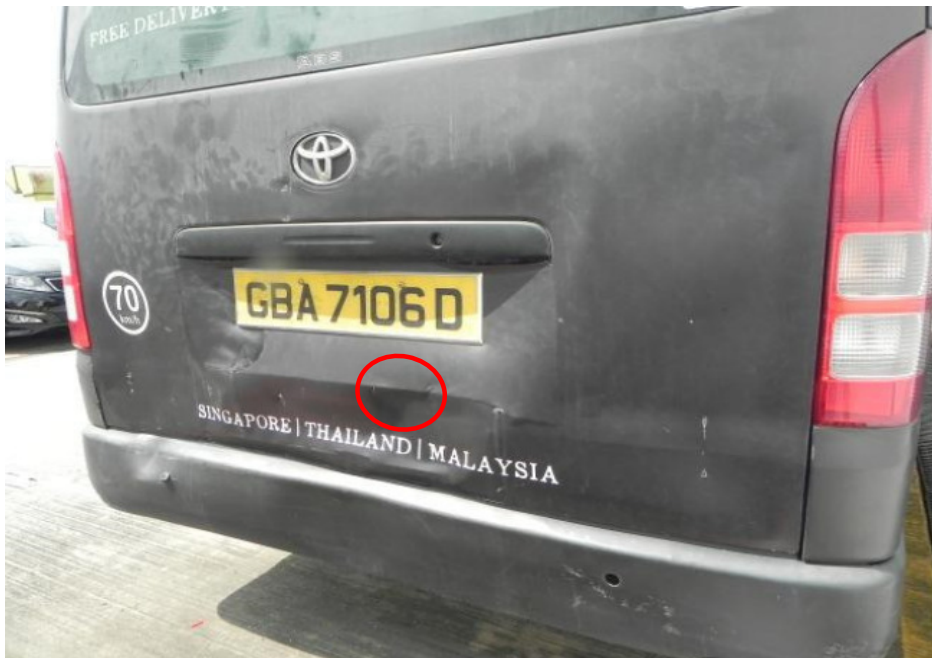
Photo 4 shows a horizontal indentation found below the rear number plate of the Toyota (circled).

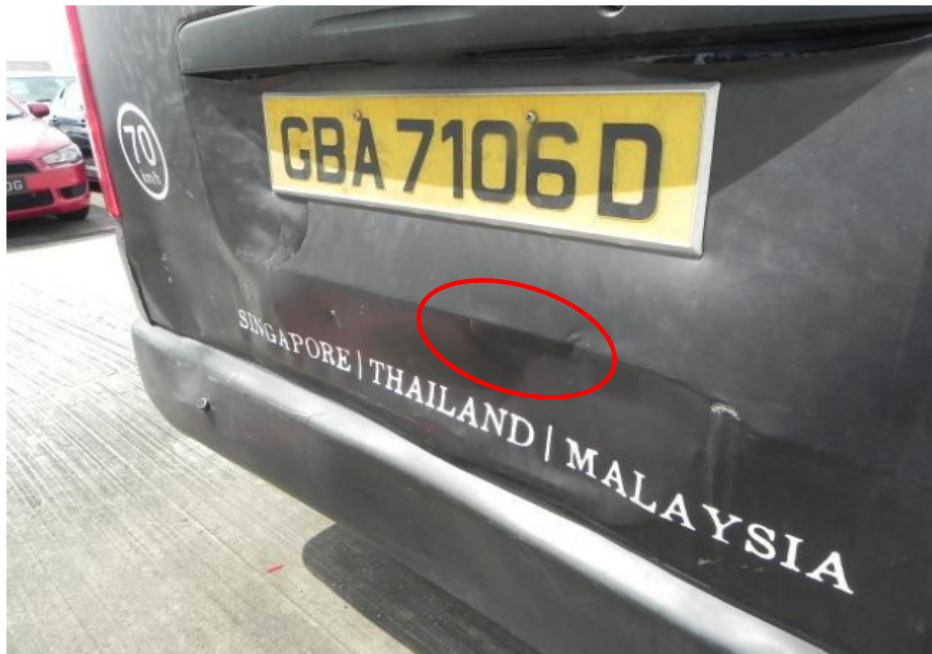
Photo 5 shows a close up view of the horizontal indentation found below the rear number plate of the Toyota (circled).

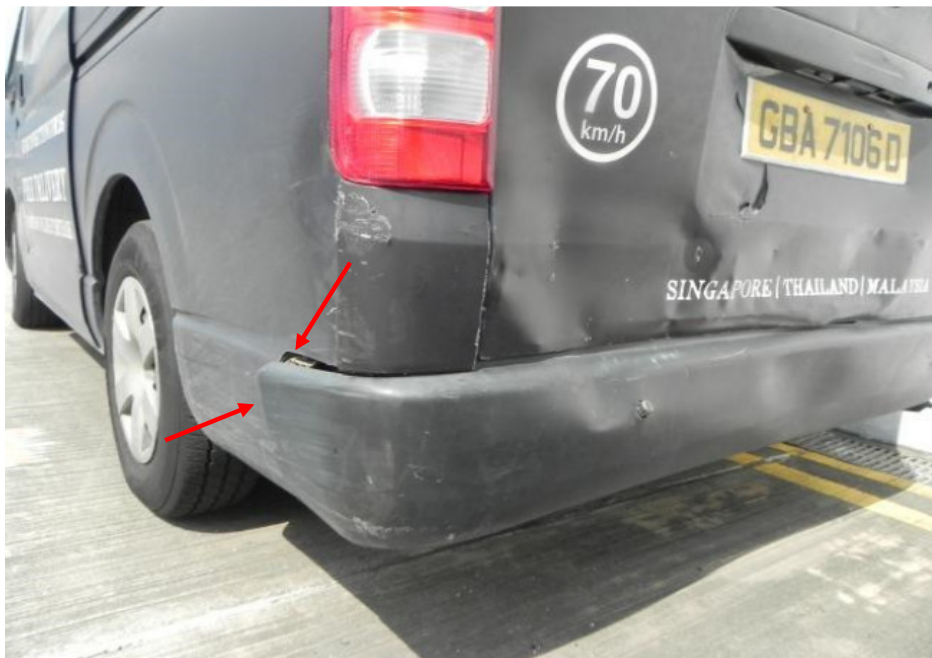
Photo 6 shows a closer view of the left corner edge of the rear bumper of the Toyota. We observed a dislodgement of the left corner edge of the rear bumper of the Toyota (arrowed).

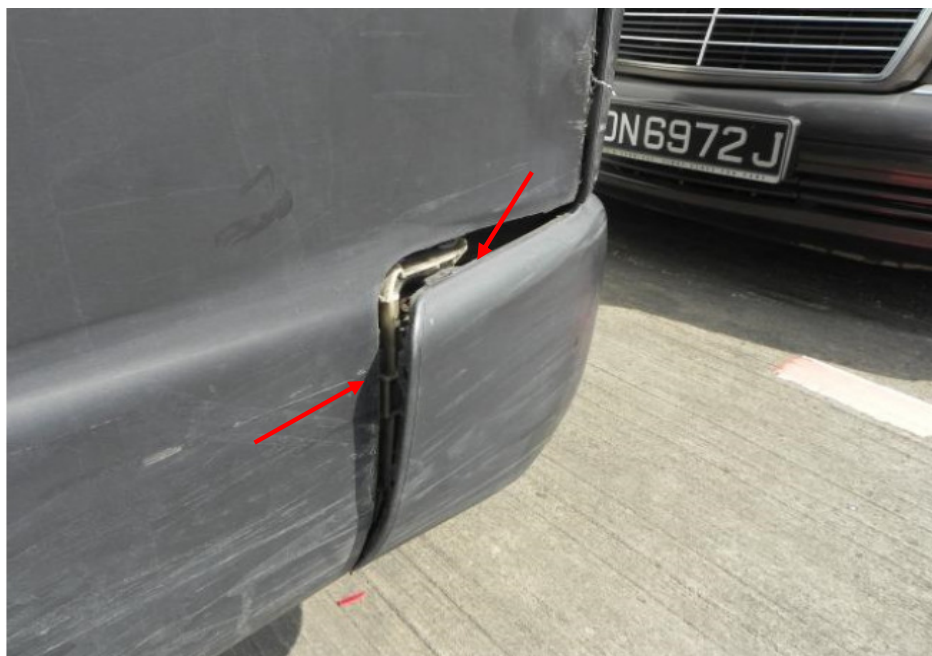
Photo 7 shows a close up view of the dislodgement observed at the left corner edge of the rear bumper of the Toyota (arrowed).

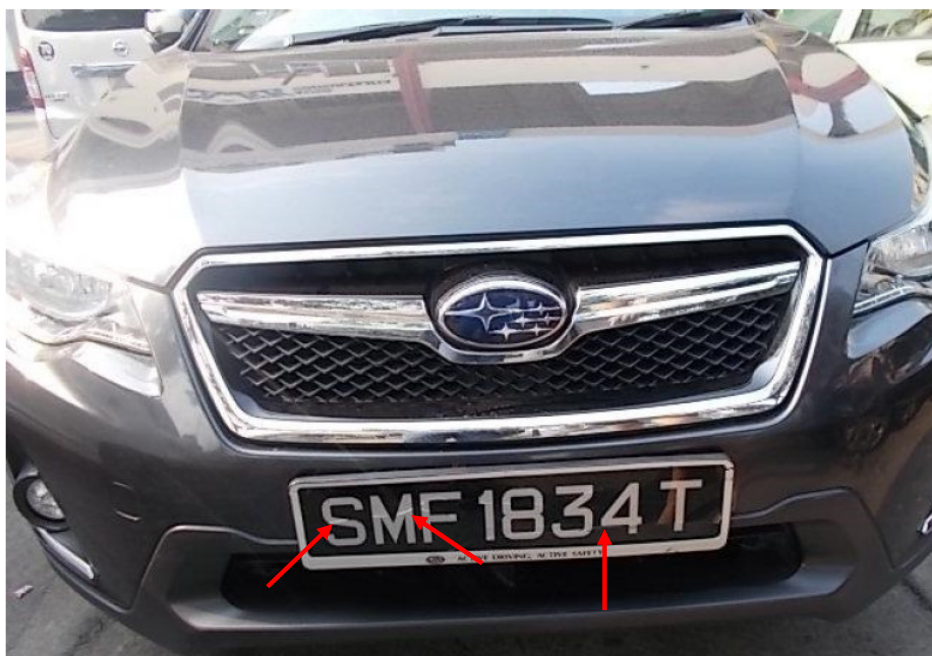
Photo 9 shows a closer view of the cracked front number plate of the Subaru at the time of reporting, which was 1 day after the accident (red arrows).

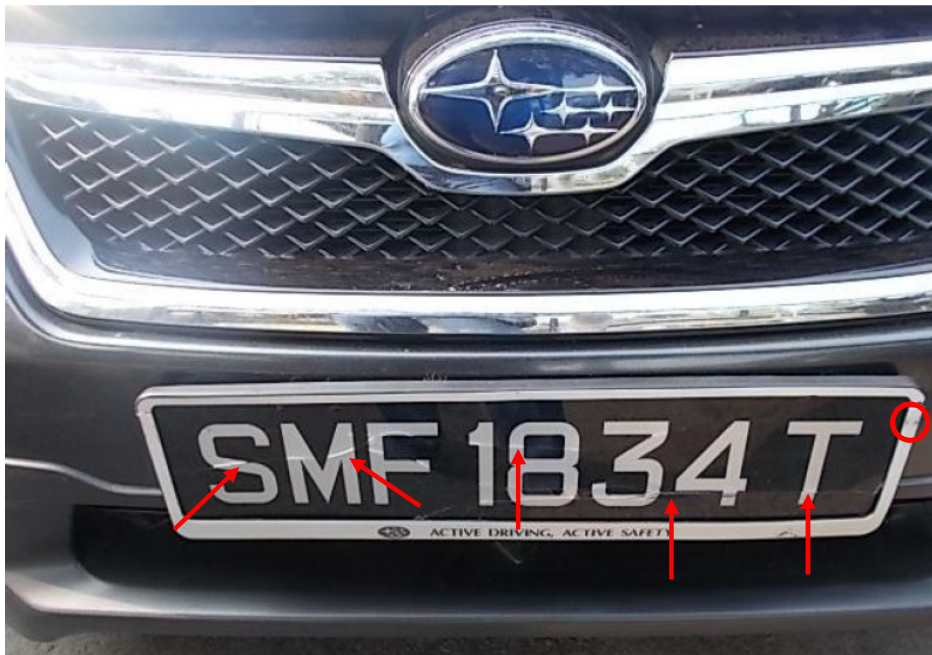
Photo 10 shows a close up view of the cracked front number plate of the Subaru (red arrows). Upon closer examination, we also observed scuff marks on the left corner of the front number plate frame (circled).

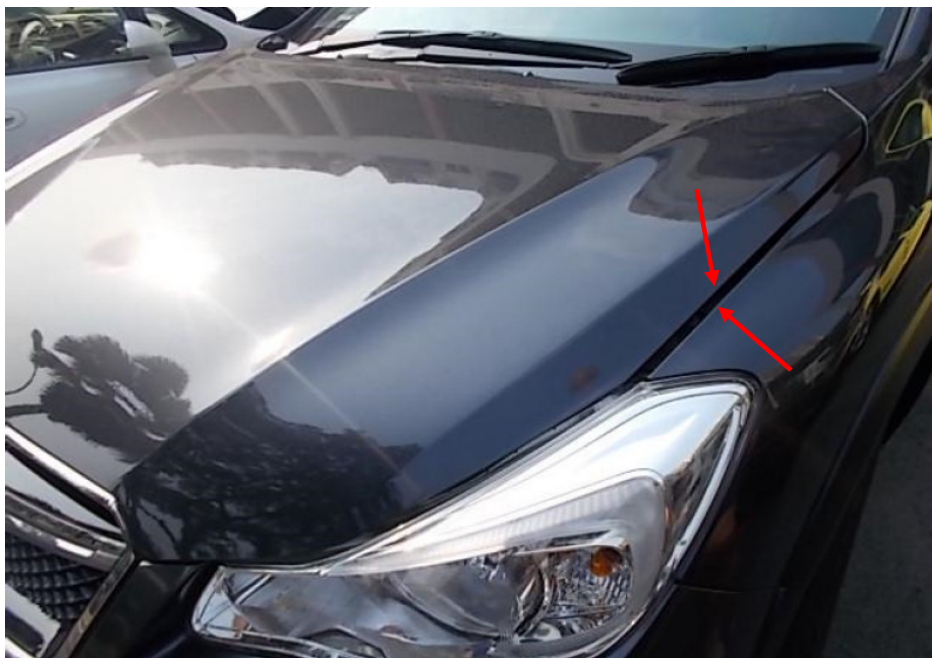
Photo 11 shows a closer view of the left corner edge of the front bonnet and left front fender of the Subaru. We observed that there was a slight misalignment at the corner edges (red arrows) which indicates there was damage to the front bonnet of the Subaru.

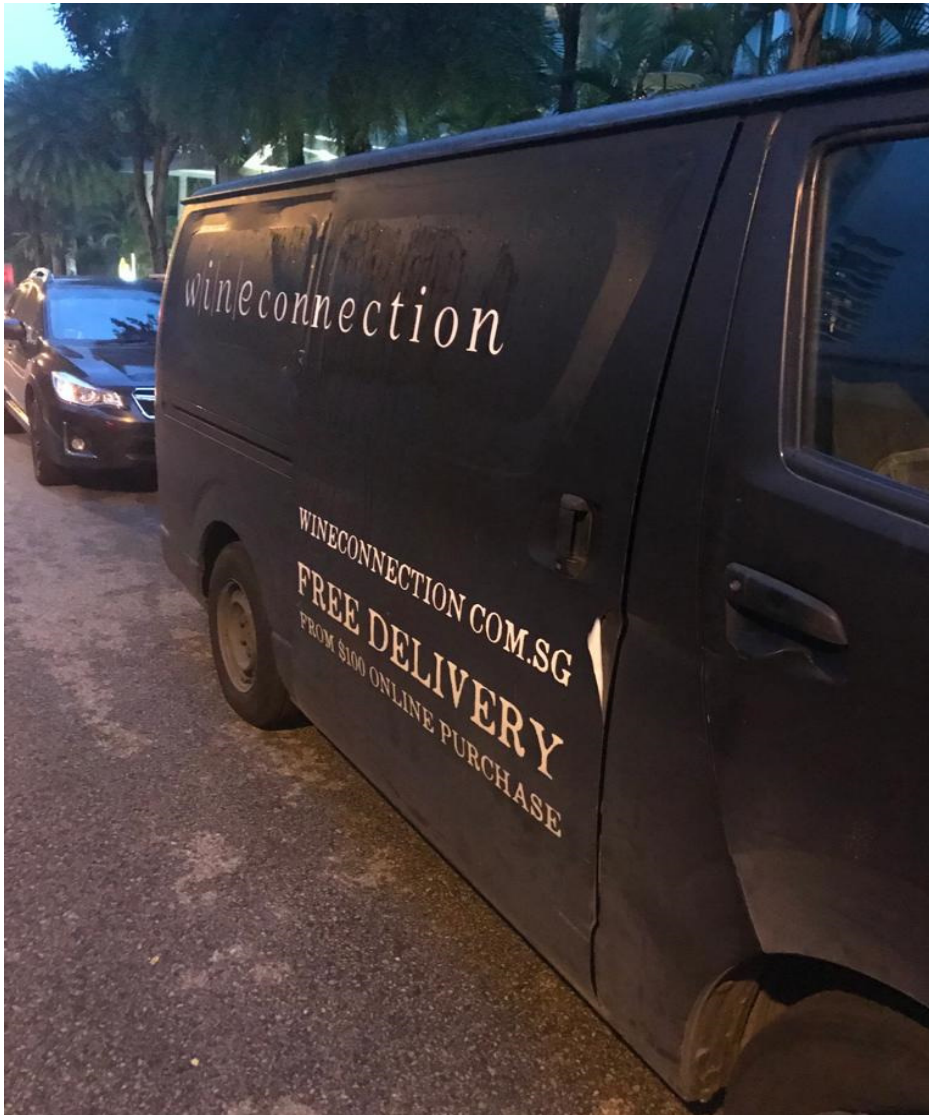
Photo 12 shows the position of the Involved Motor Vehicles at the accident location. The Subaru was observed to be directly behind the rear of the Toyota.

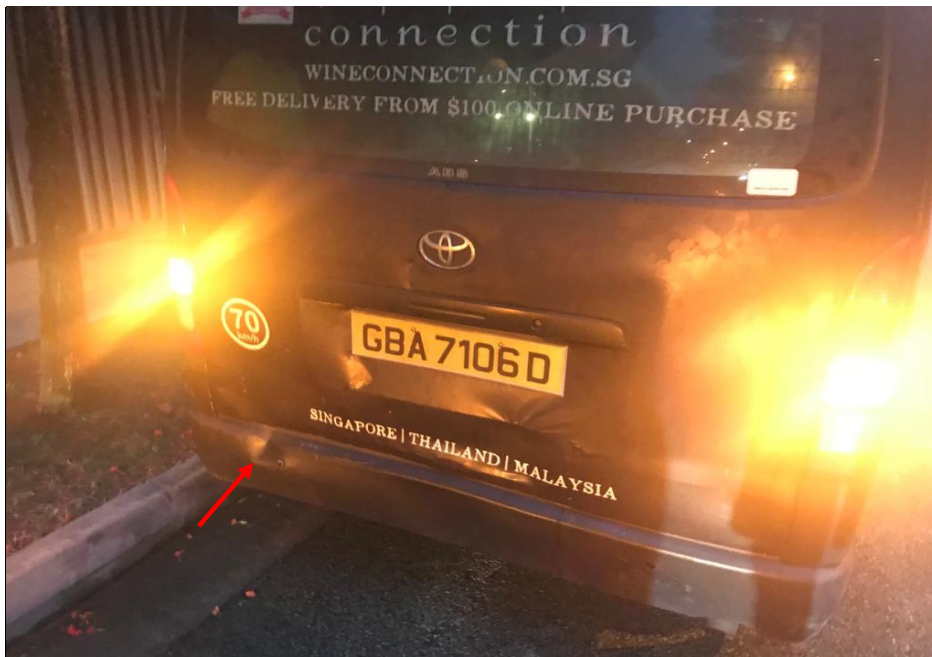
Photo 13 shows a closer view of the rear portion of the Toyota post- accident. Upon closer examination, we observed a dent on the left portion of the Toyota's rear bumper (arrowed).

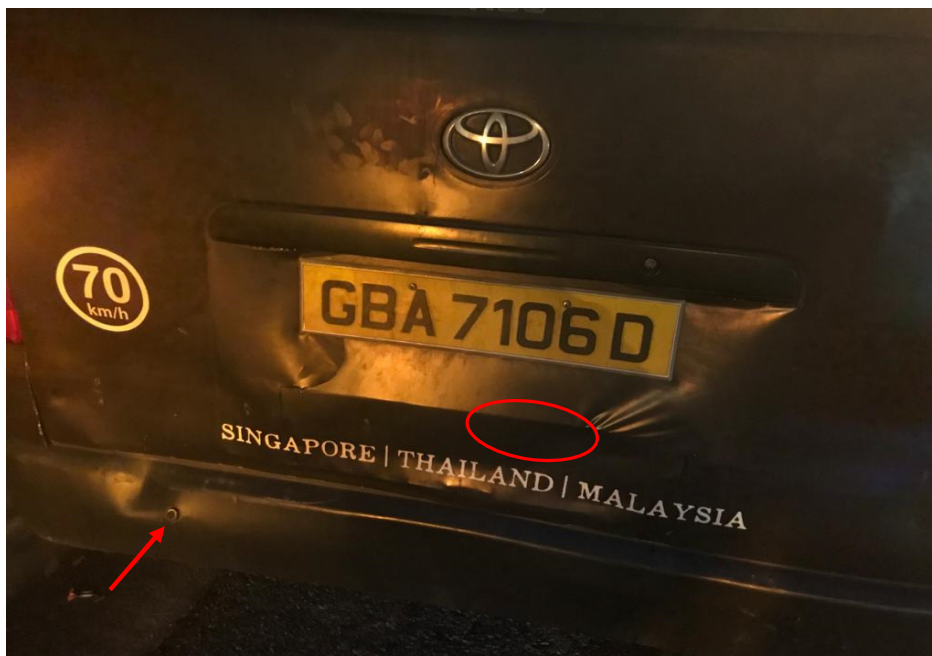
Photo 14 shows a close up view of the rear portion of the Toyota post- accident. Upon closer examination, we also observed the dislodged reverse sensor on the left portion of the Toyota's rear bumper (arrowed) as well as a horizontal indentation which resembled the top centre portion of the Subaru's front grille (circled).

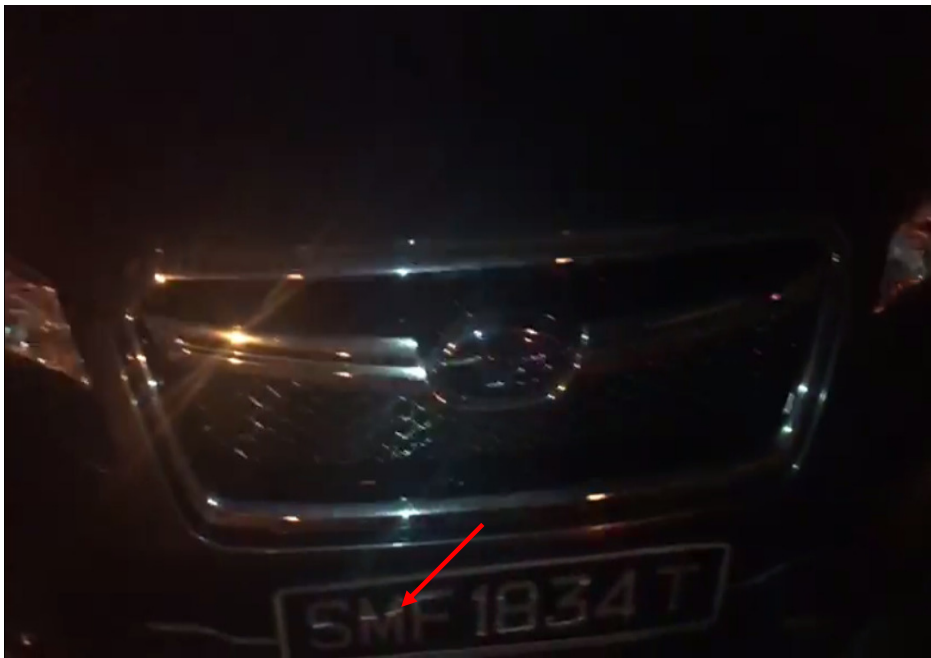
Photo 15 shows a close up view of the cracked front number plate of the Subaru post- accident (arrowed).

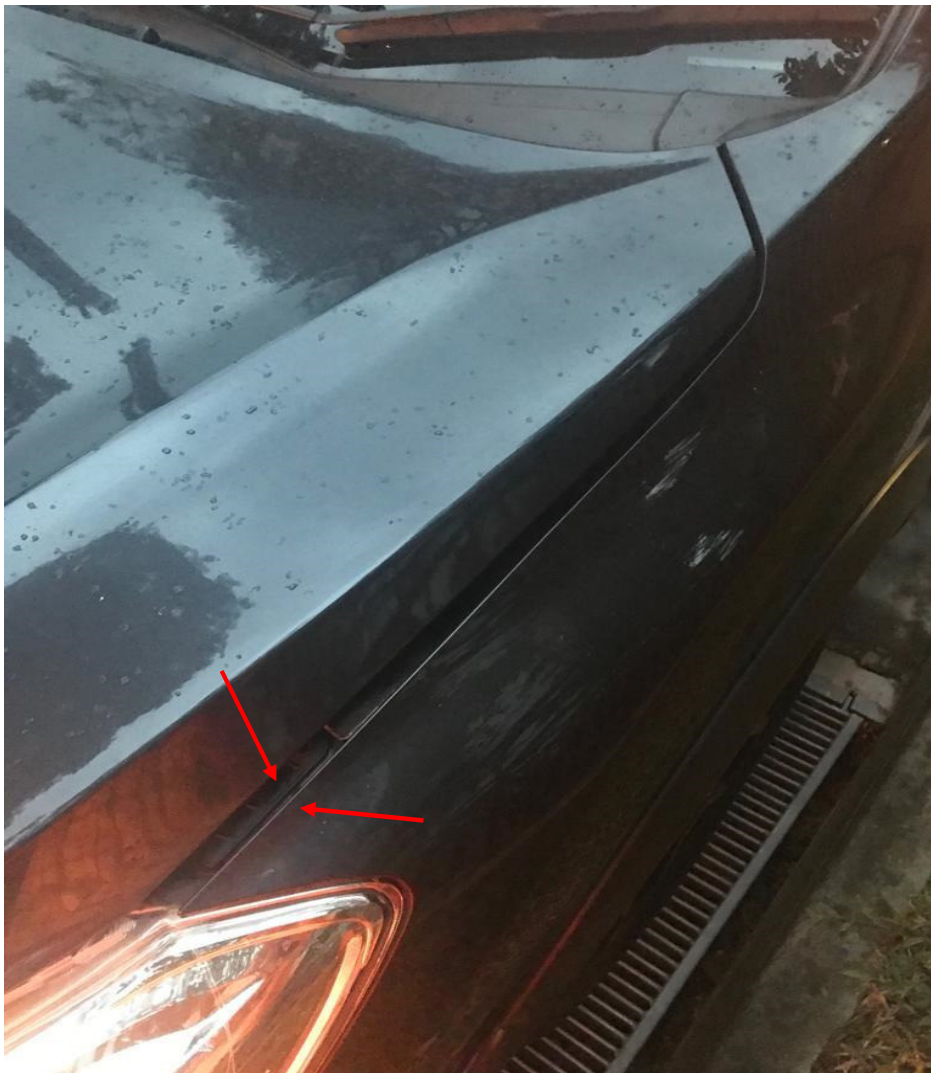
Photo 16 shows the slight misalignment of the front bonnet and left front fender of the Subaru post- accident (arrowed) which indicates there was damage to the front bonnet of the Subaru.

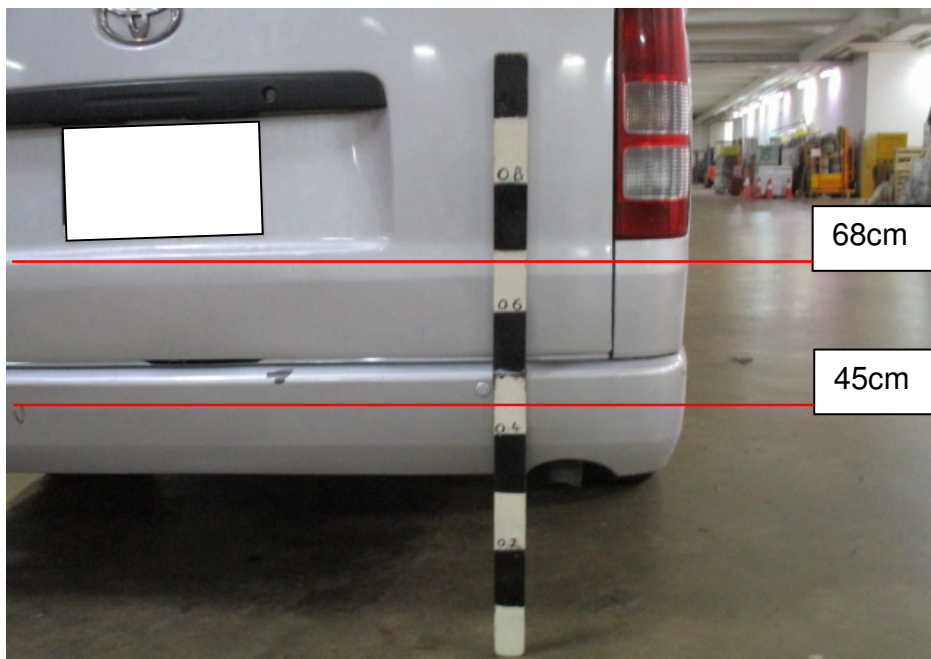
Photo 17 shows the height measurement being conducted on the rear portion of the Toyota (using a similar make and model). The height range above ground level of the damages found on the Toyota, was measured to be approximately between 45cm to 68cm.

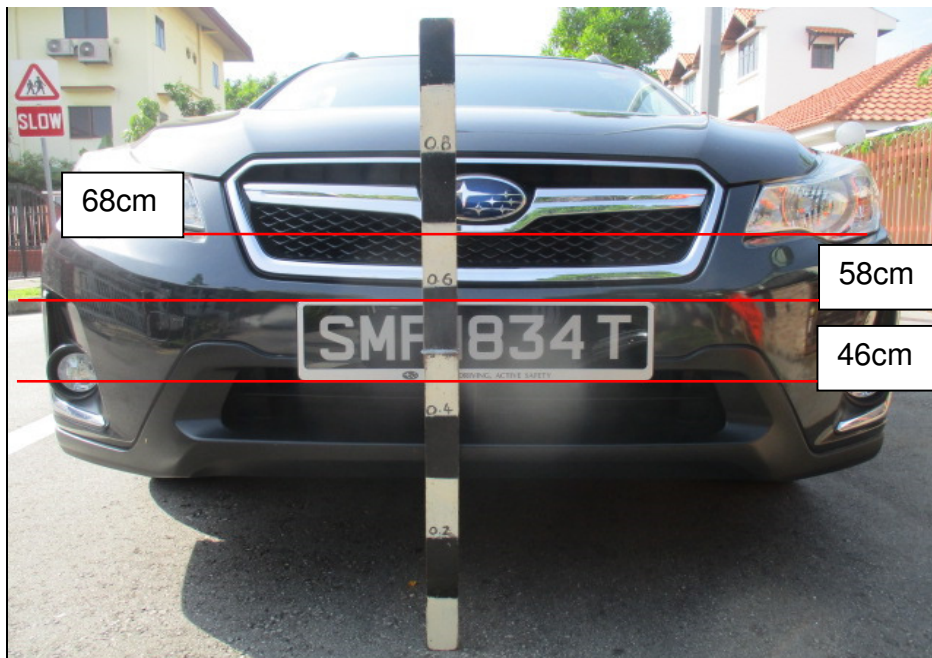
Photo 18 shows the height measurement being conducted on the front portion of the Subaru. The height range above ground level of the damages found on the front number plate and front number plate frame of the Subaru, was measured to be approximately between 46cm to 58cm. The body part at the height of 68cm above ground level was the top centre portion of the Subaru's front grille, which corresponds to the horizontal indentation found on the Toyota's tail gate.
