## LKK Auto Consultants Pte Ltd

Vehicle No. SHD 777B  
Insured Veh. SGW 4542Y  
Claim No. SNM21D200519/C02  
Policy No. DMPCSNW00009832100  
Accident Date 20/01/2021  
Inspection Date 22/01/2021

## ADJUSTMENT ON REPAIR COST FOR VEHICLE NO. SHD 777B

PHOTOGRAPHS FOR VEHICLE NO. SHD 777B

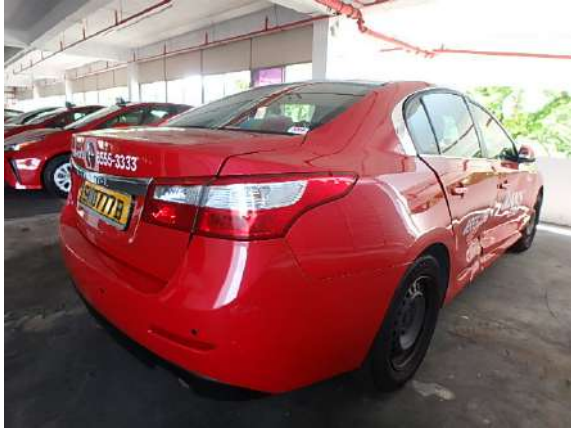
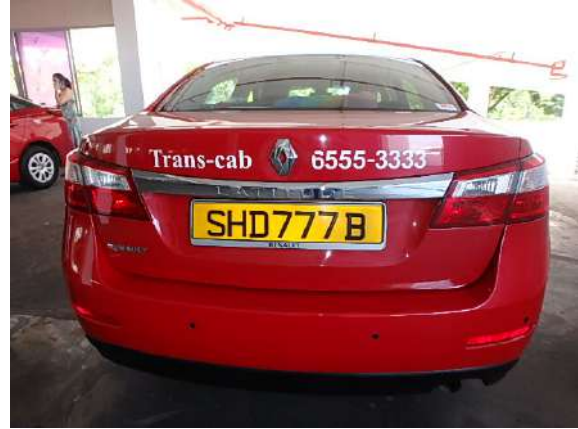
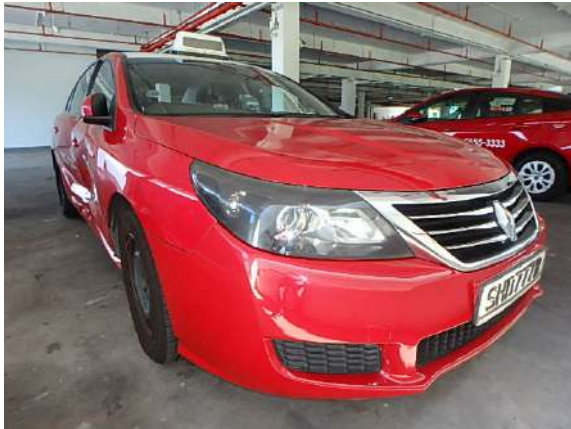
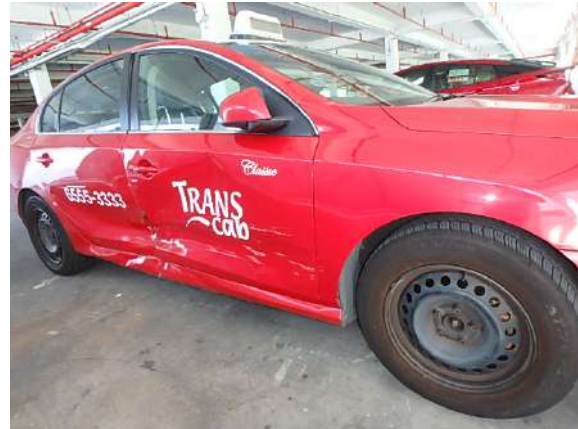
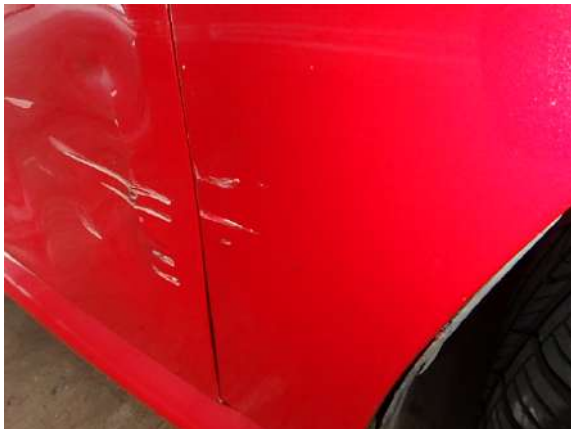
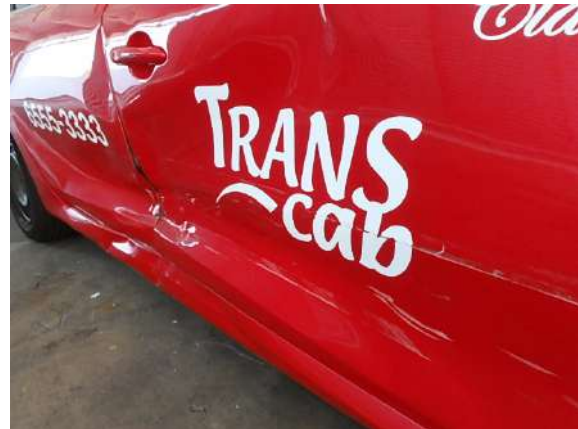
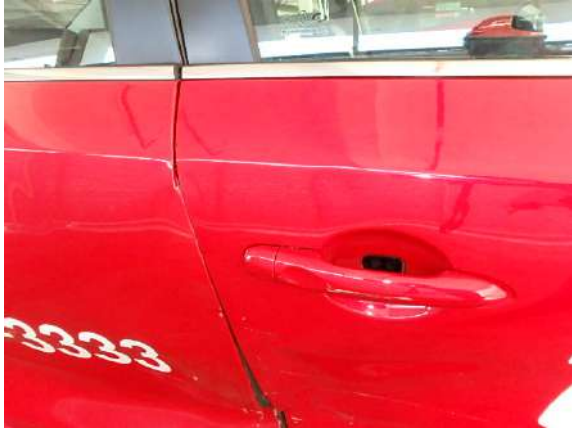
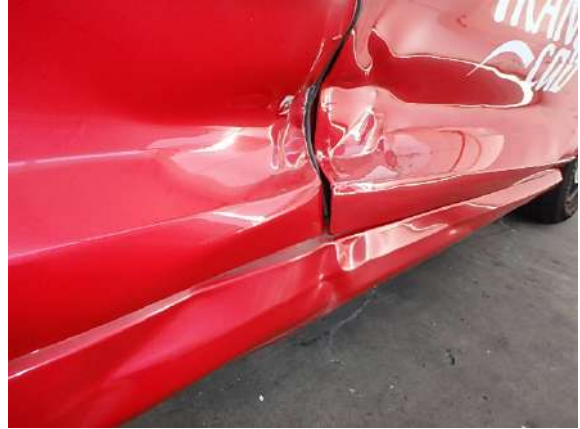
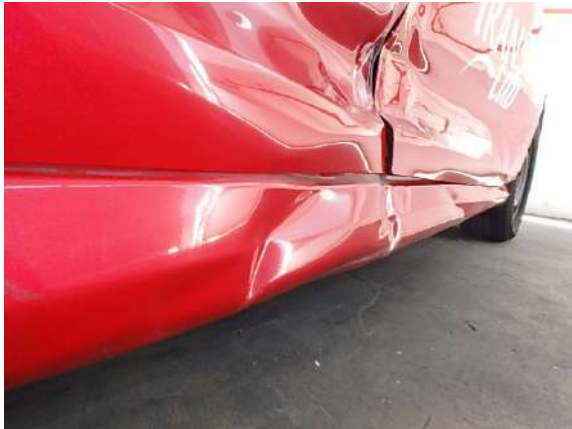
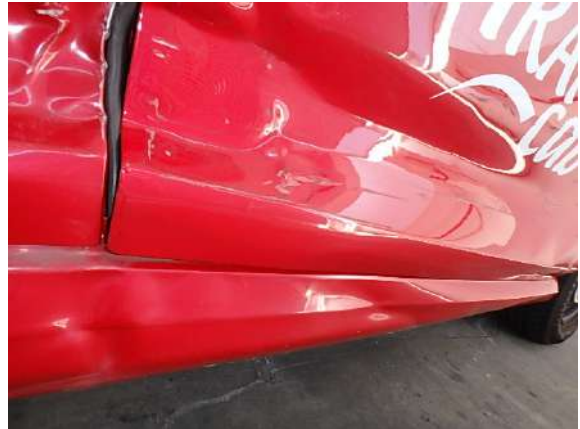
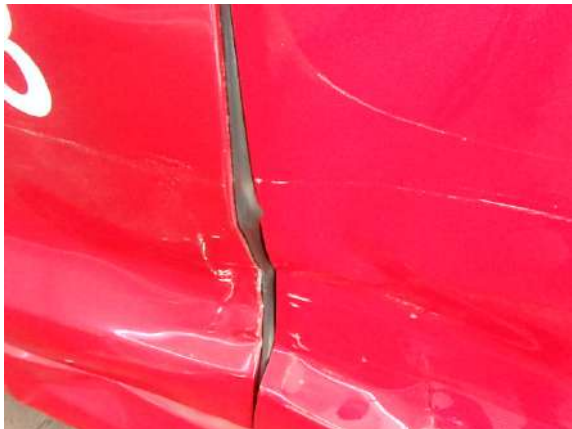
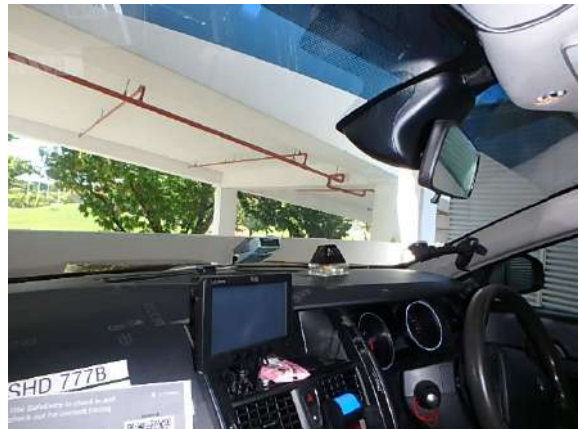
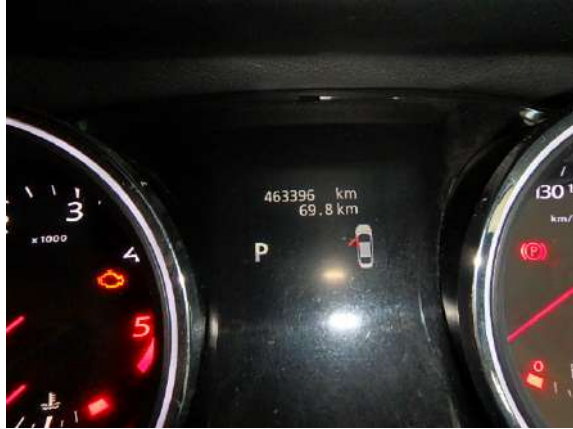
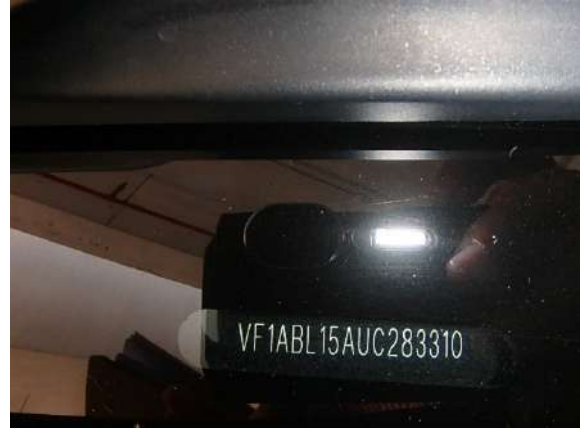
<b>R/H Front Tyre</b>	215/60 R16	SAILUN	9 mm
	<b>L/H Front Tyre</b>	215/60 R16	SAILUN	9 mm
	<b>R/H Rear Tyre</b>	215/60 R16	SAILUN	9 mm
	<b>L/H Rear Tyre</b>	215/60 R16	SAILUN	9 mm
<b>4. Description of Damages</b>				
	THE VEHICLE SUSTAINED DAMAGES AT THE O/S BODY. DAMAGES SEE DETAILS.			
<b>5. General Information</b>				
	<b>Accident Date</b>	20/01/2021	<b>Inspection Date</b>	22/01/2021
	<b>Survey held at</b>	TRANS-CAB AUTO SERVICES PTE LTD NO.2 ANG MO KIO ST 63 SINGAPORE 569111		
<b>5a. Remarks</b>				
	A)THE INSPECTION WAS CONDUCTED ON A"WITHOUT PREJUDICE" BASIS. B)IN ACCORDANCE TO YOUR INSTRUCTIONS, WE HAVE NOT AUTHORISED REPAIRS.			
<b>5b. Estimate Days of Repair</b>				
	ESTIMATED NORMAL PERIOD FOR REPAIR:		<b>7 Working Days</b>
