Your Ref: TP/IP/58069/2020
Our Ref : CI/TPD21001202/P

2nd March 2021

MECHANICAL INSPECTION REPORT OF MOTOR CAR SKZ 6635L

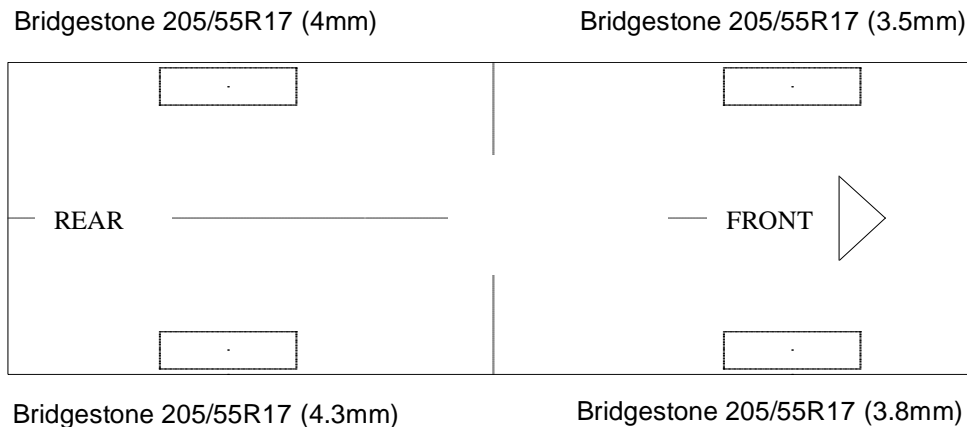
6. The condition of the Motor Car's 4 tyres was observed to be in serviceable condition. I did not find any tear, cut or burst mark(s) on the outer and the inner sidewalls as well as across the tread of the 4 tyres. The 4 tyres were also observed to be sufficiently inflated for vehicular operation. The tyre brand, tyre size and remaining tread depth of the 4 tyres were recorded as follows:-

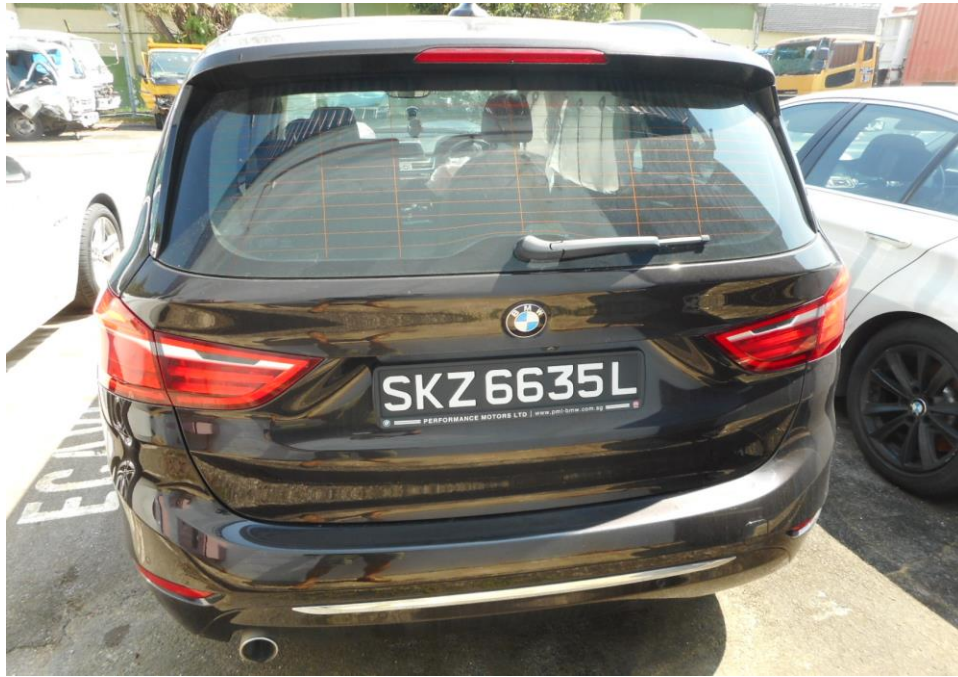
Photo 1 shows a general view of the Motor Car's rear body at the time of my inspection. The rear portion of the Motor Car was observed to have been undamaged by the accident.

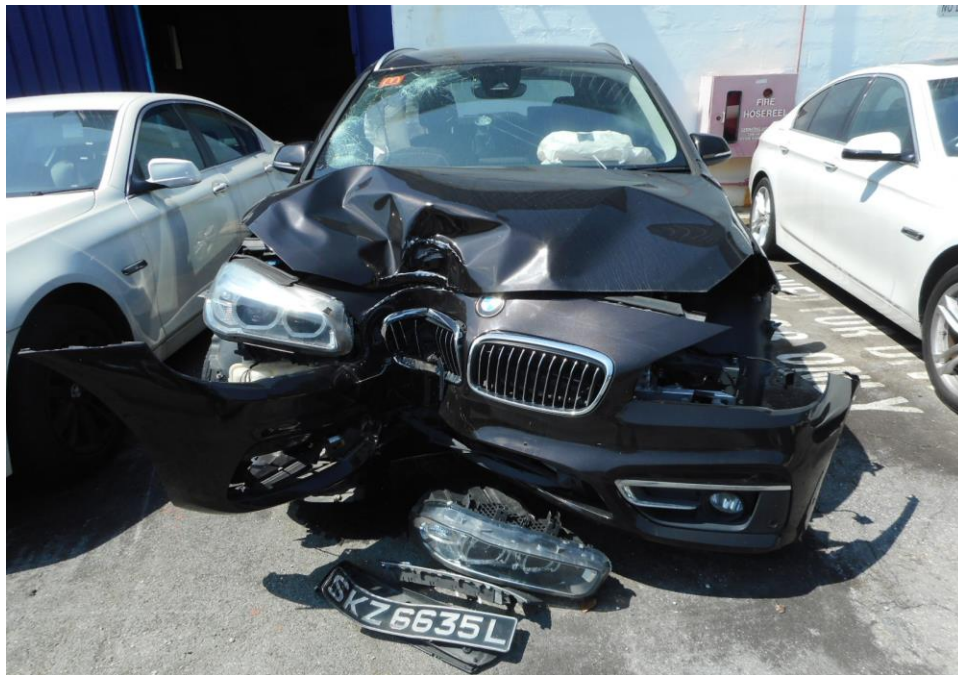
Photo 2 shows a general view of the Motor Car's front body at the time of my inspection. The Motor car was observed to have sustained damage at its front portion. Its front windscreen, front bonnet, front bumper, front left headlamp was amongst the body parts that were damaged as a result of the accident. The Supplemental Restraint System (SRS) was activated as a result of the accident.

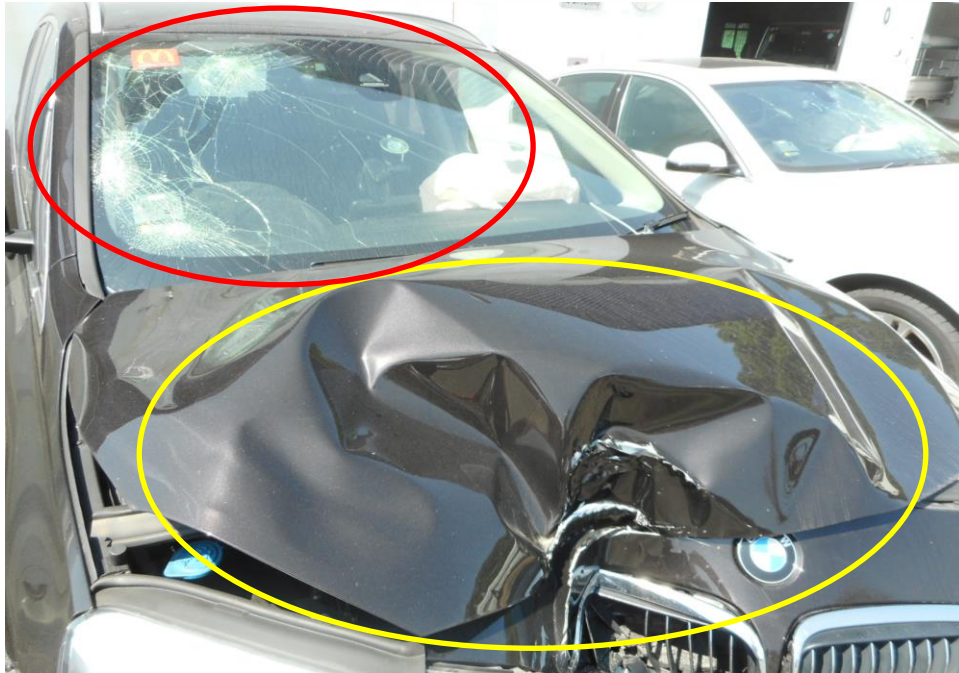
Photo 3 shows the close up view of the Motor Car's front body at the time of my inspection. The Motor car was observed to have sustained damage at its front portion. Its front windscreen (red circle) and front bonnet (yellow circle) was damaged as a result of the accident.

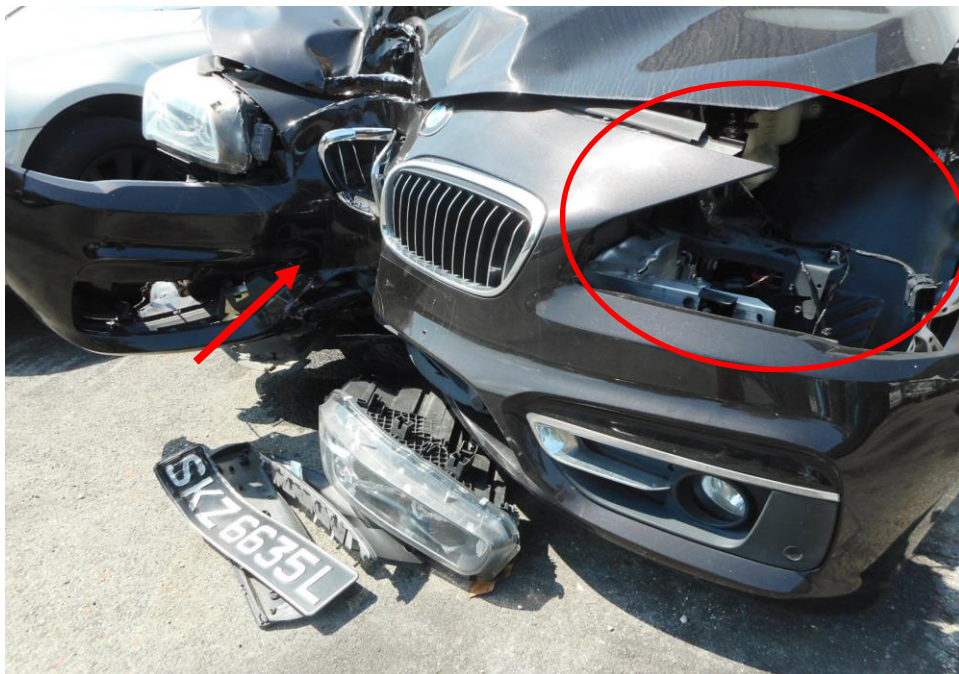
Photo 4 shows the close up view of the Motor Car's front body at the time of my inspection. The Motor car was observed to have sustained damage at its front portion. Its front left headlamp (circled) and front bumper (arrowed) was amongst the body parts and various components in the engine compartments were also damaged as a result of the accident.

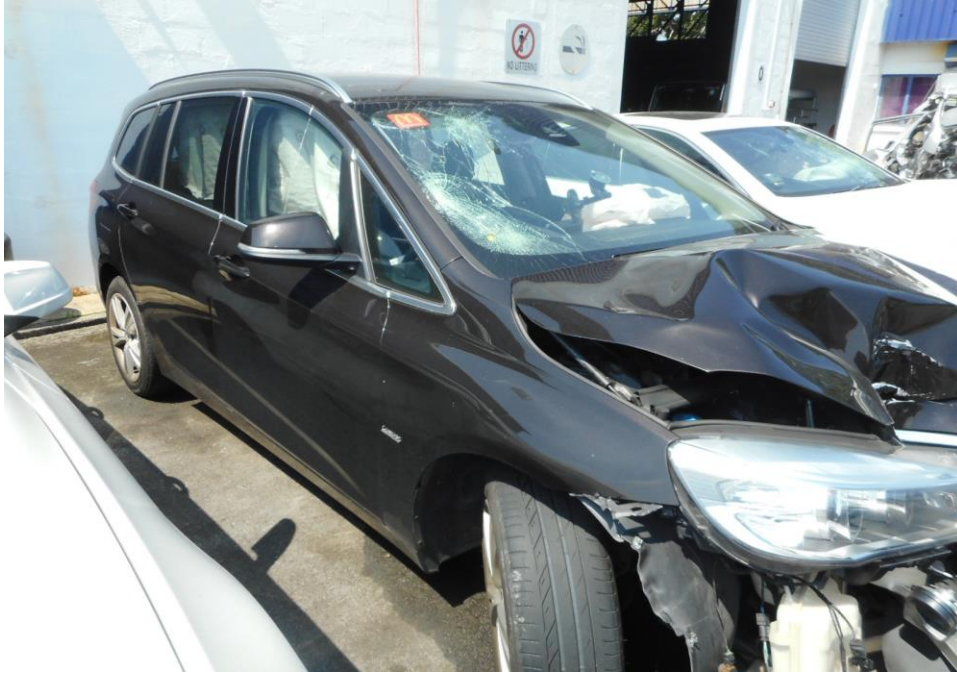
Photo 5 shows a general view of the Motor Car's right body at the time of my inspection. The right portion of the Motor Car was observed to have been undamaged by the accident.

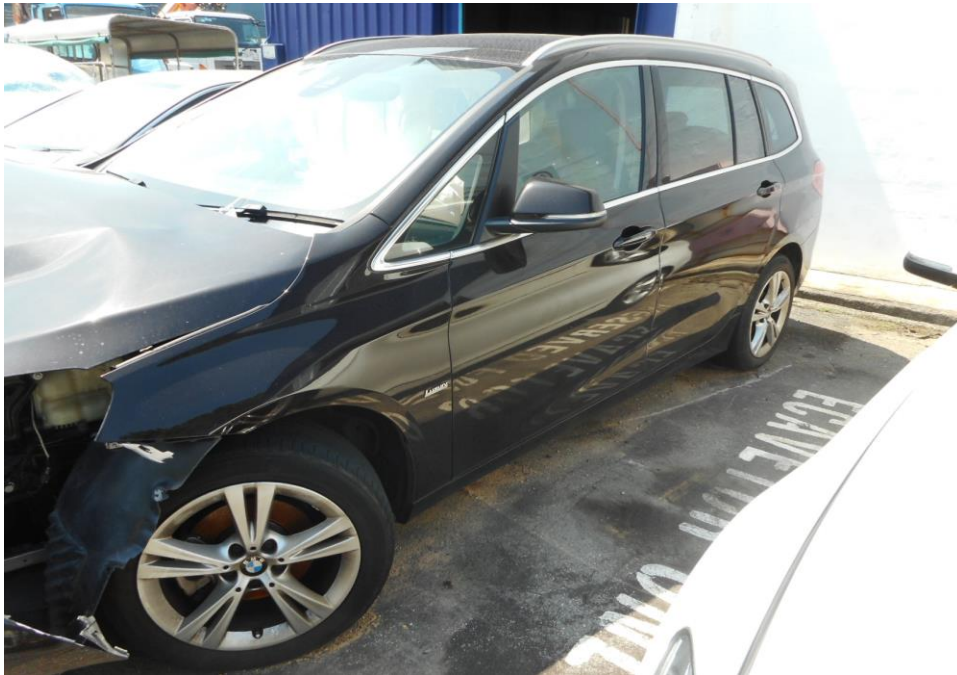
Photo 6 shows a general view of the Motor Car's left body at the time of my inspection. The left portion of the Motor Car was observed to have been undamaged by the accident.

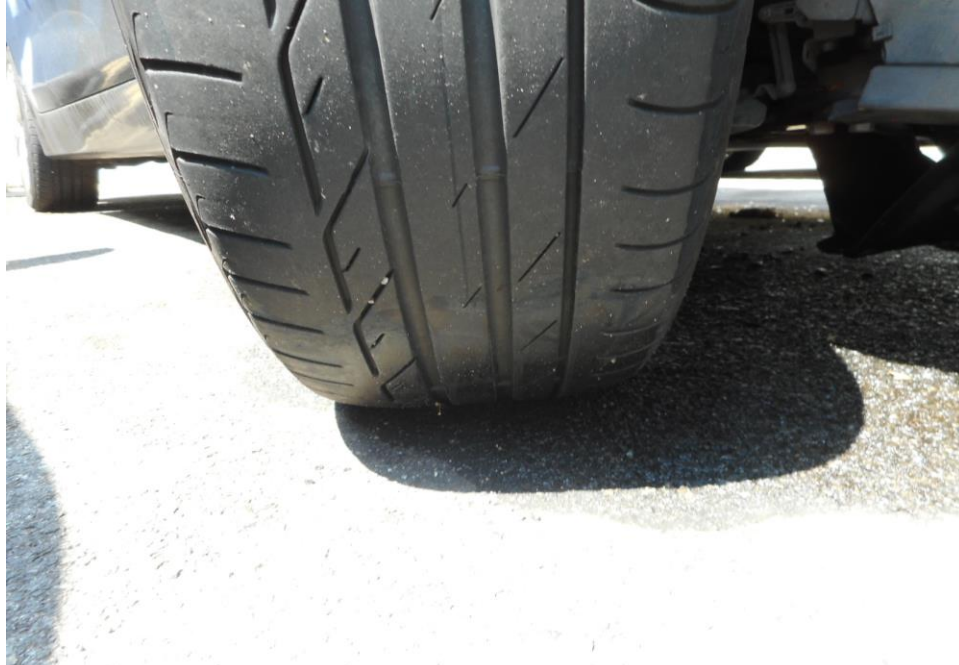
Photo 7 shows the condition of the front right tyre of the Motor Car, which was observed to be in serviceable condition with remaining tread depth of approximately 3.8mm. The tyre, which was wrapped around alloy wheel rim, was also observed to be sufficiently inflated for vehicular operation.

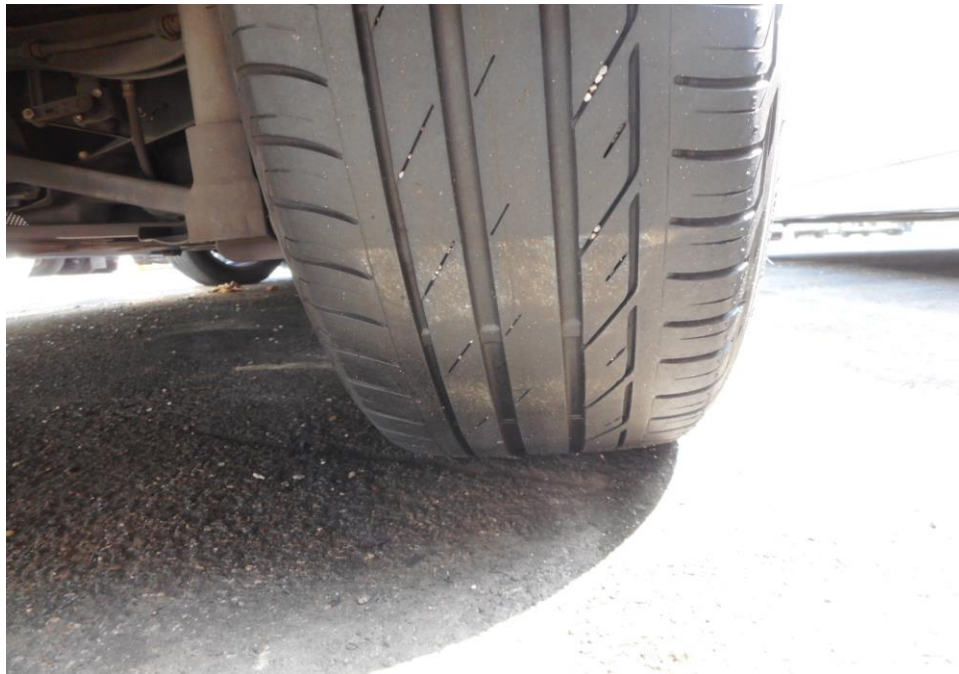
Photo 8 shows the condition of the rear right tyre of the Motor Car, which was observed to be in serviceable condition with remaining tread depth of approximately 4.3mm. The tyre was also observed to be sufficiently inflated for vehicular operation with no tear, cut or burst mark(s).

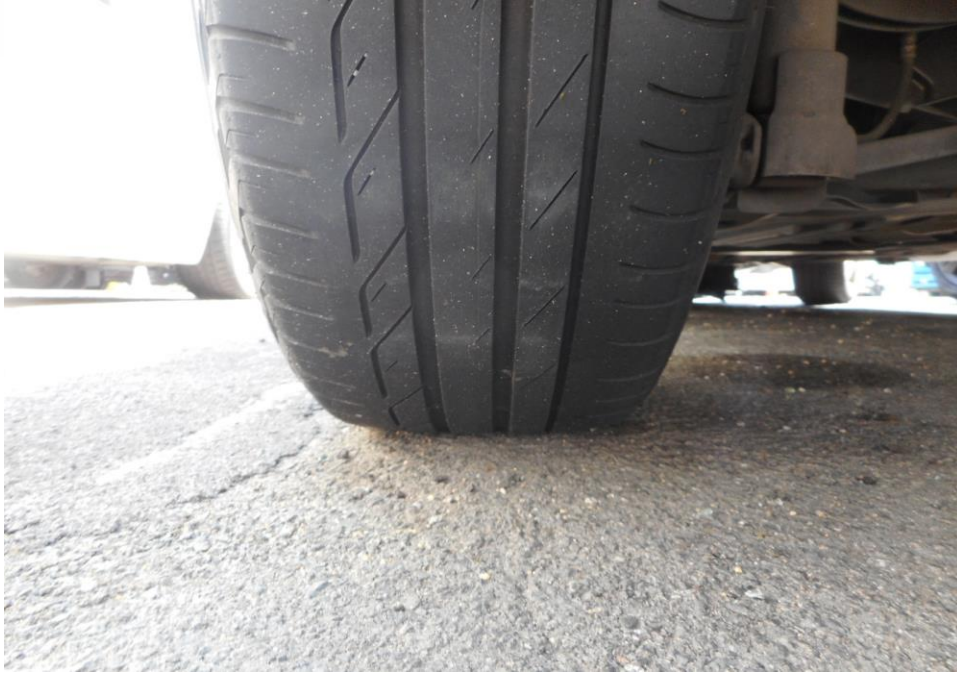
Photo 9 shows the condition of the rear left tyre of the Motor Car, which was observed to be in serviceable condition with remaining tread depth of approximately 4mm. The tyre was also observed to be sufficiently inflated for vehicular operation with no tear, cut or burst mark(s).

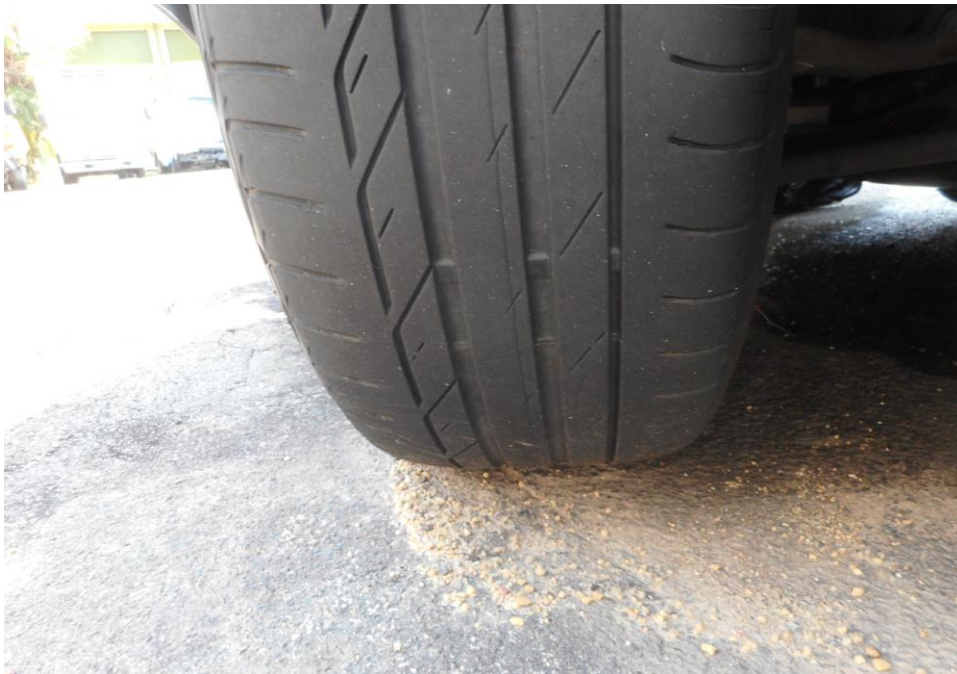
Photo 10 shows the condition of the front left tyre of the Motor Car, which was observed to be in serviceable condition with remaining tread depth of approximately 3.5mm. The tyre was also observed to be sufficiently inflated for vehicular operation with no tear, cut or burst mark(s).

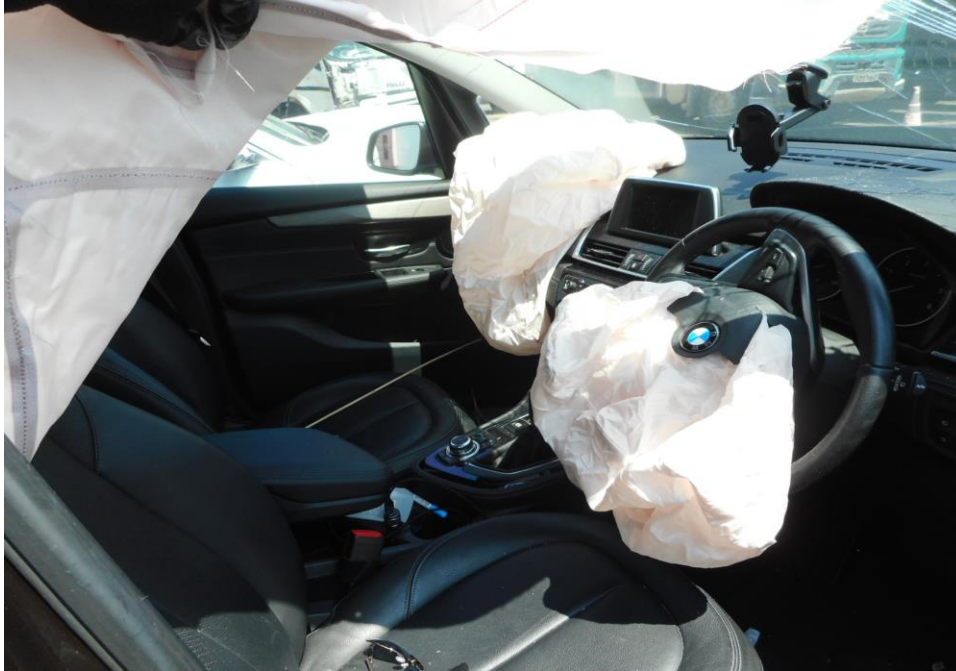
Photo 11 shows the deployment of the Supplemental Restraint System (SRS) airbag in the Motor Car as a result of the accident.

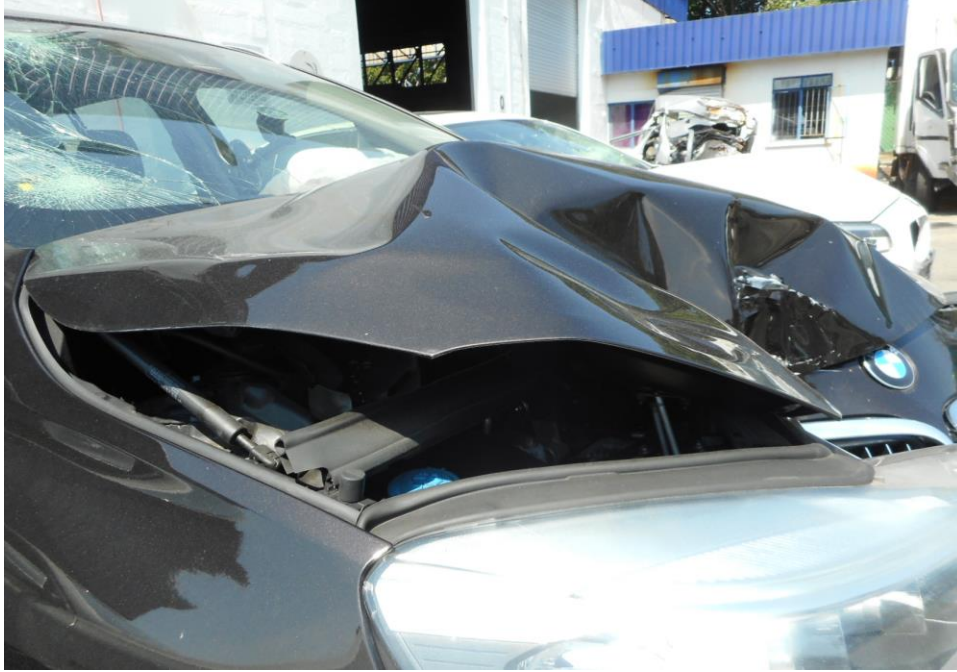
8. We were unable to raise the front bonnet of the Motor car to conduct the examination of the Motor Car's engine compartment because the damage caused by the accident had resulted in the damages to the lock mechanism of the bonnet and the structure of the engine compartment. (unable to open)
See photo 12 below.

Photo 12 shows a close up view of the damaged front bonnet lock mechanism and the structure of the engine compartment of the Motor Car at the time of my inspection resulting it unable to open a result of the accident. (Unable to open)

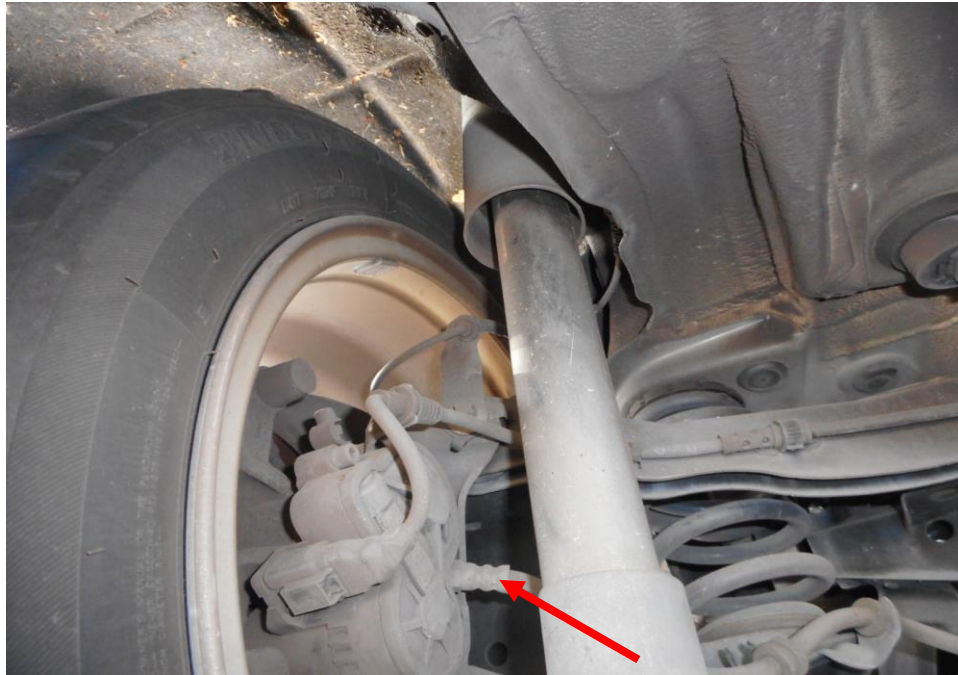
Photo 13 shows the brake hose/pipe (arrowed) at the rear left wheel of the Motor Car. No leakage of brake fluid was observed. Visual examination of the various components of the braking system like the drum brake, brake booster, brake pedal etc. had revealed all to be intact and without visible damage.

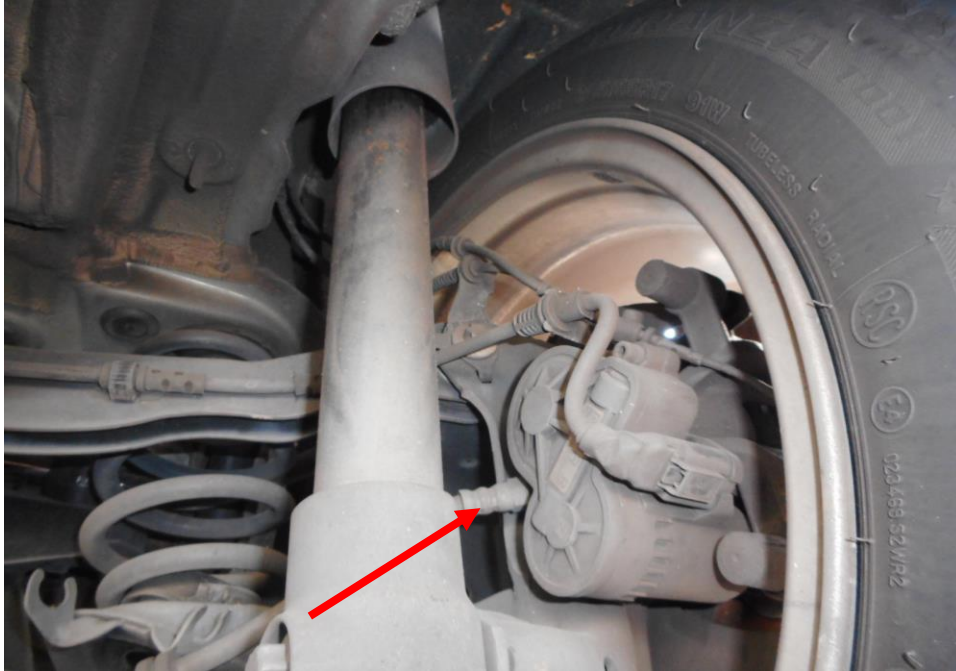
Photo 14 shows the brake hose/pipe (arrowed) at the rear right wheel of the Motor Car. No leakage of brake fluid was observed. Visual examination of the various components of the braking system like the drum brake, brake booster, brake pedal etc. had revealed all to be intact and without visible damage.

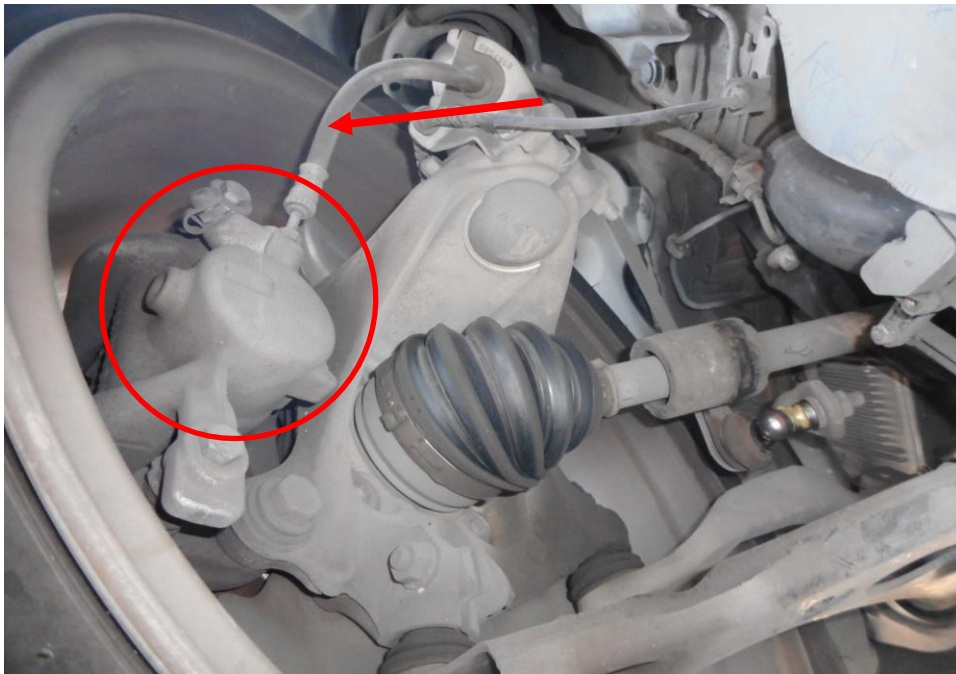
Photo 15 shows the brake hose/pipe (arrowed) at the front right wheel of the Motor Car. No leakage of brake fluid was observed. Visual examination of the various components of the braking system like the brake caliper (circled), brake booster, brake pedal etc. had revealed all to be intact and without visible damage at the time of accident. There was also no sign of fluid stain(s) observed on the various undercarriage components.

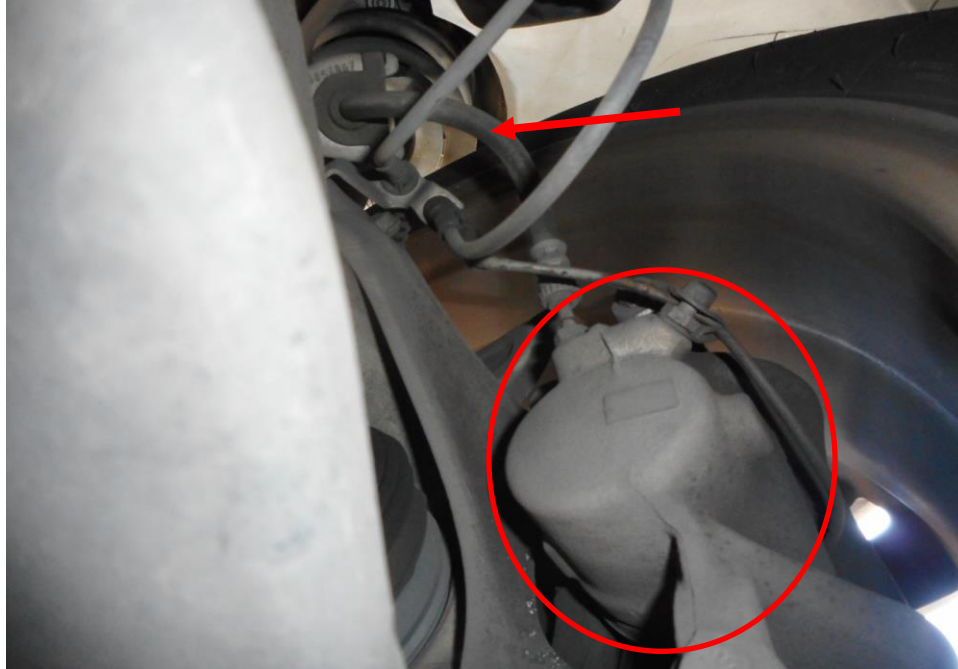
Photo 16 shows the brake hose/pipe (arrowed) at the front left wheel of the Motor Car. No leakage of brake fluid was observed. Visual examination of the various components of the braking system like the brake caliper (circled), brake booster, brake pedal etc had revealed all to be intact and without visible damage at the time of accident. There was also no sign of fluid stain(s) observed on the various undercarriage components.

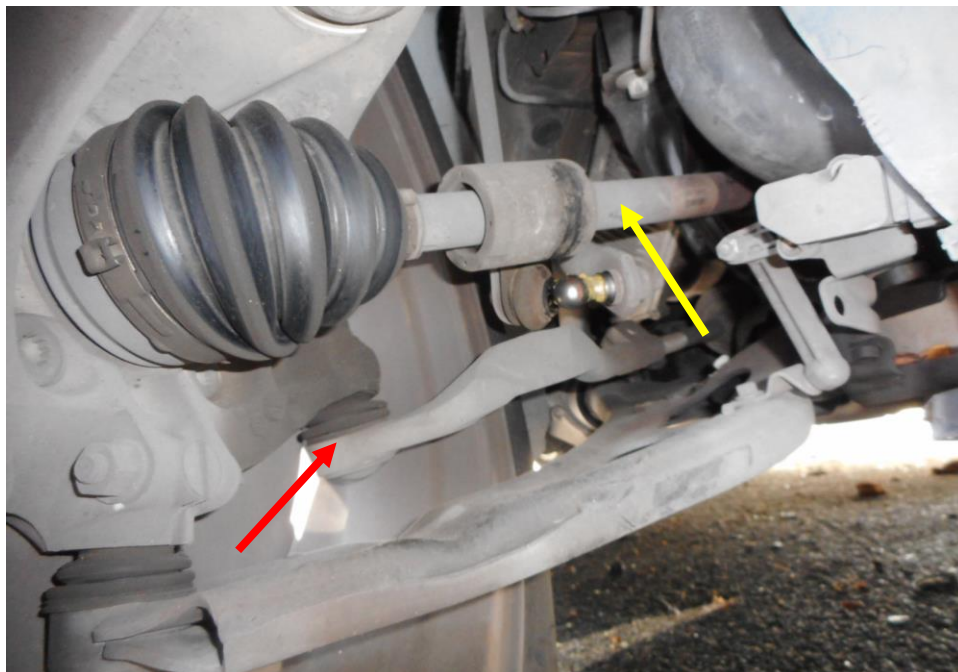
Photo 17 shows the various undercarriage components at the front right wheel of the Motor Car, in particular the steering tie rod end (arrowed) and the driveshaft (yellow arrowed). The various steering components were all found to be intact, suggesting that the steering system of the Motor Car was likely to be in serviceable condition at the material time of accident. There was also no sign of fluid stain(s) observed on the various undercarriage components.

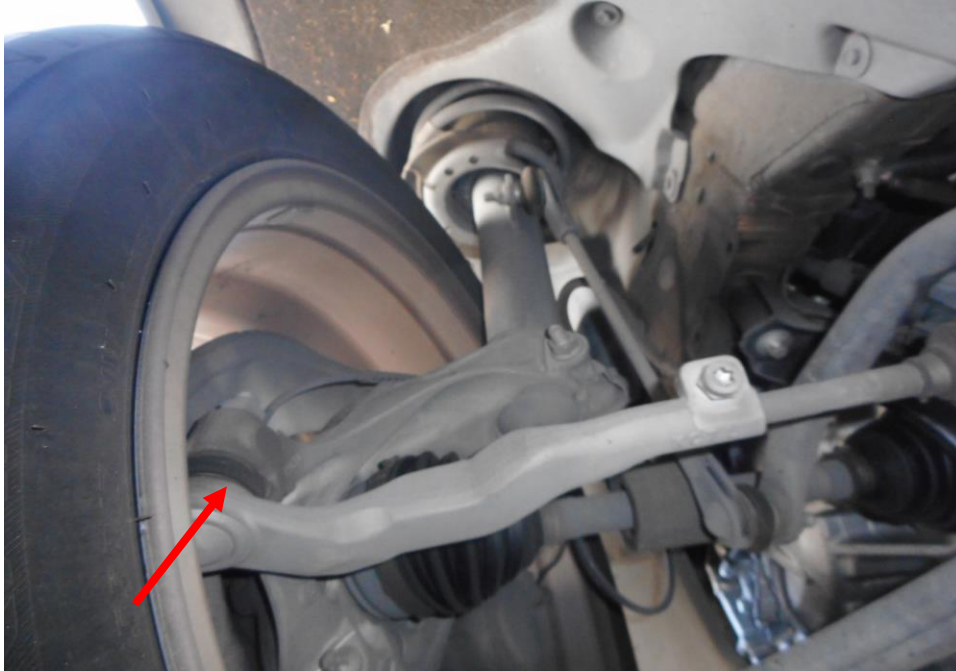
Photo 18 shows the various undercarriage components at the front left wheel of the Motor Car, in particular the steering tie rod end (arrowed). The various undercarriage components of the Motor Car were all found to be intact without any visible damage. There was also no sign of fluid stain(s) observed on the various undercarriage components.

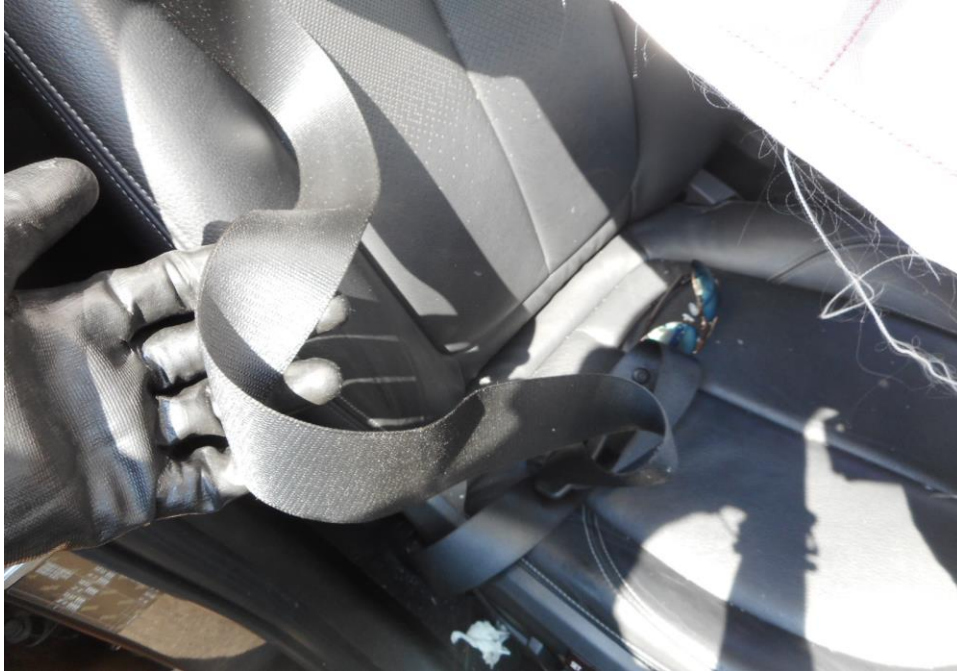
14. The front right seat belt of the "Motor Car" was worn and the left seat belt was not worn at the material time of accident as the respective pre-tensioners that were fitted at the side of each seat was activated upon the material time. See photo 19 and 20 below.

Photo 19 shows that the seat belt on the right seat was worn at the material time of accident as the safety pre-tensioners was activated at the moment of impact and caused the seat belt to be locked into the last position.

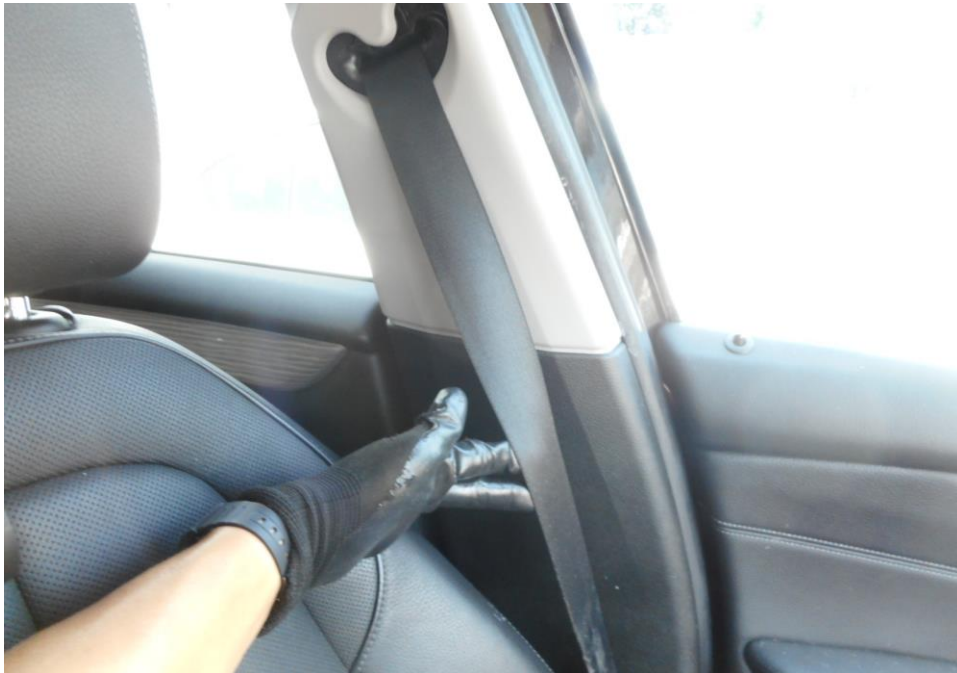
Photo 20 shows that the seat belt on the left seat was not worn at the material time of accident as the safety pre-tensioners was activated at the moment of impact and caused the seat belt to be locked into the last position.
