Your Ref: TP/IP/56369/2020  
Our Ref : CI/TPD21001203/P

Traffic Police Department  
Singapore Police Force  
10 Ubi Avenue 3  
Singapore 408865

### **MECHANICAL INSPECTION REPORT OF MOTOR VAN GBD 7996K**

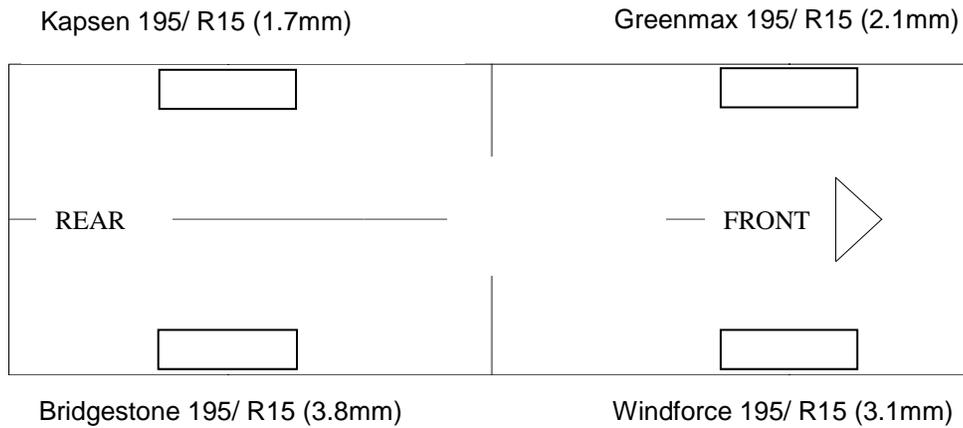
6. The 4 tyres of the Motor Van were observed to be in serviceable condition and sufficiently inflated for vehicular operation. I did not find any tear, cut or burst mark(s) on the outer and the inner sidewalls as well as across the tread of the 4 tyres. The tyre brand, tyre size and remaining tread depth of the 4 tyres of the Motor Van were recorded as follows:-

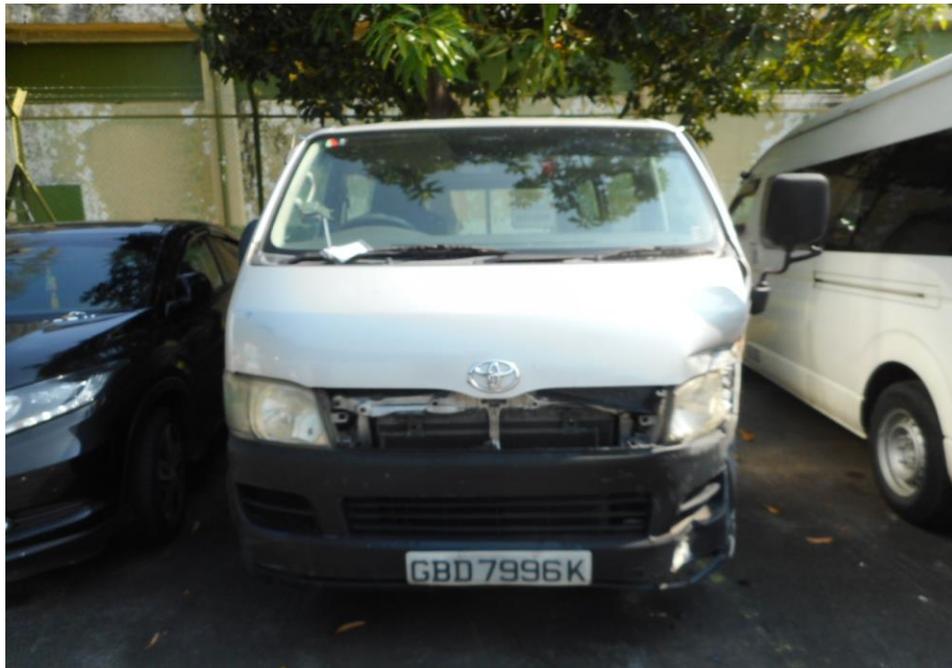
4. The mileage of the Motor Van at the time of my inspection was not recorded as the engine was unable to be started up despite multiple attempts in jumpstarting it.
5. The Motor Van appeared to have sustained damage at its frontal portion. Its front body panel, front left headlamp, front bumper and front left door were damaged at the time of my inspection as a result of the accident.

**Photo 1** shows a general view of the Motor Van's frontal portion at the time of my inspection. It appeared to have sustained damage at its frontal portion. Its front body panel, front left headlamp, front bumper and front left door were damage at the time of my inspection as a result of the accident.

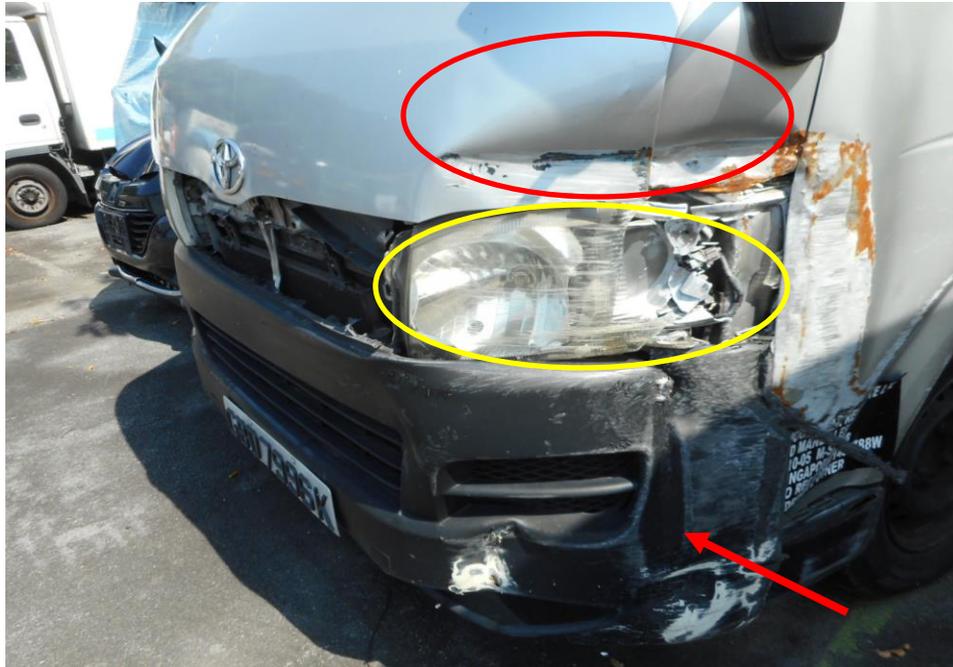
**Photo 2** shows a close up view of the Motor Van's frontal portion at the time of my inspection. It appeared to have sustained damage at its frontal portion. Its front body panel (red circle) front left headlamp (yellow circle) and front bumper (arrowed) were damage at the time of my inspection as a result of the accident.

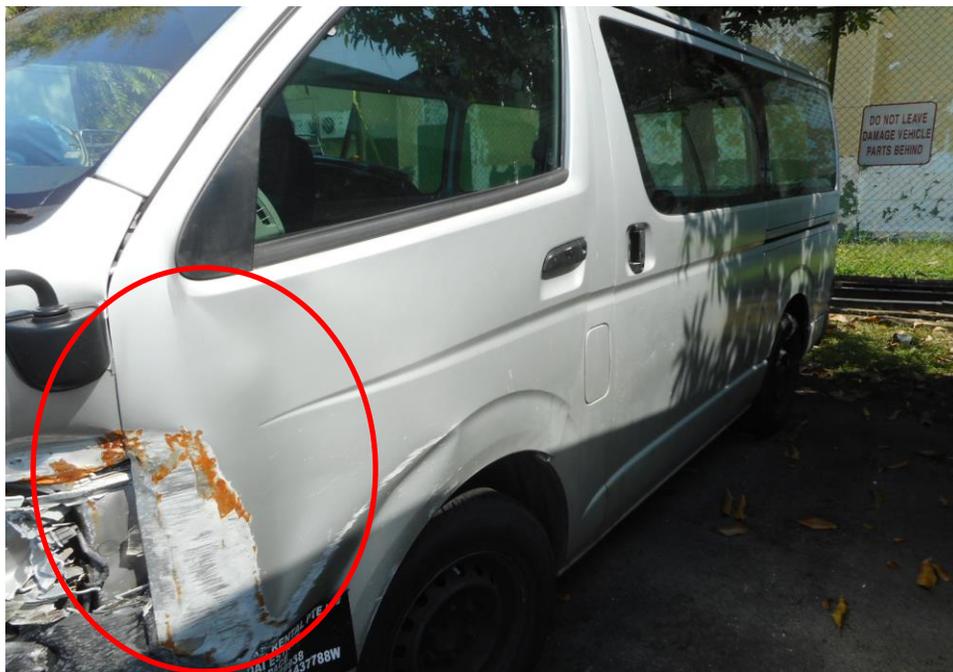
**Photo 3** shows a close up view of the Motor Van's frontal portion at the time of my inspection. It appeared to have sustained damage at its frontal portion. Its front left door (circled) were damage at the time of my inspection as a result of the accident.

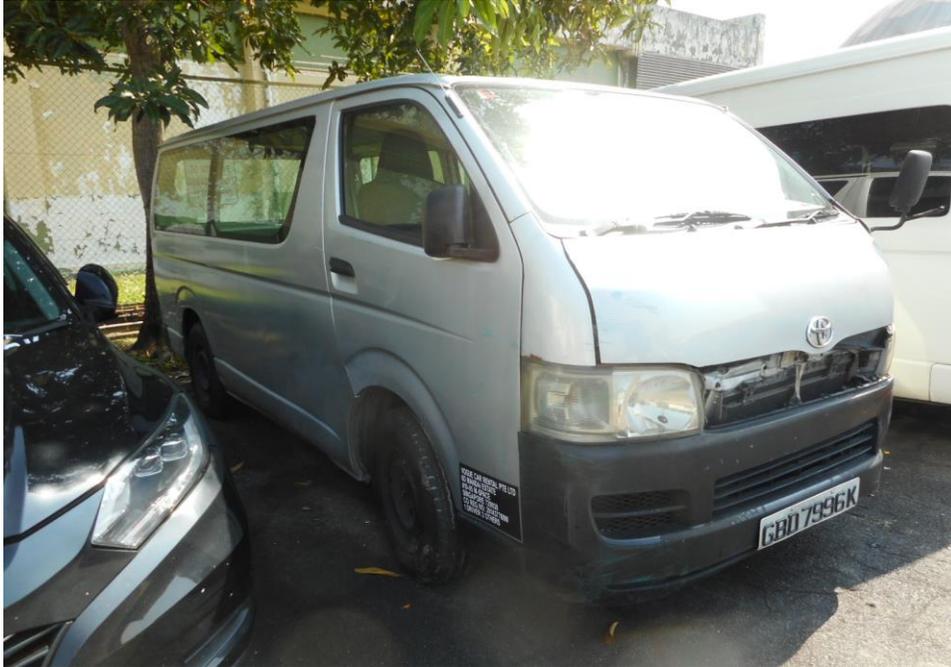
**Photo 4** shows a general view of the right body of the Motor Van at the time of my inspection. The Motor Van was observed to be intact and unaffected by the accident.

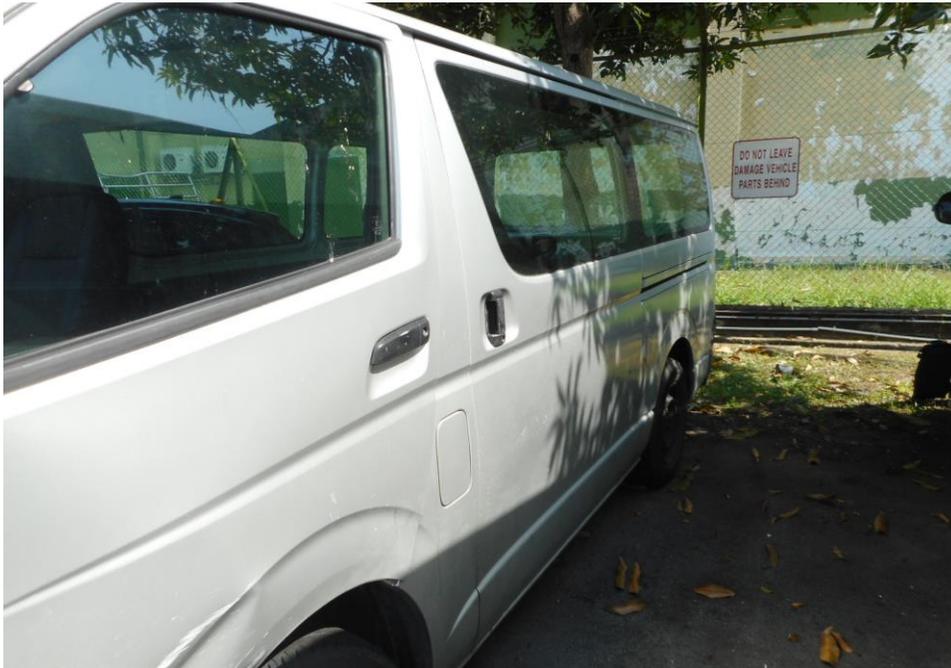
**Photo 5** shows a general view of the left body of the Motor Van at the time of my inspection. The Motor Van was observed to be intact and unaffected by the accident.

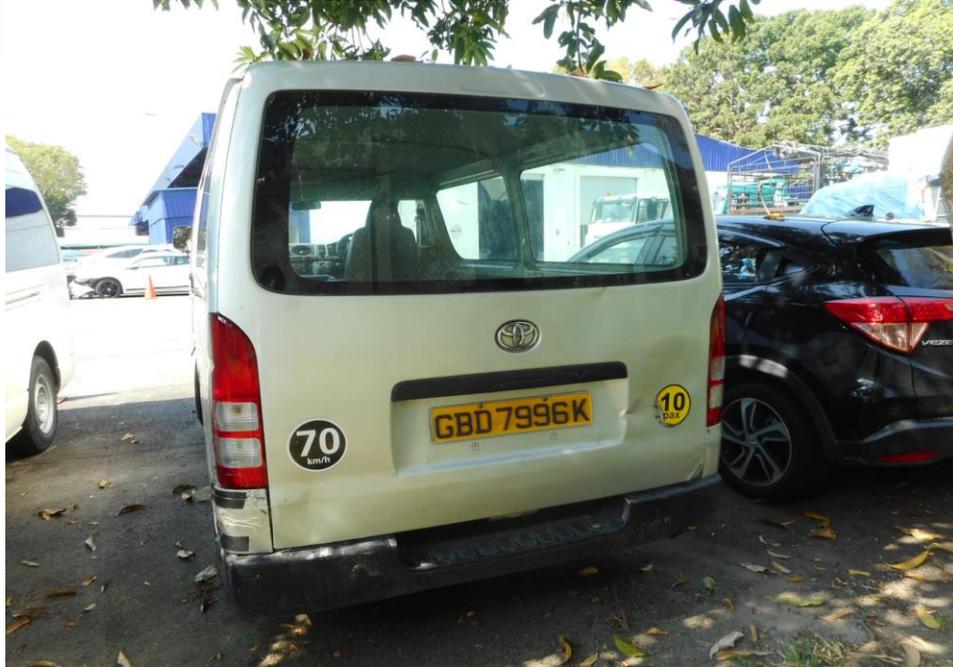
**Photo 6** shows a general view of the rear body of the Motor Van at the time of my inspection. The Motor Van was observed to be intact and unaffected by the accident.

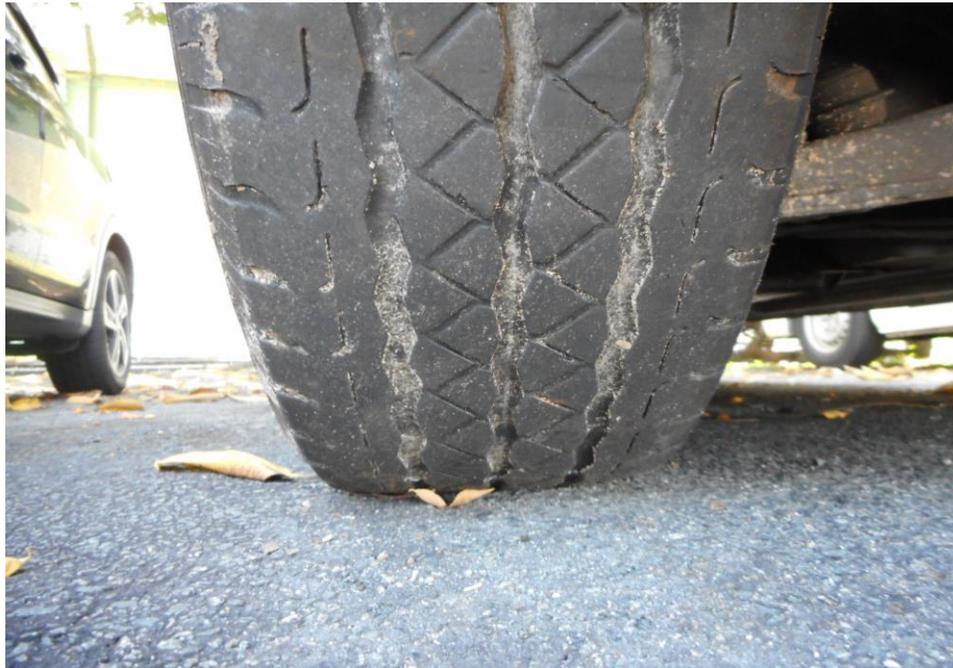
**Photo 7** shows the condition of the front right tyre of the Motor Van, which was observed to be in serviceable condition with remaining tread depth of approximately 3.1mm. The tyre, which was wrapped around standard steel wheel rim, was also observed to be sufficiently inflated for vehicular operation. There was no tear, cut or burst mark(s) on the outer and the inner sidewalls as well as across the tread of the 4 tyres that were fitted on the Motor Van.

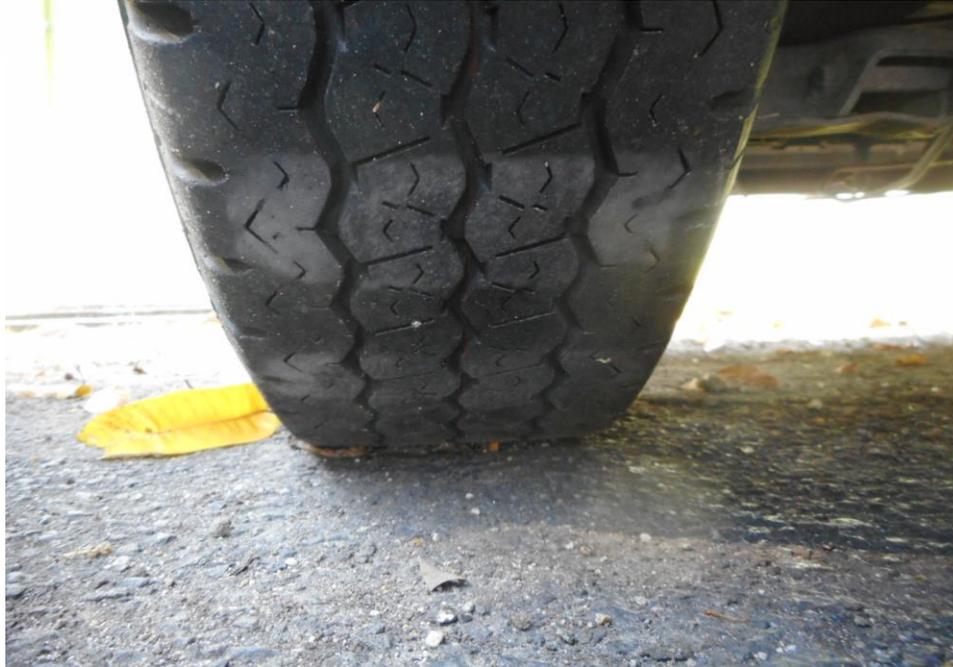
**Photo 8** shows the condition of the rear right tyre of the Motor Van, which was observed to be in serviceable condition with remaining tread depth of approximately 3.8mm. The tyre, which was wrapped around standard steel wheel rim, it was observed to be sufficiently inflated for vehicular operation.

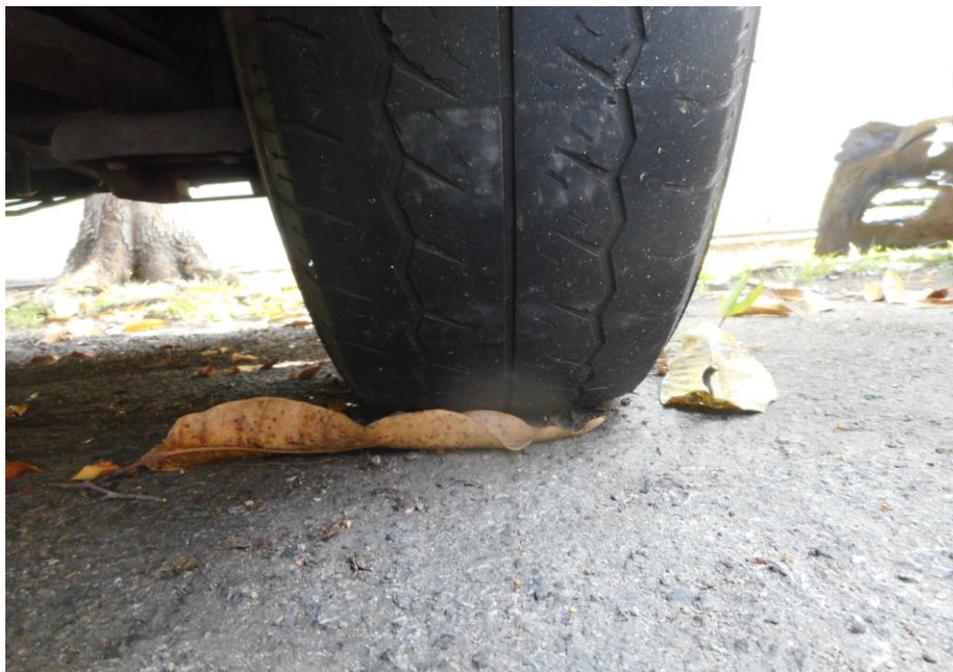
**Photo 9** shows the condition of the rear left tyres of the Motor Van, which was observed to be in serviceable condition with remaining tread depth of approximately 1.7mm. The tyres, which were wrapped around standard steel wheel rim, were also observed to be sufficiently inflated for vehicular operation. There was also no damage found on all 4 steel wheel rims of the Motor Van.

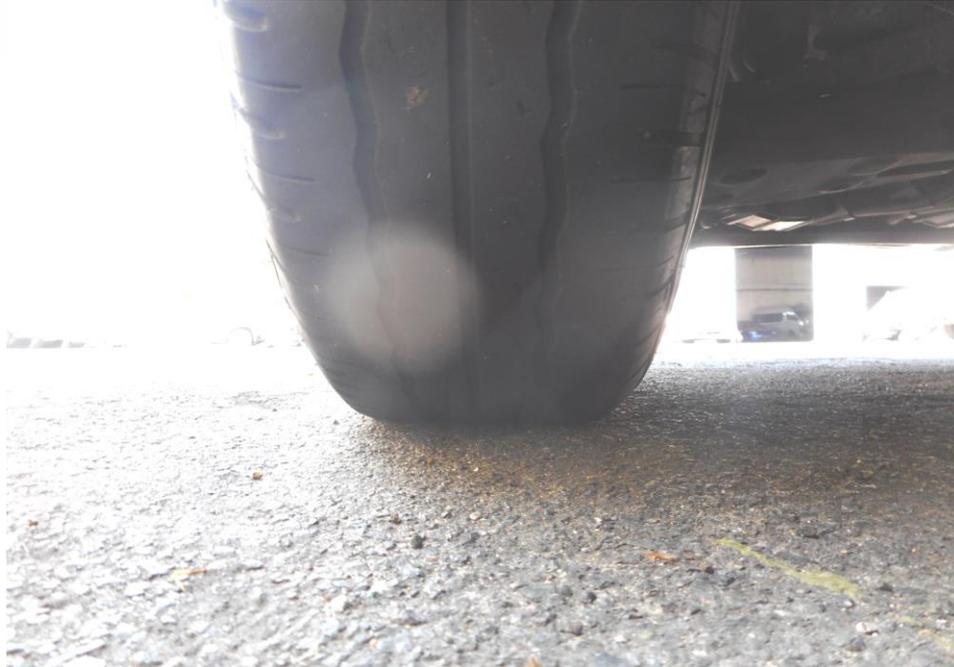
**Photo 10** shows the condition of the rear right tyres of the Motor Van, which were observed to be in serviceable condition with remaining, tread depth of approximately 2.1mm. There was also no tear, cut or burst mark(s) on the outer and the inner sidewalls as well as across the tread of the 4 tyres that were fitted on the Motor Van.

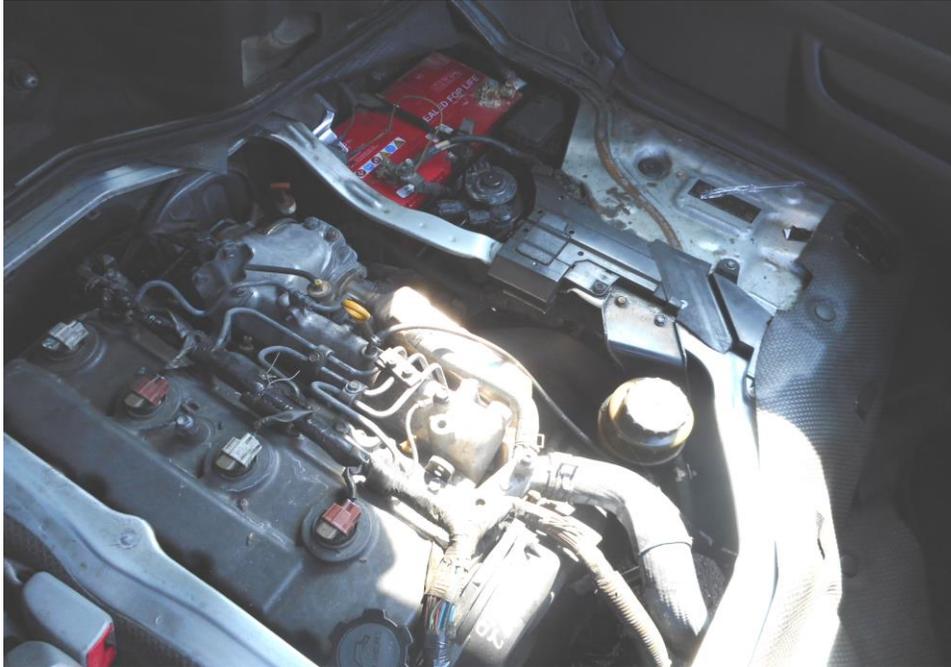
**Photo 11** shows a general view of the Motor Van's engine compartment, which was accessed by lifting the front cabin of the Motor Van. The various parts and components inside the engine compartment were unaffected by the accident. There was also no sign(s) or indication(s) of fresh fluid leakage and/or fluid stain within the engine compartment

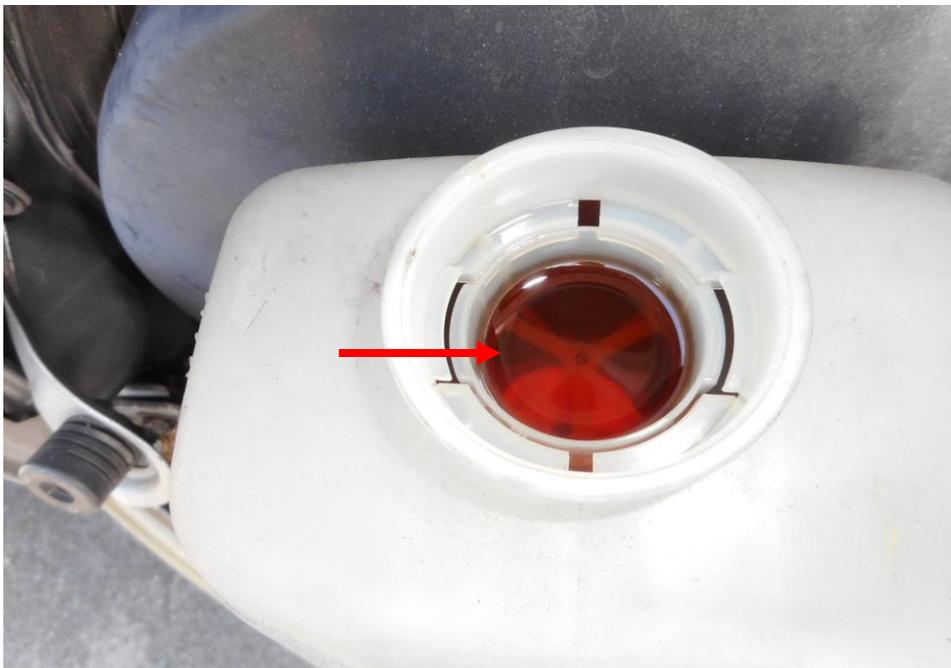
**Photo 12** shows the brake fluid reservoir of the Motor Van at the time of my inspection. The brake fluid was observed to be of sufficient level (arrowed) and without any visible contamination.

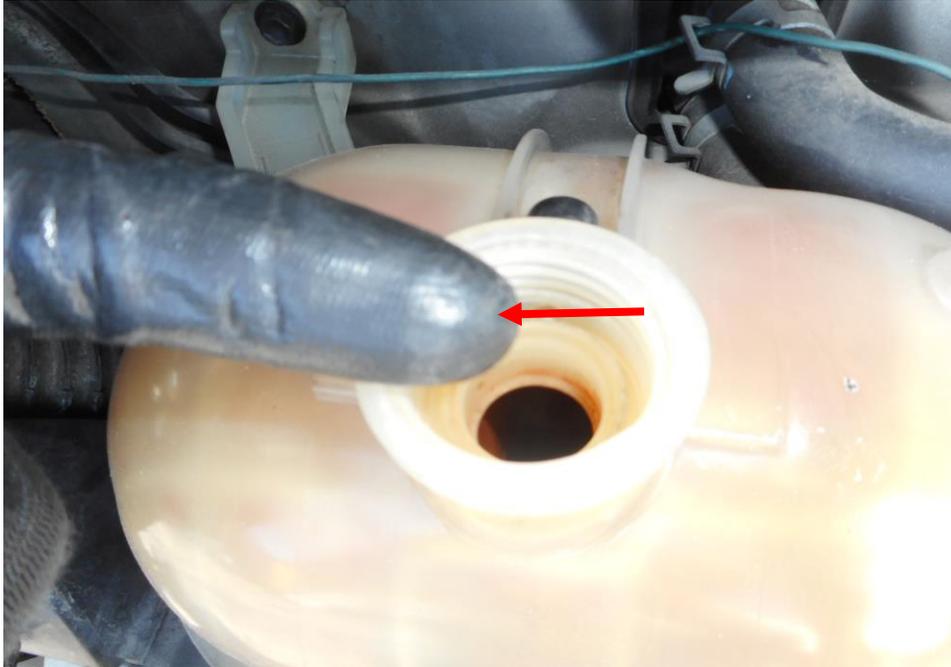
8. Upon examination of the Motor Van's engine compartment, I had observed all the parts and components inside the engine compartment to be intact and unaffected by the accident. The engine coolant was observed to be insufficient. However, the brake fluid, power steering fluid and engine oil and were all found to be of sufficient level for operating purposes. Visually, there was also no contamination found to these fluids.
9. Further examination of the engine compartment revealed, there was no sign(s) or indication(s) of fresh fluid leakage and/or fluid stain within the engine compartment of the Motor Van.
10. My subsequent checks on the underside of the Motor Van also revealed no fluid stain. Visually, the various undercarriage components of the Motor Van were all observed to be intact and without any visible damage. See photo 11 – 16 below.

**Photo 13** shows the engine coolant reservoir of the Motor Van at the time of my inspection. The engine coolant was observed to be of insufficient level (arrowed).

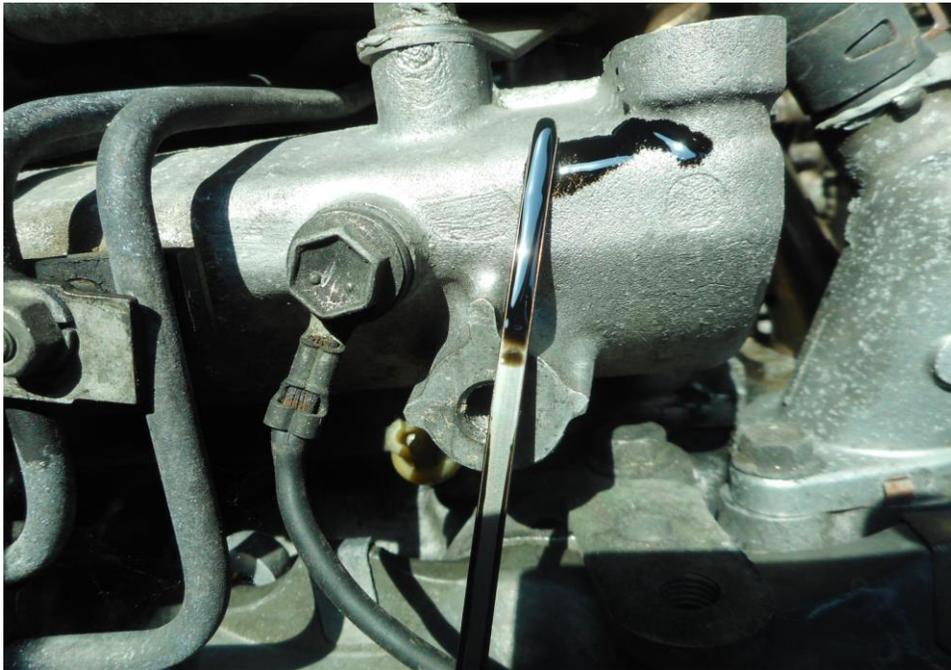
**Photo 14** shows the engine oil dip stick of the Motor Van at the time of my inspection. The engine oil was observed to be of sufficient level and without any visible contamination.

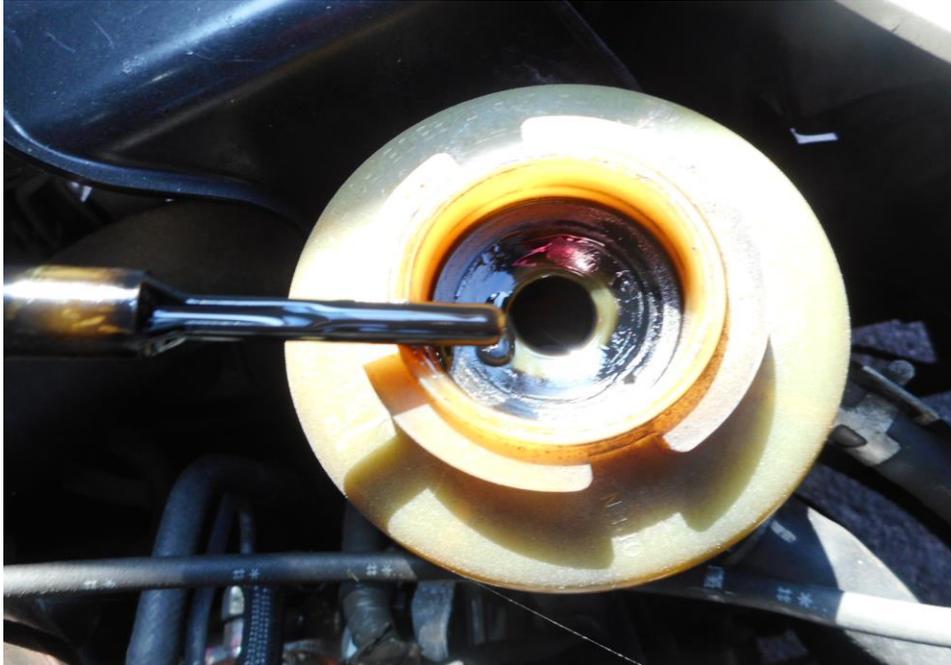
**Photo 15** shows the power steering fluid dip stick of the Motor Van at the time of my inspection. The engine oil was observed to be of sufficient level and without any visible contamination.

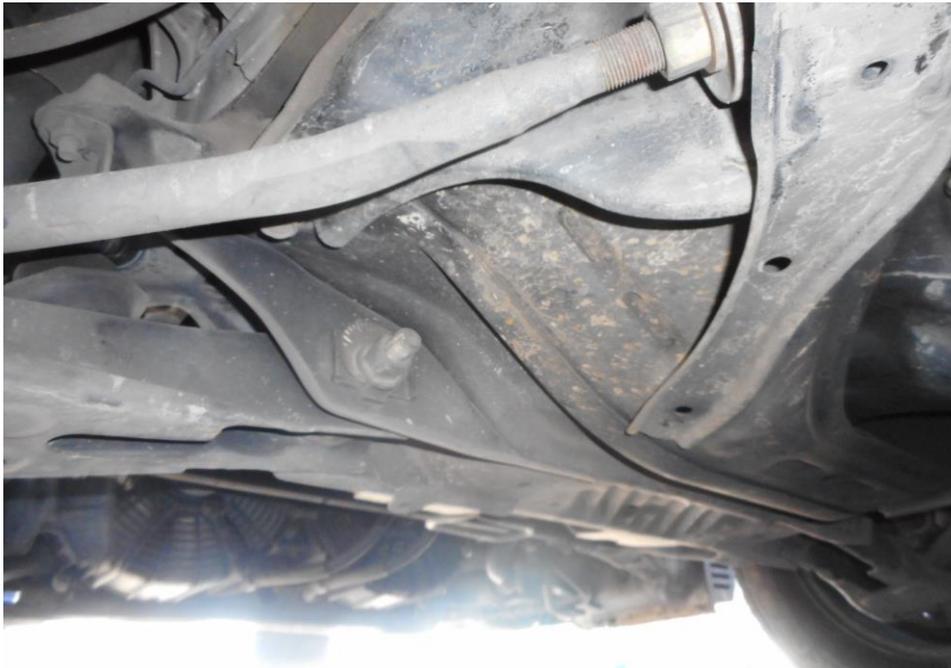
**Photo 16** shows the undercarriage of the Motor Van, at the area where the engine housing and transmission housing are located. . I did not find any sign(s) or indication(s) of fluid leak and/or fluid stain(s) on the underside of the Motor Van.

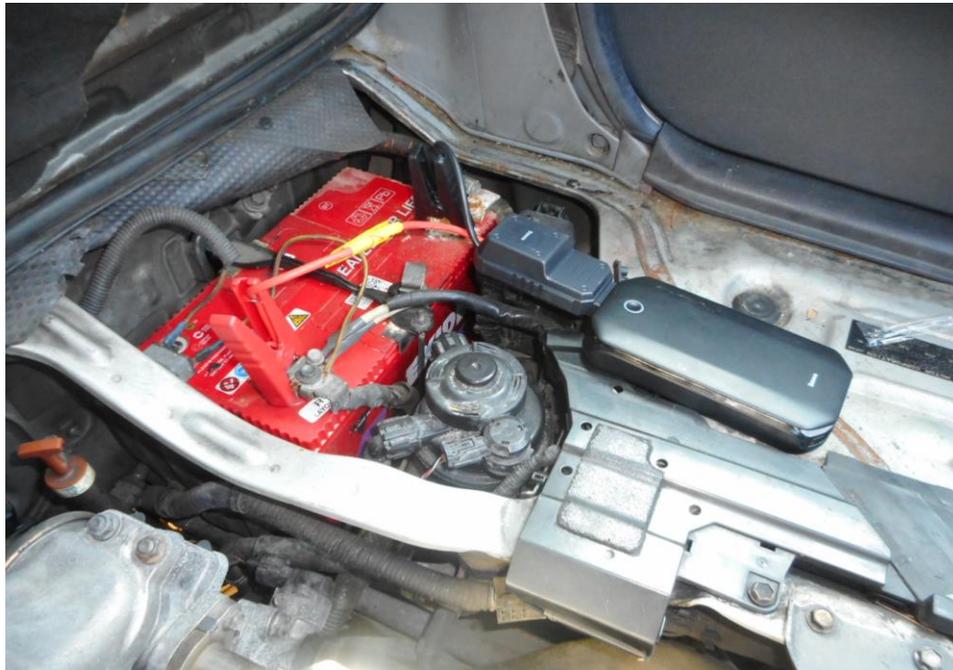
11. For this inspection, I was not able to conduct any tests on the steering system of the Motor Van as the power steering system requires the Motor Van's engine to be started to conduct the test. (Unable to be started)

**Photo 17** shows the jumpstarting process of the Motor Van's engine. The engine of the Motor Van was unable to be jumpstarted up despite multiple attempts in starting it.

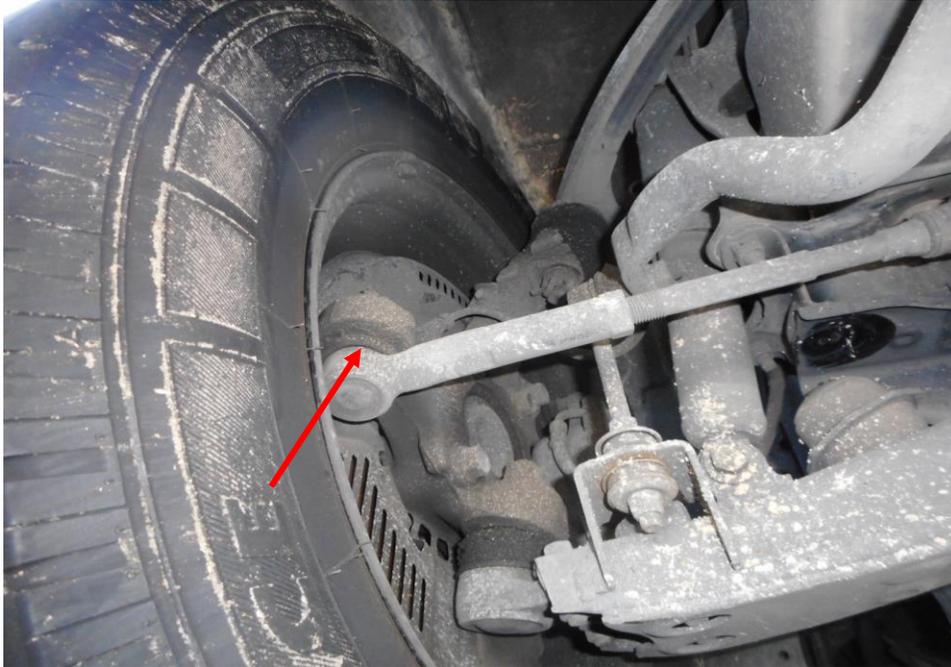
**Photo 18** shows the various undercarriage components at the front right wheel of the Motor Van, in particular the steering tie rod end (arrowed). The various steering components were all found to be intact, suggesting that the steering system of the Motor Van was likely to be in serviceable condition at the material time of accident. There was also no sign of fluid stain(s) observed on the various undercarriage components.

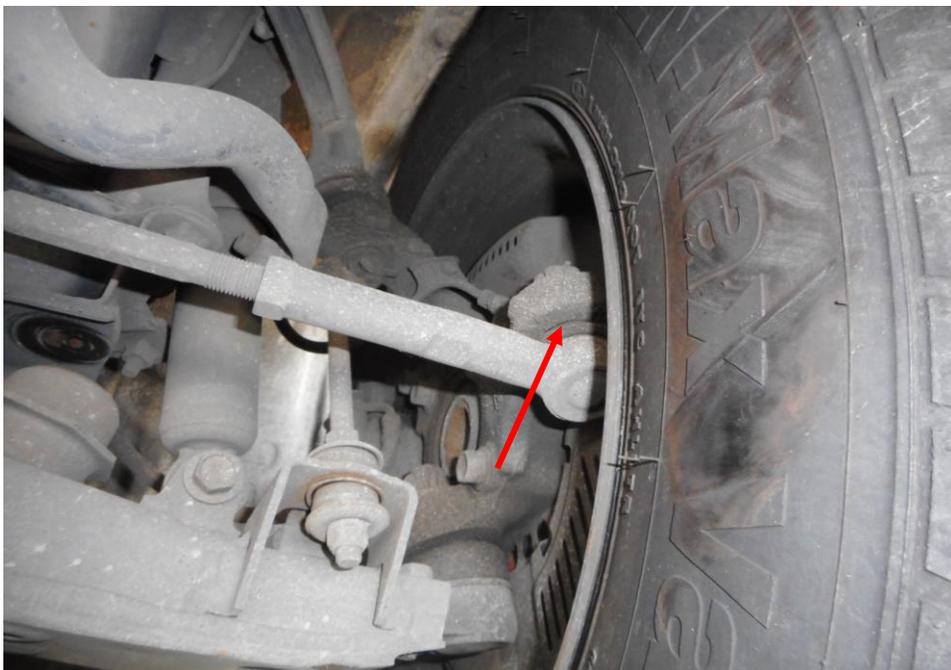
**Photo 19** shows the various undercarriage components at the front left wheel of the Motor Van, in particular the steering tie rod end (arrowed). The various undercarriage components of the Motor Van were all found to be intact without any visible damage. There was also no sign of fluid stain(s) observed on the various undercarriage components.

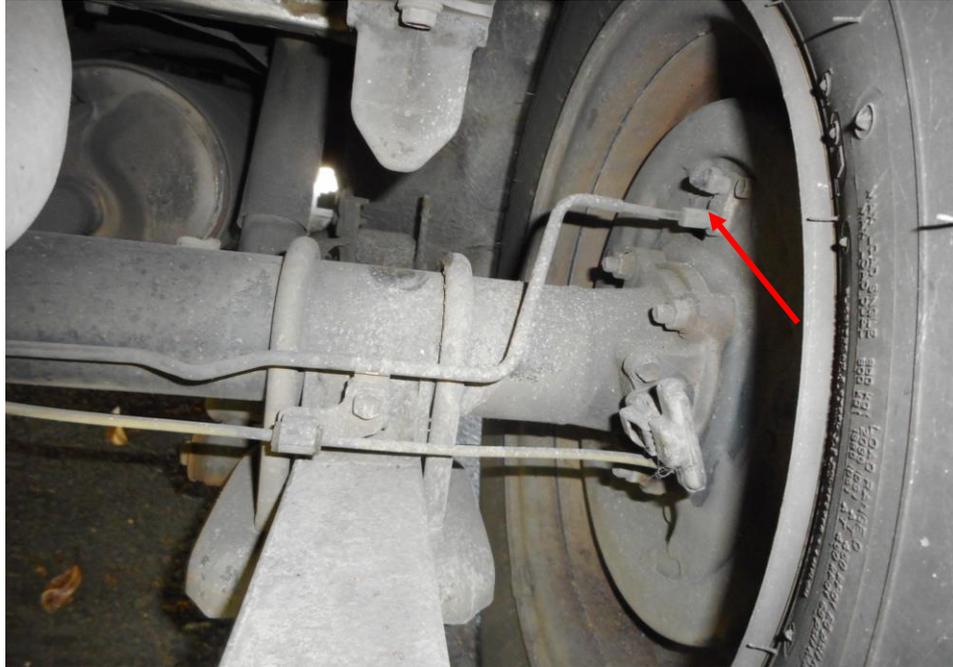
**Photo 20** shows the brake pipe (arrowed) at the rear right wheel of the Motor Van. I did not observe any leakage of brake fluid at the time of my inspection of the Motor Van. My static tests of the Motor Van's braking system, along with my visual examination of the various mechanical components in the braking system, had indicated that there was no internal leakage of pressure/vacuum. Hence the braking system of the Motor Van was likely to be in serviceable condition at the material time of accident.

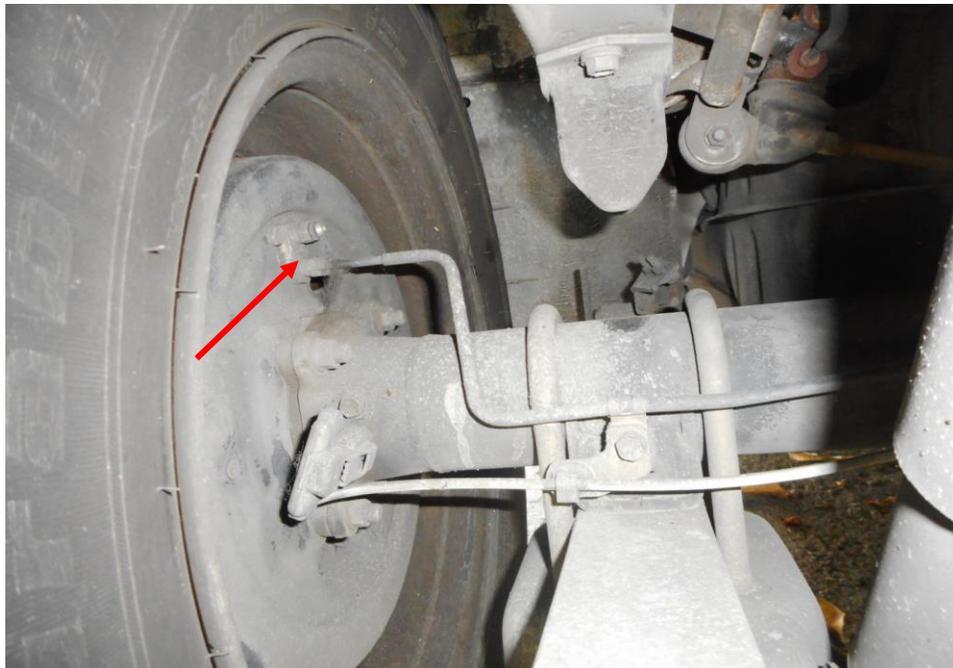
**Photo 21** shows the brake pipe (arrowed) at the rear left wheel of the Motor Van. I did not observe any leakage of brake fluid at the time of my inspection of the Motor Van. My static tests of the Motor Van's braking system, along with my visual examination of the various mechanical components in the braking system had indicated that there was no internal leakage of pressure/vacuum. Hence the braking system of the Motor Van was likely to be in serviceable condition at the material time of accident.

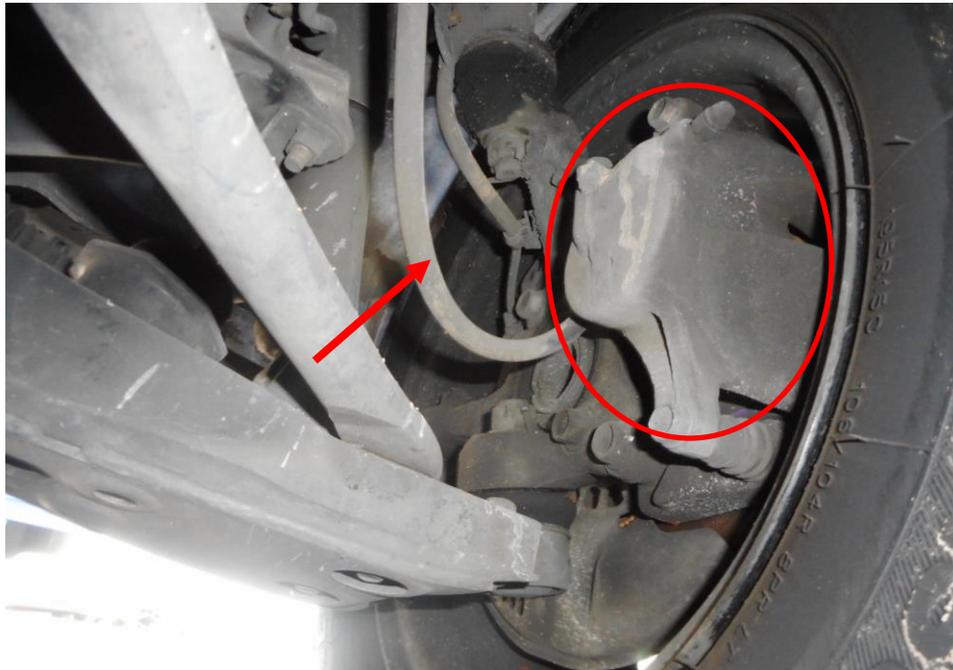
**Photo 22** shows the brake hose/pipe (arrowed) at the front right wheel of the Motor Van. No leakage of brake fluid was observed. Visual examination of the various components of the braking system like the brake caliper (circled), brake booster, brake pedal etc had revealed all to be intact and without visible damage at the time of accident. There was also no sign of fluid stain(s) observed on the various undercarriage components.

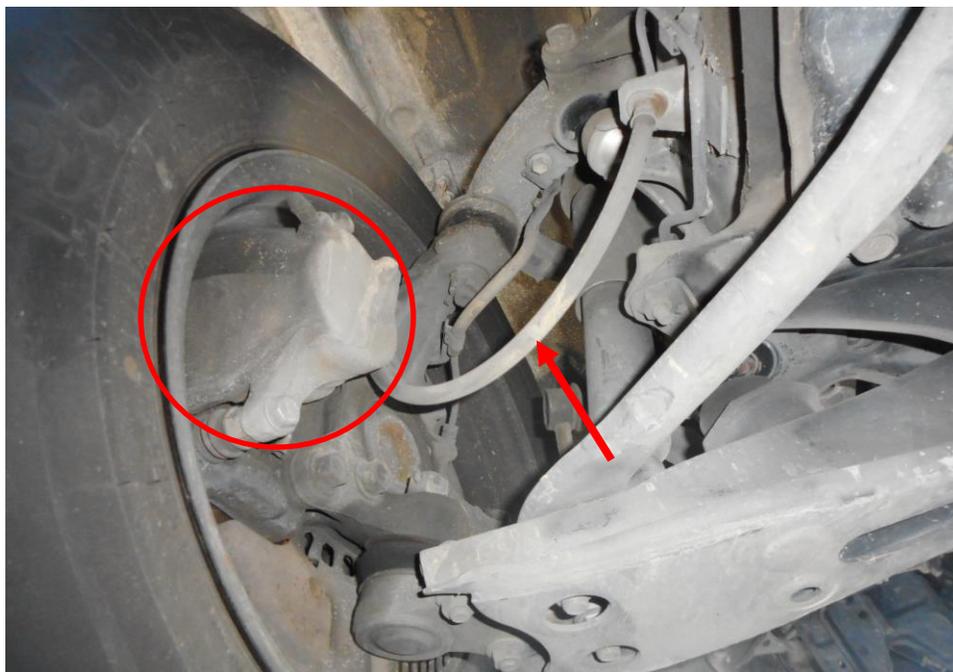
**Photo 23** shows the brake hose/pipe (arrowed) at the front left wheel of the Motor Van. No leakage of brake fluid was observed. Visual examination of the various components of the braking system like the brake caliper (circled), brake booster, brake pedal etc had revealed all to be intact and without visible damage at the time of accident. There was also no sign of fluid stain(s) observed on the various undercarriage components.
