Your Ref: TP/IP/ 00087/2021  
Our Ref : CI/TPD21001204/P

**Fatal Accident Investigation Team**

**MECHANICAL INSPECTION REPORT OF MOTOR CAR SJP 5485Z**

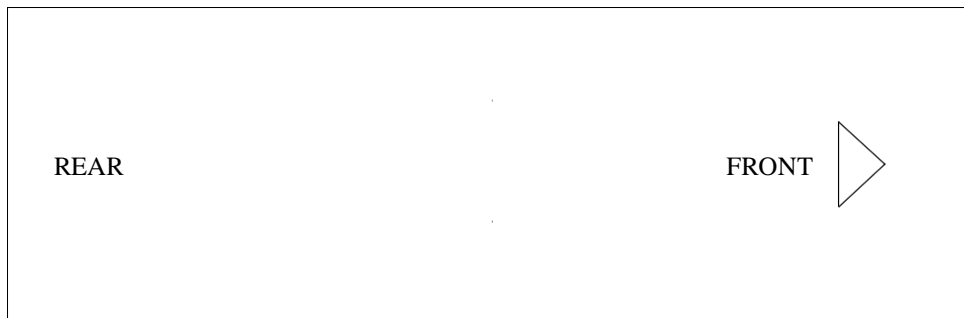
6. The condition of the Motor Car's 4 tyres was observed to be in serviceable condition. I did not find any tear, cut or burst mark(s) on the outer and the inner sidewalls as well as across the tread of the 4 tyres. The front right tyre was observed to slip out of the rim as a result of the accident. However the other 3 tyre were observed to be sufficiently inflated for vehicular operation. The tyre brand, tyre size and remaining tread depth of the 4 tyres were recorded as follows:-

Kapsen 195/65R15 (2.4mm)

Atrezzo 195/65R15 (7.2mm)

Michelin 195/65R15 (2.5mm)

Sailun 195/65R15 (7.1mm) (Slip off)

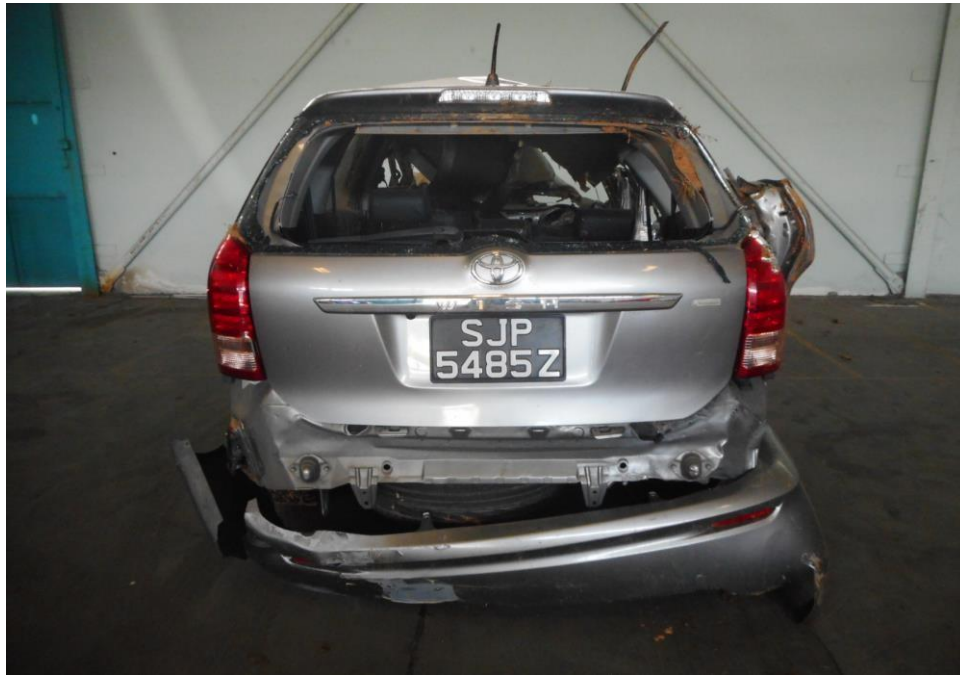
**Photo 1** shows the general view of the Motor Car's rear portion at the time of my inspection. The Motor Car was observed to sustained damage at its rear portion. Its rear bumper and rear windscreen were amongst the body parts that were damaged as a result of the accident.

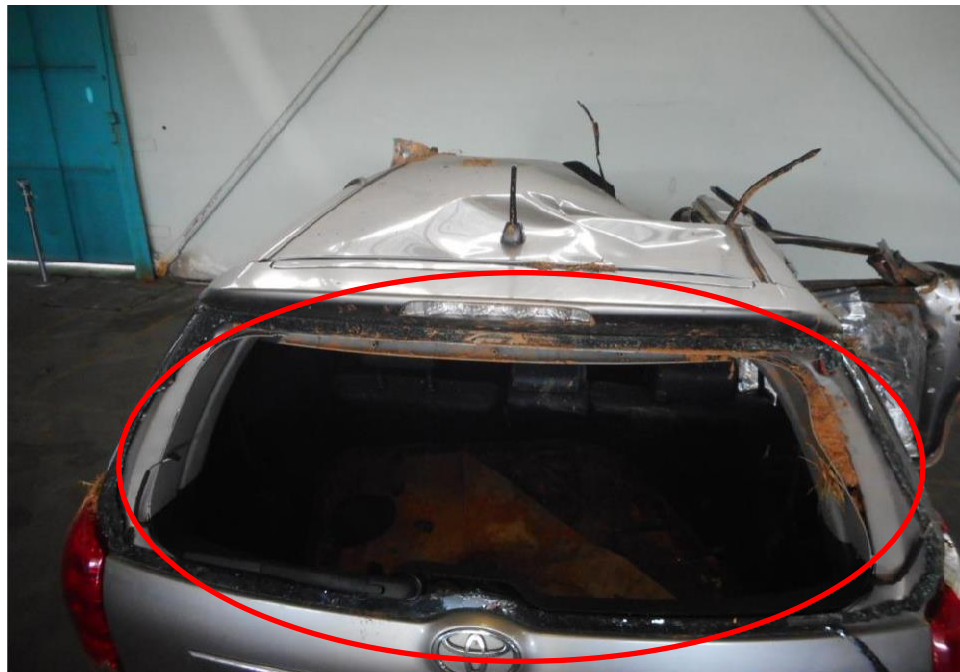
**Photo 2** shows the close up view of the Motor Car's rear portion at the time of my inspection. The Motor Car was observed to sustained damage at its rear portion. Its rear windscreen (circled) were amongst the body parts that were damaged as a result of the accident.

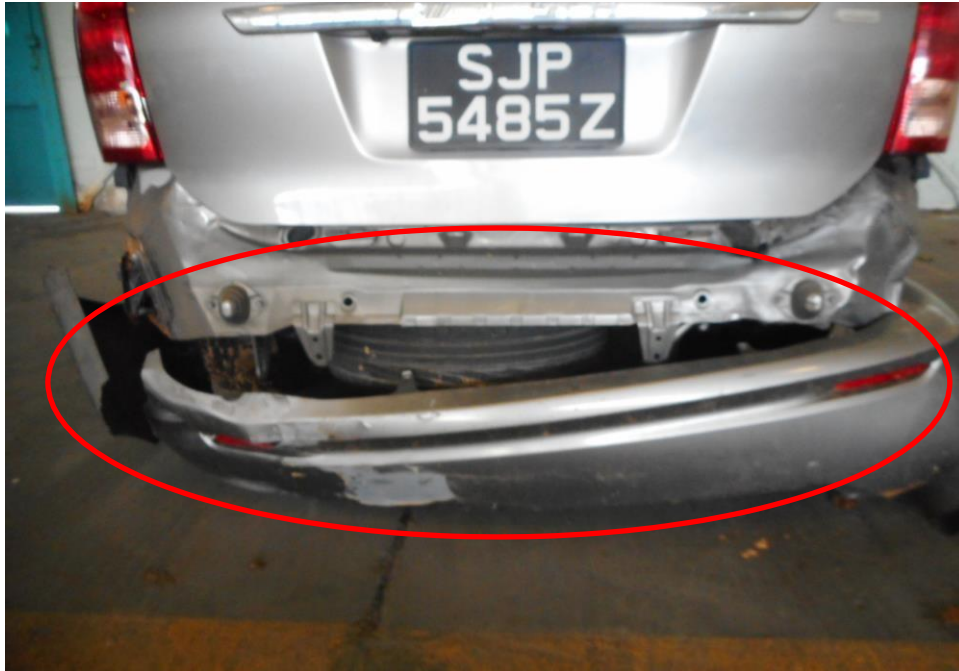
**Photo 3** shows the close up view of the Motor Car's rear portion at the time of my inspection. The Motor Car was observed to sustained damage at its rear portion. Its rear bumper (circled) were amongst the body parts that were damaged as a result of the accident.

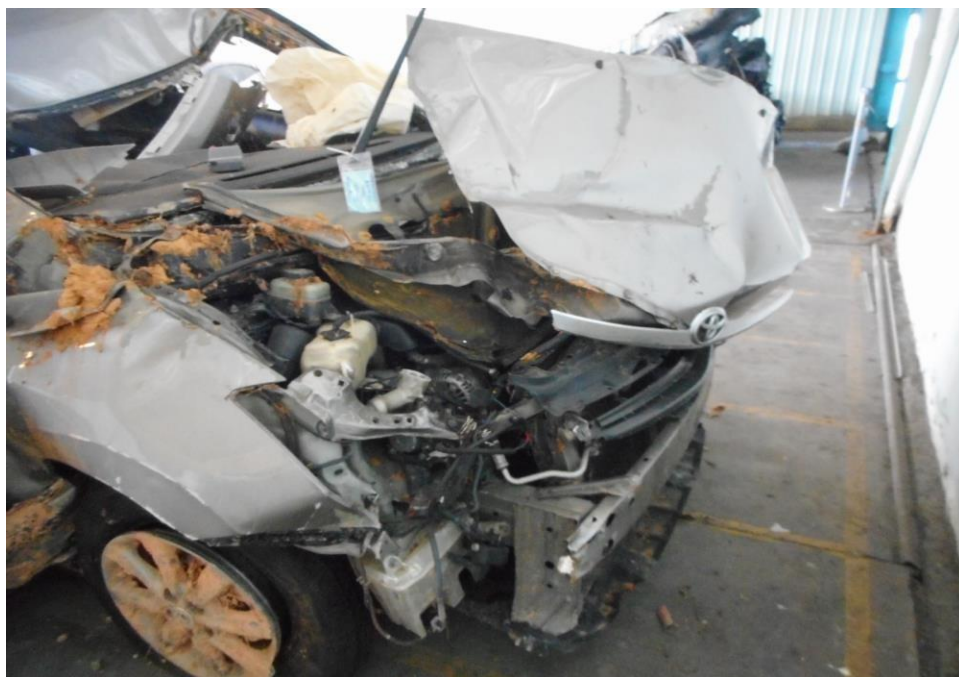
**Photo 4** shows a general view of the Motor Car's front body and roof at the time of my inspection. The Motor Car was observed to sustained damage at its front and roof portion. Its front windscreen, front bonnet and roof was amongst the body parts and various components in the engine compartments were also damaged as a result of the accident. The Supplemental Restraint System (SRS) was activated as a result of the accident.

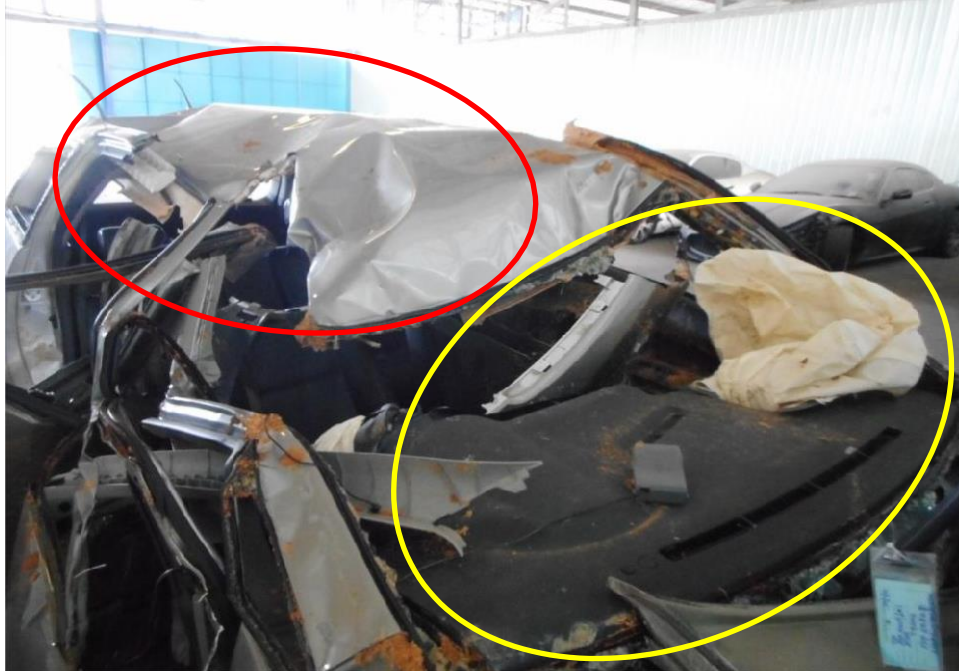
**Photo 5** shows the close up view of the Motor Car's front body at the time of my inspection. The Motor Car was observed to have sustained damage at its front and roof portion. Its front windscreen (yellow circle) and roof (red circle) were amongst the body parts that were damaged as a result of the accident.

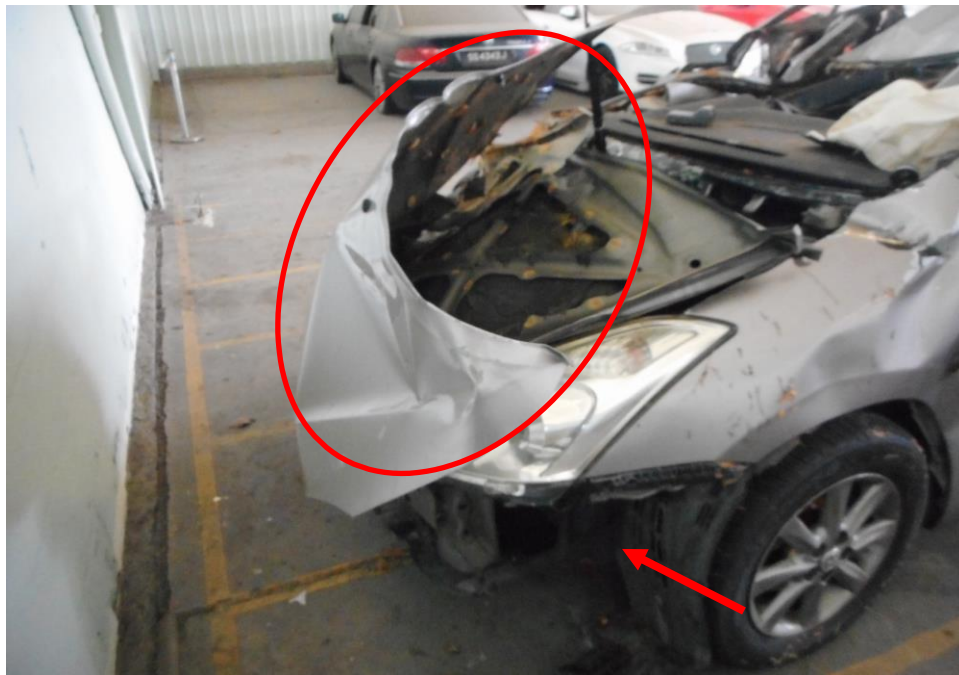
**Photo 6** shows the close up view of the Motor Car's front body at the time of my inspection. The Motor Car was observed to have sustained damage at its front portion. Its front bonnet (circled) and front bumper (arrowed) were amongst the body parts that were damaged as a result of the accident.

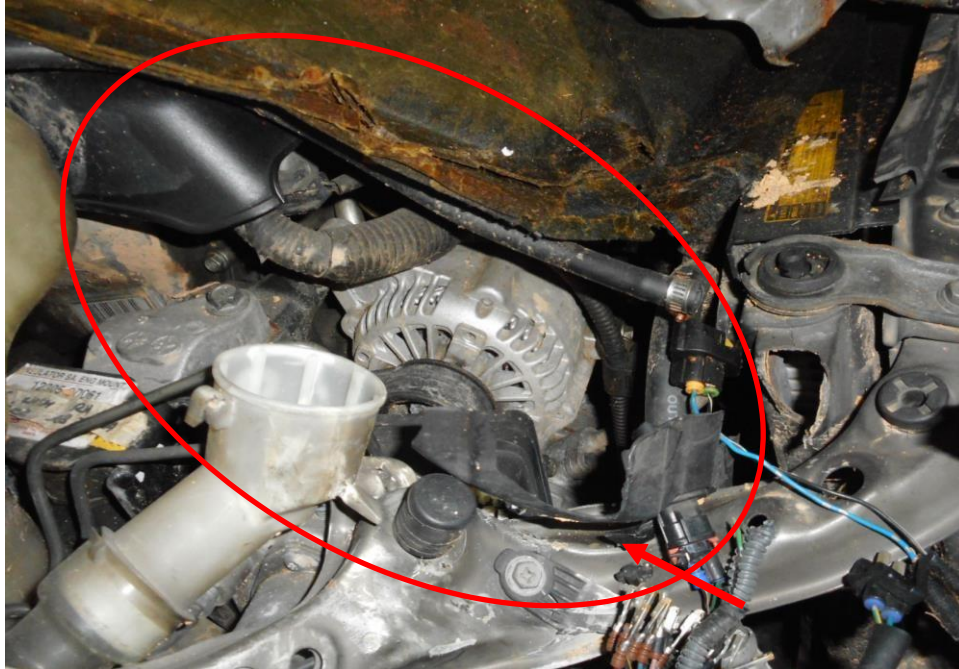
**Photo 7** shows the close up view of the Motor Car's front engine compartment at the time of my inspection. The Motor Car was observed to have sustained damage at its engine compartment. Its engine system (circled) were amongst the components that were damaged as a result of the accident.

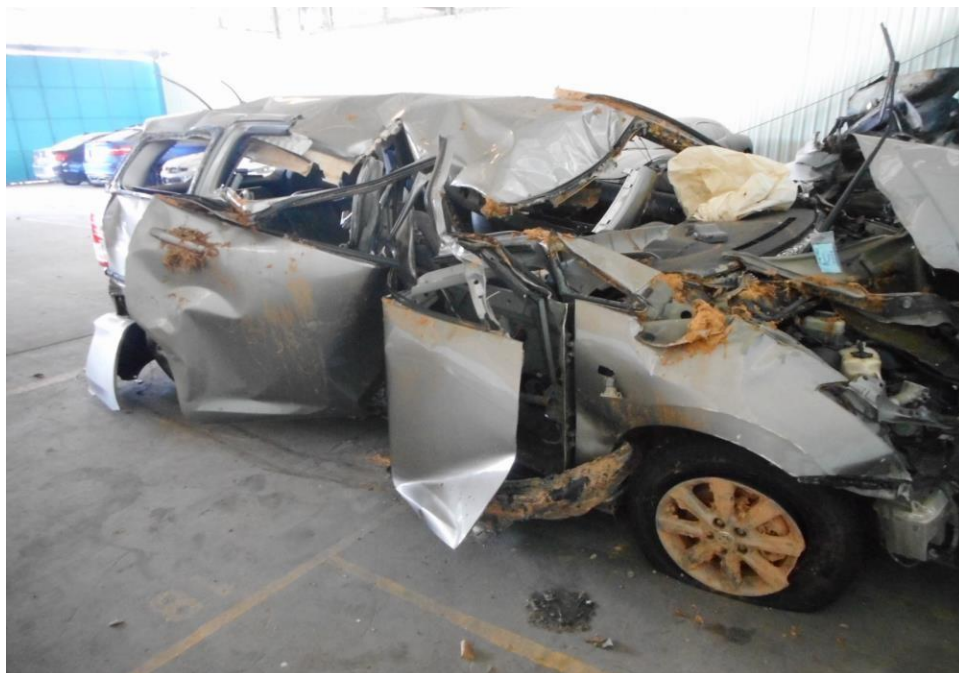
**Photo 8** shows a general view of the Motor Car's right body at the time of my inspection. The Motor Car was observed to sustained damage at its right portion. Its right body panels were amongst the body parts that were damaged as a result of the accident.

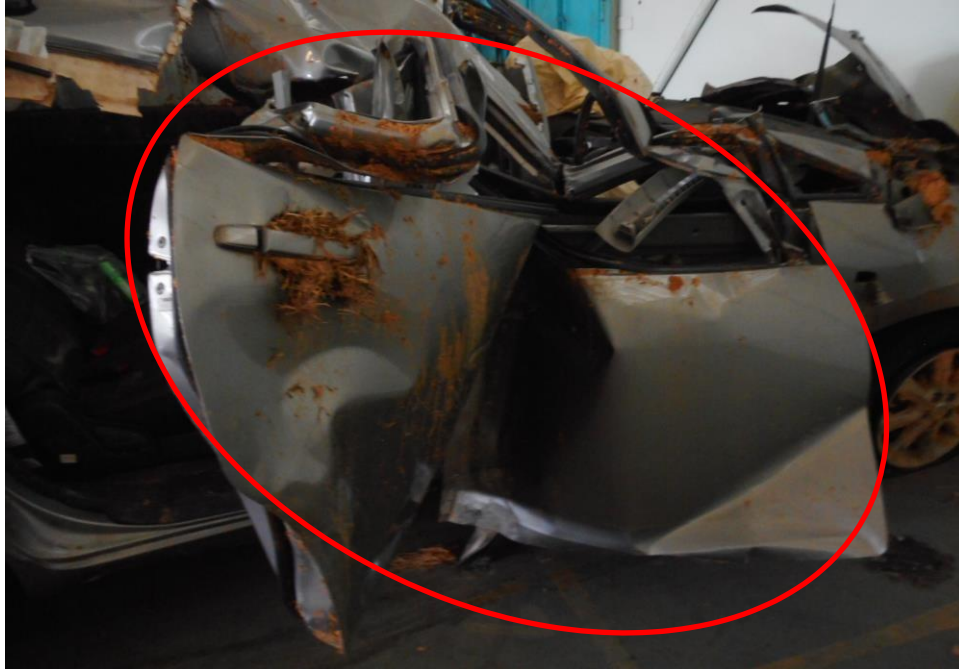
**Photo 9** shows a close up view of the Motor Car's right body at the time of my inspection. The Motor Car was observed to sustained damage at its right portion. Its right body panels (circled) were amongst the body parts that were damaged as a result of the accident.

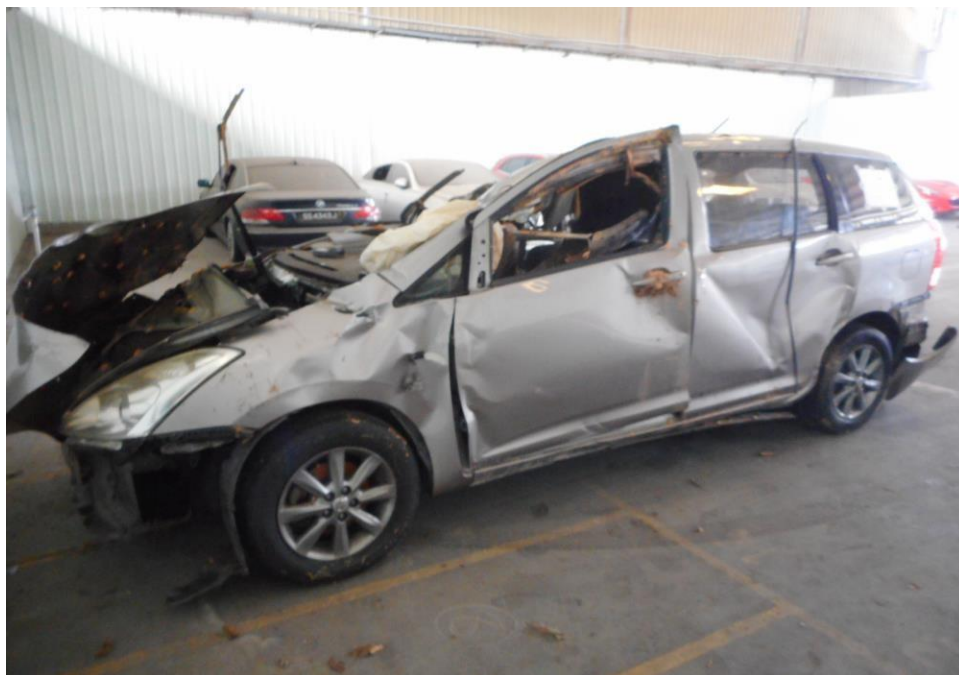
**Photo 10** shows a general view of the Motor Car's left body at the time of my inspection. The Motor Car was observed to sustained damage at its left portion. Its left body panels were amongst the body parts that were damaged as a result of the accident.

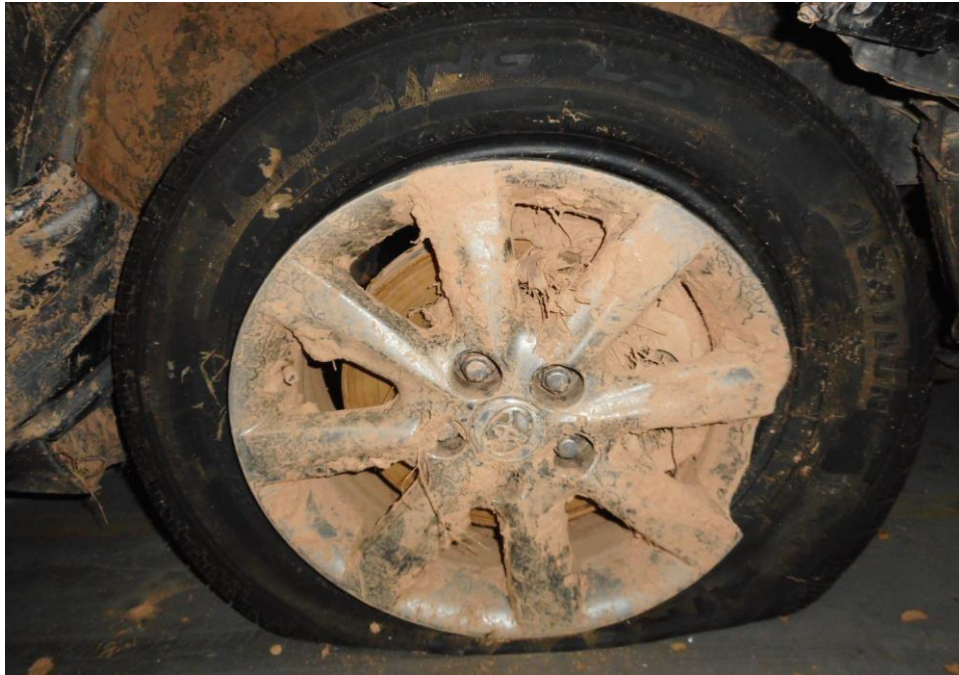
7. The front right tyre was observed to slip out of the rim as a result of the accident. However the other 3 tyre were observed to be wrapped around standard alloy wheel rims that were found to be without any damage. See photo 1 – 15 below.

**Photo 11** shows the condition of the front right tyre of the Motor Car, which was observed to slip off the rim as a result of the accident. The remaining tread depth of approximately 7.1mm. The tyre was observed to be deflated with no tear, cut or burst mark(s).

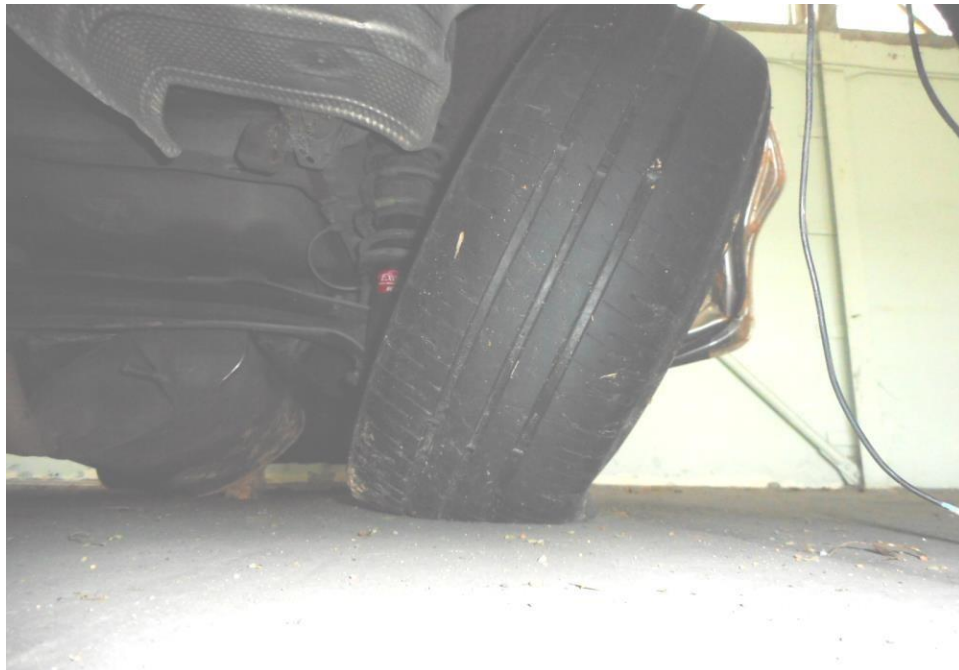
**Photo 12** shows the condition of the rear right tyre of the Motor Car, which was observed to be in serviceable condition with remaining tread depth of approximately 4.6mm. The tyre, which was wrapped around alloy wheel rim, was also observed to be sufficiently inflated for vehicular operation.

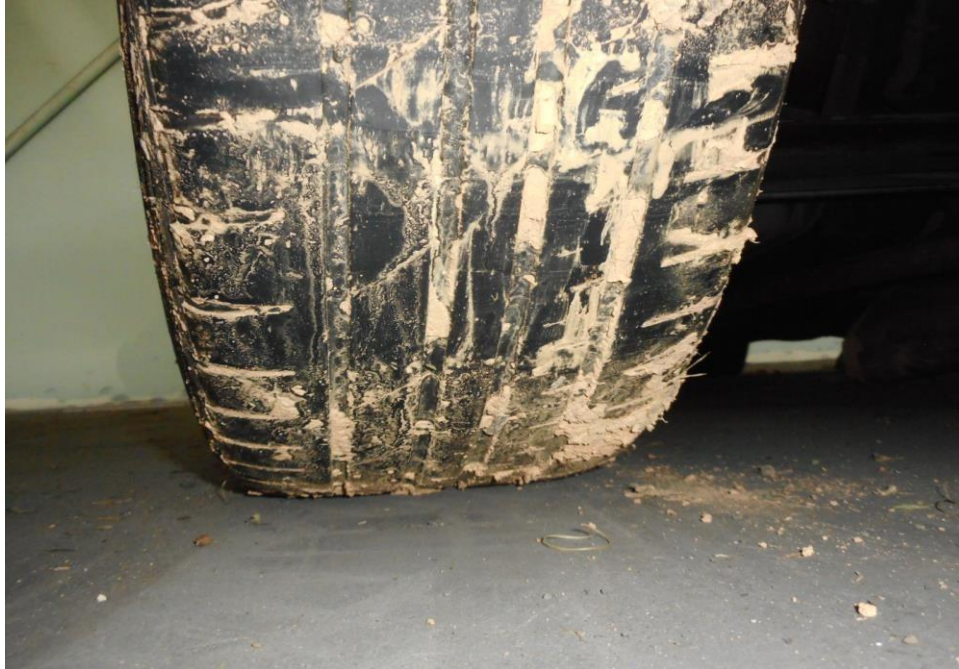
**Photo 13** shows the condition of the rear left tyre of the Motor Car, which was observed to be in serviceable condition with remaining tread depth of approximately 2.4mm. The tyre, which was wrapped around alloy wheel rim, was also observed to be sufficiently inflated for vehicular operation.

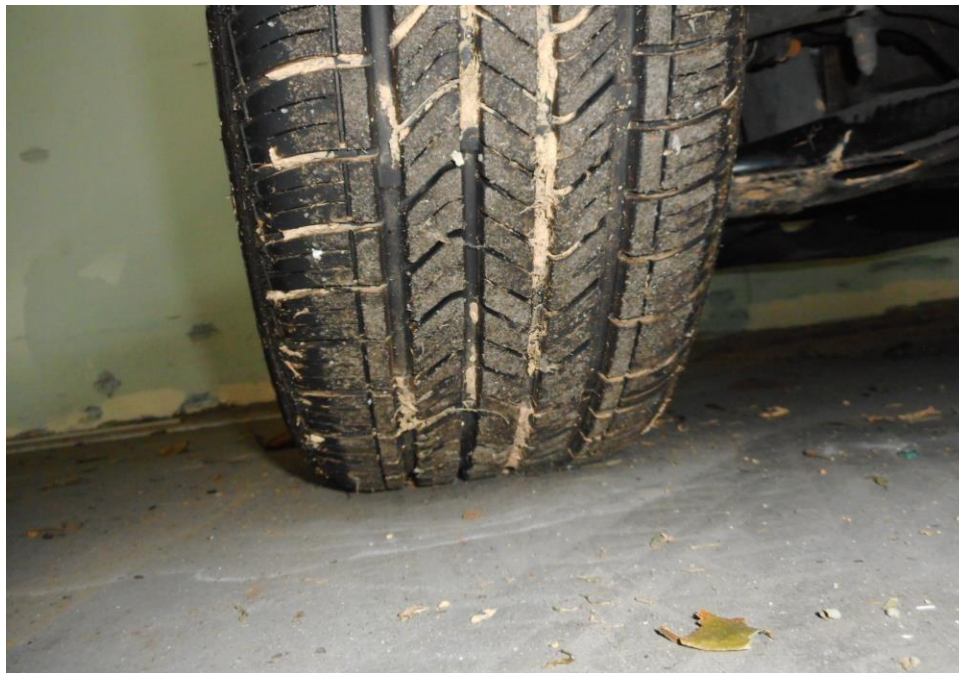
**Photo 14** shows the condition of the front left tyre of the Motor Car, which was observed to be in serviceable condition with remaining tread depth of approximately 7.2mm. There was also no tear, cut or burst mark(s) on the outer and the inner sidewalls as well as across the tread of the Motor Car's 4 tyres.

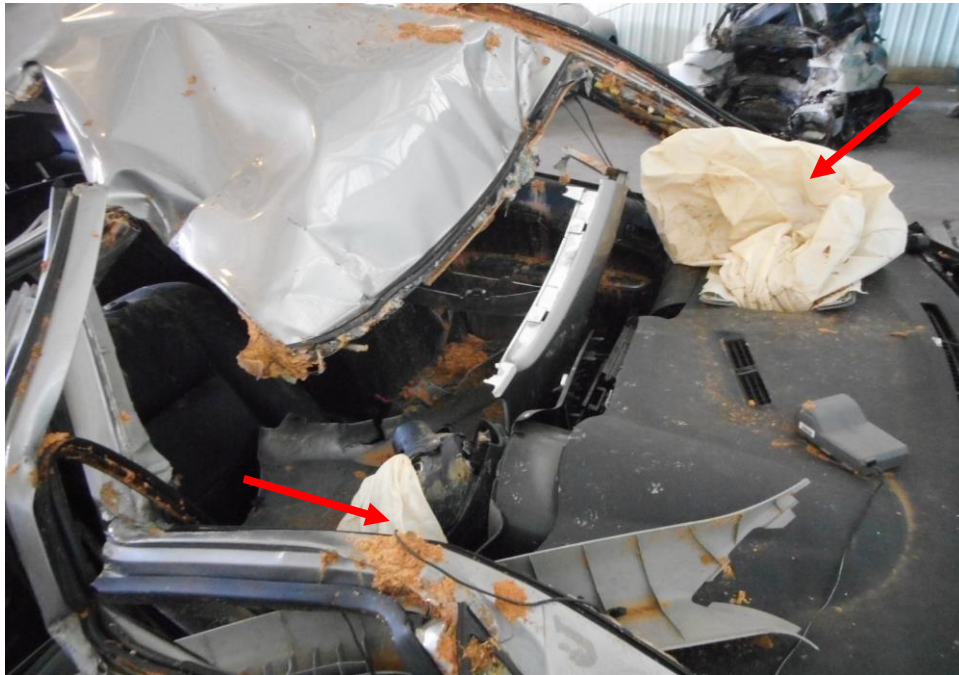
**Photo 15** shows the deployment of the Supplemental Restraint System (SRS) airbags (arrowed) in the Motor Car as a result of the accident.

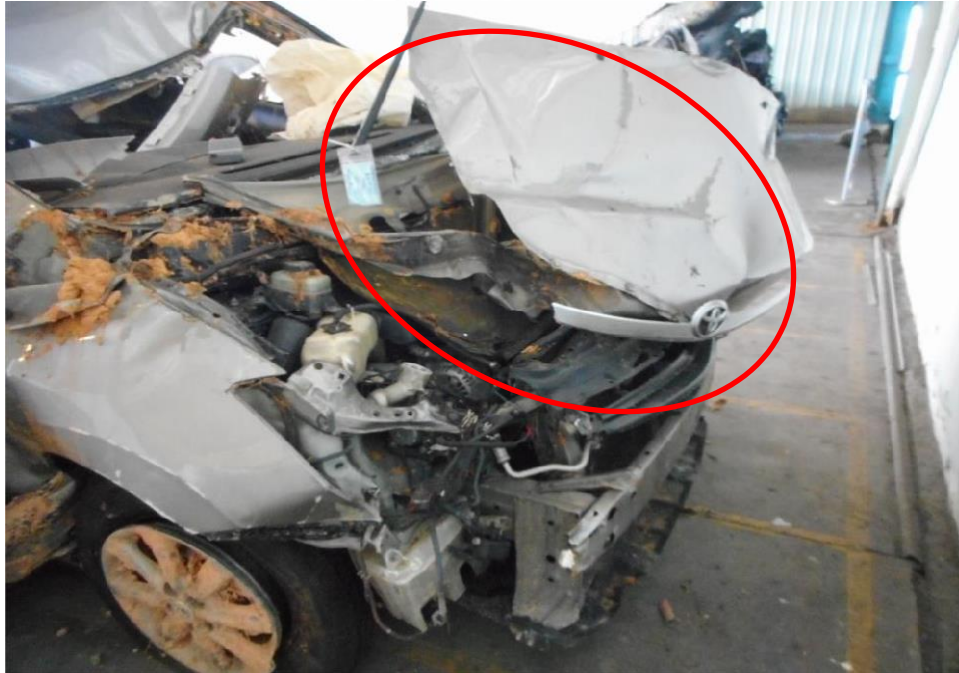
8. We were unable to raise the front bonnet of the Motor Car to conduct the examination of the Motor Car's engine compartment because the damage caused by the accident had resulted in the damages to the lock mechanism of the bonnet and the structure of the engine compartment. (unable to open)  
See photo 16 below

**Photo 16** shows a close up view of the damaged front bonnet lock mechanism and the structure of the engine compartment of the Motor Car at the time of my inspection resulting it unable to open a result of the accident (circled) (Unable to open)

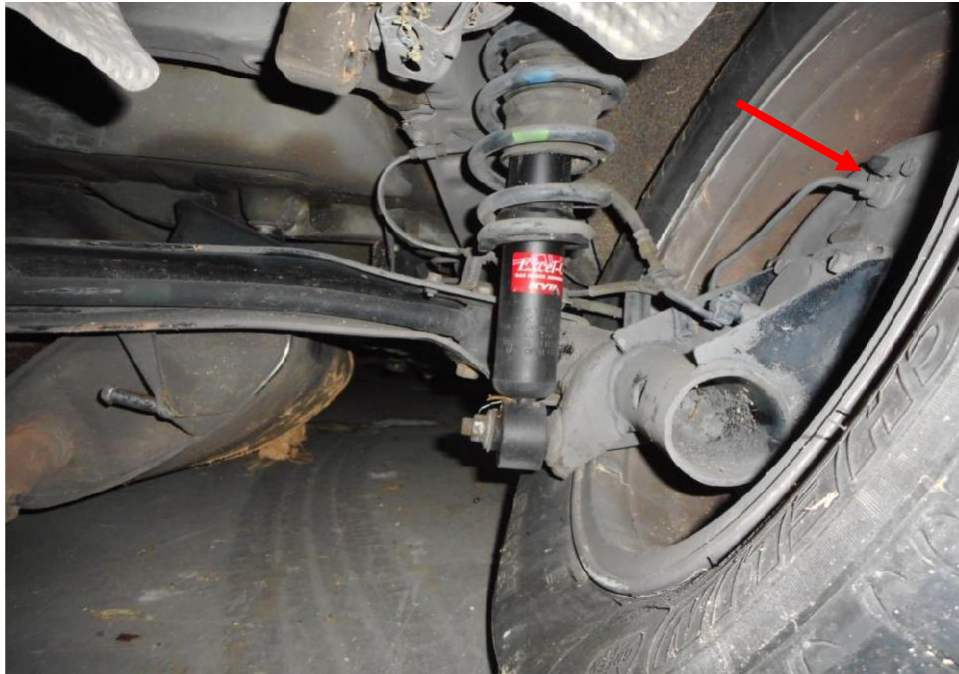
**Photo 17** shows the brake hose/pipe (arrowed) at the rear right wheel of the Motor Car. No leakage of brake fluid was observed. Visual examination of the various components of the braking system like the drum brake and brake hoses had revealed to be intact and without visible damage.

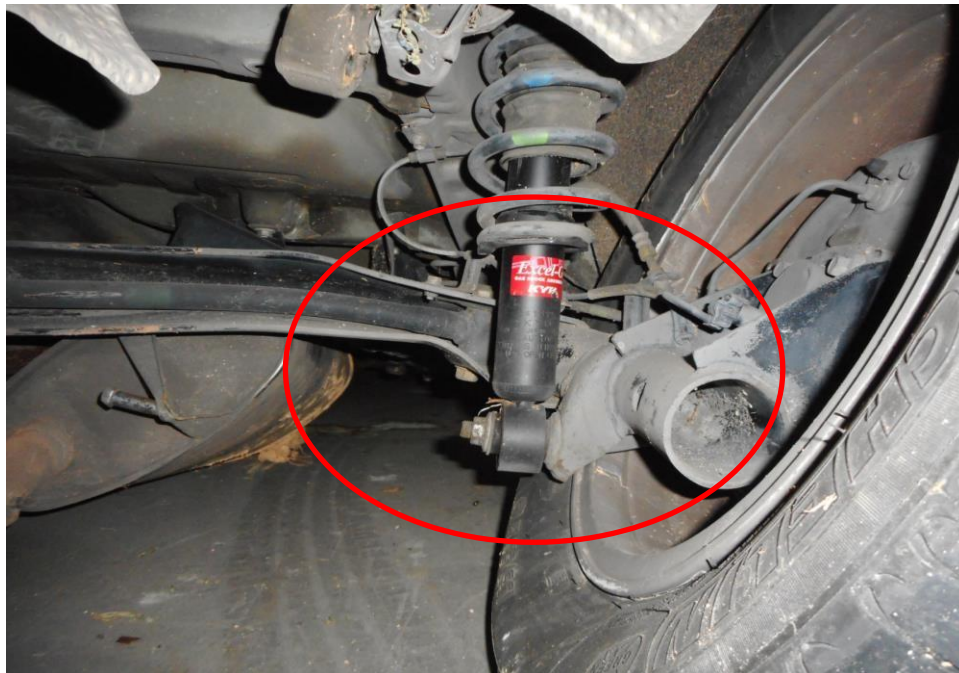
**Photo 18** shows the rear axle at the rear right wheel of the Motor Car. The axle was observed to be bent and damage (circled) as a result of the accident.

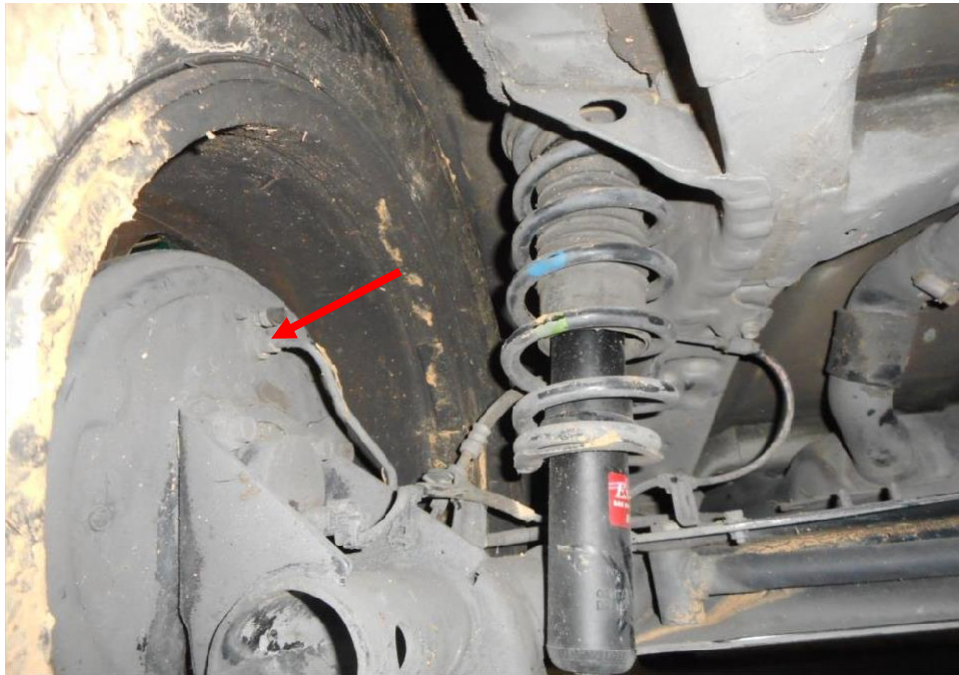
**Photo 19** shows the brake hose/pipe (arrowed) at the rear left wheel of the Motor Car. I did not observe any leakage of brake fluid at the time of my inspection of the Motor Car and the undercarriage component of the Motor Car were also all found to be intact

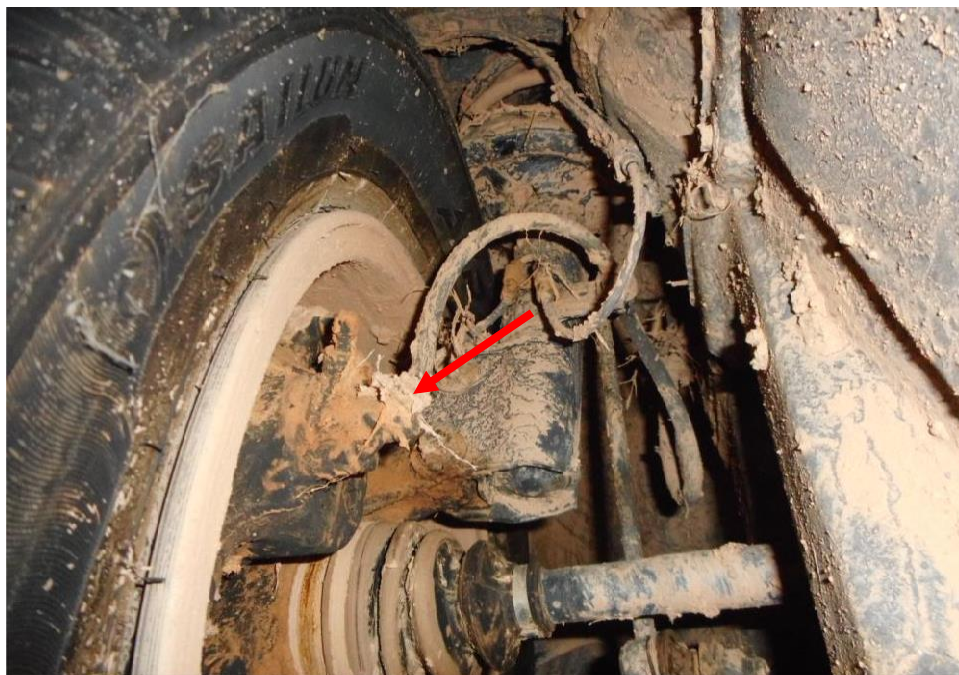
**Photo 20** shows the brake hose/pipe (arrowed) at the front right wheel of the Motor Car. I did not observe any leakage of brake fluid at the time of my inspection of the Motor Car. The undercarriage components of the Motor Car were also all found to be intact and without any visible damage. The undercarriage components were cover in mud as due to the result of the accident.

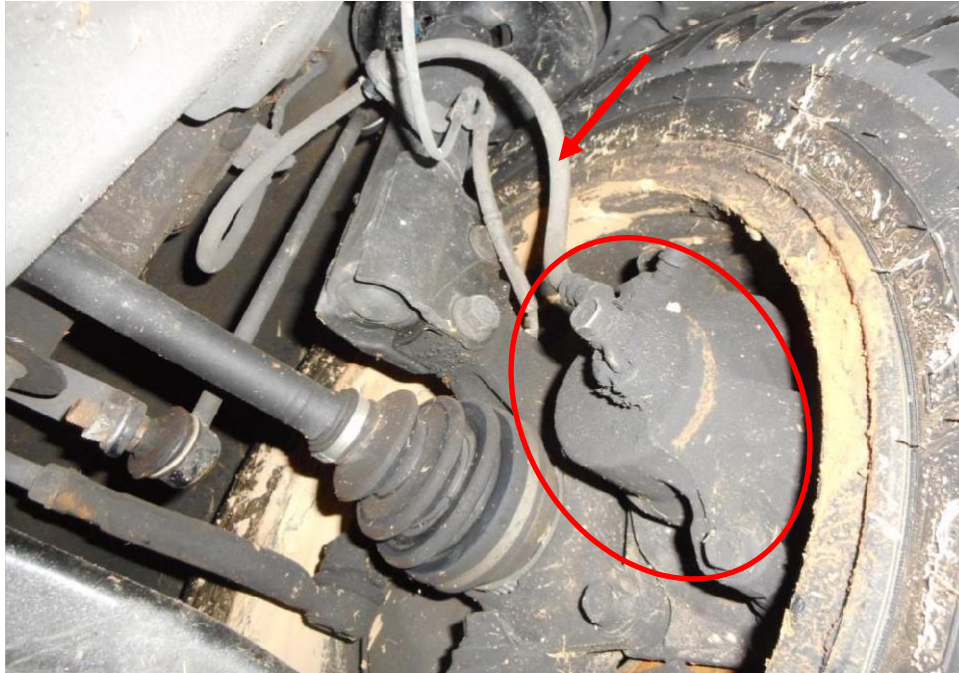
**Photo 21** shows the brake hose/pipe (arrowed) at the front left wheel of the Motor Car. No leakage of brake fluid was observed. Visual examination of the various components of the braking system like the brake caliper (circled) had revealed all to be intact and without visible damage.

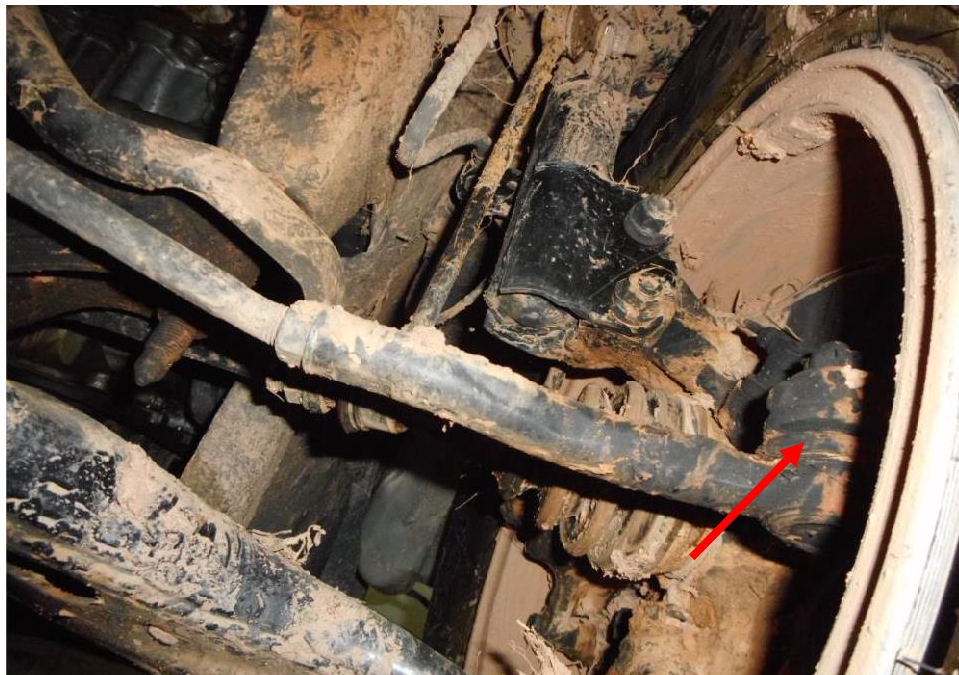
**Photo 22** shows the various undercarriage components at the front right wheel of the Motor Car, in particular the steering tie rod (red arrow). The various steering components were all found to be intact, suggesting that the steering system of the Motor Car was likely to be in serviceable condition at the material time of accident. There was also no sign of fluid stain observed on the various undercarriage components at the front right wheel of the Motor Car. The undercarriage components were cover in mud as due to the result of the accident.

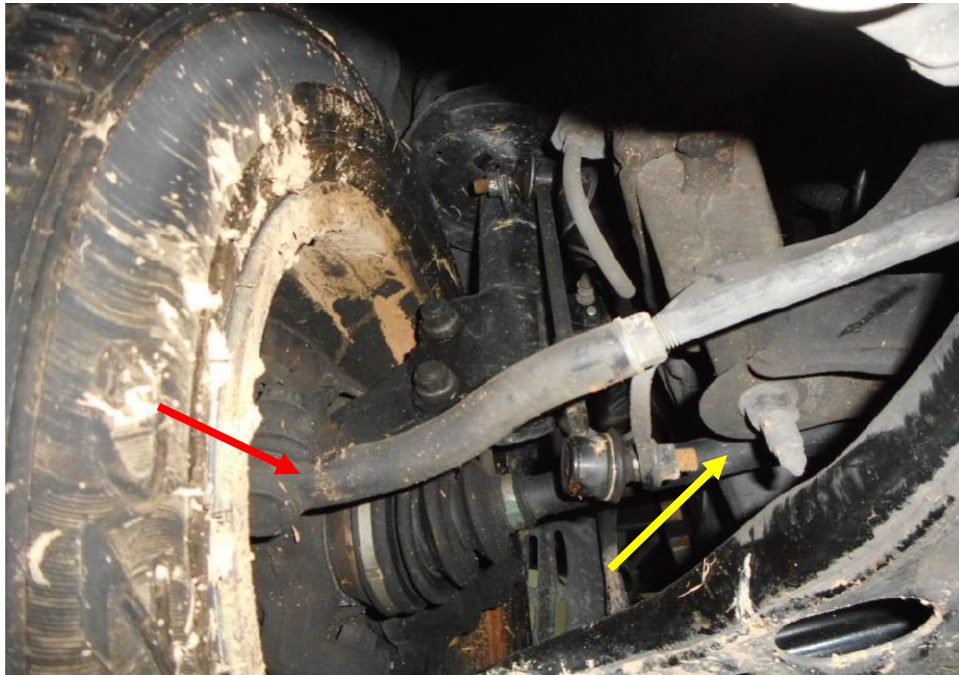
**Photo 23** shows the various undercarriage components at the front left wheel of the Motor Car, in particular the steering tie rod (red arrow) and drive shaft (yellow arrow). The various steering components were all found to be intact, suggesting that the steering system of the Motor Car was likely to be in serviceable condition at the material time of accident. There was also no sign of fluid stain observed on the various undercarriage components at the front left wheel of the Motor Car.

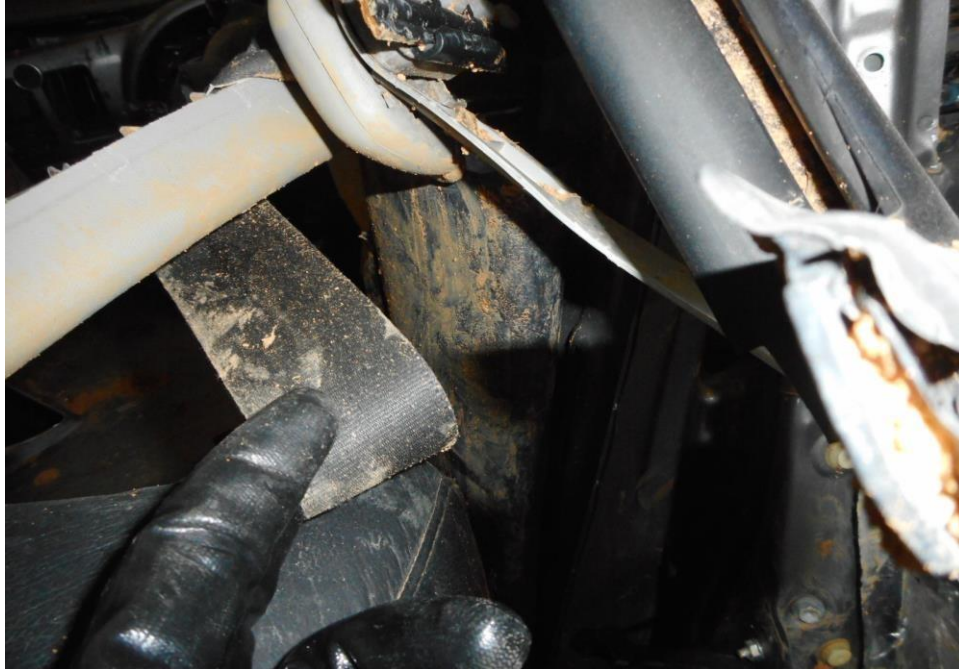
13. The front right seat belt was worn and the left seat belt was not worn of the "Motor Car" was worn at the material time of accident, as the respective pre-tensioners that were fitted at the side of each seat was activated upon the material time. See photo 24 and 25 below.

**Photo 24** shows that that the seat belt on the right seat was worn at the material time of accident as the safety pre-tensioners was activated at the moment of impact and caused the seat belt to be locked into the last position.

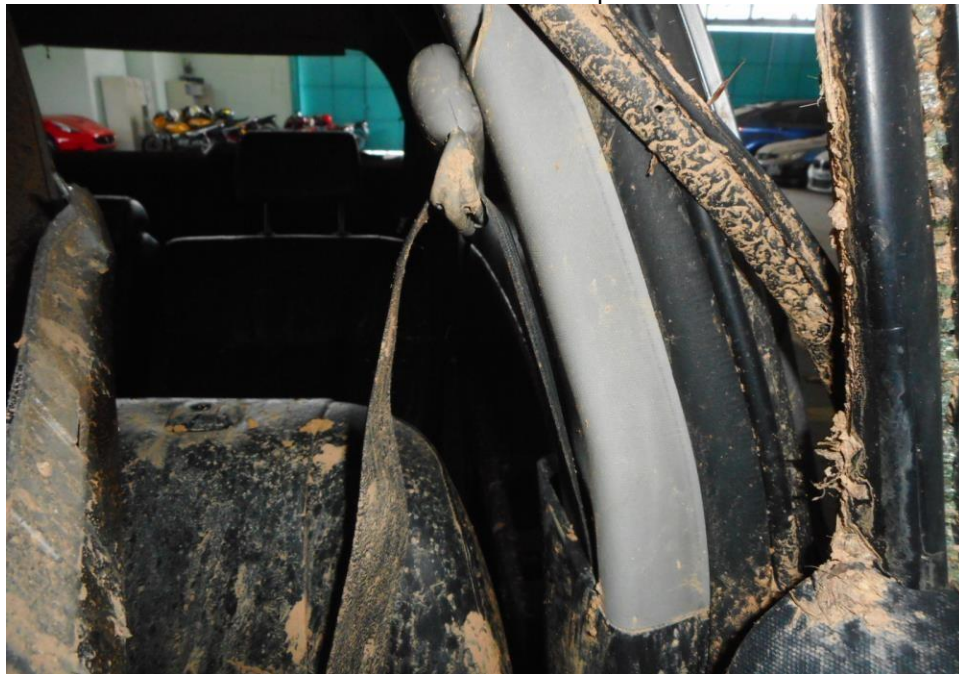
**Photo 25** shows that that the seat belt on the left seat was not worn at the material time of accident as the safety pre-tensioners was activated at the moment of impact and caused the seat belt to be locked into the last position.
