Our Ref: CC4/AIG17021548/ua3

**ACCIDENT INVOLVING SBP 96R AND SLH 5262T ON 09.11.2017 ALONG / AT
STILL ROAD SOUTH - EAST COAST EXPRESSWAY (JUNCTION BEFORE
MARINE PARADE)**

**AUTOMOBILE TECHNICAL INVESTIGATION REPORT OF ACCIDENT
INVOLVING SLH 5262T AND SBP 96R ON 9 NOVEMBER 2017**

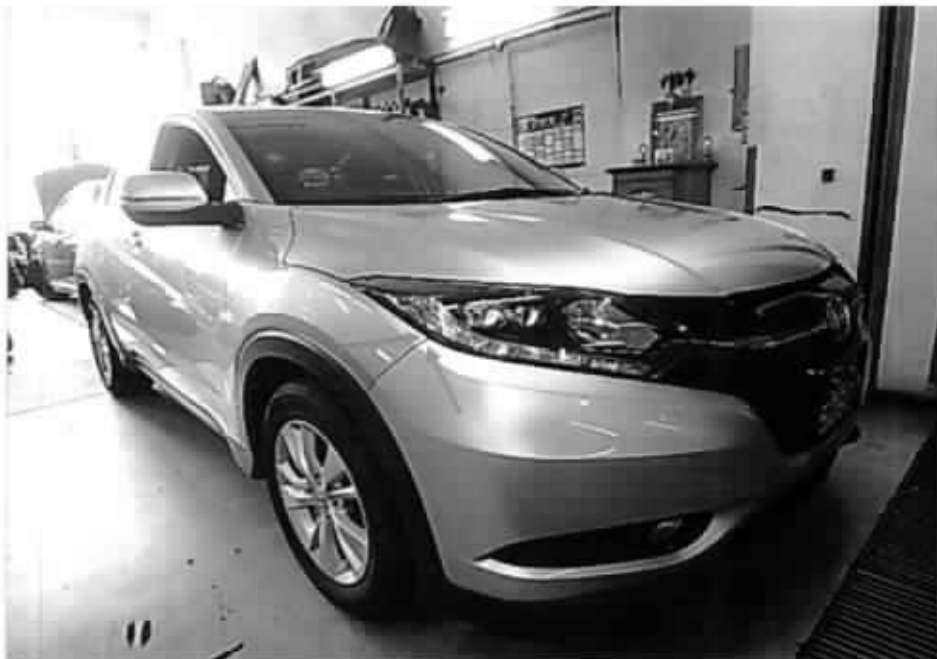
7. From our examination of the photographs taken during the Pre- Repair Survey conducted by LKK Auto Consultants Pte. Ltd. about 1 day after the accident, we observed reddish paint transfer marks and paint graze marks on the driver door of the Honda. There were also black marks on the right passenger door. However we noted that the front bumper was not misaligned at its right corner edge. See photos 1 - 6 below.

Photo 1 shows a general view of the right front portion of the Honda at the time of the Pre- Repair Survey conducted by LKK Auto Consultants Pte. Ltd. about 1 day after the accident. We noted that the front bumper was not misaligned at its right corner edge (arrowed).

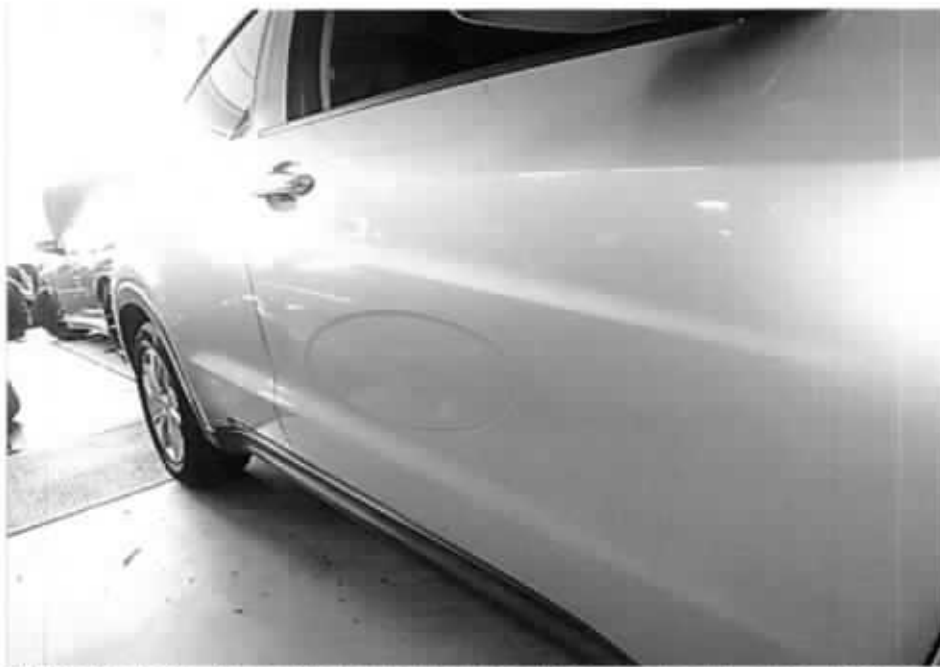
Photo 2 shows the reddish paint transfer marks and paint graze marks we observed on the driver door of the Honda (circled).

- a) the height above ground level of the area where the reddish paint transfer marks were found on the driver door of the Honda was measured to be approximately 68cm;

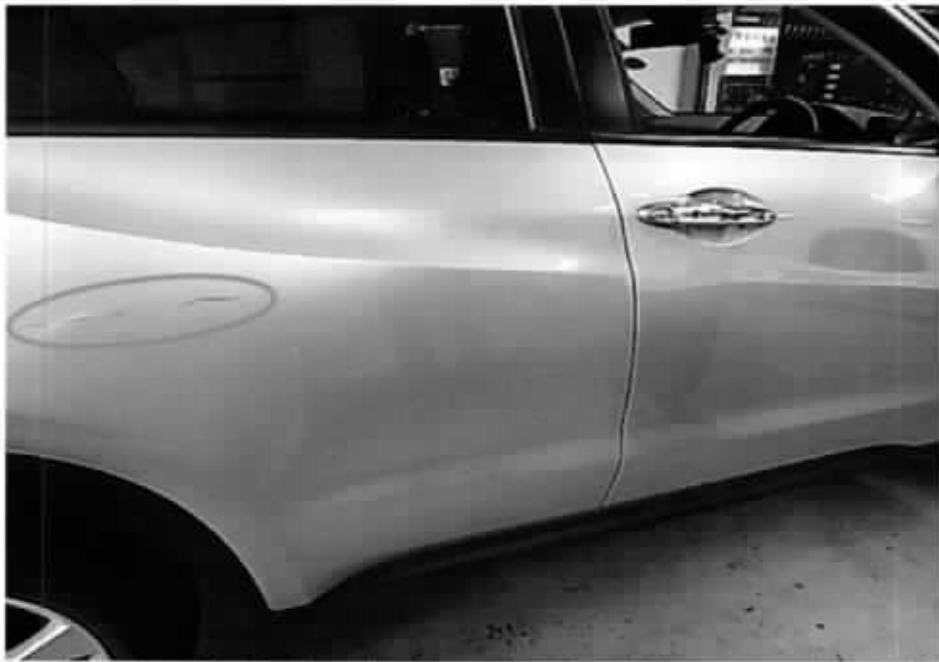
Photo 4 shows the black marks observed on the right passenger door of the Honda (circled).

- b) the height above ground level of the area where the black marks were found on the right passenger door of the Honda was measured to be approximately 88cm;

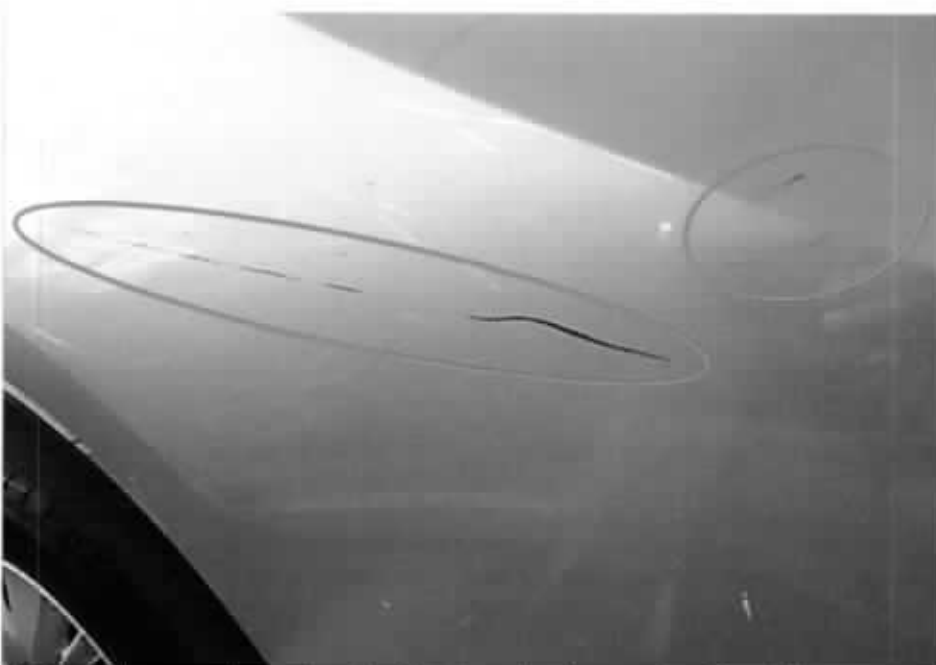
Photo 5 shows a closer view the black marks observed on the right passenger door of the Honda (circled).

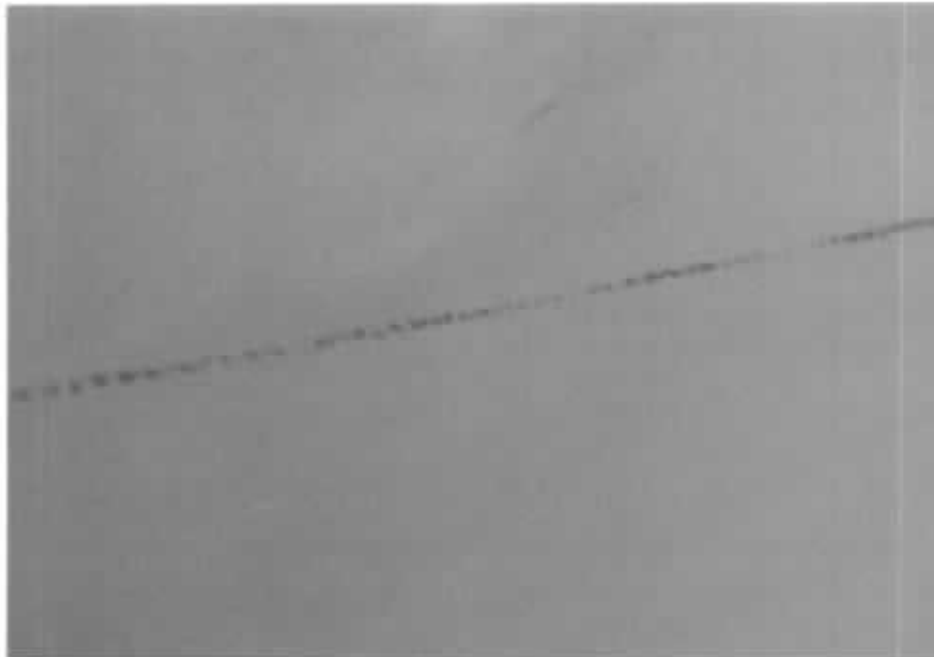
Photo 6 shows a close up view the black marks observed on the right passenger door of the Honda.

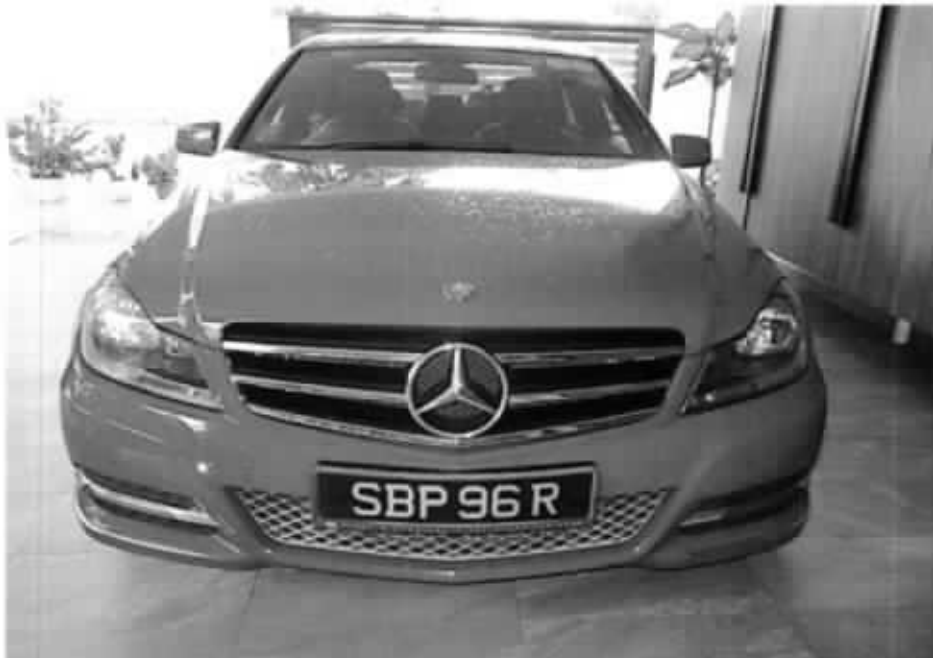
11. At the time of our inspection, we observed paint graze marks and paint scuff marks on the front left portion of the Mercedes. We found paint graze marks on the top portion of the Mercedes's left front tyre fender. There were also scuff marks on the lower portion of the Mercedes's left side mirror. However, it was noted that the front bumper was not misaligned at its corner edges. See photos 7 - 14 below.

Photo 7 shows the general view of the front portion of the Mercedes at the time of our inspection.

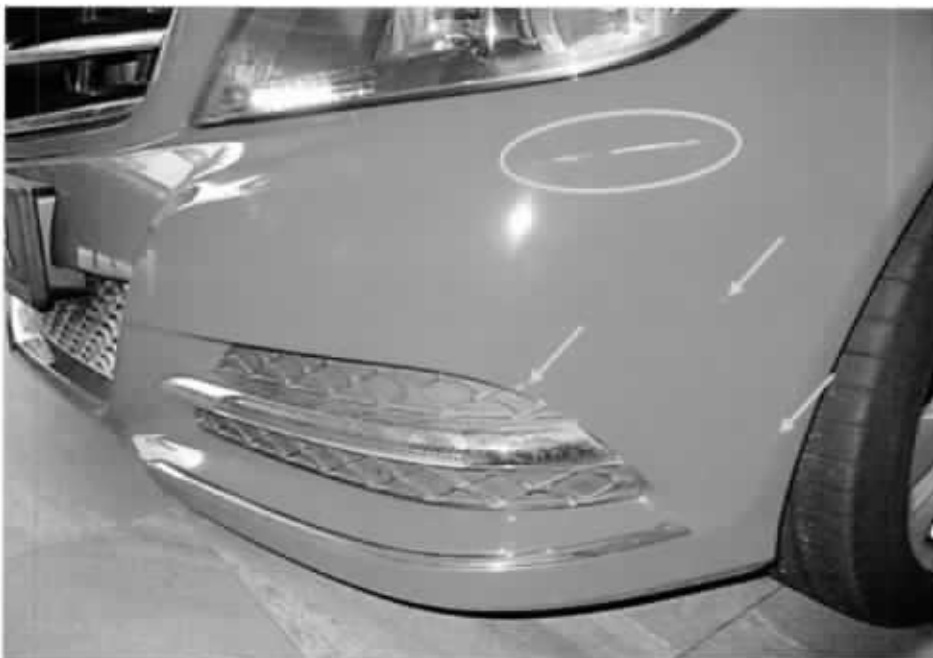
Photo 8 shows the paint graze marks (circled) and paint scuff marks (arrowed) found on the front left portion of the Mercedes.

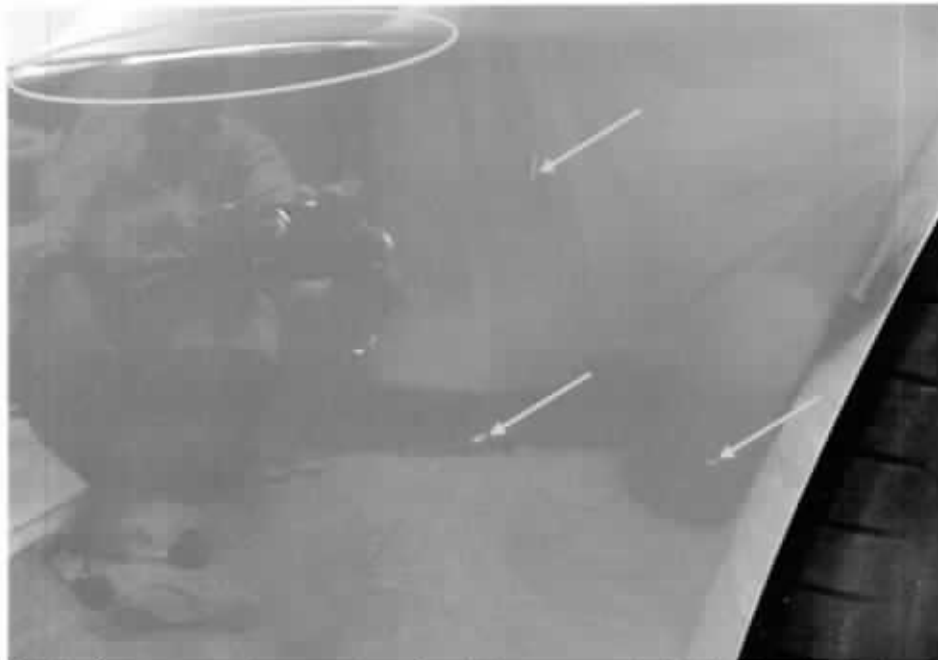
Photo 9 shows a close up view of paint graze marks (circled) and paint scuff marks (arrowed) found on the front left portion of the Mercedes.

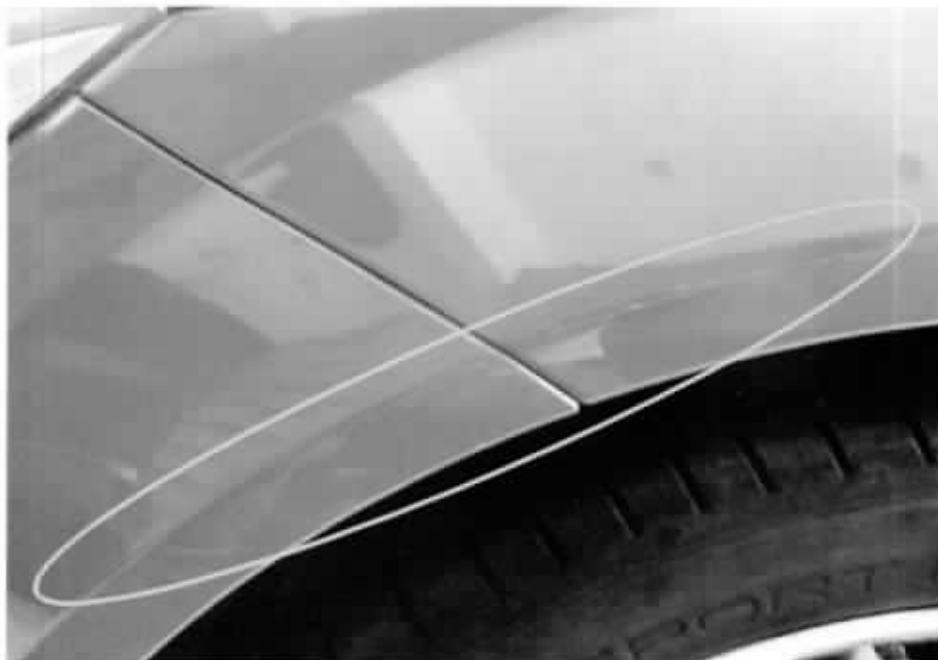
Photo 10 shows a close up view of the paint graze marks on the top portion of the Mercedes's left front tyre fender (circled).

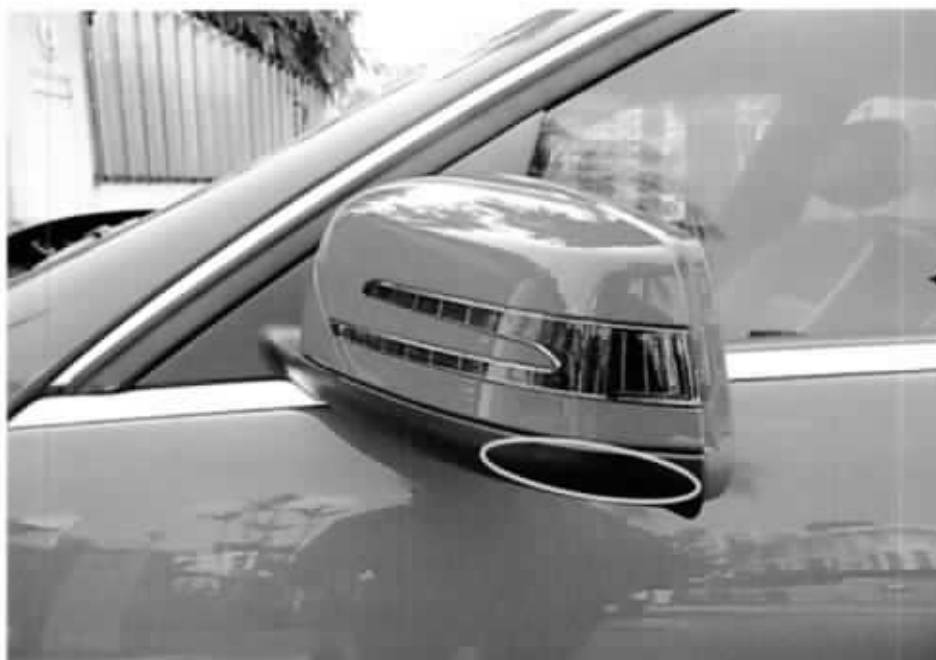
Photo 11 shows a view of the left side mirror of the Mercedes at the time of our inspection. We noticed scuff marks on the lower portion of the left side mirror (circled).

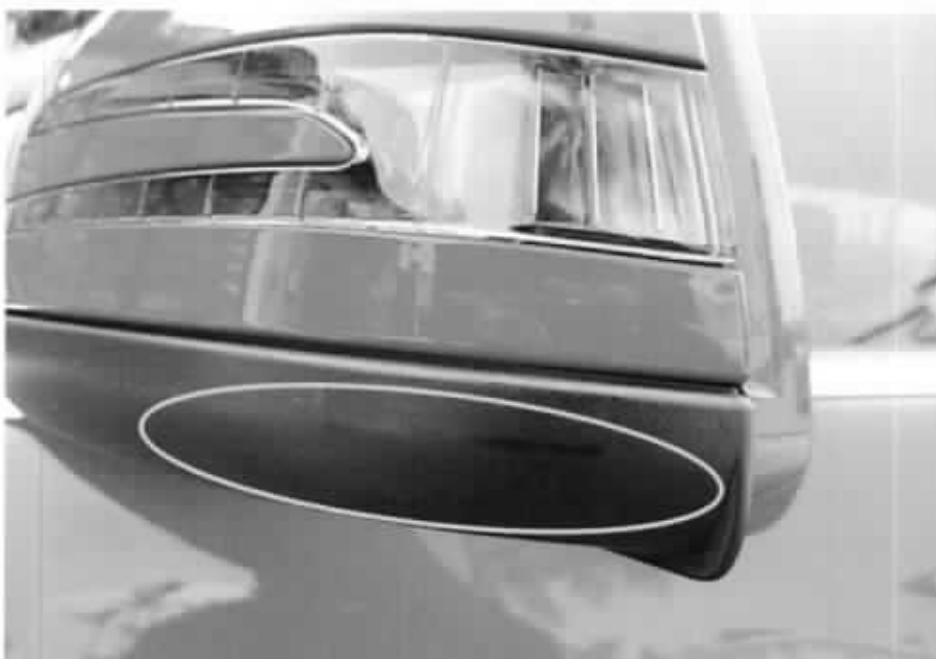
Photo 12 shows a close up view of the left side mirror of the Mercedes at the time of our inspection. We noticed scuff marks on the lower portion of the left side mirror (circled).

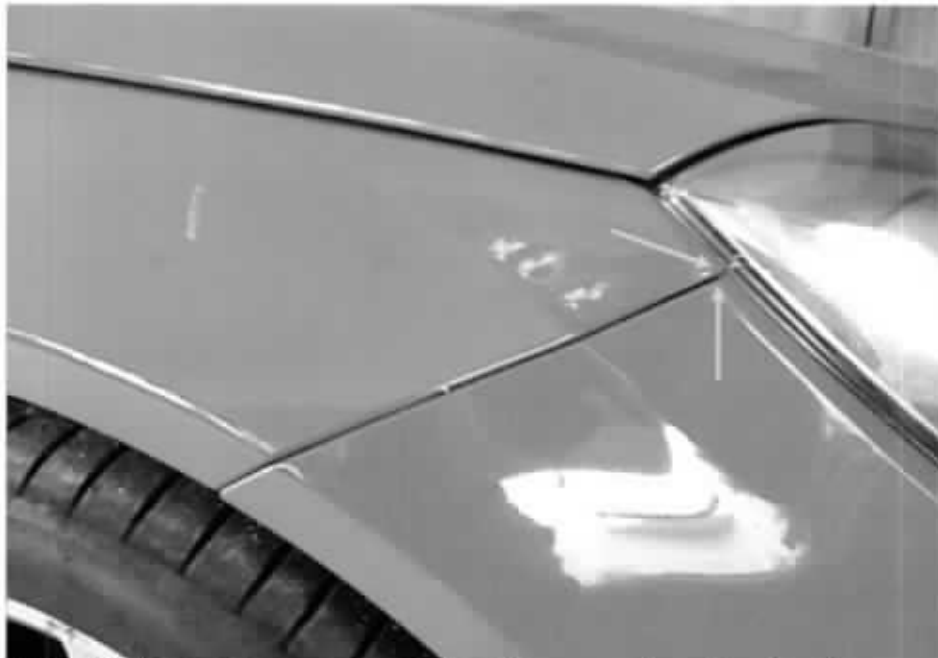
Photo 13 shows a close up view of the right corner edge of the front bumper of the Mercedes. We observed that there was no misalignment at the corner edges (arrowed).

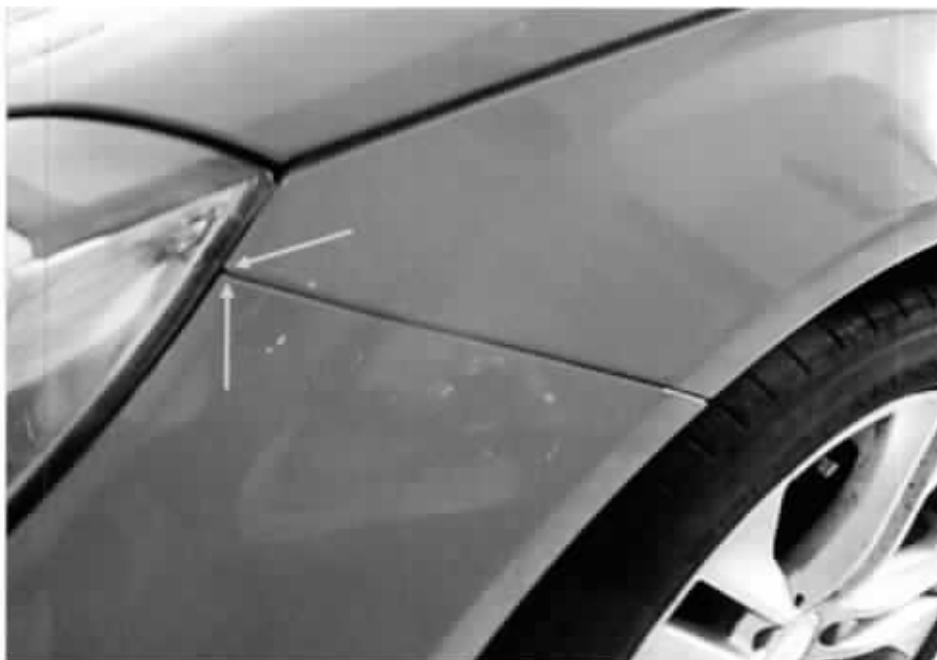
Photo 14 shows a close up view of the left corner edge of the front bumper of the Mercedes. We observed that there was no misalignment at the corner edges (arrowed).

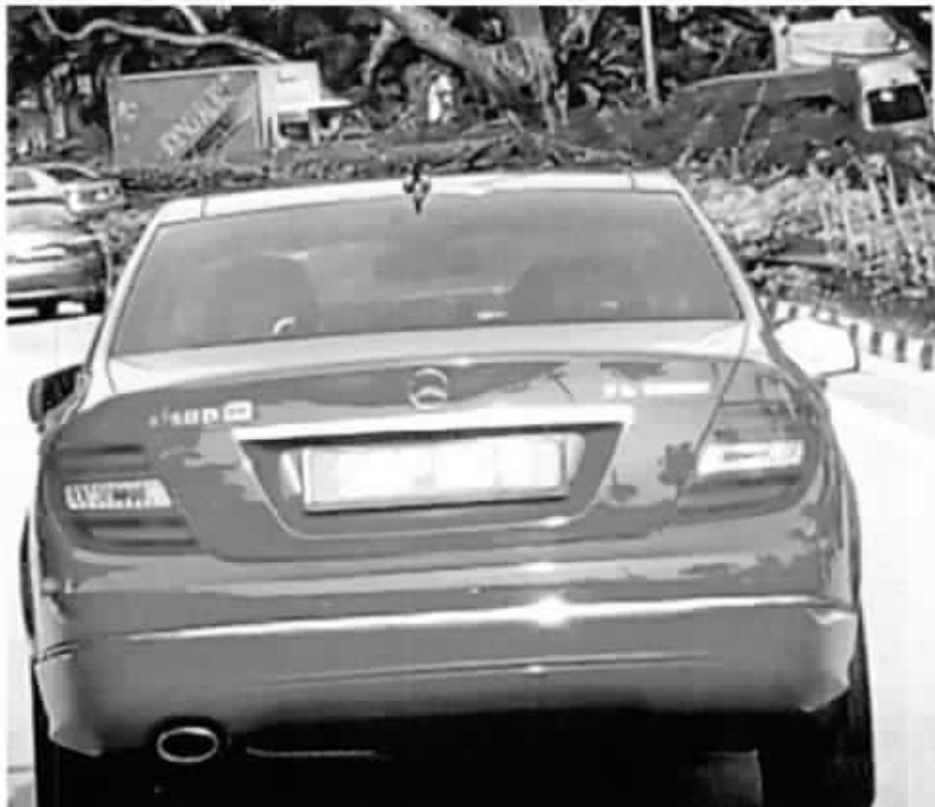
Photo 15 shows the rear portion of the Mercedes which was taken by Mr Cheaw's passenger as the Mercedes left the accident scene. No other observations could be made from the photograph.

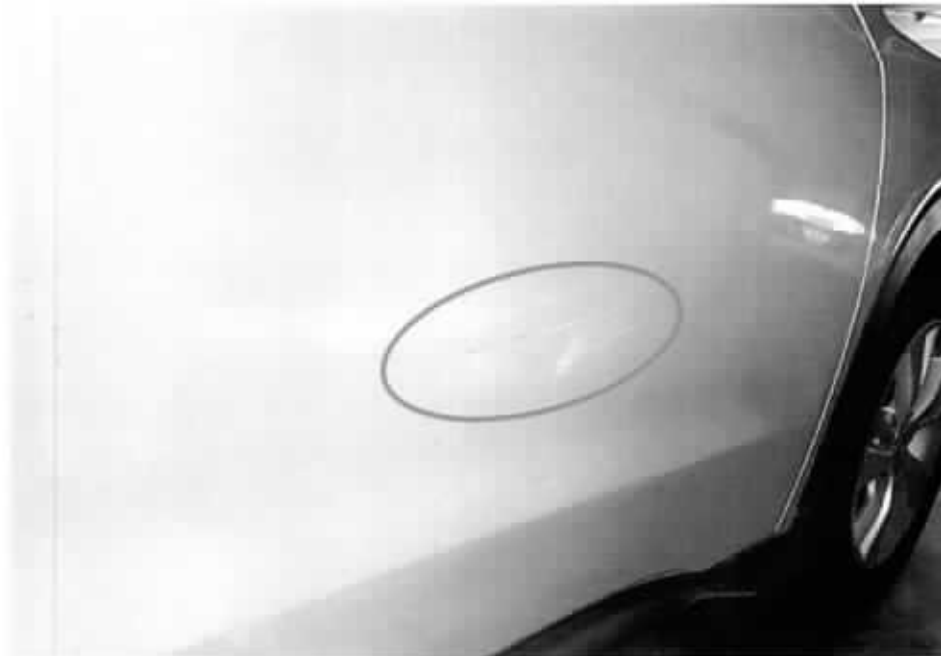
Photo 16 shows upon review of the available photographs taken at the workshop depicting the damages sustained to the right portion of Honda, we observed the same reddish paint transfer marks and paint graze marks on the driver door of the Honda as per the Pre- Repair Survey photographs (circled).

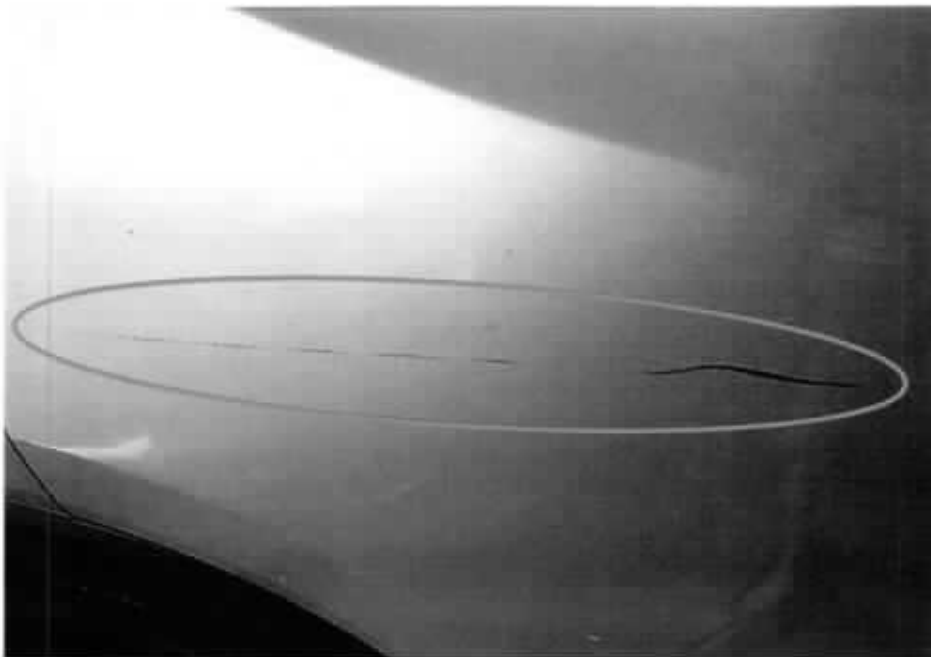
Photo 18 shows upon review of the available photographs depicting the damages sustained to the right portion of Honda, we observed the same black marks on the right passenger door of the Honda as per the Pre- Repair Survey photographs (circled).

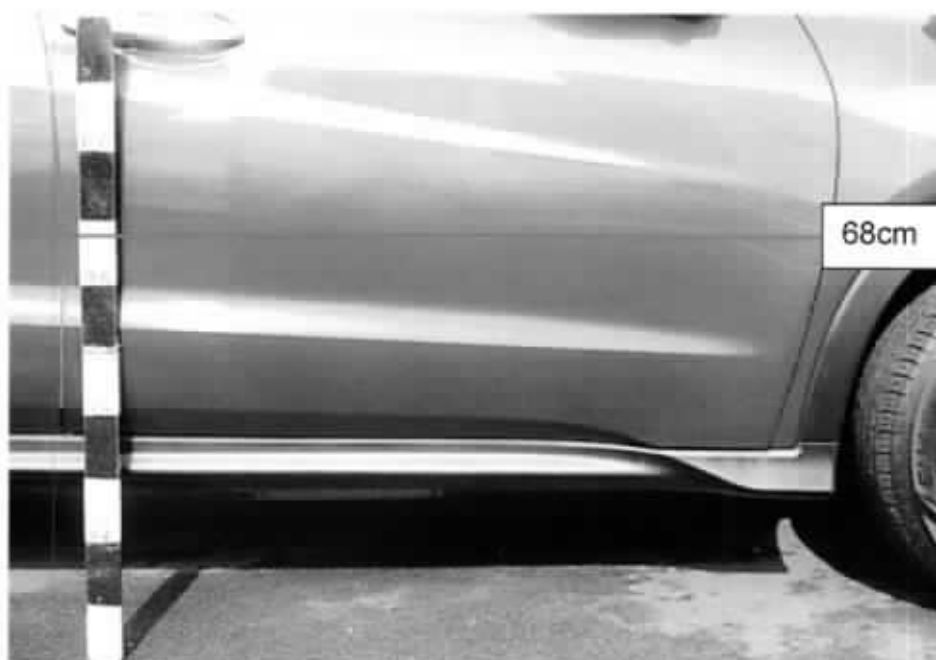
Photo 19 shows the height measurement being conducted on the right passenger door of the Honda (using a similar make and model). The height above ground level of the area where the reddish paint transfer marks were found was measured to be approximately 68cm.

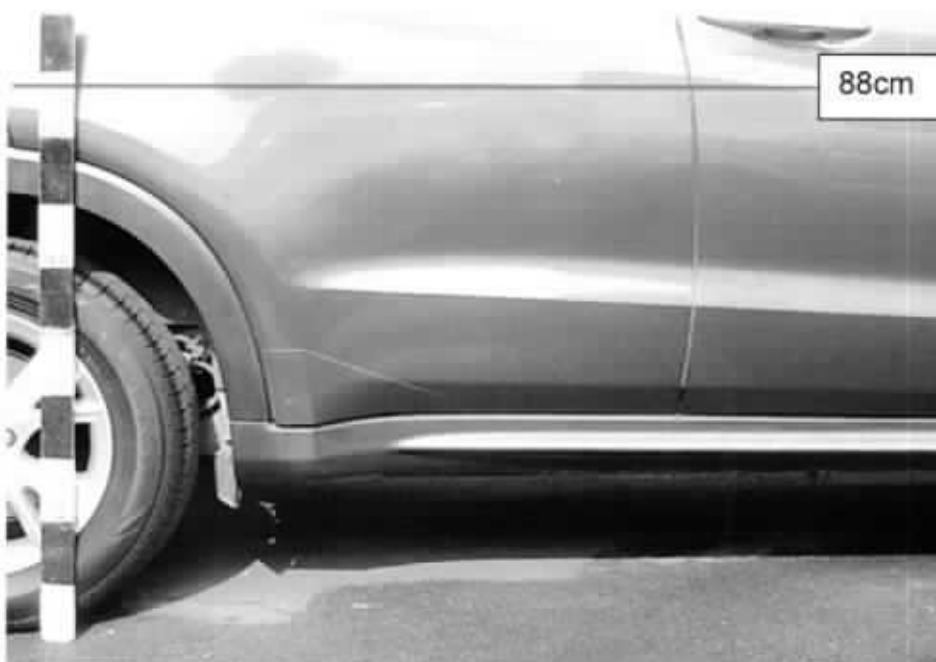
Photo 20 shows the height measurement being conducted on the right passenger door of the Honda. The height above ground level of the area where the black marks were found was measured to be approximately 88cm.

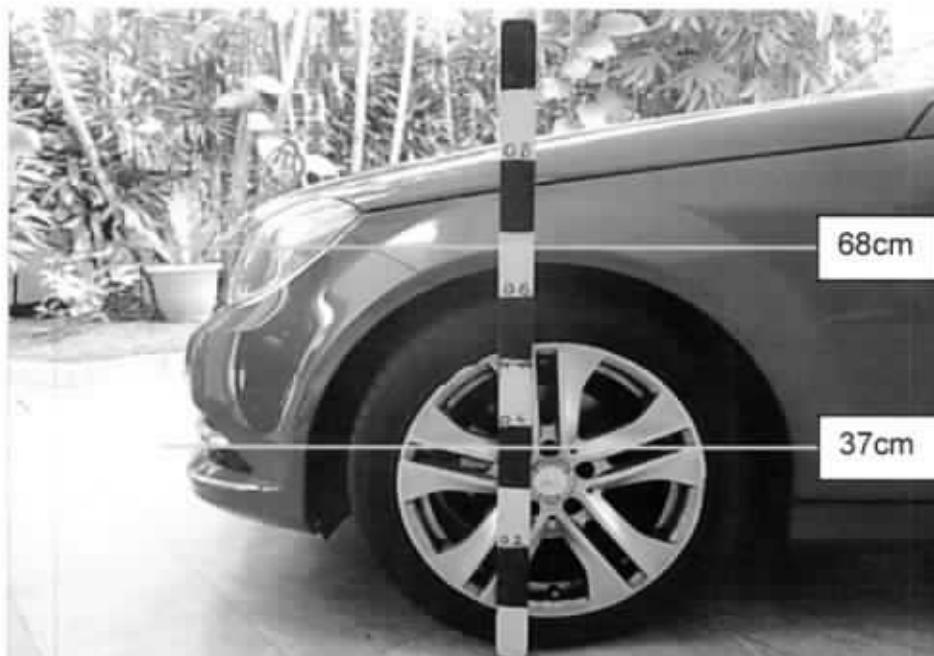
Photo 21 shows the height measurement being conducted on the left front portion of the Mercedes. The height range of the paint graze marks found on the left front portion of the Mercedes is between 37cm to 68cm above ground level.

- c) the height range of the paint graze marks found on the left front portion of the Mercedes is between 37cm to 68cm above ground level;
- d) the body part at 88cm above ground was the lower portion of the Mercedes's left side mirror where the scuff marks were found;

18. Both damages are corresponding to their respective heights and are consistent to their nature of contact. Furthermore, the pattern of the graze marks observed on the left front portion of the Mercedes corresponds to the pattern of the graze marks observed on the right portion of the Honda.

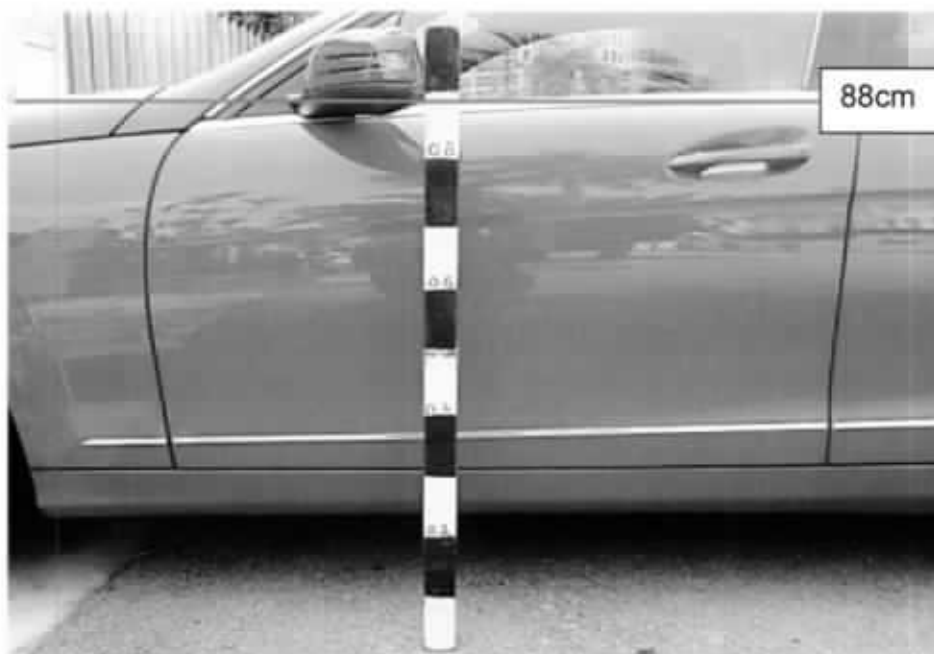
Photo 22 shows the height measurement being conducted on the left portion of the Mercedes. The body part at 88cm above ground was the lower portion of the left side mirror where the scuff marks were found.
