Your Ref : 0257700407SG
Our Ref : CC4/AIG17021548/N

8 March 2018

**AUTOMOBILE TECHNICAL INVESTIGATION REPORT OF ACCIDENT
INVOLVING SLH 5262T AND SBP 96R ON 9 NOVEMBER 2017**

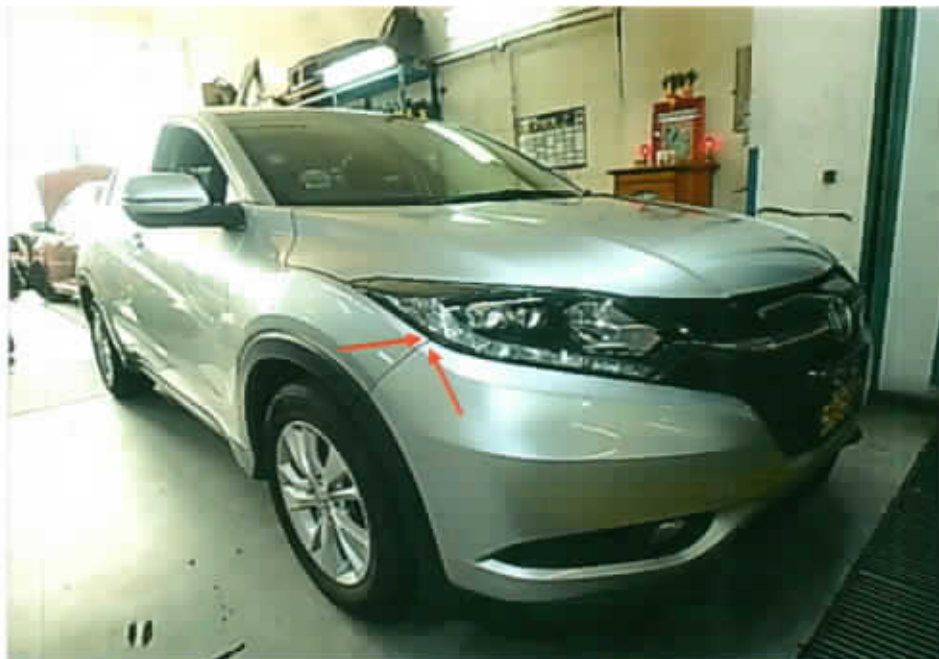
Photo 1 shows a general view of the right front portion of the Honda at the time of the Pre- Repair Survey conducted by LKK Auto Consultants Pte. Ltd. about 1 day after the accident. We noted that the front bumper was not misaligned at its right corner edge (arrowed).

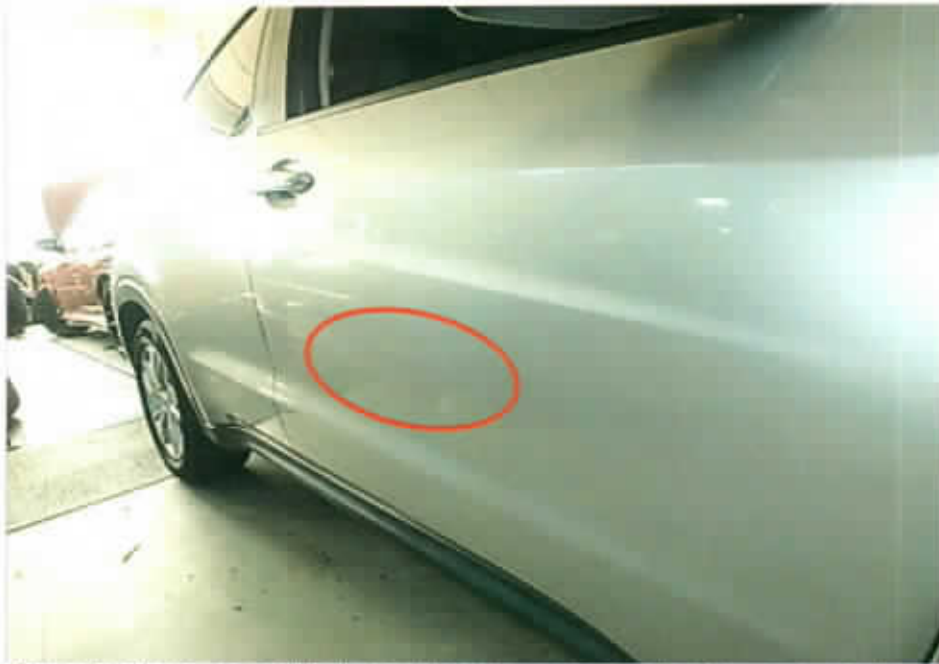
Photo 2 shows the reddish paint transfer marks and paint graze marks we observed on the driver door of the Honda (circled).

17. The contact was relatively minor and had occurred when the Mercedes was attempting to switch lanes as the Honda was approaching which resulted in slight contact of grazing nature between the left front portion of the Mercedes and the right portion of the Honda, causing significant permanent damage to both vehicles. The black marks on the right passenger door of the Honda as well as the reddish paint transfer marks on the driver door of the Honda were a result of this contact.

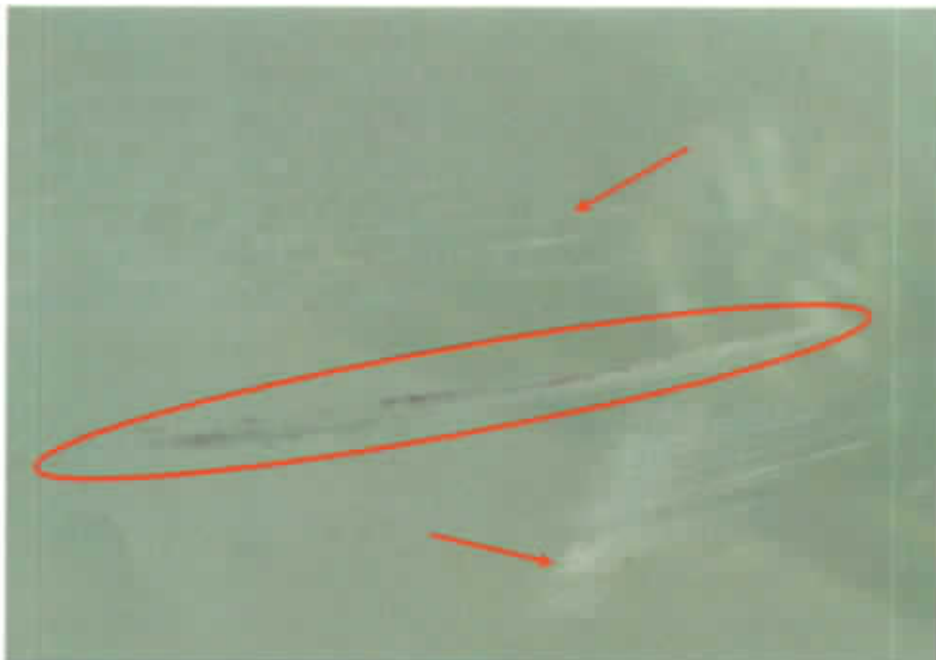
Photo 3 shows a close up view of the reddish paint transfer marks (circled) and paint graze marks (arrowed) we observed on the driver door of the Honda.

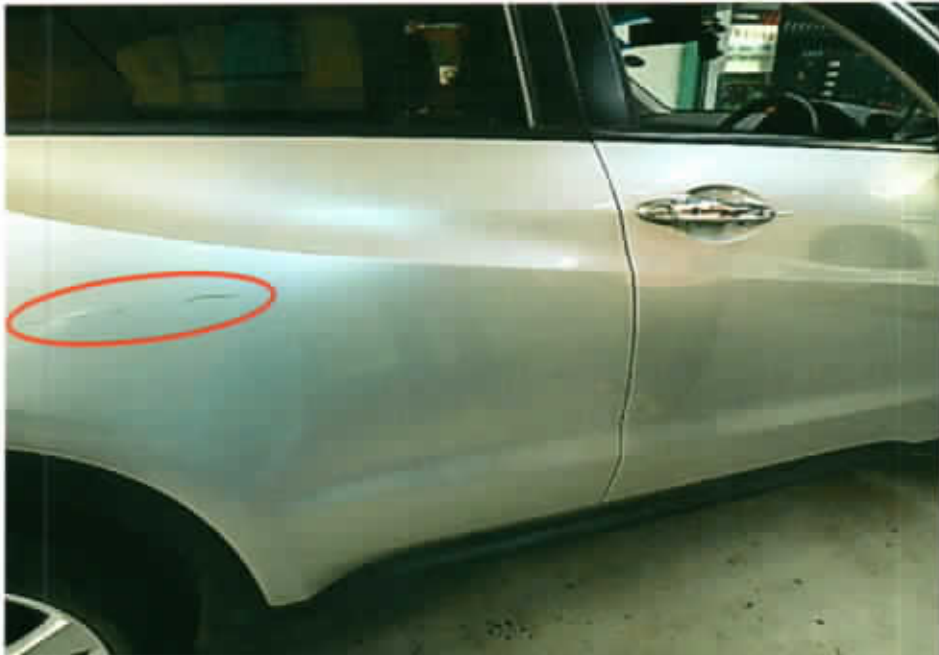
Photo 4 shows the black marks observed on the right passenger door of the Honda (circled).

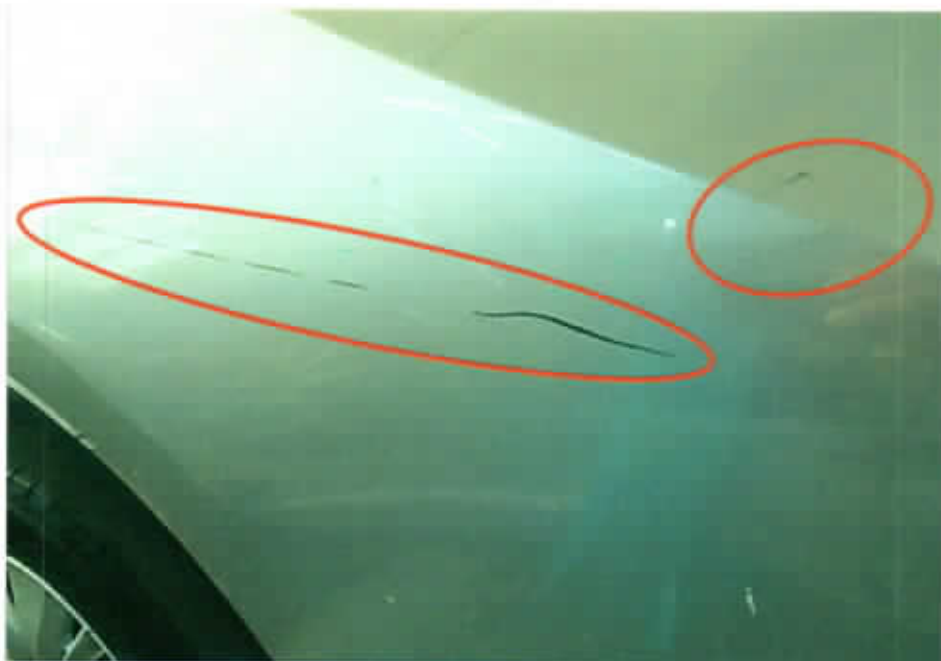
Photo 5 shows a closer view the black marks observed on the right passenger door of the Honda (circled).

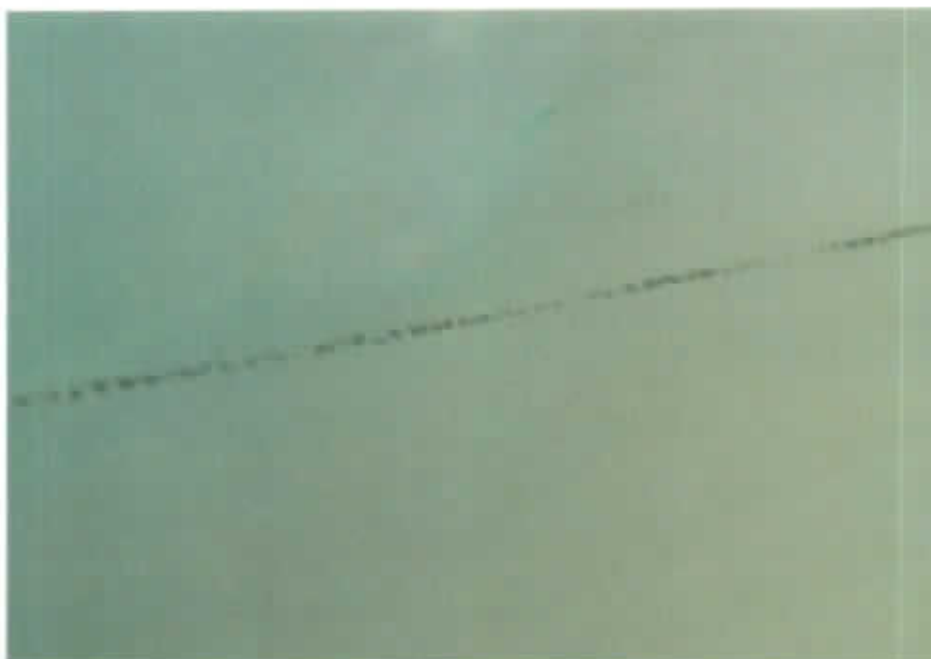
Photo 6 shows a close up view the black marks observed on the right passenger door of the Honda.

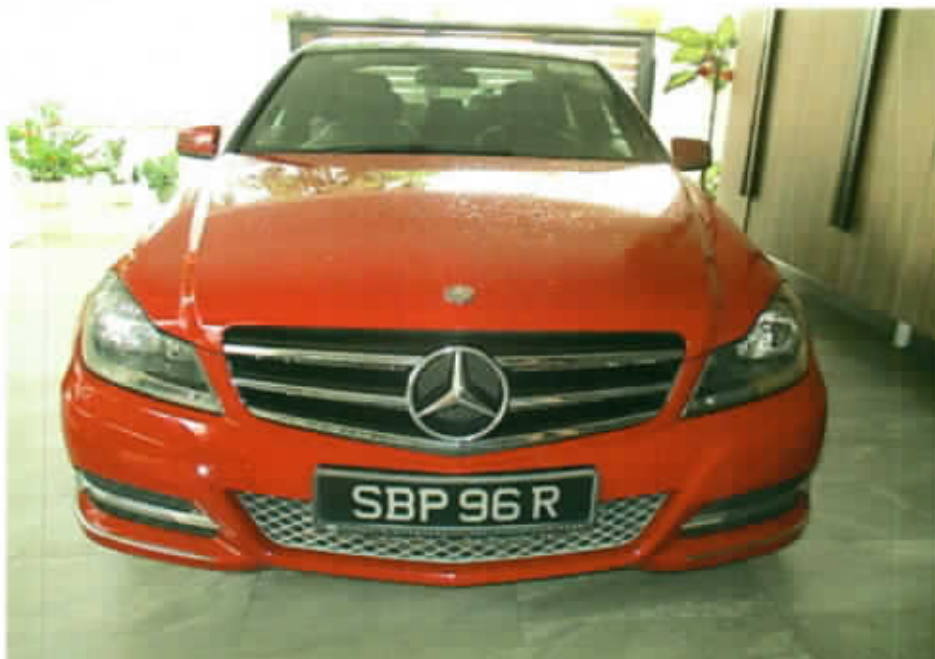
Photo 7 shows the general view of the front portion of the Mercedes at the time of our inspection.

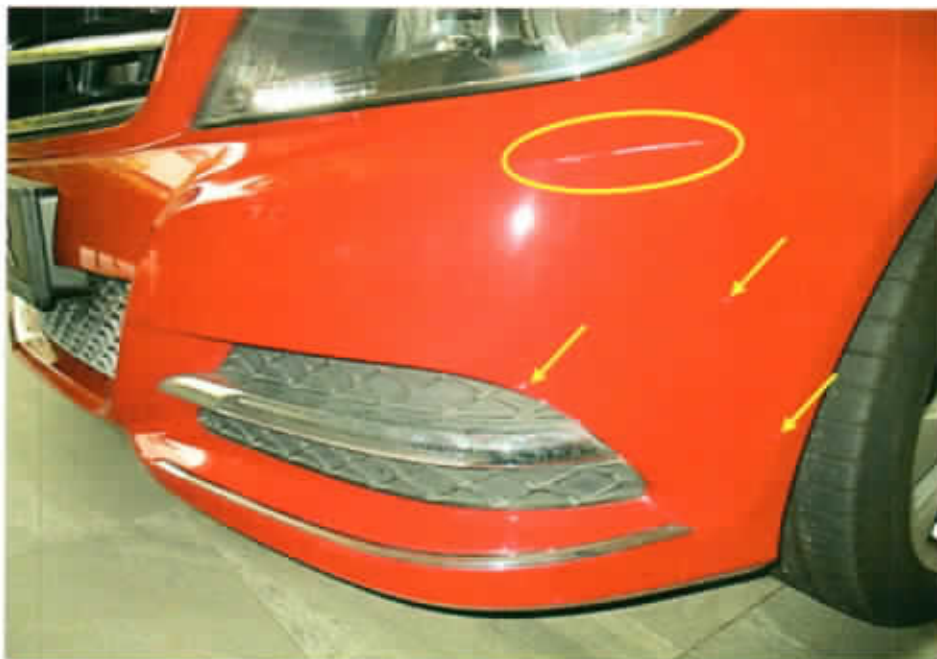
Photo 8 shows the paint graze marks (circled) and paint scuff marks (arrowed) found on the front left portion of the Mercedes.

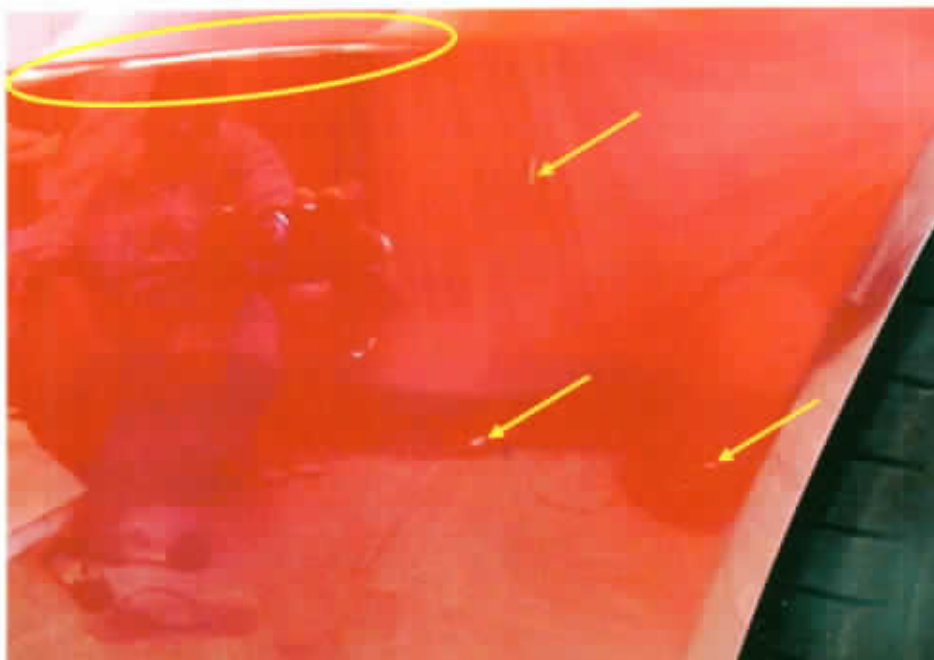
Photo 9 shows a close up view of paint graze marks (circled) and paint scuff marks (arrowed) found on the front left portion of the Mercedes.

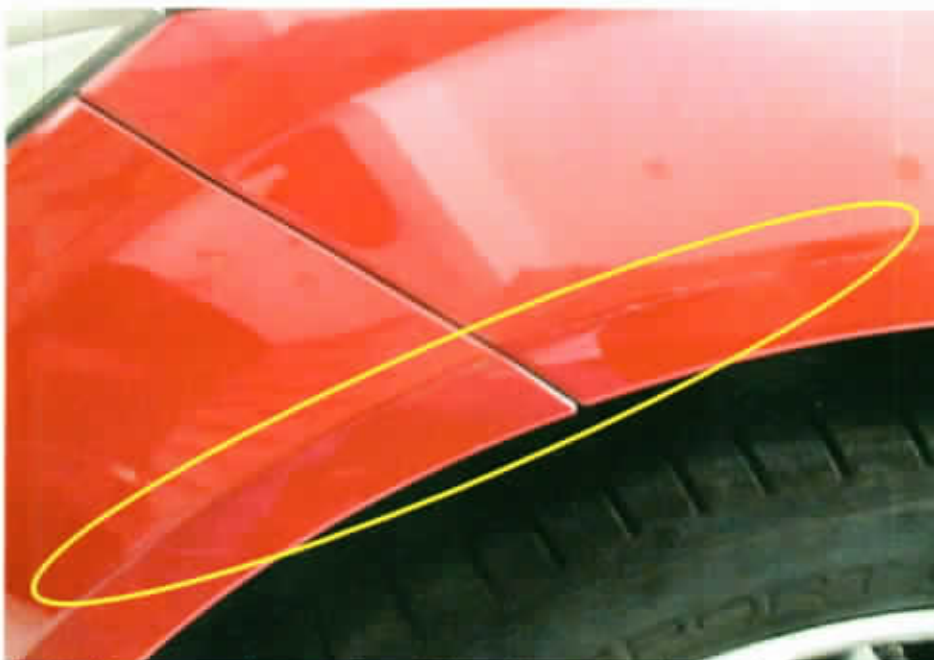
Photo 10 shows a close up view of the paint graze marks on the top portion of the Mercedes's left front tyre fender (circled).

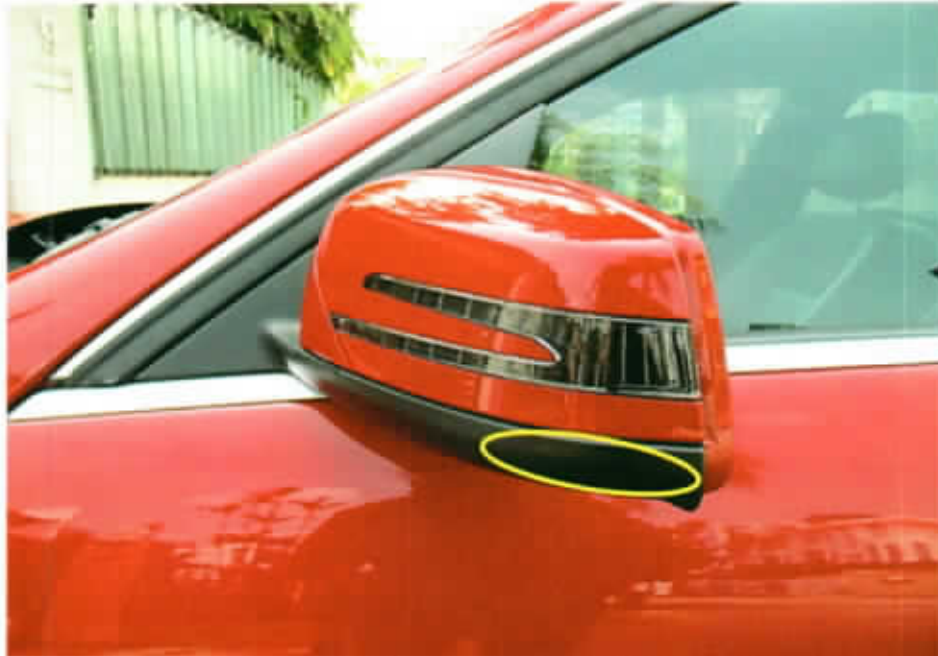
Photo 11 shows a view of the left side mirror of the Mercedes at the time of our inspection. We noticed scuff marks on the lower portion of the left side mirror (circled).

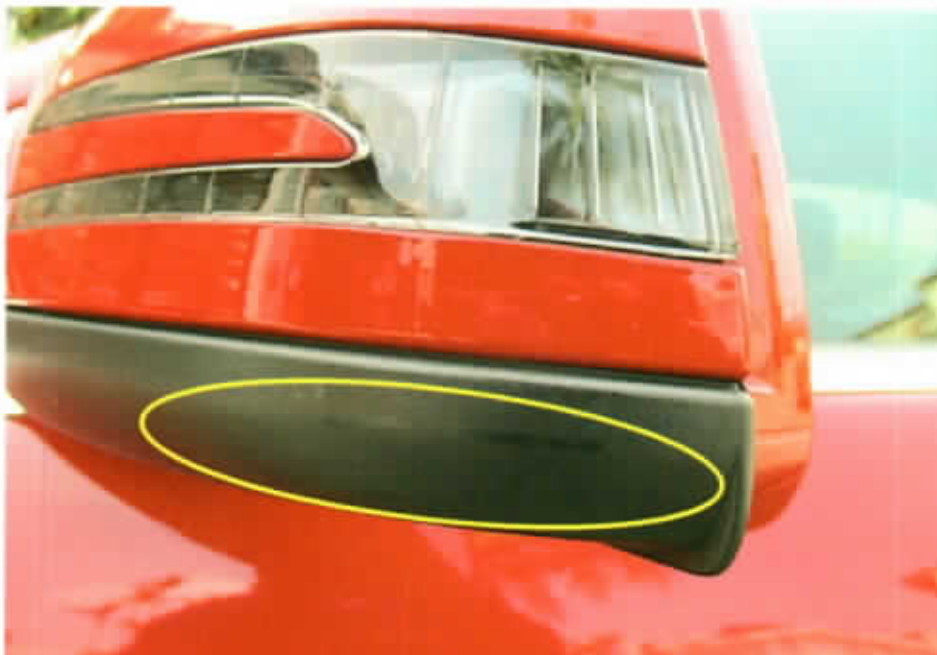
Photo 12 shows a close up view of the left side mirror of the Mercedes at the time of our inspection. We noticed scuff marks on the lower portion of the left side mirror (circled).

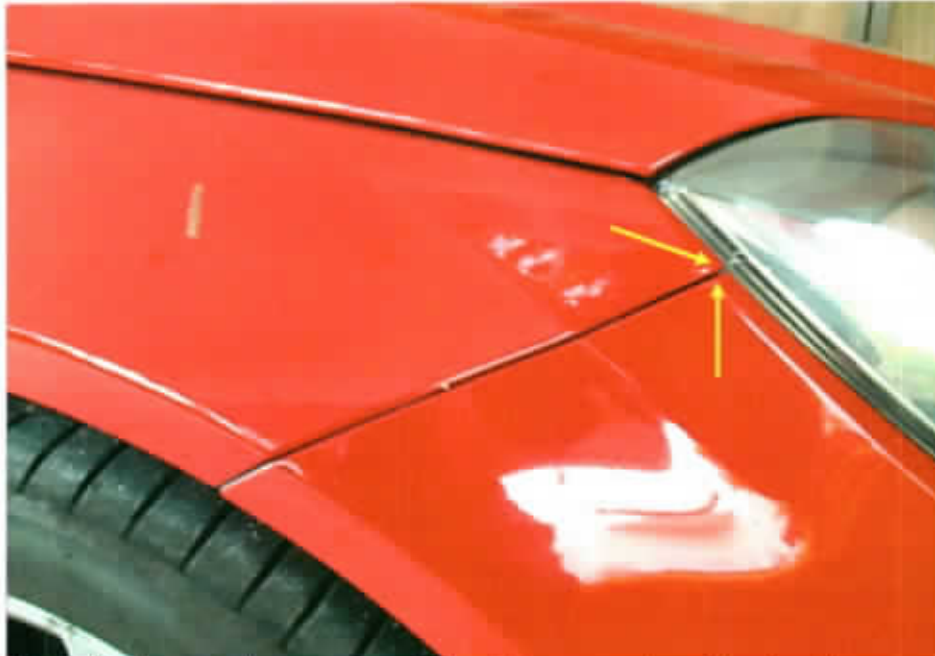
Photo 13 shows a close up view of the right corner edge of the front bumper of the Mercedes. We observed that there was no misalignment at the corner edges (arrowed).

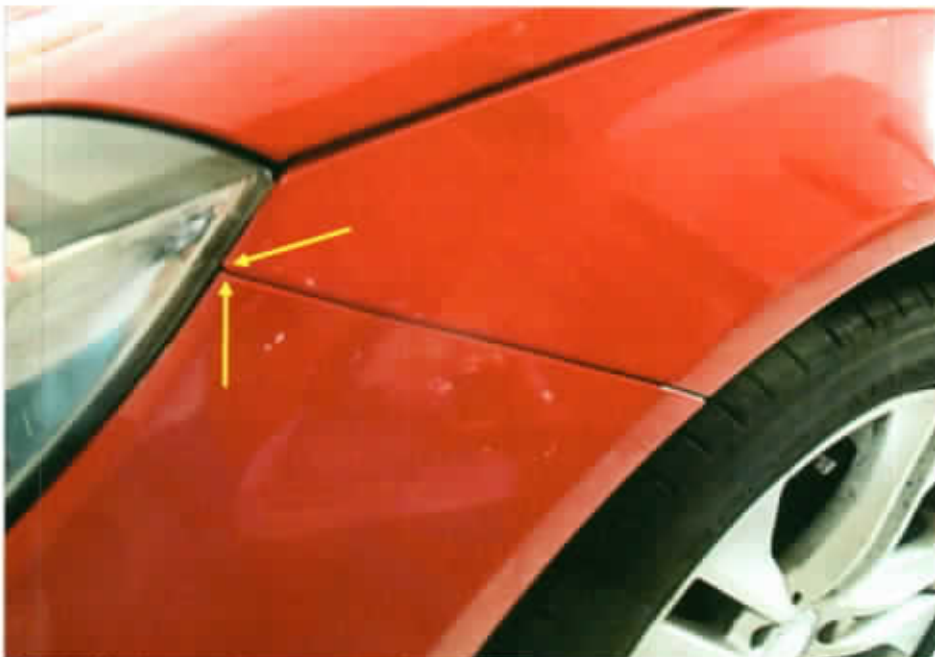
Photo 14 shows a close up view of the left corner edge of the front bumper of the Mercedes. We observed that there was no misalignment at the corner edges (arrowed).

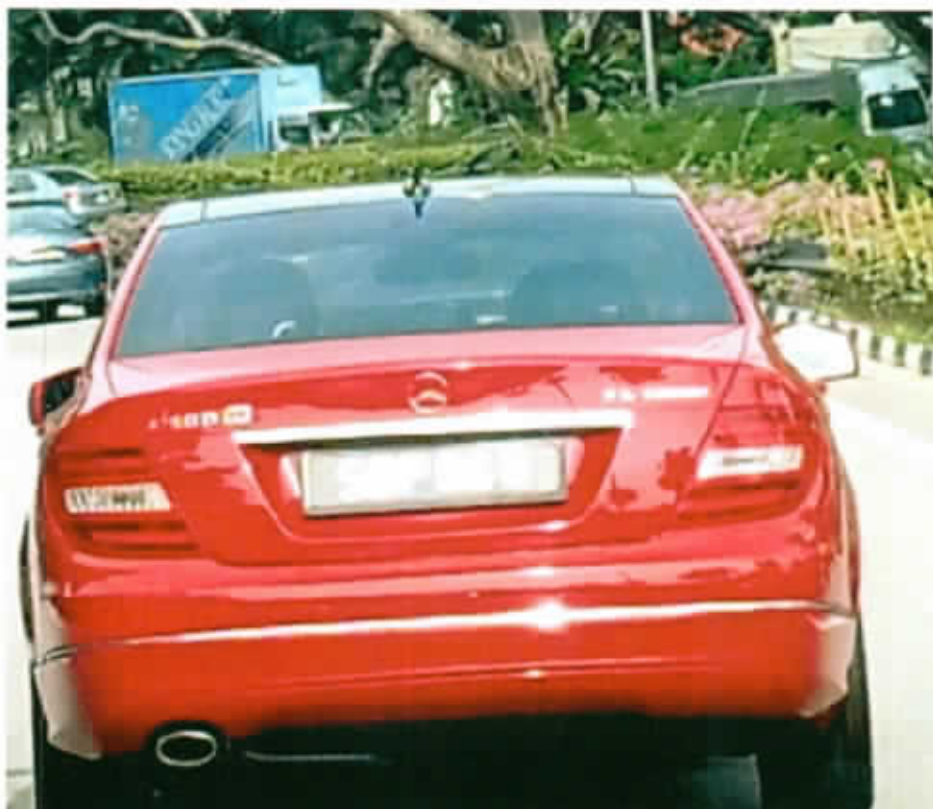
Photo 15 shows the rear portion of the Mercedes which was taken by Mr Cheaw's passenger as the Mercedes left the accident scene. No other observations could be made from the photograph.

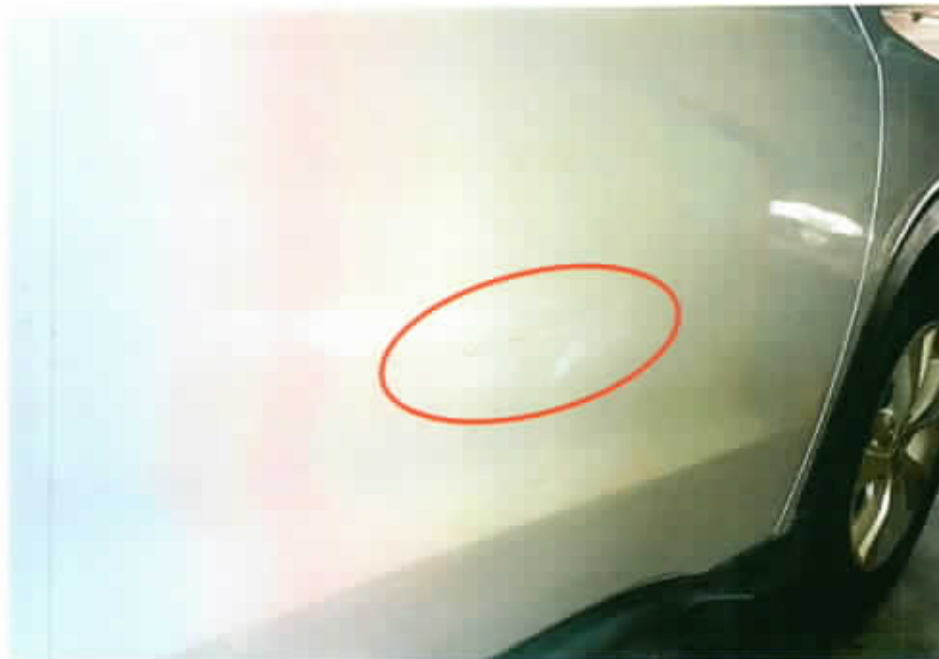
Photo 16 shows upon review of the available photographs taken at the workshop depicting the damages sustained to the right portion of Honda, we observed the same reddish paint transfer marks and paint graze marks on the driver door of the Honda as per the Pre- Repair Survey photographs (circled).

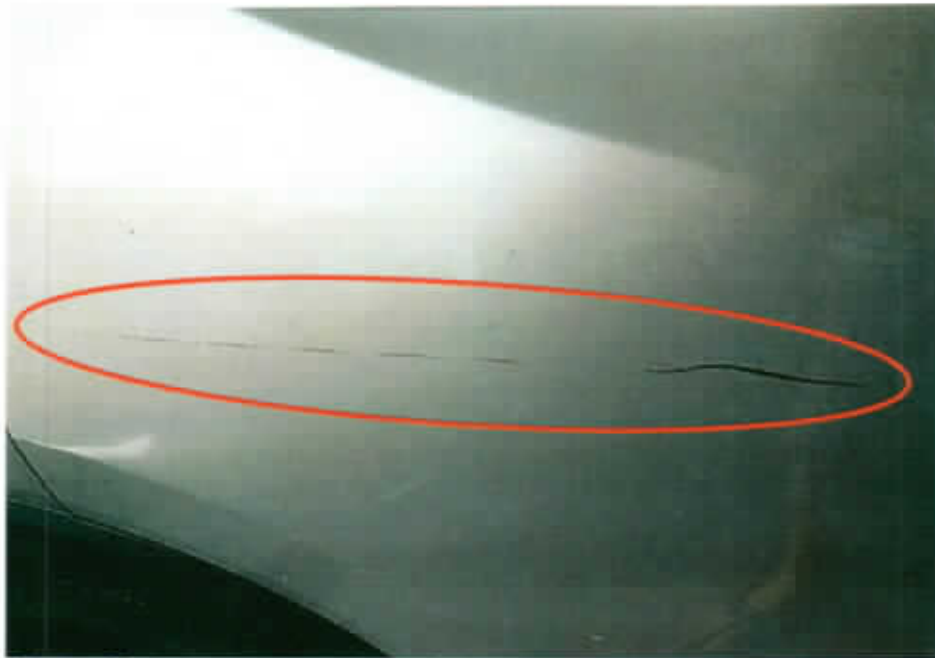
Photo 18 shows upon review of the available photographs depicting the damages sustained to the right portion of Honda, we observed the same black marks on the right passenger door of the Honda as per the Pre- Repair Survey photographs (circled).

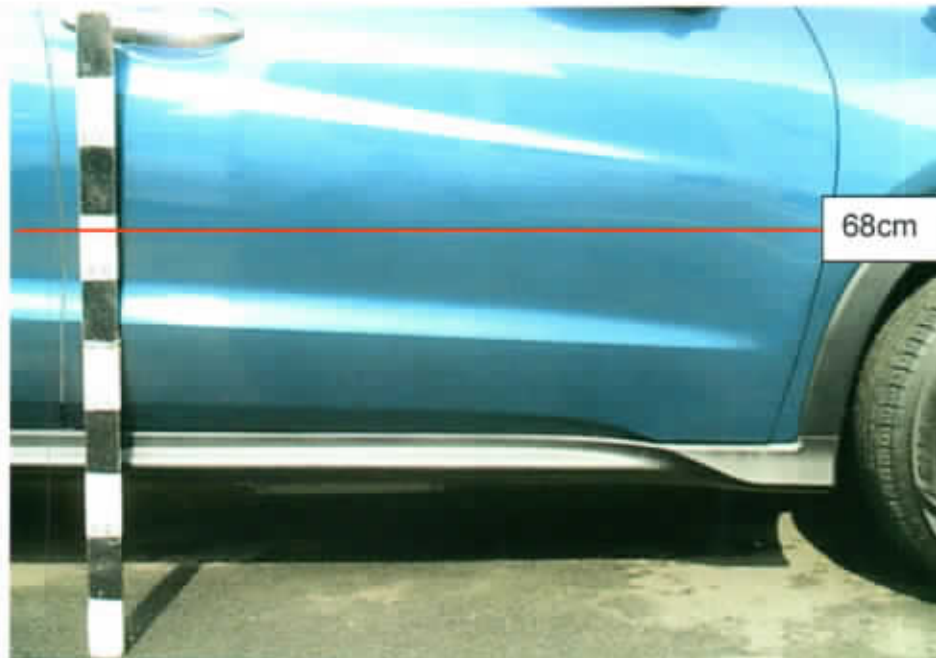
Photo 19 shows the height measurement being conducted on the right passenger door of the Honda (using a similar make and model). The height above ground level of the area where the reddish paint transfer marks were found was measured to be approximately 68cm.

- a) the height above ground level of the area where the reddish paint transfer marks were found on the driver door of the Honda was measured to be approximately 68cm;

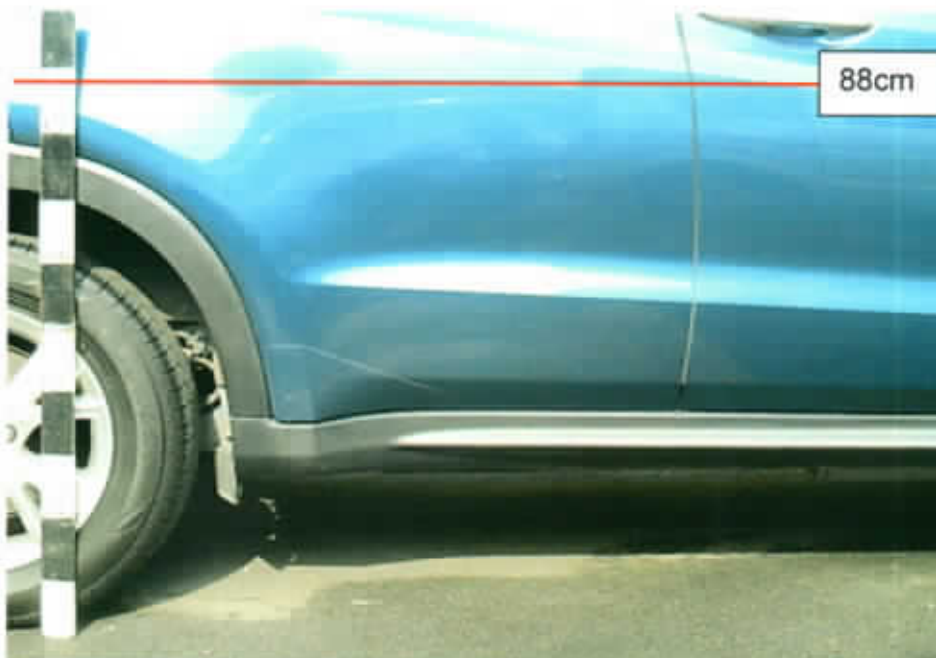
Photo 20 shows the height measurement being conducted on the right passenger door of the Honda. The height above ground level of the area where the black marks were found was measured to be approximately 88cm.

- b) the height above ground level of the area where the black marks were found on the right passenger door of the Honda was measured to be approximately 88cm;

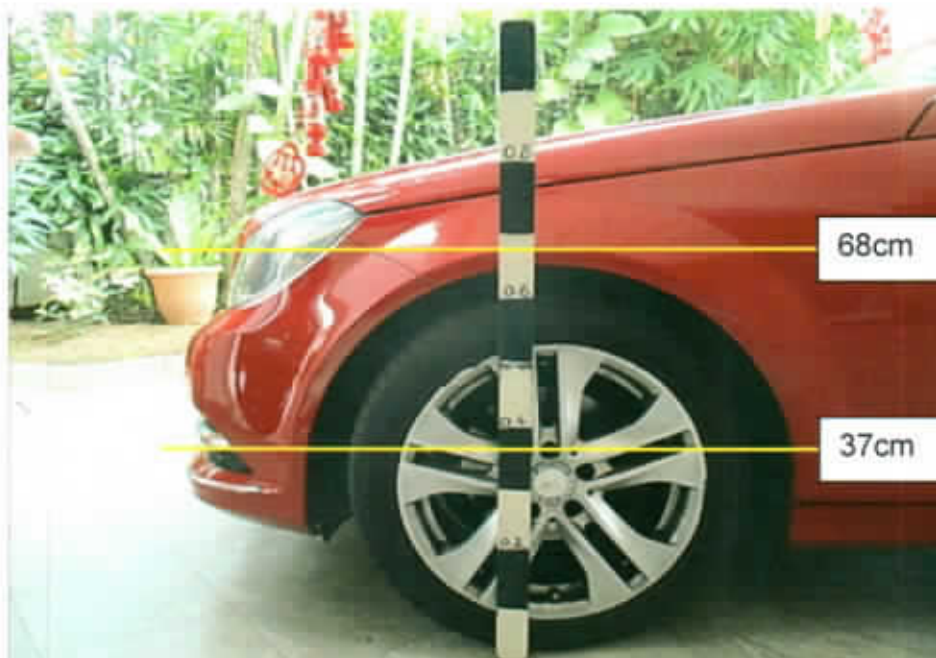
Photo 21 shows the height measurement being conducted on the left front portion of the Mercedes. The height range of the paint graze marks found on the left front portion of the Mercedes is between 37cm to 68cm above ground level.

- c) the height range of the paint graze marks found on the left front portion of the Mercedes is between 37cm to 68cm above ground level;
- d) the body part at 88cm above ground was the lower portion of the Mercedes's left side mirror where the scuff marks were found;

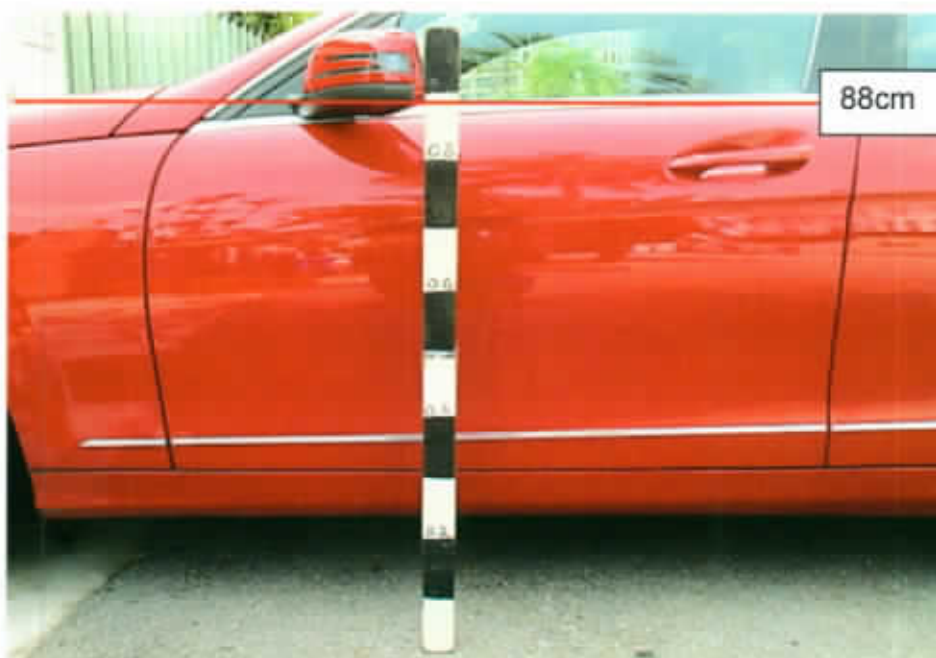
Photo 22 shows the height measurement being conducted on the left portion of the Mercedes. The body part at 88cm above ground was the lower portion of the left side mirror where the scuff marks were found.
