Your Ref : 0257700407SG
Our Ref : CC4/AIG17021548/N

8 March 2018

**AUTOMOBILE TECHNICAL INVESTIGATION REPORT OF ACCIDENT
INVOLVING SLH 5262T AND SBP 96R ON 9 NOVEMBER 2017**

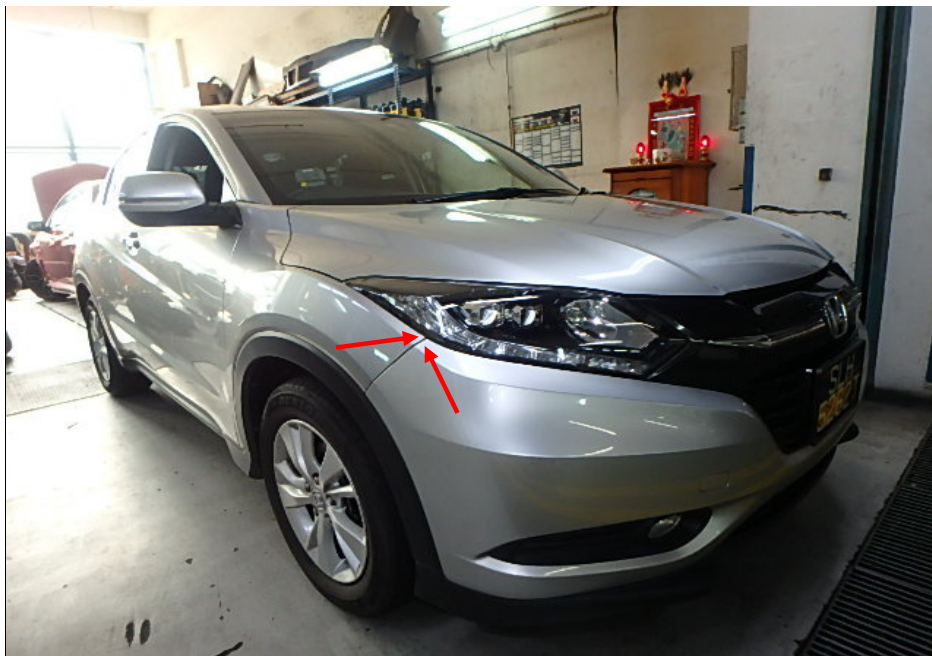
Photo 1 shows a general view of the right front portion of the Honda at the time of the Pre- Repair Survey conducted by LKK Auto Consultants Pte. Ltd. about 1 day after the accident. We noted that the front bumper was not misaligned at its right corner edge (arrowed).

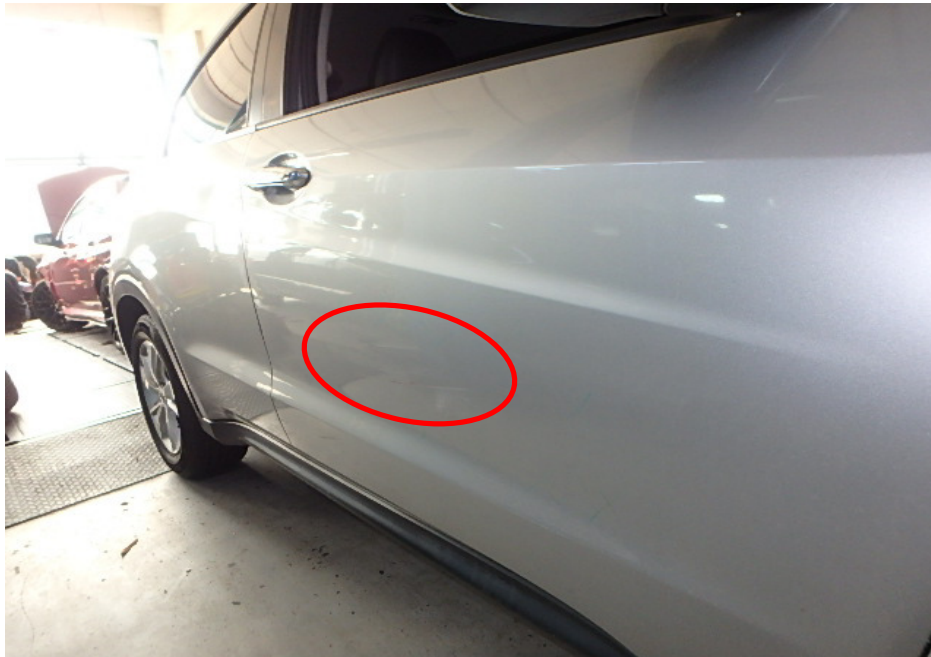
Photo 2 shows the reddish paint transfer marks and paint graze marks we observed on the driver door of the Honda (circled).

17. The contact was relatively minor and had occurred when the Mercedes was attempting to switch lanes as the Honda was approaching which resulted in slight contact of grazing nature between the left front portion of the Mercedes and the right portion of the Honda, causing significant permanent damage to both vehicles. The black marks on the right passenger door of the Honda as well as the reddish paint transfer marks on the driver door of the Honda were a result of this contact.

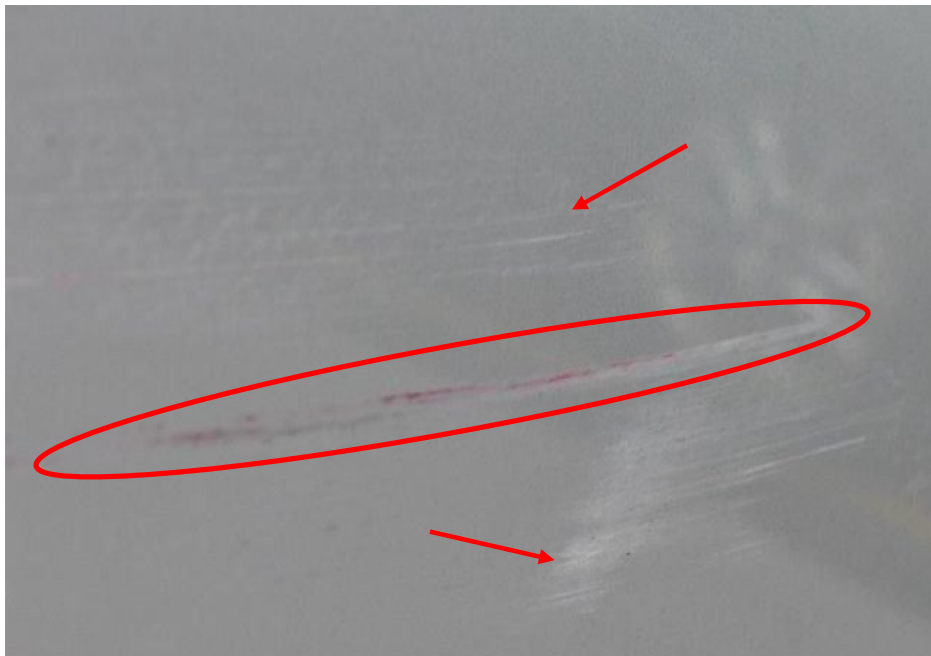
Photo 3 shows a close up view of the reddish paint transfer marks (circled) and paint graze marks (arrowed) we observed on the driver door of the Honda.

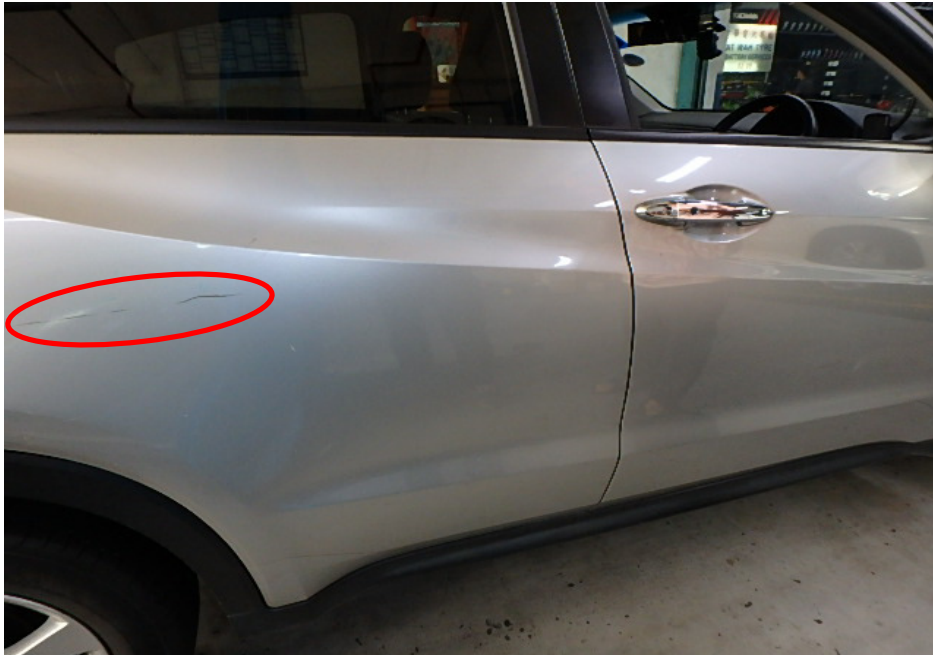
Photo 4 shows the black marks observed on the right passenger door of the Honda (circled).

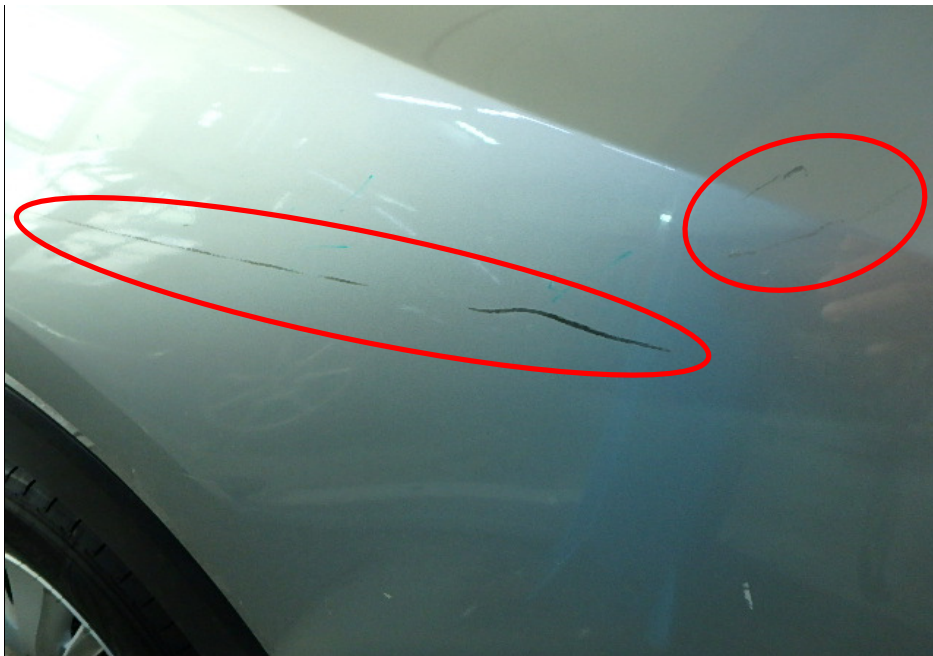
Photo 5 shows a closer view the black marks observed on the right passenger door of the Honda (circled).

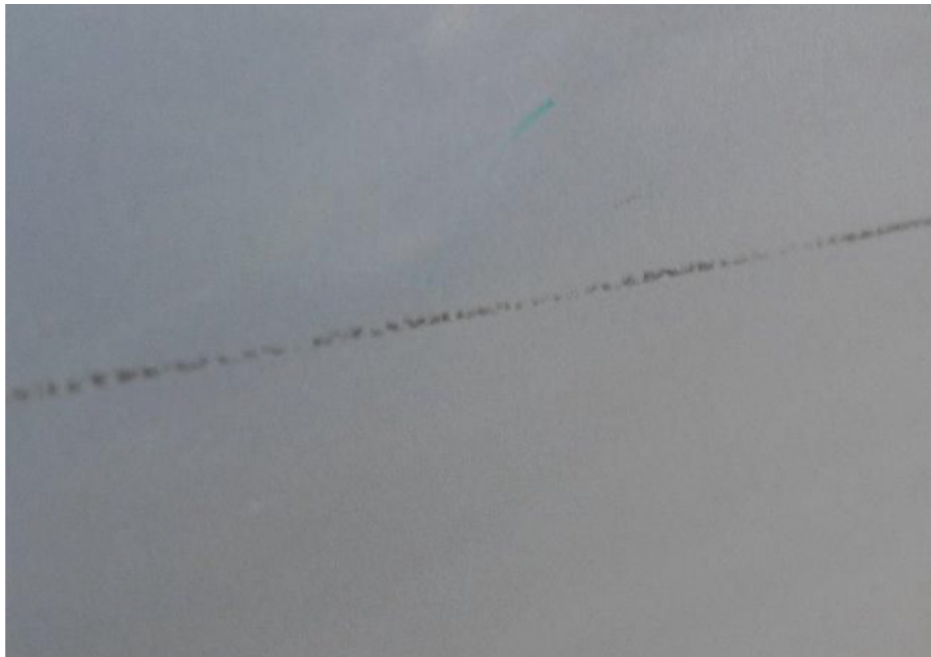
Photo 6 shows a close up view the black marks observed on the right passenger door of the Honda.

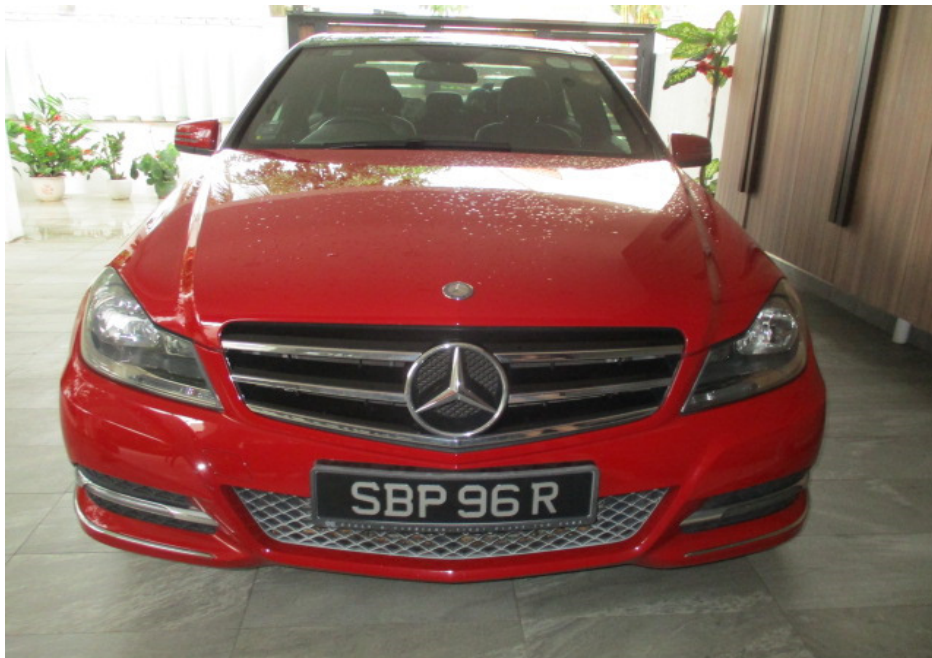
Photo 7 shows the general view of the front portion of the Mercedes at the time of our inspection.

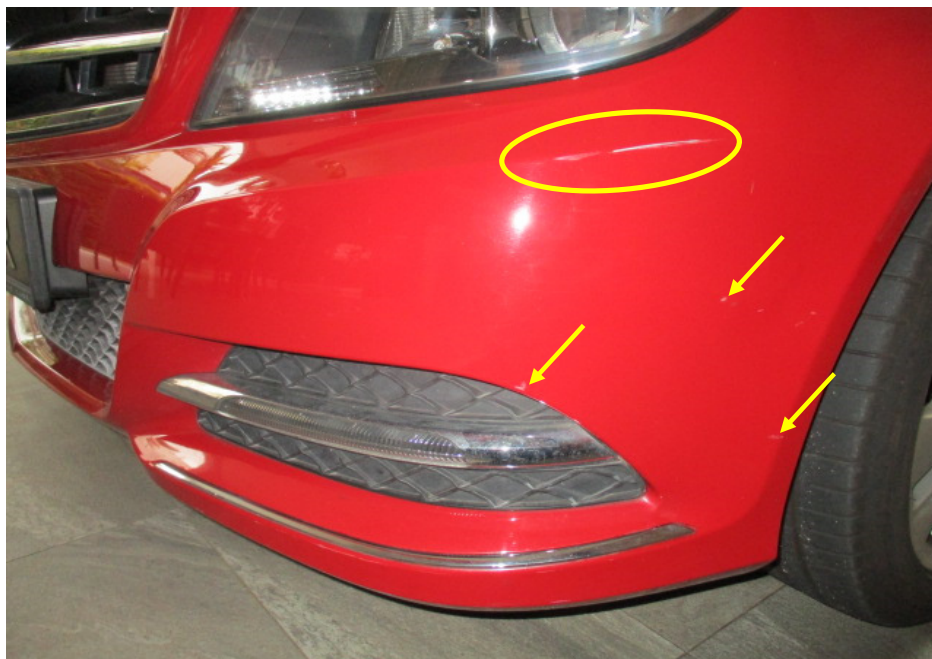
Photo 8 shows the paint graze marks (circled) and paint scuff marks (arrowed) found on the front left portion of the Mercedes.

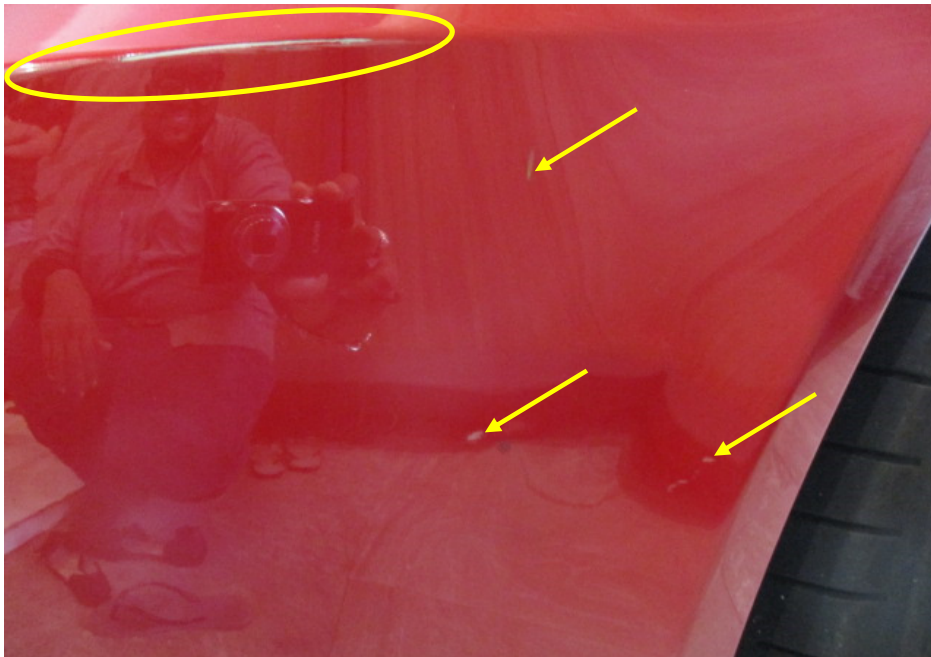
Photo 9 shows a close up view of paint graze marks (circled) and paint scuff marks (arrowed) found on the front left portion of the Mercedes.

18. Both damages are corresponding to their respective heights and are consistent to their nature of contact. Furthermore, the pattern of the graze marks observed on the left front portion of the Mercedes corresponds to the pattern of the graze marks observed on the right portion of the Honda.

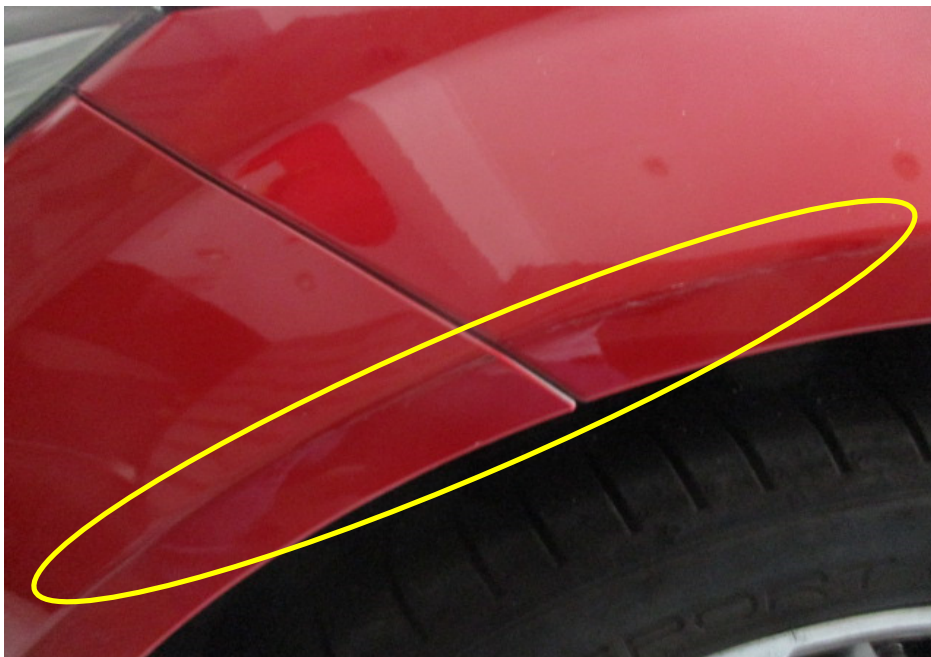
Photo 10 shows a close up view of the paint graze marks on the top portion of the Mercedes's left front tyre fender (circled).

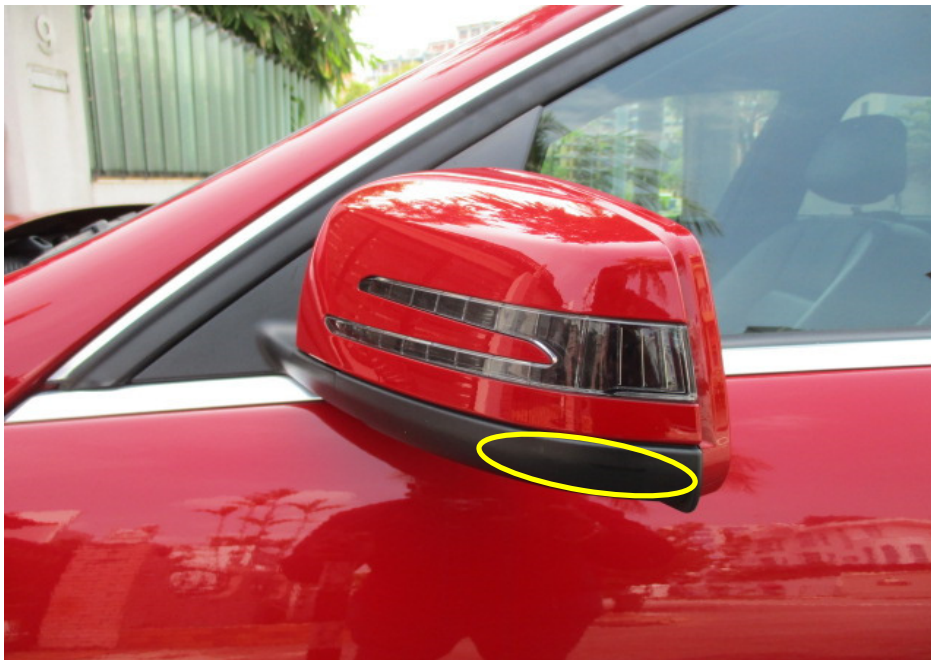
Photo 11 shows a view of the left side mirror of the Mercedes at the time of our inspection. We noticed scuff marks on the lower portion of the left side mirror (circled).

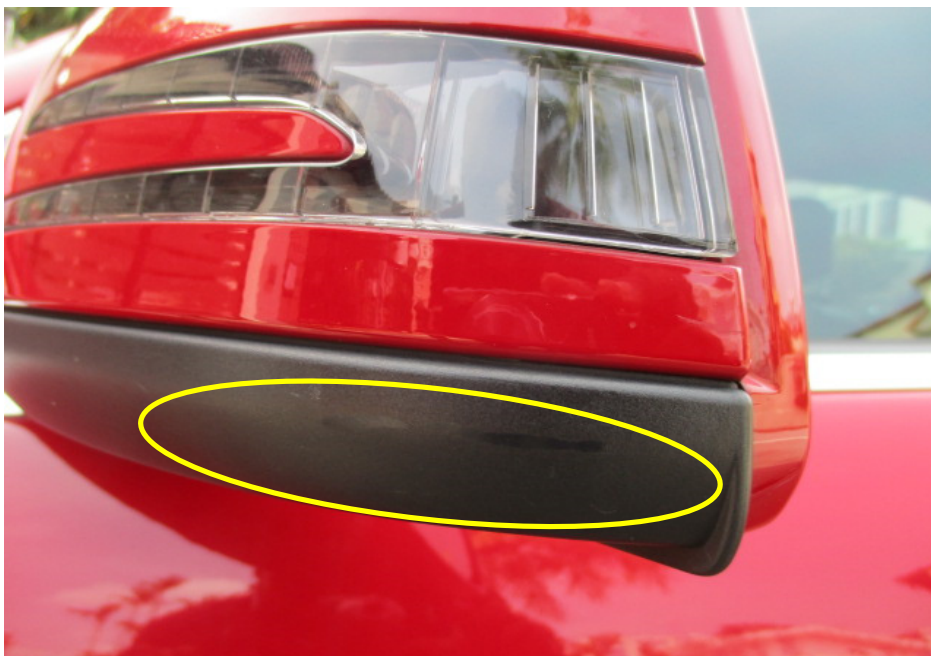
Photo 12 shows a close up view of the left side mirror of the Mercedes at the time of our inspection. We noticed scuff marks on the lower portion of the left side mirror (circled).

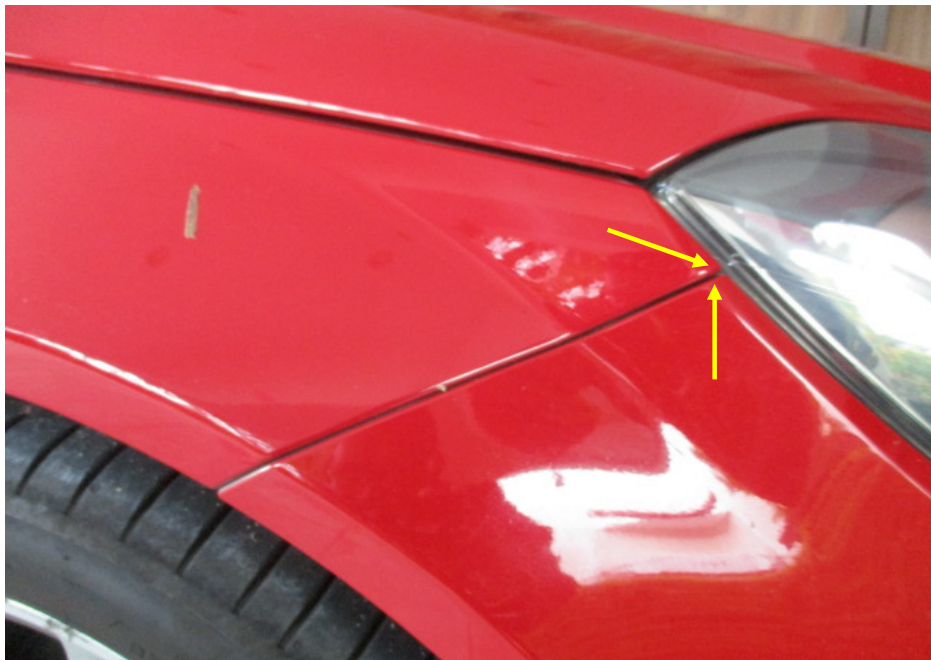
Photo 13 shows a close up view of the right corner edge of the front bumper of the Mercedes. We observed that there was no misalignment at the corner edges (arrowed).

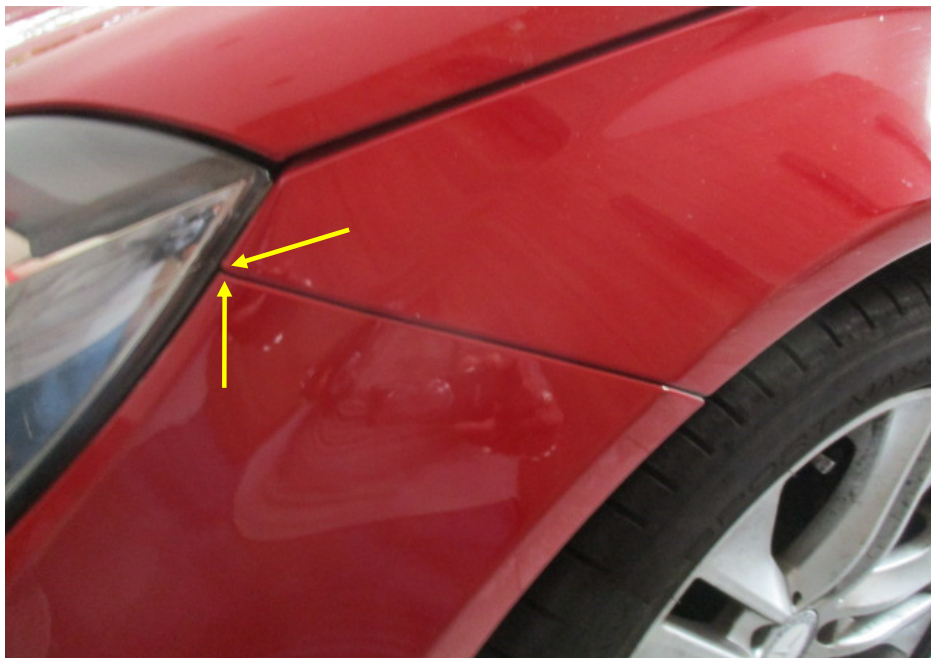
Photo 14 shows a close up view of the left corner edge of the front bumper of the Mercedes. We observed that there was no misalignment at the corner edges (arrowed).

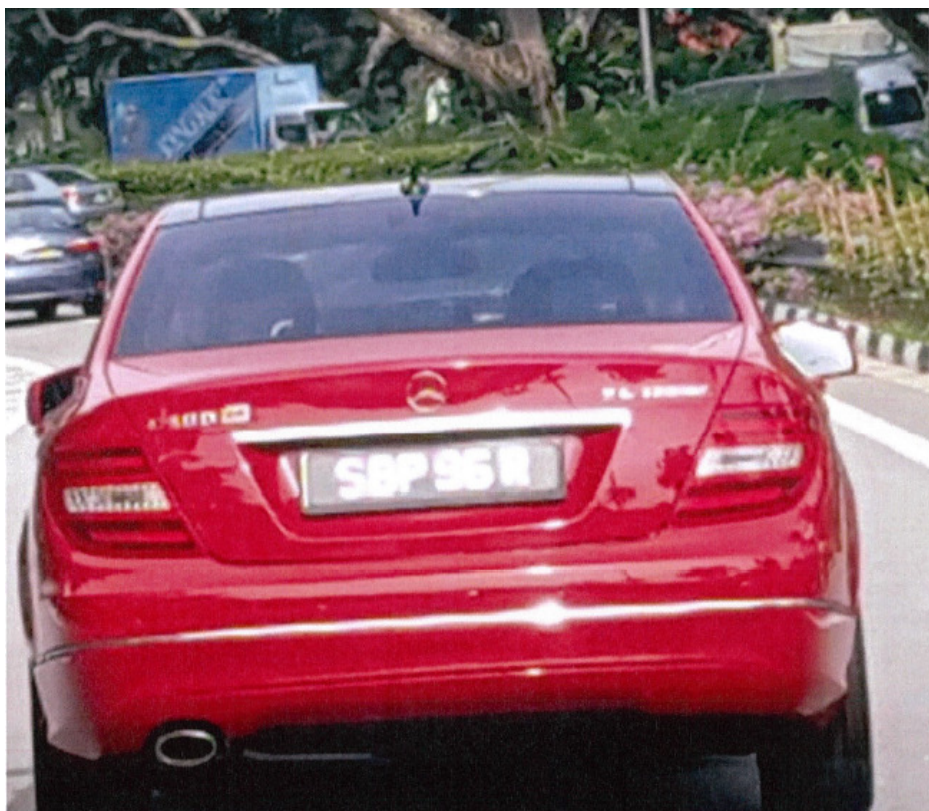
Photo 15 shows the rear portion of the Mercedes which was taken by Mr Cheaw's passenger as the Mercedes left the accident scene. No other observations could be made from the photograph.

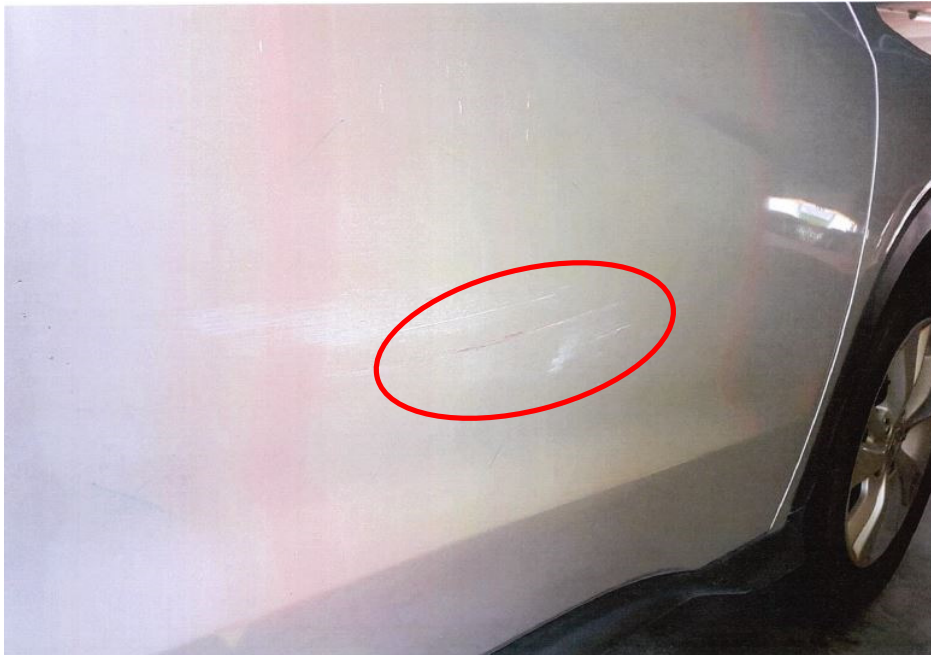
Photo 16 shows upon review of the available photographs taken at the workshop depicting the damages sustained to the right portion of Honda, we observed the same reddish paint transfer marks and paint graze marks on the driver door of the Honda as per the Pre- Repair Survey photographs (circled).

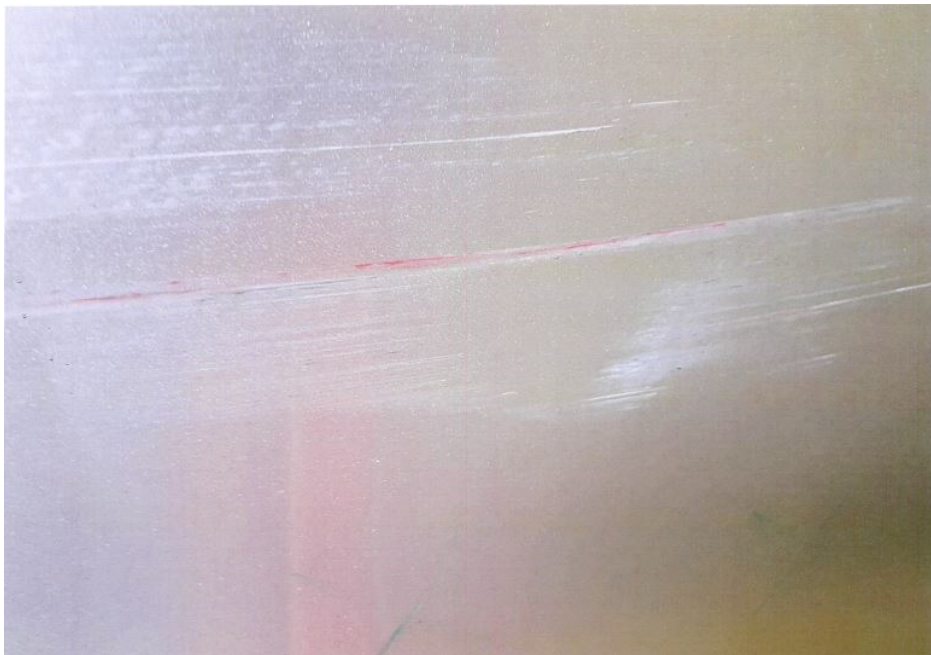
Photo 17 shows a close up view of the same reddish paint transfer marks and paint graze marks on the driver door of the Honda as per the Pre- Repair Survey photographs.

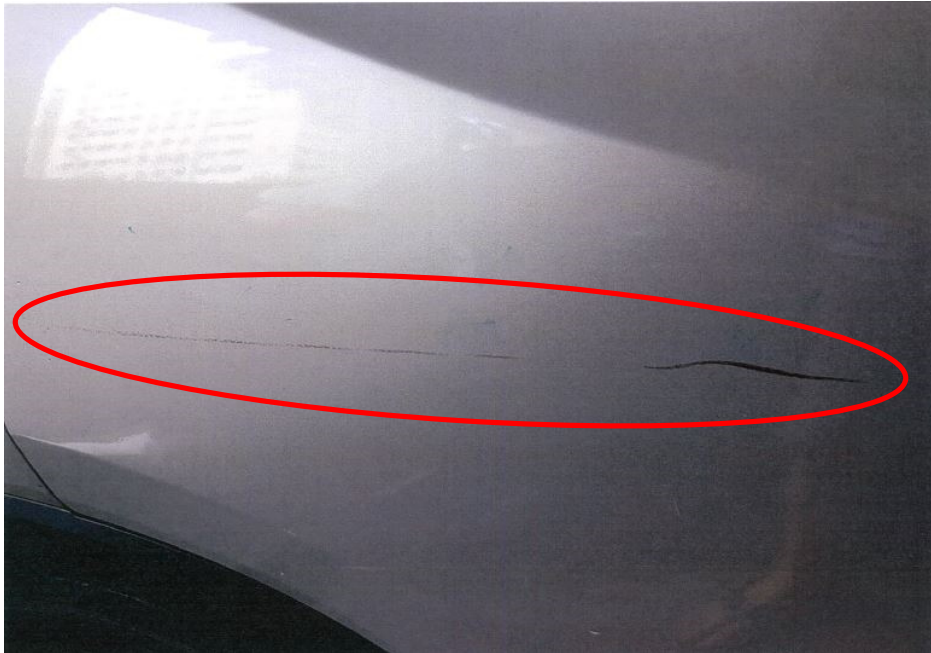
Photo 18 shows upon review of the available photographs depicting the damages sustained to the right portion of Honda, we observed the same black marks on the right passenger door of the Honda as per the Pre- Repair Survey photographs (circled).

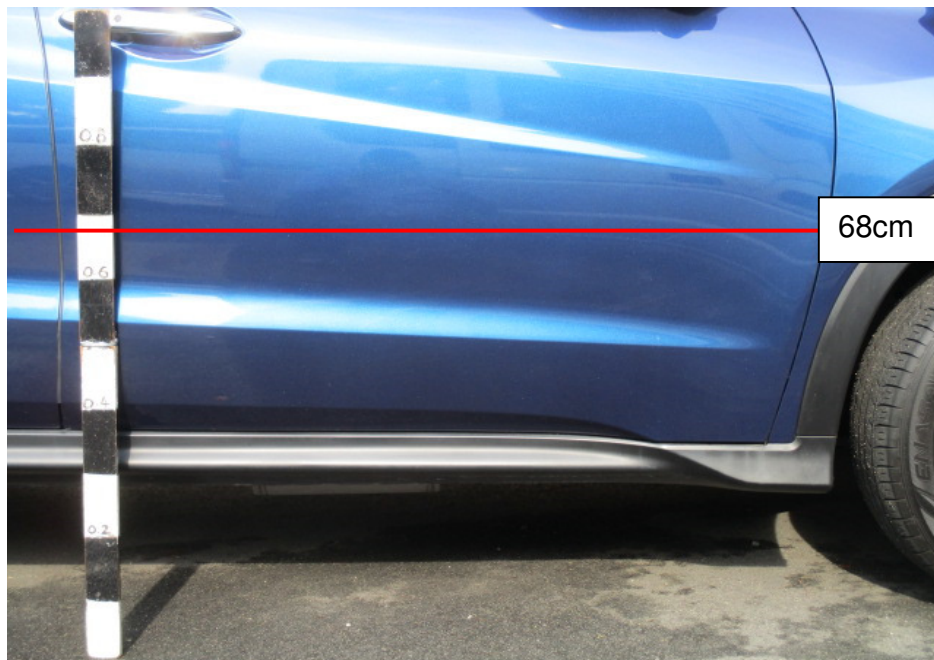
Photo 19 shows the height measurement being conducted on the right passenger door of the Honda (using a similar make and model). The height above ground level of the area where the reddish paint transfer marks were found was measured to be approximately 68cm.

- a) the height above ground level of the area where the reddish paint transfer marks were found on the driver door of the Honda was measured to be approximately 68cm;

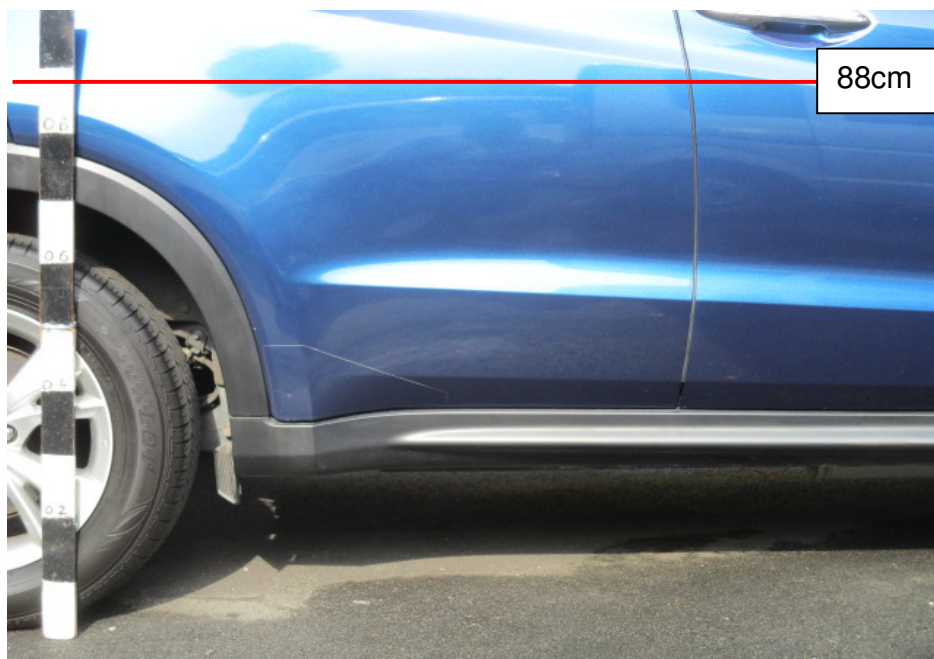
Photo 20 shows the height measurement being conducted on the right passenger door of the Honda. The height above ground level of the area where the black marks were found was measured to be approximately 88cm.

- b) the height above ground level of the area where the black marks were found on the right passenger door of the Honda was measured to be approximately 88cm;

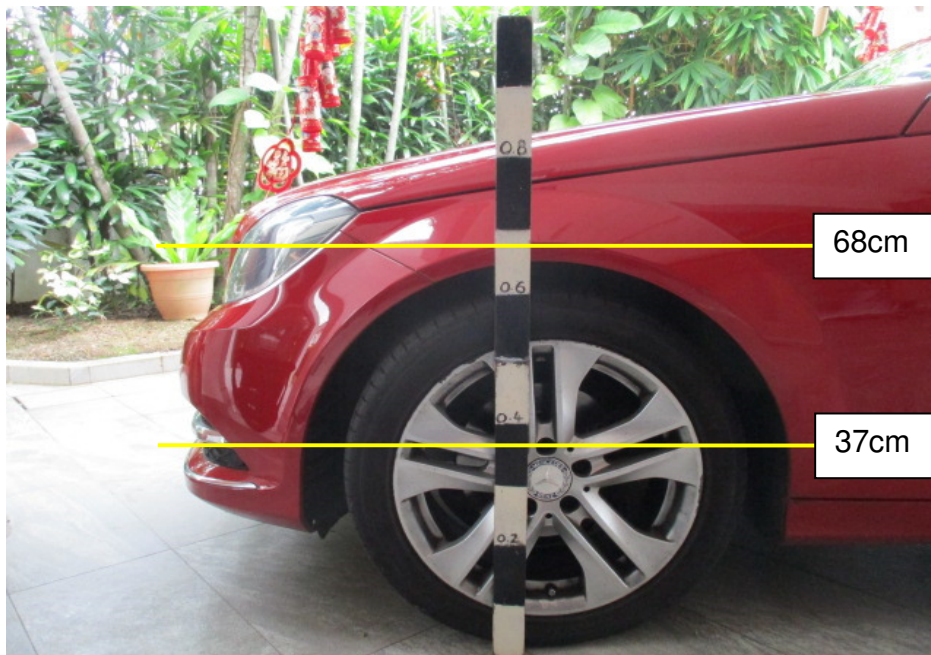
Photo 21 shows the height measurement being conducted on the left front portion of the Mercedes. The height range of the paint graze marks found on the left front portion of the Mercedes is between 37cm to 68cm above ground level.

- c) the height range of the paint graze marks found on the left front portion of the Mercedes is between 37cm to 68cm above ground level;
- d) the body part at 88cm above ground was the lower portion of the Mercedes's left side mirror where the scuff marks were found;

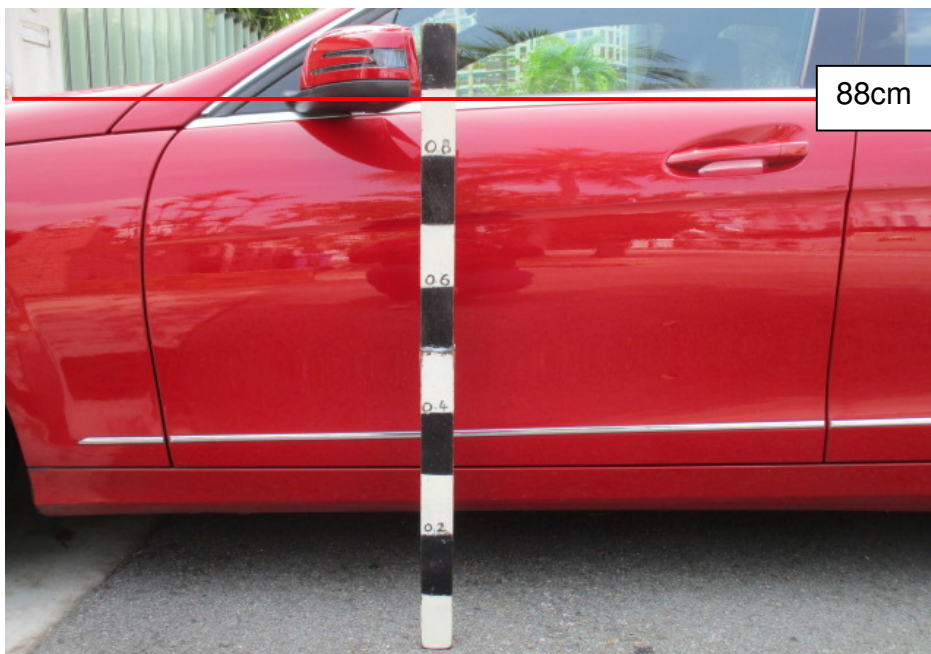
Photo 22 shows the height measurement being conducted on the left portion of the Mercedes. The body part at 88cm above ground was the lower portion of the left side mirror where the scuff marks were found.
