Your Ref: M2100440
Our Ref: CS4/TMI21001430/P

**TECHNICAL INVESTIGATION REPORT OF FIRE INCIDENT INVOLVING THE
INSURED VEHICLE GBD 8221G ON 21th January 2021**

Vehicle Registration No.	: GBD 8221G
Make / Model	: NV200 1.5LMT ABS AIRBAG 2WD 6DR EURO 5
Chassis No	: VSKYBAM20Z0096837
Year of Registration	: 28 MAY 2015
Mileage	: N.A (wiring affected)

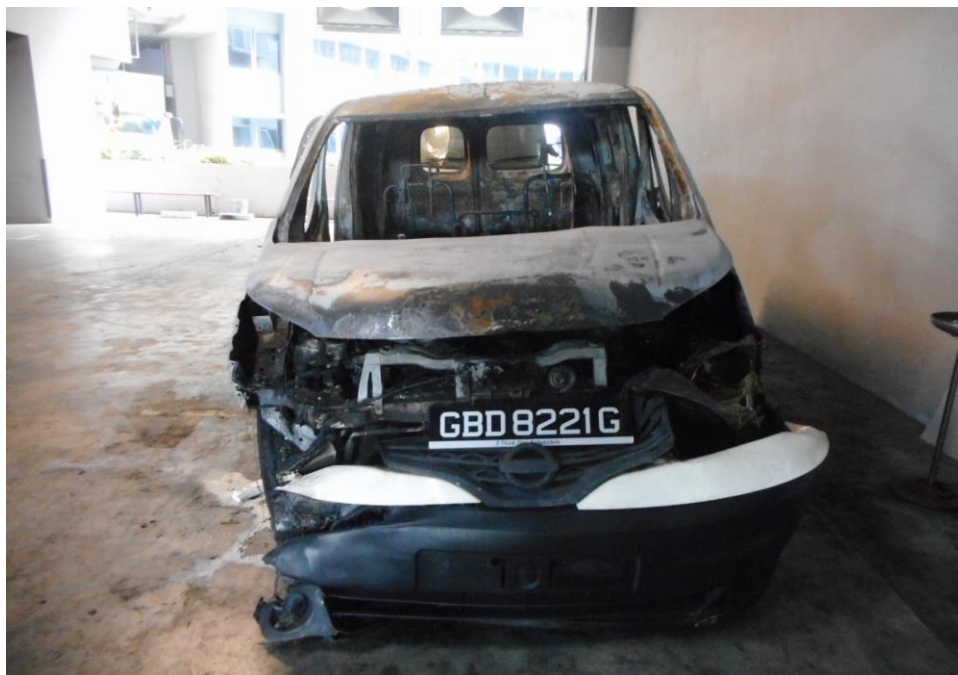
Photo 1 shows the general view of the front portion of the Insured Vehicle at the time of our inspection. The Insured Vehicle was observed to have sustained extensive fire damage all around. Its engine compartment and interior compartment were completely burnt. Rust had accumulated all over the front and centre portion of the Insured Vehicle as a result of exposure to environmental condition for a period of time.

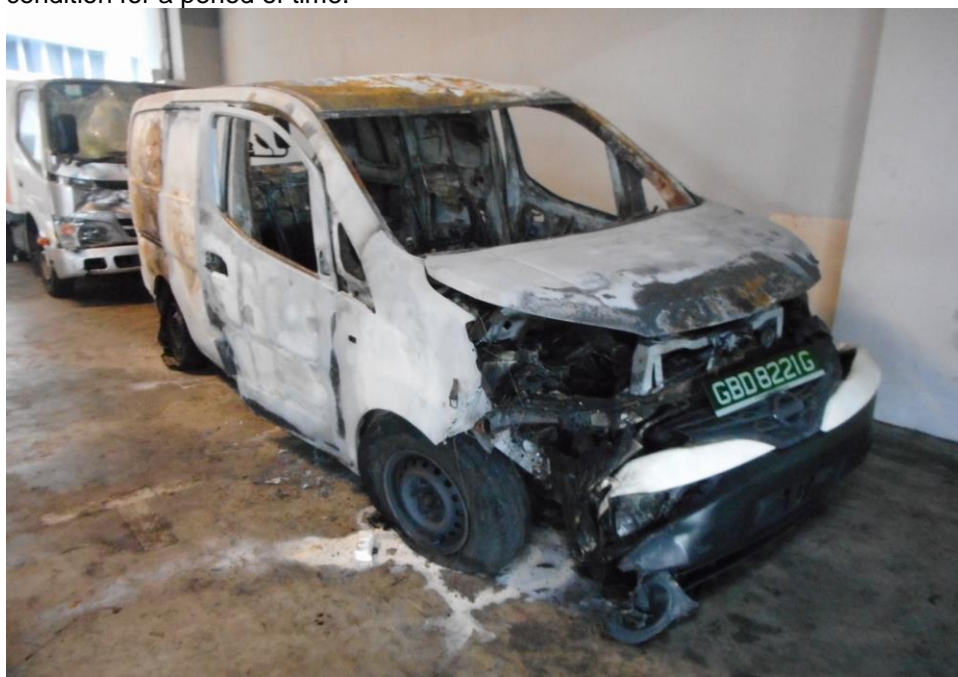
Photo 2 shows the general view of the right body of the Insured Vehicle at the time of our inspection. The Insured Vehicle was observed to have sustained extensive fire damage all around. Rust had accumulated all over the front and interior compartment of the Insured Vehicle as a result of exposure to environmental condition for a period of time.

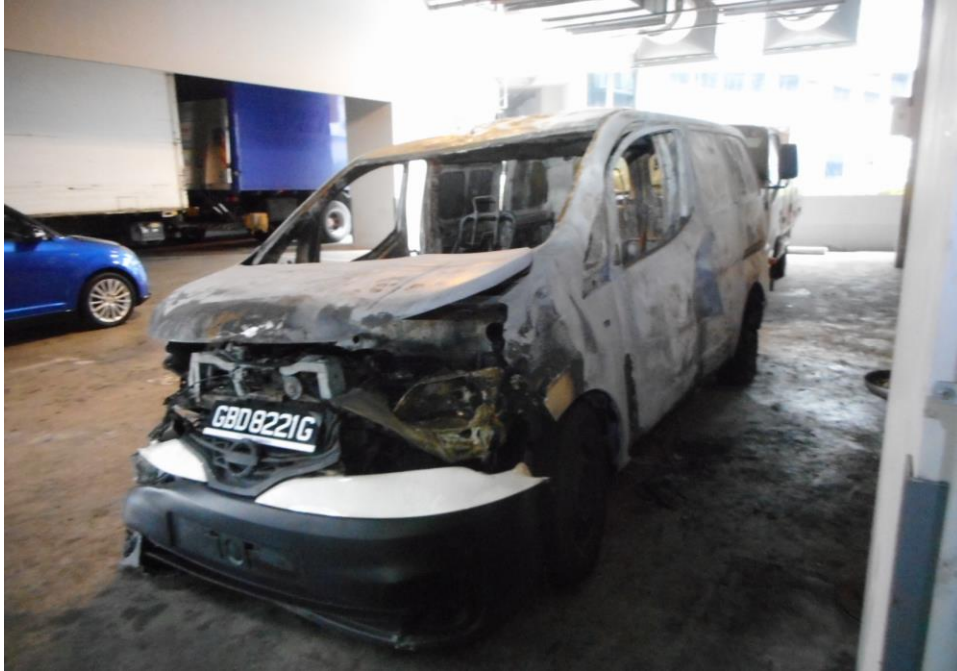
Photo 3 shows the general view of the left body of the Insured Vehicle at the time of our inspection. The Insured Vehicle was observed to have sustained extensive fire damage all around. Rust had accumulated all over the front and centre portion of the Insured Vehicle as a result of exposure to environmental condition for a period of time.

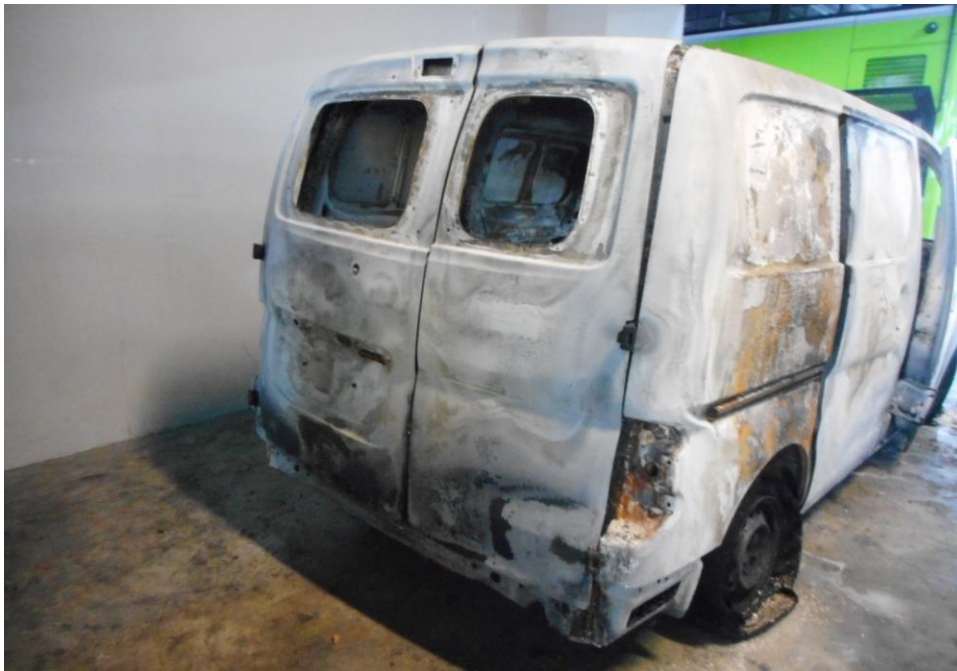
Photo 4 shows the general view of the rear portion of the Insured Vehicle. The Insured Vehicle was observed to have sustained extensive fire damage all around. Rust had accumulated all over the front and centre portion of the Insured Vehicle as a result of exposure to environmental condition for a period of time.

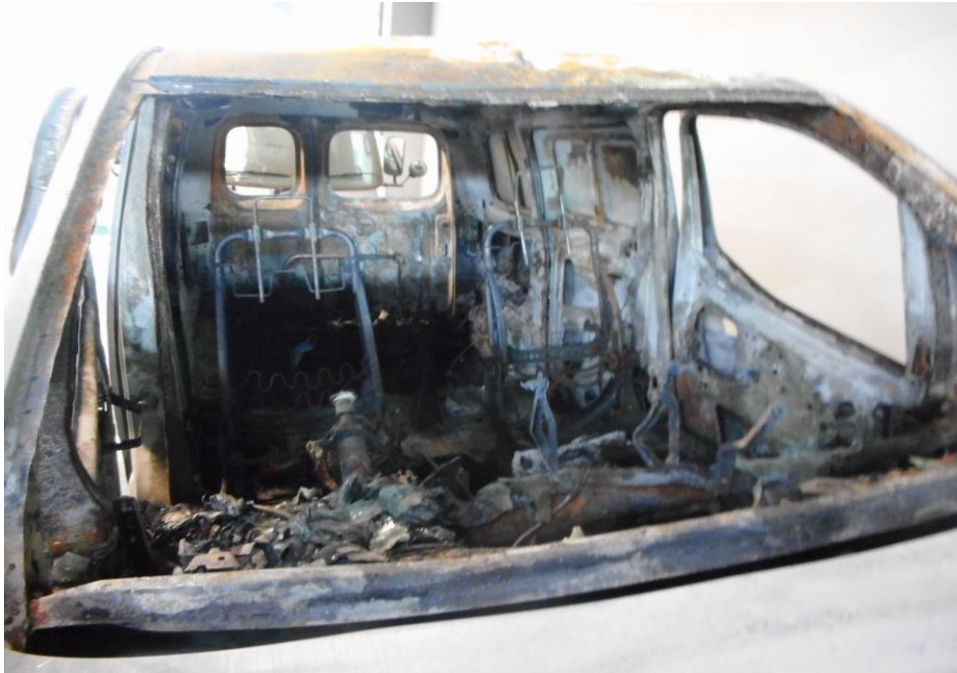
Photo 5 shows the general view of the interior compartment of the Insured Vehicle at the time of our inspection. Its interior compartment was completely burnt as a result of the fire.

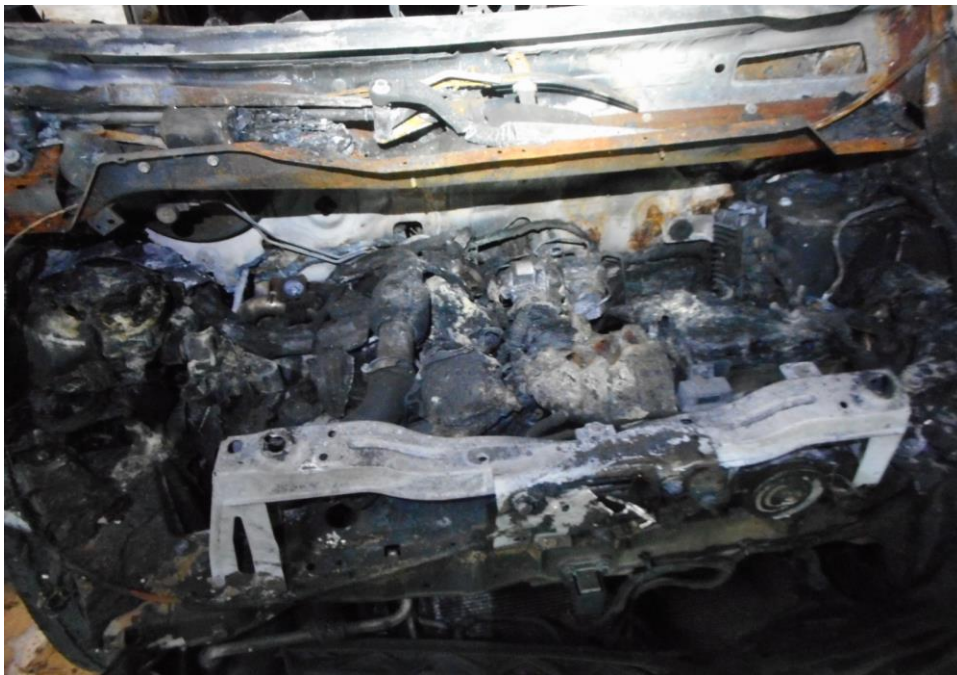
Photo 6 shows the engine compartment of the Insured Vehicle at the time of our inspection. The entire engine compartment of the Insured Vehicle was observed to be severely burnt. Most of the parts inside the engine compartment were found to be burnt and/or melted as a result of the fire.

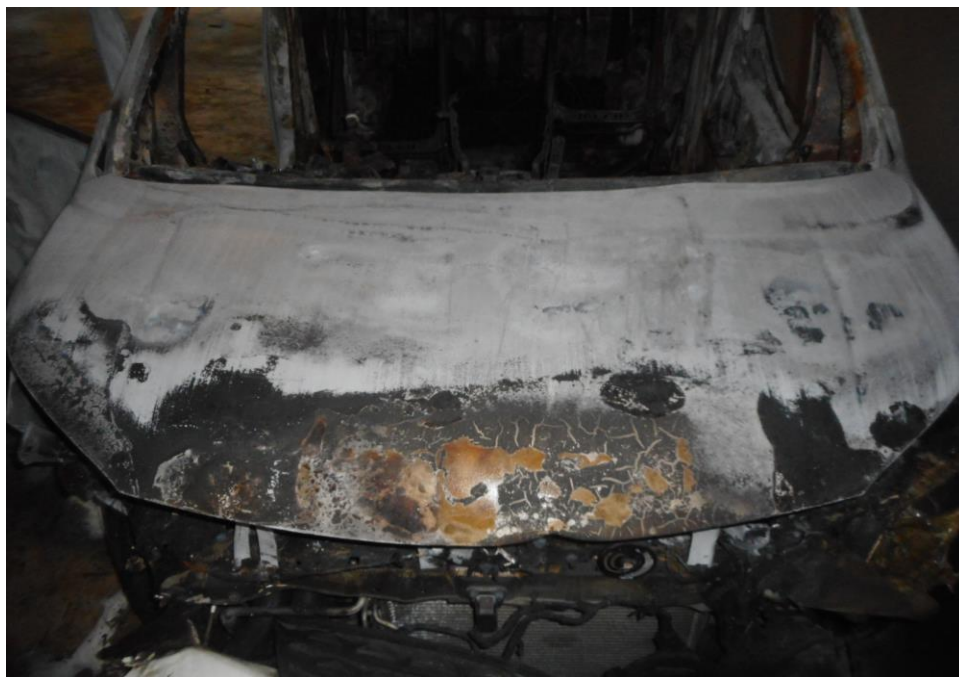
8. These whitish burn marks are a result of exposure to prolong heat intensity. Rust would normally start to develop around these areas soon after a fire as the prolonged exposure to high heat intensity usually causes the bare steel/metal material of the body parts to be exposed to natural environmental condition. The rust that had developed on the whole vehicle, in the immediate vicinity of where these whitish burn marks were found, would also support our findings of where the fire had affected the Insured Vehicle. See photo 7- 10 below.

Photo 7 shows the exterior of the front bonnet of the Insured Vehicle at the time of our inspection. The high heat intensity burn marks (whitish burn marks) and rust that had development found on the exterior surface of the bonnet indicates that the fire had originated from the front portion of the Insured Vehicle.

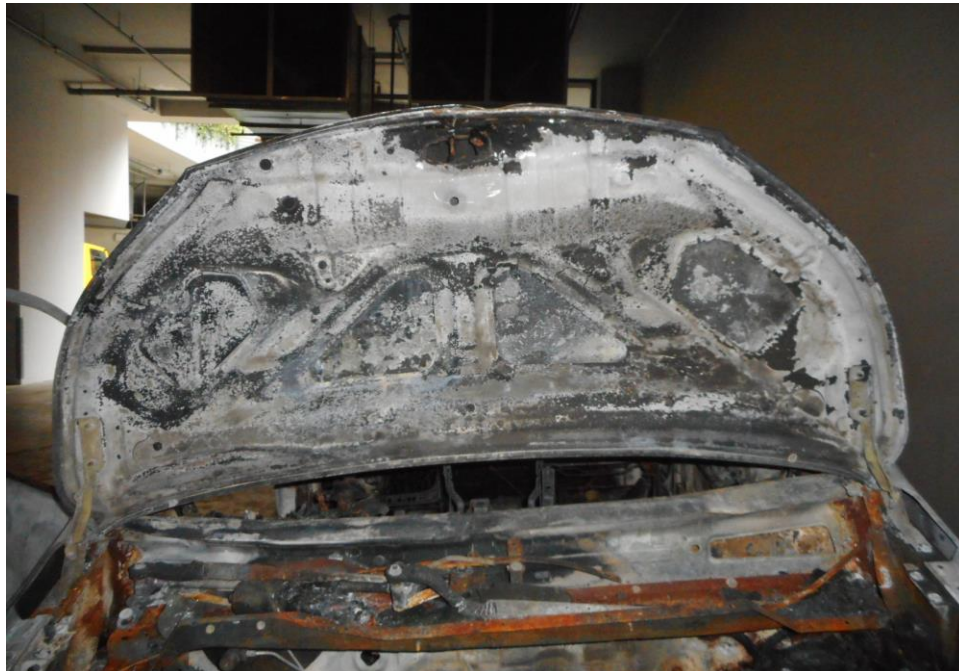
Photo 8 shows the underside of the front bonnet cover of the Insured Vehicle at the time of our inspection. The High heat intensity burn marks (whitish burn marks) and rust that had development found on the exterior surface of the bonnet indicates that the fire had originated from the front portion of the Insured Vehicle.

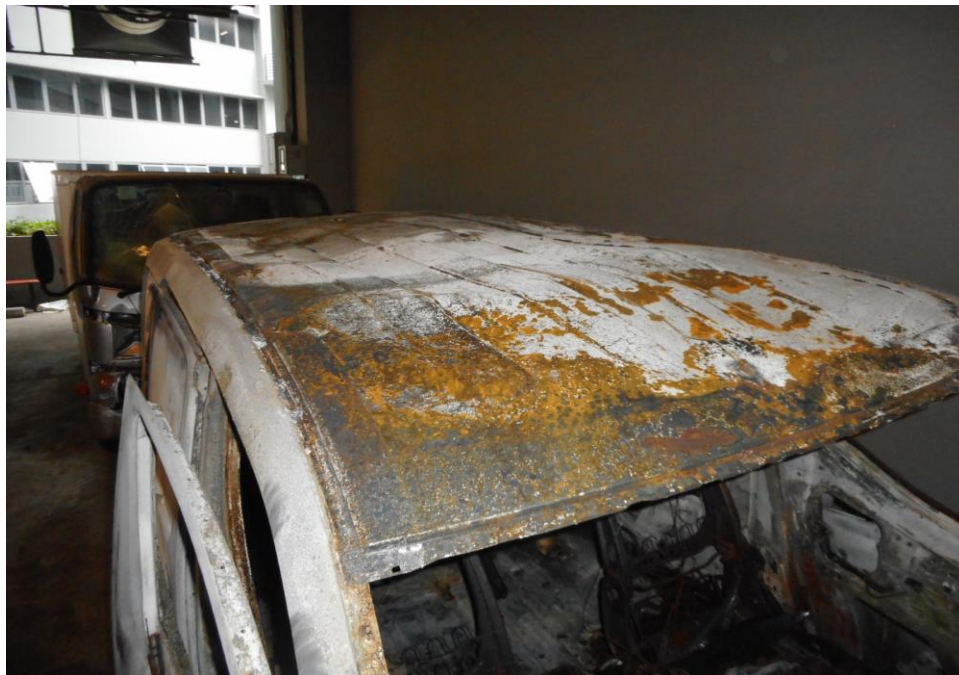
Photo 9 shows the exterior of the centre portion of the Insured Vehicle at the time of our inspection. The high heat intensity burn marks (whitish burn marks) and rust that had development found on the exterior surface indicates that the fire had originated from the frontal portion of the Insured Vehicle.

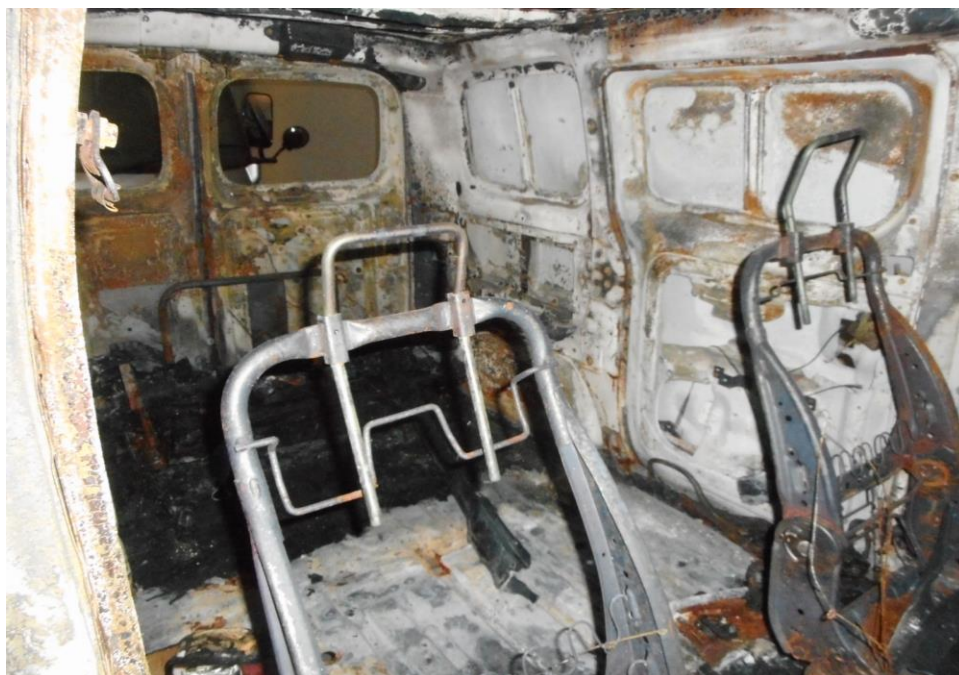
Photo 10 shows the interior of the Insured Vehicle at the time of our inspection. The High heat intensity burn marks (whitish burn marks) and rust that had developed on the interior surfaces of the Insured Vehicle due to the fire that had spread all around..

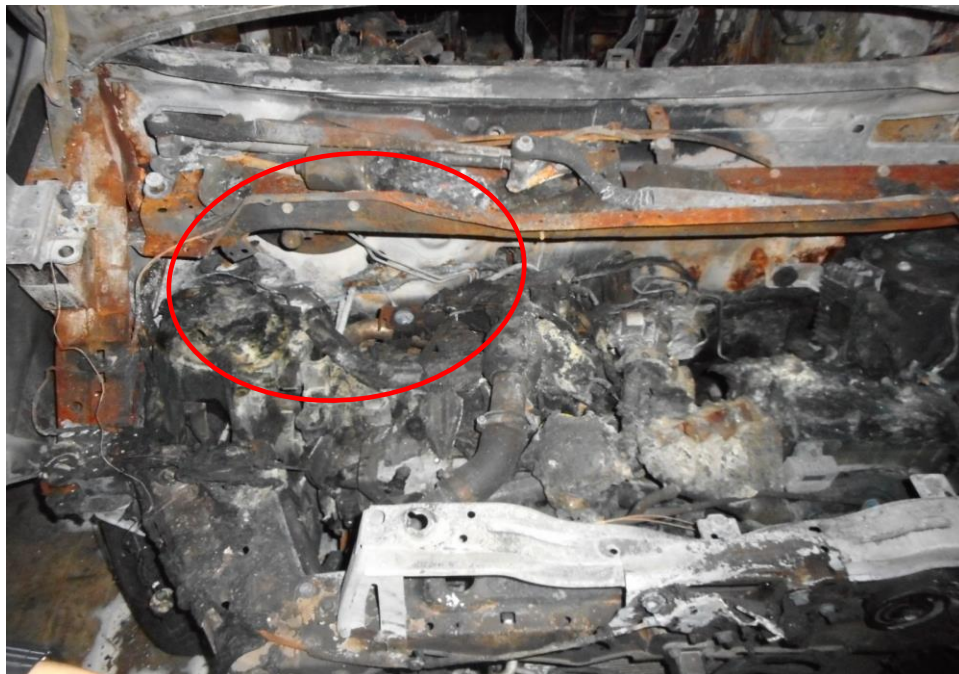
9. Upon closer examination of the front engine compartment and cabin interior portion of the Insured Vehicle which was where the fire had started, we had observed that the front driver's portion of the engine compartment had sustained a stronger high heat intensity burn mark as compared to the surrounding areas of the engine compartment.

Photo 11 shows the general view of the engine compartment of the Insured Vehicle at the time of our inspection. We had observed that the front driver's portion (circled) of the engine compartment had sustained a stronger high heat intensity burn marks as compared to the surrounding areas of the engine compartment

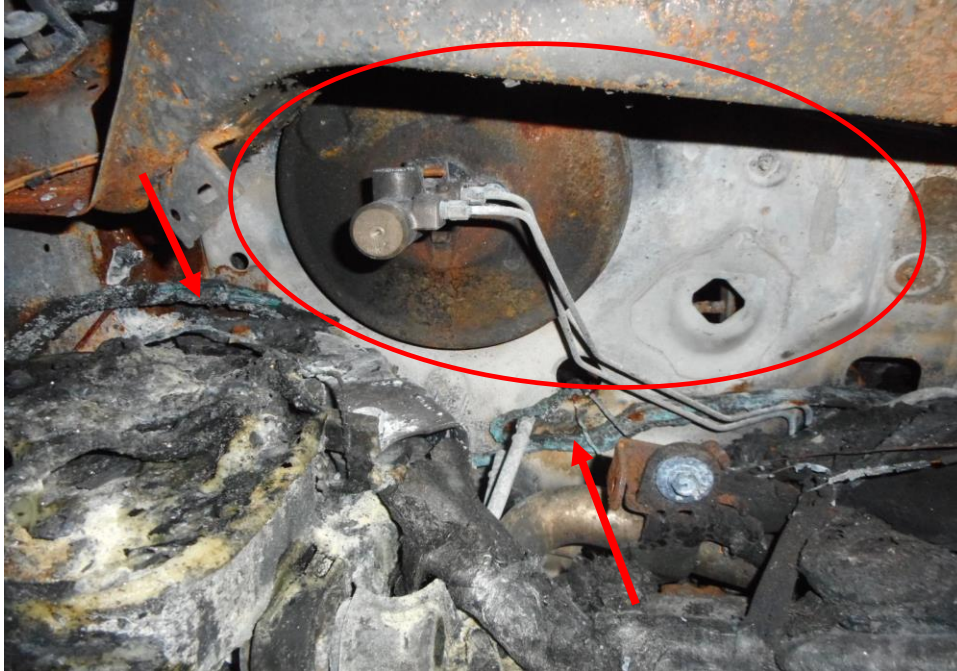
10. We had also found broken copper wirings and traces of greenish residue on these wirings harnesses that were leading from the battery to the electrical components in the cabin of the Insured Vehicle. This due likely been where the fire had started from.

Photo 12 shows the close up view of the engine compartment of the Insured Vehicle at the time of our inspection. We had observed that the front driver's portion of the engine compartment had sustained a stronger high heat intensity burn marks as compared to the surrounding areas of the engine compartment and we had also found traces of greenish residue on the wirings harnesses (arrowed) leading from the battery to the electrical components in the cabin of the Insured Vehicle.

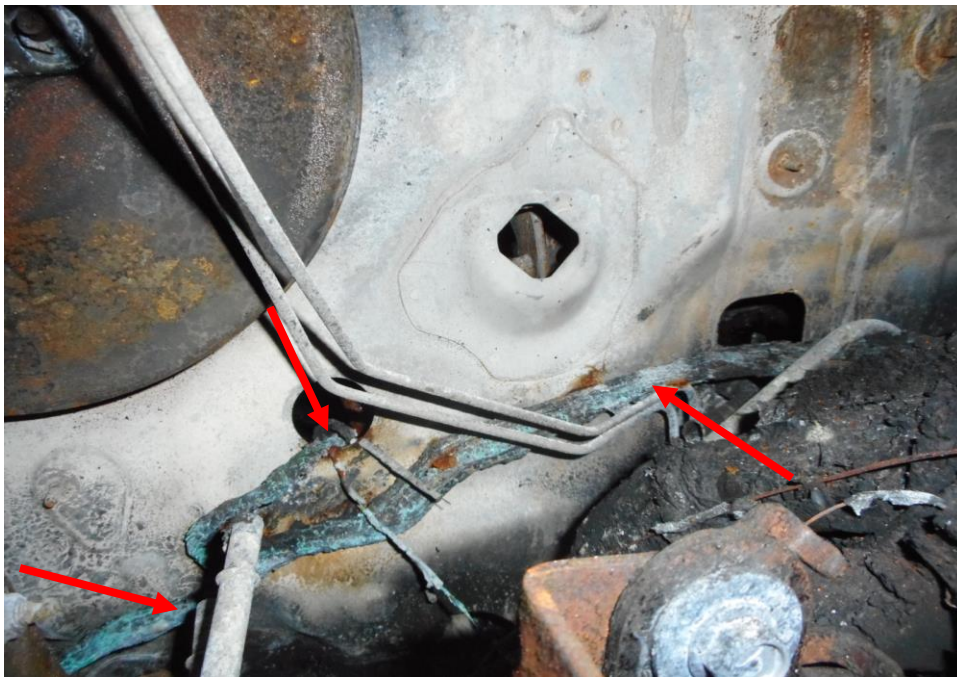
11. The wirings were original wirings fitted from the manufacturer. The presence of greenish residue indicates internal heating of copper wires, a sign of an electrical short circuit occurring. The greenish residue is normally left behind from the oxidation as a result of chemical reaction involving the copper wires and the broken copper wiring was due to the intense heat generate from the short circuit that had caused it to break off. This physical evidence would then appear to suggest that the cause of fire to the Insured Vehicle could have possibly been due to electrical in nature. See photos 11 - 16 below.

Photo 13 shows the close up view of the engine compartment of the Insured Vehicle at the time of our inspection. We had also found traces of greenish residue on the wirings harnesses (arrowed) leading from the battery to the electrical components in the cabin of the Insured Vehicle.

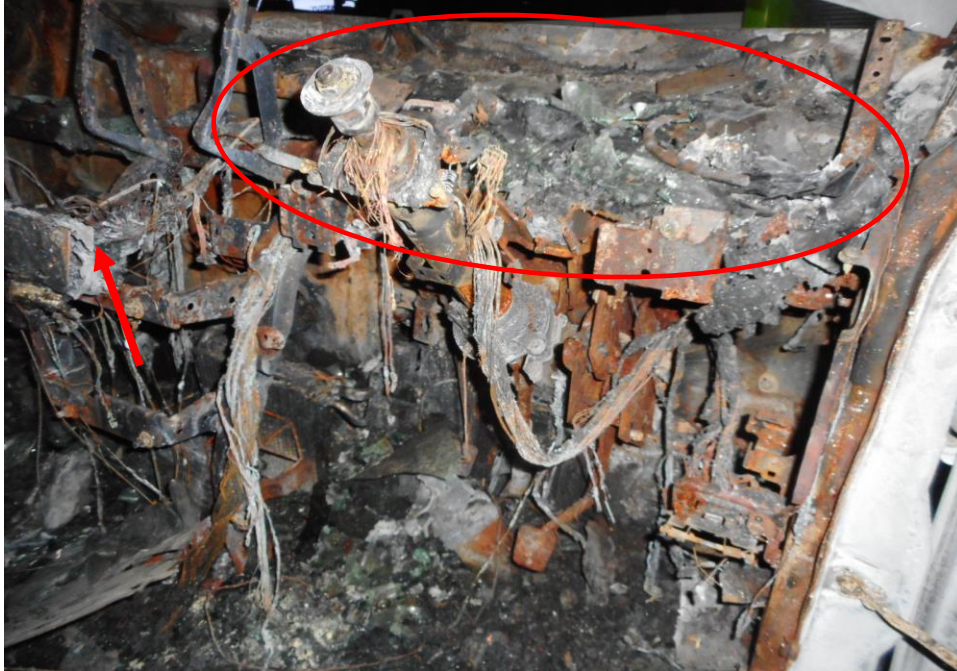
Photo 14 shows the general view of the interior compartment of the Insured Vehicle at the time of our inspection. The fire damage to the Insured Vehicle has affected its engine and interior compartment. Its interior dashboard (circled), radio head unit (arrowed), various original wiring harnesses was amongst the parts in the compartment that were found to have been affected as a result of the fire.

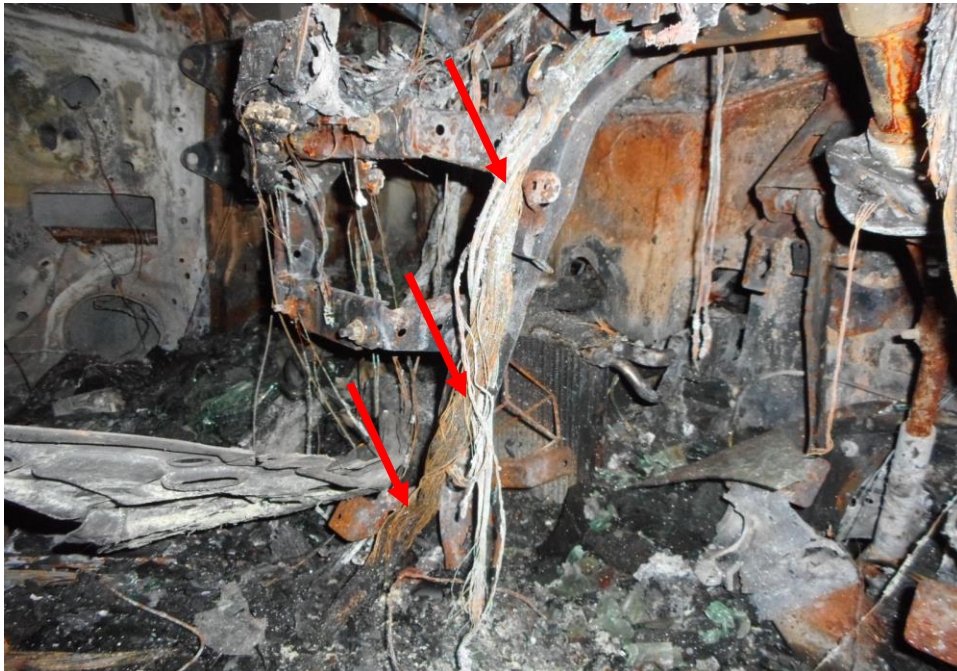
Photo 15 shows the close up view of the interior compartment of the Insured Vehicle at the time of our inspection. We had also found traces of greenish residue on the wirings harnesses and the broken copper wirings this is due to the intense heat generate from the short circuit that had likely been where the fire had started from (arrowed) leading from the battery to the electrical components in the cabin of the Insured Vehicle.

27. Having investigated and technically analysed the damages of burnt nature to the Insured Vehicle, we are of the view that the cause of fire to the Insured Vehicle was of electrical nature. For this particular case, the fire had originated along the original wiring harnesses leading from the battery to the electrical components of the Insured Vehicle.
28. We did not find any evidence which had suggested that the cause of fire to the Insured Vehicle was due to poor maintenance and/or recurring electrical problem.
29. There was no modification(s) or additional electronic and/or electrical component(s) fitted on the Insured Vehicle at the time of our inspection of the Insured Vehicle.

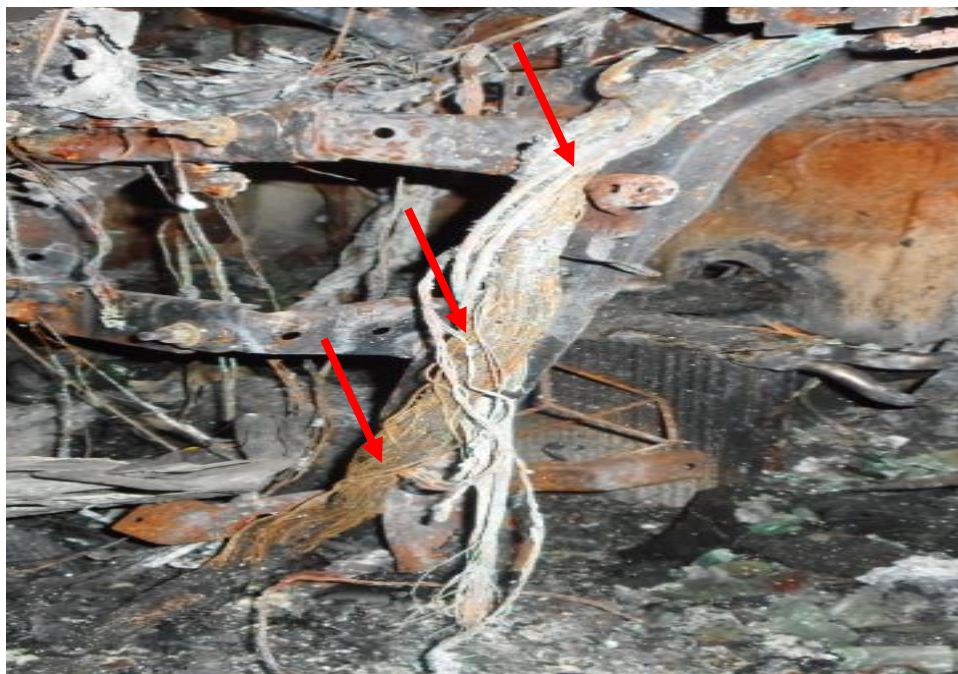
Photo 16 shows the close up view of the interior compartment of the Insured Vehicle at the time of our inspection. We had also found traces of greenish residue on the wirings harnesses and the broken copper wirings this is due to the intense heat generated from the short circuit and this had likely been where the fire had started from and spread to the whole vehicle (arrowed)

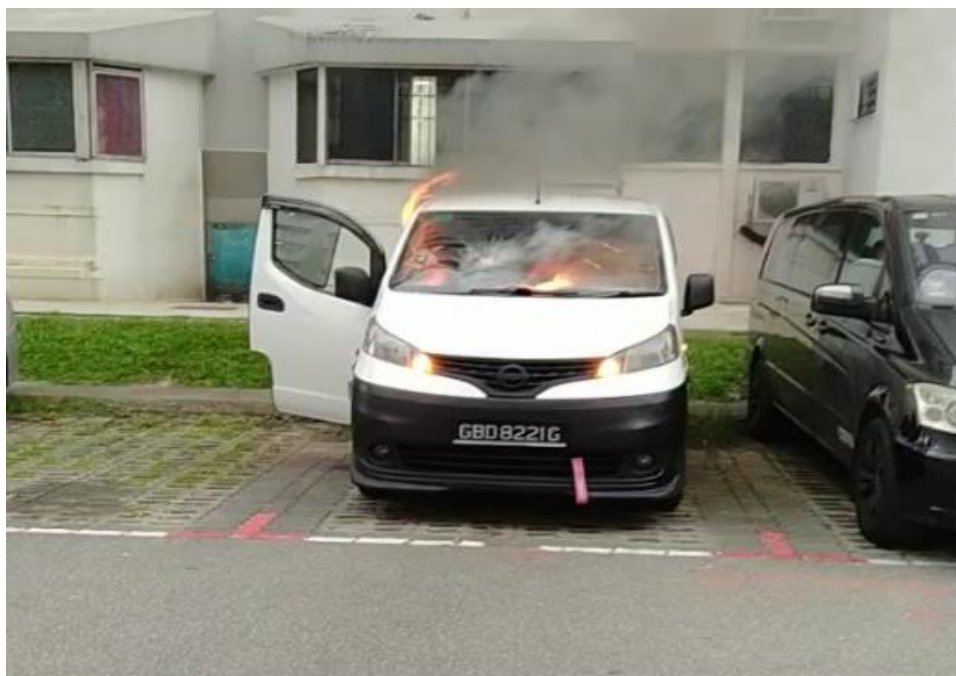
Photo 17 shows the Insured Vehicle at the parking lot when the fire had just started up, the fire observed to be emitting from the interior of the Insured Vehicle. In general, the information that could be gathered from this photograph had corresponded to the events that were related to us by Mr Irman, location when the fire broke out.

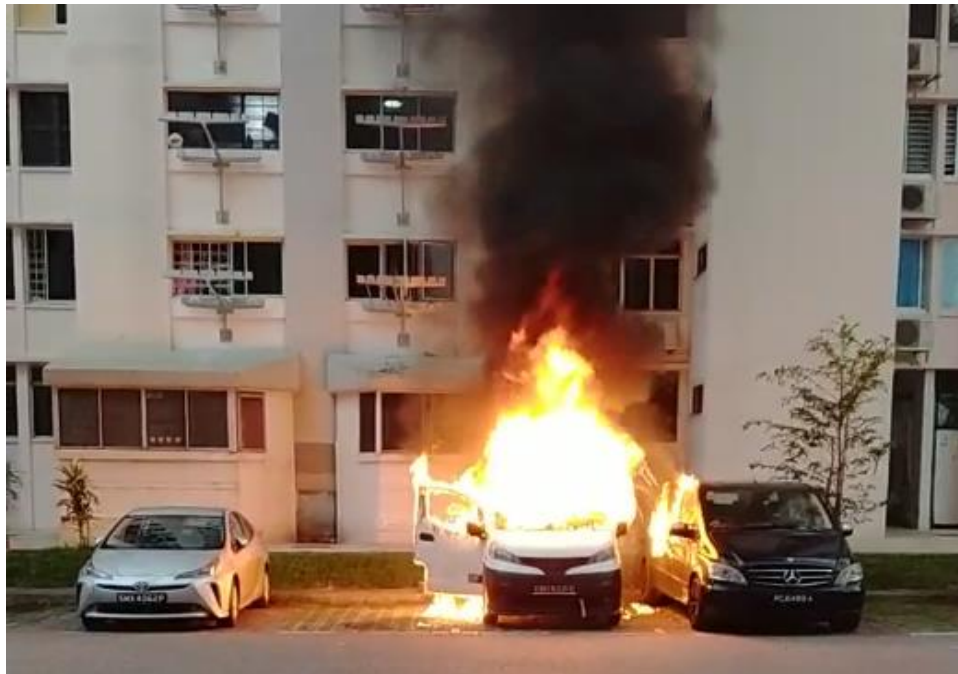
Photo 18 shows the Insured Vehicle at the parking lot when the fire had gone out of control, there was a vehicle parked right next to it and had been affected by the fire from the Insured Vehicle. The fire observed to be emitting from the interior of the Insured Vehicle. In general, the information that could be gathered from this photograph had corresponded to the events that were related to us by Mr Irman, location when the fire broke out.

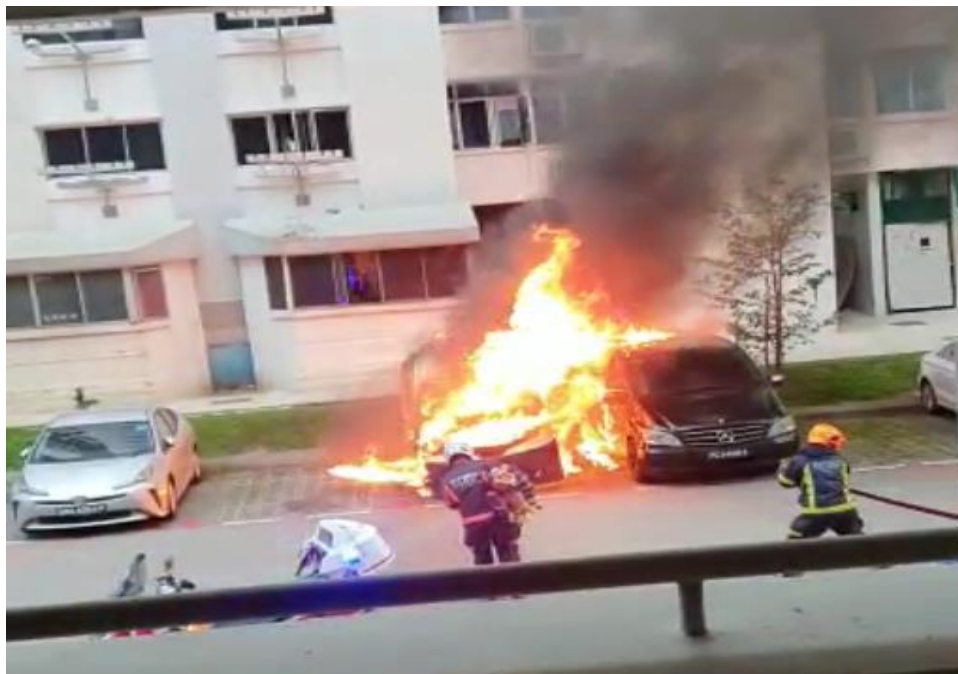
Photo 19 shows the SCDF officers arriving on scene and preparing to put out the fire. In general, the information that could be gathered from this photograph had corresponded to the events that were related to us by Mr Irman, location when the fire broke out.

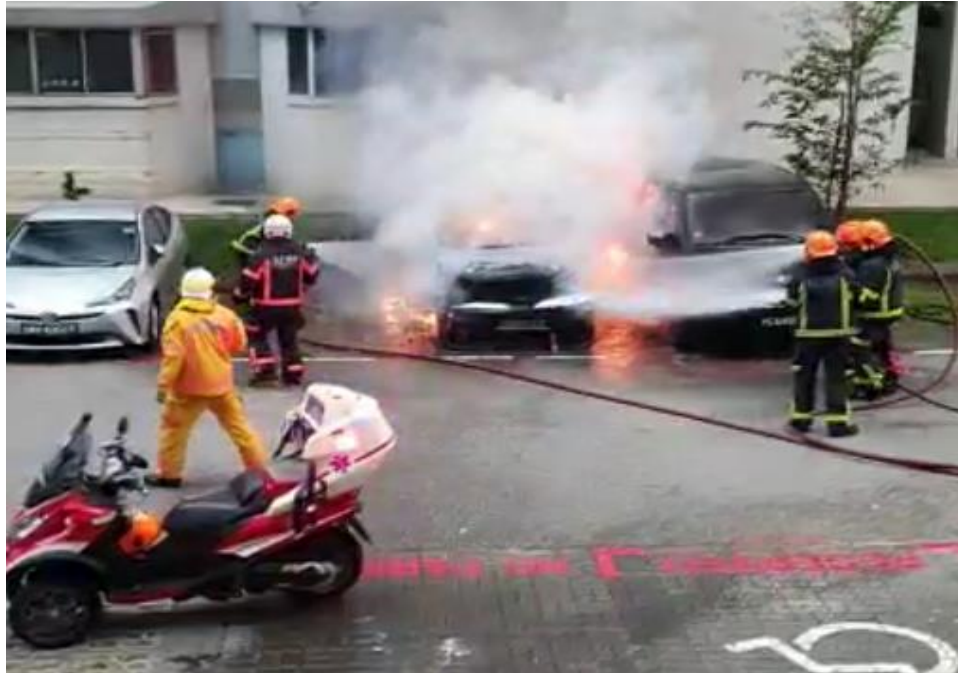
Photo 20 shows the SCDF officers on scene putting out the fire. In general, the information that could be gathered from this photograph had corresponded to the events that were related to us by Mr Irman, location when the fire broke out.

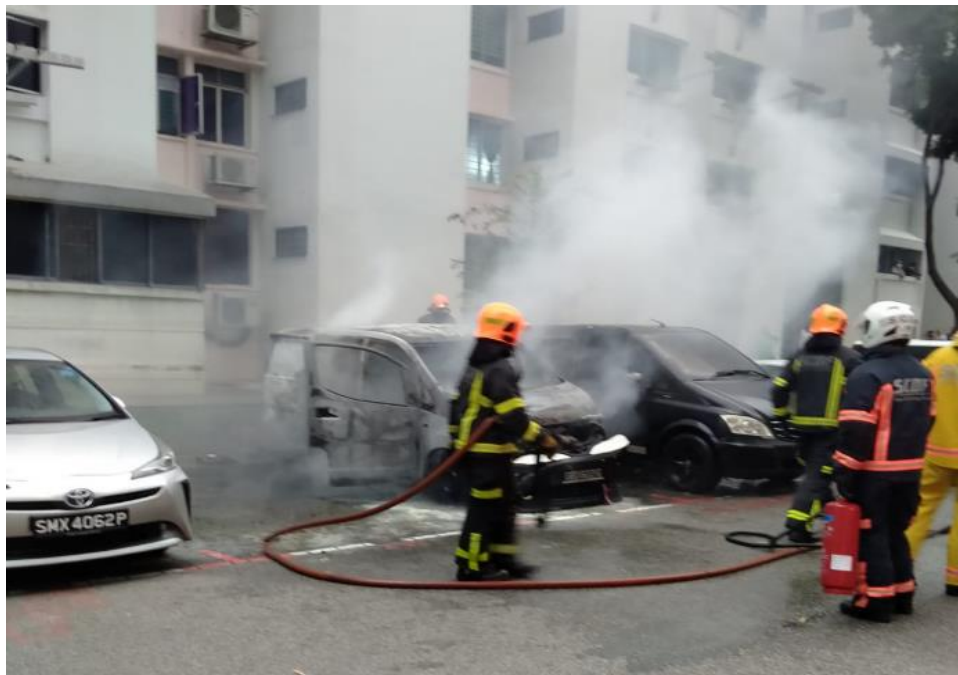
Photo 21 shows the SCDF officers on scene investigating the scene after the fire was put out. In general, the information that could be gathered from this photograph had corresponded to the events that were related to us by Mr Irman, location when the fire broke out.

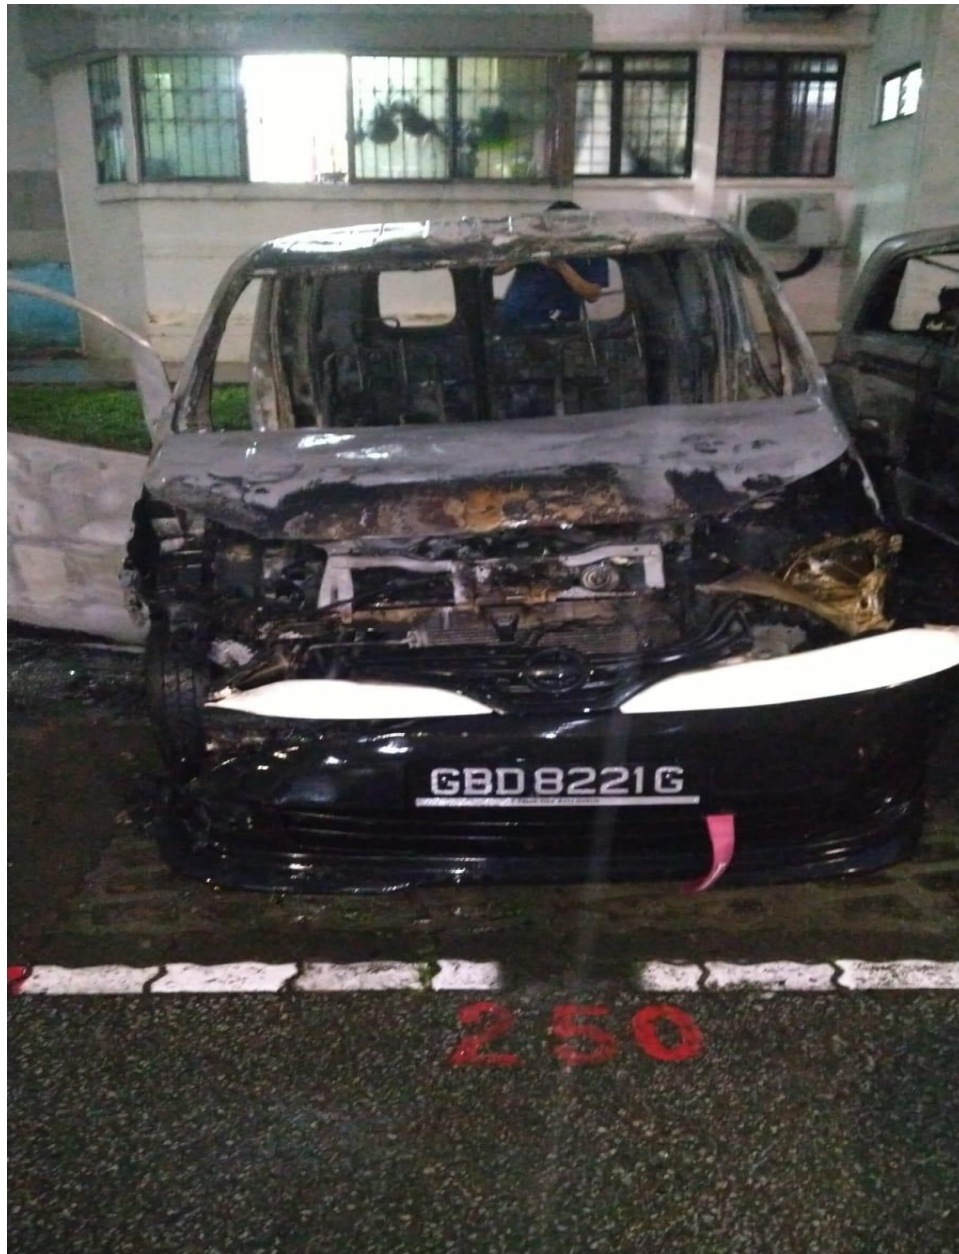
Photo 22 shows the exterior of the Insured Vehicle after the fire was put out. The high heat intensity burn marks (whitish burn marks) and rust that had development found on the exterior surface of the Insured Vehicle. In general, the information that could be gathered from this photograph had corresponded to the events that were related to us by Mr Irman, location when the fire broke out.
