Your Ref: Honda Fit Hybrid
(chassis number GP53424689)
Our Ref : CI/TP21001455/D

30 January 2021

INSPECTION REPORT OF AN UNREGISTERD HONDA FIT HYBRID MOTOR CAR WITH CHASSIS NUMBER GP53424689

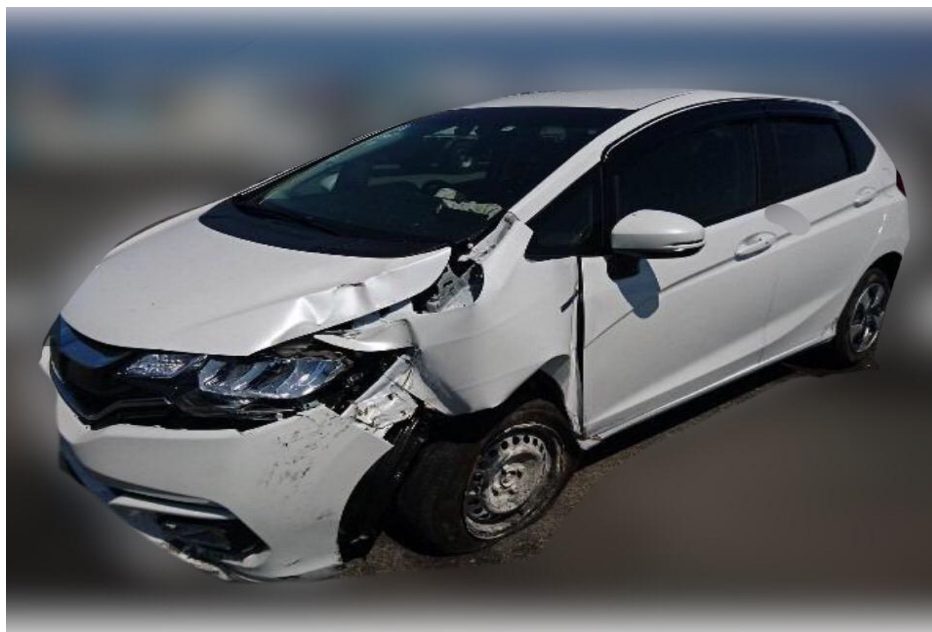
Photo 1 shows the front left body of the Motor Car prior to any repairs being carried out (photograph provided to me). The Motor Car was observed to have sustained damages at its front left portion. Body parts damaged had include its front bumper, front left headlamp, front bonnet and front left fender amongst others. The front left undercarriage parts were also damaged as seen from the orientation of the front left wheel, which was pushed backwards.

23. The body parts at the front left portion, rear left portion, front left and rear undercarriage of the Motor Car were all visually examined, and it was noted that the repair/restoration works carried out to the damaged area of the Motor Car (refer photograph 1 & 2 above) were reasonably adequate and in order.

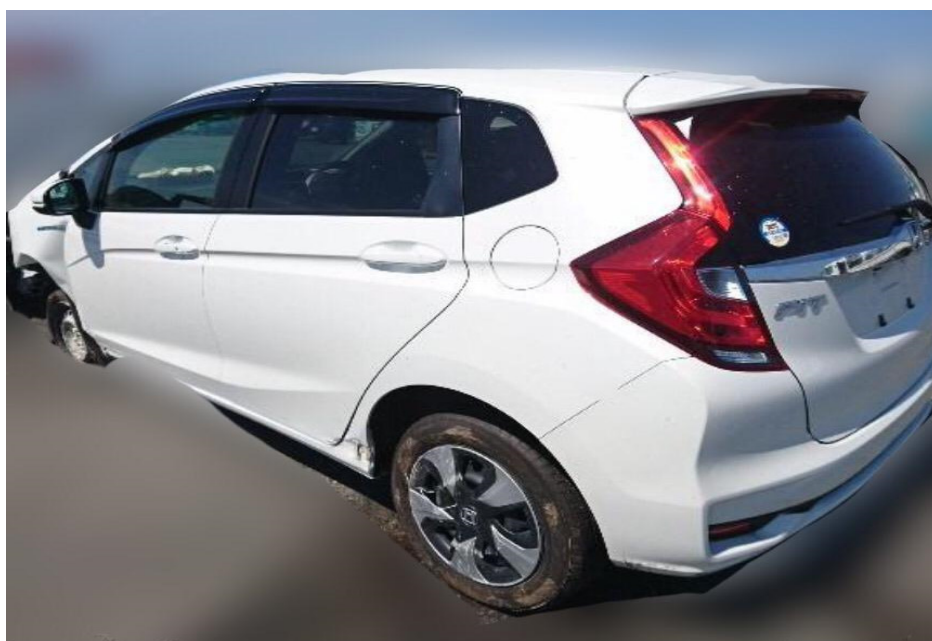
Photo 2 shows the rear left body of the Motor Car prior to any repairs being carried out (photograph provided to me). The Motor Car was observed to have also sustained damages at its rear left portion. Body parts damaged had include its rear left fender, rear left wheel and rear left door amongst others. The rear undercarriage parts were also damaged as seen from the orientation of the rear right wheel (refer to photograph 3 below).

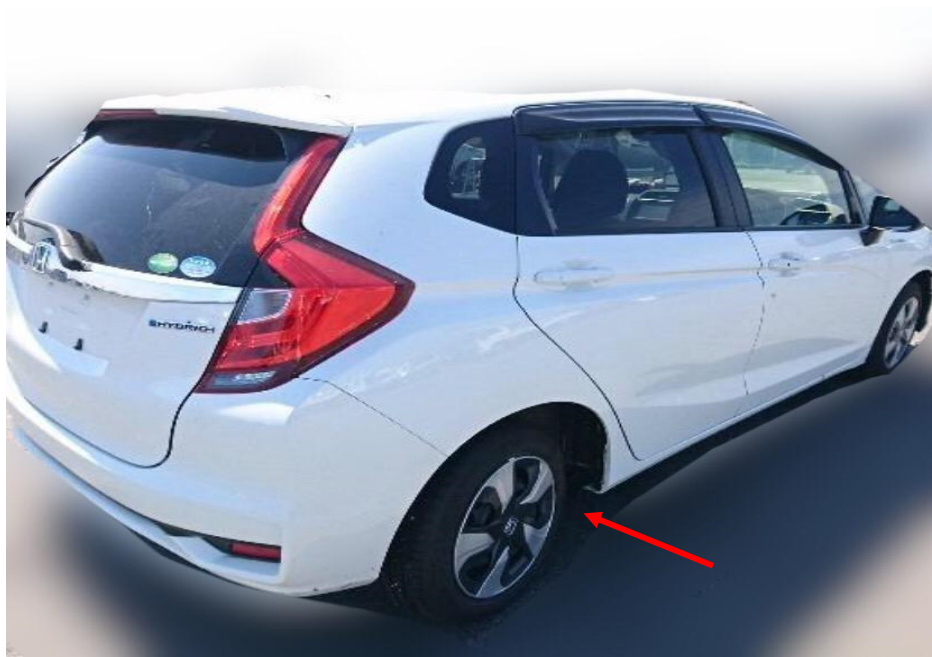
Photo 3 shows the rear right body of the Motor Car prior to any repairs being carried out (photograph provided to me). The right rear wheel was orientated inwards (arrowed), which indicates damage to the rear undercarriage parts of the Motor Car.

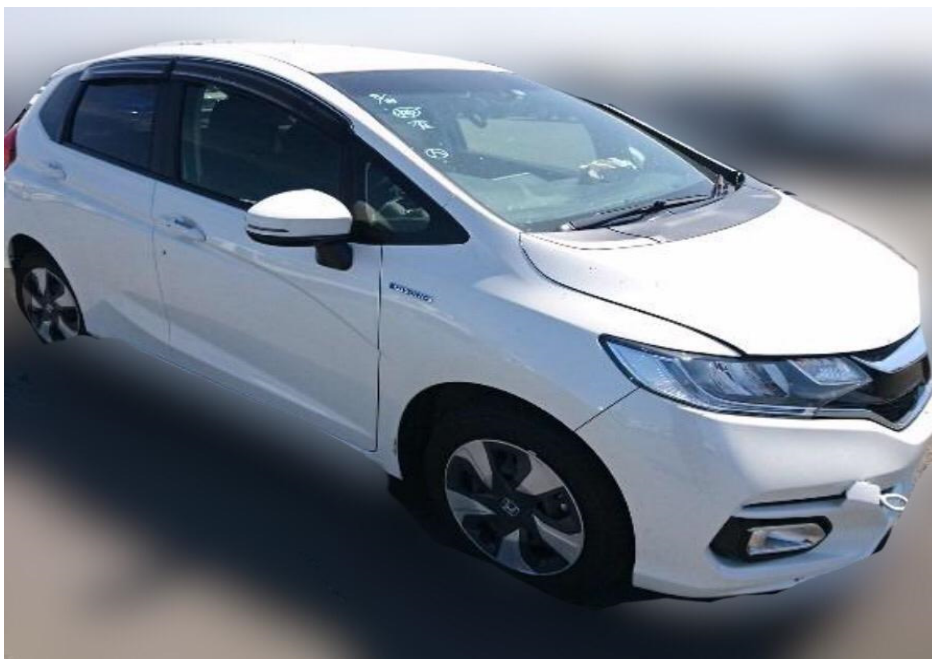
Photo 4 shows the front right body of the Motor Car prior to any repairs being carried out (photograph provided to me). There was no damage observed along the right side of the Motor Car. The airbags of the Motor Car were also not activated.

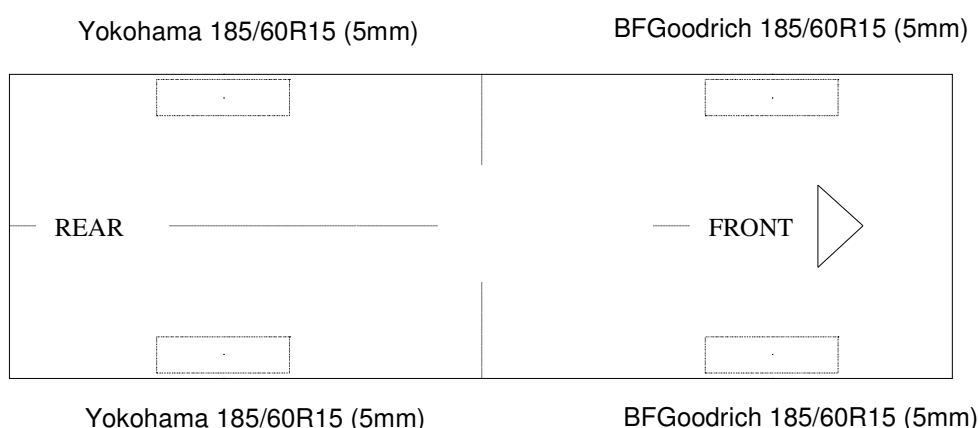
9. It was fitted with 15inch sport wheel rims that were wrapped with tyres that were observed to be of serviceable condition. The tyres were also sufficiently inflated for vehicular operation. The tyre brand, tyre size and approximate remaining tread depth of the 4 tyres of the Motor Car were recorded as follows: -

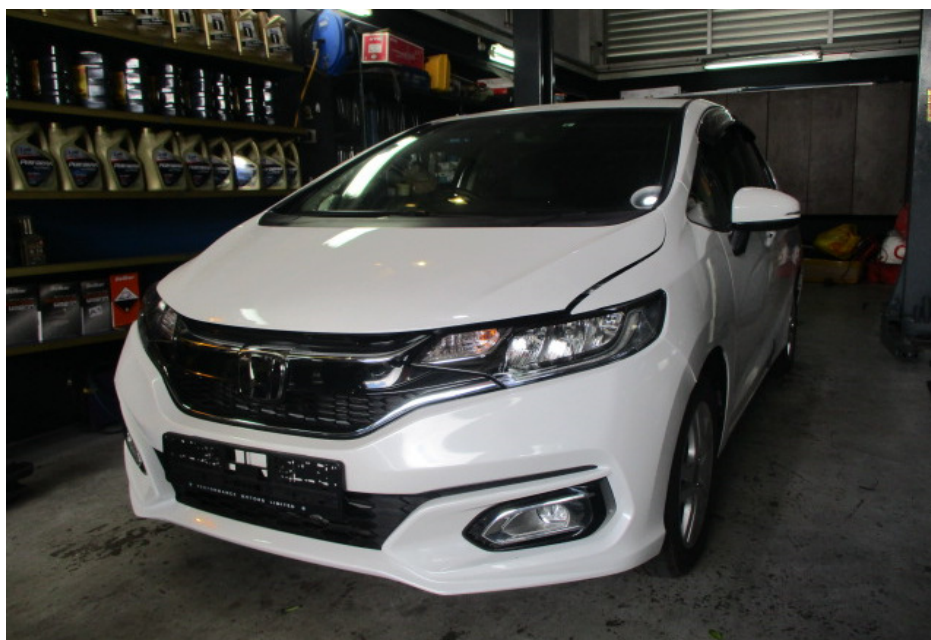
Photo 5 shows a general view of the front left body of the Motor Car at the time of my inspection. The Motor Car was observed to be in a relatively good general condition with no loose exterior fittings observed. The body parts at the front left portion of the Motor Car were visually examined and it was observed that the repair/restoration works carried out to the damaged area of the Motor Car (refer to photograph 1) were reasonably adequate and in order.

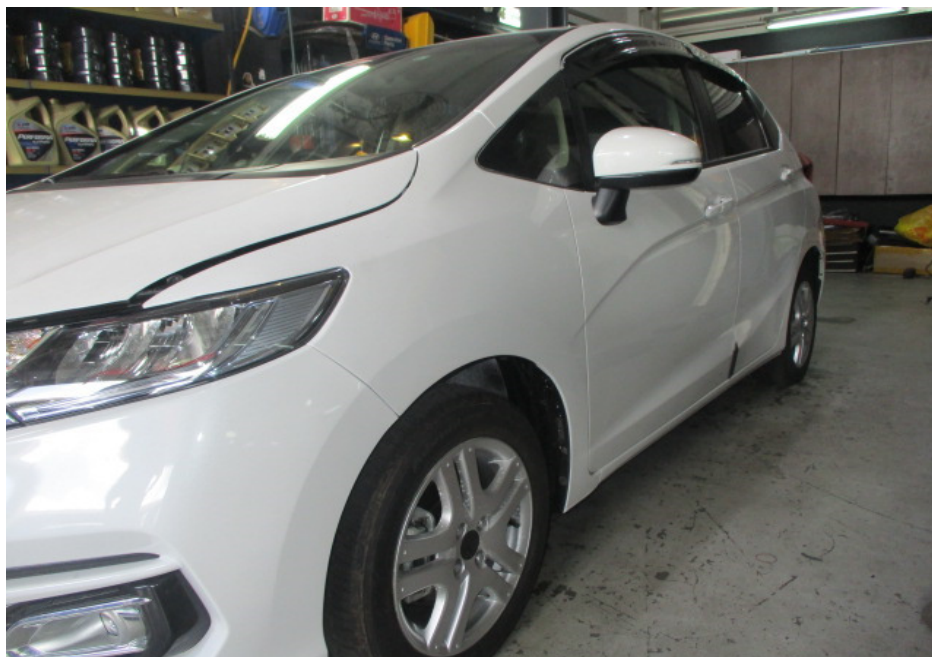
Photo 6 shows a closer view of the front bumper, front left headlamp, front bonnet and front left fender of the Motor Car. The body parts at the front left portion of the Motor Car were visually examined and it was observed that the repair/restoration works carried out to the damaged area of the Motor Car (refer to photograph 1 above) were reasonably adequate and in order.

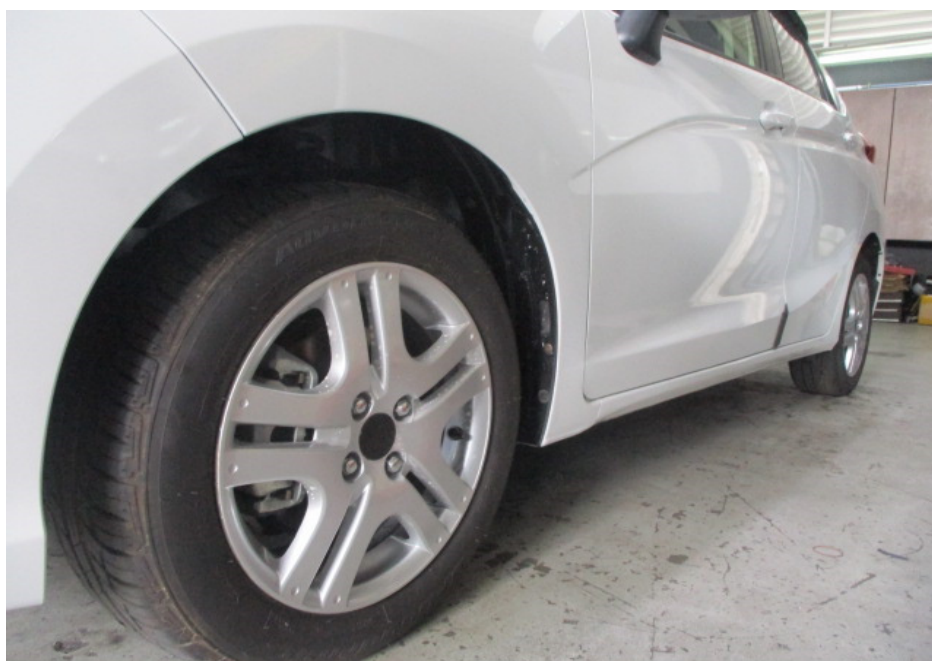
Photo 7 shows a closer view of the front left wheel rim and front left fender of the Motor Car at the time of my inspection. The body parts at the front left portion of the Motor Car were visually examined and it was observed that the repair/restoration works carried out to the damaged area of the Motor Car (refer to photograph 1 above) were reasonably adequate and in order.

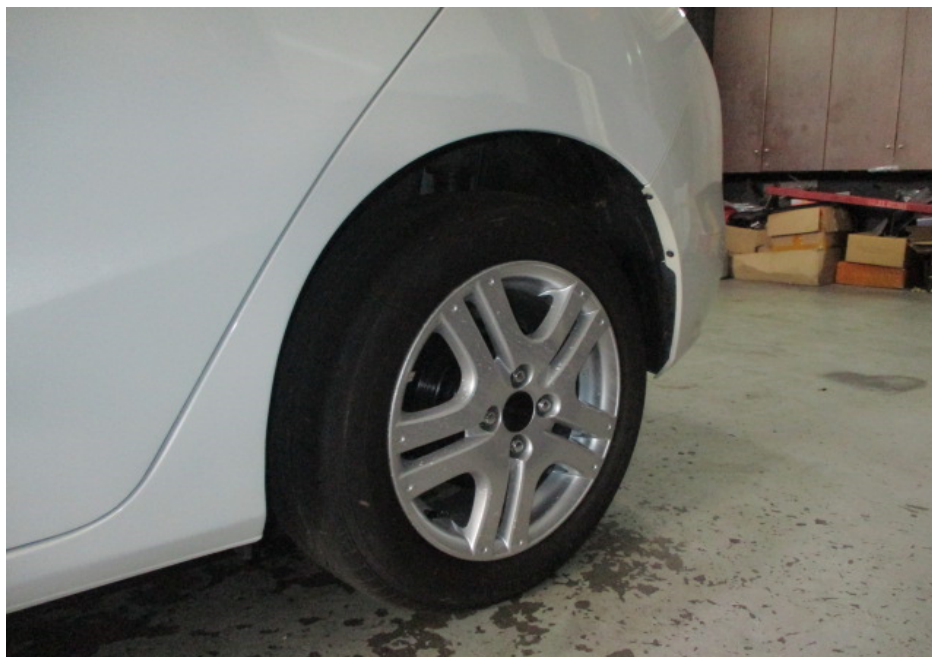
Photo 8 shows a closer view of the rear left wheel rim, rear left fender and rear left door of the Motor Car at the time of my inspection. The body parts at the rear left portion of the Motor Car were visually examined and it was observed that the repair/restoration works carried out to the damaged area of the Motor Car (refer to photograph 2 above) were reasonably adequate and in order.

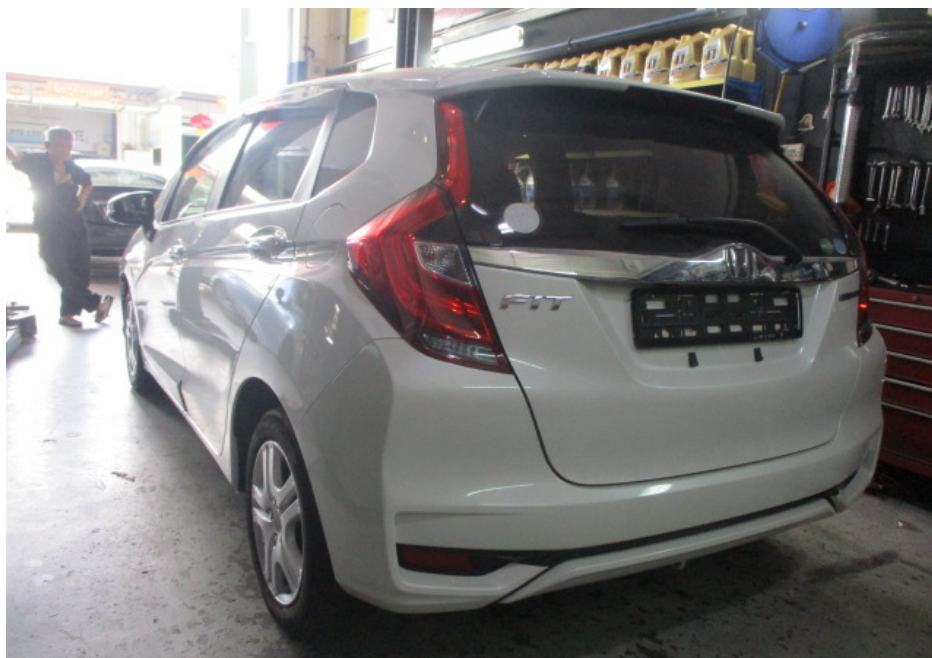
Photo 9 shows a general view of the rear left body of the Motor Car at the time of my inspection. The Motor Car was observed to be in a relatively good general condition with no loose exterior fittings observed. The body parts at the rear left portion of the Motor Car were visually examined and it was observed that the repair/restoration works carried out to the damaged area of the Motor Car (refer to photograph 2) were reasonably adequate and in order.

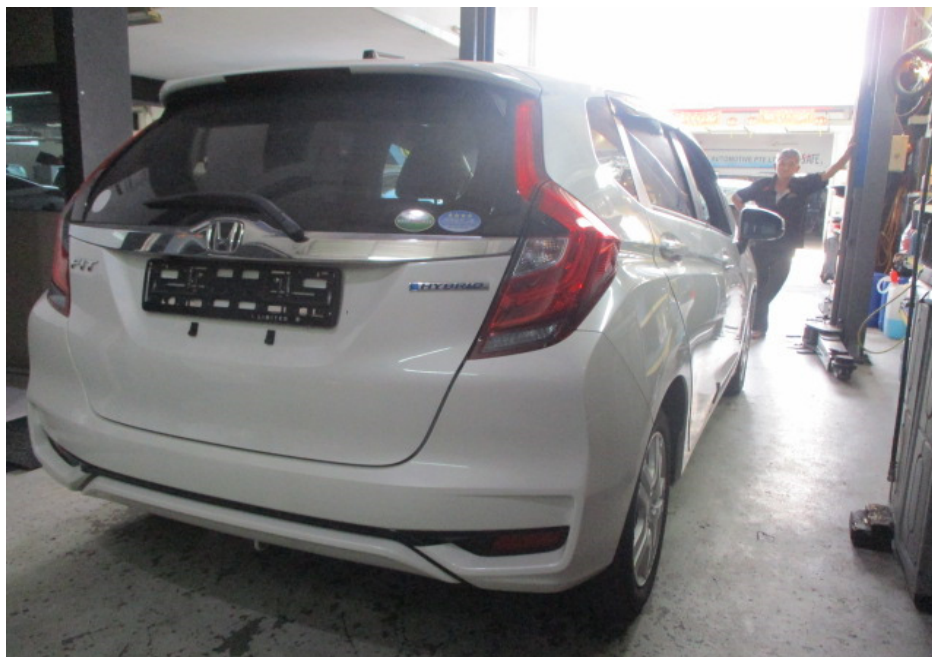
Photo 10 shows a general view of the rear right body of the Motor Car at the time of my inspection. The Motor Car was observed to be in a relatively good general condition with no loose exterior fittings observed. The mileage of the Motor Car recorded at the time of my inspection was 4,765km.

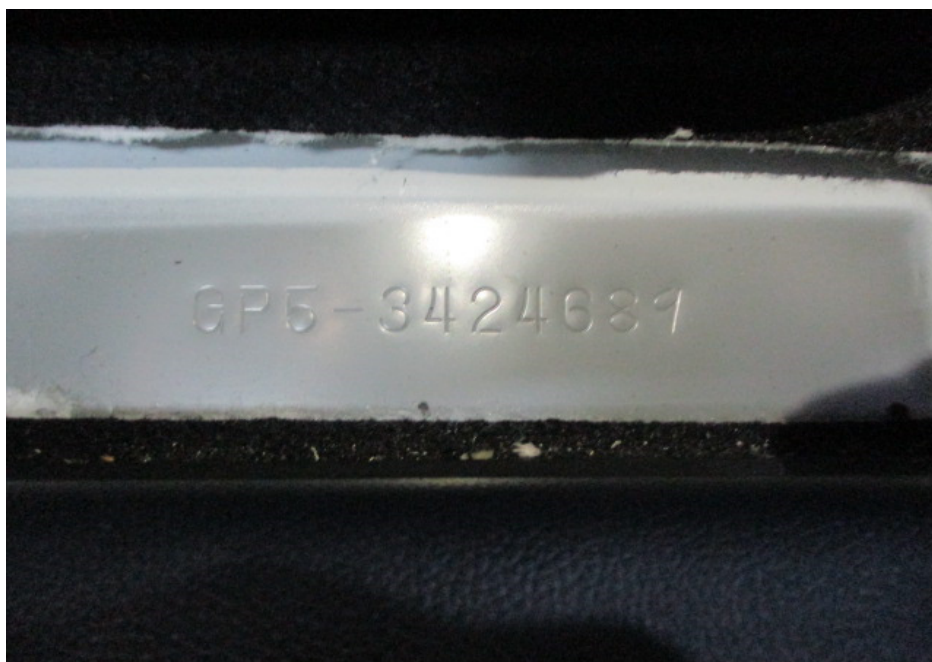
Photo 11 shows the chassis number of the Motor Car. The chassis number recorded was GP53424689.

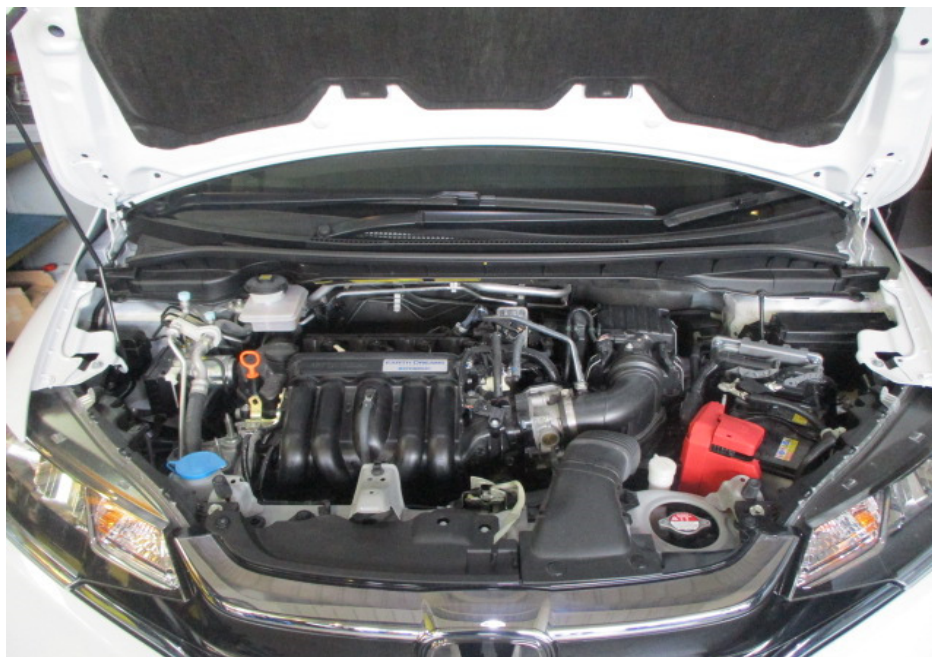
Photo 12 shows a general view of the engine compartment of the Motor Car at the time of my inspection. The various parts and components inside the engine compartment were all observed to be intact and properly fitted. There was also no sign(s) or indication(s) of fluid leak and/or fluid stain found inside the engine compartment.

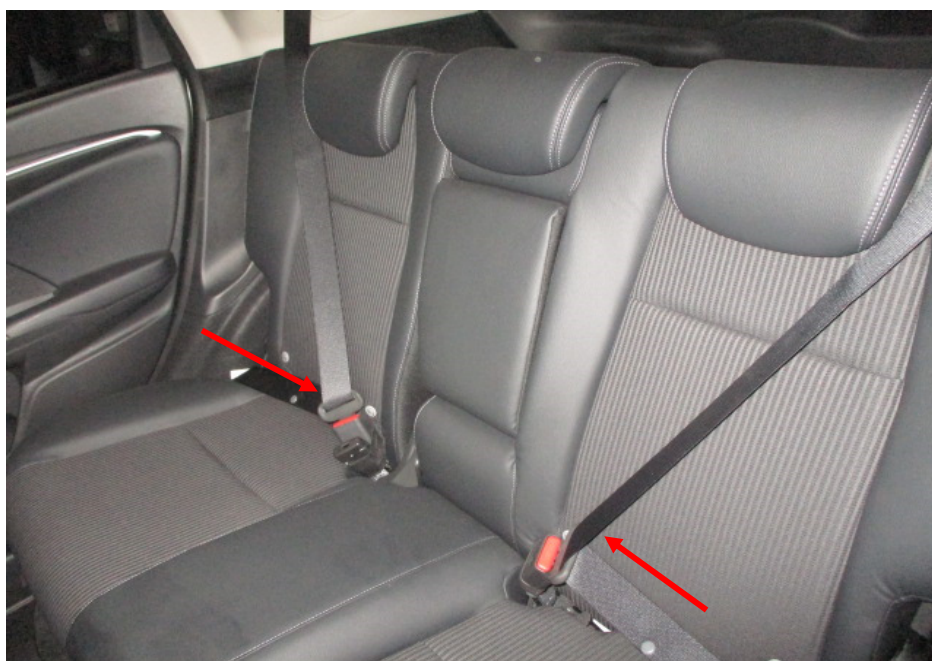
Photo 13 shows the rear seats of the Motor Car. All the seats of the Motor Car were secured via seat rails to the floorboard. They were also fitted with a retractable seat belt reel and a pre-tensioner. The seat belts (arrowed) of the Motor Car were tested and were able to be fastened into the respective pre-tensions that were fitted on the side of each individual seat.

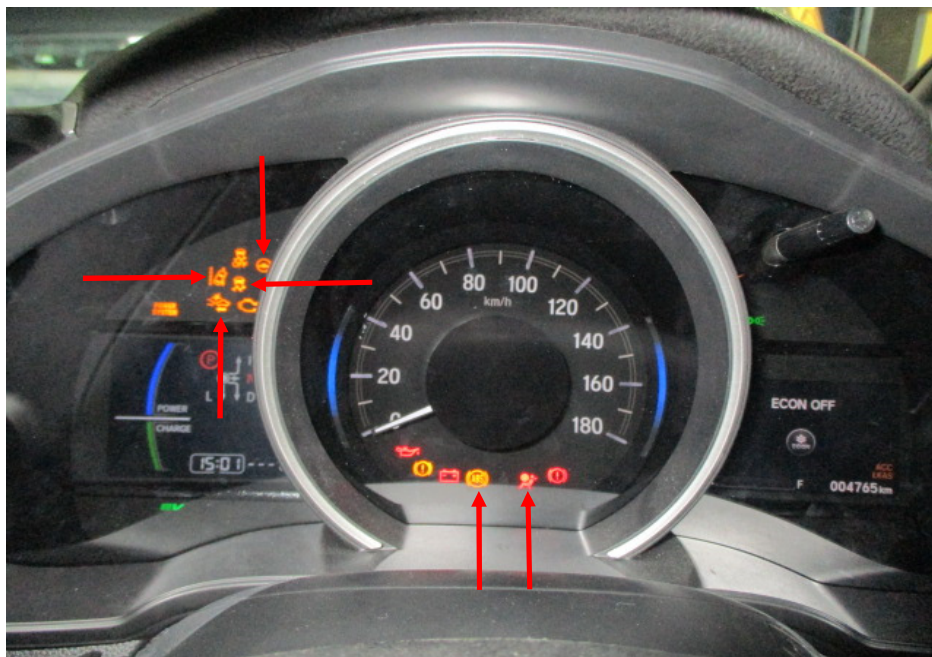
Photo 14 shows the warning lights for the various electronic safety features appearing on the instrument panel of the Motor Car during its self-test when the engine is cranked, in particular the ABS, SRS, EPS, SC, LDW and CMBS lights (arrowed).

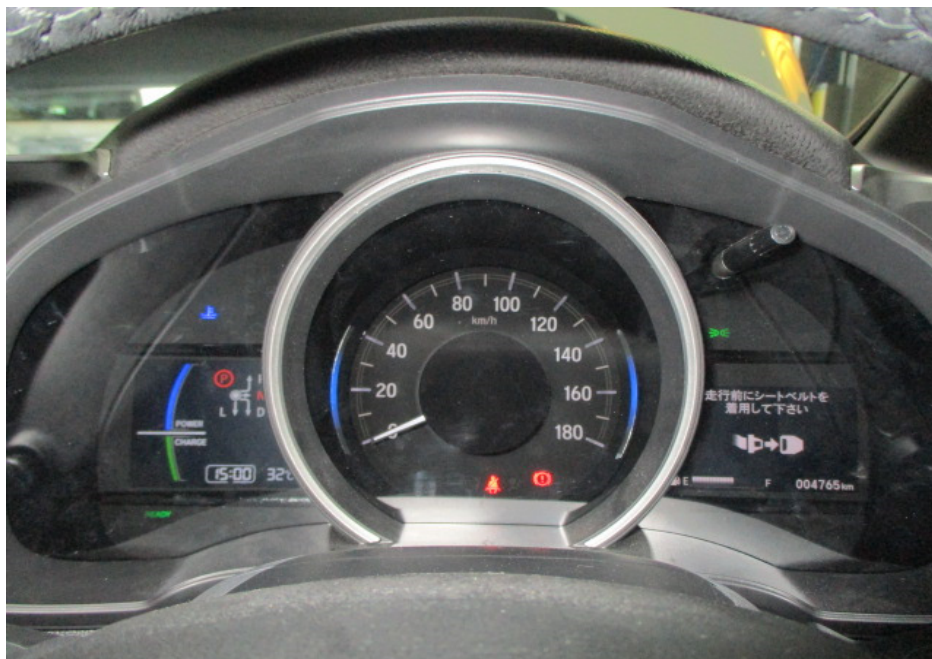
Photo 15 shows the respective warning lights no longer illuminated, indicating that there is no fault detected to the ABS, SRS, EPS, SC, LDW and CMBS systems of the Motor Car during the self-test. These electronic systems were hence in working condition at the time of my inspection.

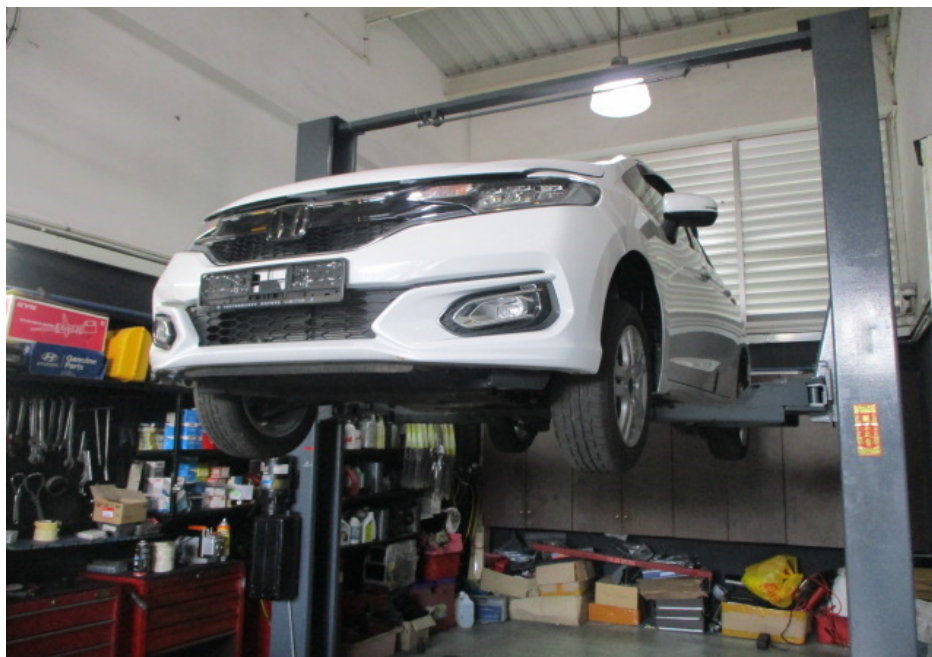
Photo 16 shows the Motor Car hoisted up for checks on its undercarriage. There was no sign(s) or indication(s) of fluid leakage and/or fluid stain(s) on the underside of the Motor Car. The undercarriage components of the Motor Car were also all observed to be intact and secured in an appropriate manner.

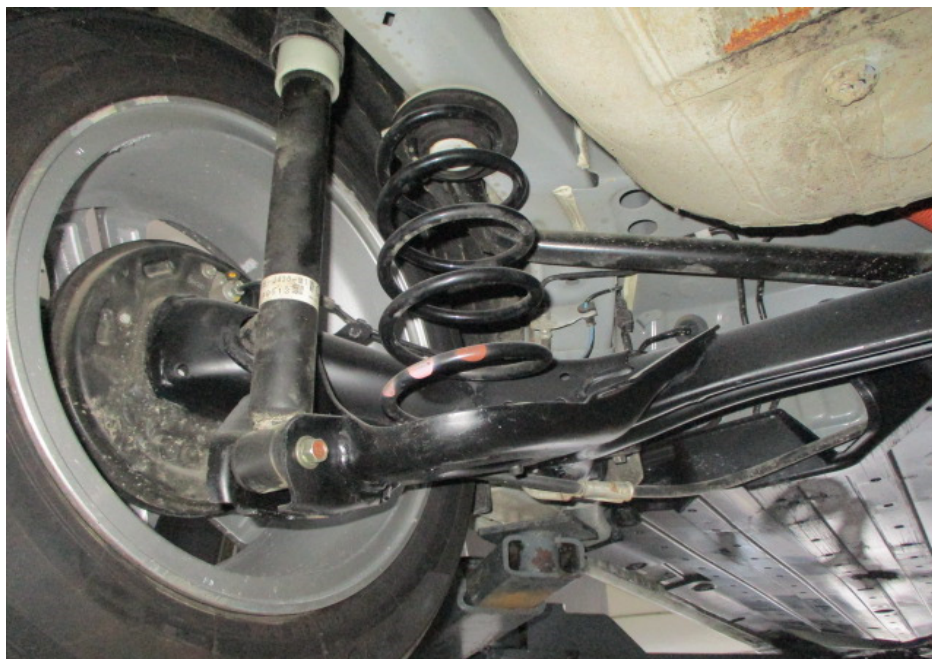
Photo 17 shows a general view of the control arms and linkages at the rear left wheel of the Motor Car. I did not observe any fluid leak and/or fluid stain on the underside of the Motor Car. All the Motor Car's undercarriage components were observed to be intact and secured in an appropriate manner.

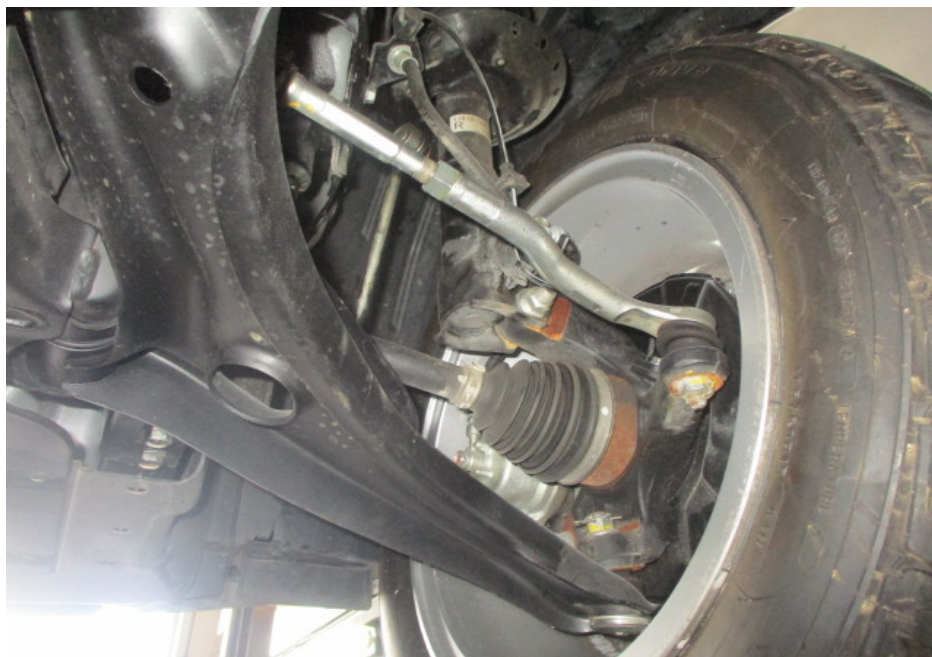
Photo 18 shows the various undercarriage components at the front right wheel of the Motor Car. The mechanical components, control arms and linkages were all found to be intact and secured in an appropriate manner.

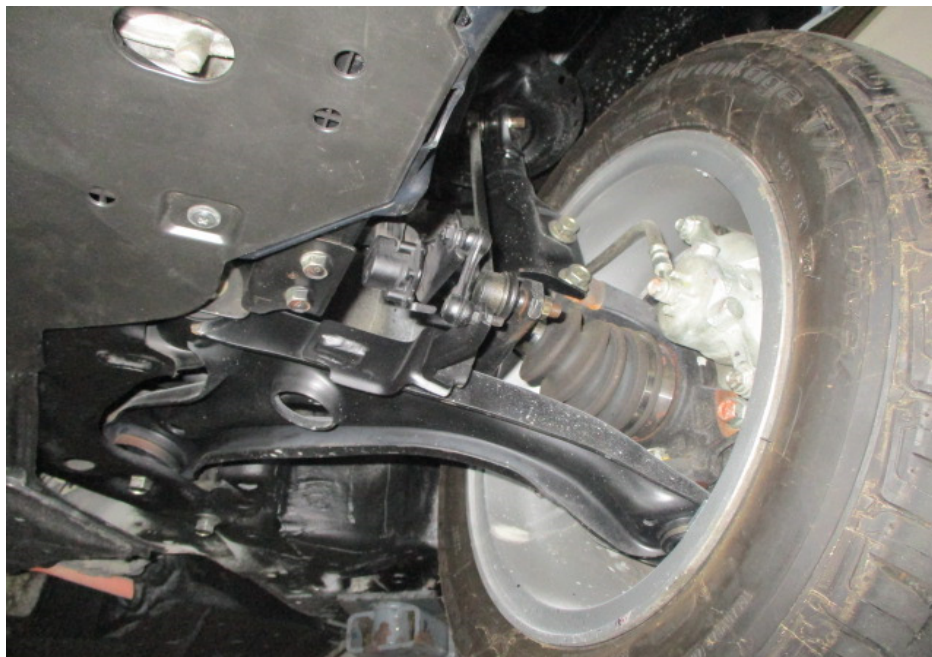
Photo 19 shows the various undercarriage components at the front left wheel of the Motor Car. The mechanical components, control arms and linkages were all found to be intact and secured in an appropriate manner. I also did not observe any fluid leak and/or fluid stain on the underside of the Motor Car.

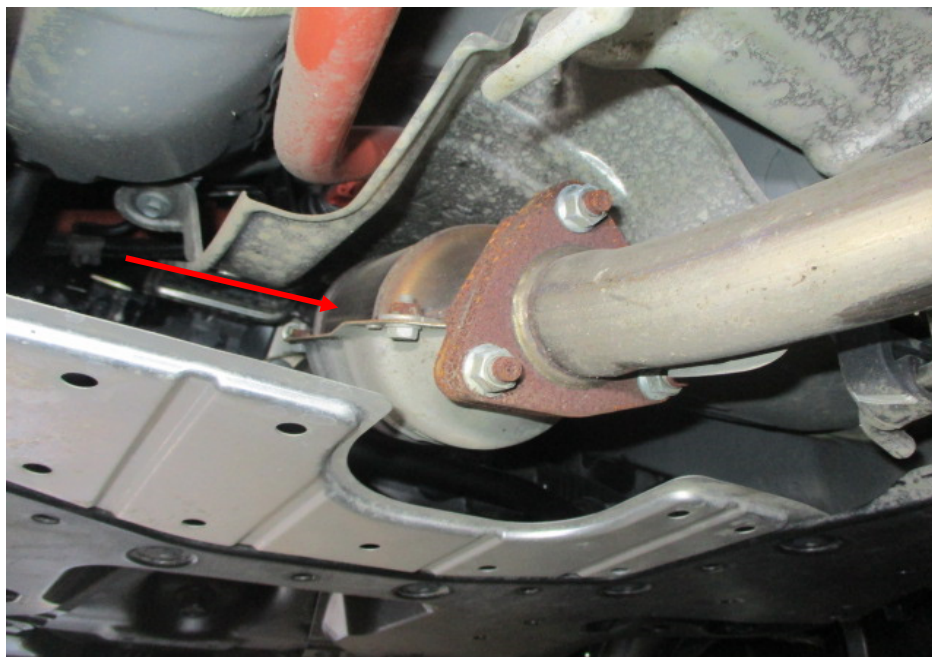
Photo 20 shows the Motor Car's catalytic convertor (arrowed). My examination of the Motor Car's exhaust system revealed no sign(s) or indication(s) of any cut or weld marks along its exhaust pipes and on its rear muffler.

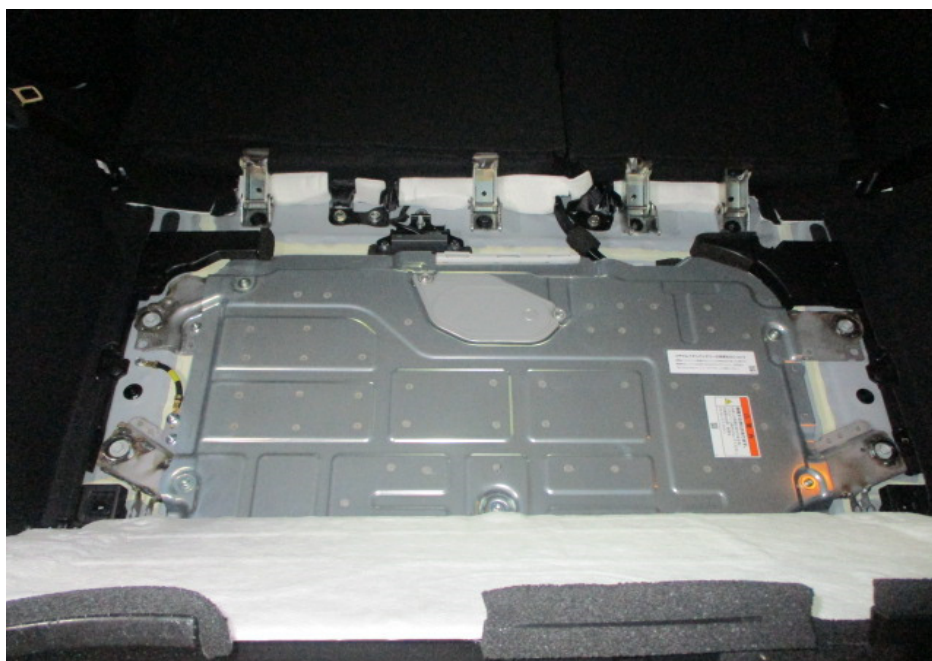
Photo 21 shows the Motor Car's electric battery that was fitted within the interior compartment, at its rear luggage compartment. The cable connections were checked and found to be securely fitted into the respective connectors. The electric battery was also observed to be fitted securely and not mounted onto any part of the Motor Car's chassis/structural body.

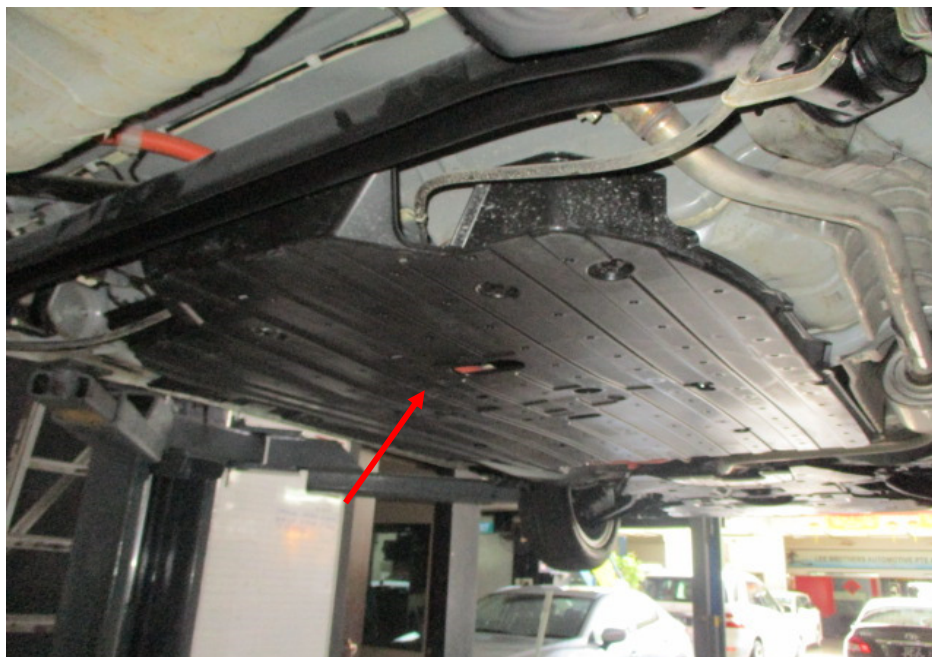
Photo 22 shows the underside of the Motor Car. I had observed that the electric cables connecting the electric motor within the engine compartment to the electric battery at the rear of the Motor Car were securely fitted into the respective connectors and protected by a dust cover (arrowed).

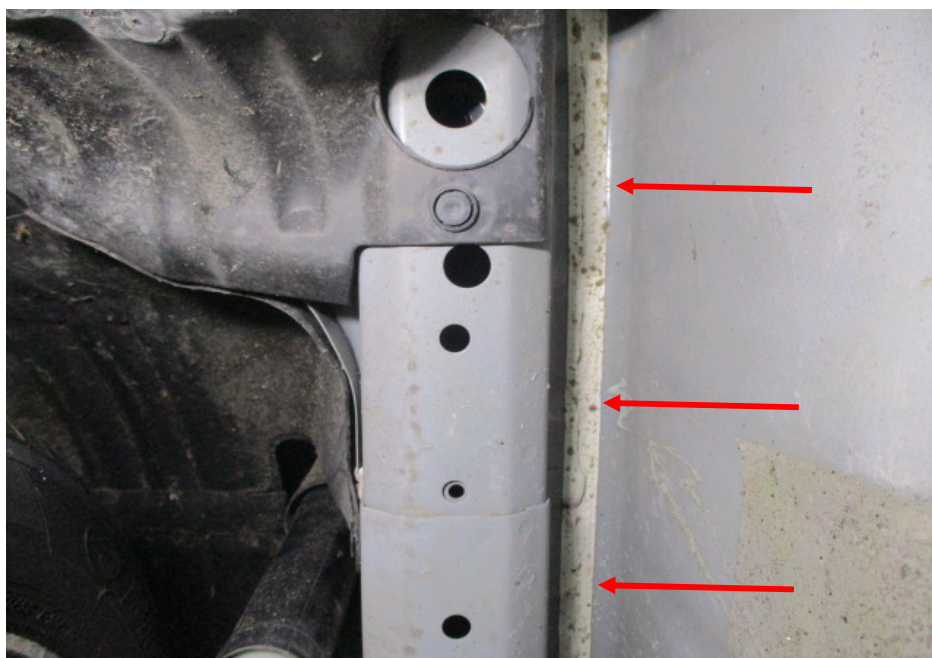
Photo 23 shows the chassis/structural body at the underside rear left of the Motor Car. The original factory sealant (arrowed) at the joints along the chassis/structural body was untouched, indicating no work was done on the chassis/structural body of the Motor Car and that the chassis/structural body was originally fitted.

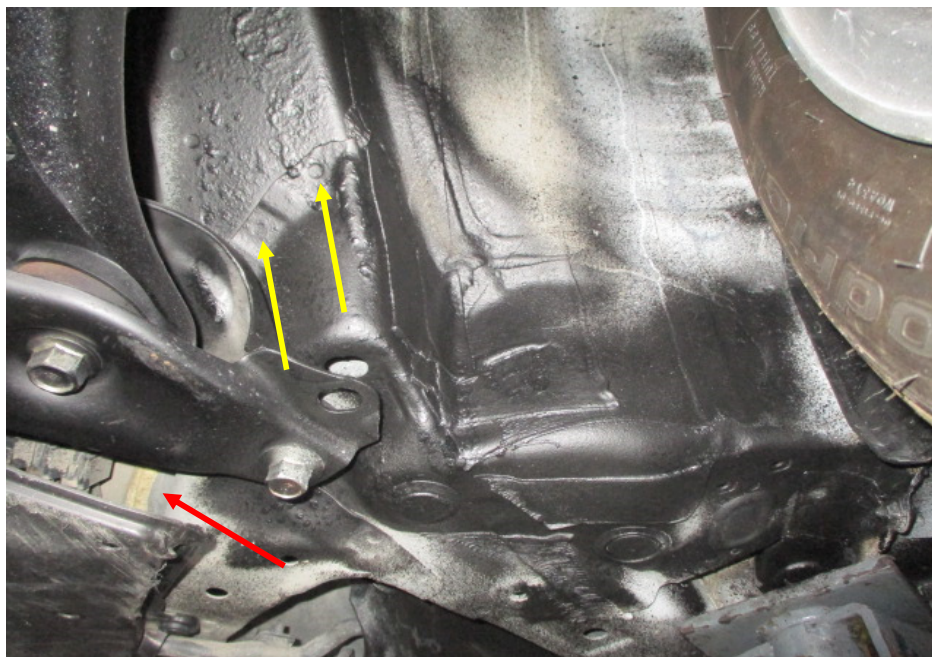
Photo 24 shows the chassis/structural body at the underside front left of the Motor Car. Although the front left chassis was coated with anti-corrosion protection, I was still able to observe original spot weld marks (yellow arrow) on the front left chassis of the Motor Car. The original factory sealant (red arrow) was also visible at some areas. This would indicate to me that the front left chassis of the Motor Car was originally fitted.

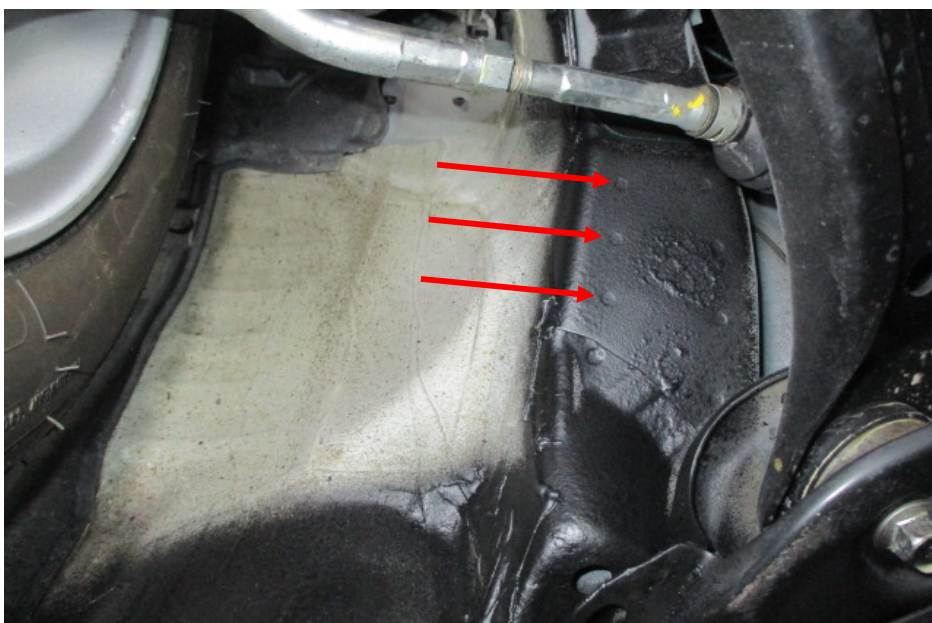
Photo 25 shows the chassis/structural body at the underside front right of the Motor Car. The front right chassis was also coated with anti-corrosion protection. Similar to the front left chassis, I was still able to observe original spot weld marks (arrowed) on the front right chassis of the Motor Car. In general, I had found no work was carried out on the chassis/structural body of the Motor Car. The chassis/structural body of the Motor Car was originally fitted.

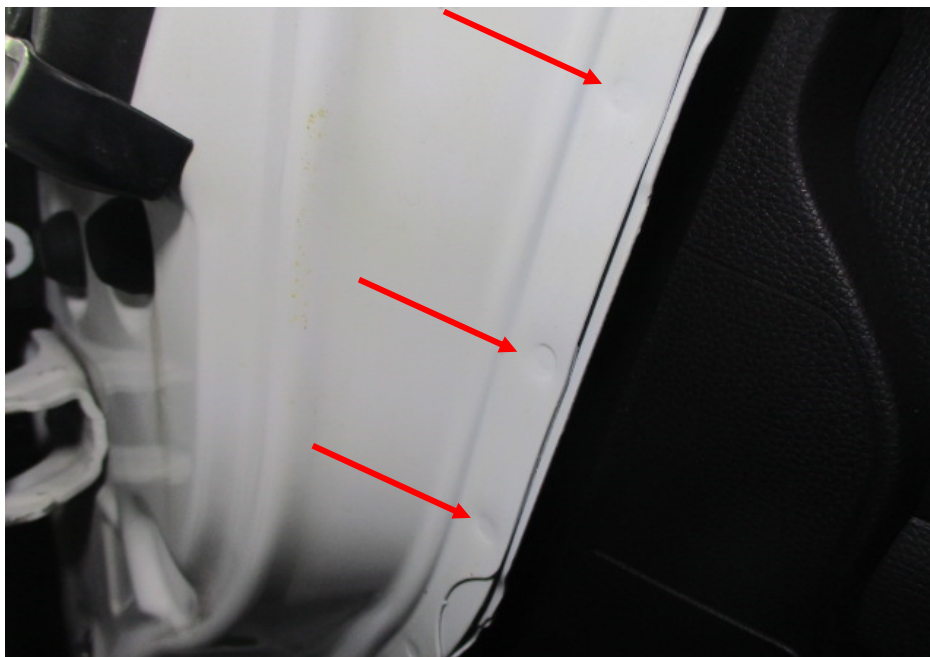
Photo 26 shows the left side "A" pillar of the Motor Car. I did not find any weld marks other than original spot weld marks (arrowed) on the left side "A" pillar of the Motor Car which, indicates that there was no re-welding works carried out. In general, I had found all the non-detachable body panels of the Motor Car to be originally fitted at the time of my inspection.
