VEHICLE DAMAGE INSPECTION REPORT

Our Ref: 277/TP/2020

Date of loss: 17/11/2020
Claimant: Uka Leasing Pte Ltd

Reg No:	GBH2821T	Make &	Toyota
Reg date:	4/4/2018	Model	Hiace
Colour:	White	Engine No:	1KD2796485
Type:	Van	Chassis No:	JTFHT02P100242131
Type of Claims:	Third Party	Odometer No:	33310km
		Engine Cap:	2982cc

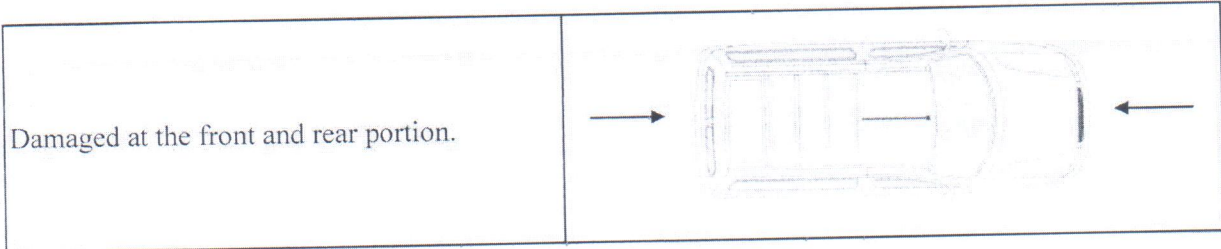
POINT OF IMPACT

Our visual inspection of the vehicle revealed that the damages noted are at the front and rear portion.
