Your Ref: Audi TT  
(chassis number TRUZZZFV1L1000422)  
Our Ref : CI/TP21001653/D

04 February 2021

**INSPECTION REPORT OF AN UNREGISTERD AUDI TT MOTOR CAR WITH  
CHASSIS NUMBER TRUZZZFV1L1000422**

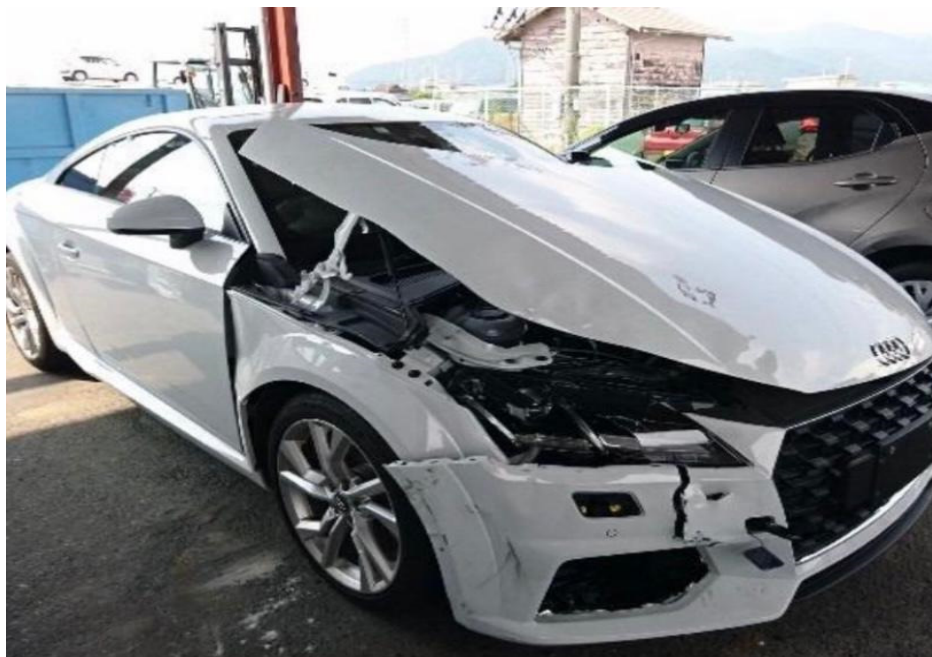
3. From the photographs provided to me, it was observed that the Motor Car had sustained damages at its frontal portion. Body parts damaged at the frontal portion include the front bumper, front bumper right lower grille, front right headlamp, front grille, front bonnet, front bonnet hinges and front right fender amongst others.
4. No physical damage was observed to other areas of the Motor Car. The airbags of the Motor Car were also not activated as seen from the photographs that were provided to me. See photo 1 – 4 below.

**Photo 1** shows the front right body of the Motor Car (photograph provided to me). The Motor Car was observed to have sustained damage at its frontal portion. The front bumper, front right headlamp, front grille, front bumper right lower grille and front bonnet were amongst the body parts that were observed to have been damaged.

22. The body parts at the frontal portion of the Motor Car were visually examined and it was noted that the repair/restoration works carried out to the damaged area of the Motor Car (refer to photograph 1 & 2 above) were reasonably adequate and in order.

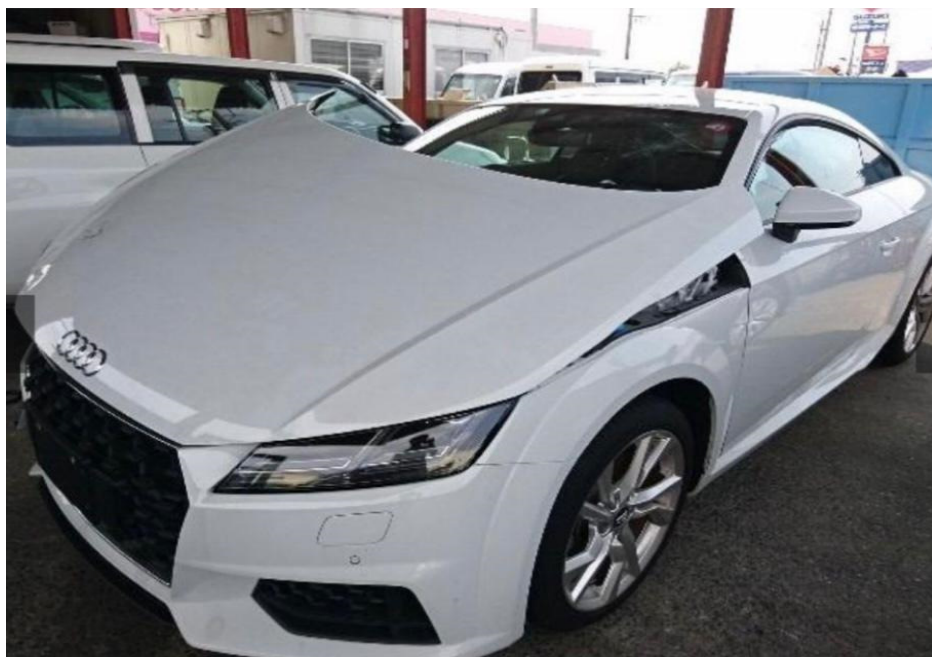
**Photo 2** shows the front left body of the Motor Car (photograph provided to me). The Motor Car was observed to have sustained damage at its frontal portion. The front bonnet and front bonnet hinges were amongst the body parts that were observed to have been damaged.

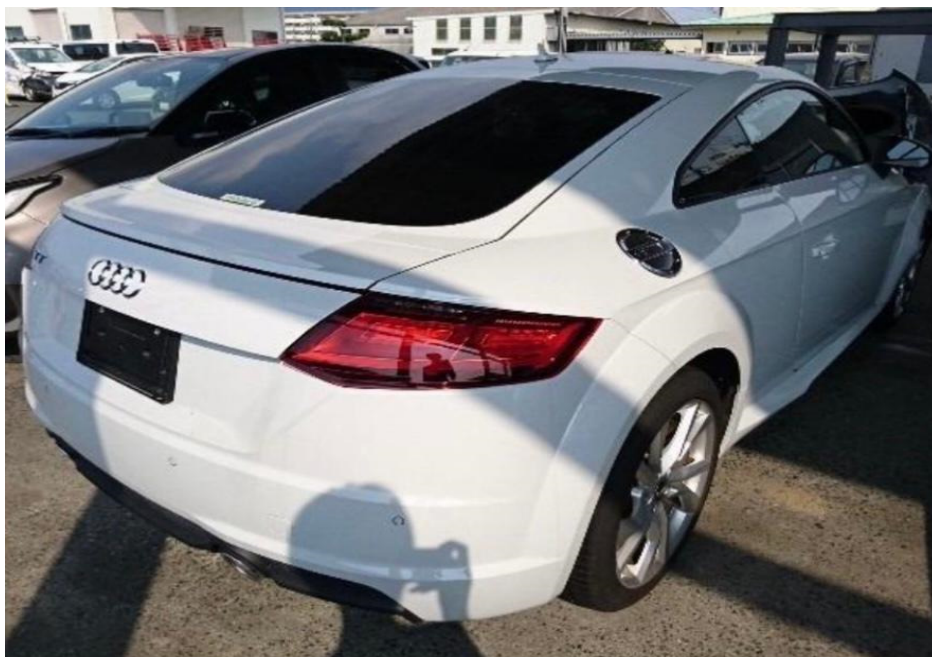
**Photo 3** shows the rear right body of the Motor Car (photograph provided to me). Apart for the frontal portion, there was no physical damage seen to other areas of the Motor Car.

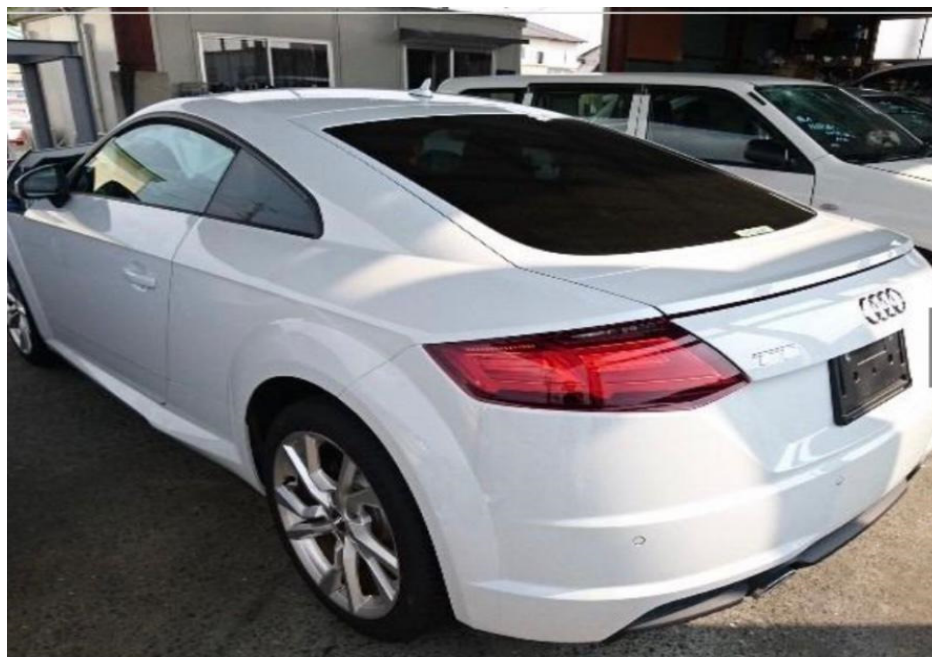
**Photo 4** shows the rear left body of the Motor Car (photograph provided to me). Apart for the frontal portion, there was no physical damage seen to other areas of the Motor Car. The airbags of the Motor Car were also not activated as seen from the photographs that were provided to me.

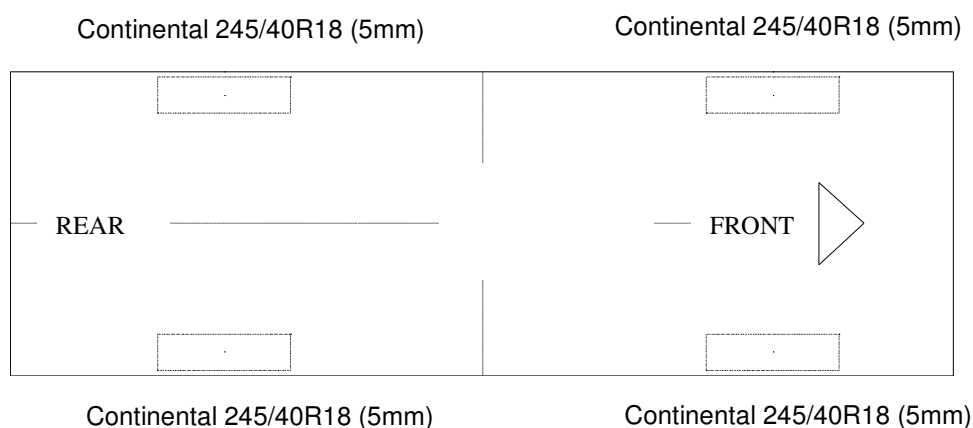
8. It was fitted with 18inch sport wheel rims that were wrapped with tyres that were observed to be of serviceable condition. The tyres were also sufficiently inflated for vehicular operation. The tyre brand, tyre size and approximate remaining tread depth of the 4 tyres of the Motor Car were recorded as follows: -

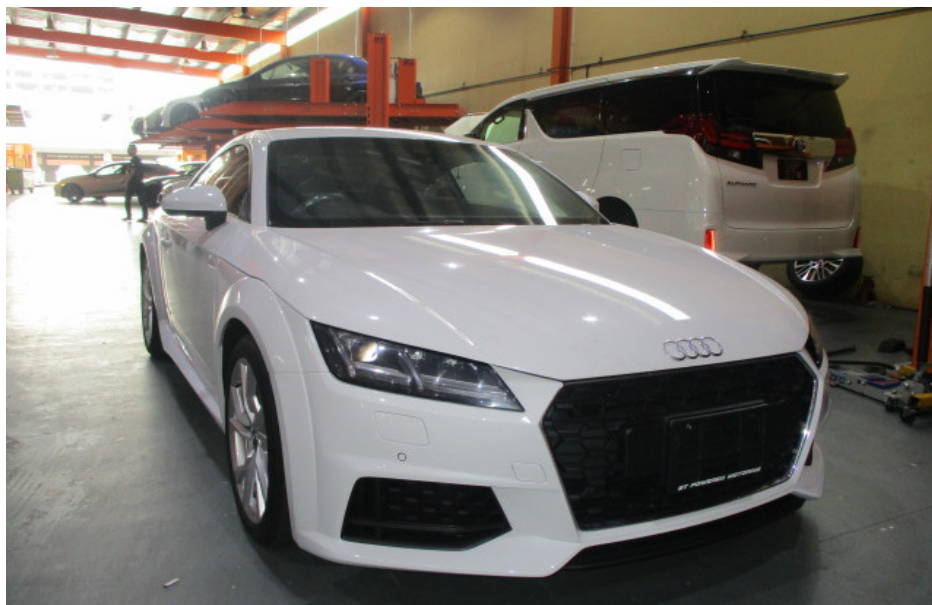
**Photo 5** shows a general view of the front right body of the Motor Car at the time of my inspection. The Motor Car was observed to be in a relatively good general condition with no loose exterior fittings observed. The body parts at the frontal portion of the Motor Car were visually examined and it was observed that the repair/restoration works carried out to the damaged area of the Motor Car (refer to photograph 1 & 2 above) were reasonably adequate and in order.

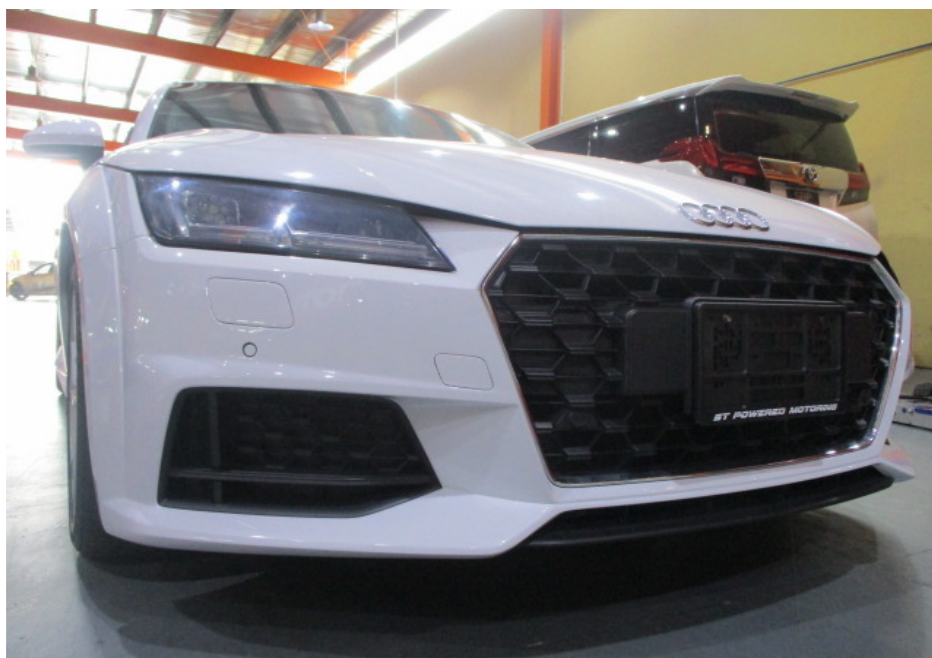
**Photo 6** shows a closer view of the front bumper, front bumper right lower grille, front right headlamp, front bonnet and front grille of the Motor Car at the time of my inspection. The body parts at the frontal portion of the Motor Car were visually examined and it was observed that the repair/restoration works carried out to the damaged area of the Motor Car (refer to photograph 1 & 2 above) were reasonably adequate and in order.

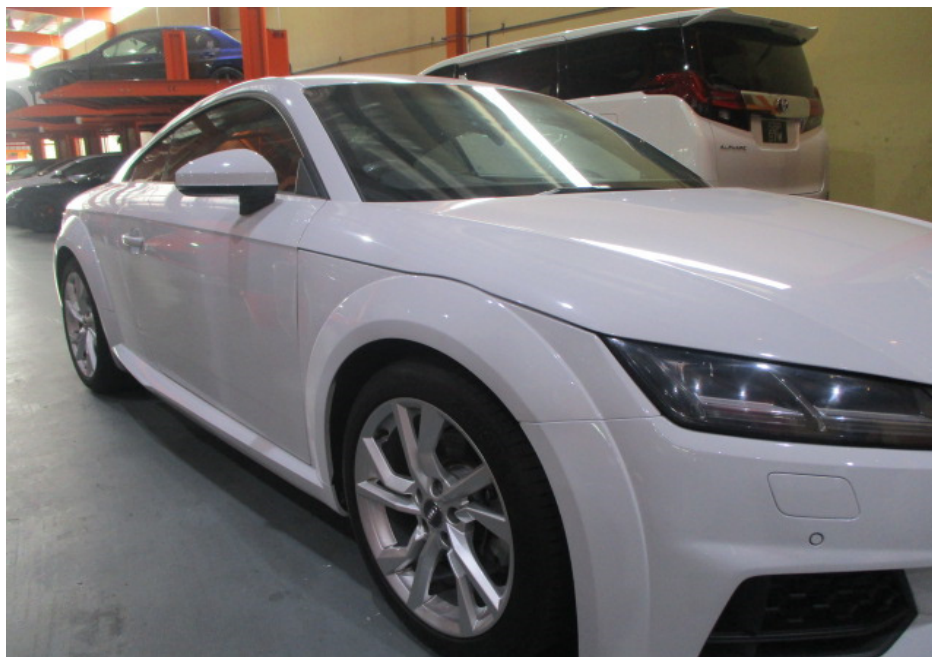
**Photo 7** shows a closer view of the front bumper, front right headlamp, front bonnet and front right fender of the Motor Car at the time of my inspection. The body parts at the frontal portion of the Motor Car were visually examined and it was observed that the repair/restoration works carried out to the damaged area of the Motor Car (refer to photograph 1 & 2 above) were reasonably adequate and in order.

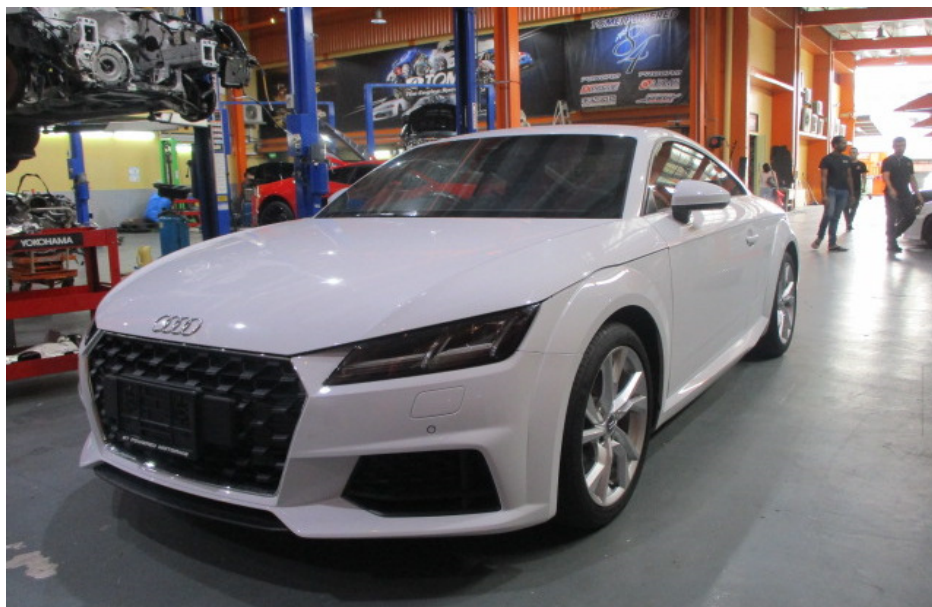
**Photo 8** shows a general view of the front left body of the Motor Car at the time of my inspection. The Motor Car was observed to be in a relatively good general condition with no loose exterior fittings observed. The body parts at the frontal portion of the Motor Car were visually examined and it was observed that the repair/restoration works carried out to the damaged area of the Motor Car (refer to photograph 1 & 2 above) were reasonably adequate and in order.

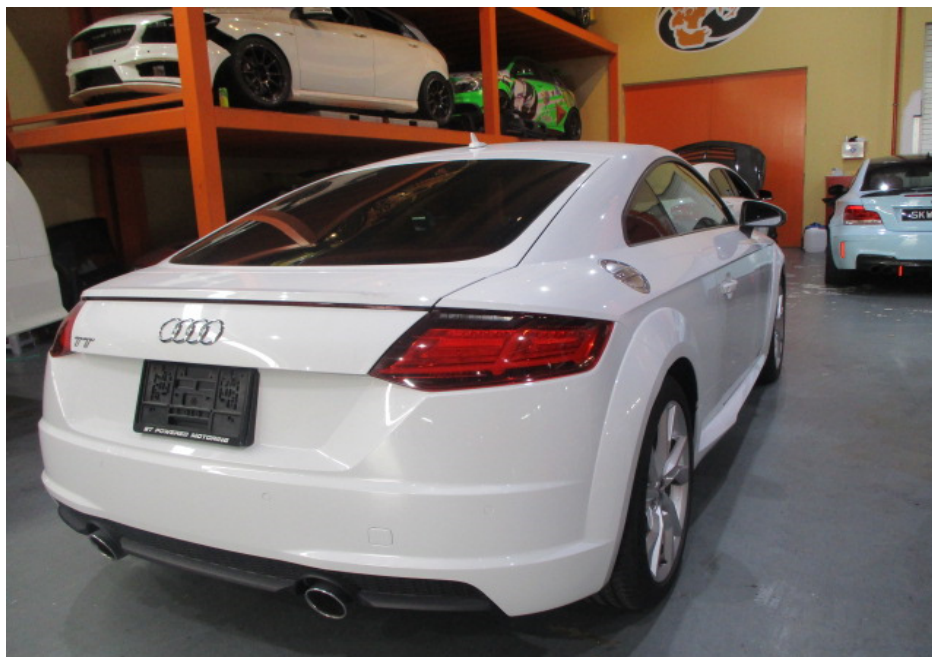
**Photo 9** shows a general view of the rear right body of the Motor Car at the time of my inspection. The Motor Car was observed to be in a relatively good general condition with no loose exterior fittings observed. The mileage of the Motor Car recorded at the time of my inspection was 6,162km.

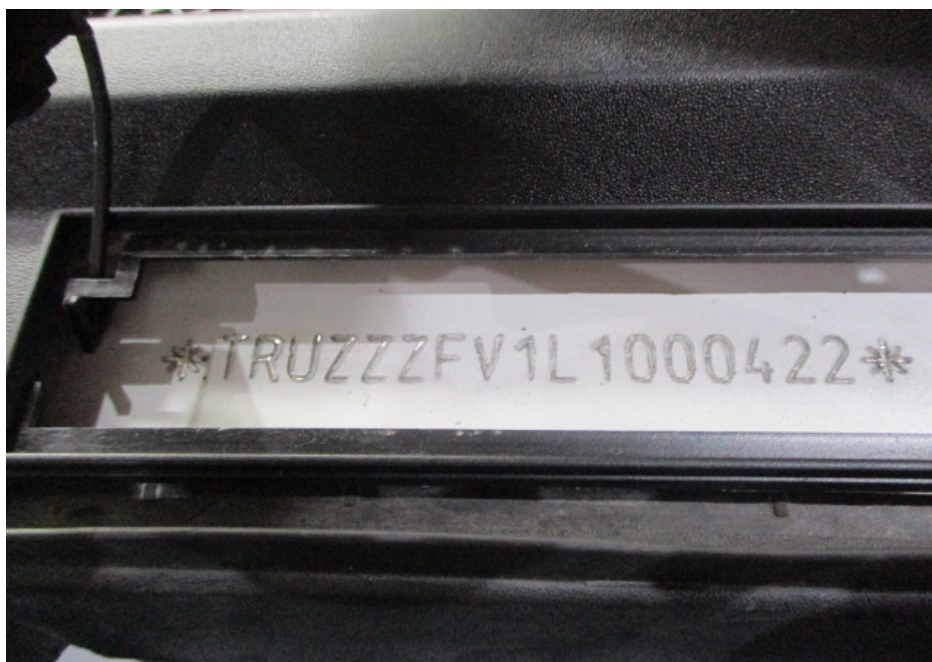
**Photo 10** shows the chassis number of the Motor Car. The chassis number recorded was TRUZZZFV1L1000422.

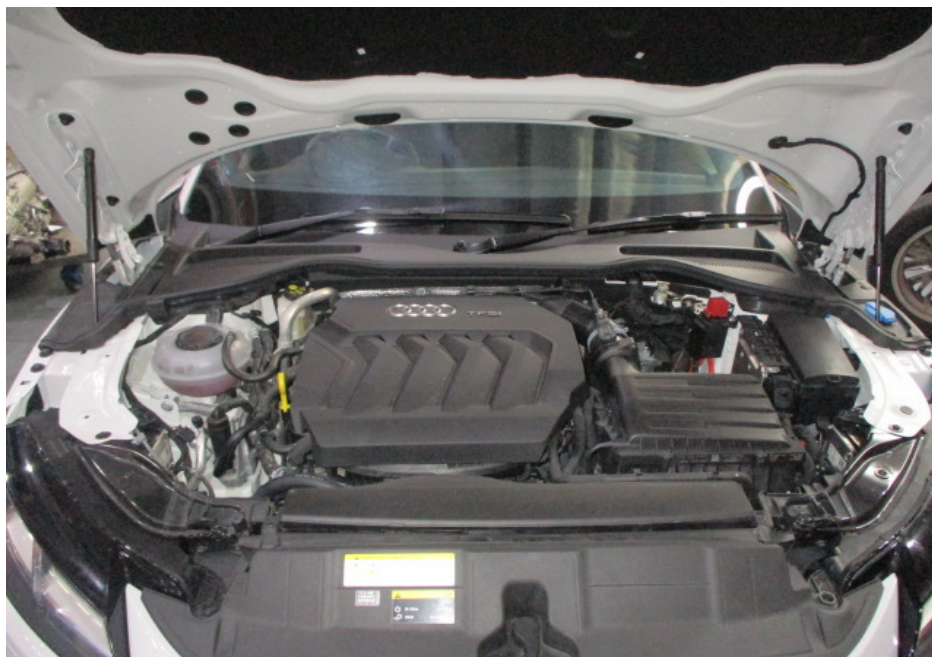
14. My examination of the engine compartment of the Motor Car revealed that the various parts and components inside the engine compartment were all intact and properly fitted. The engine oil, brake fluid and engine coolant were all found to be of sufficient level for operating purposes. Visually, there was also no contamination found to these fluids.
15. My checks on the underside of the Motor Car revealed no sign(s) or indication(s) of fluid leakage and/or fluid stain(s). The engine block and automatic transmission assembly were both secured properly. All undercarriage components of the Motor Car were also observed to be intact and secured in an appropriate manner.

**Photo 11** shows a general view of the engine compartment of the Motor Car at the time of my inspection. The various parts and components inside the engine compartment were all observed to be intact and properly fitted. There was also no sign(s) or indication(s) of fluid leak and/or fluid stain found inside the engine compartment.

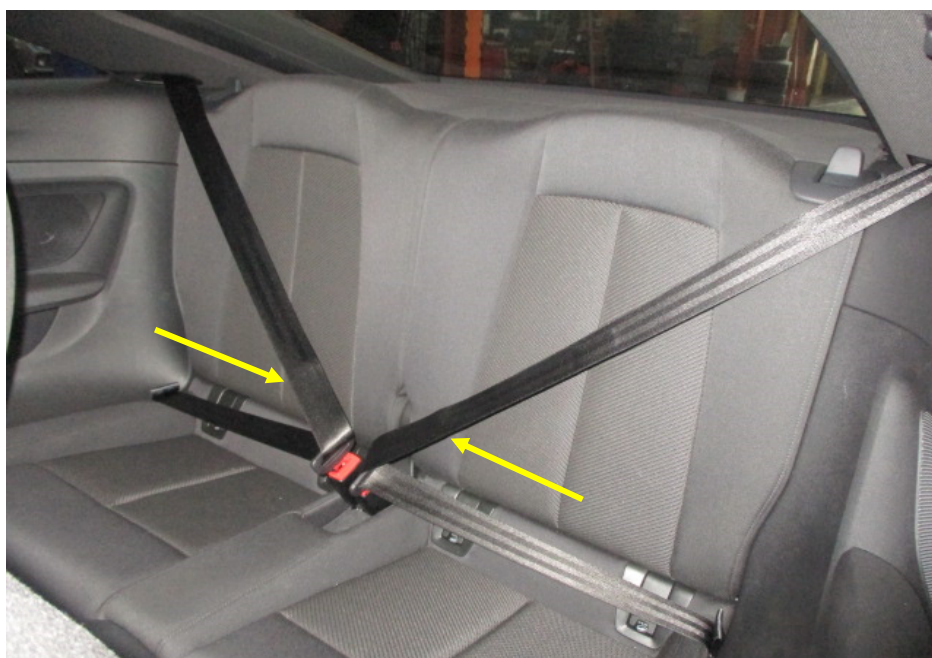
12. The seats of the Motor Car were found to be secured to the floorboard of the Motor Car via seat rails bolted onto the floorboard. Retractable seat belt reels and pre-tensioners were fitted on all seats of the Motor Car. The seat belts were tested and were able to be fastened securely into the respective pre-tensioners that were fixed to the side of all the seats.

**Photo 12** shows the rear seats of the Motor Car. All the seats of the Motor Car were secured via seat rails to the floorboard. They were also fitted with a retractable seat belt reel and a pre-tensioner. The seat belts (arrowed) were tested and were able to be fastened into the respective pre-tensions that were fitted on the side of each individual seat.

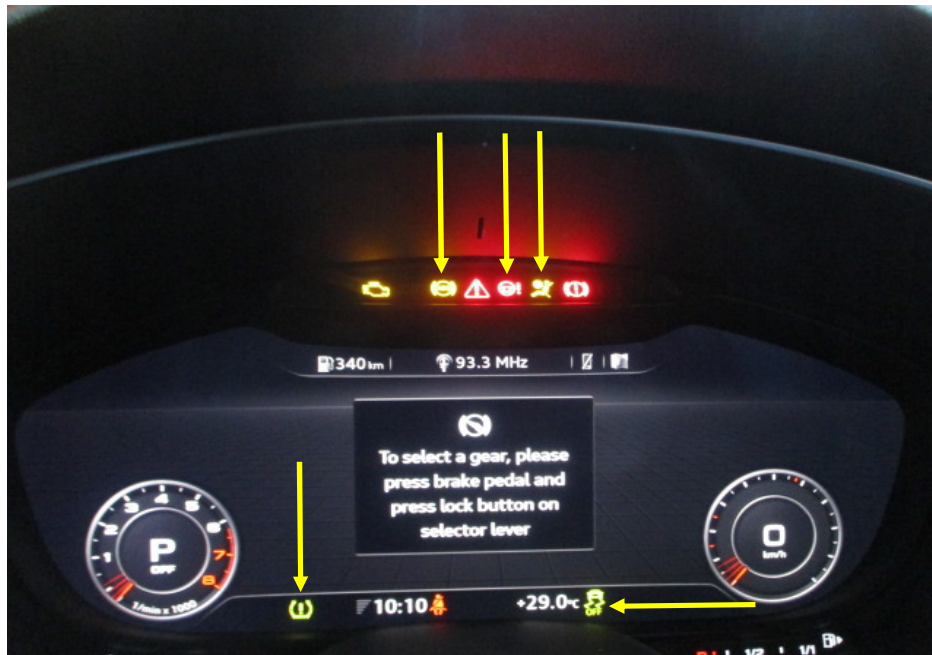
**Photo 13** shows the warning lights for the various electronic safety features appearing on the instrument panel of the Motor Car during its self-test when the engine is cranked, in particular the ABS, SRS, EPS, TPM and ESC lights (arrowed).

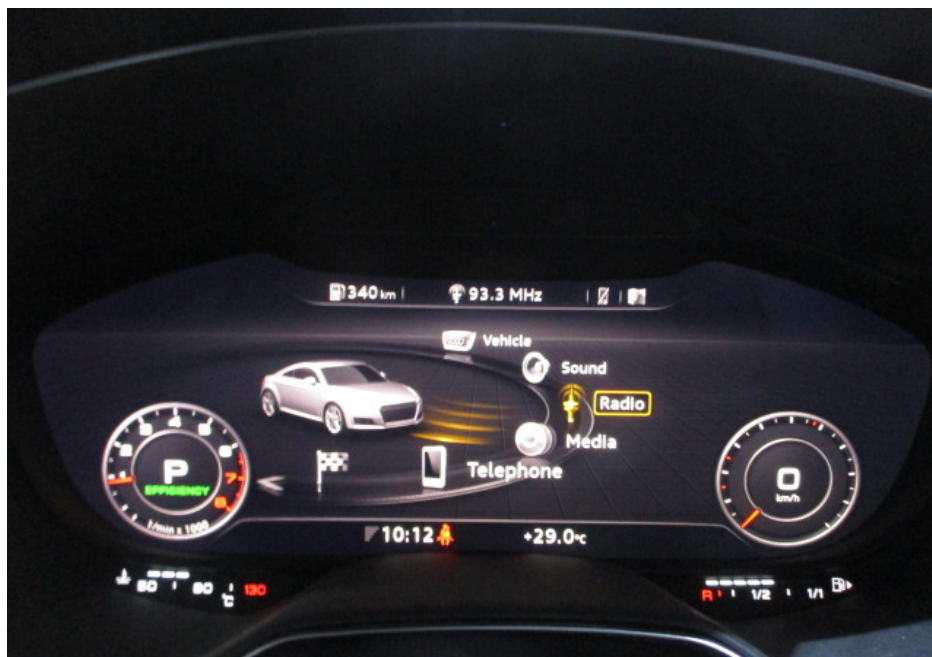
13. The Motor Car's automatic self-test of the functionality of its various electronic safety features like the Anti-Lock Brake System (ABS), Supplemental Restraint System (SRS), Electronic Power Steering (EPS), Tyre Pressure Monitor (TPM) and Electronic Stability Control (ESC) during cranking of the engine had indicated that these electronic systems were in working condition. This was determined from the respective warning lights disappearing from the instrument panel after the self-test.

**Photo 14** shows the respective warning lights no longer illuminated, indicating that there is no fault detected to the ABS, SRS, EPS, TPM and ESC systems of the Motor Car during the self-test. These electronic systems were hence in working condition at the time of my inspection.

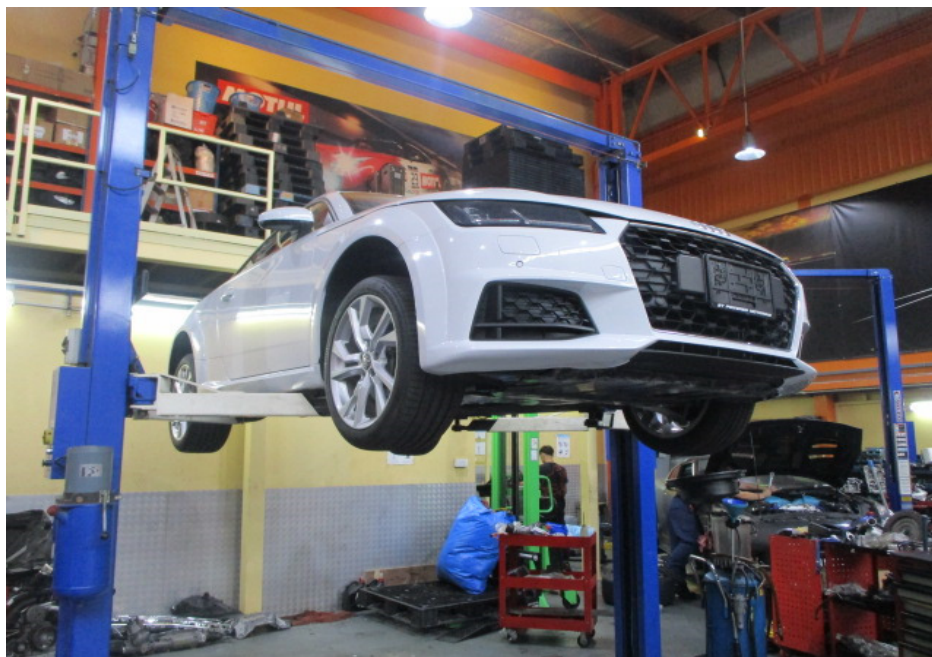
**Photo 15** shows the Motor Car hoisted up for checks on its undercarriage. There was no sign(s) or indication(s) of fluid leakage and/or fluid stain(s) on the underside of the Motor Car. The undercarriage components of the Motor Car were also all observed to be intact and secured in an appropriate manner.

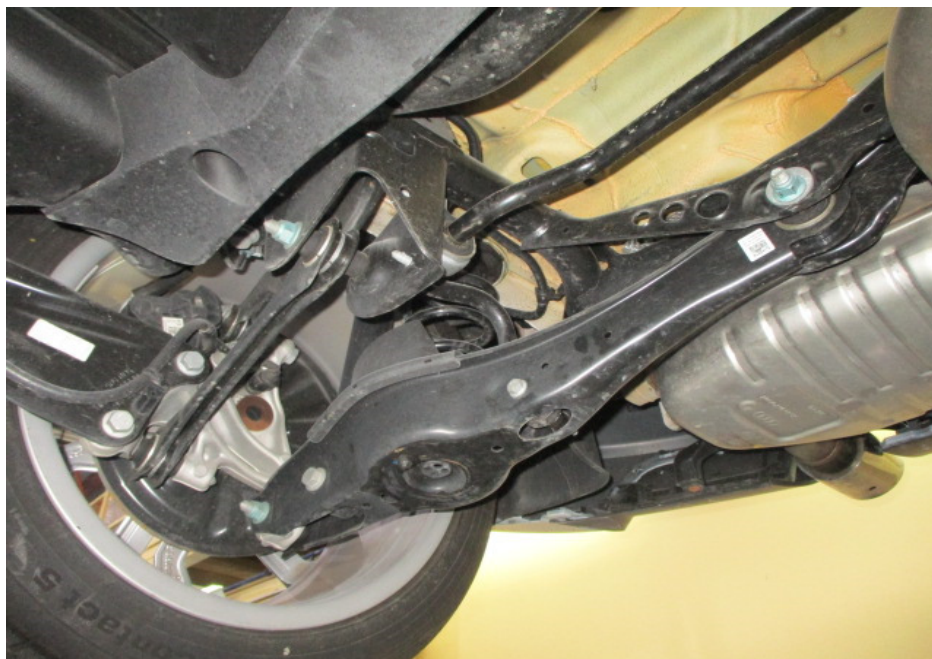
**Photo 16** shows a general view of the control arms and linkages at the rear right wheel of the Motor Car. I did not observe any fluid leak and/or fluid stain on the underside of the Motor Car. All of the Motor Car's undercarriage components were observed to be intact and secured in an appropriate manner.

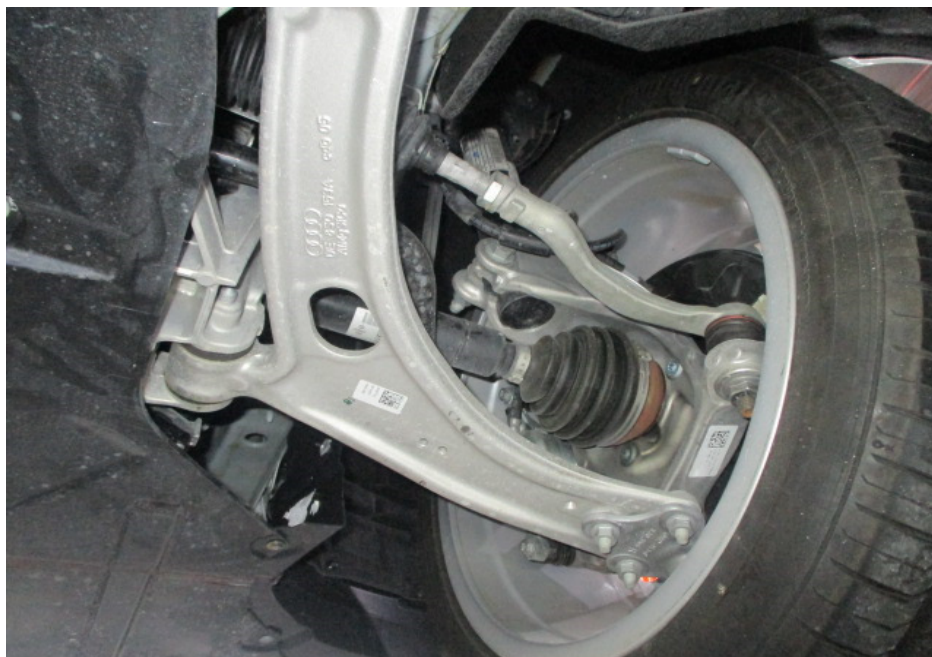
**Photo 17** shows the various undercarriage components at the front right wheel of the Motor Car. The mechanical components, control arms and linkages were all found to be intact and secured in an appropriate manner.

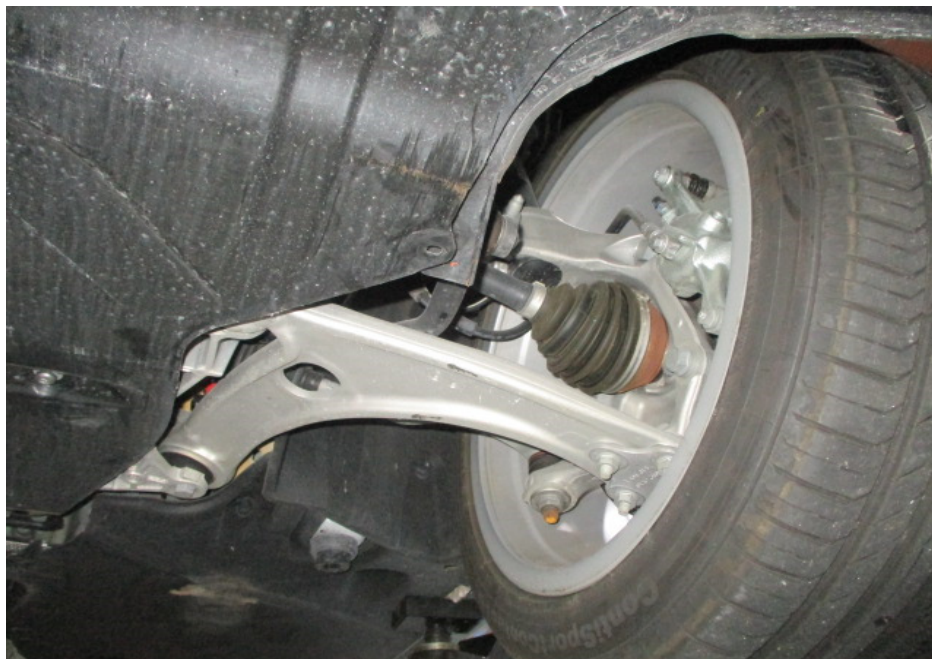
**Photo 18** shows the various undercarriage components at the front left wheel of the Motor Car. The mechanical components, control arms and linkages were all found to be intact and secured in an appropriate manner. I also did not observe any fluid leak and/or fluid stain on the underside of the Motor Car.

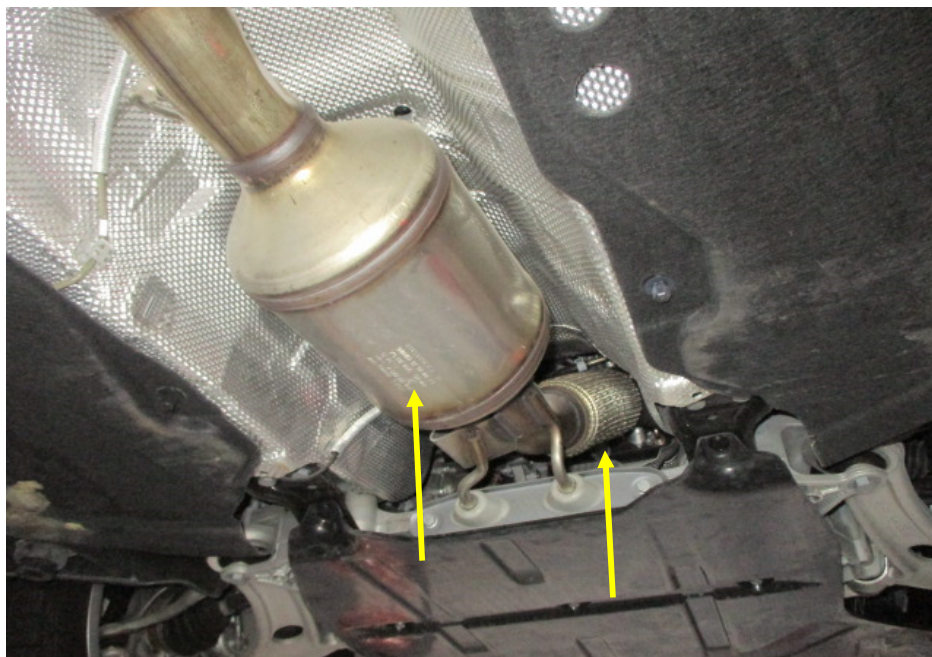
**Photo 19** shows the Motor Car's catalytic converters (arrowed). My examination of the Motor Car's exhaust system revealed no sign(s) or indication(s) of any cut or weld marks along its exhaust pipes and on its rear muffler.

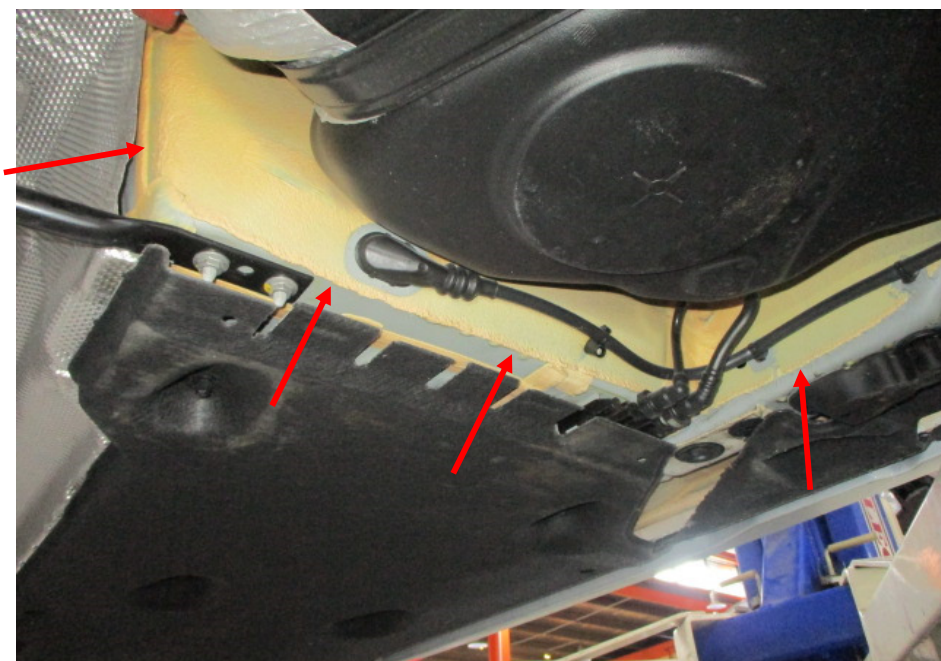
**Photo 20** shows the floorboard at the underside right centre of the Motor Car. The original factory sealant (arrowed) at the joints along the floorboard (non-detachable body panel) was untouched, indicating no work was done on the floorboard of the Motor Car. In general, I had found all the non-detachable body panels of the Motor Car to be originally fitted at the time of my inspection.

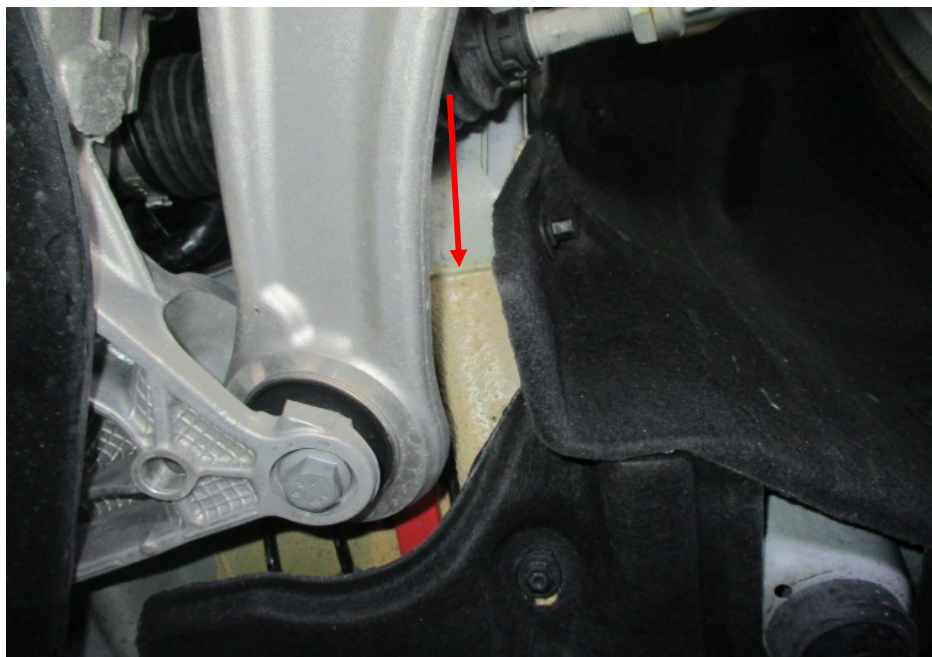
**Photo 21** shows the chassis/structural body at the underside front left of the Motor Car. The original factory sealant (arrowed) at the joints along the chassis/structural body was observed to be untouched. In general, I had found no work was carried out on the chassis/structural body of the Motor Car. The chassis/structural body of the Motor Car was originally fitted.

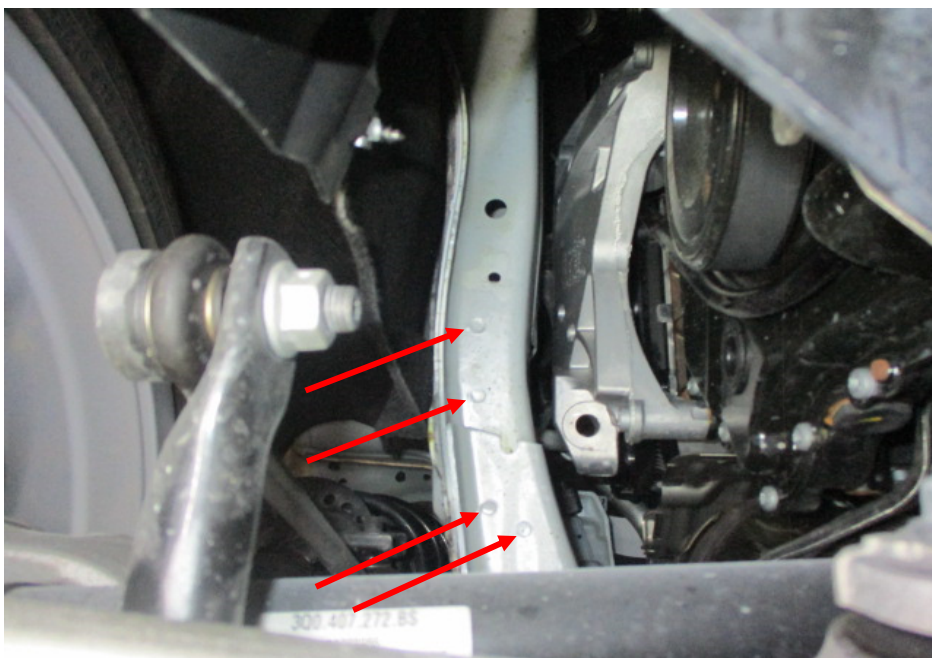
11. Visually, I did not find any weld marks, other than the original spot weld marks, on the chassis/structural body of the Motor Car. The original factory sealant at the joints along the chassis/structural body was also untouched, again indicating that no replacement of the chassis/structural body was carried out; and that the chassis/structural body was originally fitted.

**Photo 22** shows the chassis/structural body at the underside front right of the Motor Car. I did not find any weld marks other than original spot weld marks (arrowed) on the chassis/structural body of the Motor Car. The original factory sealant at the joints along the chassis/structural body was untouched, indicating no work was done on the chassis/structural body of the Motor Car and that the chassis/structural body was originally fitted.

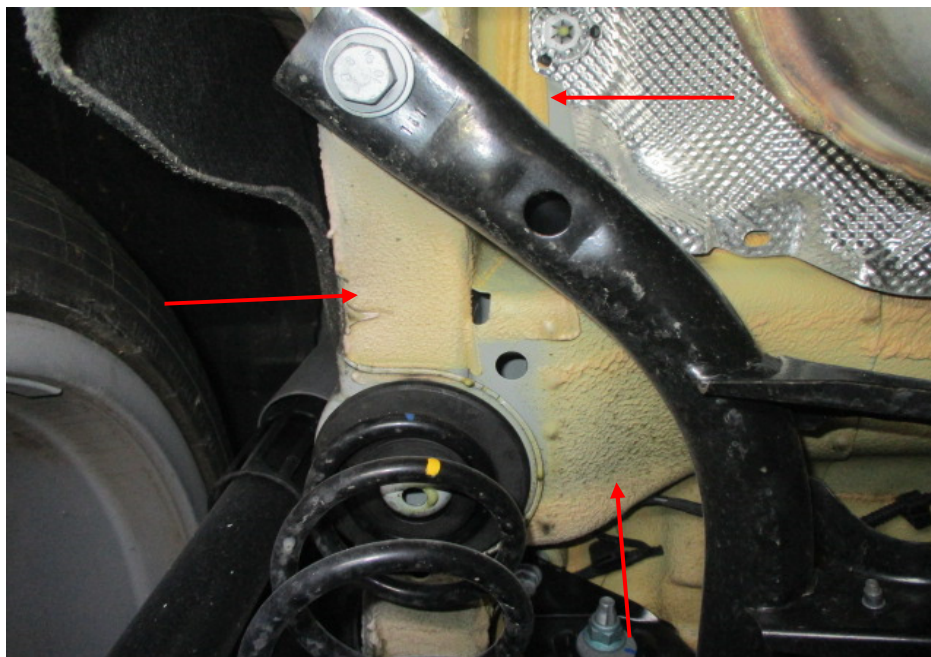
**Photo 23** shows the chassis/structural body at the underside rear left of the Motor Car. The original factory sealant (arrowed) at the joints along the chassis/structural body was observed to be untouched. In general, I had found no work was carried out on the chassis/structural body of the Motor Car. The chassis/structural body of the Motor Car was originally fitted.
