Your Ref: Mini Cooper S  
(chassis number WMWXR52000TM81667)  
Our Ref : CI/TP21001654/D

04 February 2021

**INSPECTION REPORT OF AN UNREGISTERD MINI COOPER S MOTOR CAR  
WITH CHASSIS NUMBER WMWXR52000TM81667**

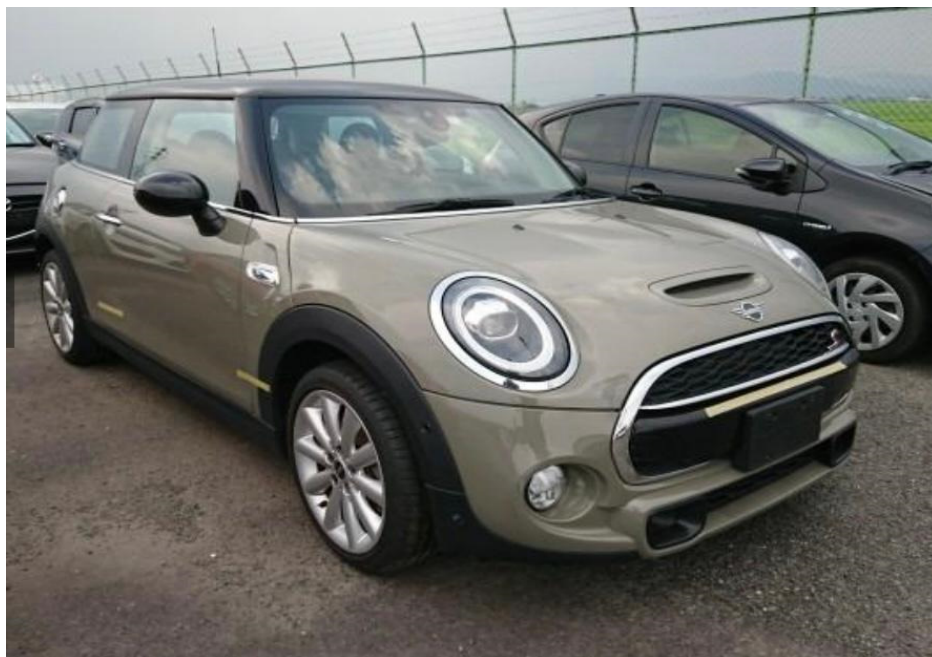
**Photo 1** shows the front right body of the Motor Car (photograph provided to me). There was no physical damage seen to the Motor Car from the photographs that were provided to me.

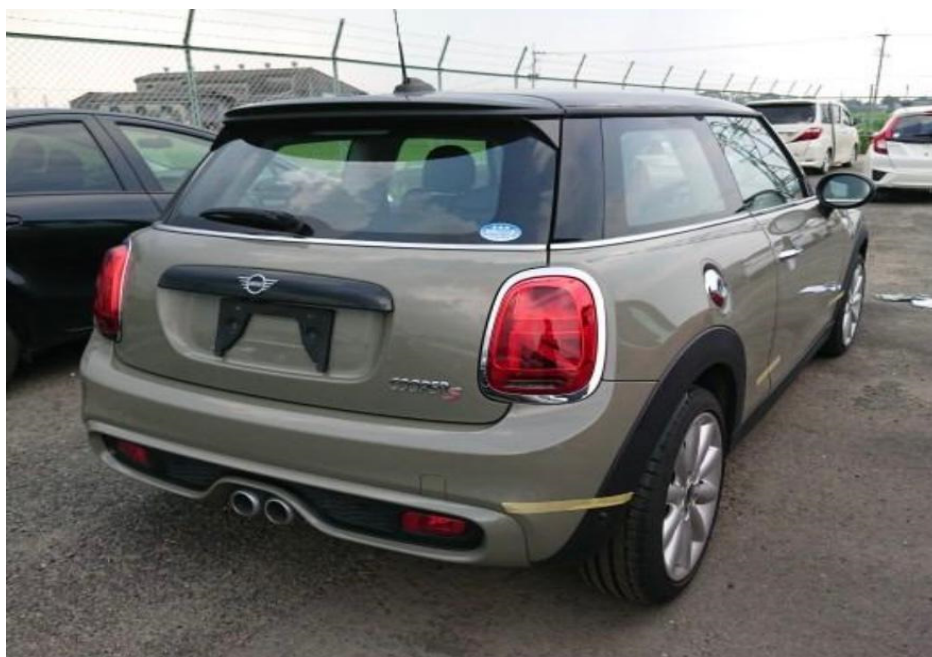
**Photo 2** shows the rear right body of the Motor Car (photograph provided to me). There was no physical damage seen to the Motor Car from the photographs that were provided to me.

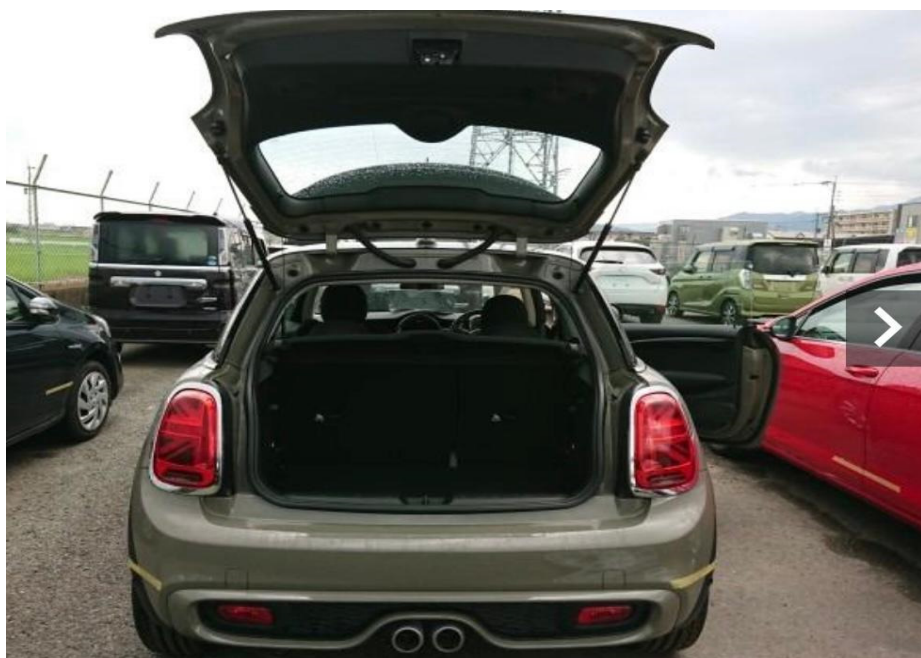
**Photo 3** shows the rear body of the Motor Car (photograph provided to me). There was no physical damage seen to the Motor Car from the photographs that were provided to me.

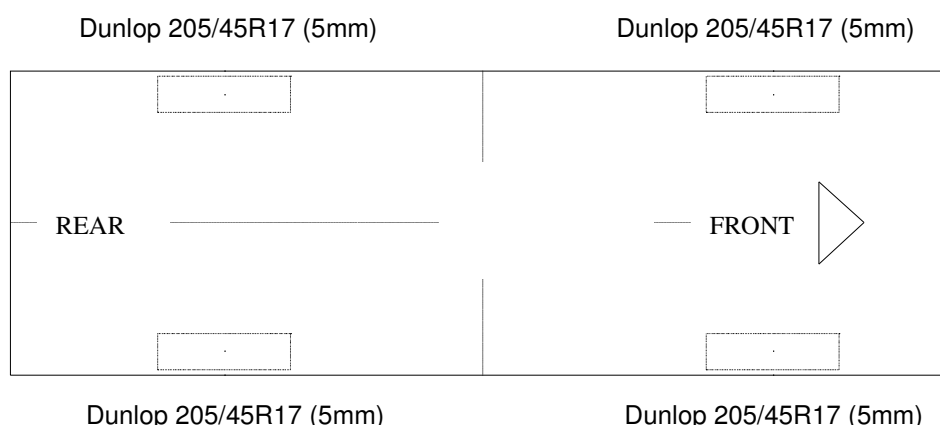
7. It was fitted with 17inch sport wheel rims that were wrapped with tyres that were observed to be of serviceable condition. The tyres were also sufficiently inflated for vehicular operation. The tyre brand, tyre size and approximate remaining tread depth of the 4 tyres of the Motor Car were recorded as follows: -

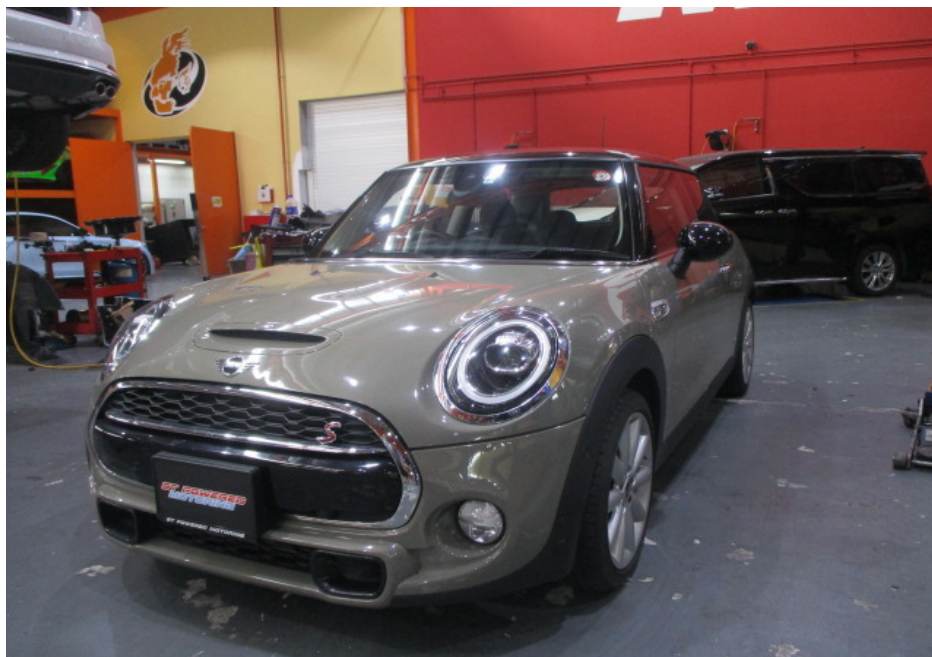
**Photo 4** shows a general view of the front left body of the Motor Car at the time of my inspection. The Motor Car was observed to be in a relatively good general condition with no loose exterior fittings observed. The mileage of the Motor Car recorded at the time of my inspection was 9,928km.

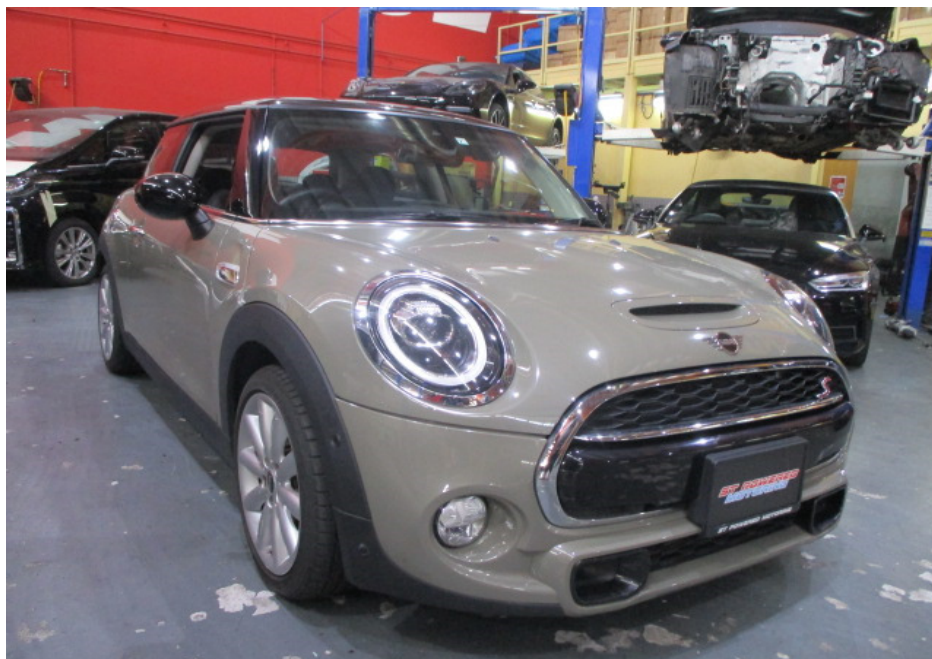
**Photo 5** shows a general view of the front right body of the Motor Car at the time of my inspection. The Motor Car was observed to be in a relatively good general condition with no loose exterior fittings observed. The mileage of the Motor Car recorded at the time of my inspection was 9,928km.

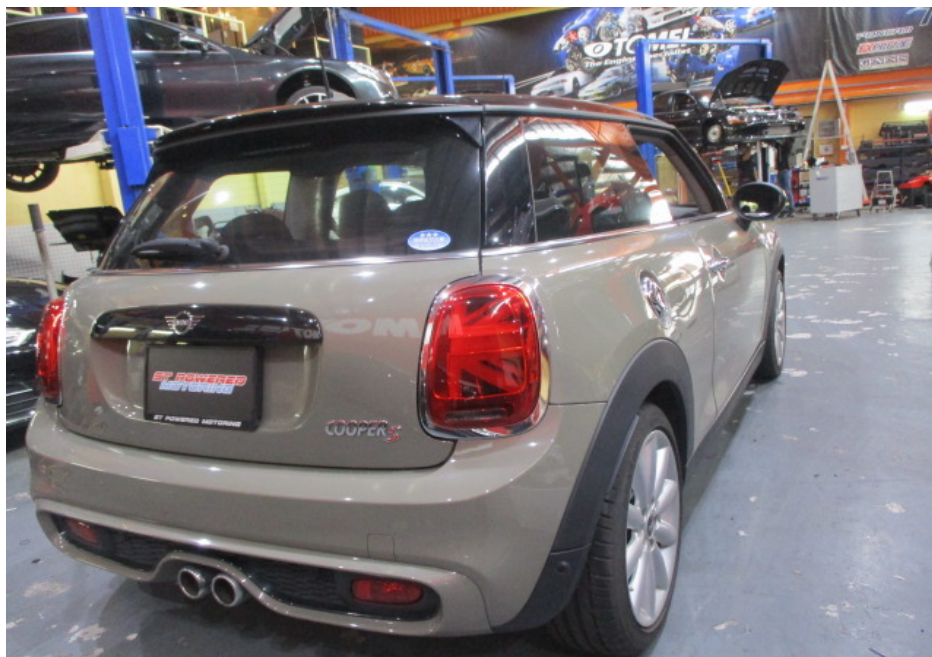
**Photo 6** shows a general view of the rear right body of the Motor Car at the time of my inspection. The Motor Car was observed to be in a relatively good general condition with no loose exterior fittings observed. The mileage of the Motor Car recorded at the time of my inspection was 9,928km.

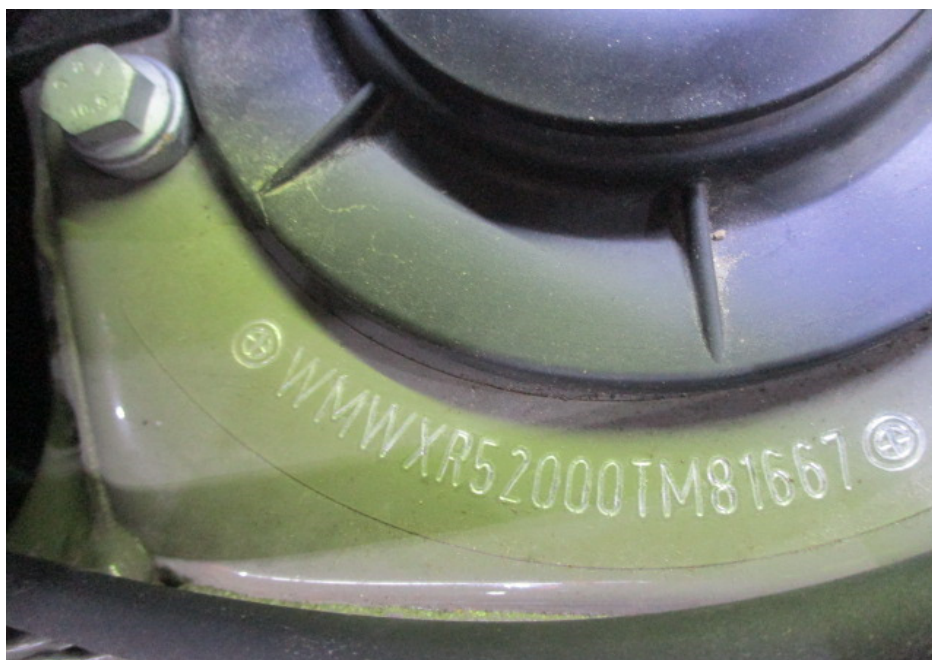
**Photo 7** shows the chassis number of the Motor Car. The chassis number recorded was WMWXR52000TM81667.

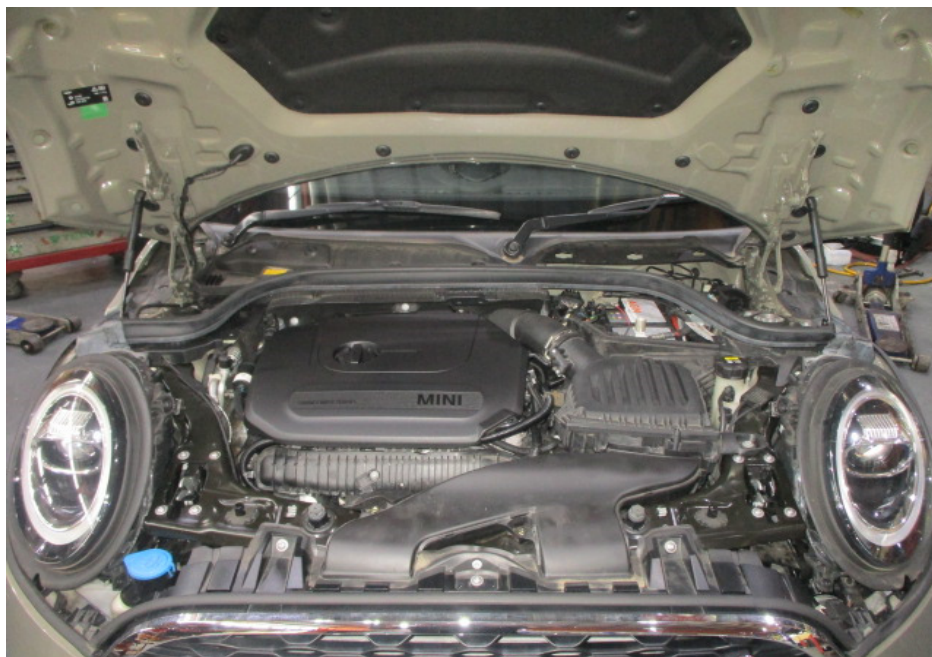
13. My examination of the engine compartment of the Motor Car revealed that the various parts and components inside the engine compartment were all intact and properly fitted. The engine oil, brake fluid and engine coolant were all found to be of sufficient level for operating purposes. Visually, there was also no contamination found to these fluids.
14. My checks on the underside of the Motor Car revealed no sign(s) or indication(s) of fluid leakage and/or fluid stain(s). The engine block and automatic transmission assembly were both secured properly. All undercarriage components of the Motor Car were also observed to be intact and secured in an appropriate manner.

**Photo 8** shows a general view of the engine compartment of the Motor Car at the time of my inspection. The various parts and components inside the engine compartment were all observed to be intact and properly fitted. There was also no sign(s) or indication(s) of fluid leak and/or fluid stain found inside the engine compartment.

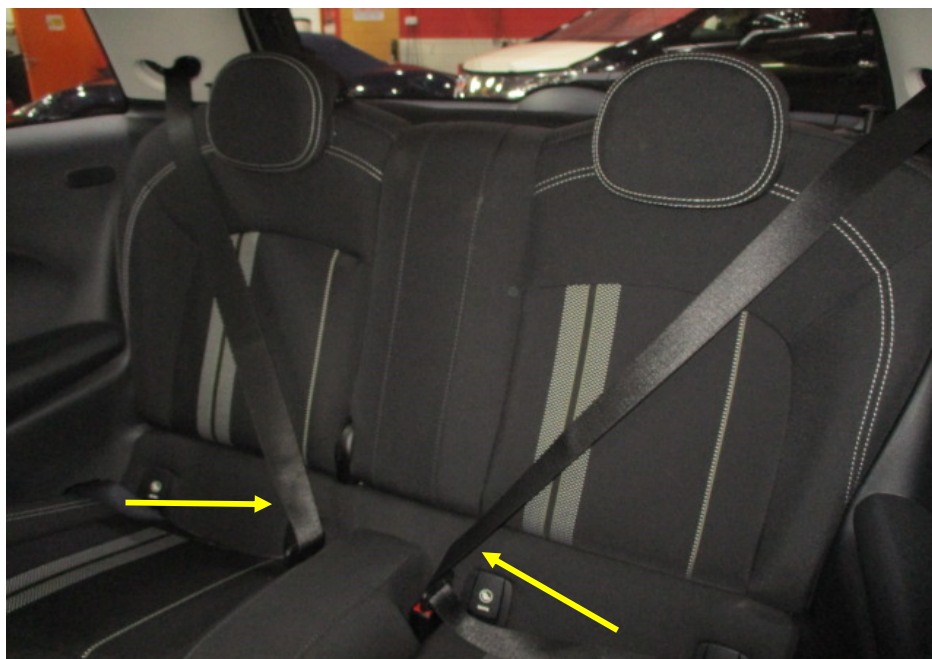
11. The seats of the Motor Car were found to be secured to the floorboard of the Motor Car via seat rails bolted onto the floorboard. Retractable seat belt reels and pre-tensioners were fitted on all seats of the Motor Car. The seat belt reels were tested and were able to be fastened securely into the respective pre-tensioners that were fixed to the side of all the seats.

**Photo 9** shows the rear seats of the Motor Car. All the seats of the Motor Car were secured via seat rails to the floorboard. They were also fitted with a retractable seat belt reel and a pre-tensioner. The seat belts (arrowed) were tested and were able to be fastened into the respective pre-tensions that were fitted on the side of each individual seat.

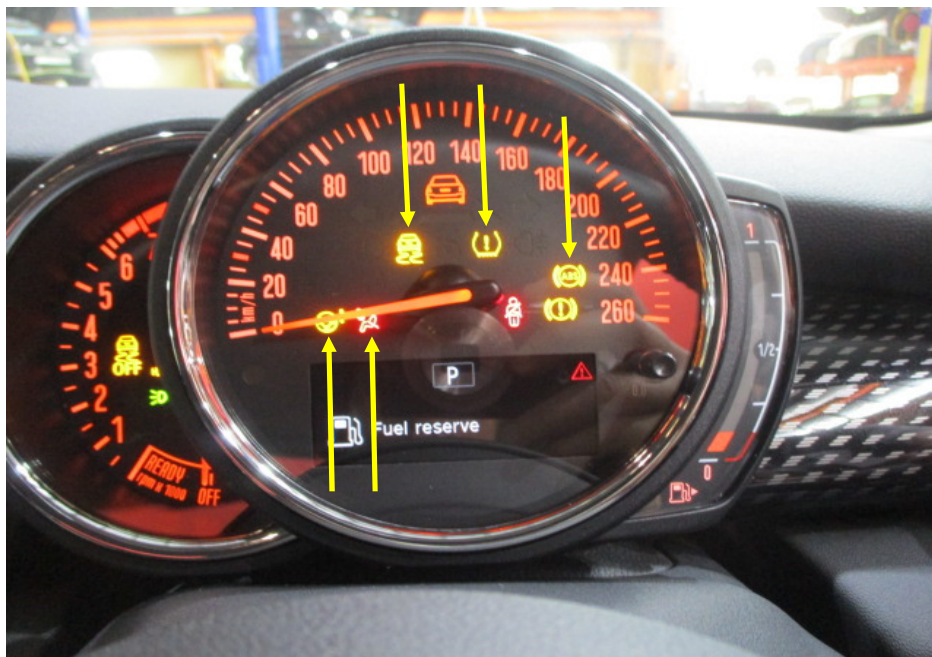
**Photo 10** shows the warning lights for the various electronic safety features appearing on the instrument panel of the Motor Car during its self-test when the engine is cranked, in particular the ABS, SRS, PAS, TPM and DSC lights (arrowed).

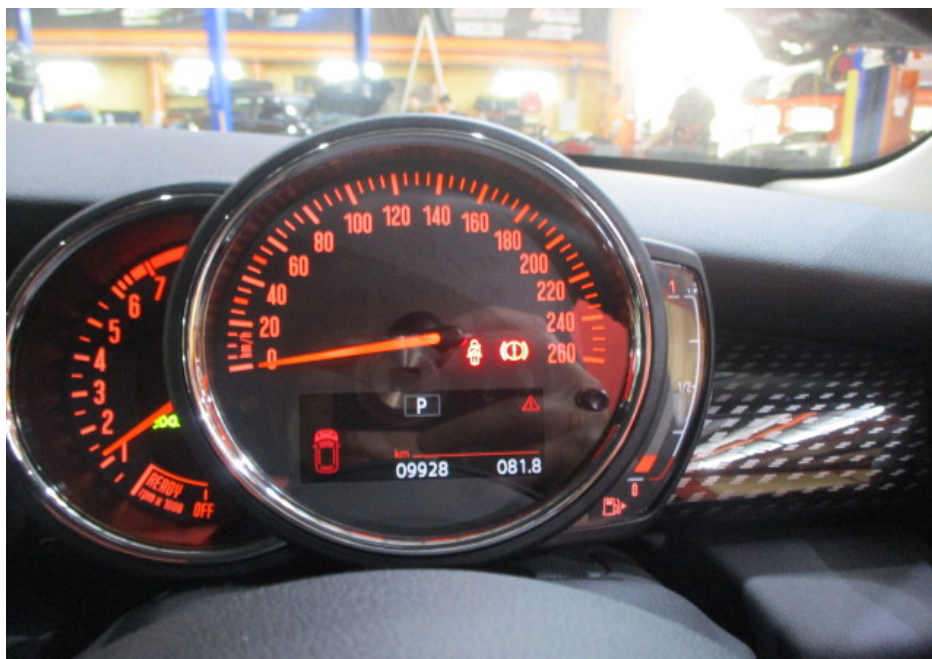
12. The Motor Car's automatic self-test of the functionality of its various electronic safety features like the Anti-Lock Brake System (ABS), Supplemental Restraint System (SRS), Power Assisted Steering (PAS), Tyre Pressure Monitor (TPM) and Dynamic Stability Control (DSC) during cranking of the engine had indicated that these electronic systems were in working condition. This was determined from the respective warning lights disappearing from the instrument panel after the self-test.

**Photo 11** shows the respective warning lights no longer illuminated, indicating that there is no fault detected to the ABS, SRS, PAS, TPM and DSC systems of the Motor Car during the self-test. These electronic systems were hence in working condition at the time of my inspection.

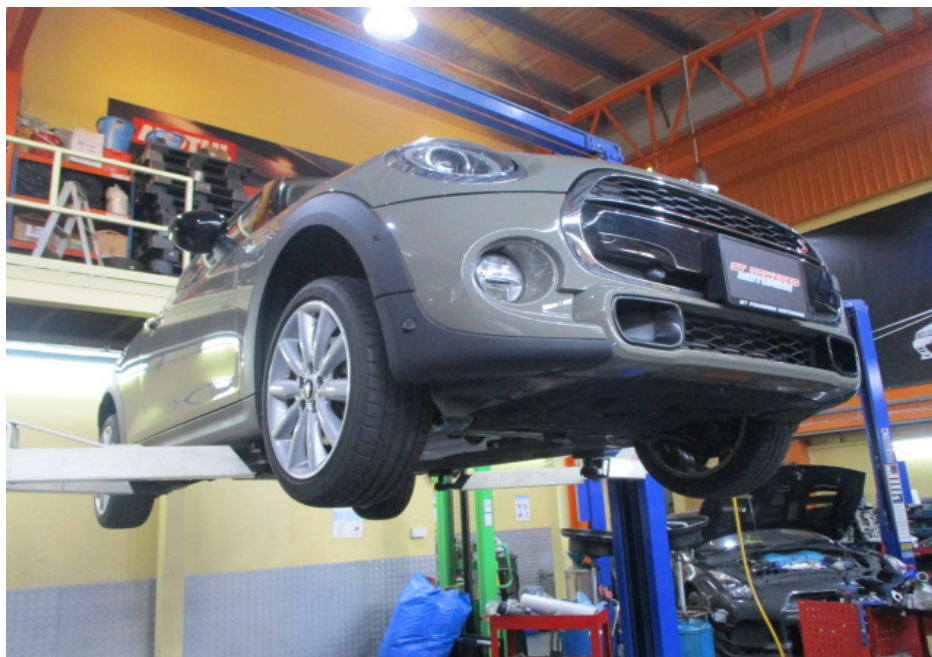
**Photo 12** shows the Motor Car hoisted up for checks on its undercarriage. There was no sign(s) or indication(s) of fluid leakage and/or fluid stain(s) on the underside of the Motor Car. The undercarriage components of the Motor Car were also all observed to be intact and secured in an appropriate manner.

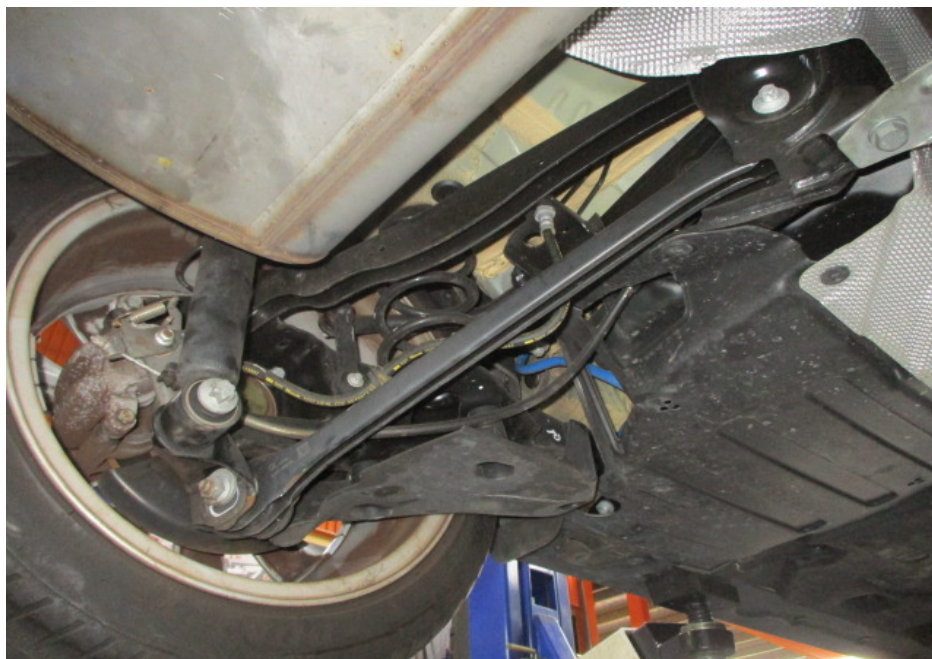
**Photo 13** shows a general view of the control arms and linkages at the rear left wheel of the Motor Car. I did not observe any fluid leak and/or fluid stain on the underside of the Motor Car. All of the Motor Car's undercarriage components were observed to be intact and secured in an appropriate manner.

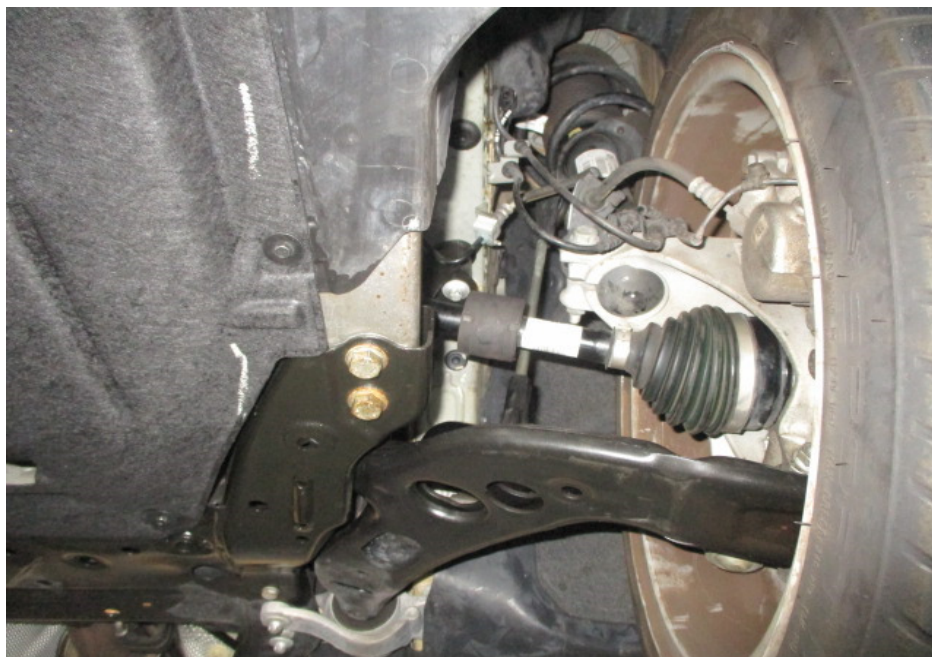
**Photo 14** shows the various undercarriage components at the front left wheel of the Motor Car. The mechanical components, control arms and linkages were all found to be intact and secured in an appropriate manner.

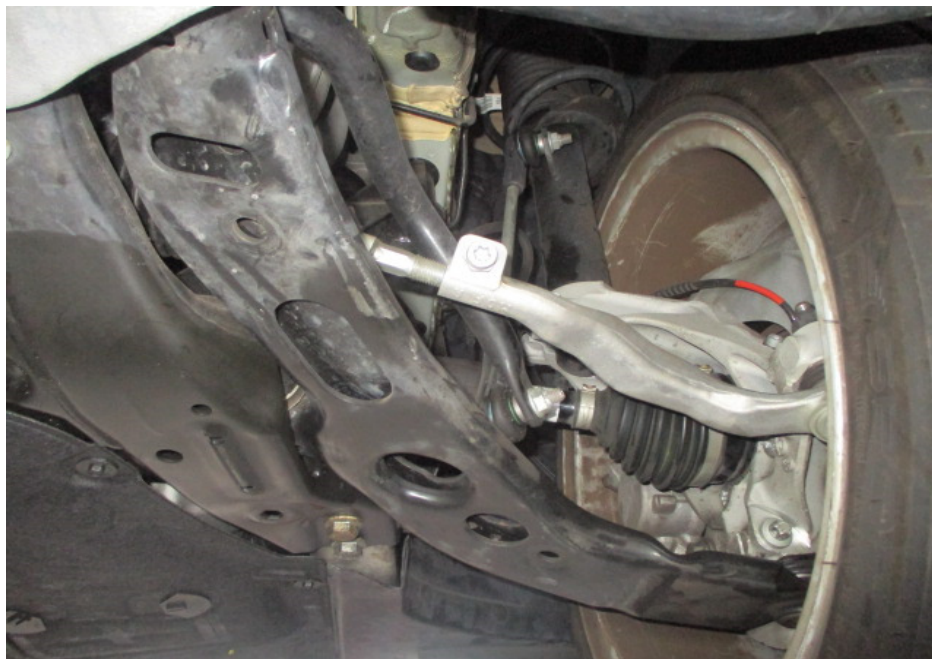
**Photo 15** shows the various undercarriage components at the front right wheel of the Motor Car. The mechanical components, control arms and linkages were all found to be intact and secured in an appropriate manner. I also did not observe any fluid leak and/or fluid stain on the underside of the Motor Car.

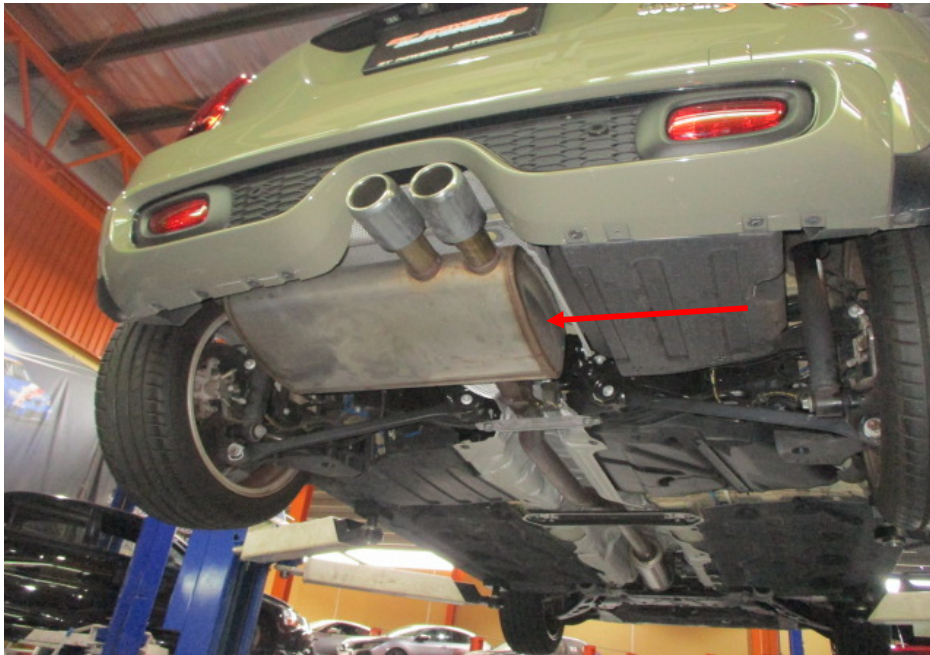
**Photo 16** shows the Motor Car's rear muffler (arrowed). My examination of the Motor Car's exhaust system revealed no sign(s) or indication(s) of any cut or weld marks along its exhaust pipes and on its catalytic converter.

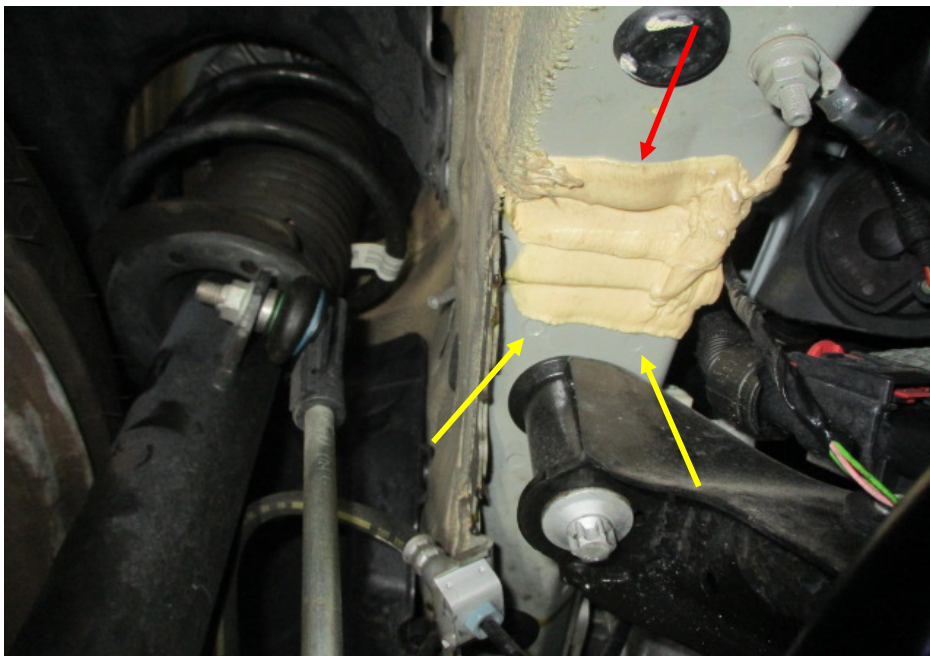
10. Visually, I did not find any weld marks, other than the original spot weld marks, on the chassis/structural body of the Motor Car. The original factory sealant at the joints along the chassis/structural body was also untouched, again indicating that no replacement of the chassis/structural body was carried out; and that the chassis/structural body was originally fitted.

**Photo 17** shows the chassis/structural body at the underside front left of the Motor Car. I did not find any weld marks other than original spot weld marks (yellow arrow) on the chassis/structural body of the Motor Car. The original factory sealant (red arrow) at the joints along the chassis/structural body was untouched, indicating no work was done on the chassis/structural body of the Motor Car and that the chassis/structural body was originally fitted.

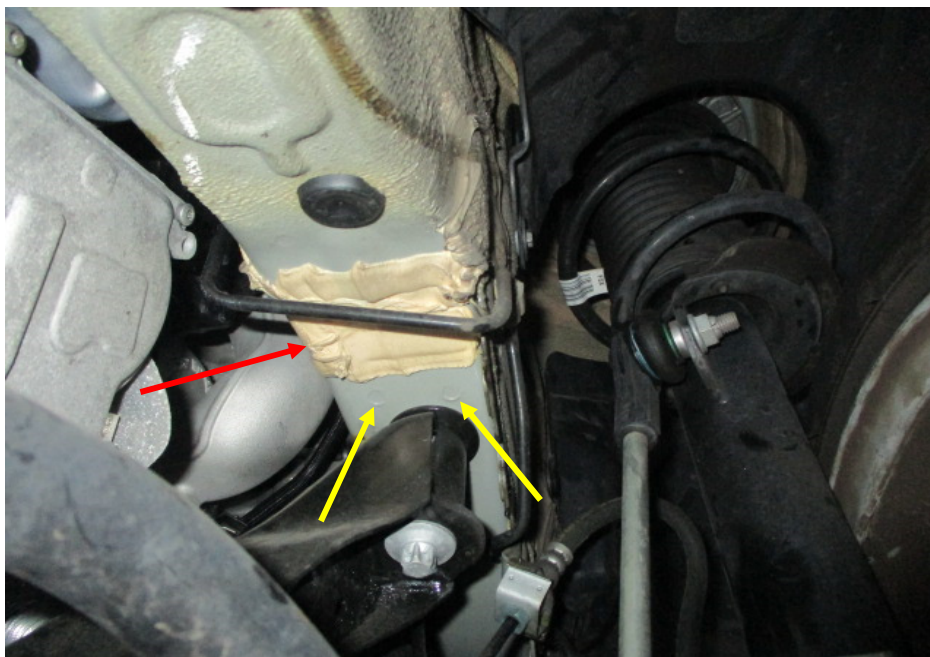
**Photo 18** shows the chassis/structural body at the underside front right of the Motor Car. I did not find any weld marks other than original spot weld marks (yellow arrow) on the chassis/structural body of the Motor Car. The original factory sealant (red arrow) at the joints along the chassis/structural body was untouched, indicating no work was done on the chassis/structural body of the Motor Car and that the chassis/structural body was originally fitted.

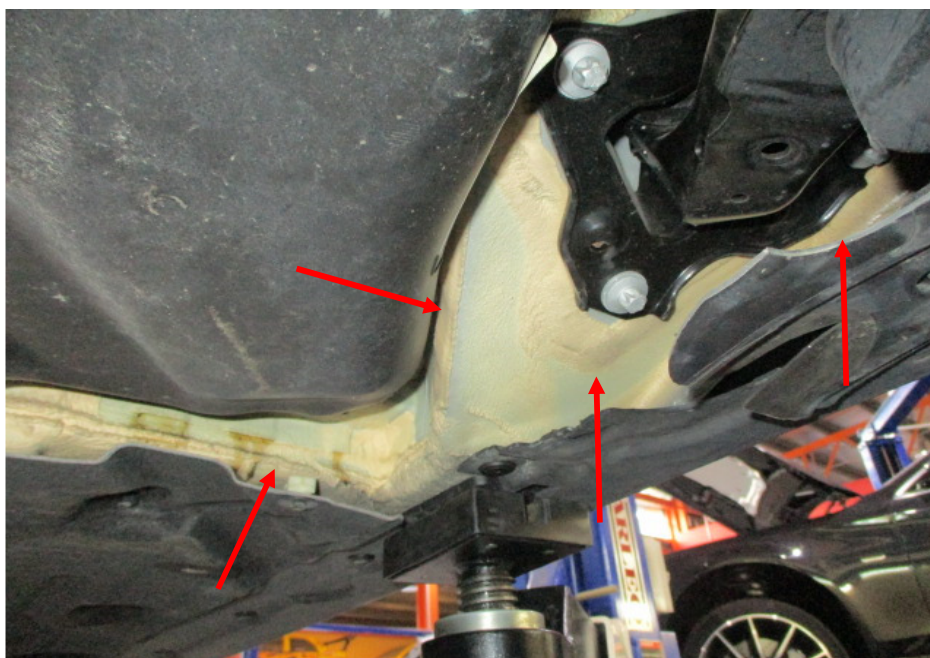
**Photo 19** shows the floorboard and chassis/structural body at the underside rear right of the Motor Car. The original factory sealant (arrowed) at the joints between the floorboard and along the chassis/structural body was observed to be untouched. In general, I had found no work was carried out on floorboard and on the chassis/structural body of the Motor Car.

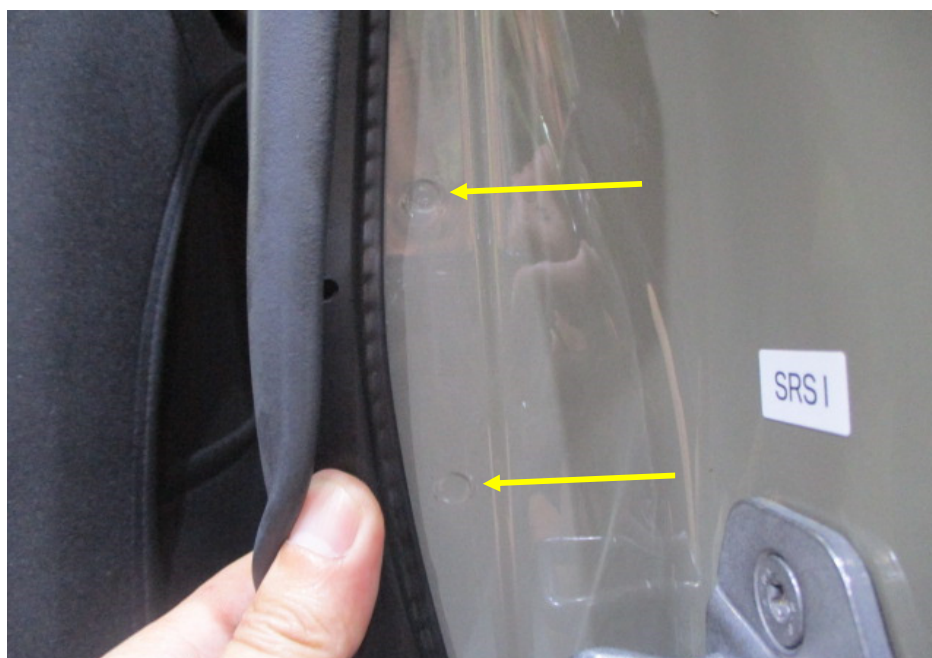
8. The detachable body panels of the Motor Car like the front fenders, front bumper, rear bumper, doors, bonnet and rear tailgate amongst others were all found to be fitted securely.
9. Checks on the non-detachable body panels like the rear fenders, floorboard, roof panel, pillars and rocker panels amongst others, revealed that these body panels were spot welded onto the chassis/structural body of the Motor Car. The original factory sealant at the joints of the non-detachable body panels was all untouched indicating no replacement of the non-detachable body panels was carried out; and that these body panels were all originally fitted.

**Photo 20** shows the rear left body panel of the Motor Car. I did not find any weld marks other than original spot weld marks (arrowed) on the rear left body panel of the Motor Car, which indicates that there was no re-welding works carried out. In general, I had found all the non-detachable body panels of the Motor Car to be originally fitted at the time of my inspection.
