VEHICLE INSPECTION REPORT

Our ref. : UAM20.08.17-AK-STP-RCG-SFA7333S

Registration no.	: SFA7333S	Odometer	: 124475 km
Make / Model	: BMW 640I A	Chassis no.	: WBALW72000C582730
Regn. date	: 05 Aug 2011	Engine no.	: 15257765N55B30A
Body colour	: Black	Engine cap.	: 2979 cc

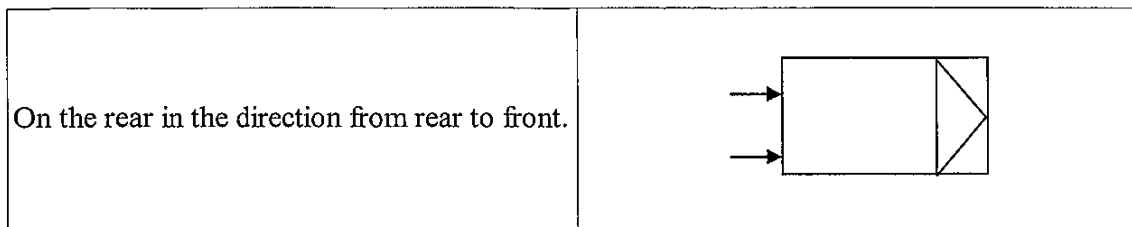
POINT OF IMPACT

The impact of the collision has damaged / affected the bootlid, rear bumper, rear end panel, taillamps, fault code and etc...
