Insured : -
Policy No. : -
Sum Insured : -
Excess : -
Our Reference : KAAS/TA/5138/0076/TP/08.18
Date : 11 September 2018

VEHICLE APPRAISAL REPORT

Registration No.	: SKX 76A	Engine No.	: Hidden From View
Make/Model	: Mercedes Benz GLC250 4matic Coupe (A)	Chassis Frame No.	: WDC2533462F442770
Year of Manufacture/Reg	: 2018	Colour	: White
Class/Type	: Coupe	Odometer Reading	: 3,957 KM

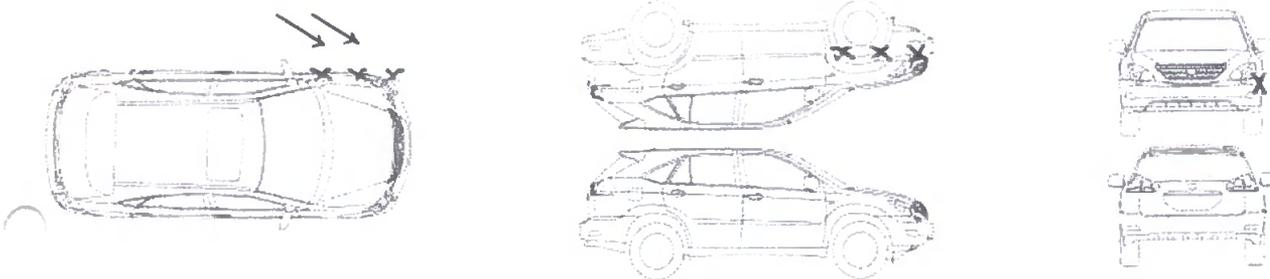
Damages sustained were consistent with the subject vehicle being involved in a collision with another vehicle and the impact was delivered to the LH Front portion from rear to front; left to right; of the vehicle.

The general area of damages is at the **LH Front portion**
(Please refer to the parts list and photographs as attached for more information)
