Your Ref : 1202100000710
Our Ref : CS4/FWD21001723/N

3 March 2021

M/s FWD Singapore Pte. Ltd.

**TECHNICAL INVESTIGATION REPORT OF FIRE INCIDENT INVOLVING THE
INSURED VEHICLE SJJ 8886L ON 3 FEBRUARY 2021**

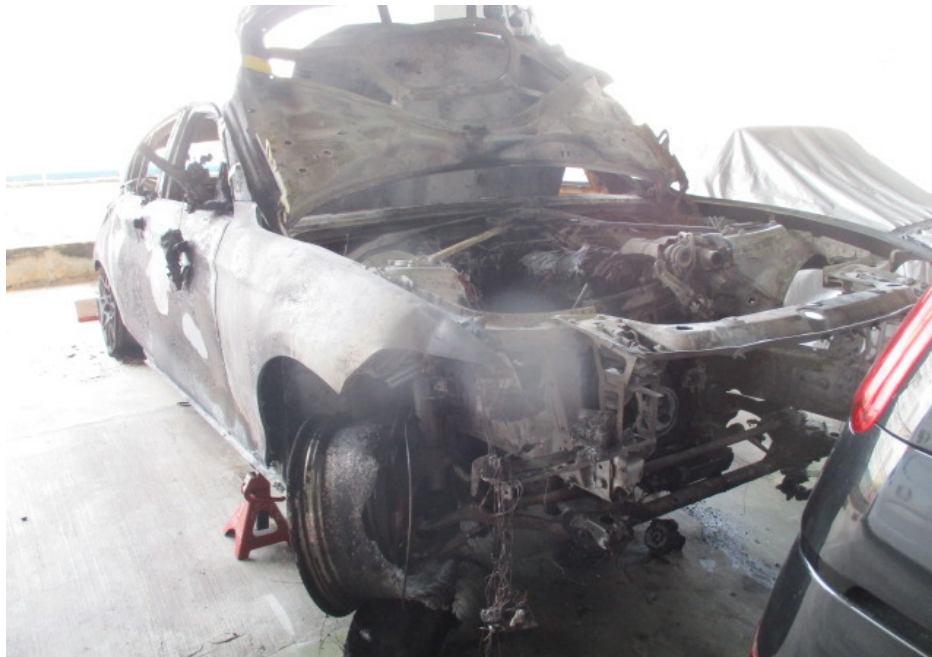
Photo 1 shows the general view of the front left portion of the Insured Vehicle at the time of our inspection. The Insured Vehicle was observed to have sustained extensive fire damage all around. Its engine compartment and interior compartment were completely burnt. Rust had accumulated all over the rear and centre portion of the Insured Vehicle as a result of exposure to environmental condition for a period of time.

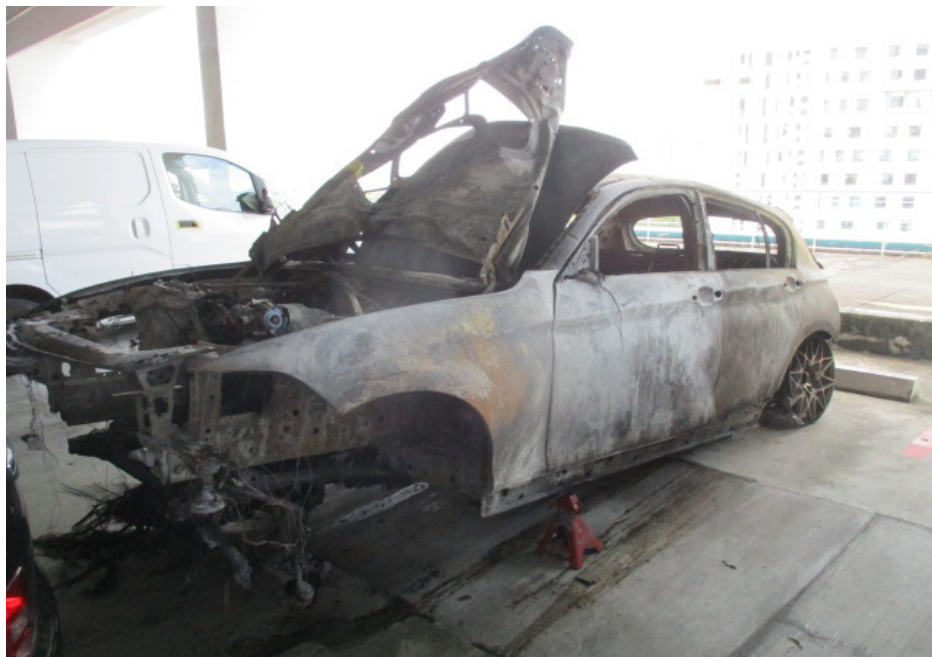
Photo 2 shows the general view of the left body of the Insured Vehicle at the time of our inspection. The Insured Vehicle was observed to have sustained extensive fire damage all around. Rust had accumulated all around the Insured Vehicle as a result of exposure to environmental condition for a period of time.

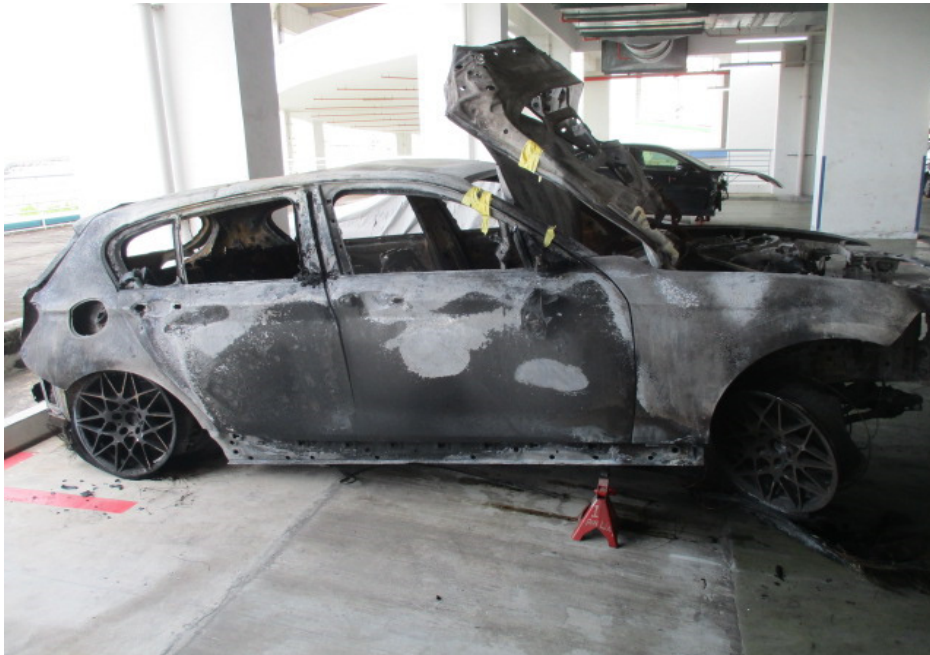
Photo 3 shows the general view of the right body of the Insured Vehicle at the time of our inspection. The Insured Vehicle was observed to have sustained extensive fire damage all around. Rust had accumulated all around the Insured Vehicle as a result of exposure to environmental condition for a period of time.

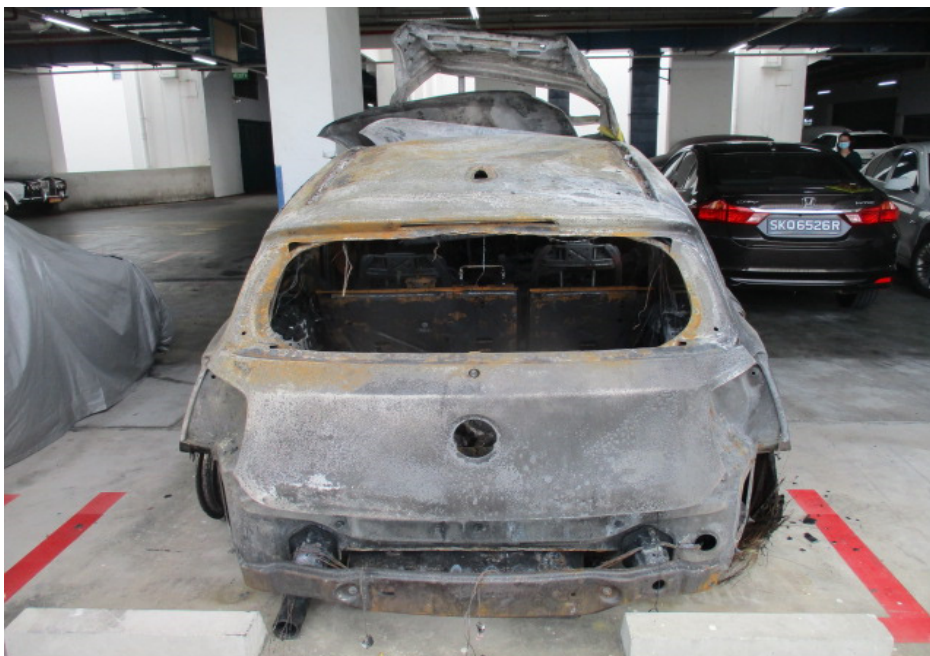
Photo 4 shows the general view of the rear portion of the Insured Vehicle at the time of our inspection. The Insured Vehicle was observed to have sustained extensive fire damage all around. Rust had accumulated all around the Insured Vehicle as a result of exposure to environmental condition for a period of time.

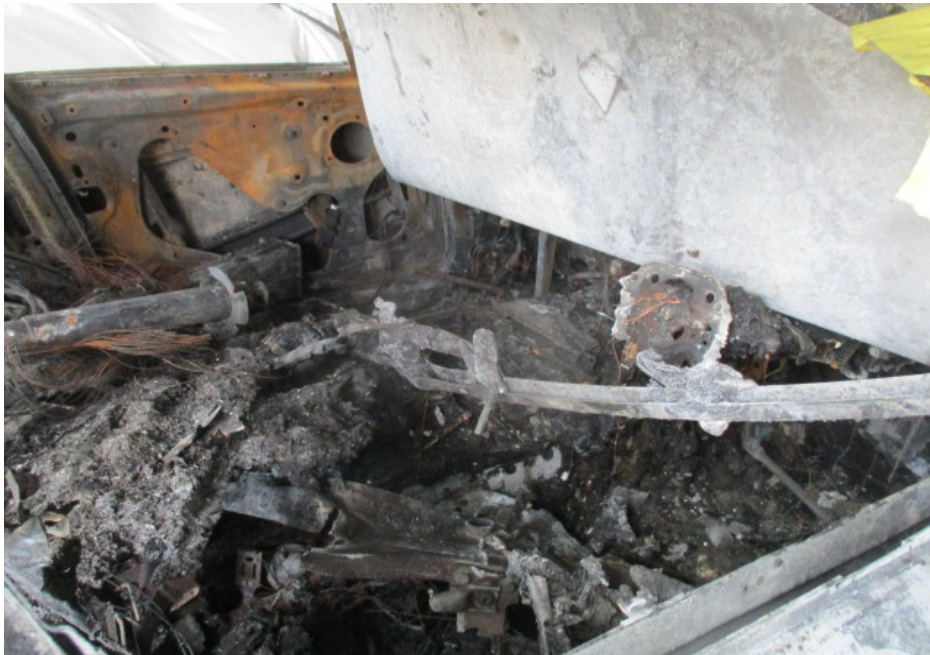
Photo 5 shows the general view of the interior compartment of the Insured Vehicle at the time of our inspection. Its interior compartment was completely burnt as a result of the fire.

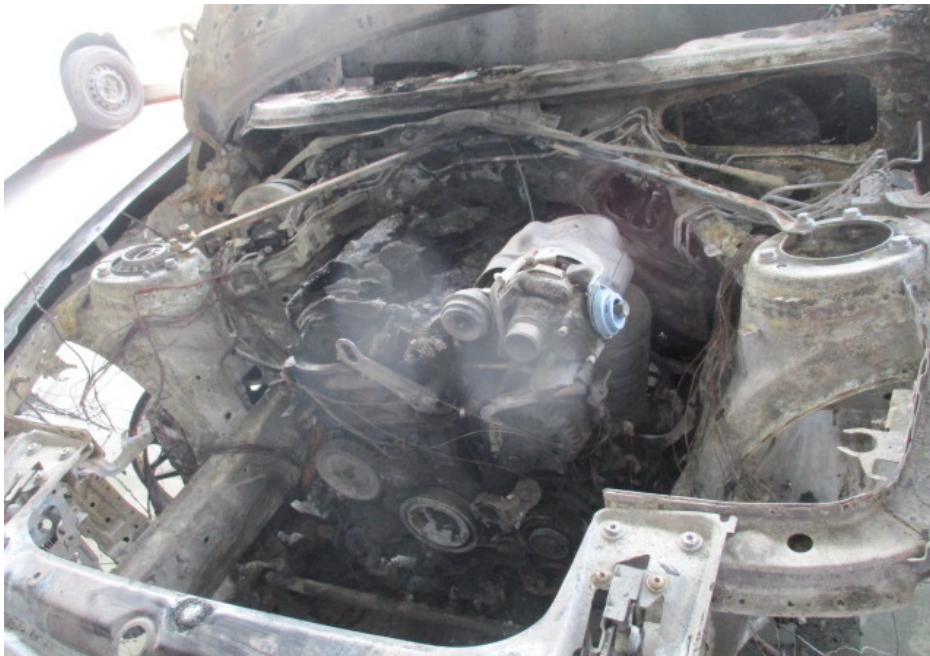
Photo 6 shows the engine compartment of the Insured Vehicle at the time of our inspection. The entire engine compartment of the Insured Vehicle was observed to be severely burnt. Most of the parts inside the engine compartment were found to be burnt and/or melted as a result of the fire.

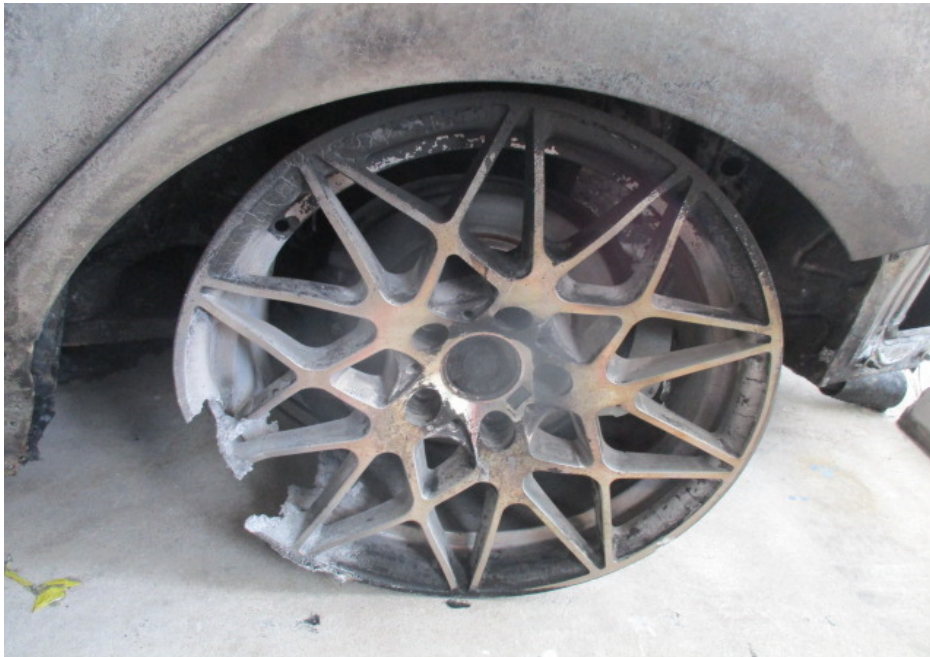
6. At the time of physical inspection of the Insured Vehicle, we had found several aftermarket 18- inch alloy rims (which had sustained minor fire damage). All these fitted components were not the standard type for the Insured Vehicle. See photo 7 below.

Photo 7 shows the non-standard rim (which had sustained minor fire damage) found to be fitted on the Insured Vehicle at the time of our inspection. The 18-inch alloy rims fitted on the Insured Vehicle were not the standard type for the Insured Vehicle.

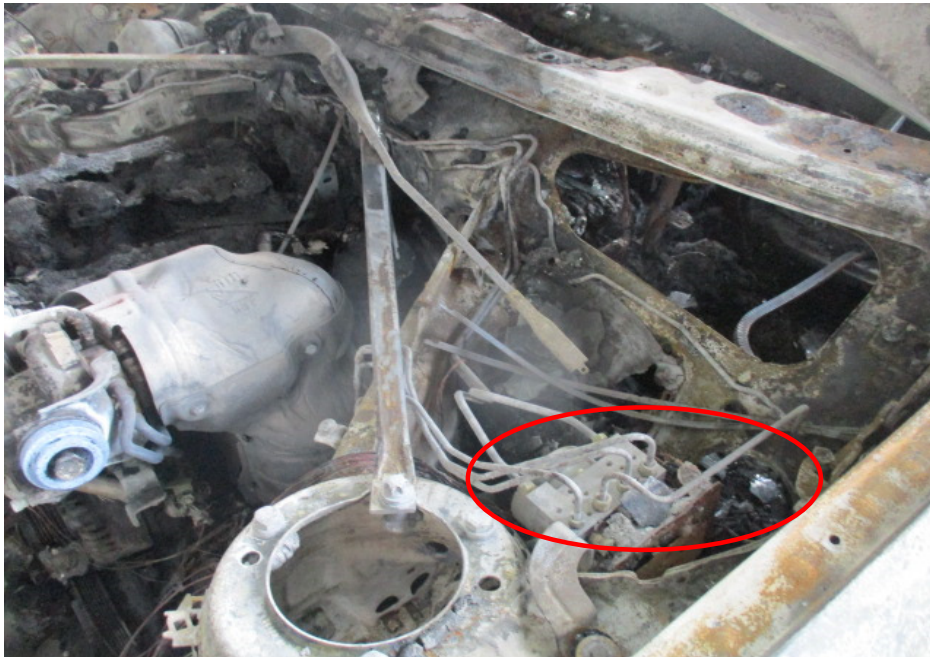
7. For this particular case, the fire appears to have originated within the engine compartment of the Insured Vehicle, somewhere around the rear left portion of the engine compartment. This can be determined from the greenish residue that was found on several stretches of burnt original factory fitted wirings mainly around the rear left portion of the engine compartment. The presence of greenish residue indicates internal heating of copper wires, a sign of an electrical short circuit occurring. The greenish residue is normally left behind from oxidation as a result of chemical reaction involving the copper wires. This physical evidence would appear to suggest that the cause of fire to the Insured Vehicle could have possibly been due to electrical in nature. See photos 8 – 11 below.

Photo 8 shows the burnt wirings around the rear left portion of the engine compartment which is near to the vicinity where the fire to the Insured Vehicle had likely started (circled).

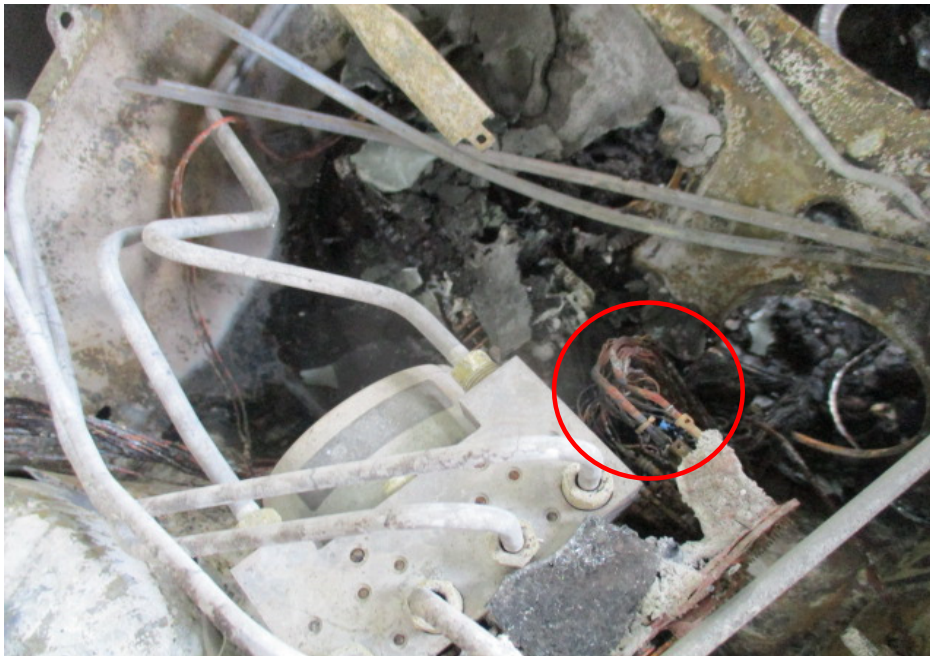
Photo 9 shows a closer view the greenish residue on several stretches of burnt wirings at the rear left portion of the engine compartment (circled), a sign of an electrical short circuit occurring. The greenish residue is normally left behind from oxidation as a result of chemical reaction involving the copper wires.

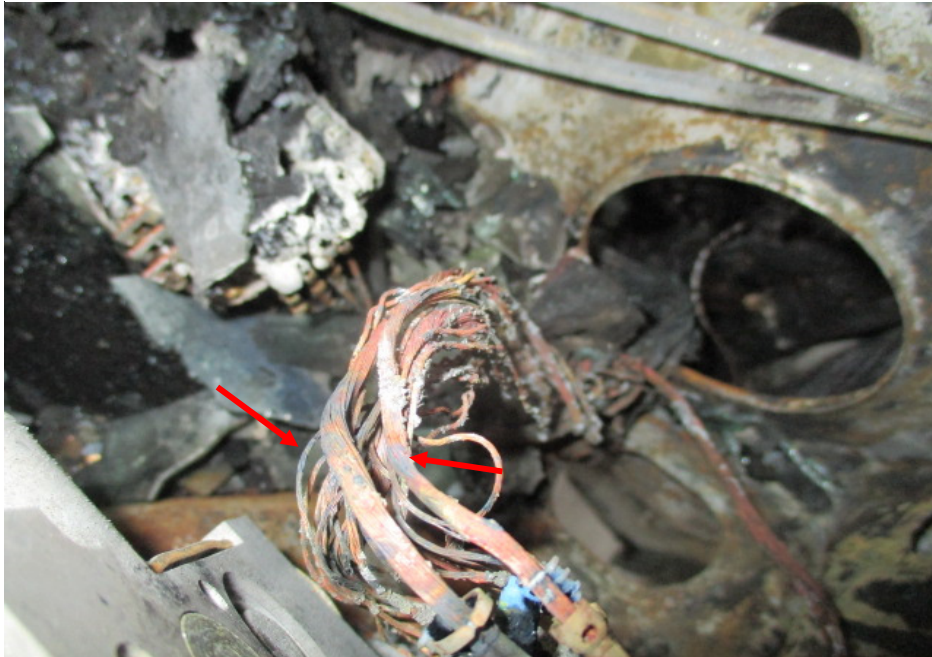
Photo 10 shows a close up view of the greenish residue on the wirings at the rear left portion of the engine compartment (arrowed). The presence of such greenish residue suggests occurrence of an electrical short circuit.

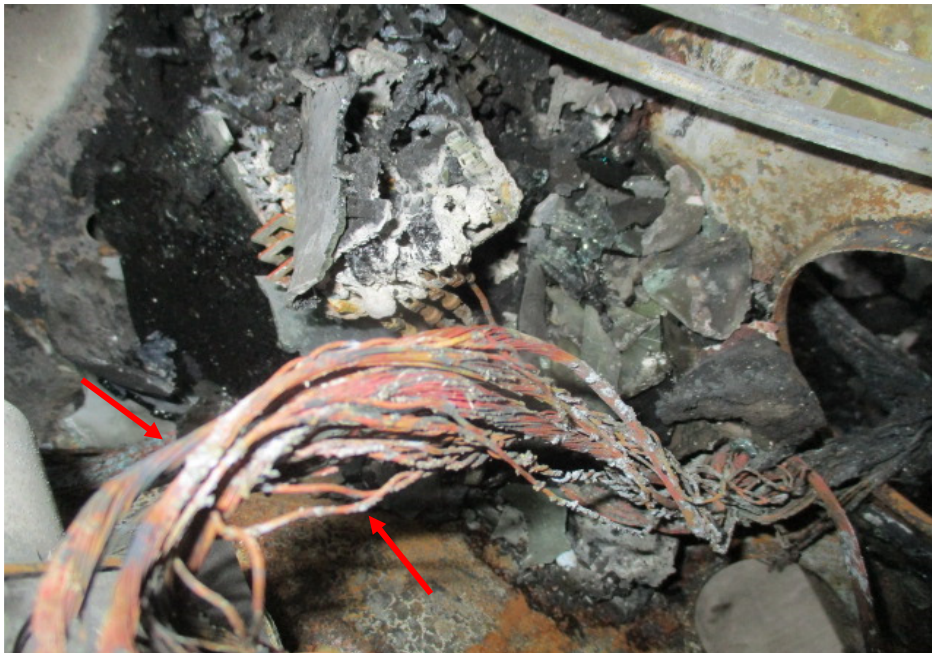
Photo 11 shows a close up view of the greenish residue on the wirings at the rear left portion of the engine compartment (arrowed). The presence of such greenish residue suggests occurrence of an electrical short circuit.

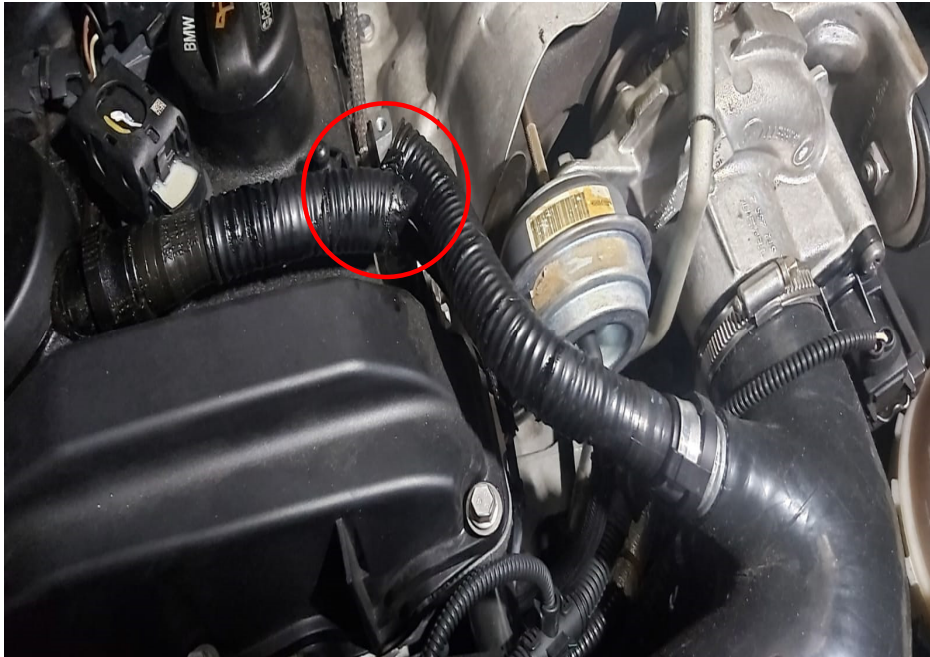
- Mr Sufiyan went on to mention that 1 week after he collected the Insured Vehicle, the engine oil warning light had come on. He went back to TT and had the engine oil topped up. Shortly after that the breather hose had cracked. Mr Sufiyan informed the broker who bought a replacement hose and changed it for him at Mr Sufiyan's carpark. See photo 12 below.

Photo 12 shows the broken breather hose of the Insured Vehicle (circled) which was later replaced by the broker as mentioned by Mr Sufiyan.

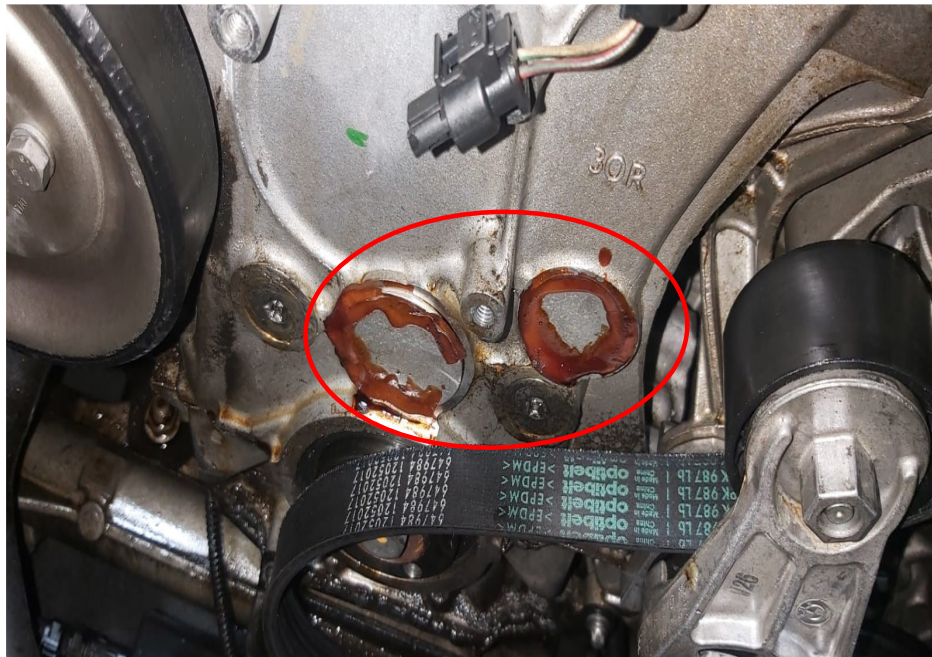
Photo 13 shows the timing cap and crank pulley oil seal (circled) which were replaced in November 2020 at Alltech Auto Service Pte. Ltd. as mentioned by Mr Sufiyan.

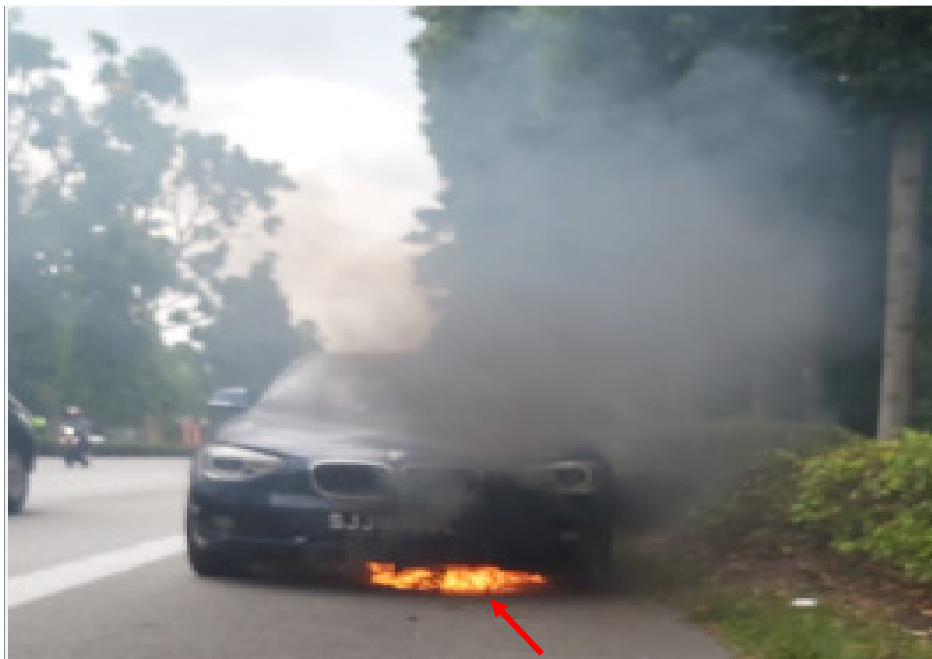
Photo 14 shows the Insured Vehicle on fire before the arrival of the SCDF. In general, the information that could be gathered from this photograph had corresponded to the events that were related to us by Mr Sufiyan, which is the fire had started from the left bottom portion of the Insured Vehicle's engine compartment (arrowed).

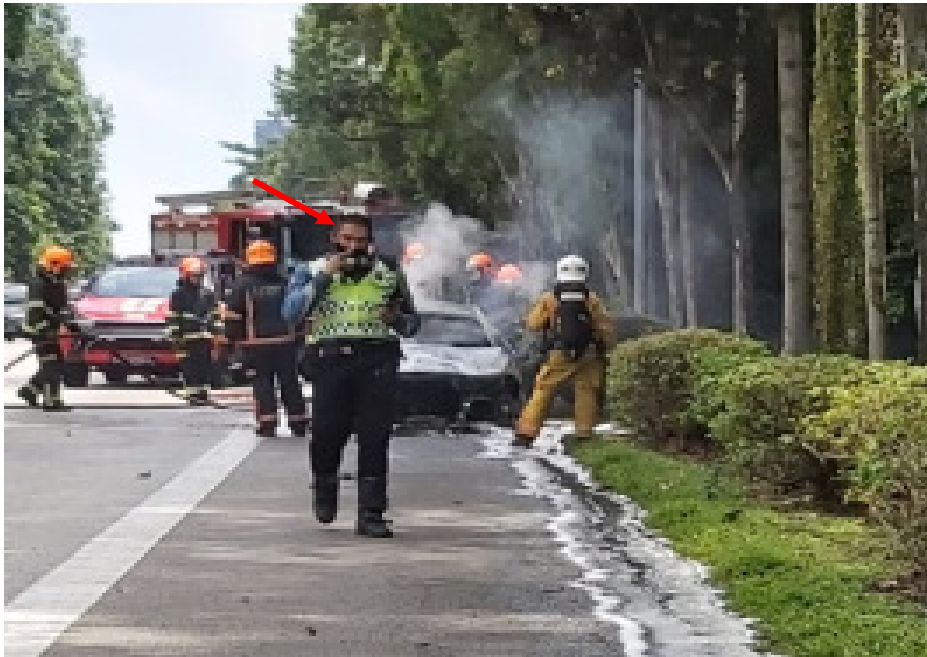
Photo 15 shows the SCDF putting out the last remnants of the fire. In general, the information that could be gathered from this photograph had corresponded to the events that were related to us by Mr Sufiyan, which is the police were present at the incident location together with the SCDF (arrowed).
