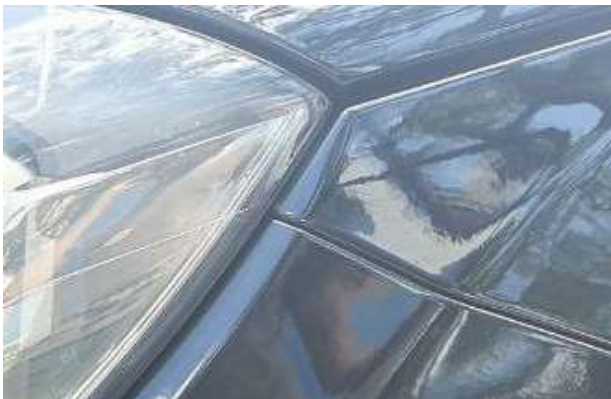
*Figure 3: My picture*

As seen above, there is NO damage caused to the headlight area as compared to the surveyor's image.

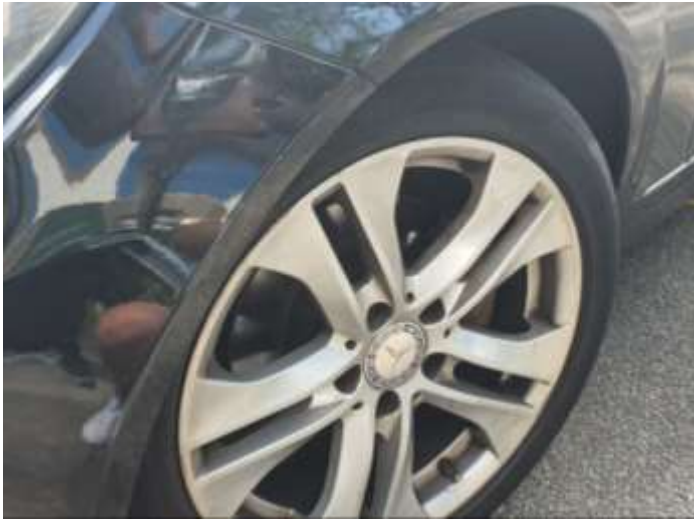
Figure 5: My picture

As seen above, the damage shown in the surveyor's picture does not exist in my picture.

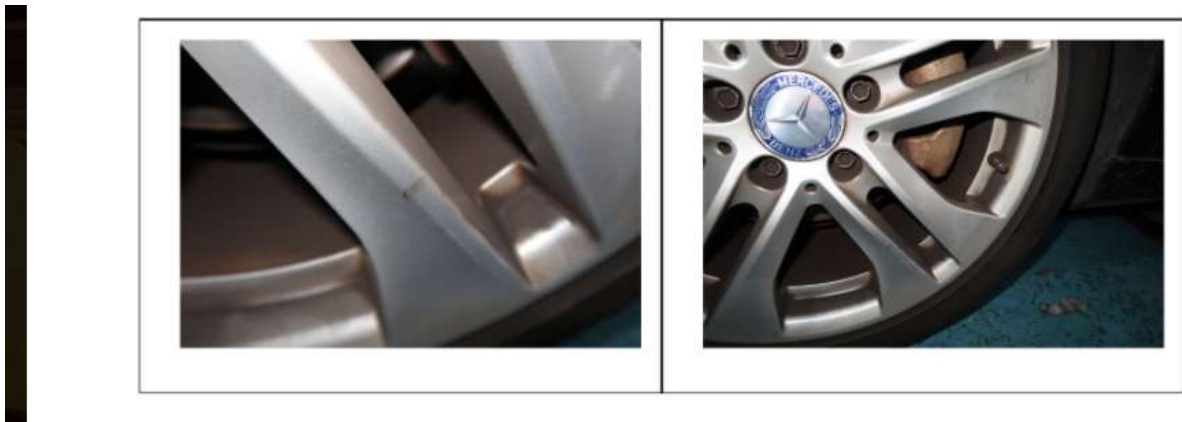
Next, as seen below, the surveyor claims that I had caused damage to the sports rim. However, I had received confirmation on the day of the accident. I understand that we are not paying for this but this is for your own information.
