Area of Damage

Damage Consistency

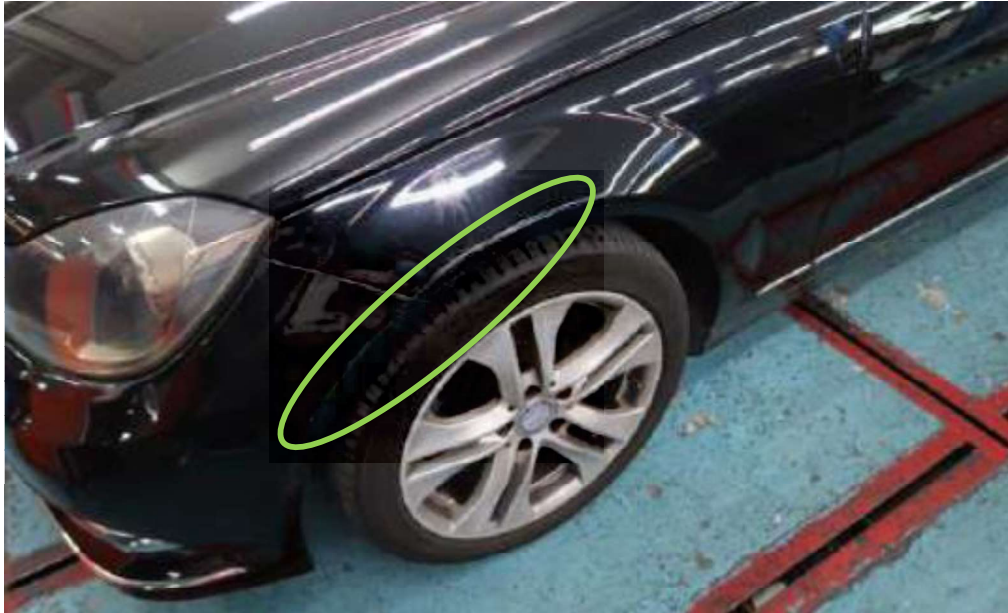
The first area of light scraping on the nearside front side of the fender and bumper was in my opinion caused in the accident as shown highlighted in the photographs below:

It is clear that the damage on the car was originally a minor side swipe type scrape that would have required a repair and repaint of the front fender, bumper and roadwheel with a four-wheel alignment check for safety.

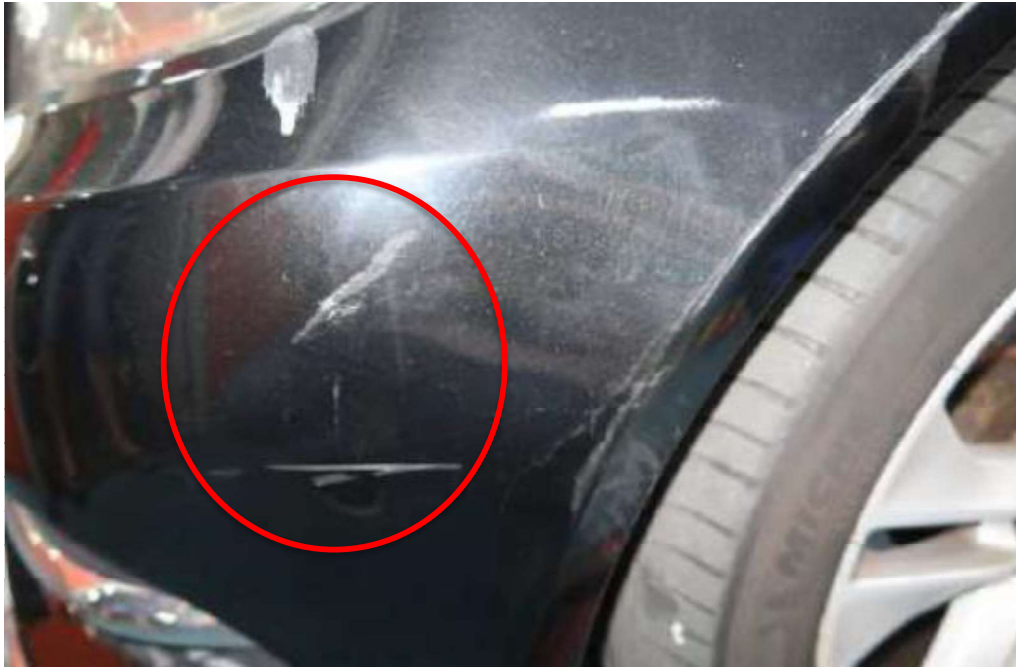
The damage on the front edge of the front bumper towards the nearside highlighted by the red circle in the photograph below could not be related to this accident as the damage is a deep gouge mark on the wrong plane of damage and of the inconsistent shape and location for a side swipe type impact. I believe this was made by a screwdriver blade type implement.

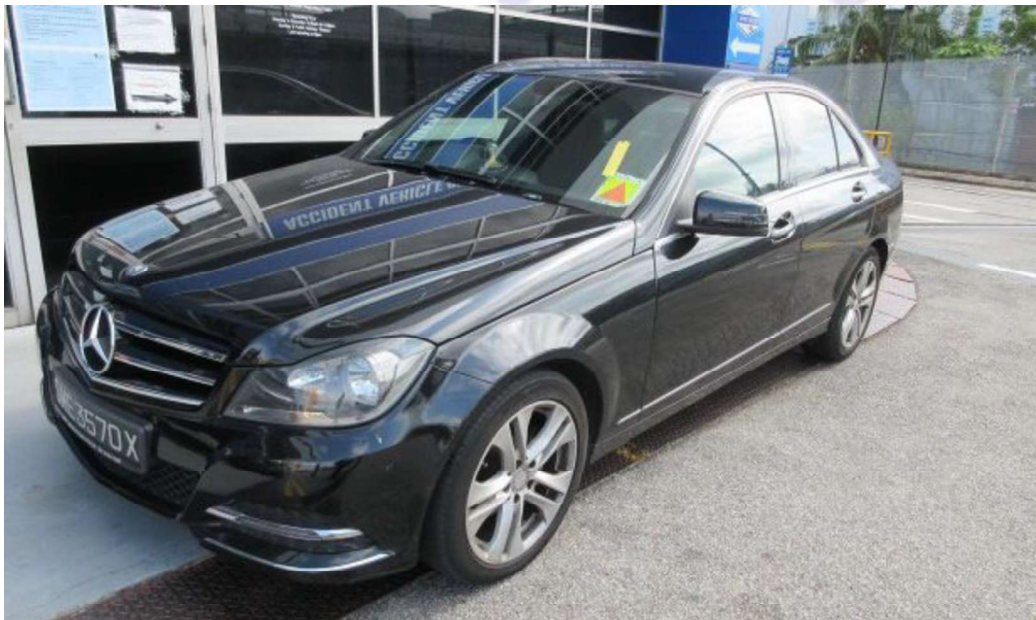
Another surprising observation from the third-party GIA Accident Report made two days after the accident is that there aren't any photographs on that report showing the area of damage. This is highly unusual and the only photograph from that report of the nearside front corner is shown below:

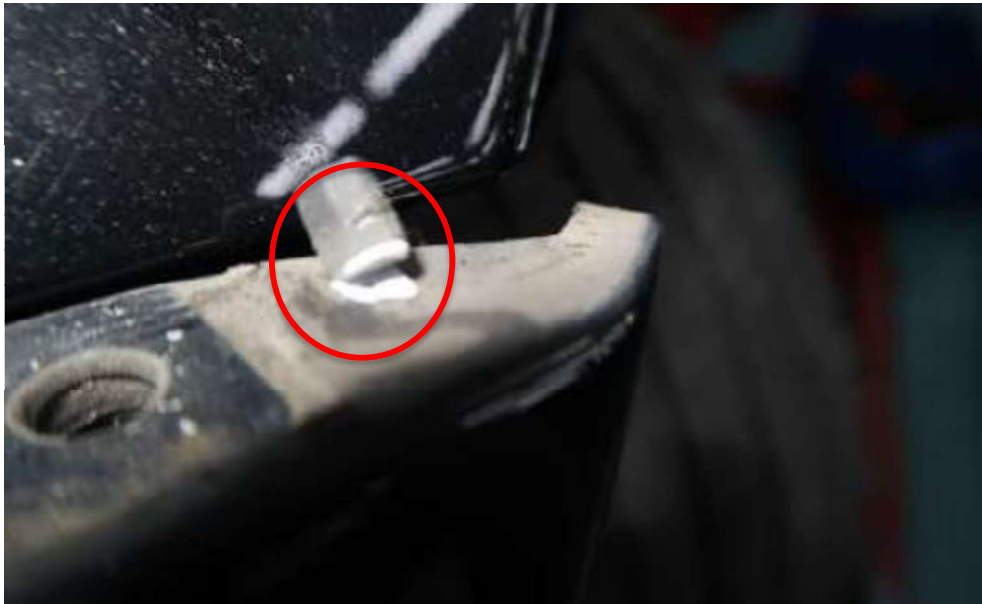
The photograph below shows locating lug that has been broken off from the front bumper. This could not have happened in the accident as there is no deformation of the bumper mounting holes which there would have to be to cause this lug to snap off.

There has been post-accident damage inflicted on the car as shown by the inconsistent damage profiles to the front bumper and headlamp as shown in this report.

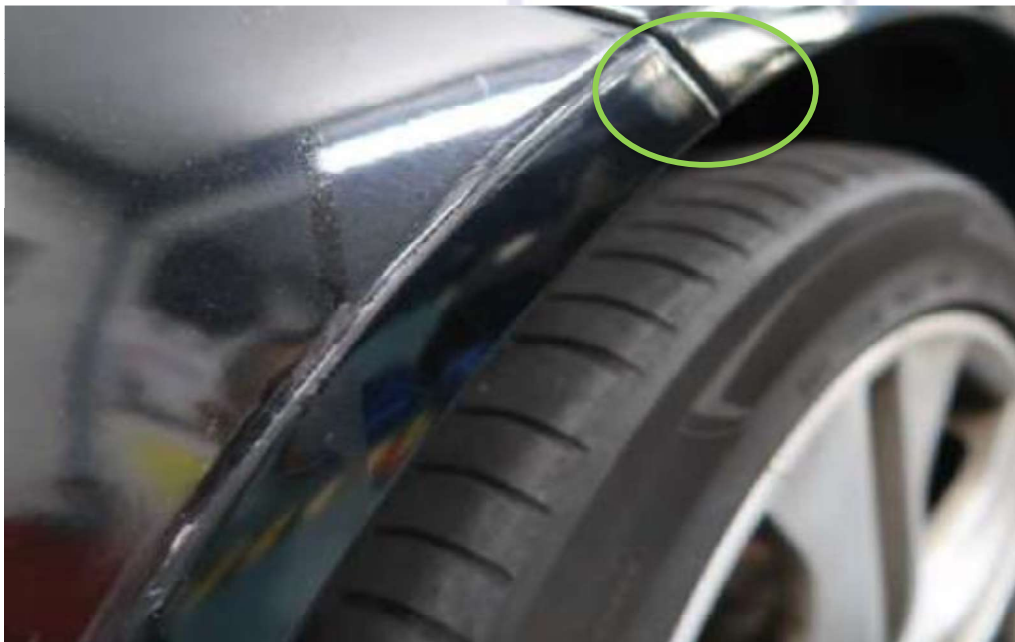
The photograph below shows the bumper and fender in perfect alignment before the car was stripped by the workshop indicating that the bumper mounting lug could not have been snapped off at this point.

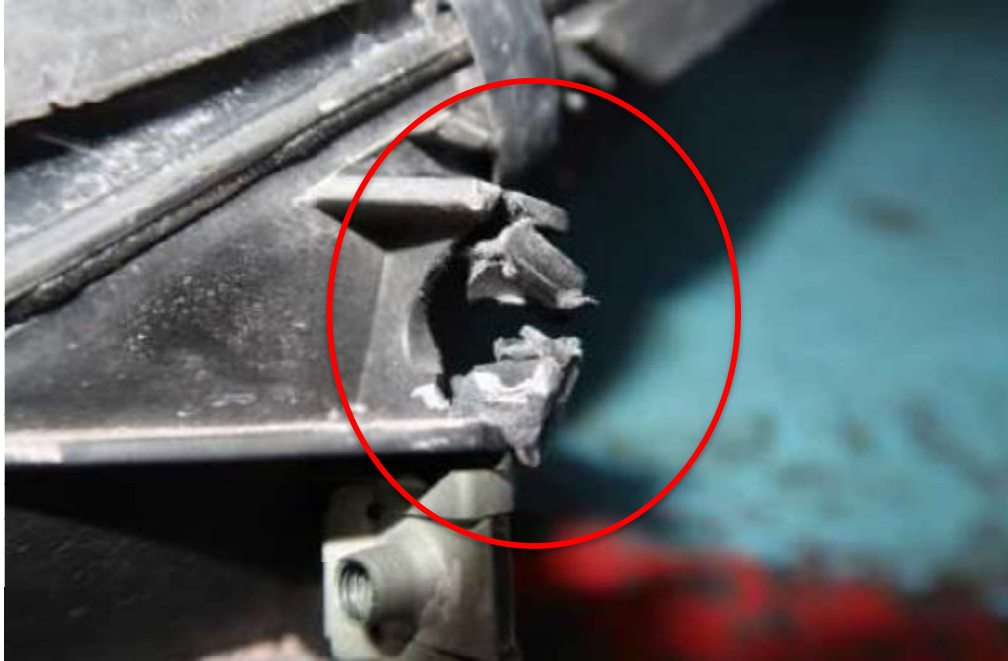
The photograph below shows the nearside headlamp mounting that is damaged. This damage could not have happened in the accident as the headlamp would not move in a way that would cause this type of damage. Again, it appears that this has happened post-accident and looks likely that a rod or screwdriver was inserted in the hole and damage caused deliberately.

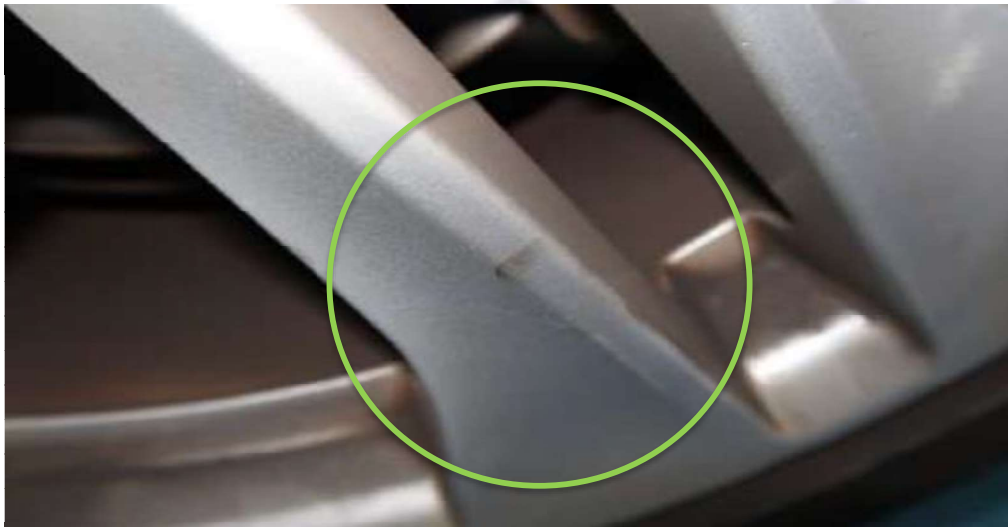
The nearside front roadwheel has very light marks on the web which could have happened in the accident and I have allowed a repaint.

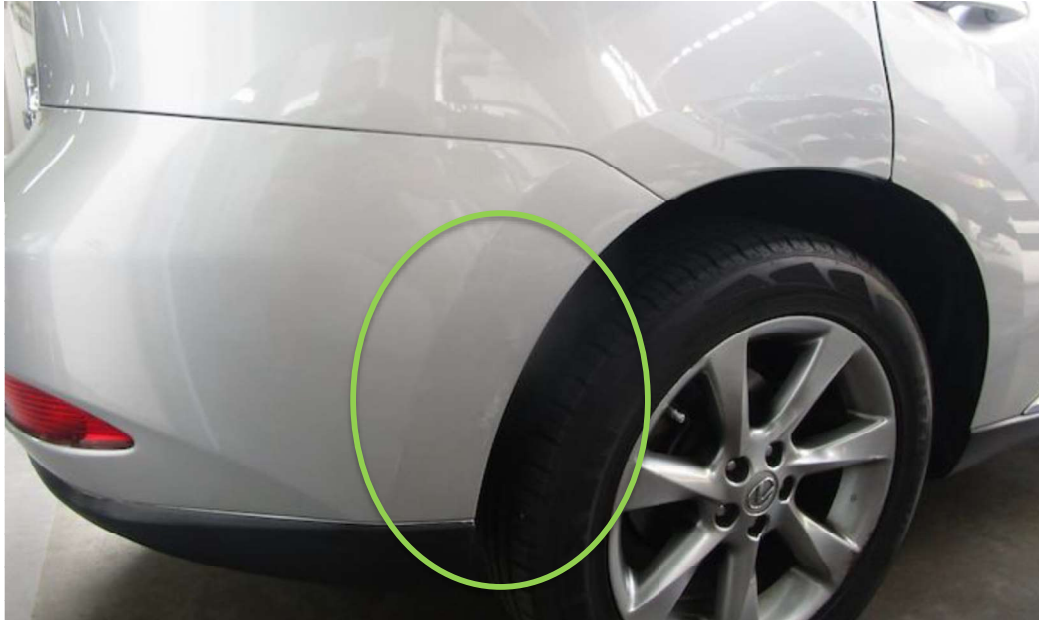
The very light damage to the offside rear of the Insured car shown below shows how light an impact that occurred:
