Your Ref: Toyota Prius Hybrid
(chassis number ZVW516149092)
Our Ref : CI/TP21001928/D

**INSPECTION REPORT OF AN UNREGISTERD TOYOTA PRIUS HYBRID
MOTOR CAR WITH CHASSIS NUMBER ZVW516149092**

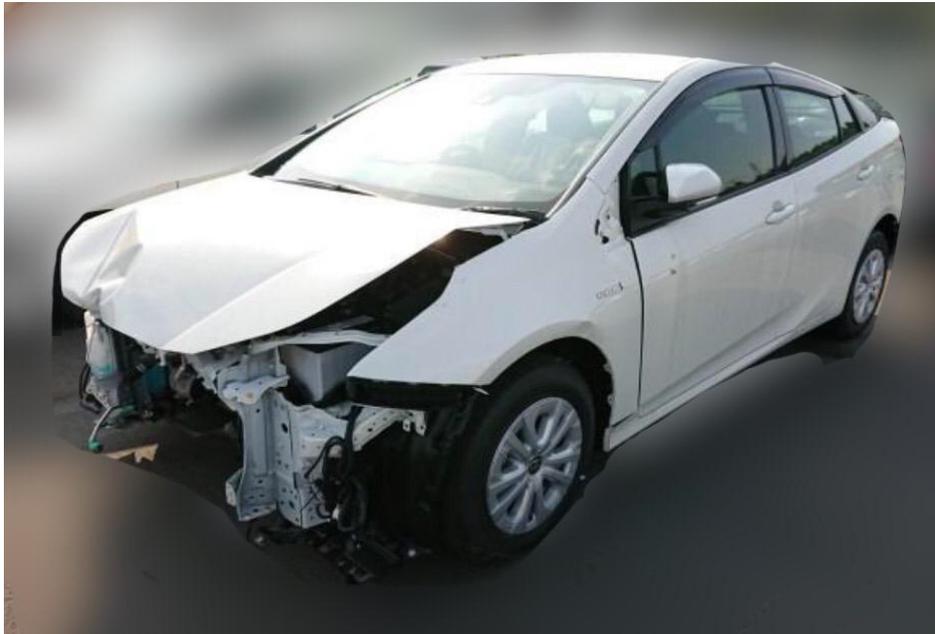
Photo 1 shows the front left body of the Motor Car prior to any repairs being carried out (photograph provided to me). The Motor Car was observed to have sustained damages at its frontal portion. Body parts damaged had include its front bumper and all its related attachments, front left headlamp, front bonnet, aircon condenser, radiator, front left fender and front left headlamp amongst others.

23. The body parts at the frontal portion and rear portion of the Motor Car were all visually examined, and it was noted that the repair/restoration works carried out to the damaged area of the Motor Car (refer photograph 1 - 4 above) were reasonably adequate and in order.

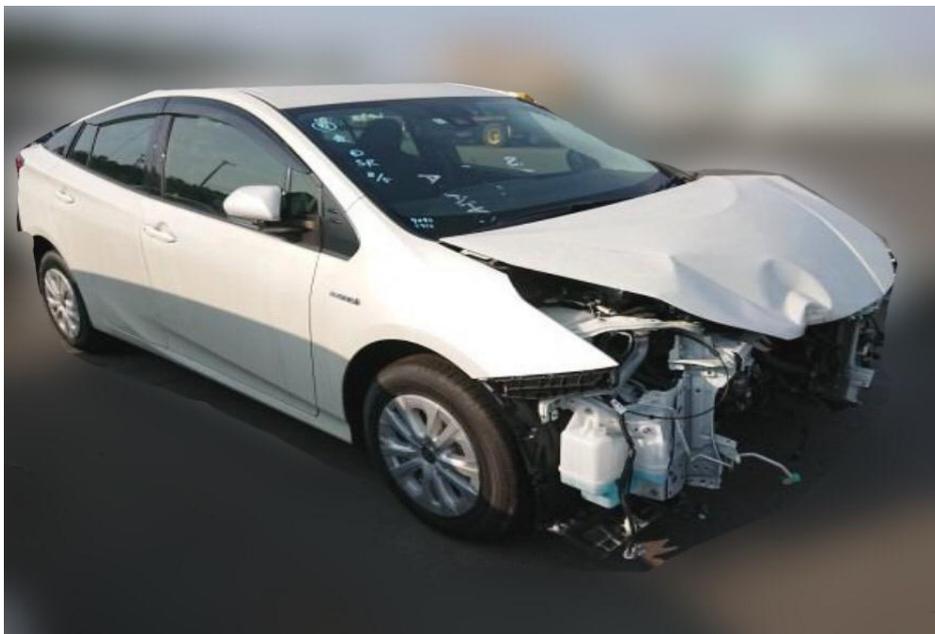
Photo 2 shows the front right body of the Motor Car prior to any repairs being carried out (photograph provided to me). The Motor Car was observed to have sustained damages at its frontal portion. Body parts damaged had include its front bumper and all its related attachments, front bumper reinforcement, front right headlamp, front bonnet, radiator grille, aircon condenser, radiator and front right headlamp amongst others.

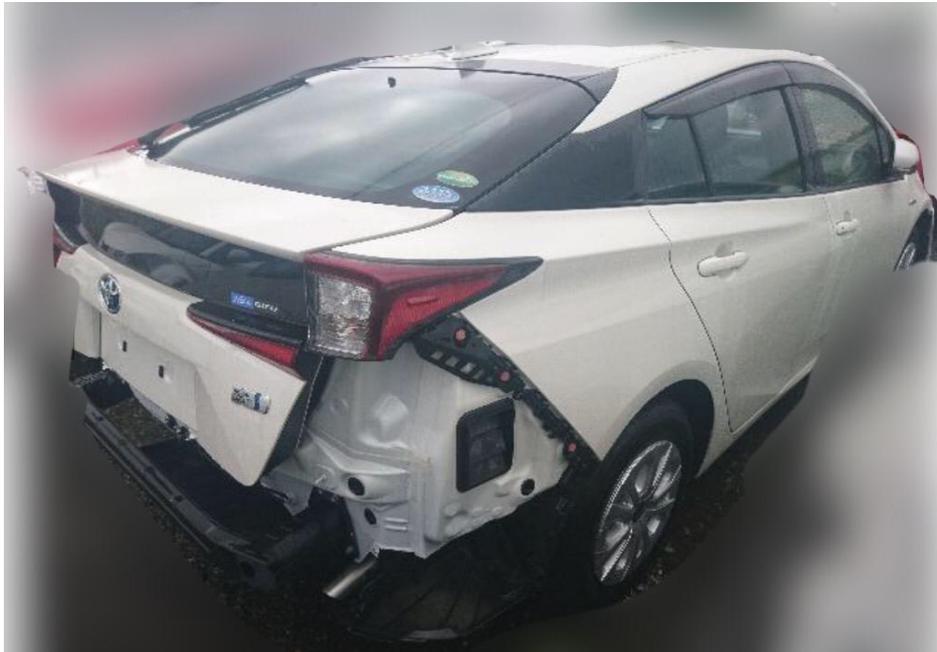
Photo 3 shows the rear right body of the Motor Car prior to any repairs being carried out (photograph provided to me). The rear bumper, rear bumper lower cover and rear bumper reflectors were observed to be dislodged/missing.

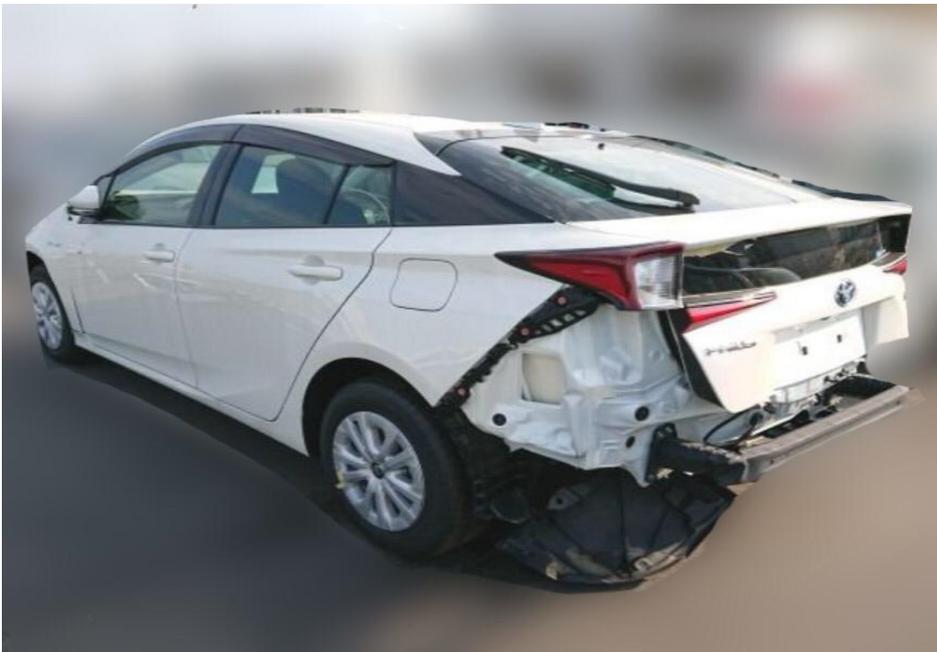
Photo 4 shows the rear left body of the Motor Car prior to any repairs being carried out (photograph provided to me). The rear bumper, rear bumper lower cover and rear bumper reflectors were observed to be dislodged/missing. The airbags of the Motor Car were not activated as seen from the photographs that were provided to me.

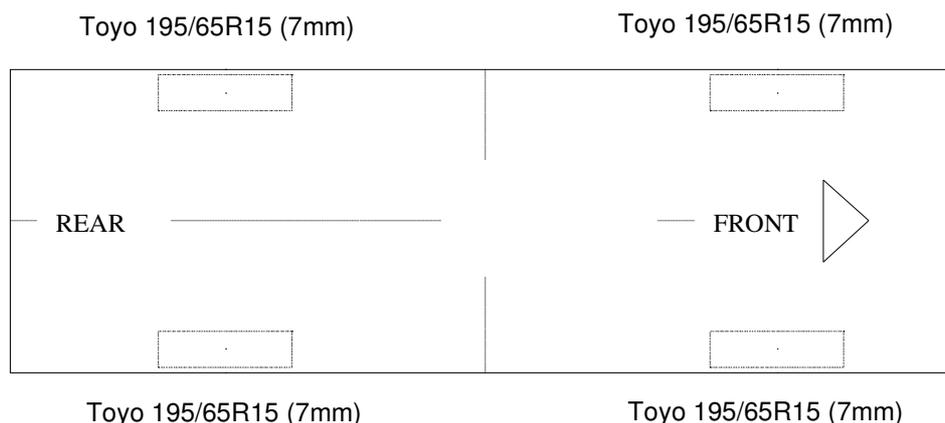
9. It was fitted with 15inch sport wheel rims that were wrapped with tyres that were observed to be of serviceable condition. The tyres were also sufficiently inflated for vehicular operation. The tyre brand, tyre size and approximate remaining tread depth of the 4 tyres of the Motor Car were recorded as follows: -

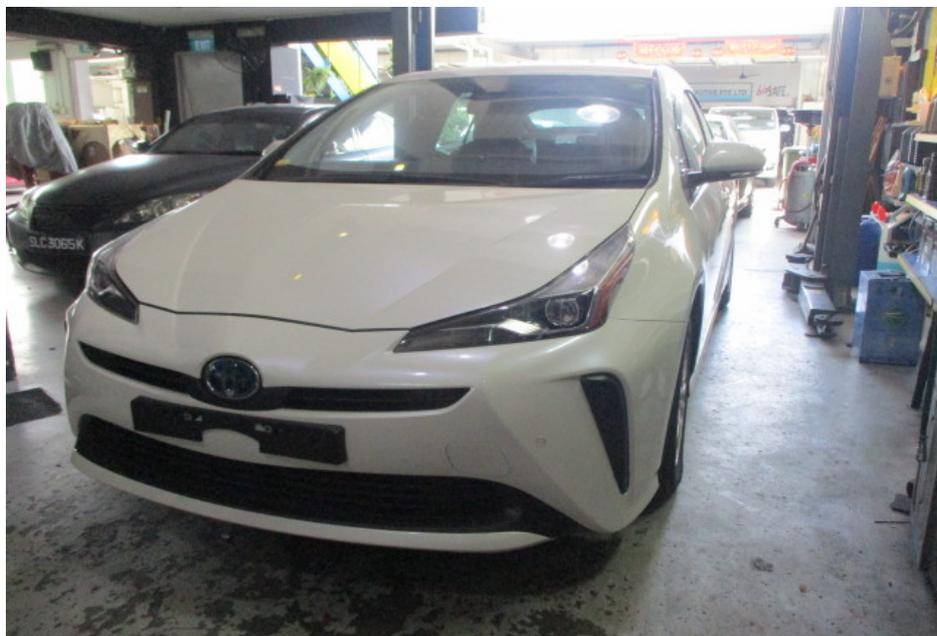
Photo 5 shows a general view of the front left body of the Motor Car at the time of my inspection. The Motor Car was observed to be in a relatively good general condition with no loose exterior fittings observed. The body parts at the frontal portion of the Motor Car were visually examined and it was observed that the repair/restoration works carried out to the damaged area of the Motor Car (refer to photograph 1 & 2 above) were reasonably adequate and in order.

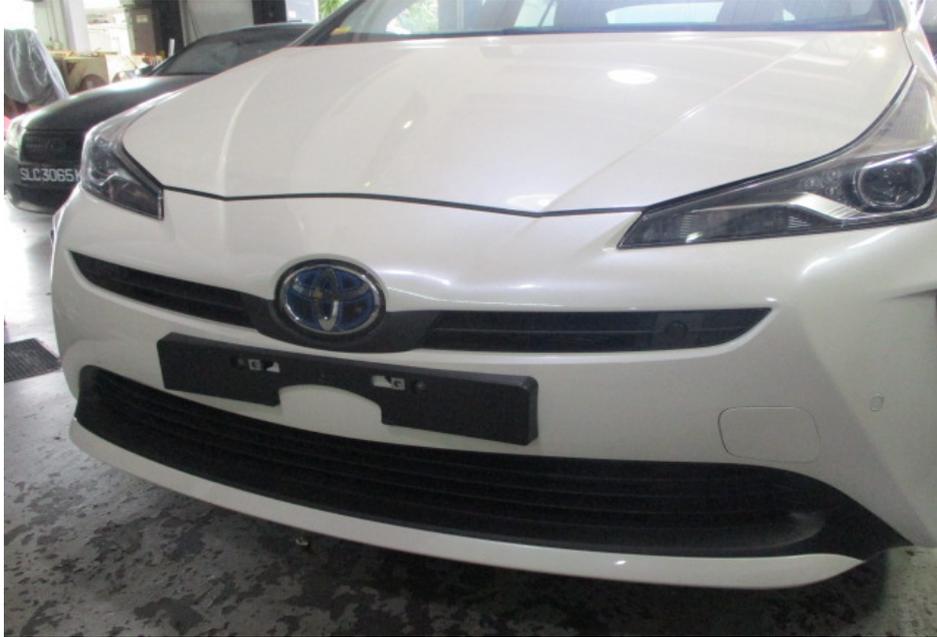
Photo 6 shows a closer view of the front bumper, front bumper lower grille, radiator grille, front headlamps and front bonnet of the Motor Car. The body parts at the frontal portion of the Motor Car were visually examined and it was observed that the repair/restoration works carried out to the damaged area of the Motor Car (refer to photograph 1 & 2 above) were reasonably adequate and in order.

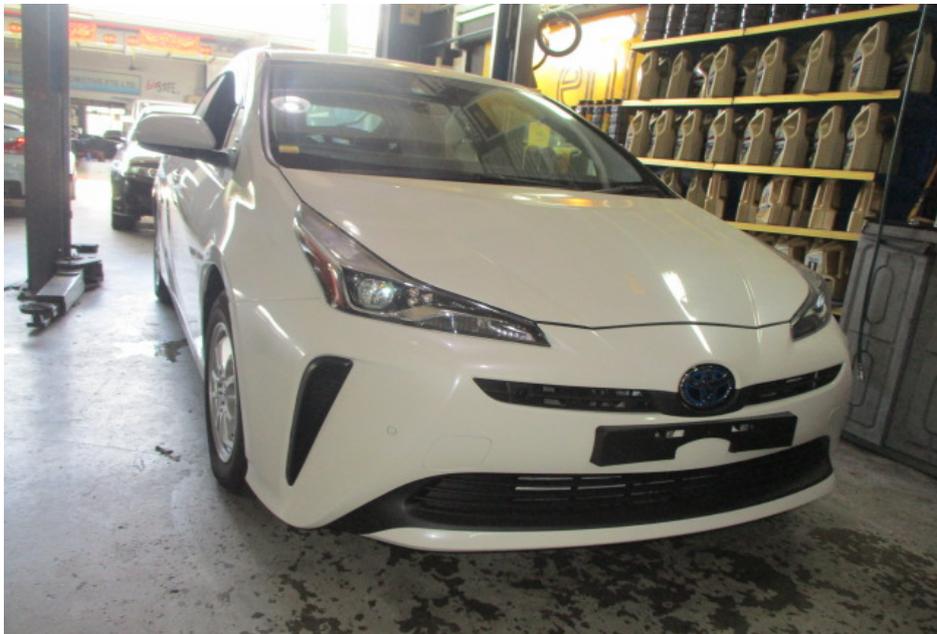
Photo 7 shows a general view of the front right body of the Motor Car at the time of my inspection. The Motor Car was observed to be in a relatively good general condition with no loose exterior fittings observed. The body parts at the frontal portion of the Motor Car were visually examined and it was observed that the repair/restoration works carried out to the damaged area of the Motor Car (refer to photograph 1 & 2 above) were reasonably adequate and in order.

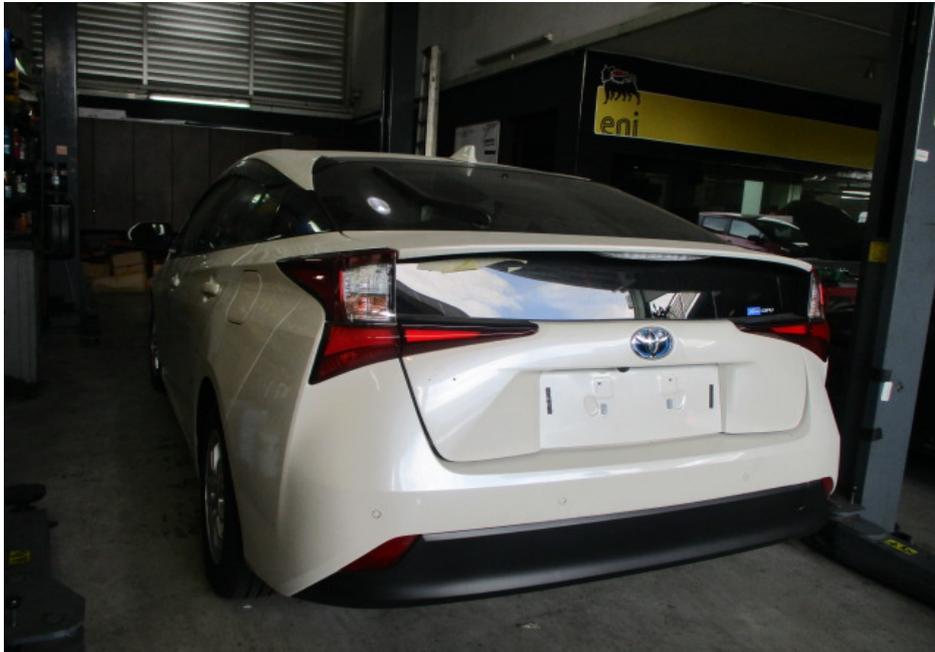
Photo 8 shows a general view of the rear left body of the Motor Car at the time of my inspection. The Motor Car was observed to be in a relatively good general condition with no loose exterior fittings observed. The body parts at the rear portion of the Motor Car were visually examined and it was observed that the repair/restoration works carried out to the damaged area of the Motor Car (refer to photograph 3 & 4 above) were reasonably adequate and in order.

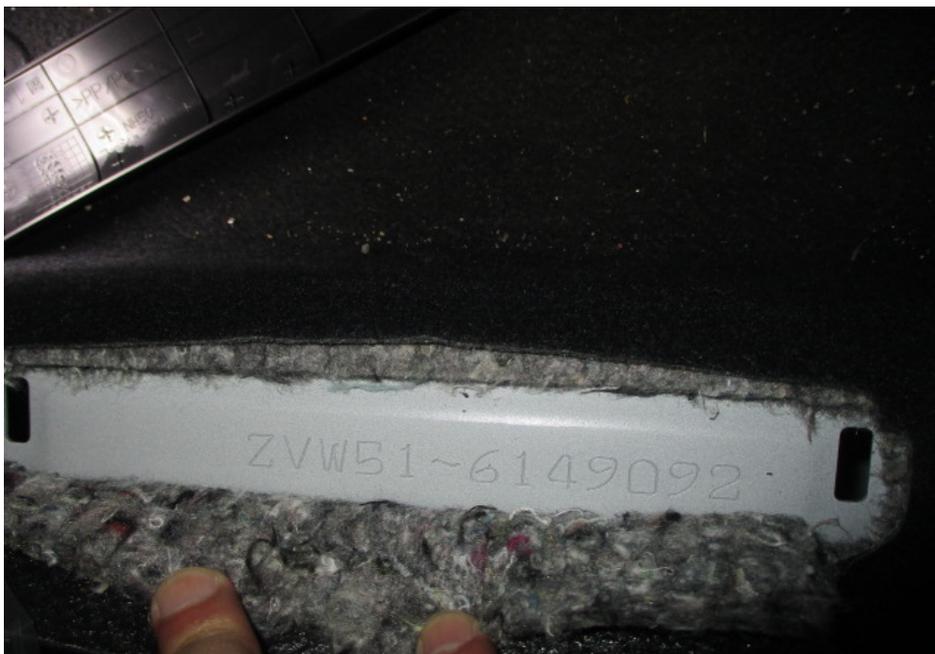
Photo 9 shows the chassis number of the Motor Car. The chassis number recorded was ZVW516149092.

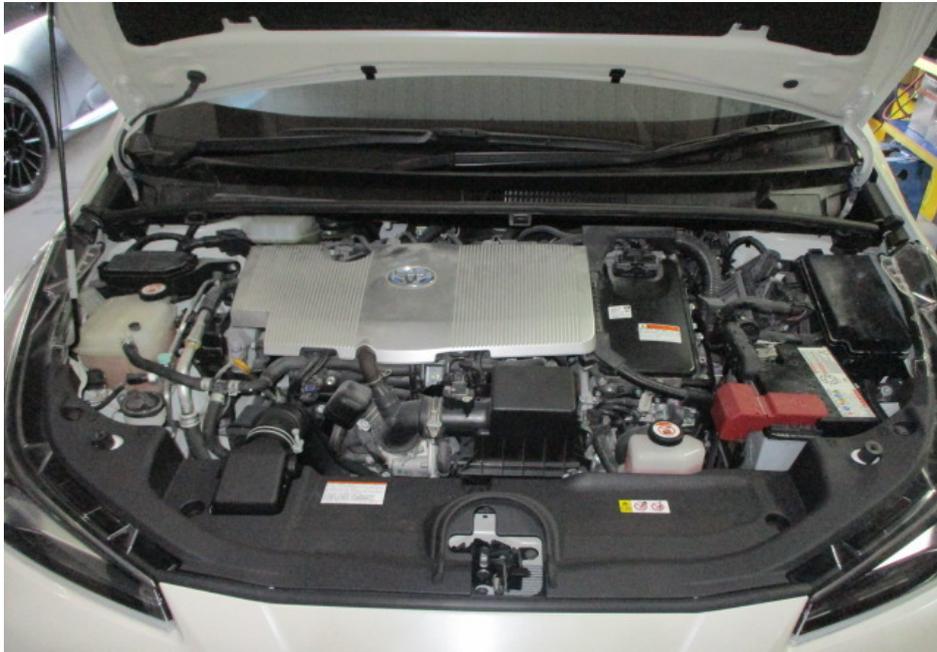
Photo 10 shows a general view of the engine compartment of the Motor Car at the time of my inspection. The various parts and components inside the engine compartment were all observed to be intact and properly fitted. There was also no sign(s) or indication(s) of fluid leak and/or fluid stain found inside the engine compartment.

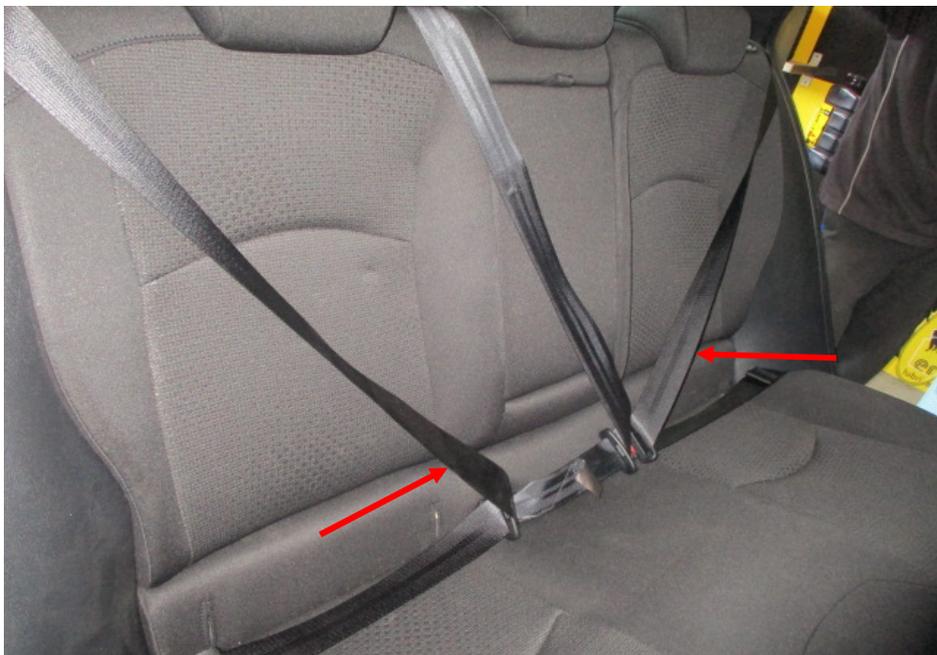
Photo 11 shows the rear seats of the Motor Car. All the seats of the Motor Car were secured via seat rails to the floorboard. They were also fitted with a retractable seat belt reel and a pre-tensioner. The seat belts (arrowed) of the Motor Car were tested and were able to be fastened into the respective pre-tensions that were fitted on the side of each individual seat.

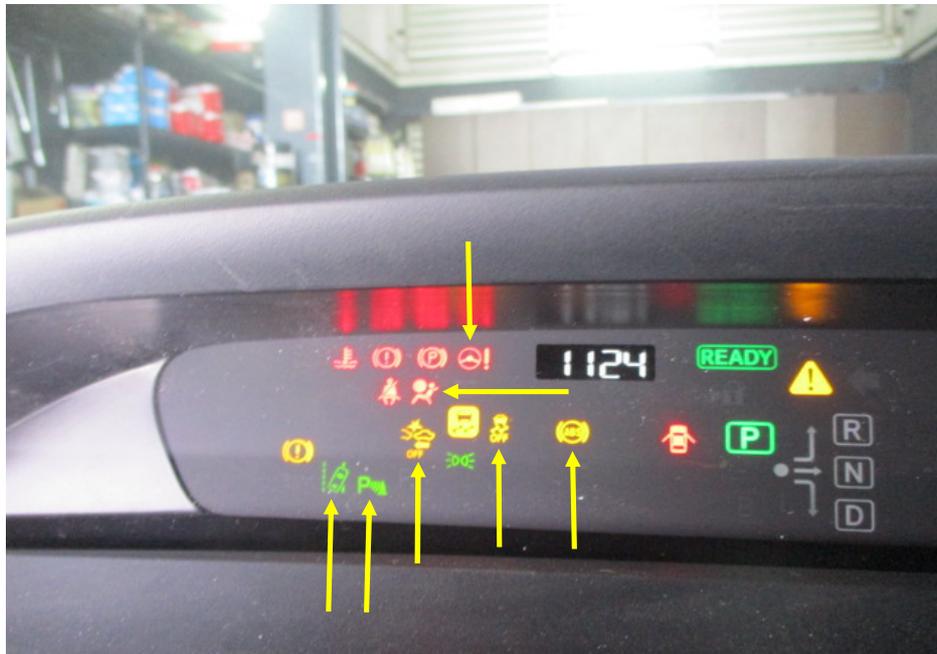
Photo 12 shows the warning lights for the various electronic safety features appearing on the instrument panel of the Motor Car during its self-test when the engine is cranked, in particular the ABS, SRS, EPS, VSC, LDA, IPA and PCS lights (arrowed).

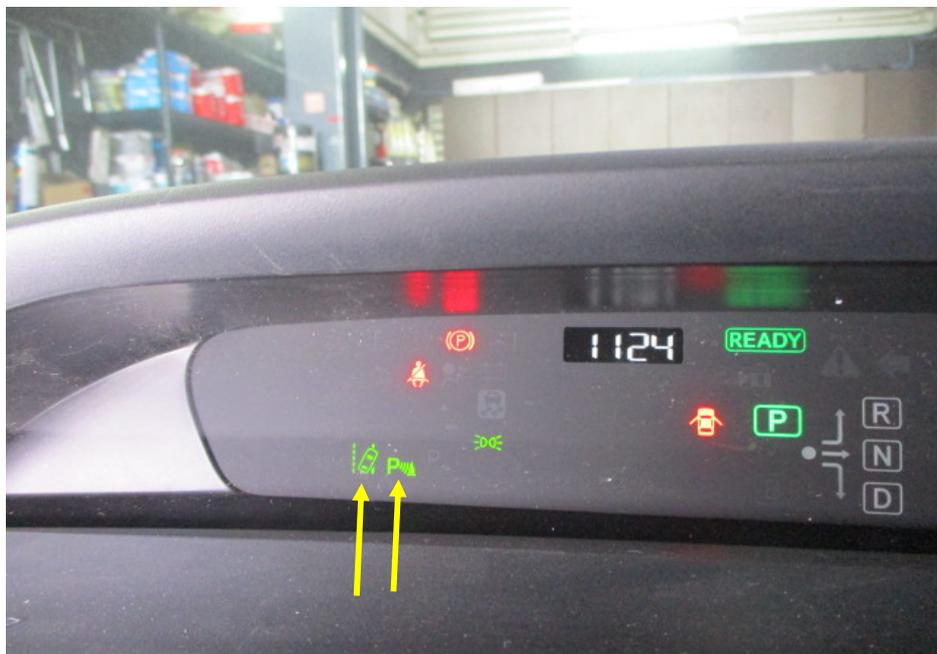
Photo 13 shows the respective warning lights no longer illuminated, indicating that there is no fault detected to the ABS, SRS, EPS, VSC and PCS systems of the Motor Car during the self-test. These electronic systems were hence in working condition at the time of my inspection. The LDA light and IPA light (arrowed) showing green indicates that the system is in working order.

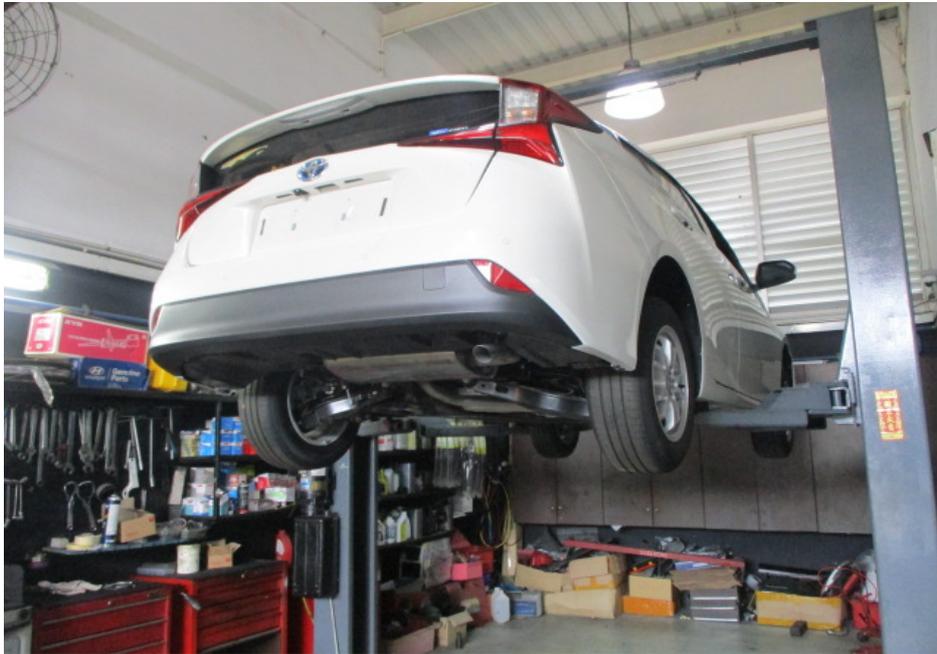
Photo 14 shows the Motor Car hoisted up for checks on its undercarriage. There was no sign(s) or indication(s) of fluid leakage and/or fluid stain(s) on the underside of the Motor Car. The undercarriage components of the Motor Car were also all observed to be intact and secured in an appropriate manner.

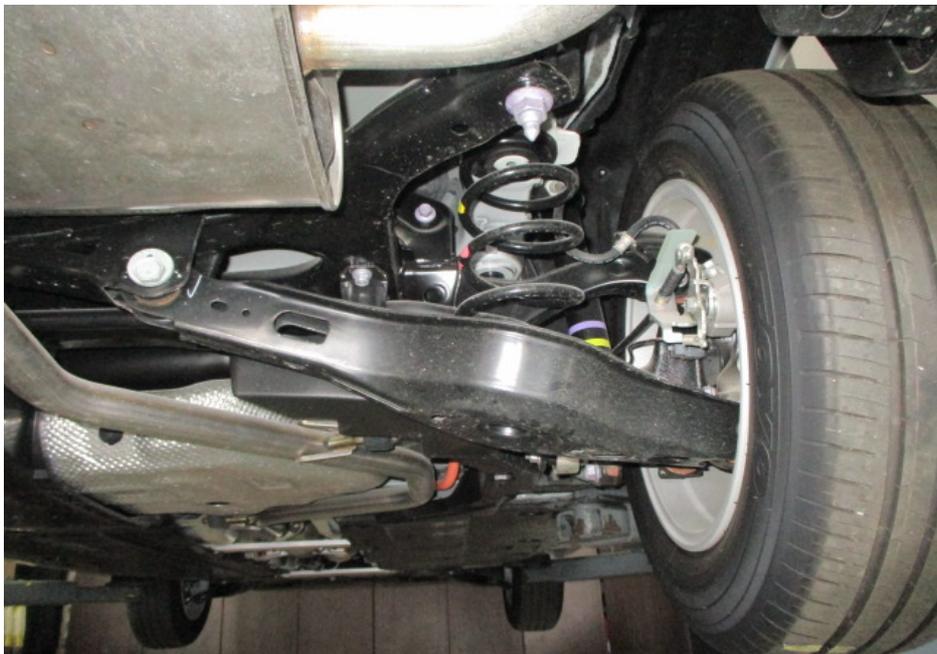
Photo 15 shows a general view of the control arms and linkages at the rear right wheel of the Motor Car. I did not observe any fluid leak and/or fluid stain on the underside of the Motor Car. All the Motor Car's undercarriage components were observed to be intact and secured in an appropriate manner.

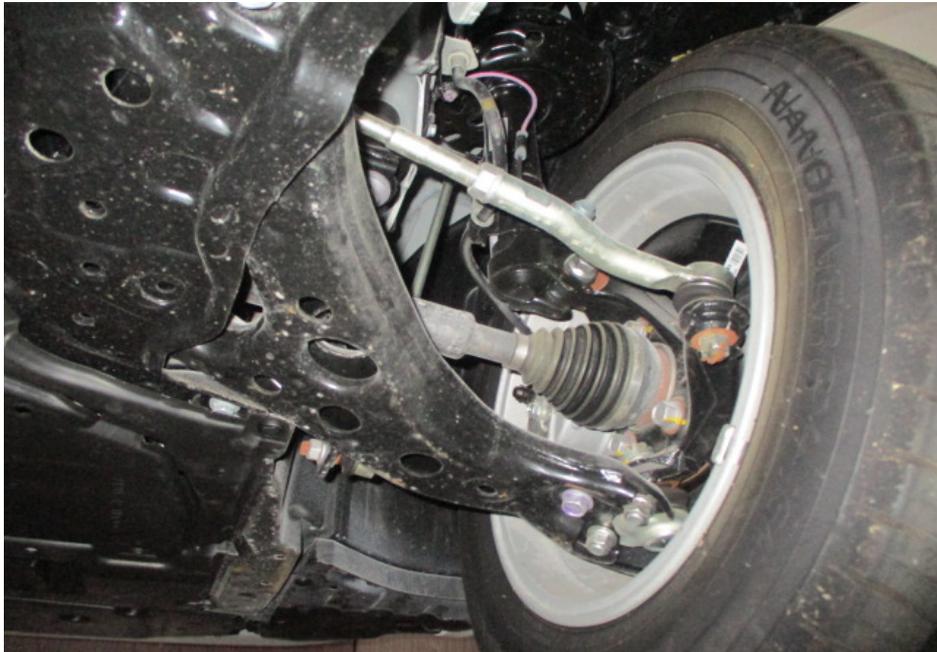
Photo 16 shows the various undercarriage components at the front right wheel of the Motor Car. The mechanical components, control arms and linkages were all found to be intact and secured in an appropriate manner.

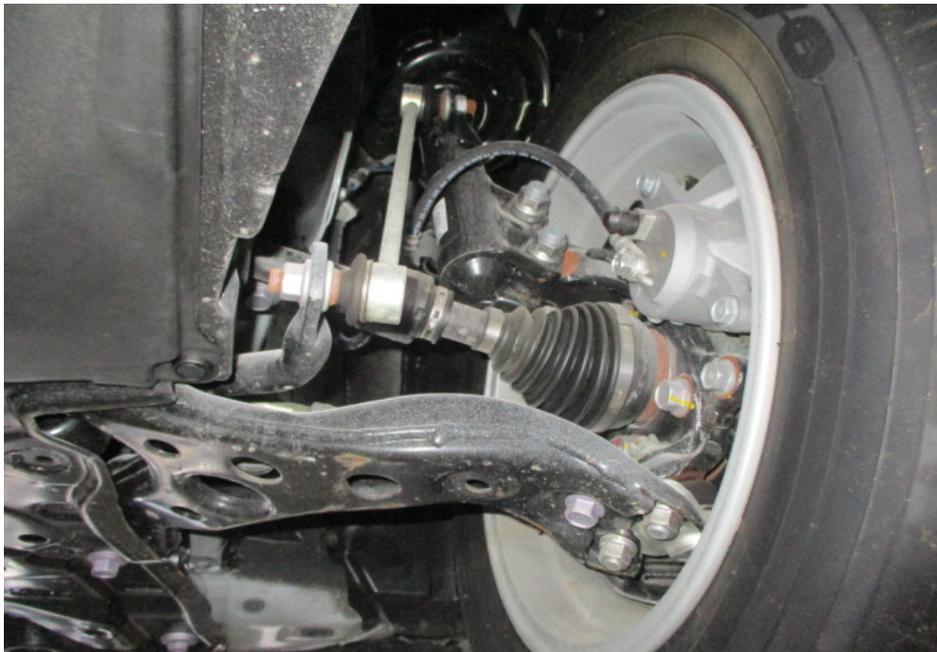
Photo 17 shows the various undercarriage components at the front left wheel of the Motor Car. The mechanical components, control arms and linkages were all found to be intact and secured in an appropriate manner. I also did not observe any fluid leak and/or fluid stain on the underside of the Motor Car.

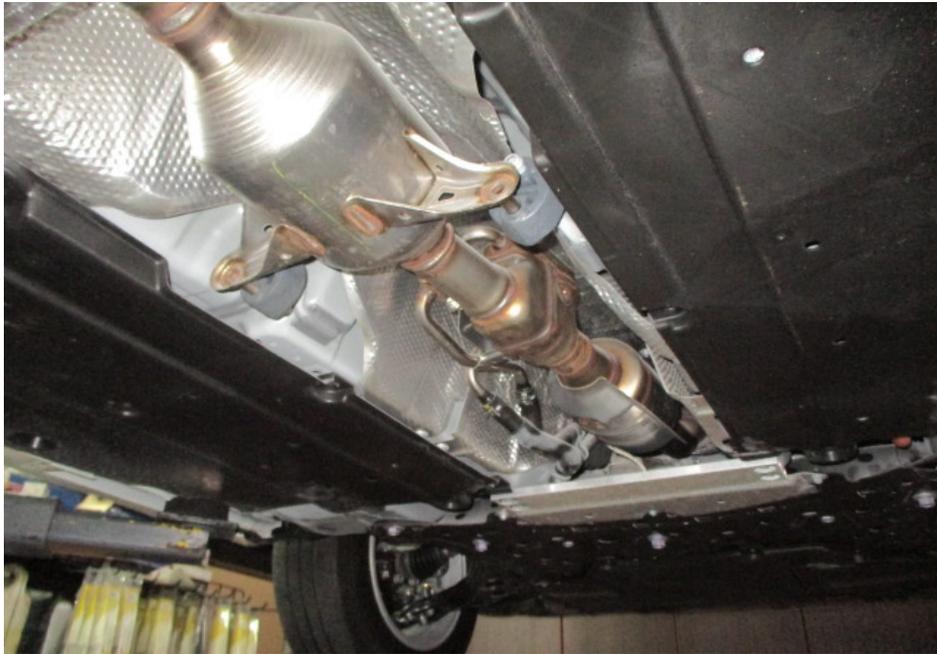
Photo 18 shows the Motor Car's centre exhaust pipe. My examination of the Motor Car's exhaust system revealed no sign(s) or indication(s) of any cut or weld marks along its catalytic convertor, exhaust pipes and on its rear muffler.

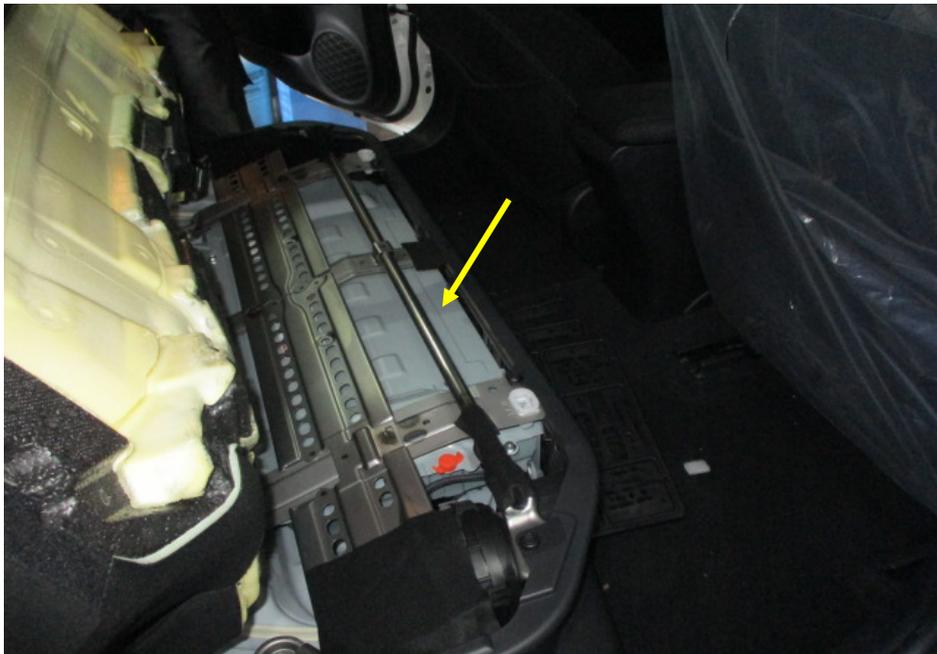
Photo 19 shows the Motor Car's electric battery (arrowed) that was fitted within the interior compartment, under the rear passenger seat. The cable connections were checked and found to be securely fitted into the respective connectors. The electric battery was also observed to be fitted securely.

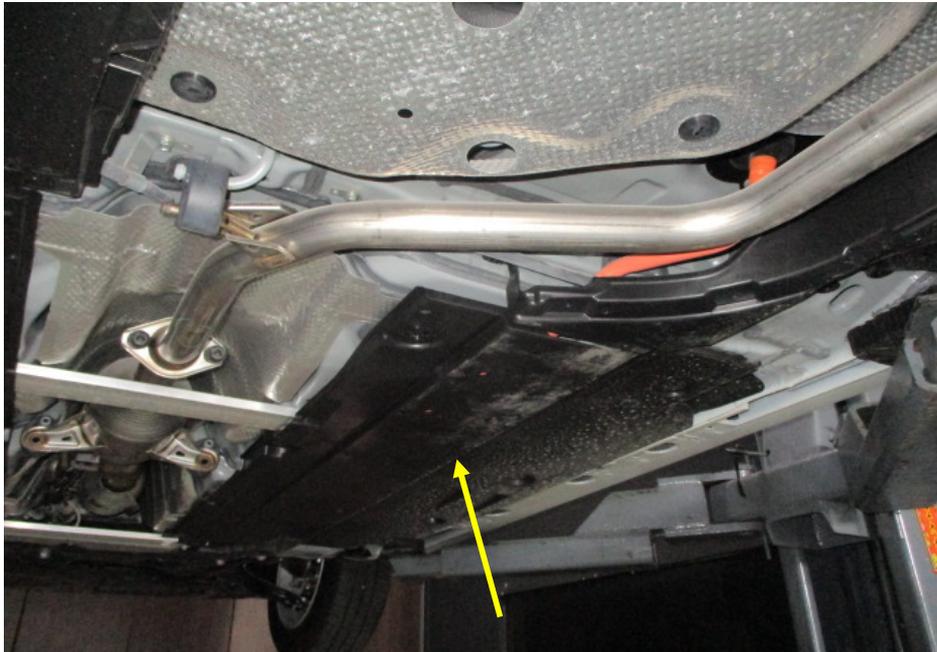
Photo 20 shows the underside of the Motor Car. I had observed that the electric cables connecting the electric motor within the engine compartment to the electric battery at the rear of the Motor Car were securely fitted into the respective connectors and protected by a dust cover (arrowed).

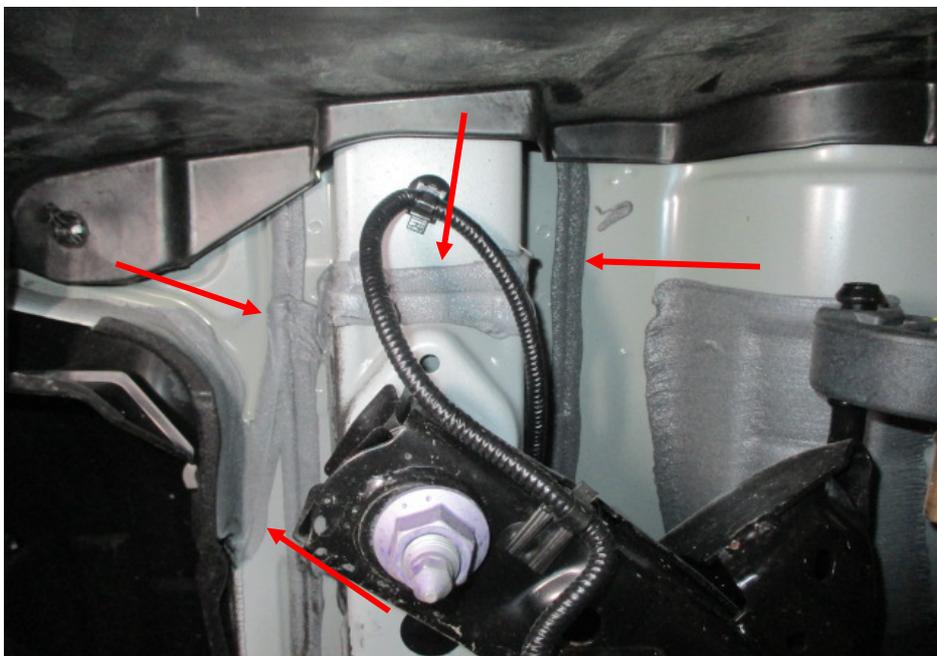
Photo 21 shows the chassis/structural body at the underside rear left of the Motor Car. The original factory sealant (arrowed) at the joints along the chassis/structural body was untouched, indicating no work was done on the chassis/structural body of the Motor Car and that the chassis/structural body was originally fitted.

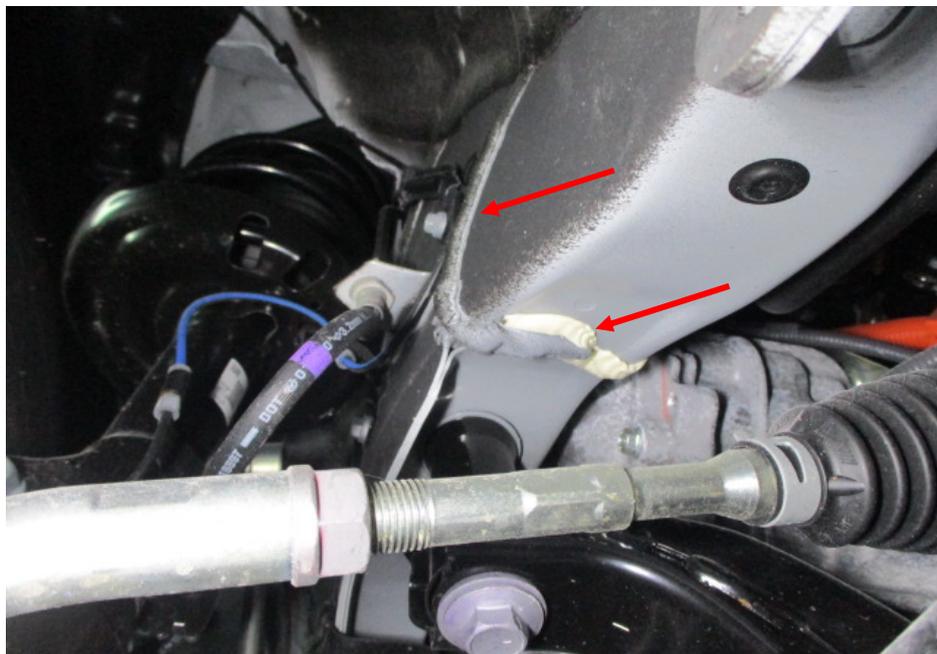
Photo 22 shows the chassis/structural body at the underside front left of the Motor Car. The original factory sealant (arrowed) at the joints along the chassis/structural body was untouched, indicating no work was done on the chassis/structural body of the Motor Car and that the chassis/structural body was originally fitted.

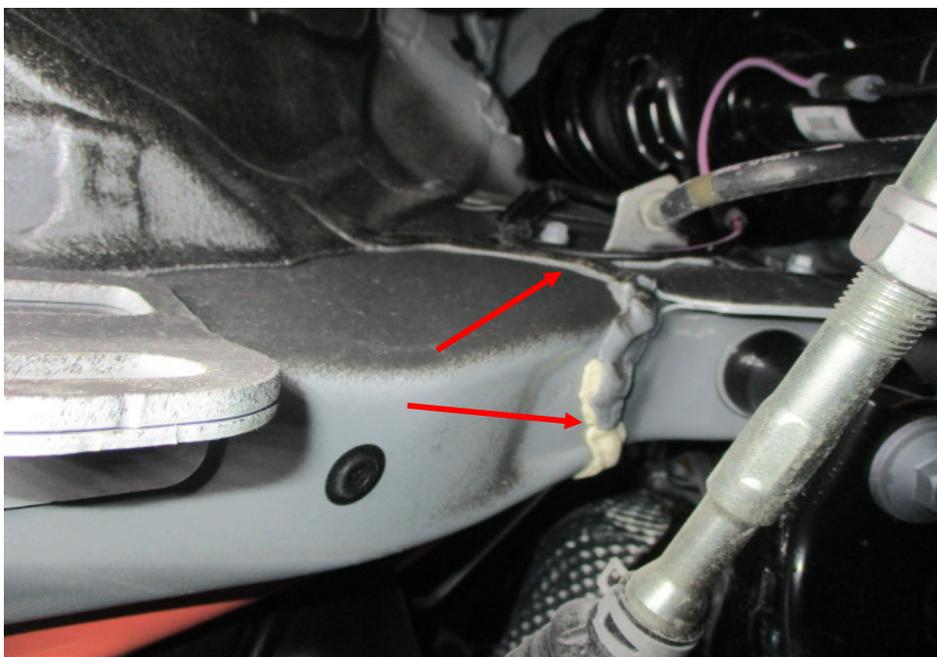
Photo 23 shows the chassis/structural body at the underside front right of the Motor Car. The original factory sealant (arrowed) at the joints along the chassis/structural body was observed to be untouched. In general, I had found no work was carried out on the chassis/structural body of the Motor Car. The chassis/structural body of the Motor Car was originally fitted.

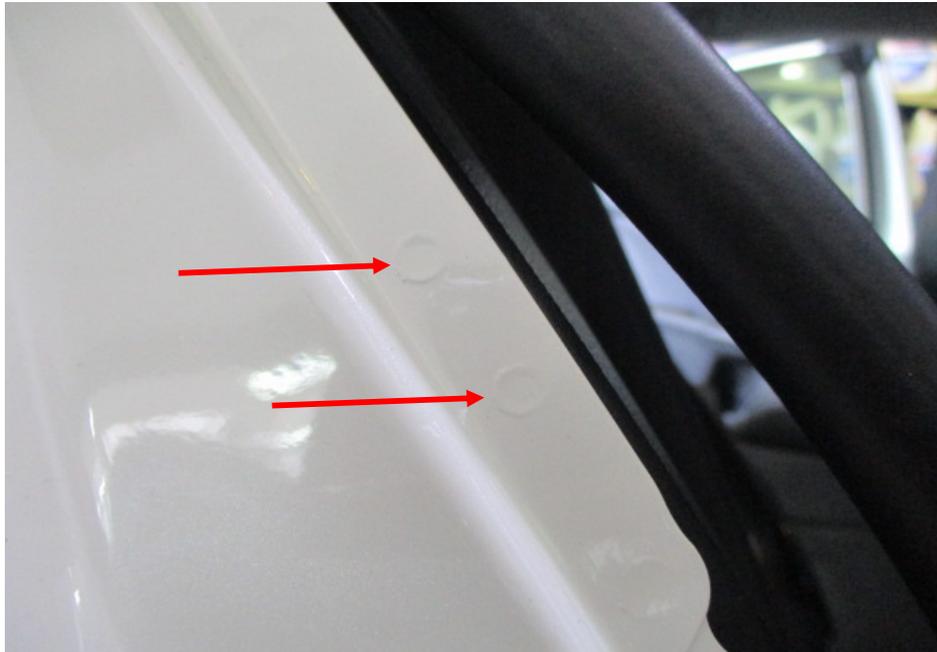
Photo 24 shows the right side "C" pillar of the Motor Car. I did not find any weld marks other than original spot weld marks (arrowed) on the right side "C" pillar of the Motor Car which, indicates that there was no re-welding works carried out. In general, I had found all the non-detachable body panels of the Motor Car to be originally fitted at the time of my inspection.
