Your Ref: BMW 430i  
(chassis number WBA4H72070BK36324)  
Our Ref : CI/TP21001929/D

09 February 2021

**INSPECTION REPORT OF AN UNREGISTERD BMW 430i MOTOR CAR WITH CHASSIS NUMBER WBA4H72070BK36324**

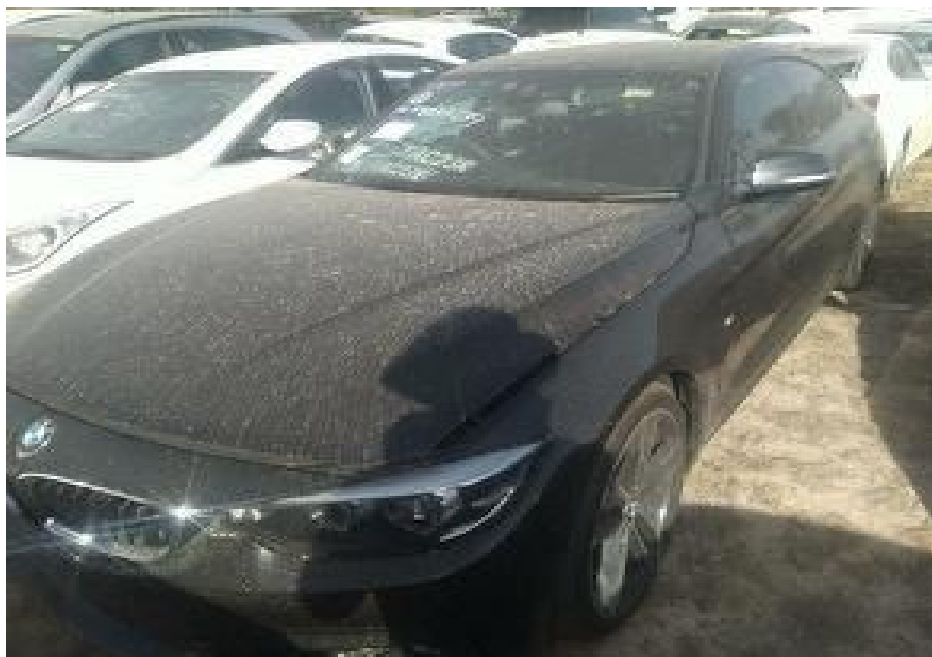
**Photo 1** shows the front left body of the Motor Car prior to any repairs being carried out (photograph provided to me). The Motor Car was observed to have sustained damages of indentation nature to multiple exterior body parts like its front bonnet. As seen from the photographs provided, the indentation was relatively minor.

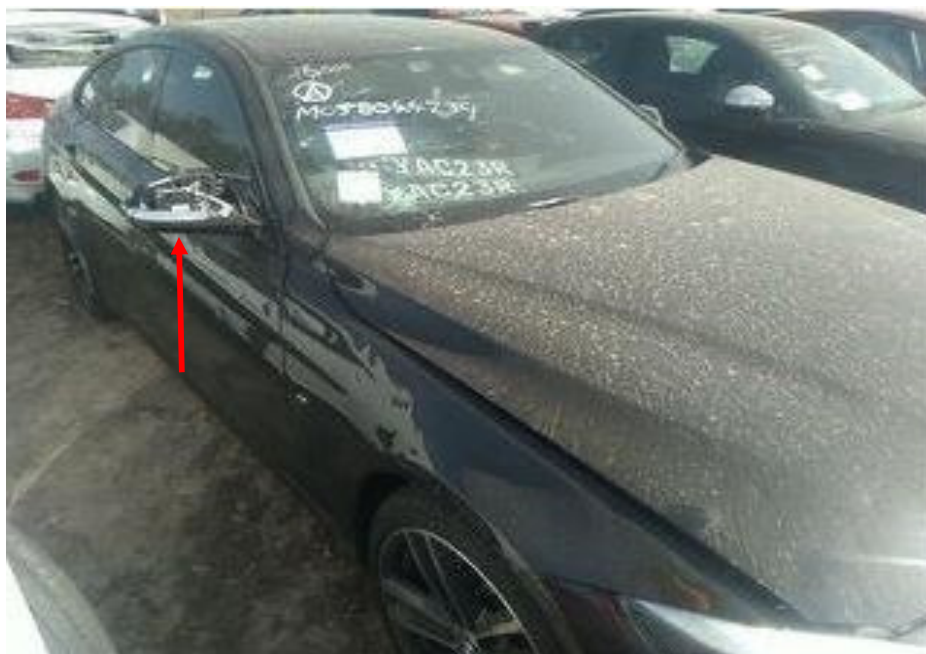
**Photo 2** shows the front right body of the Motor Car prior to any repairs being carried out (photograph provided to me). The Motor Car was observed to have sustained damages of indentation nature to multiple exterior body parts like its front bonnet. As seen from the photographs provided, the indentation was relatively minor. The right side wing mirror (arrowed) was also observed to be broken.

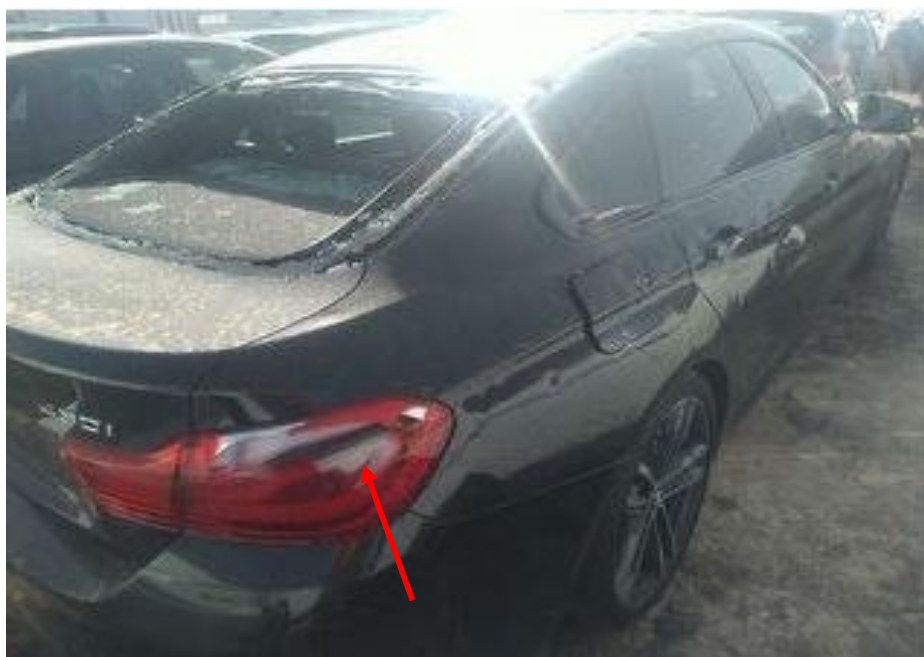
**Photo 3** shows the rear right body of the Motor Car prior to any repairs being carried out (photograph provided to me). Relatively minor indentation damage was seen on the rear right fender, rear bootlid and rear roof panel amongst others. The rear right taillamp (arrowed) was also observed to be broken.

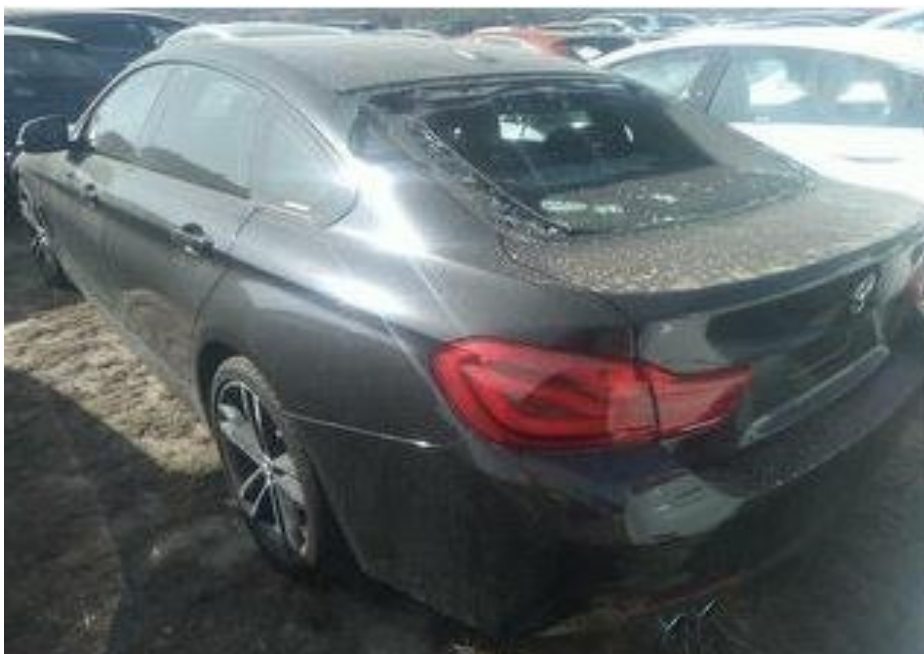
**Photo 4** shows the rear left body of the Motor Car prior to any repairs being carried out (photograph provided to me). The Motor Car was observed to have sustained damages of indentation nature to multiple exterior body parts like its rear bootlid amongst others. As seen from the photographs provided, the indentation was relatively minor. The rear windscreen was also observed to be broken.

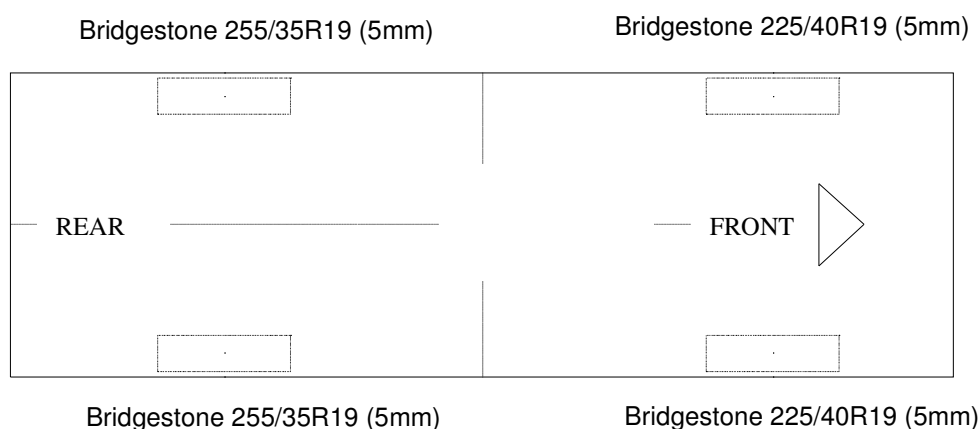
8. It was fitted with 19inch sport wheel rims that were wrapped with tyres that were observed to be of serviceable condition. The tyres were also sufficiently inflated for vehicular operation. The tyre brand, tyre size and approximate remaining tread depth of the 4 tyres of the Motor Car were recorded as follows: -

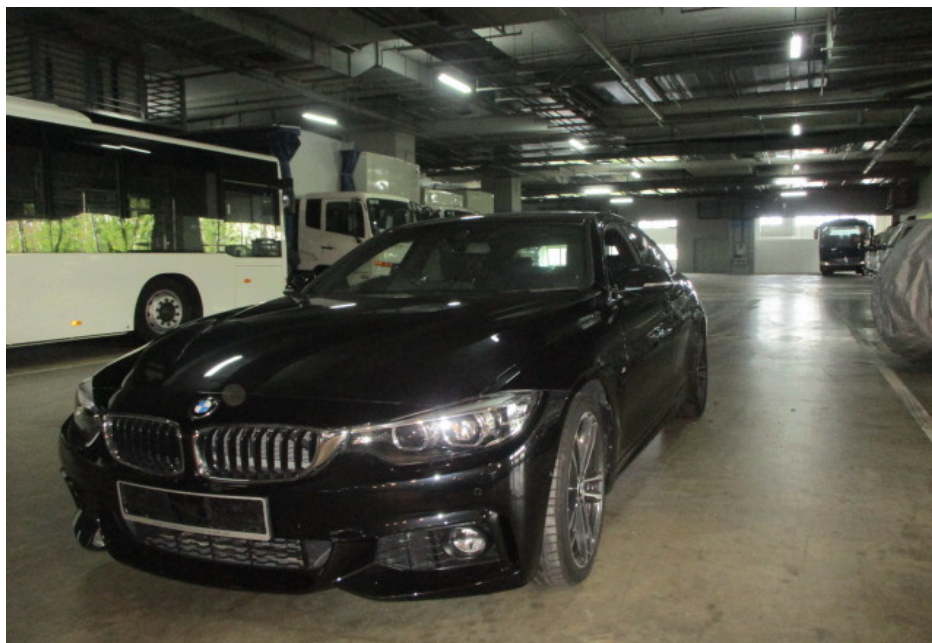
**Photo 5** shows a general view of the front left body of the Motor Car at the time of my inspection. The Motor Car was observed to be in a relatively good general condition with no loose exterior fittings observed. The exterior body parts at the frontal body of the Motor Car were visually examined and it was observed that the repair/restoration works carried out to the damaged area of the Motor Car (refer photograph 1 & 2 above) were reasonably adequate and in order.

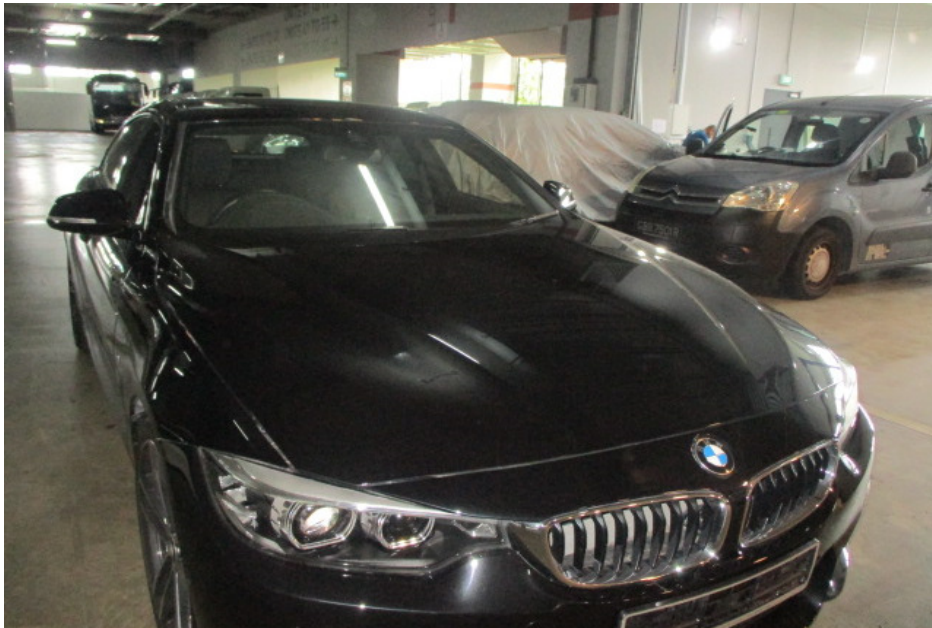
**Photo 6** shows a general view of the frontal body of the Motor Car at the time of my inspection. The Motor Car was observed to be in a relatively good general condition with no loose exterior fittings observed. The exterior body parts at the frontal body of the Motor Car were visually examined and it was observed that the repair/restoration works carried out to the damaged area of the Motor Car (refer photograph 1 & 2 above) were reasonably adequate and in order.

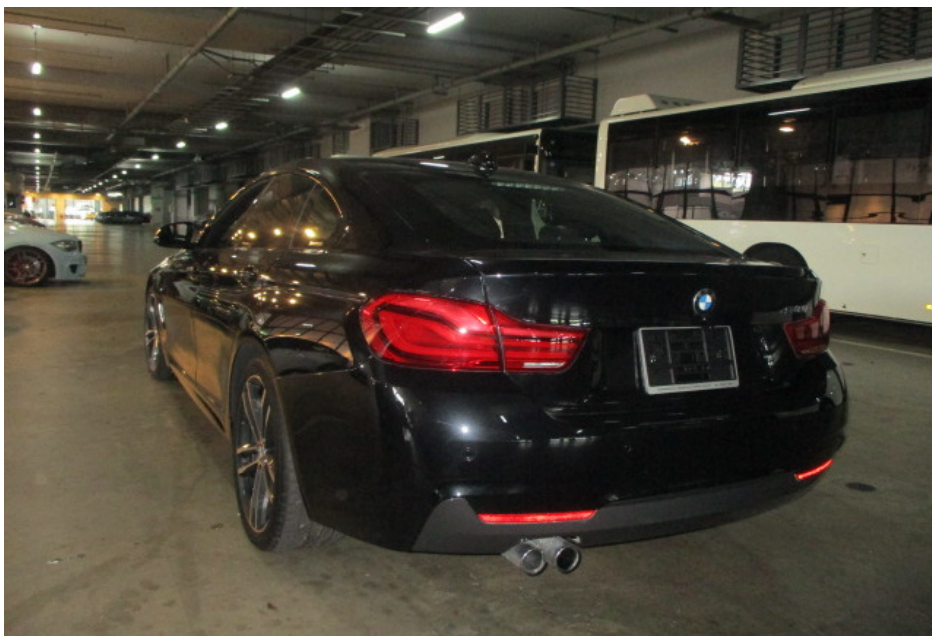
**Photo 7** shows a general view of the rear left body of the Motor Car at the time of my inspection. The Motor Car was observed to be in a relatively good general condition with no loose exterior fittings observed. The exterior body parts at the rear body of the Motor Car were visually examined, and it was observed that the repair/restoration works carried out to the damaged area of the Motor Car (refer photograph 3 & 4 above) were reasonably adequate and in order.

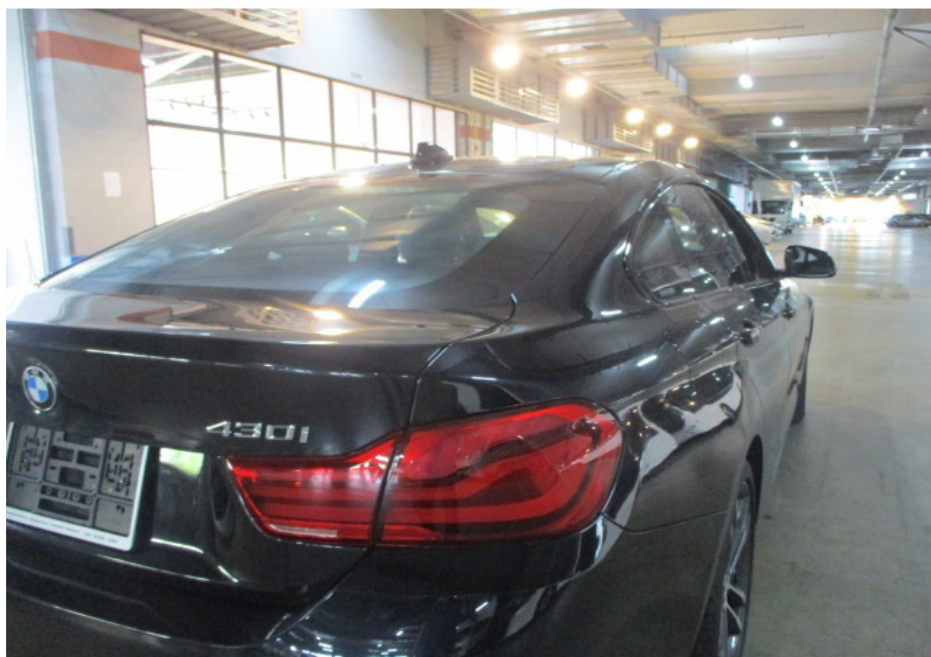
**Photo 8** shows a general view of the rear right body of the Motor Car at the time of my inspection. The exterior body parts of the Motor Car like the rear right taillamp and rear windscreen were visually examined, and it was observed that the repair/restoration works carried out to the damaged area of the Motor Car (refer photograph 3 above) were reasonably adequate and in order.

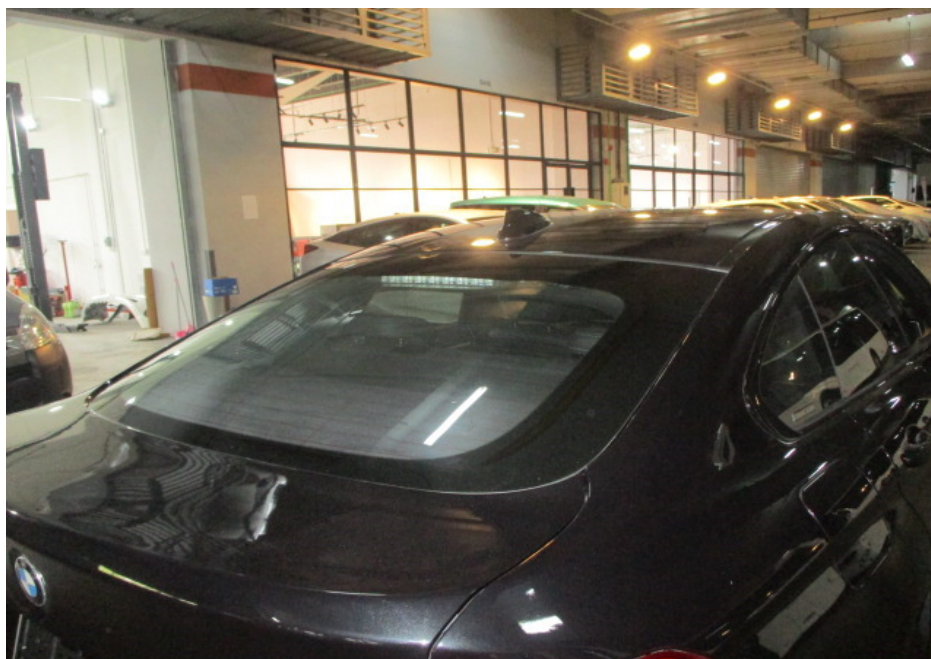
**Photo 9** shows a general view of the rear body of the Motor Car at the time of my inspection. The Motor Car was observed to be in a relatively good general condition with no loose exterior fittings observed. The exterior body parts at the rear body of the Motor Car were visually examined and it was observed that the repair/restoration works carried out to the damaged area of the Motor Car (refer photograph 3 & 4 above) were reasonably adequate and in order.

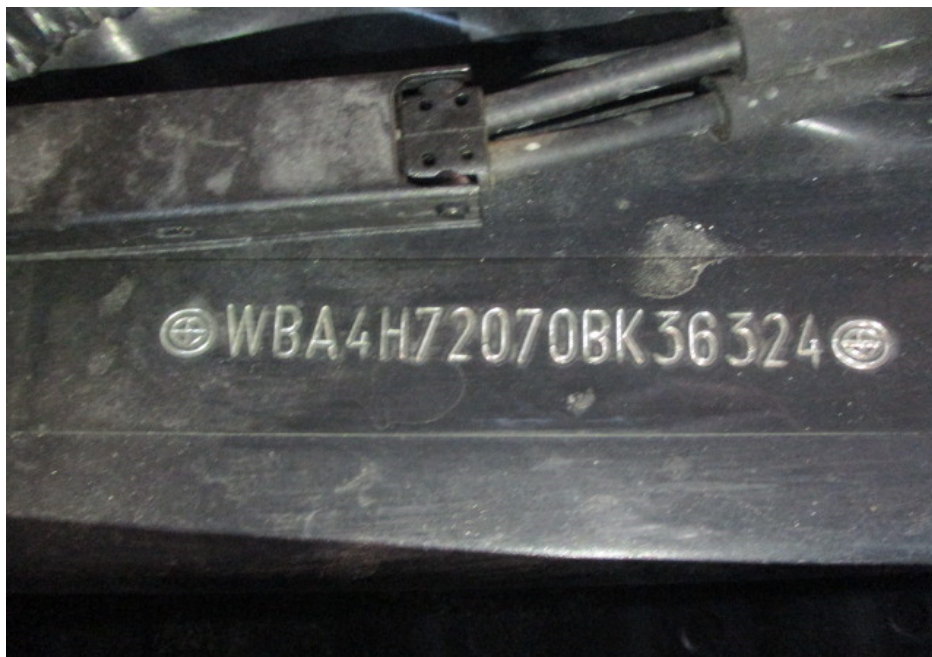
**Photo 10** shows the chassis number of the Motor Car. The chassis number recorded was WBA4H72070BK36324.

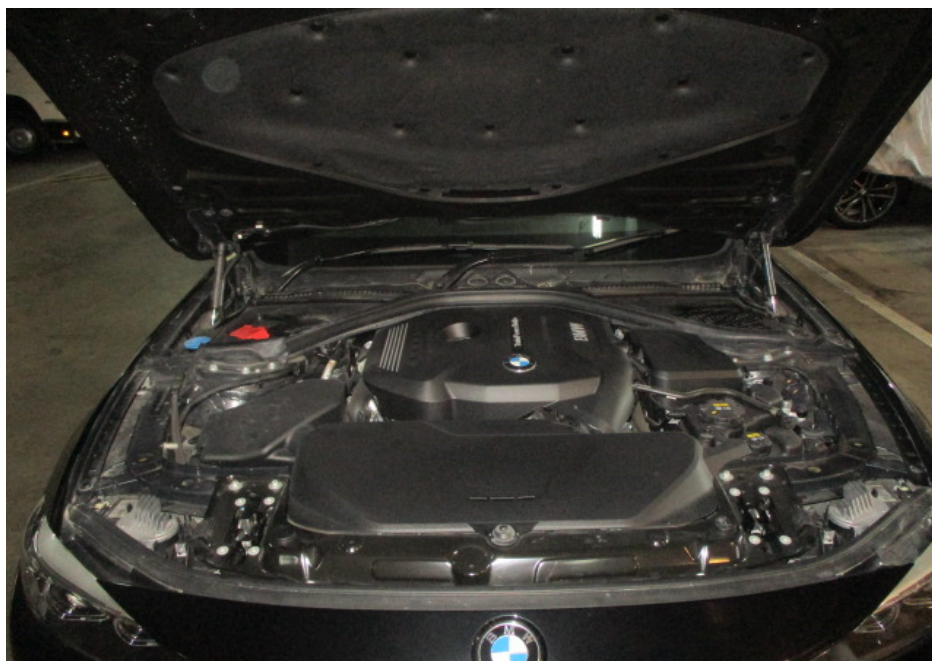
**Photo 11** shows a general view of the engine compartment of the Motor Car at the time of my inspection. The various parts and components inside the engine compartment were all observed to be intact and properly fitted. There was also no sign(s) or indication(s) of fluid leak and/or fluid stain found inside the engine compartment.

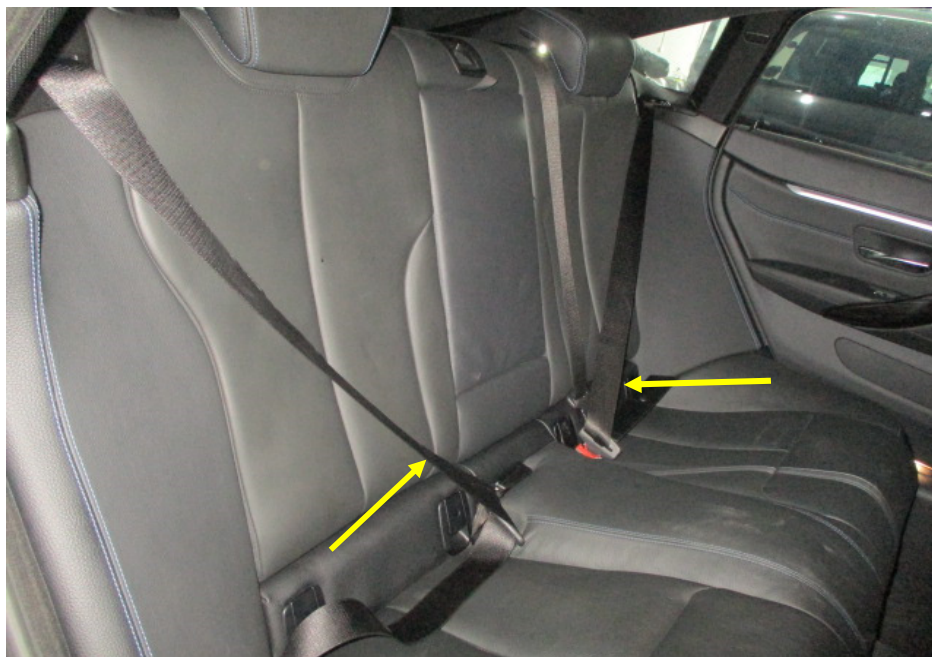
**Photo 12** shows the rear seats of the Motor Car. All the seats of the Motor Car were secured via seat rails to the floorboard. They were also fitted with a retractable seat belt reel and a pre-tensioner. The seat belts (arrowed) were tested and were able to be fastened into the respective pre-tensions that were fitted on the side of each individual seat.

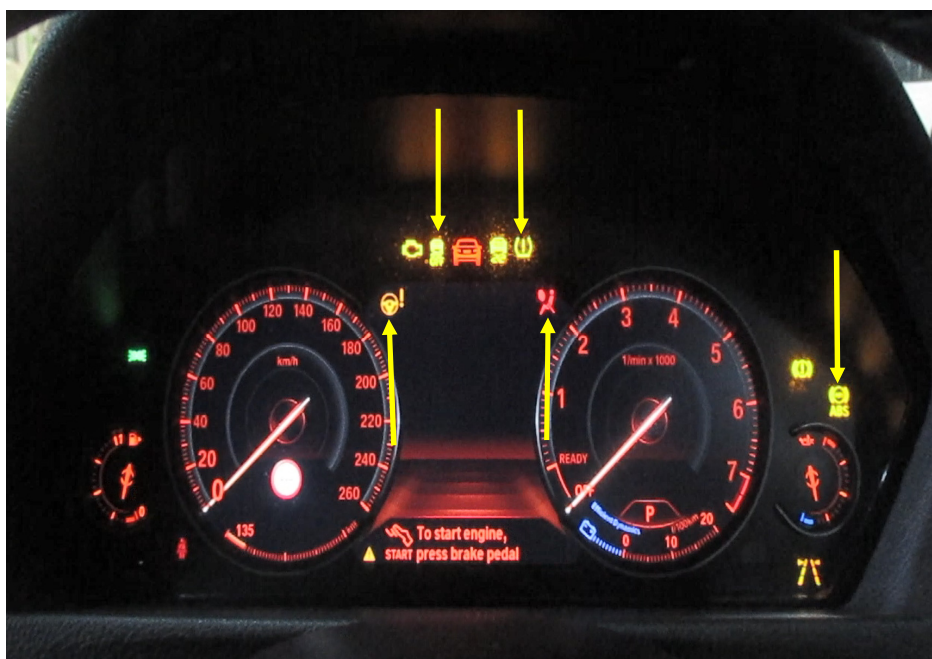
**Photo 13** shows the warning lights for the various electronic safety features appearing on the instrument panel of the Motor Car during its self-test when the engine is cranked, in particular the ABS, SRS, IAS, TPM and DSC lights (arrowed).

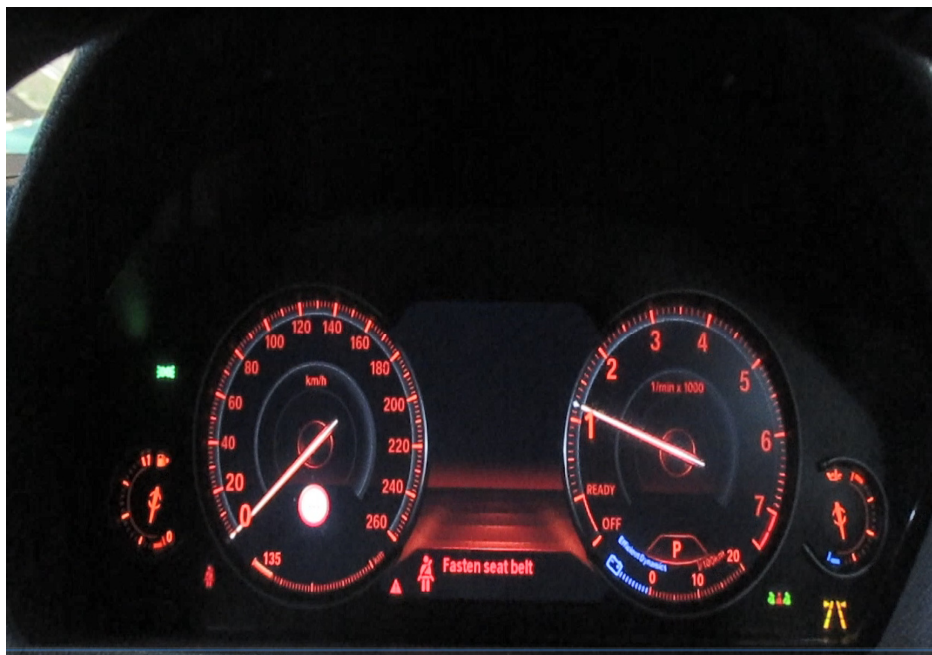
**Photo 14** shows the respective warning lights no longer illuminated, indicating that there is no fault detected to the ABS, SRS, IAS, TPM and DSC systems of the Motor Car during the self-test. These electronic systems were hence in working condition at the time of my inspection.

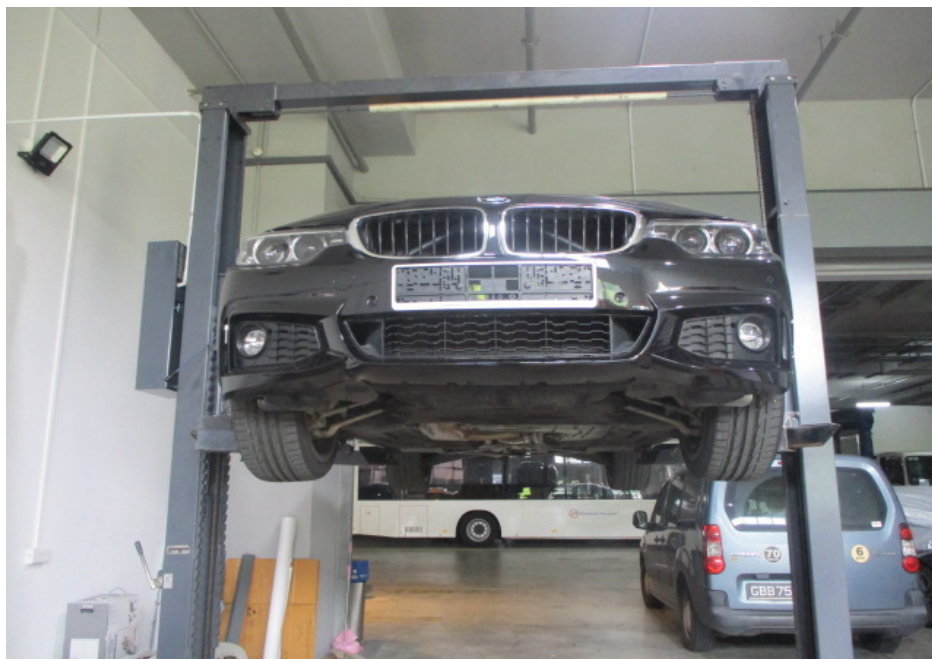
**Photo 15** shows the Motor Car hoisted up for checks on its undercarriage. There was no sign(s) or indication(s) of fluid leakage and/or fluid stain(s) on the underside of the Motor Car. The undercarriage components of the Motor Car were also all observed to be intact and secured in an appropriate manner.

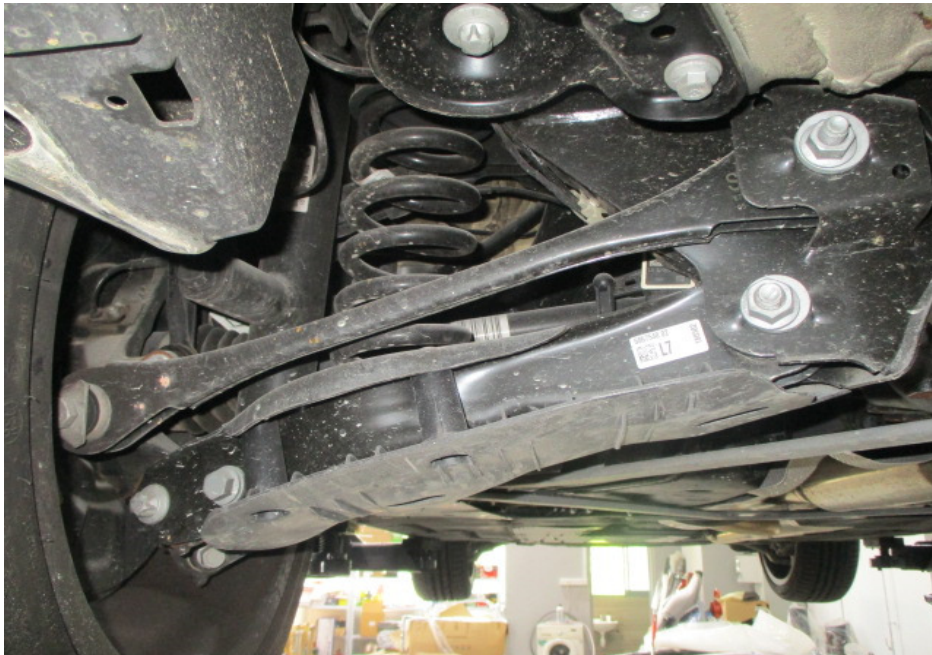
**Photo 16** shows a general view of the control arms and linkages at the rear left wheel of the Motor Car. I did not observe any fluid leak and/or fluid stain on the underside of the Motor Car. All the Motor Car's undercarriage components were observed to be intact and secured in an appropriate manner.

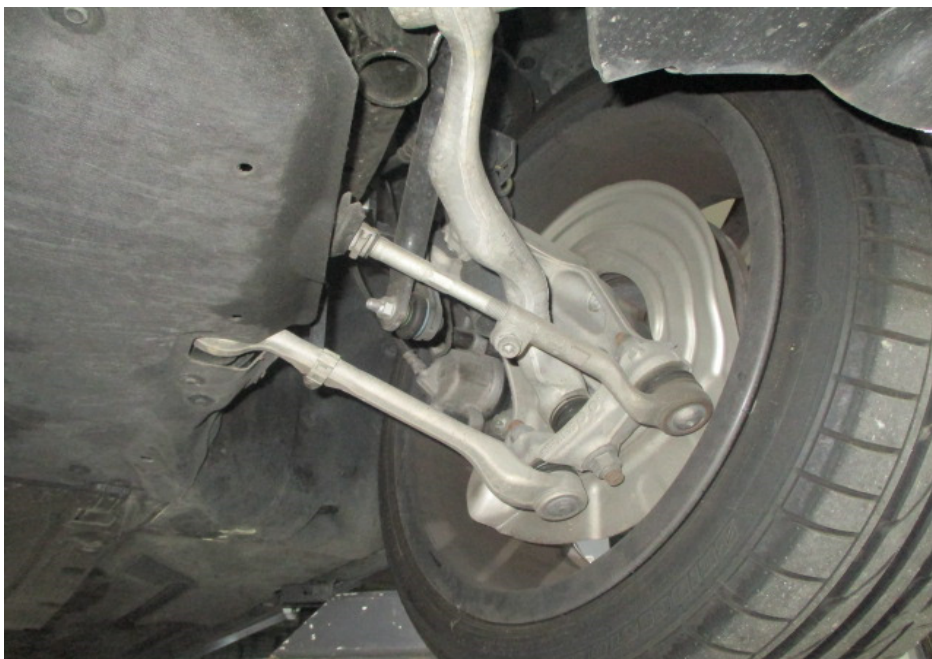
**Photo 17** shows the various undercarriage components at the front left wheel of the Motor Car. The mechanical components, control arms and linkages were all found to be intact and secured in an appropriate manner.

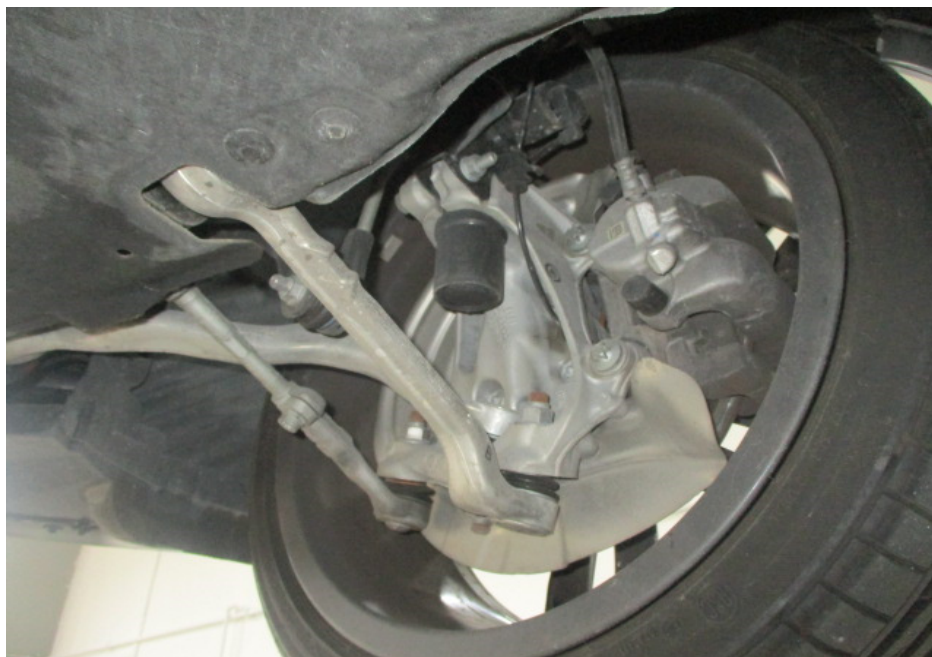
**Photo 18** shows the various undercarriage components at the front right wheel of the Motor Car. The mechanical components, control arms and linkages were all found to be intact and secured in an appropriate manner. I also did not observe any fluid leak and/or fluid stain on the underside of the Motor Car.

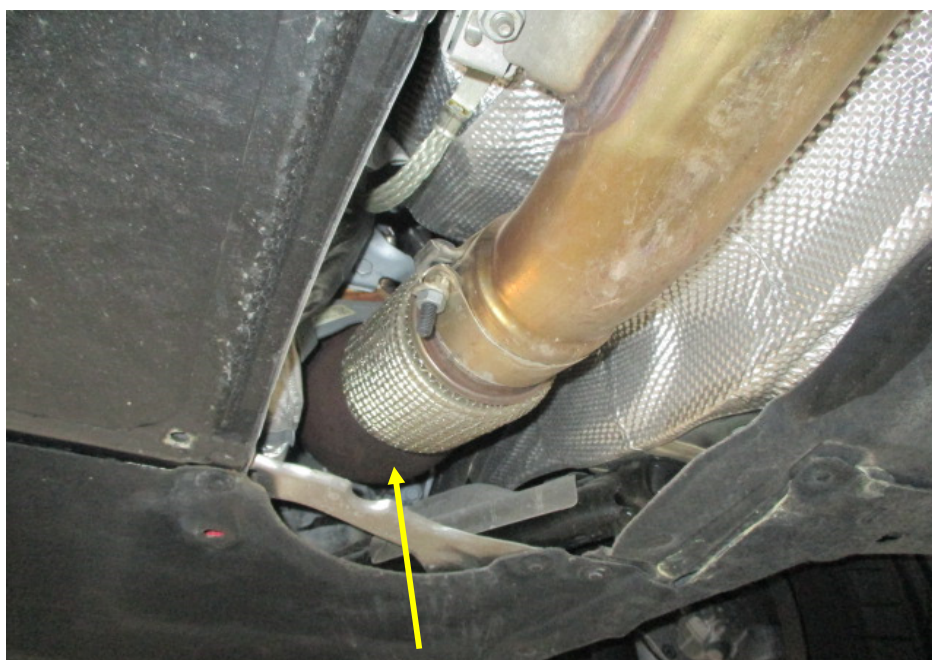
**Photo 19** shows the Motor Car's catalytic converter (arrowed). My examination of the Motor Car's exhaust system revealed no sign(s) or indication(s) of any cut or weld marks along its exhaust pipes and on its rear muffler.

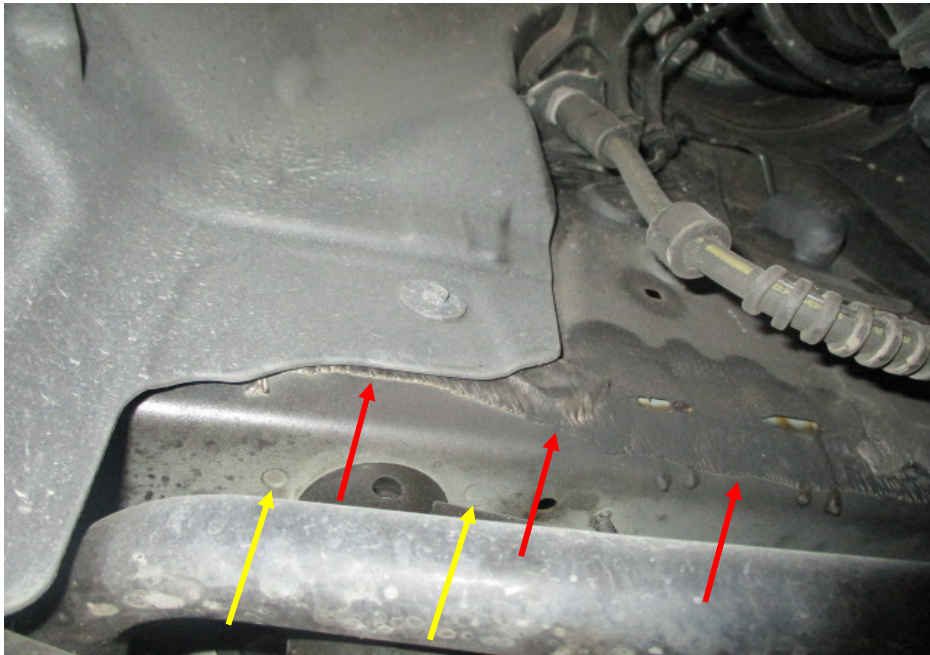
**Photo 20** shows the chassis/structural body at the underside front left of the Motor Car. I did not find any weld marks other than original spot weld marks (yellow arrow) on the chassis/structural body of the Motor Car. The original factory sealant (red arrow) at the joints along the chassis/structural body was untouched, indicating no work was done on the chassis/structural body of the Motor Car and that the chassis/structural body was originally fitted.

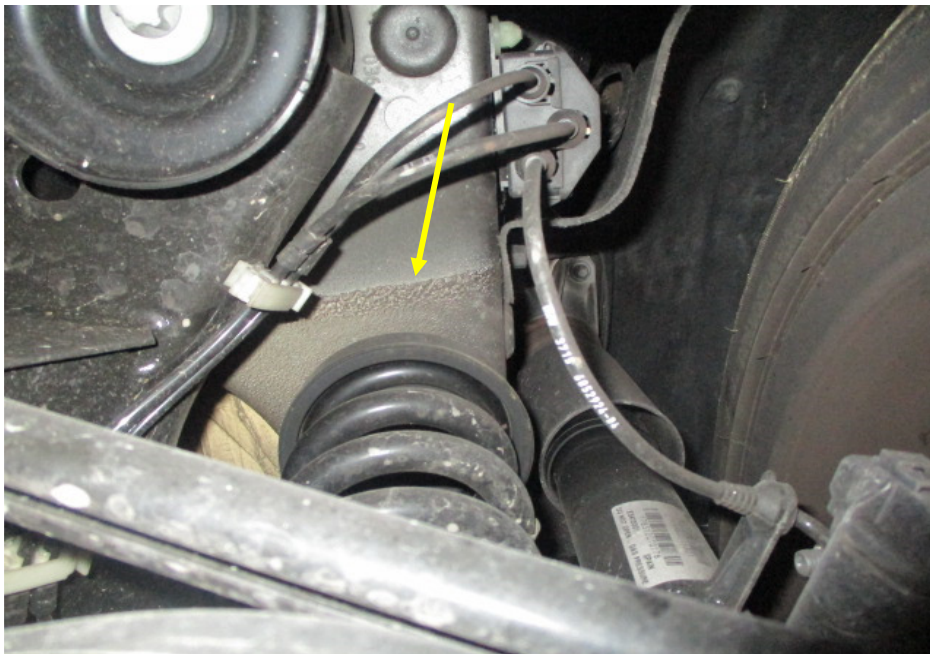
**Photo 21** shows the chassis/structural body at the underside rear right of the Motor Car. The original factory sealant (arrowed) at the joints along the chassis/structural body was observed to be untouched. In general, I had found no work was carried out on the chassis/structural body of the Motor Car. The chassis/structural body of the Motor Car was originally fitted.

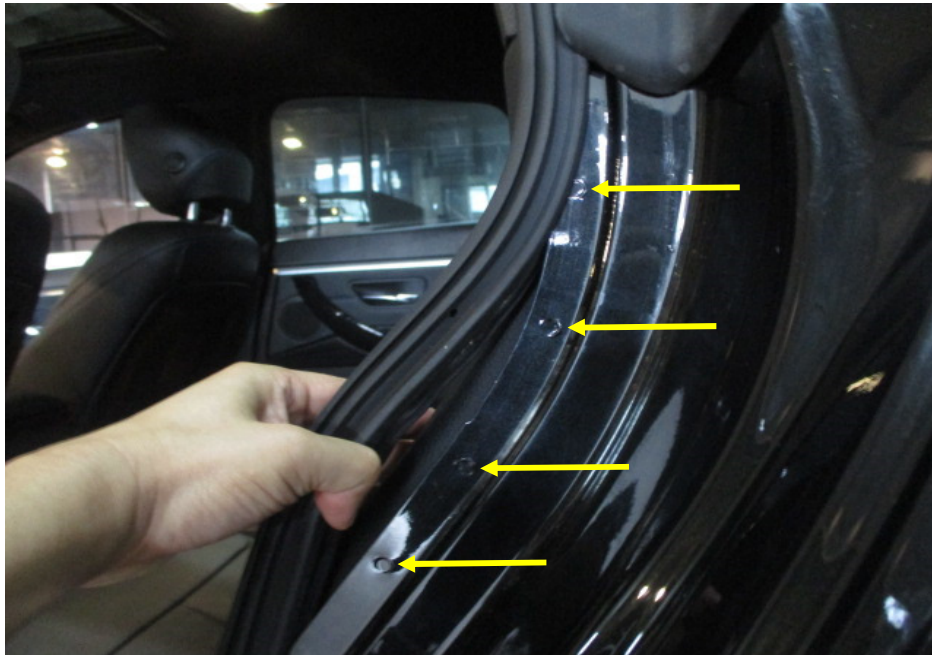
**Photo 22** shows the left side "C" pillar of the Motor Car. I did not find any weld marks other than original spot weld marks (arrowed) on the left side "C" pillar of the Motor Car which, indicates that there was no re-welding works carried out. In general, I had found all the non-detachable body panels of the Motor Car to be originally fitted at the time of my inspection.
