Your Ref: Porsche Panamera GTS  
(chassis number WP0ZZZ97ZKL138301)  
Our Ref : CI/TP21002077/D

15 February 2021

**INSPECTION REPORT OF AN UNREGISTERD PORSCHE PANAMERA GTS  
MOTOR CAR WITH CHASSIS NUMBER WP0ZZZ97ZKL138301**

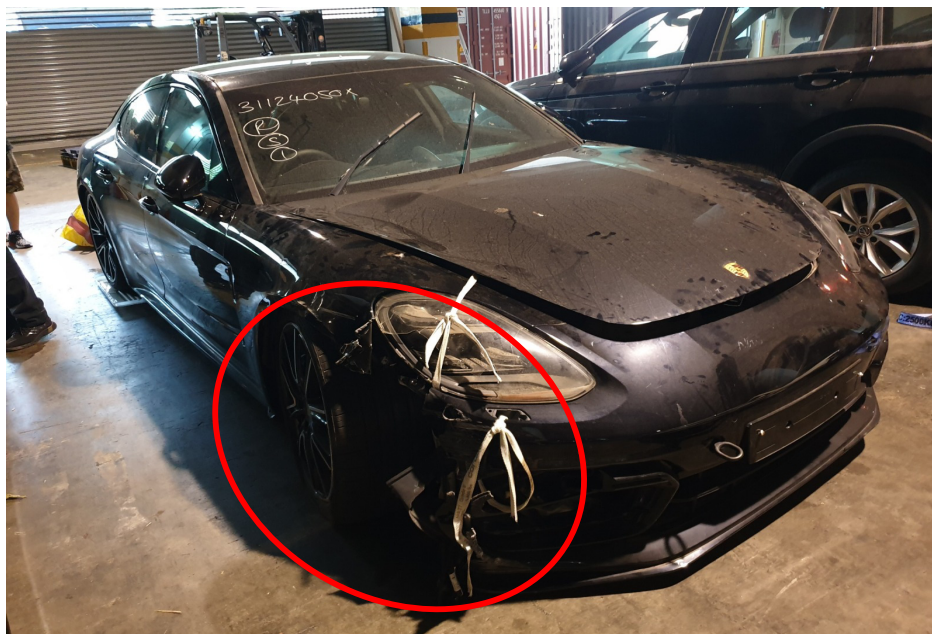
3. From the photographs provided to me, it was observed that the Motor Car had sustained damages at its front right portion. Body parts damaged include the front bumper, front bumper right lower grille, front right day running light, front right headlamp and front right fender amongst others.
4. The orientation of the front right wheel and front left wheel, as seen from the photographs, indicates to me that the front right undercarriage parts of the Motor Car were also damaged. The airbags of the Motor Car were not activated. See photo 1 – 4 below.

**Photo 1** shows the front right body of the Motor Car (photograph provided to me). The Motor Car was observed to have sustained damage at its front right portion. The front bumper, front bumper right lower grille, front right day running light, front right headlamp and front right fender were amongst the body parts that were observed to have been damaged. The front right wheel and front left wheel (refer to photograph 2 below) were orientated in different directions, which suggests to me that the front right undercarriage parts of the Motor Car were also damaged.

23. The body parts at the front right portion of the Motor Car were visually examined and it was noted that the repair/restoration works carried out to the damaged area of the Motor Car (refer to photograph 1 above) were reasonably adequate and in order.

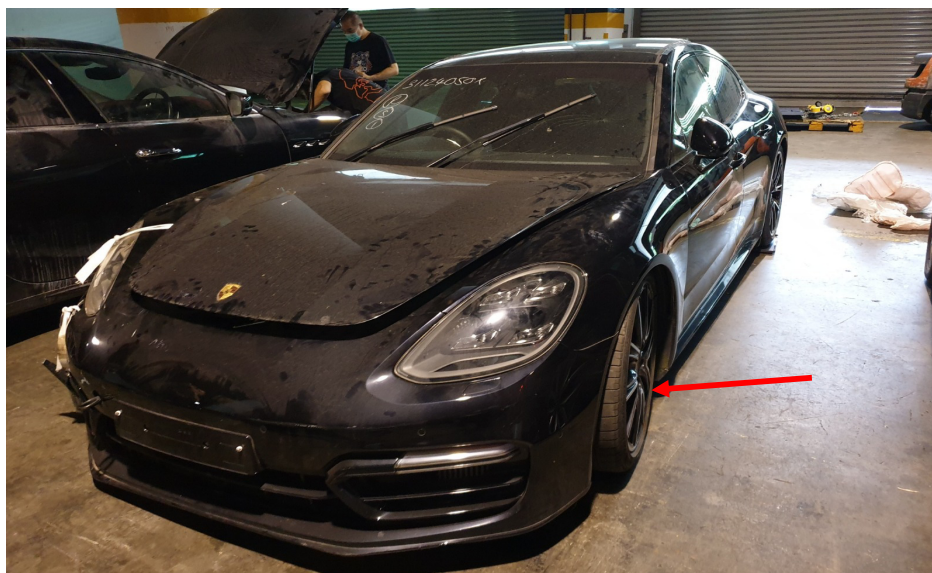
**Photo 2** shows the front left body of the Motor Car (photograph provided to me). The front left wheel (arrowed) was orientated slightly towards the left as compared to the front right wheel, which was orientated slightly to the right (refer to photograph 1 above). This would indicate to me that there was damage to the front right undercarriage parts of the Motor Car, given that the front left portion of the Motor Car was seen to be undamaged.

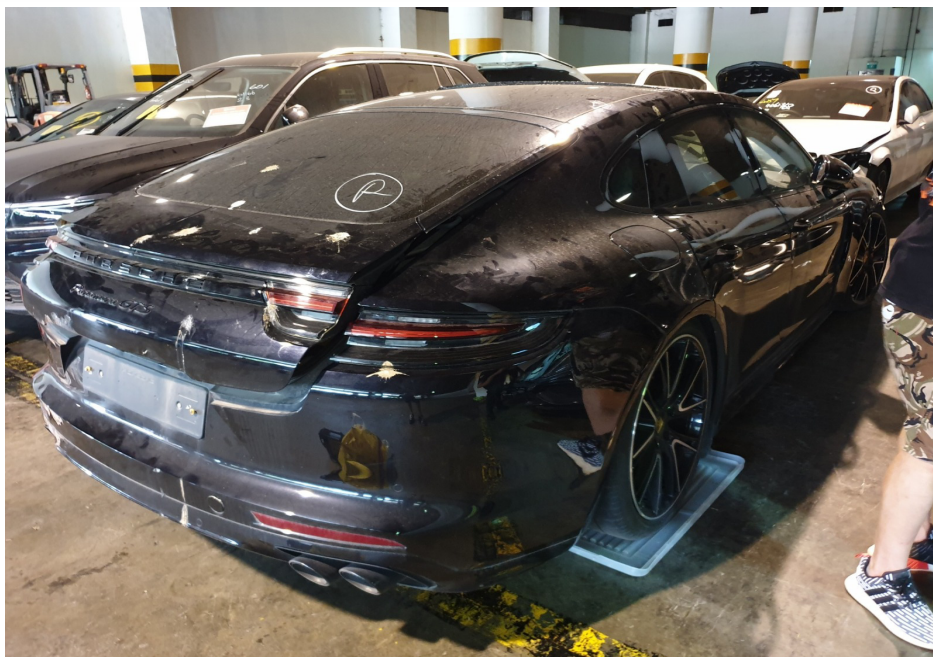
**Photo 3** shows the rear right body of the Motor Car (photograph provided to me). Apart for the front right portion, there was no physical damage seen to other areas of the Motor Car. The airbags of the Motor Car were also not activated as seen from the photographs that were provided to me.

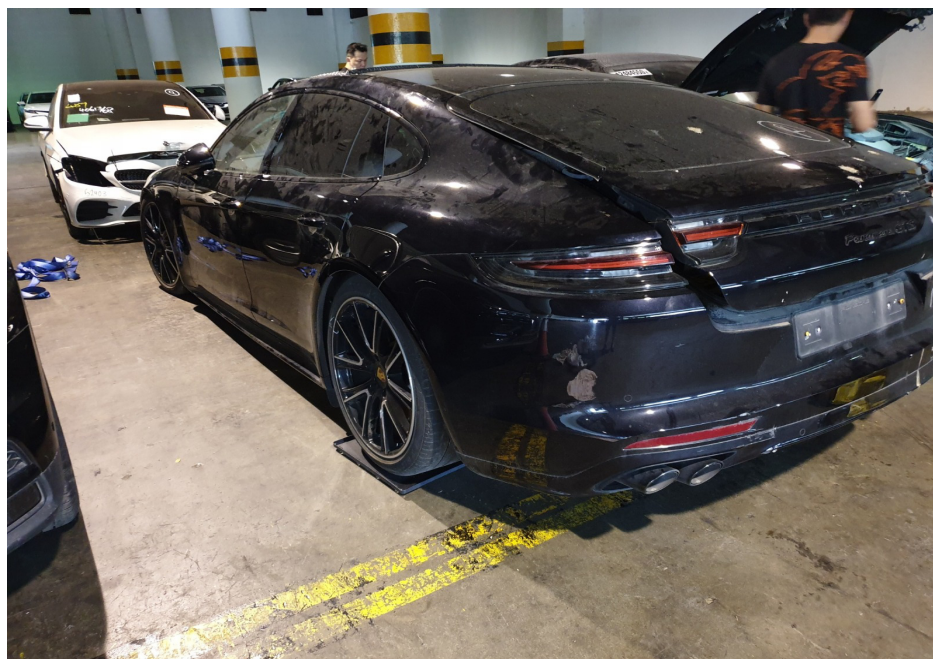
**Photo 4** shows the rear left body of the Motor Car (photograph provided to me). Apart for the front right portion, there was no physical damage seen to other areas of the Motor Car.

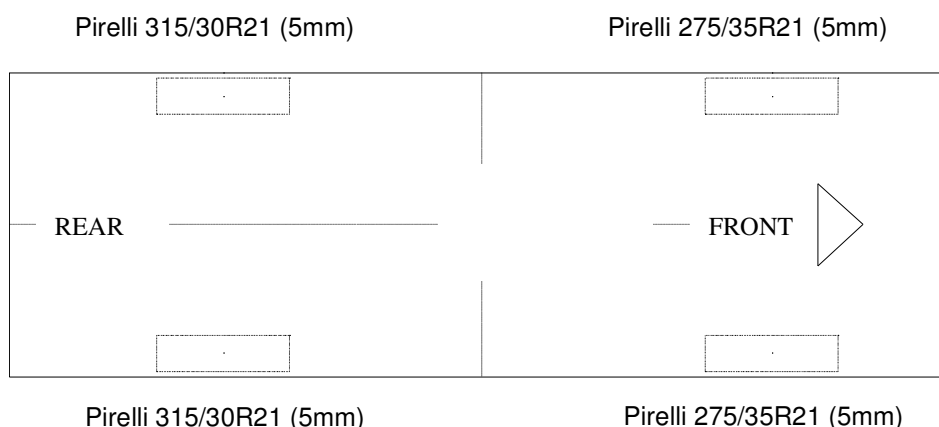
9. It was fitted with 21inch sport wheel rims that were wrapped with tyres that were observed to be of serviceable condition. The tyres were also sufficiently inflated for vehicular operation. The tyre brand, tyre size and approximate remaining tread depth of the 4 tyres of the Motor Car were recorded as follows: -

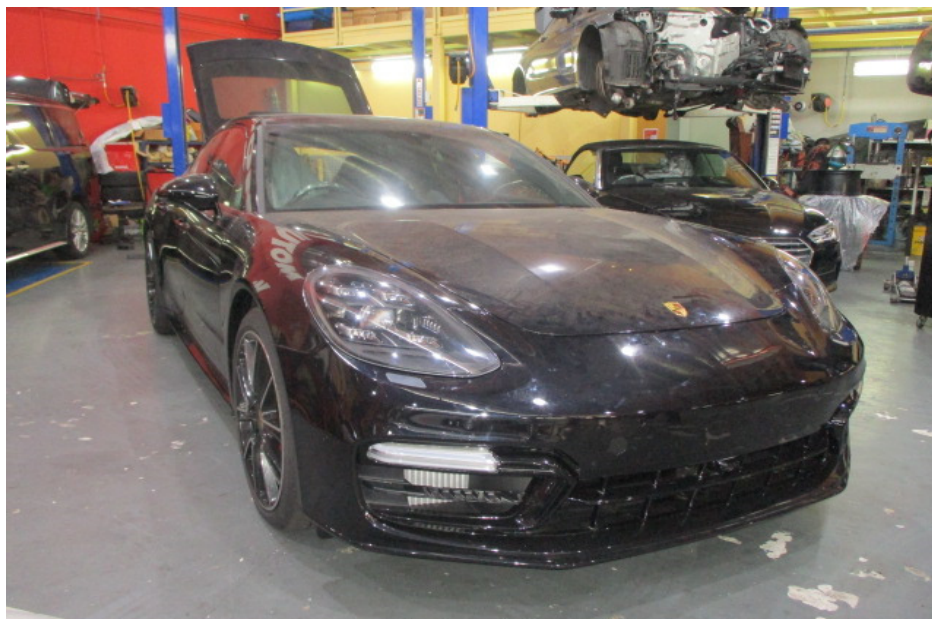
**Photo 5** shows a general view of the front right body of the Motor Car at the time of my inspection. The Motor Car was observed to be in a relatively good general condition with no loose exterior fittings observed. The body parts at the front right portion of the Motor Car were visually examined and it was observed that the repair/restoration works carried out to the damaged area of the Motor Car (refer to photograph 1 above) were reasonably adequate and in order.

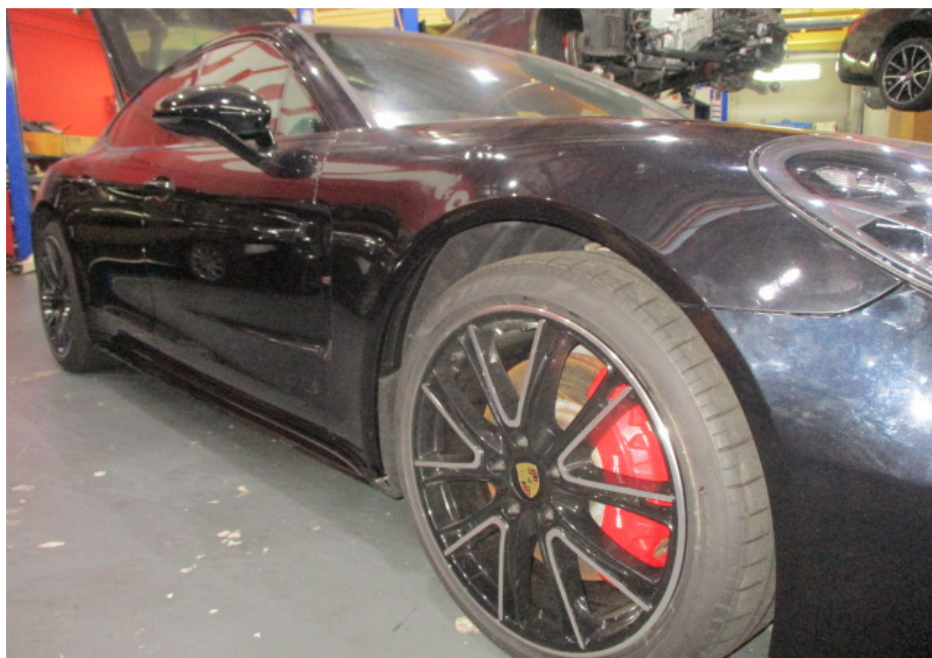
**Photo 6** shows a closer view of the front bumper, front right headlamp, front right fender and front right wheel of the Motor Car at the time of my inspection. The body parts at the front right portion of the Motor Car were visually examined and it was observed that the repair/restoration works carried out to the damaged area of the Motor Car (refer to photograph 1 above) were reasonably adequate and in order.

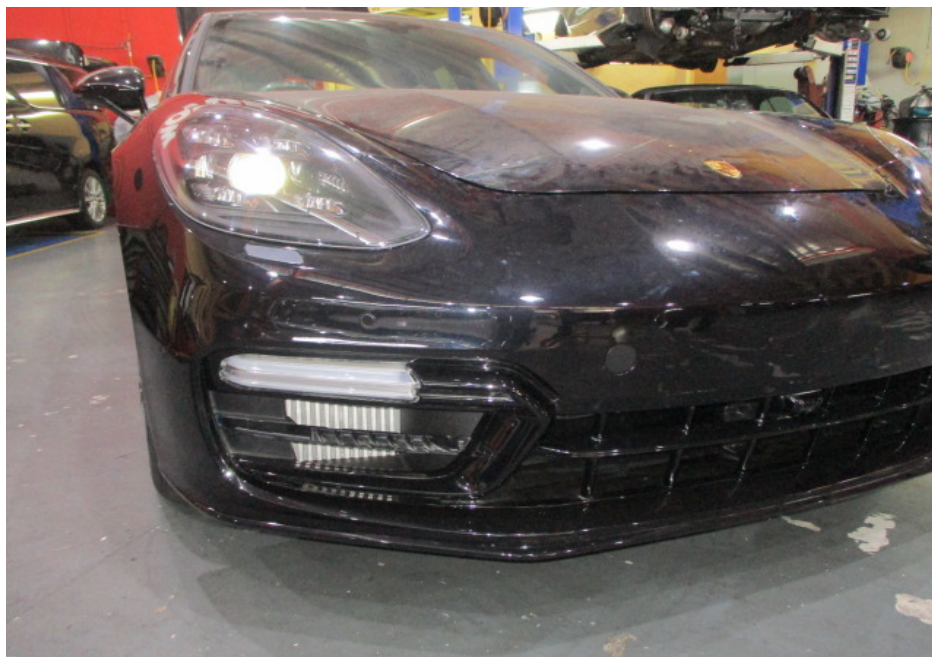
**Photo 7** shows a closer view of the front bumper, front bumper right lower grille, front right day running light and front right headlamp of the Motor Car at the time of my inspection. The body parts at the front right portion of the Motor Car were visually examined and it was observed that the repair/restoration works carried out to the damaged area of the Motor Car (refer to photograph 1 above) were reasonably adequate and in order.

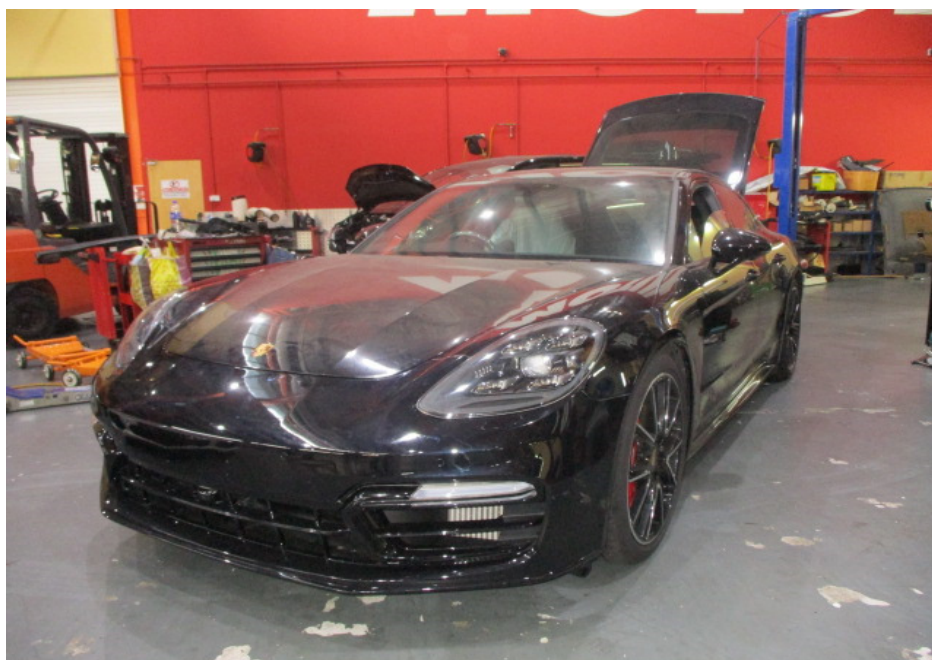
**Photo 8** shows a general view of the front left body of the Motor Car at the time of my inspection. The Motor Car was observed to be in a relatively good general condition with no loose exterior fittings observed. The mileage of the Motor Car recorded at the time of my inspection was 13,590km.

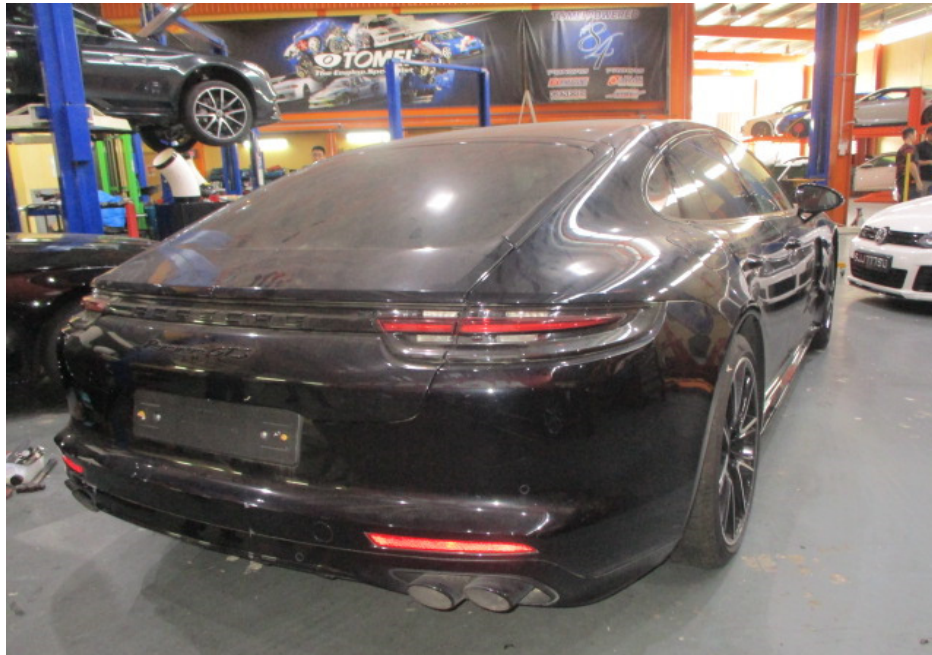
**Photo 9** shows a general view of the rear right body of the Motor Car at the time of my inspection. The Motor Car was observed to be in a relatively good general condition with no loose exterior fittings observed. The mileage of the Motor Car recorded at the time of my inspection was 13,590km.

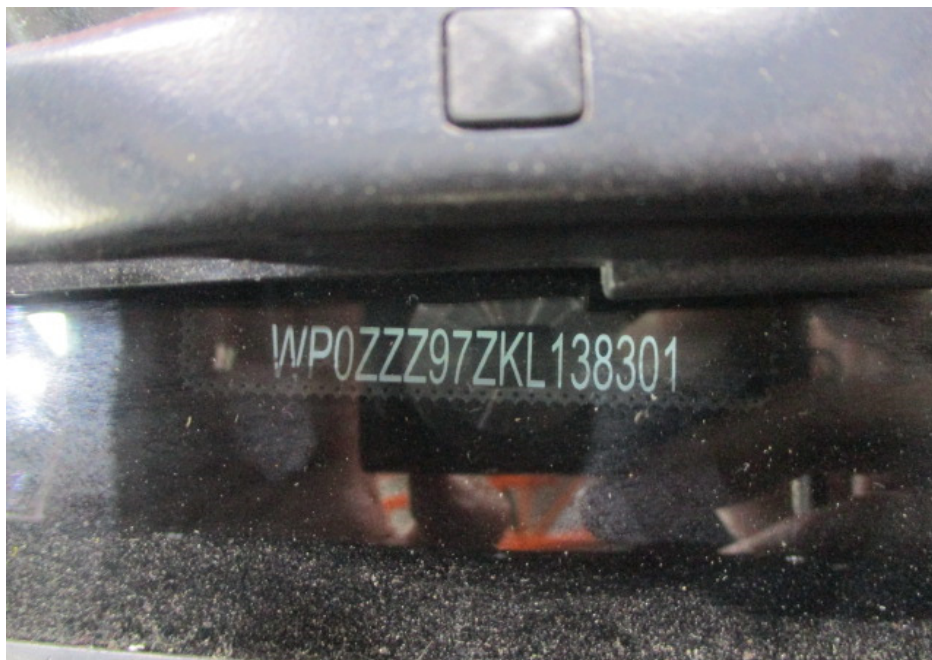
**Photo 10** shows the chassis number of the Motor Car. The chassis number recorded was WP0ZZZ97ZKL138301.

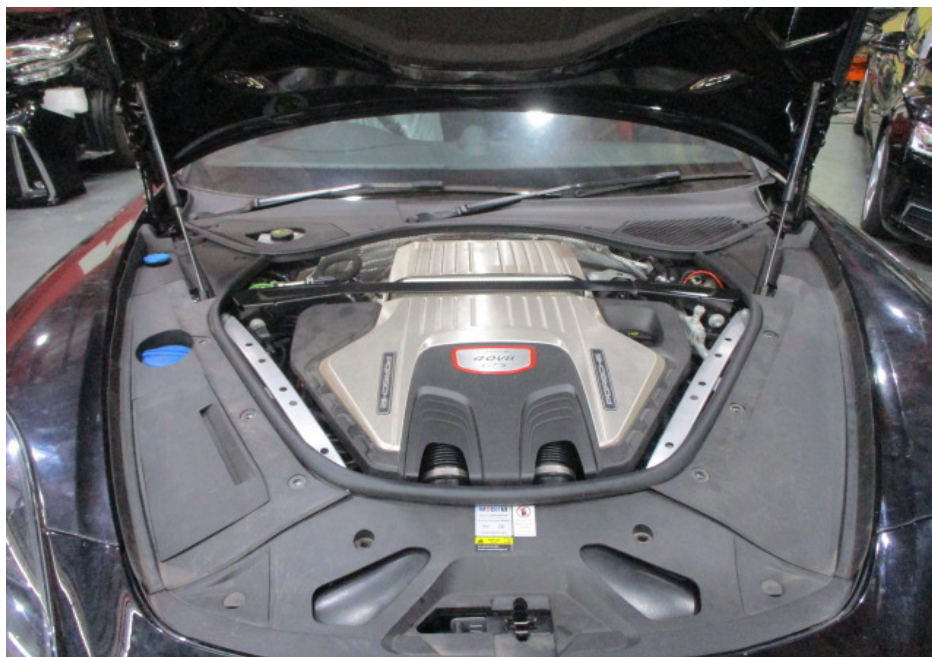
**Photo 11** shows a general view of the engine compartment of the Motor Car at the time of my inspection. The various parts and components inside the engine compartment were all observed to be intact and properly fitted. There was also no sign(s) or indication(s) of fluid leak and/or fluid stain found inside the engine compartment.

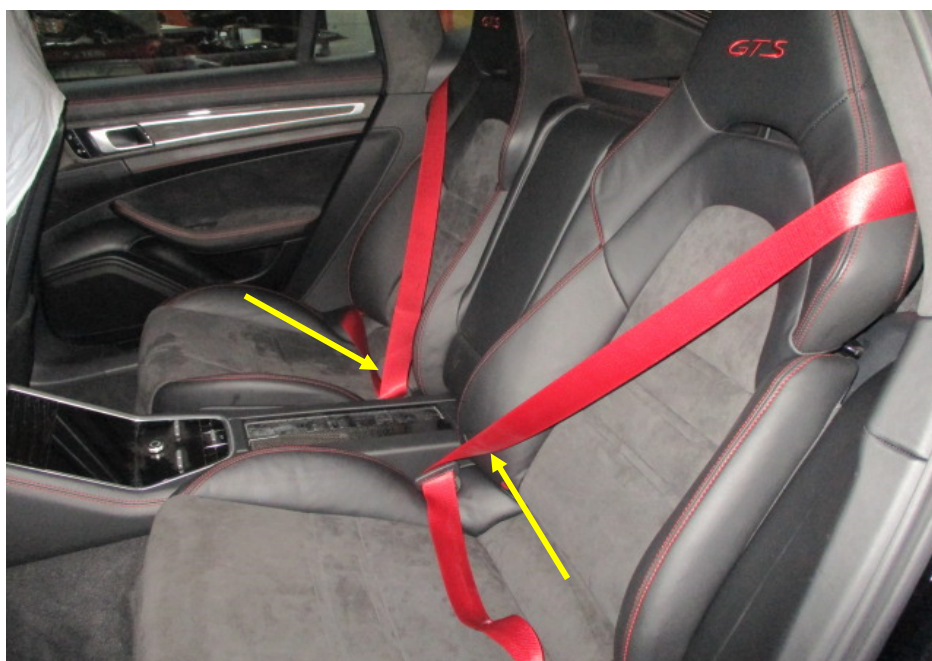
**Photo 12** shows the rear seats of the Motor Car. All the seats of the Motor Car were secured via seat rails to the floorboard. They were also fitted with a retractable seat belt reel and a pre-tensioner. The seat belts (arrowed) were tested and were able to be fastened into the respective pre-tensions that were fitted on the side of each individual seat.

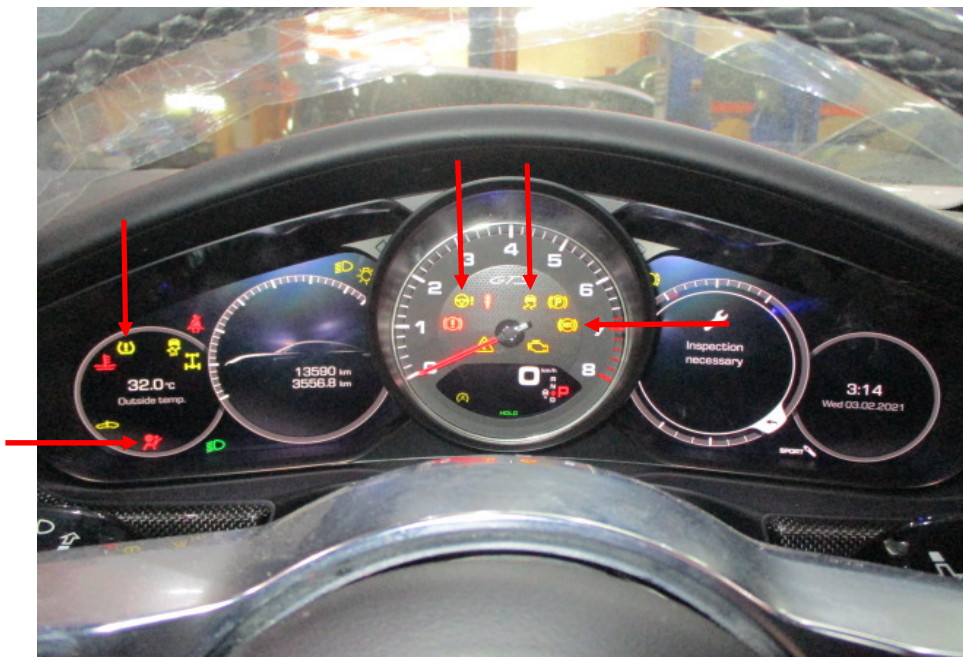
**Photo 13** shows the warning lights for the various electronic safety features appearing on the instrument panel of the Motor Car during its self-test when the engine is cranked, in particular the ABS, SRS, PSS, TPM and PSM lights (arrowed).

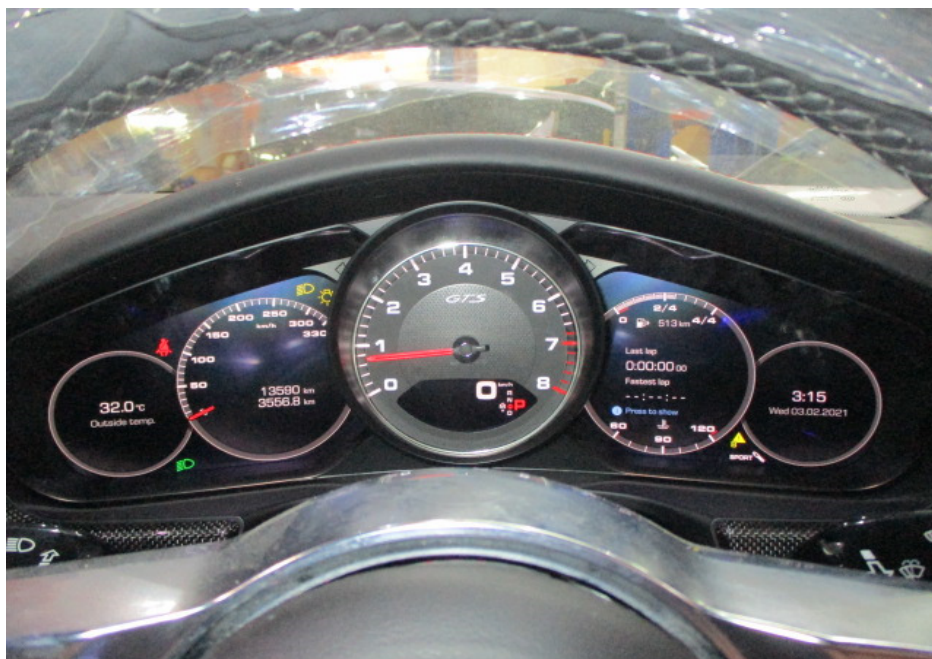
**Photo 14** shows the respective warning lights no longer illuminated, indicating that there is no fault detected to the ABS, SRS, PSS, TPM and PSM systems of the Motor Car during the self-test. These electronic systems were hence in working condition at the time of my inspection.

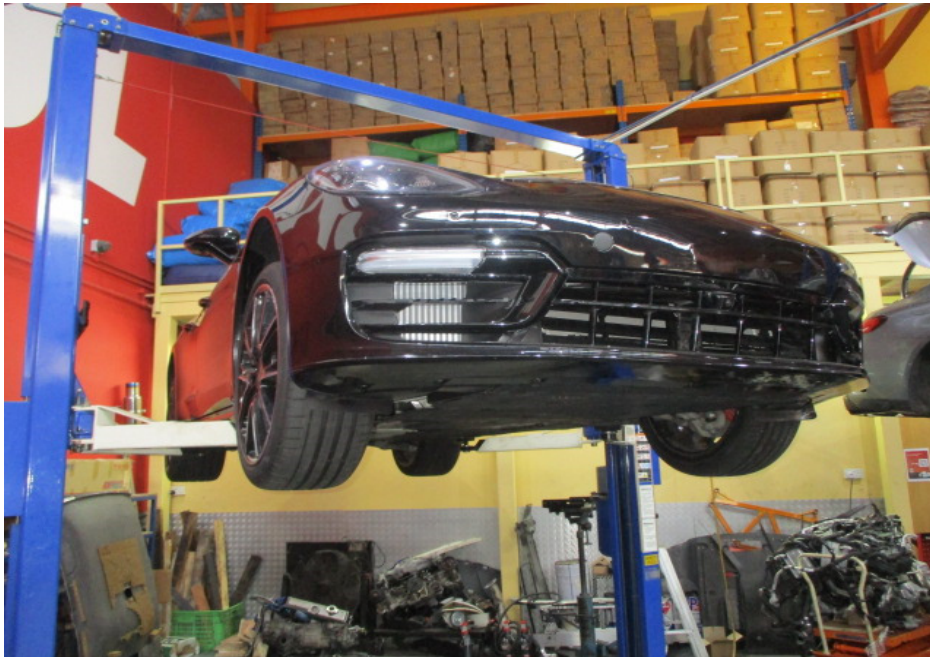
**Photo 15** shows the Motor Car hoisted up for checks on its undercarriage. There was no sign(s) or indication(s) of fluid leakage and/or fluid stain(s) on the underside of the Motor Car. The undercarriage components of the Motor Car were also all observed to be intact and secured in an appropriate manner.

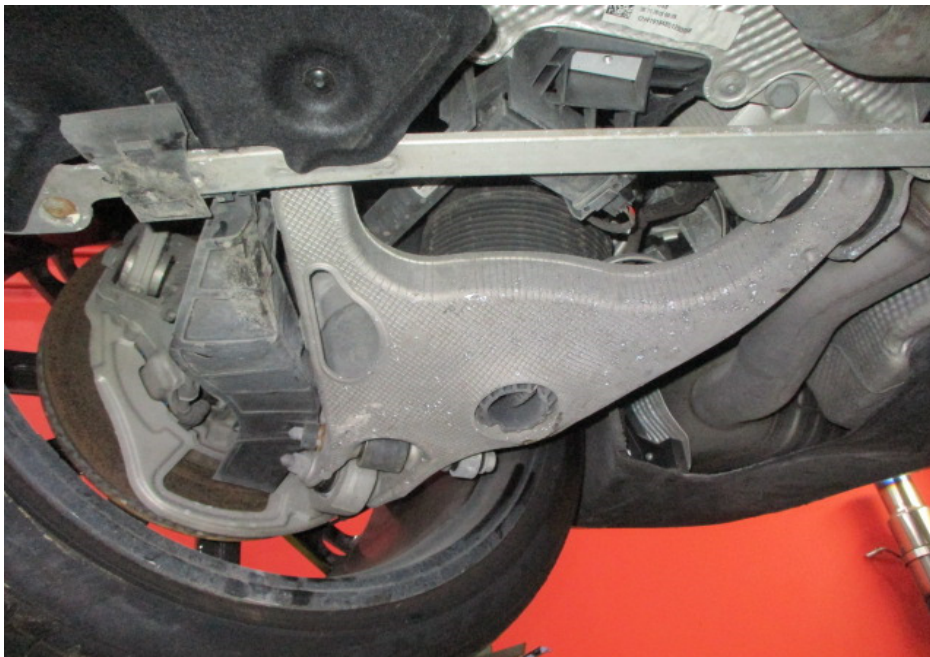
**Photo 16** shows a general view of the control arms and linkages at the rear right wheel of the Motor Car. I did not observe any fluid leak and/or fluid stain on the underside of the Motor Car. All of the Motor Car's undercarriage components were observed to be intact and secured in an appropriate manner.

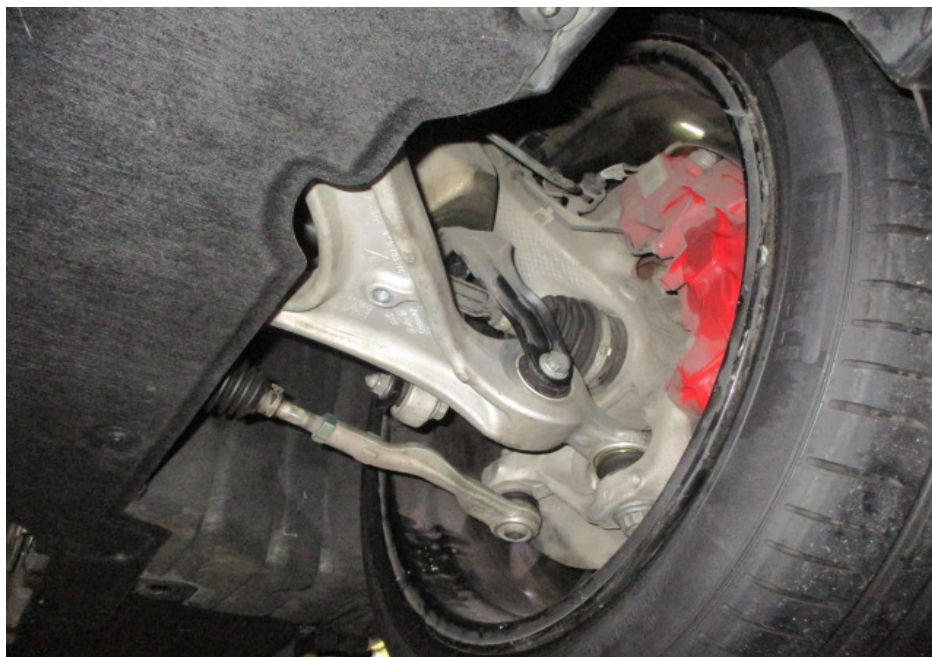
**Photo 17** shows the various undercarriage components at the front left wheel of the Motor Car. The mechanical components, control arms and linkages were all found to be intact and secured in an appropriate manner.

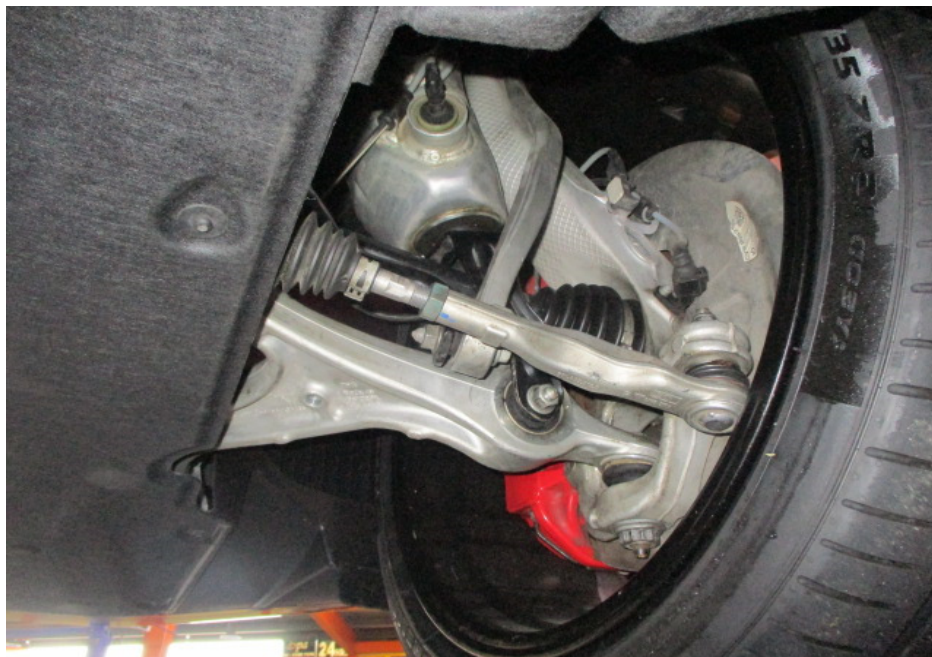
**Photo 18** shows the various undercarriage components at the front right wheel of the Motor Car. The mechanical components, control arms and linkages were all found to be intact and secured in an appropriate manner. I also did not observe any fluid leak and/or fluid stain on the underside of the Motor Car.

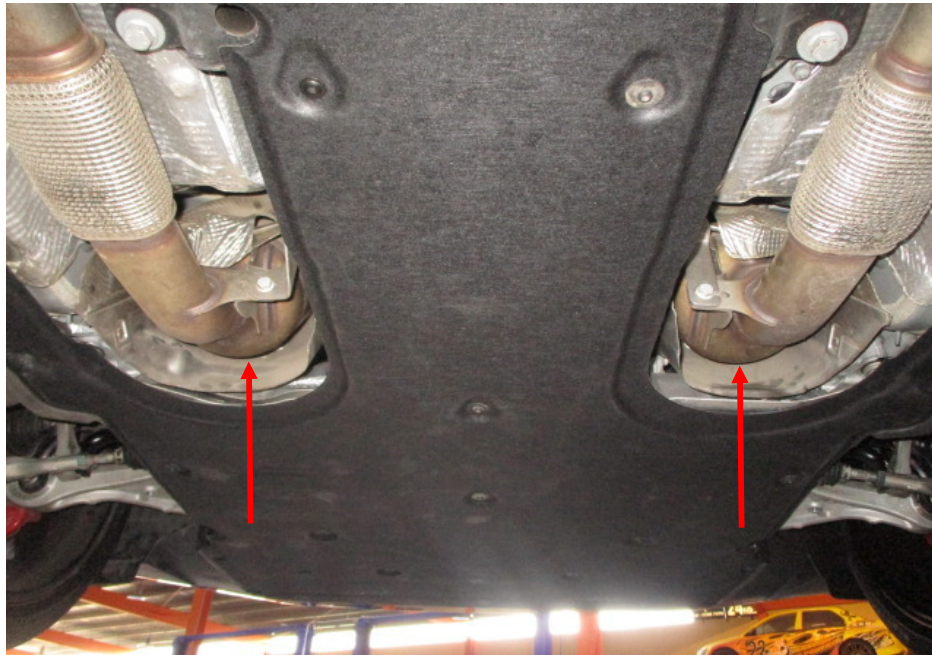
**Photo 19** shows the Motor Car's catalytic converters (arrowed). My examination of the Motor Car's exhaust system revealed no sign(s) or indication(s) of any cut or weld marks along its exhaust pipes and on its rear mufflers.

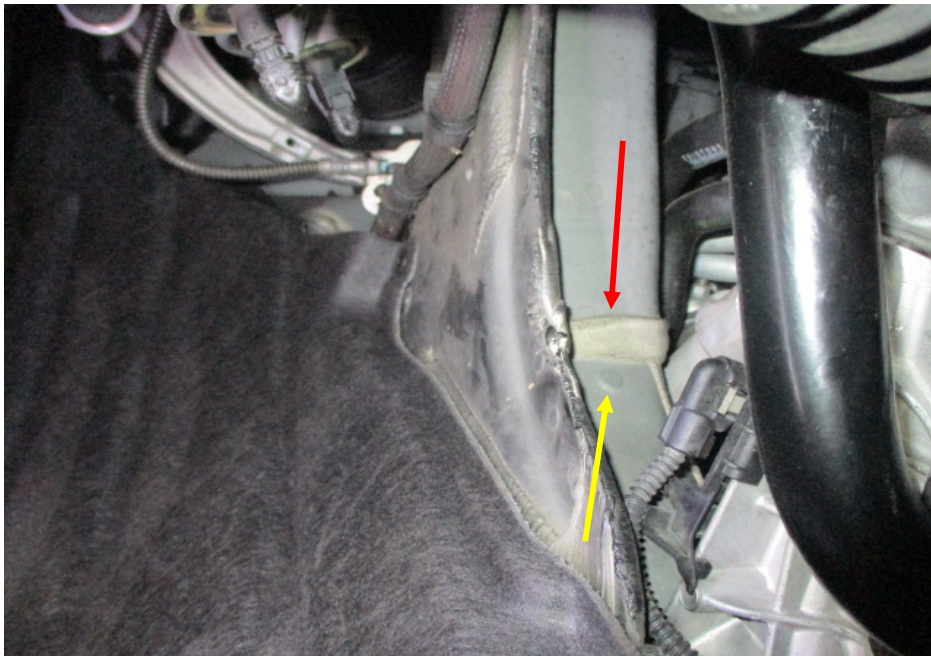
**Photo 20** shows the chassis/structural body at the underside front right of the Motor Car. I did not find any weld marks other than original spot weld marks (yellow arrow) on the chassis/structural body of the Motor Car. The original factory sealant (red arrow) at the joints along the chassis/structural body was untouched, indicating no work was done on the chassis/structural body of the Motor Car and that the chassis/structural body was originally fitted.

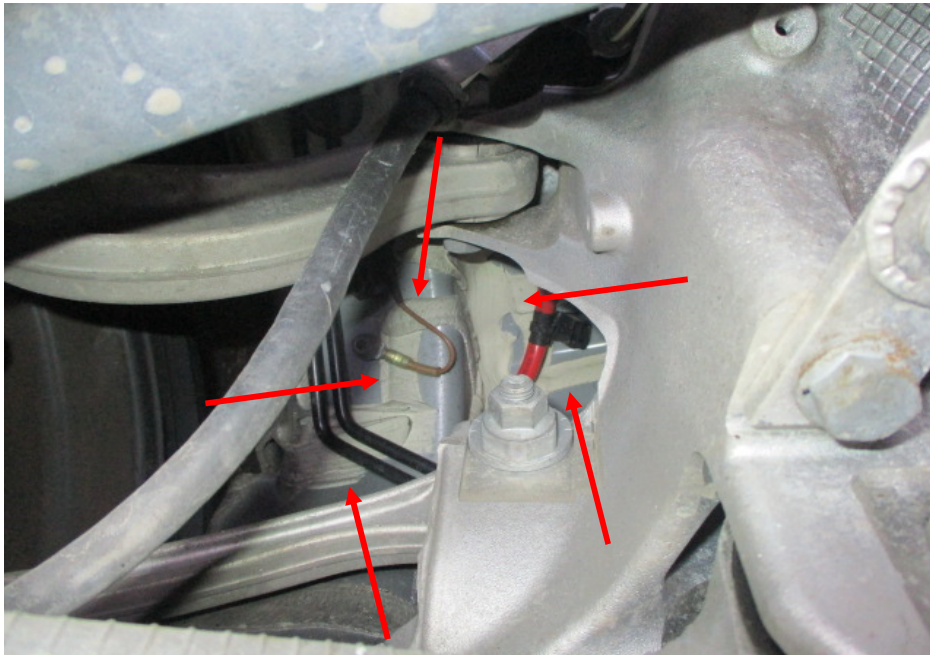
**Photo 21** shows the chassis/structural body at the underside rear left of the Motor Car. The original factory sealant (arrowed) at the joints along the chassis/structural body was observed to be untouched. In general, I had found no work was carried out on the chassis/structural body of the Motor Car. The chassis/structural body of the Motor Car was originally fitted.
