Your Ref: Audi A7  
(chassis number WAUZZZF28KN025368)  
Our Ref : CI/TP21002078/D

15 February 2021

**INSPECTION REPORT OF AN UNREGISTERD AUDI A7 MOTOR CAR WITH CHASSIS NUMBER WAUZZZF28KN025368**

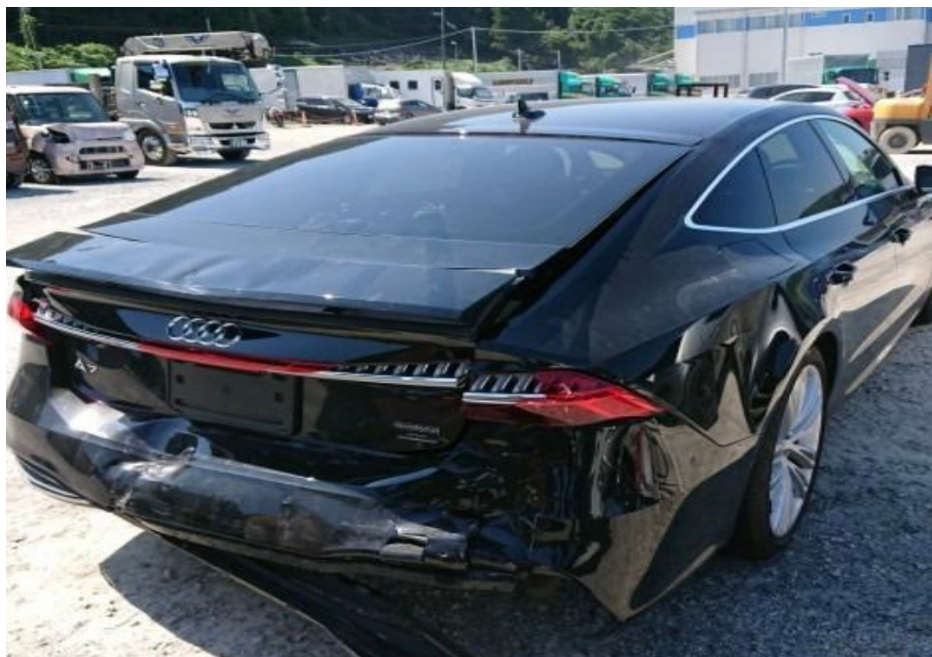
**Photo 1** shows the rear right body of the Motor Car (photograph provided to me). The Motor Car was observed to have sustained damage at its rear portion. The rear bumper, rear bumper lower cover, rear taillamps, rear bootlid, rear bootlid lamp and rear bootlid spoiler were amongst the body parts that were observed to have been damaged.

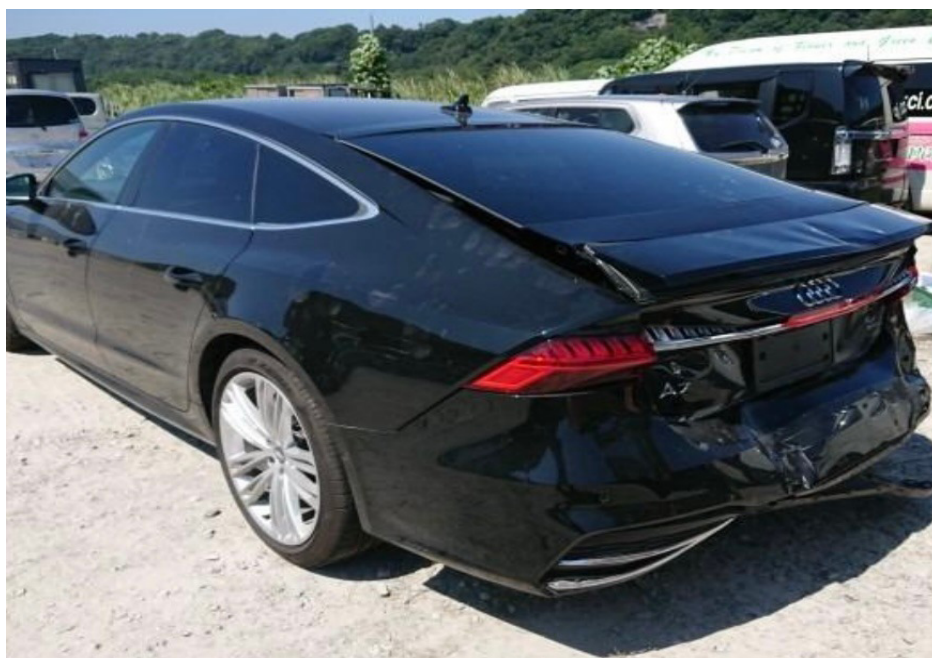
**Photo 2** shows the rear left body of the Motor Car (photograph provided to me). The Motor Car was observed to have sustained damage at its rear portion. The rear bumper, rear bumper lower cover, rear taillamps, rear bootlid, rear bootlid lamp and rear bootlid spoiler were amongst the body parts that were observed to have been damaged.

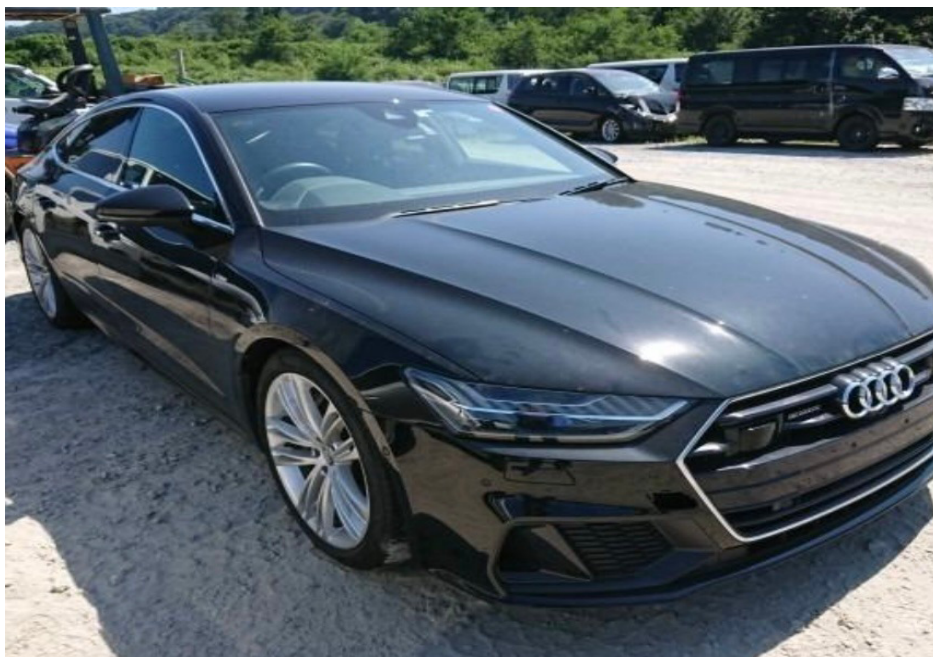
**Photo 3** shows the front right body of the Motor Car (photograph provided to me). Apart for the rear portion, there was no physical damage seen to other areas of the Motor Car.

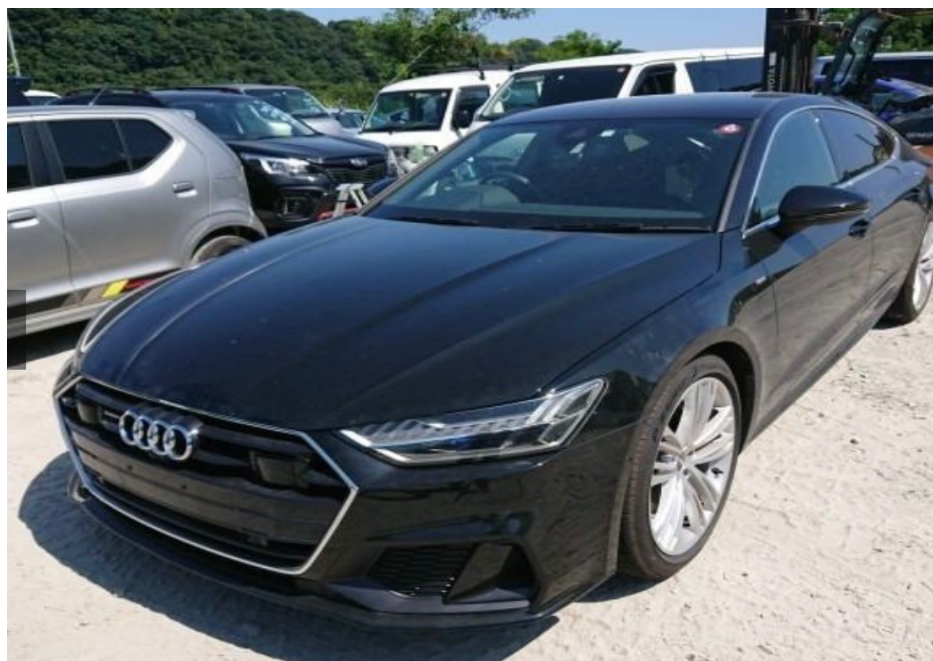
**Photo 4** shows the front left body of the Motor Car (photograph provided to me). Apart for the rear portion, there was no physical damage seen to other areas of the Motor Car. The airbags of the Motor Car were also not activated as seen from the photographs that were provided to me.

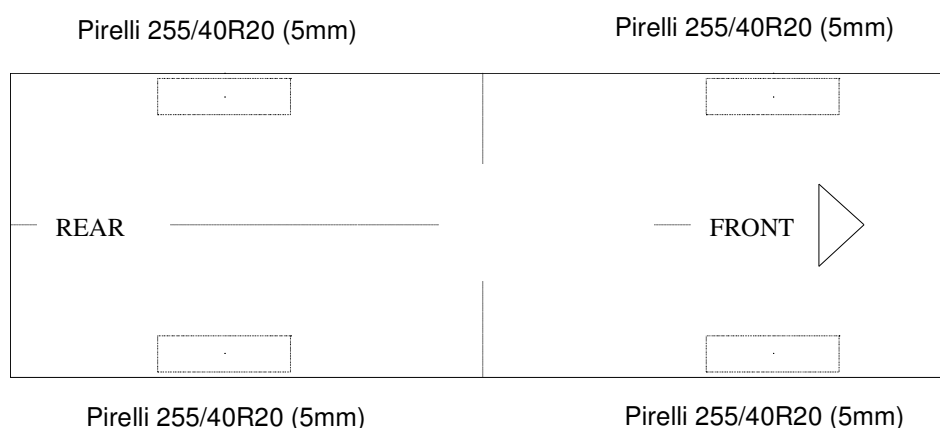
8. It was fitted with 20inch sport wheel rims that were wrapped with tyres that were observed to be of serviceable condition. The tyres were also sufficiently inflated for vehicular operation. The tyre brand, tyre size and approximate remaining tread depth of the 4 tyres of the Motor Car were recorded as follows: -

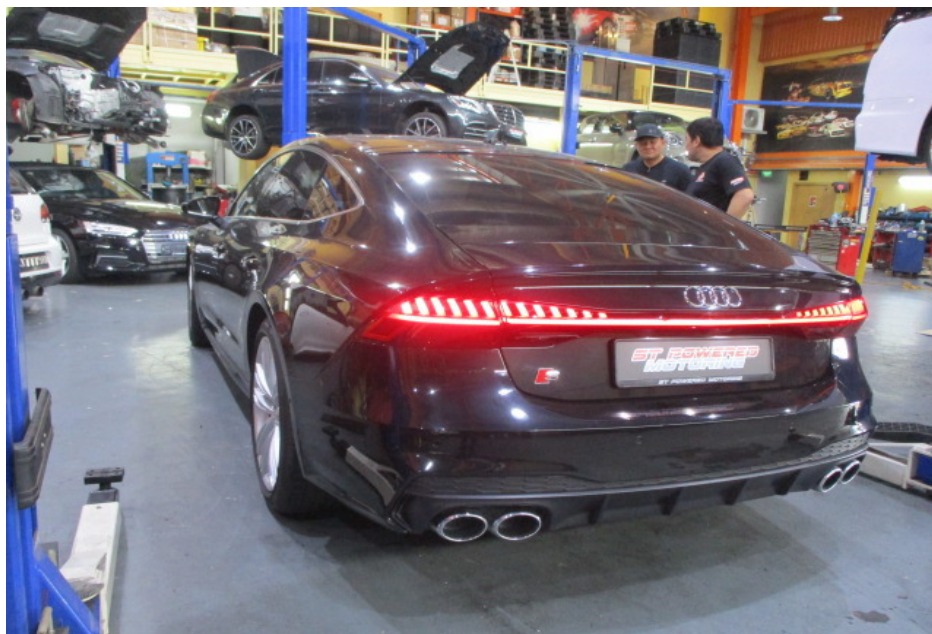
**Photo 5** shows a general view of the rear left body of the Motor Car at the time of my inspection. The Motor Car was observed to be in a relatively good general condition with no loose exterior fittings observed. The body parts at the rear portion of the Motor Car were visually examined and it was observed that the repair/restoration works carried out to the damaged area of the Motor Car (refer to photograph 1 & 2 above) were reasonably adequate and in order.

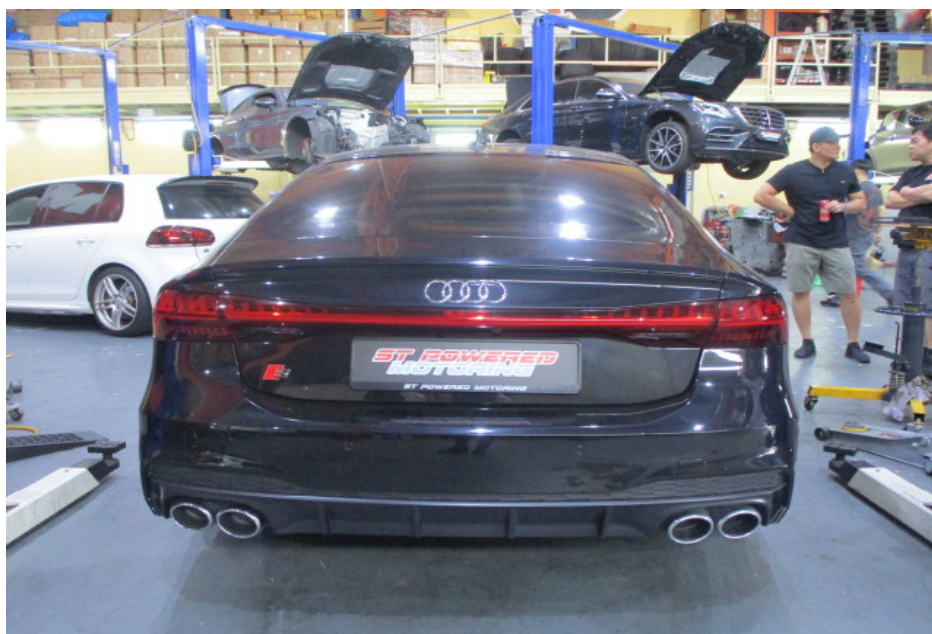
**Photo 6** shows a general view of the rear body of the Motor Car at the time of my inspection. The Motor Car was observed to be in a relatively good general condition with no loose exterior fittings observed. The body parts at the rear portion of the Motor Car were visually examined and it was observed that the repair/restoration works carried out to the damaged area of the Motor Car (refer to photograph 1 & 2 above) were reasonably adequate and in order.

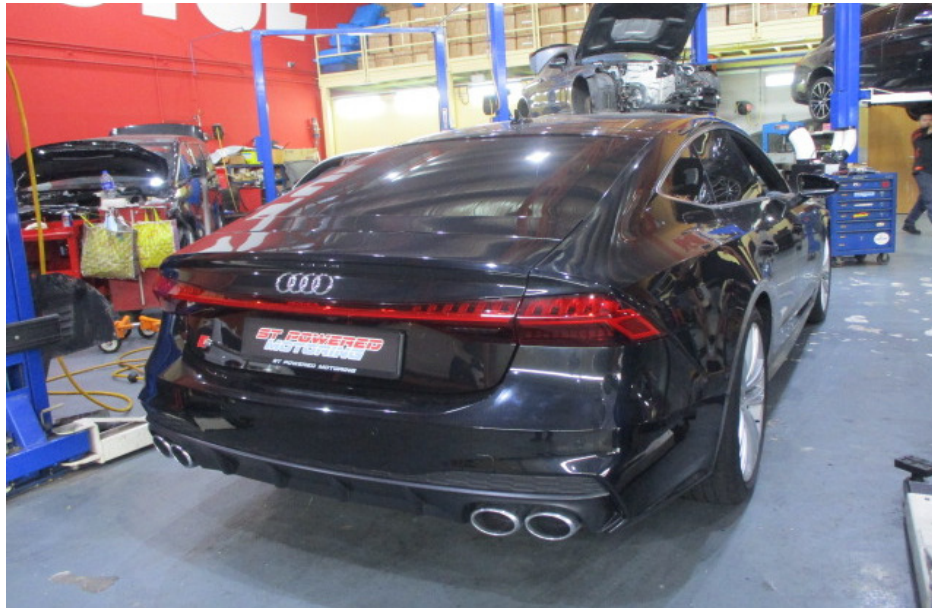
**Photo 7** shows a general view of the rear right body of the Motor Car at the time of my inspection. The Motor Car was observed to be in a relatively good general condition with no loose exterior fittings observed. The body parts at the rear portion of the Motor Car were visually examined and it was observed that the repair/restoration works carried out to the damaged area of the Motor Car (refer to photograph 1 & 2 above) were reasonably adequate and in order.

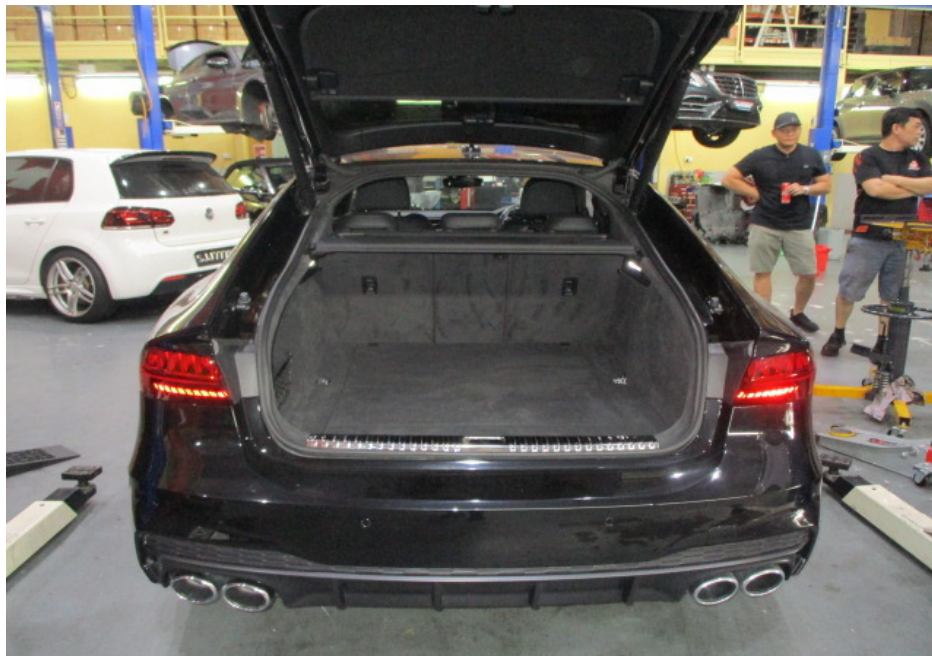
**Photo 8** shows a general view of the rear boot compartment of the Motor Car at the time of my inspection. The Motor Car was observed to be in a relatively good general condition with no loose exterior fittings observed. The body parts at the rear portion of the Motor Car were visually examined and it was observed that the repair/restoration works carried out to the damaged area of the Motor Car (refer to photograph 1 & 2 above) were reasonably adequate and in order.

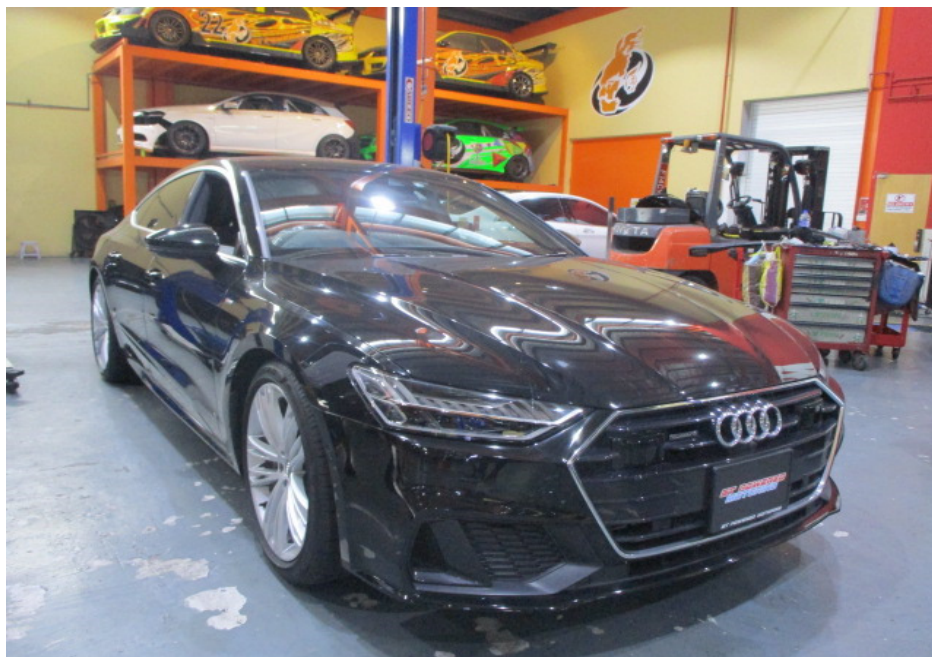
**Photo 9** shows a general view of the front right body of the Motor Car at the time of my inspection. The Motor Car was observed to be in a relatively good general condition with no loose exterior fittings observed. The mileage of the Motor Car recorded at the time of my inspection was 27,877km.

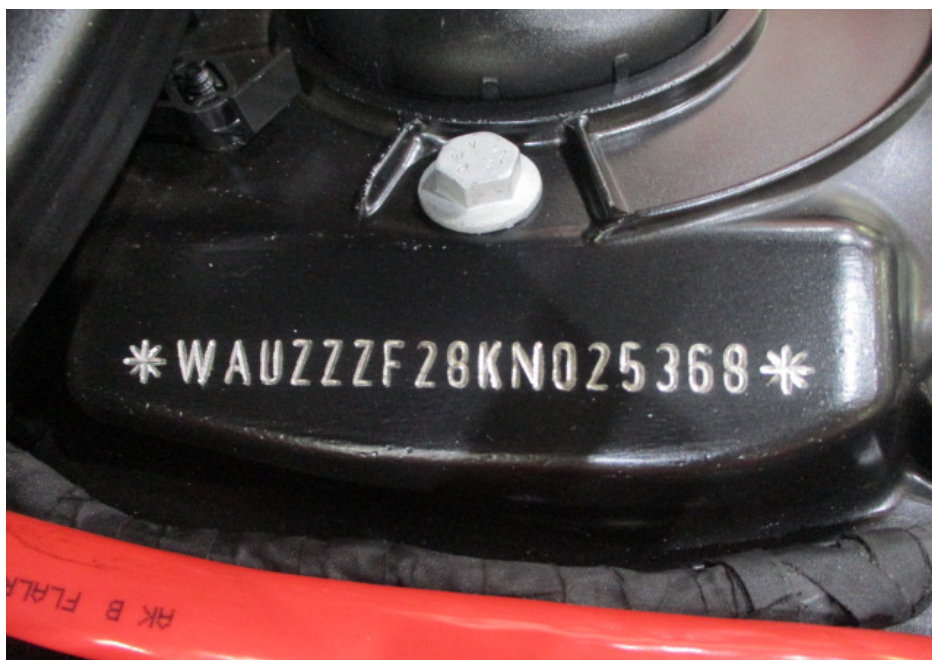
**Photo 10** shows the chassis number of the Motor Car. The chassis number recorded was WAUZZZF28KN025368.

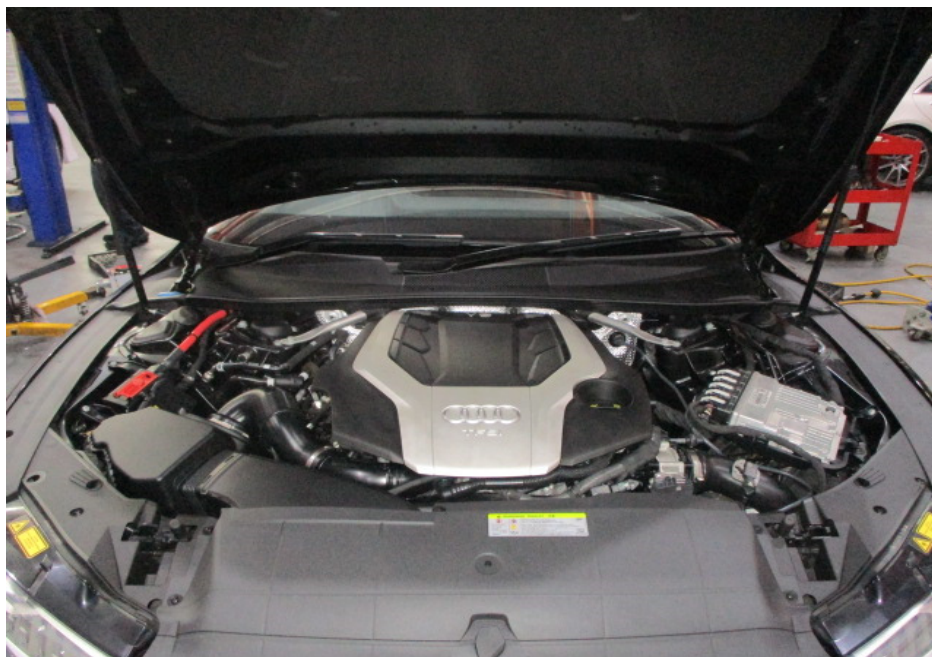
**Photo 11** shows a general view of the engine compartment of the Motor Car at the time of my inspection. The various parts and components inside the engine compartment were all observed to be intact and properly fitted. There was also no sign(s) or indication(s) of fluid leak and/or fluid stain found inside the engine compartment.

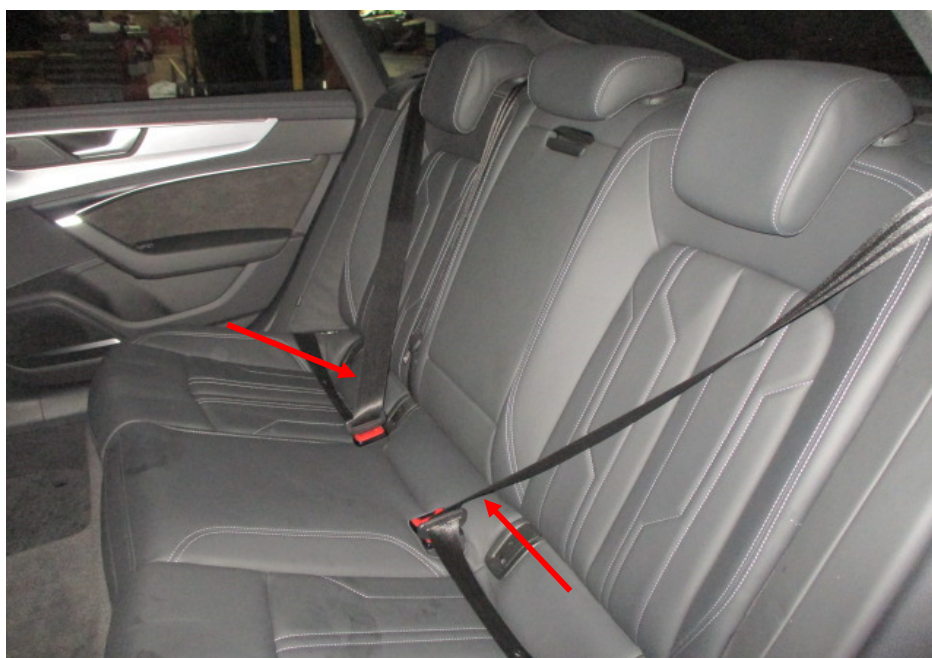
**Photo 12** shows the rear seats of the Motor Car. All the seats of the Motor Car were secured via seat rails to the floorboard. They were also fitted with a retractable seat belt reel and a pre-tensioner. The seat belts (arrowed) were tested and were able to be fastened into the respective pre-tensions that were fitted on the side of each individual seat.

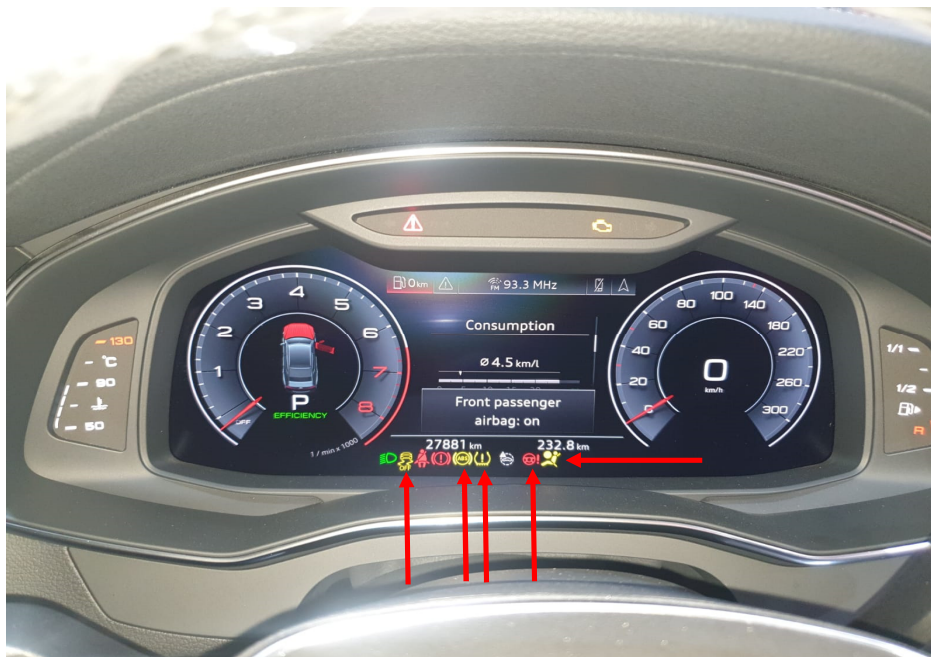
**Photo 13** shows the warning lights for the various electronic safety features appearing on the instrument panel of the Motor Car during its self-test when the engine is cranked, in particular the ABS, SRS, EPS, TPM and ESC lights (arrowed).

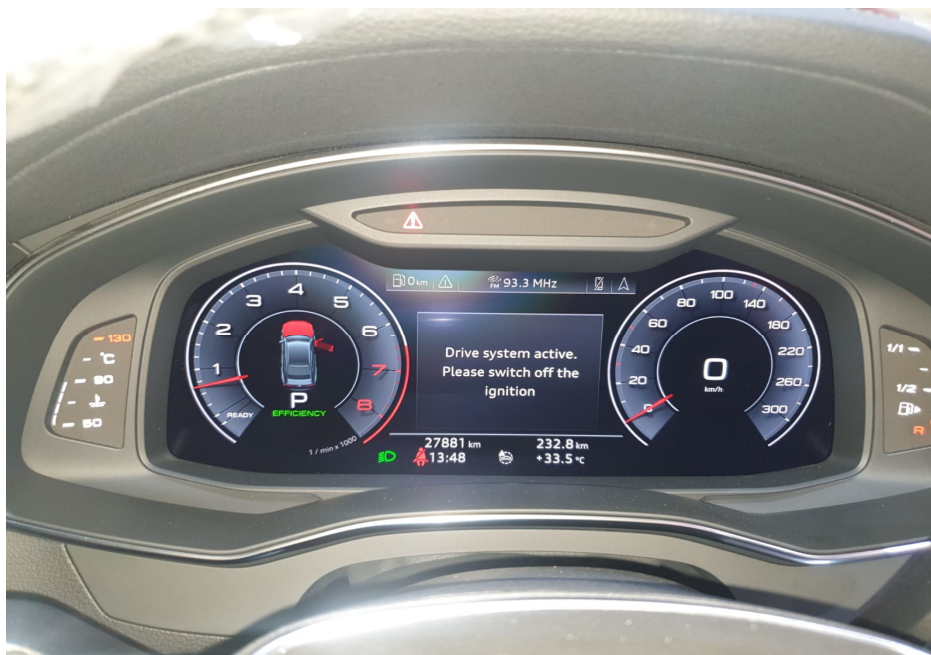
**Photo 14** shows the respective warning lights no longer illuminated, indicating that there is no fault detected to the ABS, SRS, EPS, TPM and ESC systems of the Motor Car during the self-test. These electronic systems were hence in working condition at the time of my inspection.

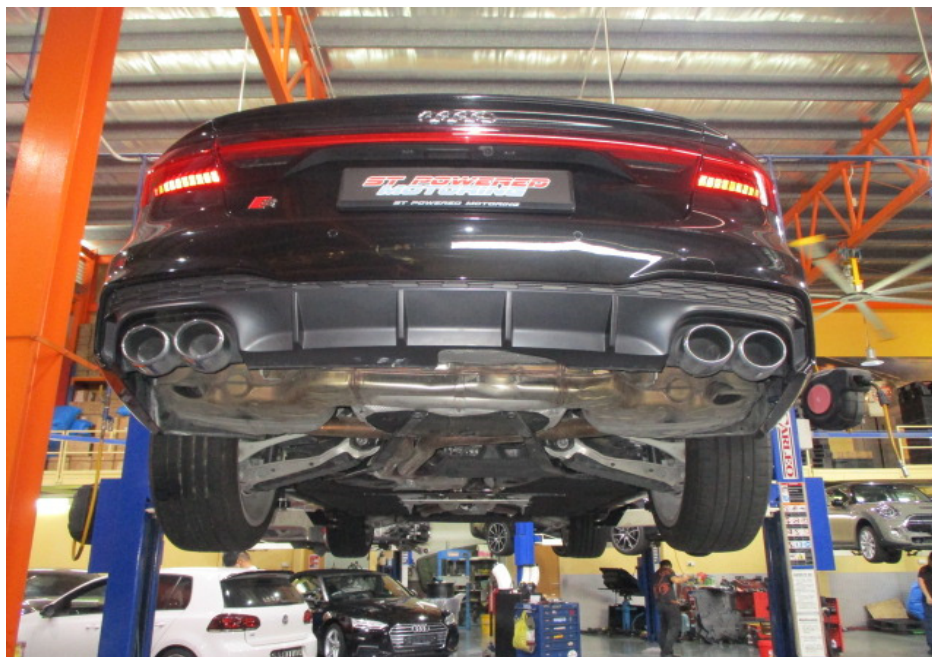
**Photo 15** shows the Motor Car hoisted up for checks on its undercarriage. There was no sign(s) or indication(s) of fluid leakage and/or fluid stain(s) on the underside of the Motor Car. The undercarriage components of the Motor Car were also all observed to be intact and secured in an appropriate manner.

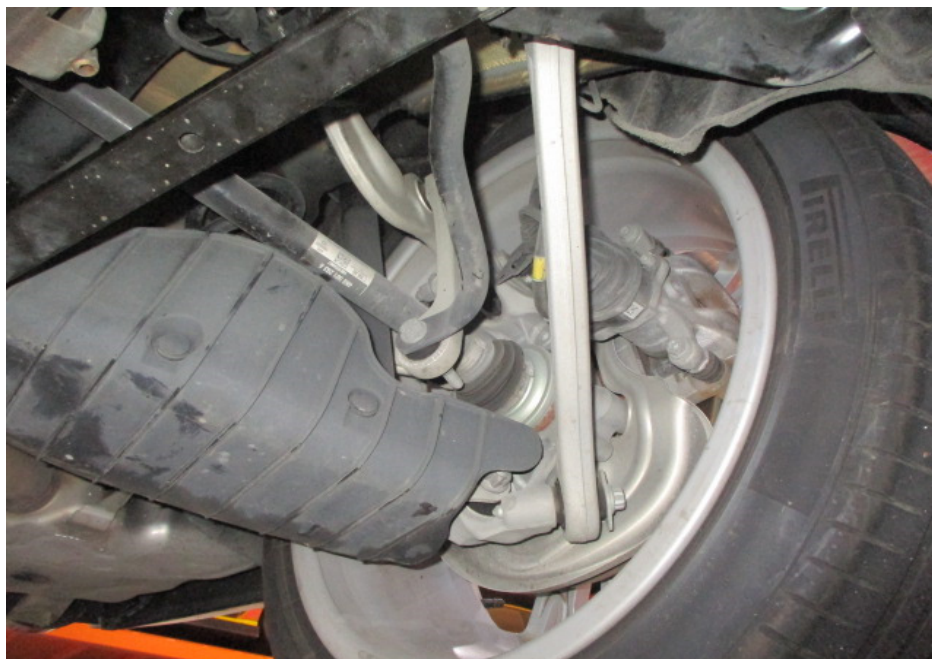
**Photo 16** shows a general view of the control arms and linkages at the rear left wheel of the Motor Car. I did not observe any fluid leak and/or fluid stain on the underside of the Motor Car. All of the Motor Car's undercarriage components were observed to be intact and secured in an appropriate manner.

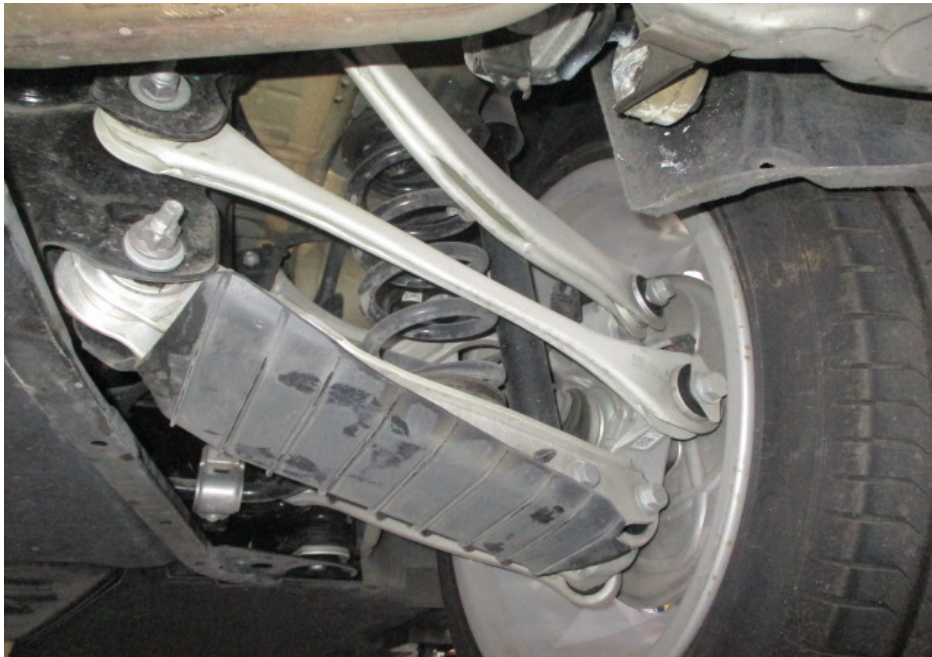
**Photo 17** shows the various undercarriage components at the rear right wheel of the Motor Car. The mechanical components, control arms and linkages were all found to be intact and secured in an appropriate manner.

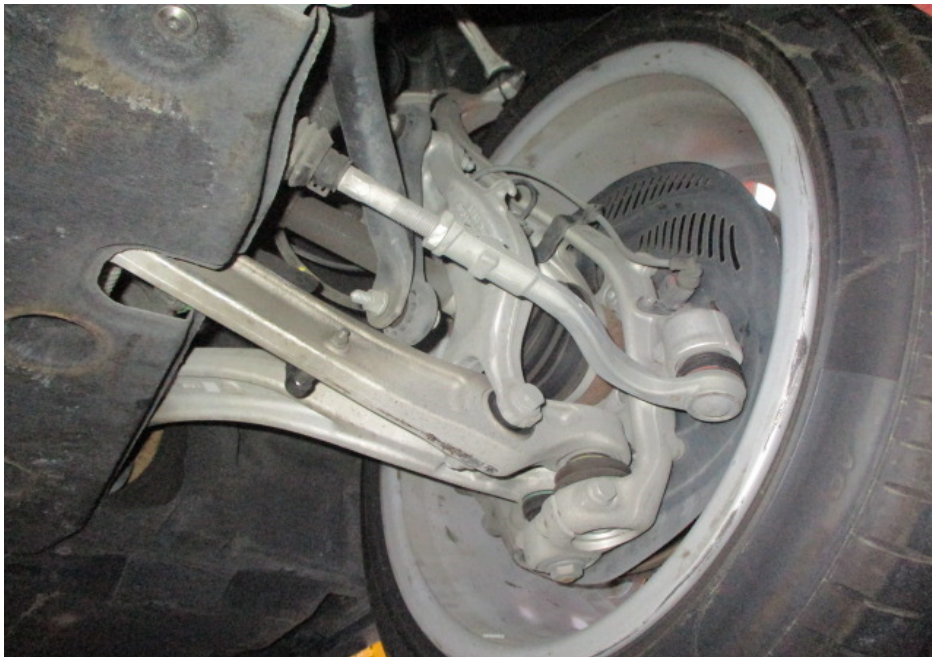
**Photo 18** shows the various undercarriage components at the front left wheel of the Motor Car. The mechanical components, control arms and linkages were all found to be intact and secured in an appropriate manner. I also did not observe any fluid leak and/or fluid stain on the underside of the Motor Car.

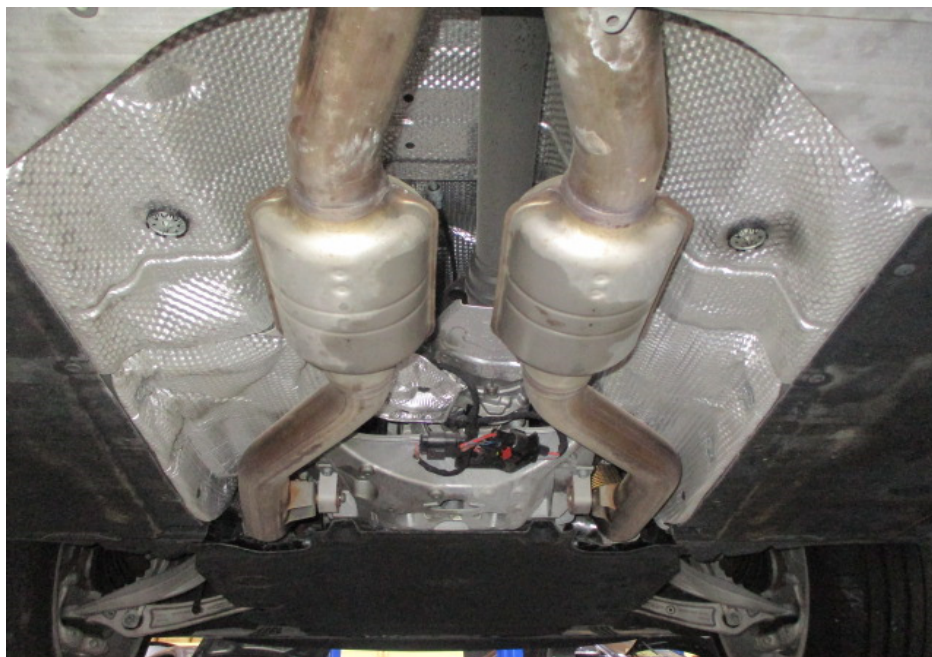
**Photo 19** shows the Motor Car's centre exhaust pipes. My examination of the Motor Car's exhaust system revealed no sign(s) or indication(s) of any cut or weld marks along its exhaust pipes, catalytic converters and on its rear mufflers.

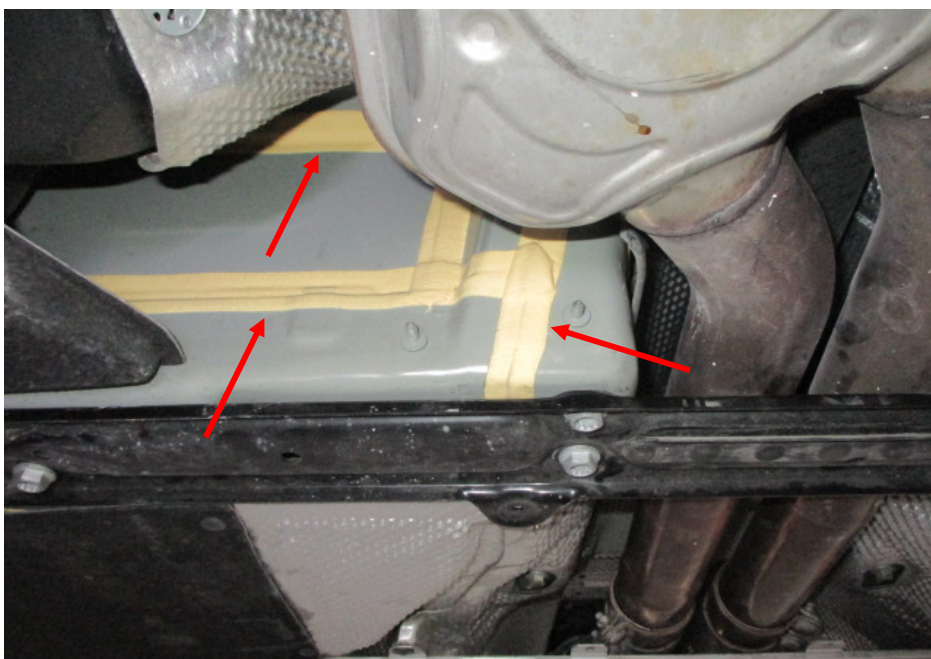
**Photo 20** shows the floorboard at the underside left centre of the Motor Car. The original factory sealant (arrowed) at the joints along the floorboard (non-detachable body panel) was untouched, indicating no work was done on the floorboard of the Motor Car. In general, I had found all the non-detachable body panels of the Motor Car to be originally fitted at the time of my inspection.

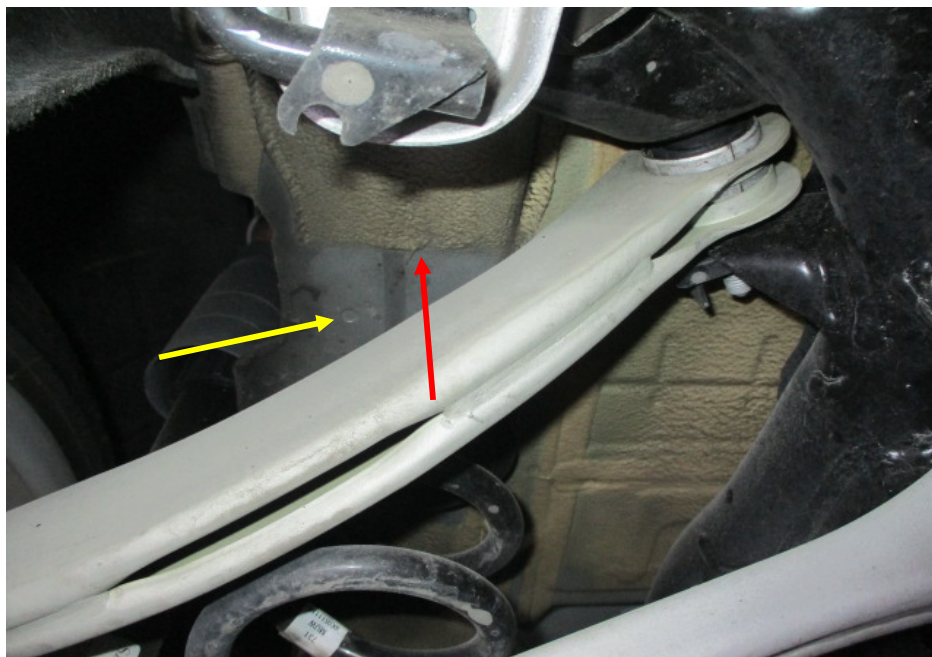
**Photo 21** shows the chassis/structural body at the underside rear left of the Motor Car. I did not find any weld marks other than original spot weld marks (yellow arrow) on the chassis/structural body of the Motor Car. The original factory sealant (red arrow) at the joints along the chassis/structural body was untouched, indicating no work was done on the chassis/structural body of the Motor Car and that the chassis/structural body was originally fitted.

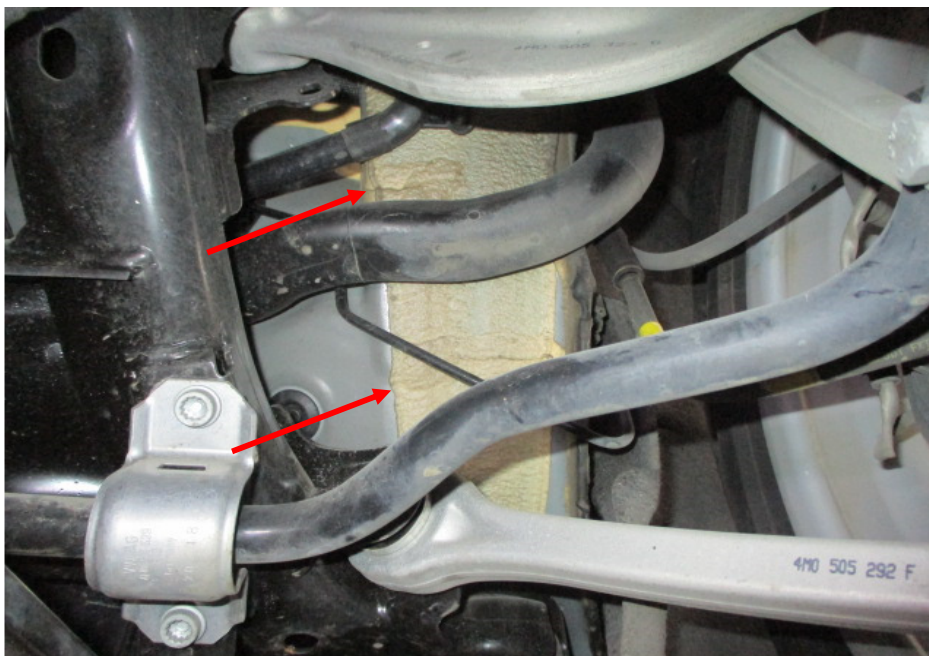
**Photo 22** shows the chassis/structural body at the underside rear right of the Motor Car. The original factory sealant (arrowed) at the joints along the chassis/structural body was observed to be untouched. In general, I had found no work was carried out on the chassis/structural body of the Motor Car. The chassis/structural body of the Motor Car was originally fitted.

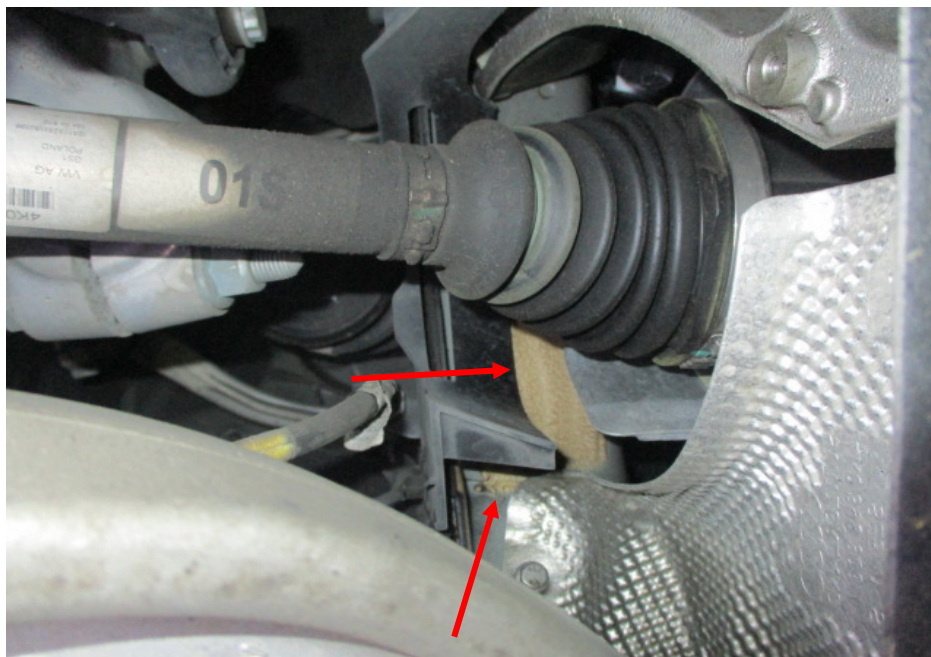
**Photo 23** shows the chassis/structural body at the underside front right of the Motor Car. The original factory sealant (arrowed) at the joints along the chassis/structural body was observed to be untouched. In general, I had found no work was carried out on the chassis/structural body of the Motor Car. The chassis/structural body of the Motor Car was originally fitted.
