Your Ref: Mercedes Benz C200 Coupe  
(chassis number WDD2053782F821547)  
Our Ref : CI/TP21002079/D

**INSPECTION REPORT OF AN UNREGISTERD MERCEDES BENZ C200  
COUPE MOTOR CAR WITH CHASSIS NUMBER WDD2053782F821547**

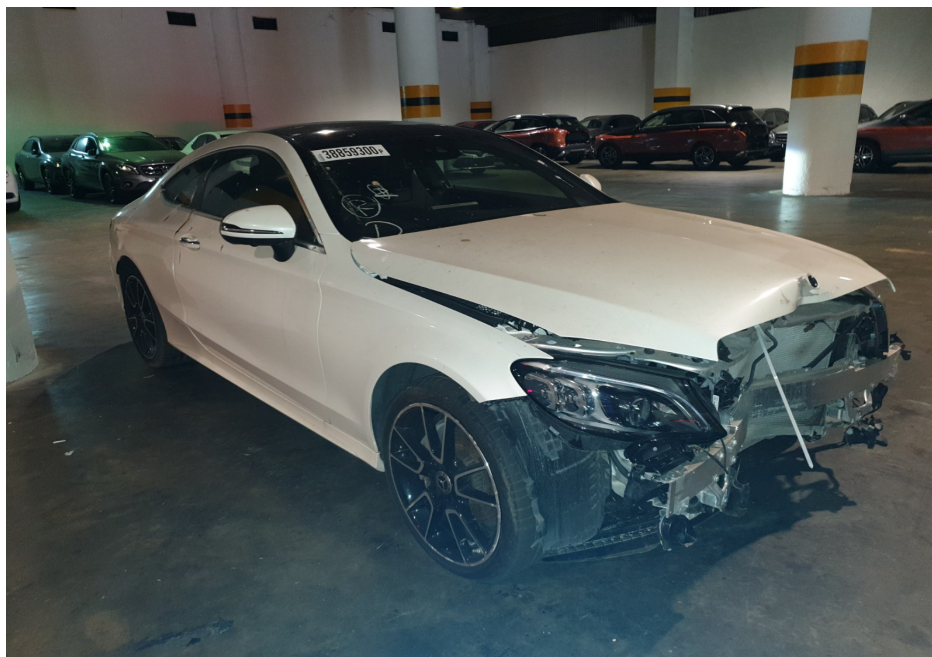
**Photo 1** shows the front right body of the Motor Car (photograph provided to me). The Motor Car was observed to have sustained damage at its frontal portion. The front bumper and all its related parts and attachments, front bumper reinforcement, front bonnet, front right headlamp, aircon condenser and radiator were amongst the body parts that were observed to have been damaged.

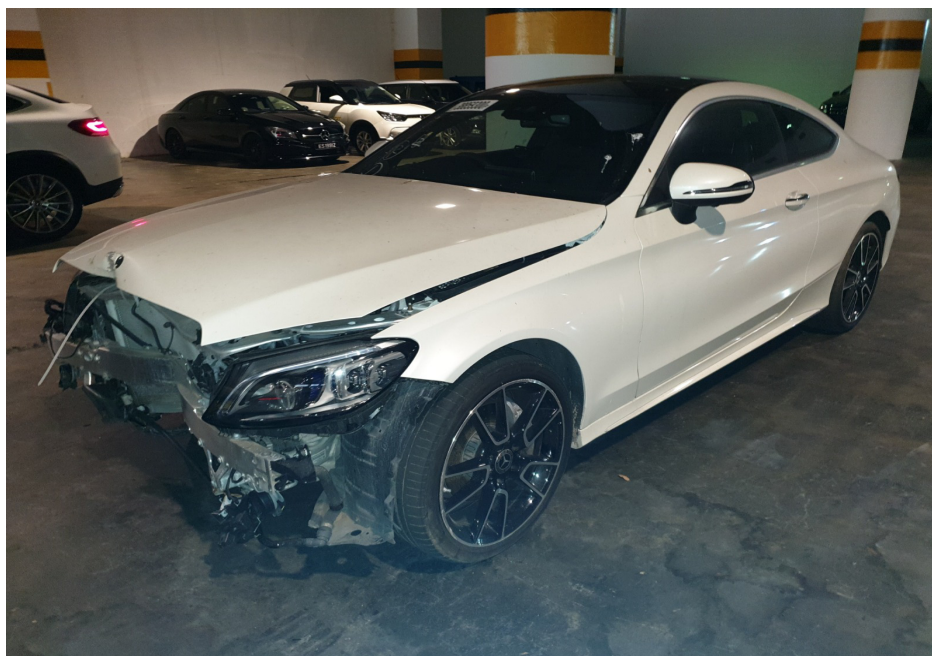
**Photo 2** shows the front left body of the Motor Car (photograph provided to me). The Motor Car was observed to have sustained damage at its frontal portion. The front bumper and all its related parts and attachments, front bumper reinforcement, front bonnet, front left headlamp, aircon condenser and radiator were amongst the body parts that were observed to have been damaged.

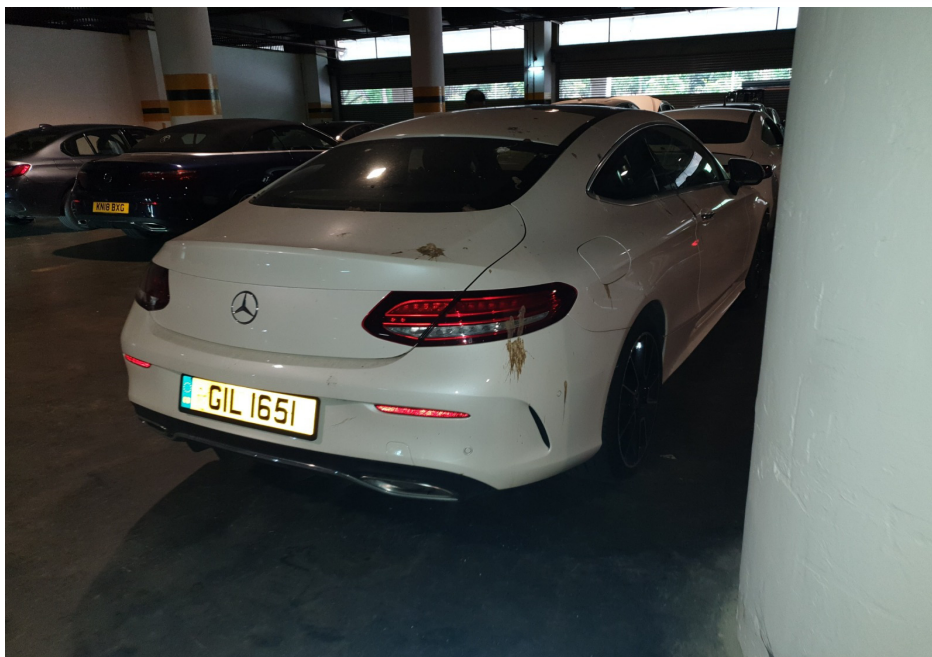
**Photo 3** shows the rear right body of the Motor Car (photograph provided to me). Apart for the frontal portion, there was no physical damage seen to other areas of the Motor Car.

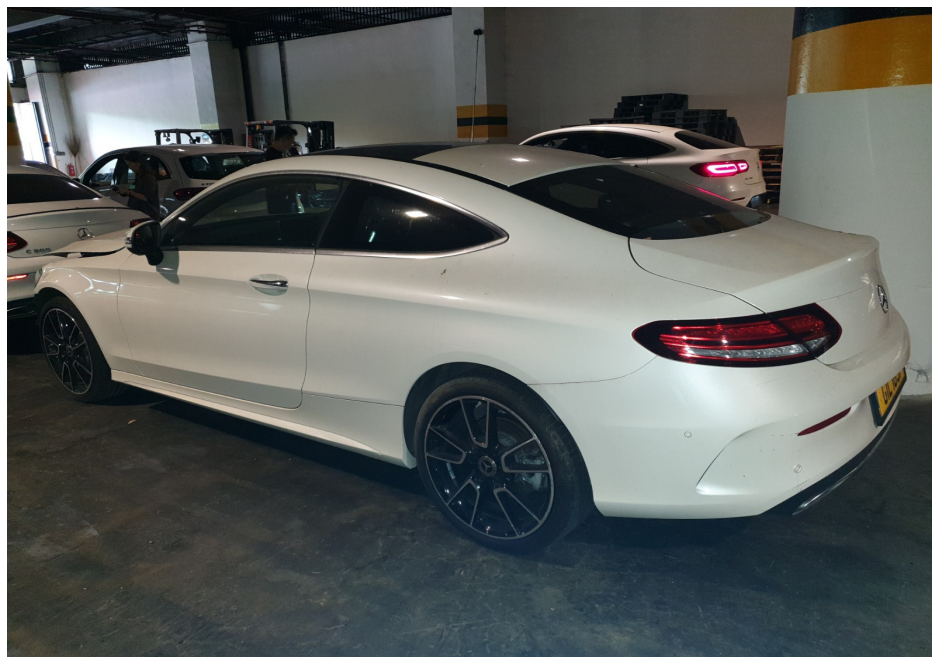
**Photo 4** shows the rear left body of the Motor Car (photograph provided to me). Apart for the rear portion, there was no physical damage seen to other areas of the Motor Car. The airbags of the Motor Car were also not activated as seen from the photographs that were provided to me.

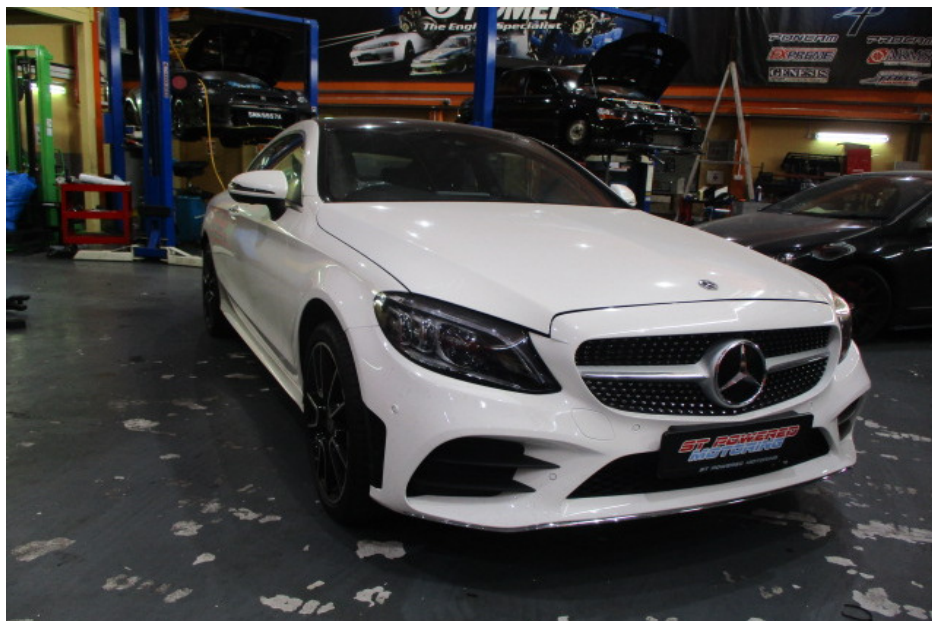
**Photo 5** shows a general view of the front right body of the Motor Car at the time of my inspection. The Motor Car was observed to be in a relatively good general condition with no loose exterior fittings observed. The body parts at the frontal portion of the Motor Car were visually examined and it was observed that the repair/restoration works carried out to the damaged area of the Motor Car (refer to photograph 1 & 2 above) were reasonably adequate and in order.

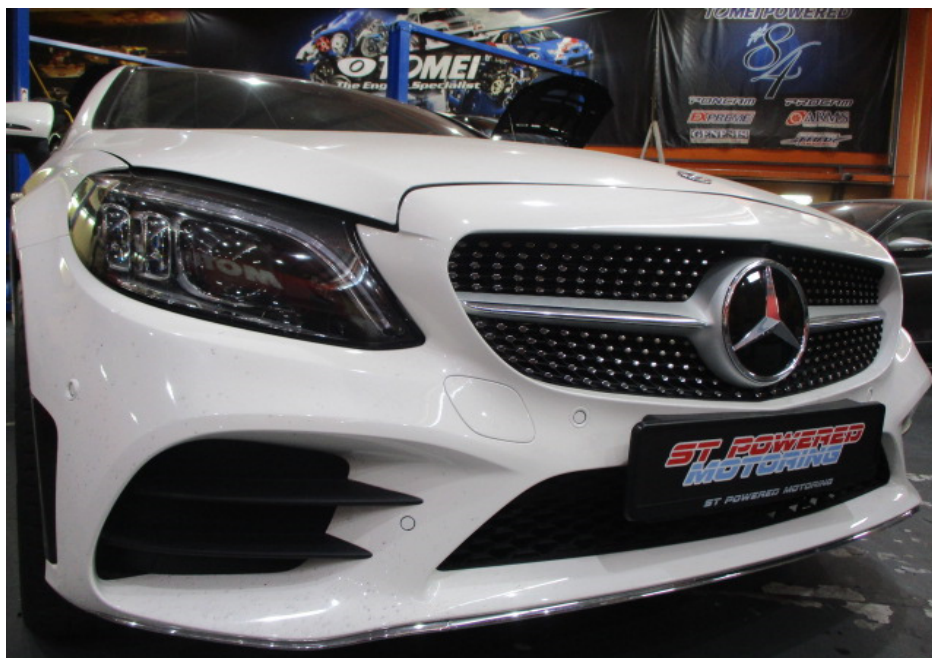
**Photo 6** shows a closer view of the front bumper, front bumper right lower grille, front right headlamp, front bonnet and radiator grille of the Motor Car at the time of my inspection. The body parts at the frontal portion of the Motor Car were visually examined and it was observed that the repair/restoration works carried out to the damaged area of the Motor Car (refer to photograph 1 & 2 above) were reasonably adequate and in order.

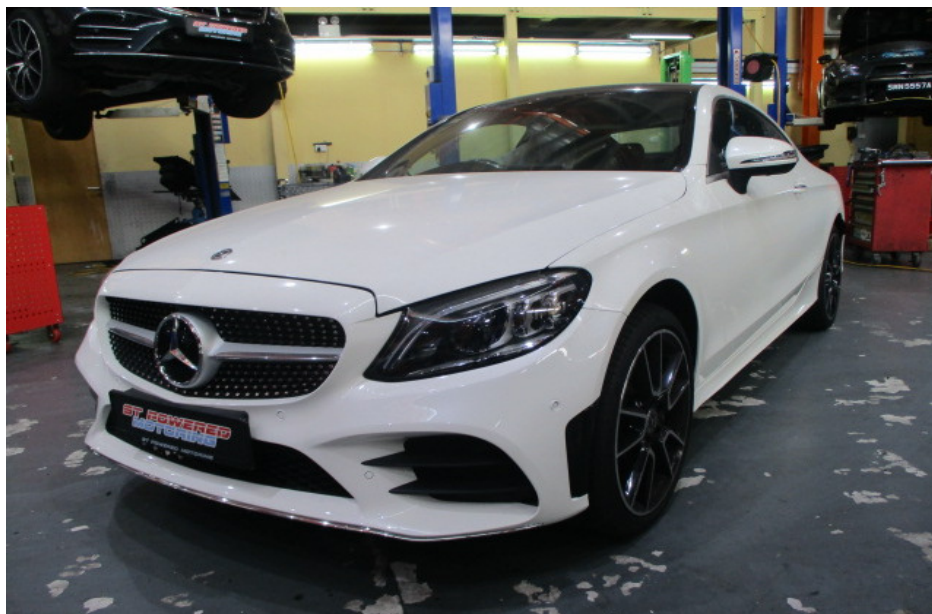
**Photo 7** shows a general view of the front left body of the Motor Car at the time of my inspection. The Motor Car was observed to be in a relatively good general condition with no loose exterior fittings observed. The body parts at the frontal portion of the Motor Car were visually examined and it was observed that the repair/restoration works carried out to the damaged area of the Motor Car (refer to photograph 1 & 2 above) were reasonably adequate and in order.

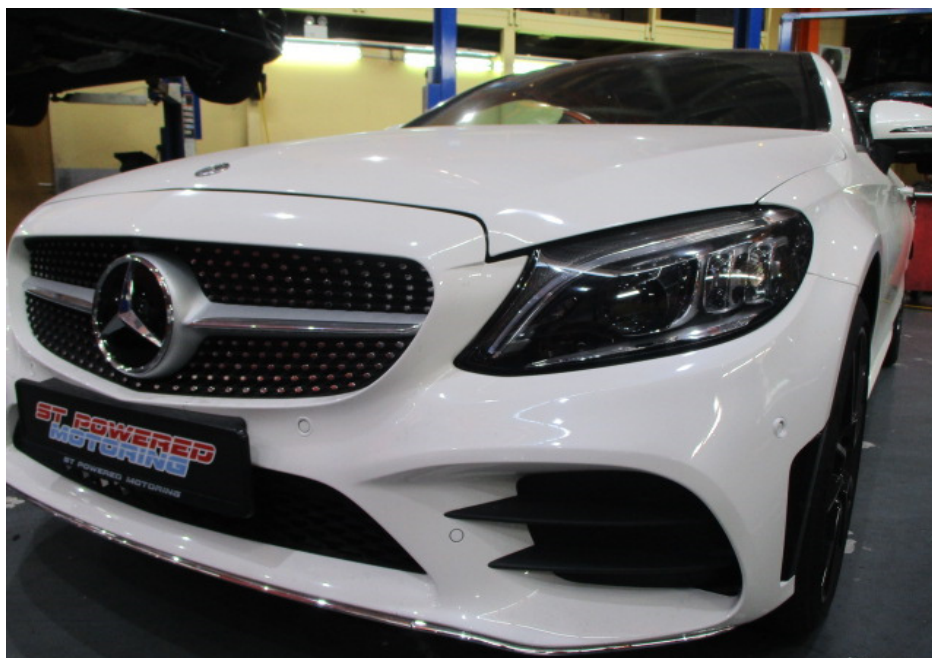
**Photo 8** shows a closer view of the front bumper, front bumper left lower grille, front left headlamp, front bonnet and radiator grille of the Motor Car at the time of my inspection. The body parts at the frontal portion of the Motor Car were visually examined and it was observed that the repair/restoration works carried out to the damaged area of the Motor Car (refer to photograph 1 & 2 above) were reasonably adequate and in order.

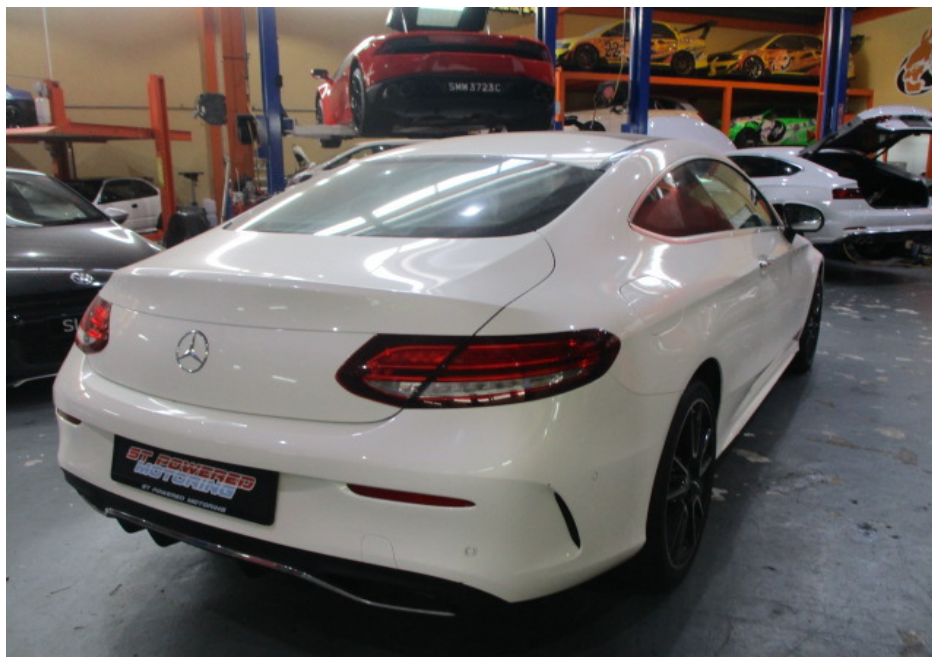
**Photo 9** shows a general view of the rear right body of the Motor Car at the time of my inspection. The Motor Car was observed to be in a relatively good general condition with no loose exterior fittings observed. The mileage of the Motor Car recorded at the time of my inspection was 13,272km.

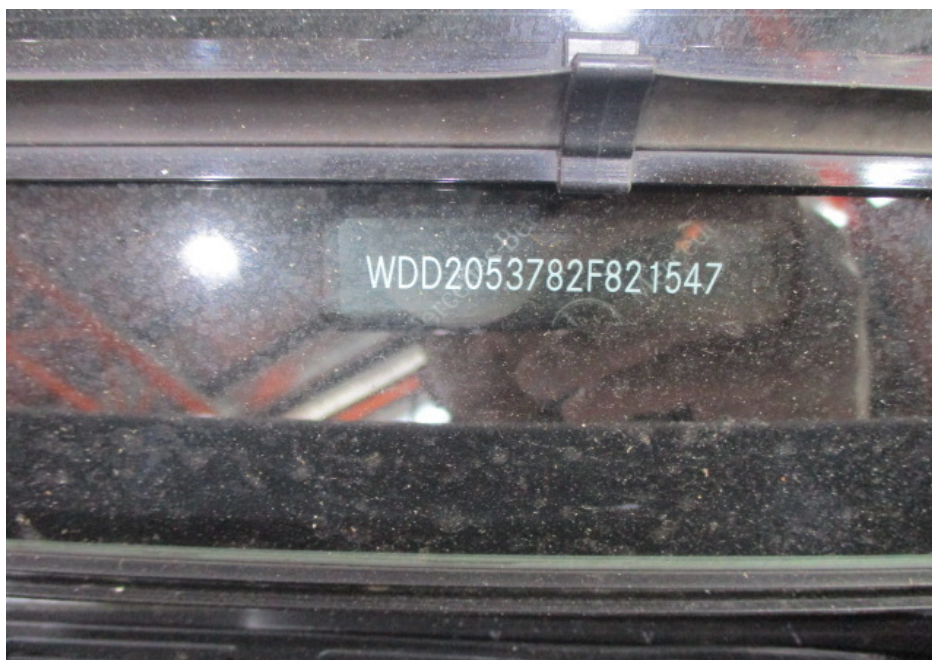
**Photo 10** shows the chassis number of the Motor Car. The chassis number recorded was WDD2053782F821547.

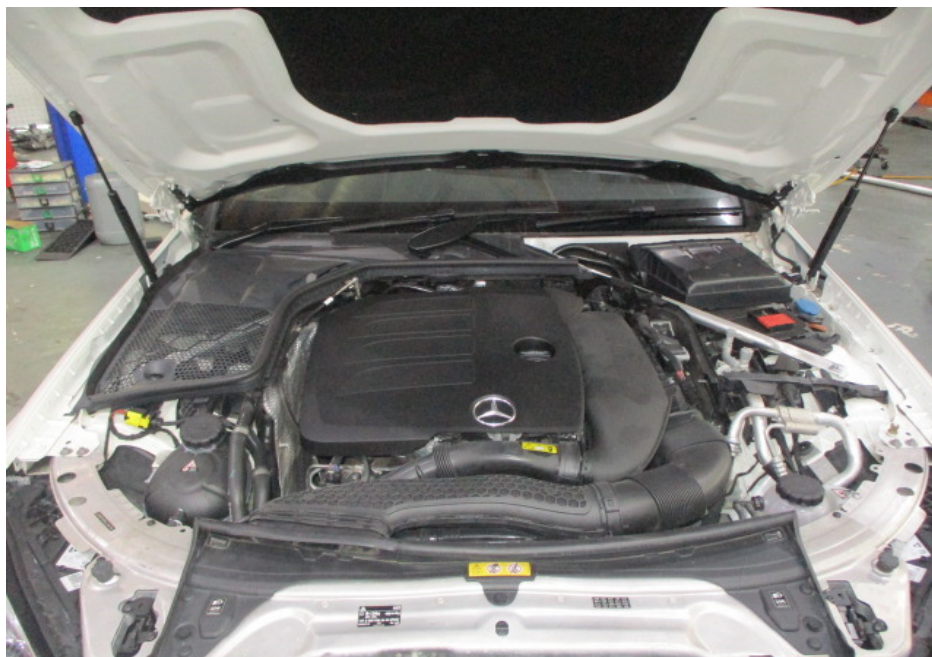
**Photo 11** shows a general view of the engine compartment of the Motor Car at the time of my inspection. The various parts and components inside the engine compartment were all observed to be intact and properly fitted. There was also no sign(s) or indication(s) of fluid leak and/or fluid stain found inside the engine compartment.

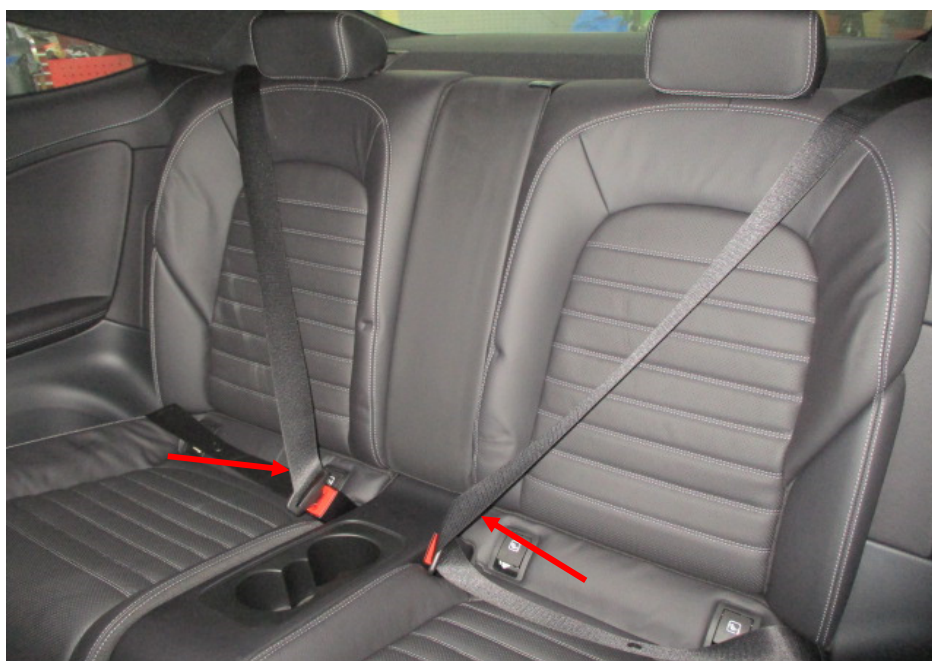
**Photo 12** shows the rear seats of the Motor Car. All the seats of the Motor Car were secured via seat rails to the floorboard. They were also fitted with a retractable seat belt reel and a pre-tensioner. The seat belts (arrowed) were tested and were able to be fastened into the respective pre-tensions that were fitted on the side of each individual seat.

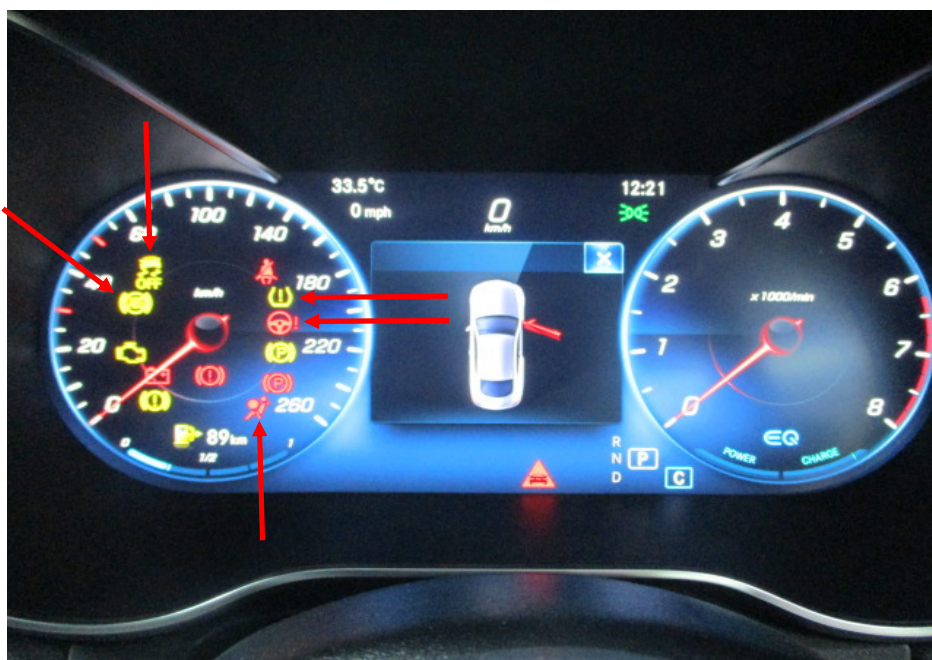
**Photo 13** shows the warning lights for the various electronic safety features appearing on the instrument panel of the Motor Car during its self-test when the engine is cranked, in particular the ABS, SRS, EPS, TPM and TCS lights (arrowed).

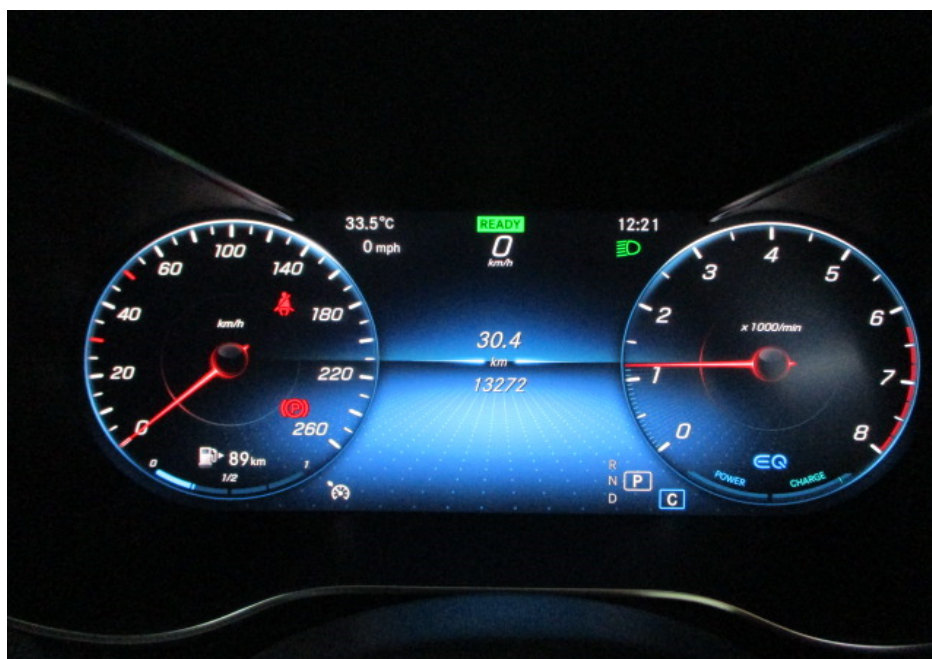
**Photo 14** shows the respective warning lights no longer illuminated, indicating that there is no fault detected to the ABS, SRS, EPS, TPM and TCS systems of the Motor Car during the self-test. These electronic systems were hence in working condition at the time of my inspection.

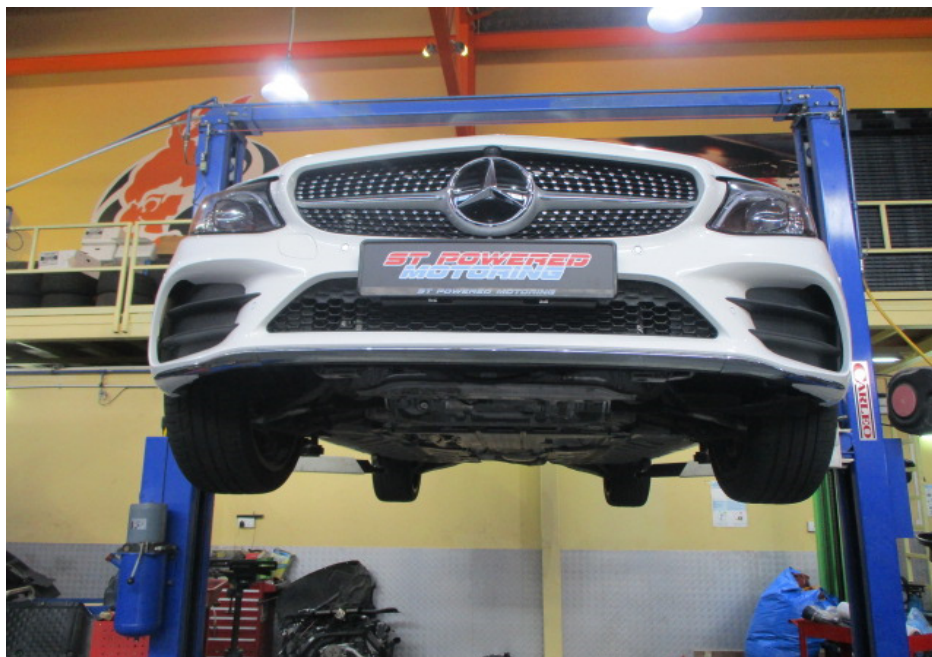
**Photo 15** shows the Motor Car hoisted up for checks on its undercarriage. There was no sign(s) or indication(s) of fluid leakage and/or fluid stain(s) on the underside of the Motor Car. The undercarriage components of the Motor Car were also all observed to be intact and secured in an appropriate manner.

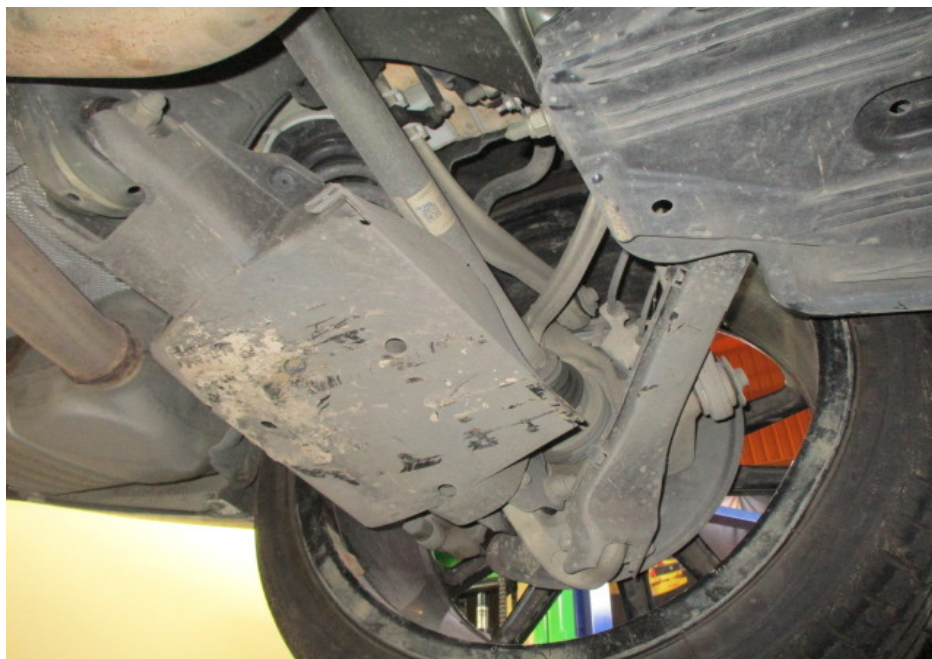
**Photo 16** shows a general view of the control arms and linkages at the rear left wheel of the Motor Car. I did not observe any fluid leak and/or fluid stain on the underside of the Motor Car. All of the Motor Car's undercarriage components were observed to be intact and secured in an appropriate manner.

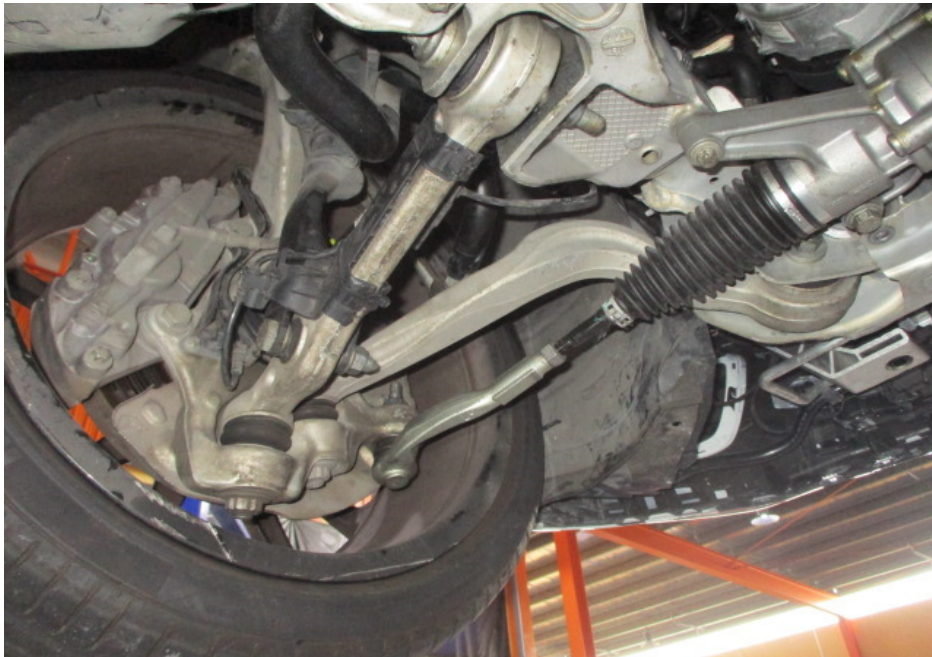
**Photo 17** shows the various undercarriage components at the front left wheel of the Motor Car. The mechanical components, control arms and linkages were all found to be intact and secured in an appropriate manner.

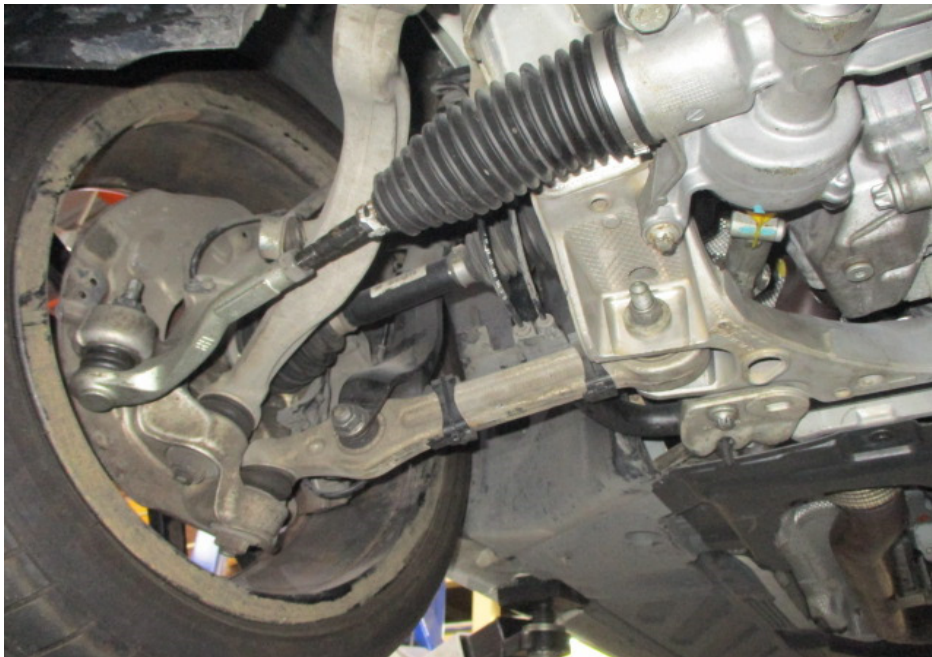
**Photo 18** shows the various undercarriage components at the front right wheel of the Motor Car. The mechanical components, control arms and linkages were all found to be intact and secured in an appropriate manner. I also did not observe any fluid leak and/or fluid stain on the underside of the Motor Car.

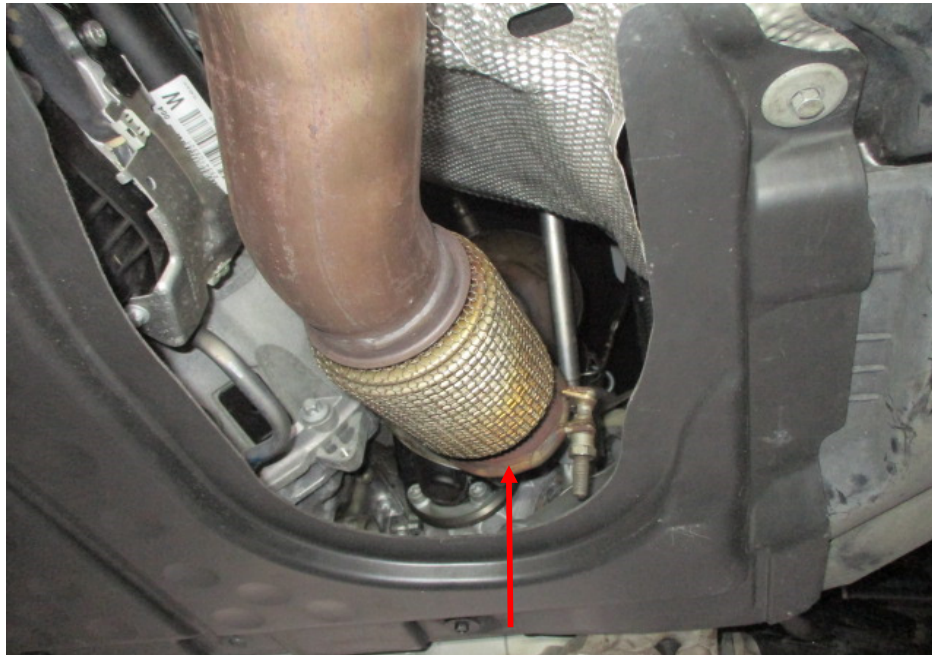
**Photo 19** shows the Motor Car's catalytic converter (arrowed). My examination of the Motor Car's exhaust system revealed no sign(s) or indication(s) of any cut or weld marks along its exhaust pipes and on its rear muffler.

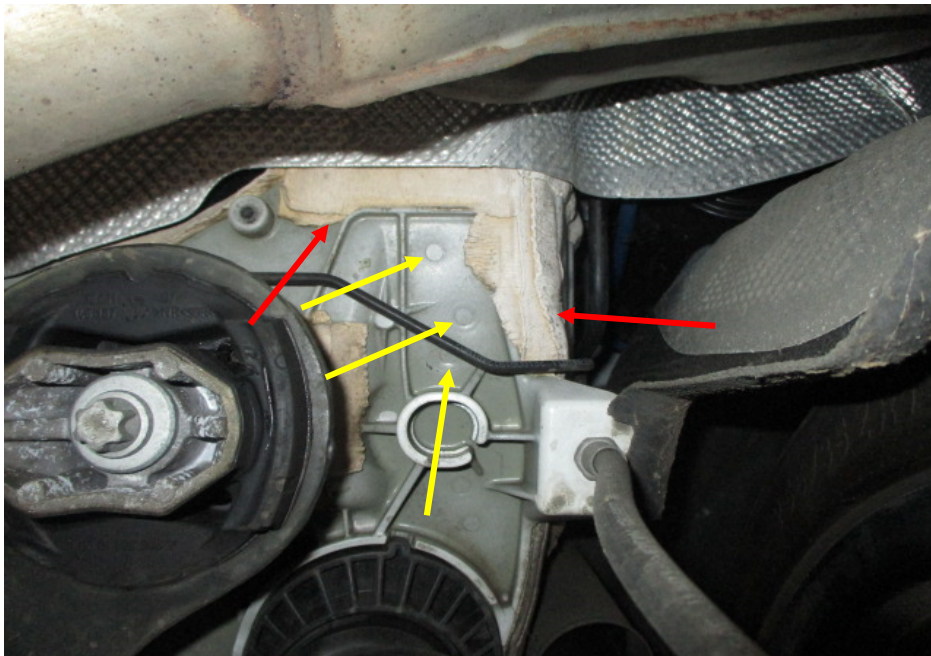
**Photo 20** shows the chassis/structural body at the underside rear right of the Motor Car. I did not find any weld marks other than original spot weld marks (yellow arrow) on the chassis/structural body of the Motor Car. The original factory sealant (red arrow) at the joints along the chassis/structural body was untouched, indicating no work was done on the chassis/structural body of the Motor Car and that the chassis/structural body was originally fitted.

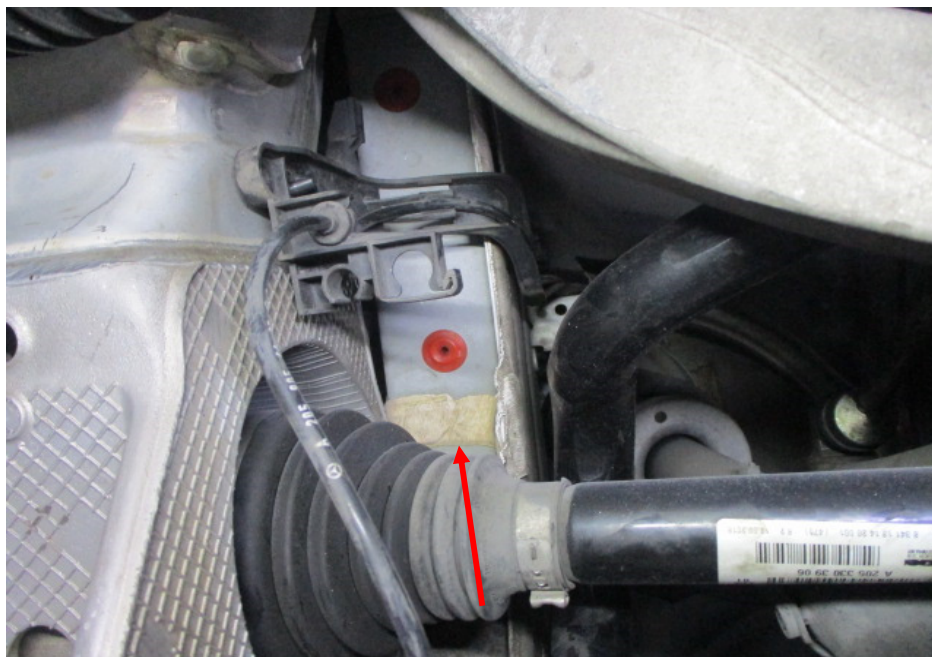
**Photo 21** shows the chassis/structural body at the underside front left of the Motor Car. The original factory sealant (arrowed) at the joints along the chassis/structural body was observed to be untouched. In general, I had found no work was carried out on the chassis/structural body of the Motor Car. The chassis/structural body of the Motor Car was originally fitted.

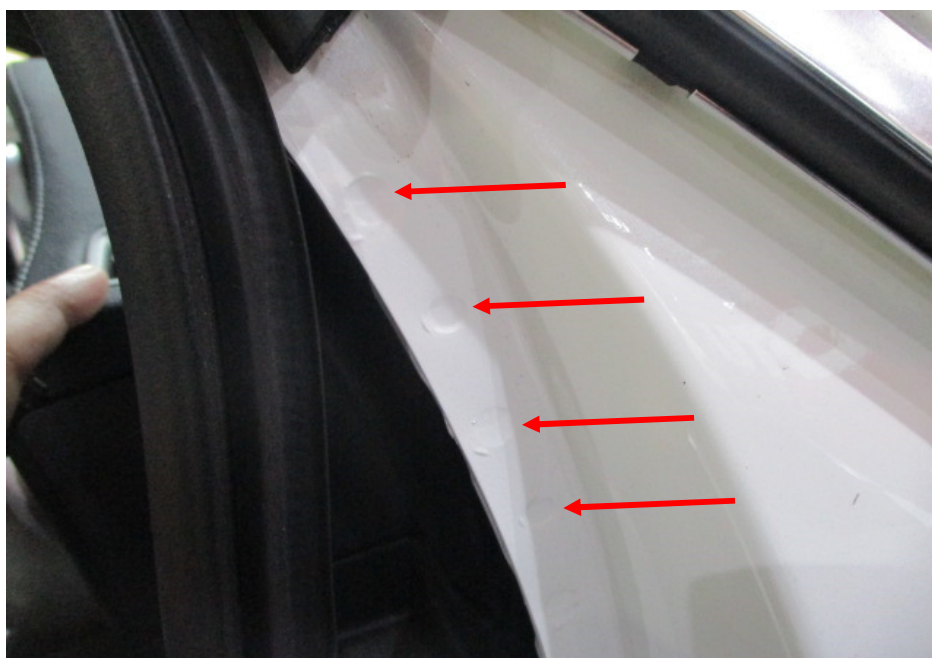
**Photo 22** shows the right side "A" pillar of the Motor Car. I did not find any weld marks other than original spot weld marks (arrowed) on the right side "A" pillar of the Motor Car which, indicates that there was no re-welding works carried out. In general, I had found all the non-detachable body panels of the Motor Car to be originally fitted at the time of my inspection.

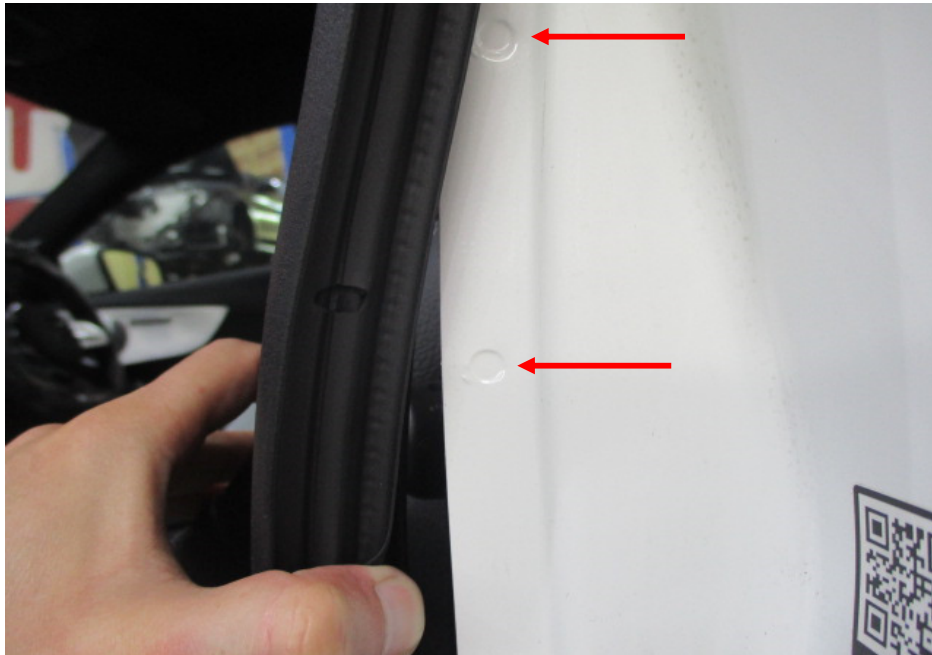
**Photo 23** shows the left rear body panel of the Motor Car. I did not find any weld marks other than original spot weld marks (arrowed) on the left rear body panel of the Motor Car which, indicates that there was no re-welding works carried out. In general, I had found all the non-detachable body panels of the Motor Car to be originally fitted at the time of my inspection.
