Your Ref: Mercedes Benz C300 Cabriolet
(chassis number WDD2054832F843592)
Our Ref : CI/TP21002080/D

**INSPECTION REPORT OF AN UNREGISTERD MERCEDES BENZ C300
CABRIOLET MOTOR CAR WITH CHASSIS NUMBER WDD2054832F843592**

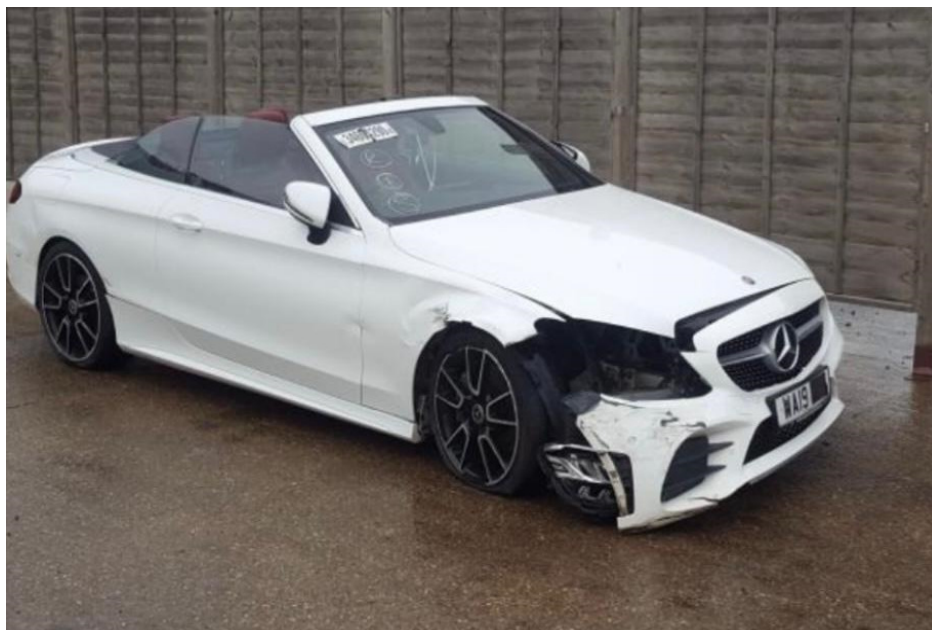
3. From the photographs provided to me, it was observed that the Motor Car had sustained damages at its front right portion. Body parts damaged include the front bumper, front right headlamp, front bonnet, front right fender, front right door, front right wheel rim and front right tyre amongst others.
4. The orientation of the front right wheel and front left wheel, as seen from the photographs, indicates to me that the front right undercarriage parts of the Motor Car were also damaged. The airbags of the Motor Car were not activated. See photo 1 – 4 below.

Photo 1 shows the front right body of the Motor Car (photograph provided to me). The Motor Car was observed to have sustained damage at its front right portion. The front bumper, front right headlamp, front bonnet, front right fender, front right door, front right wheel rim and front right tyre amongst others were amongst the body parts that were observed to have been damaged. The front right wheel and front left wheel (refer to photograph 2 below) were orientated in different directions, which suggests to me that the front right undercarriage parts of the Motor Car were also damaged.

23. The body parts at the front right portion of the Motor Car were visually examined and it was noted that the repair/restoration works carried out to the damaged area of the Motor Car (refer to photograph 1 above) were reasonably adequate and in order.

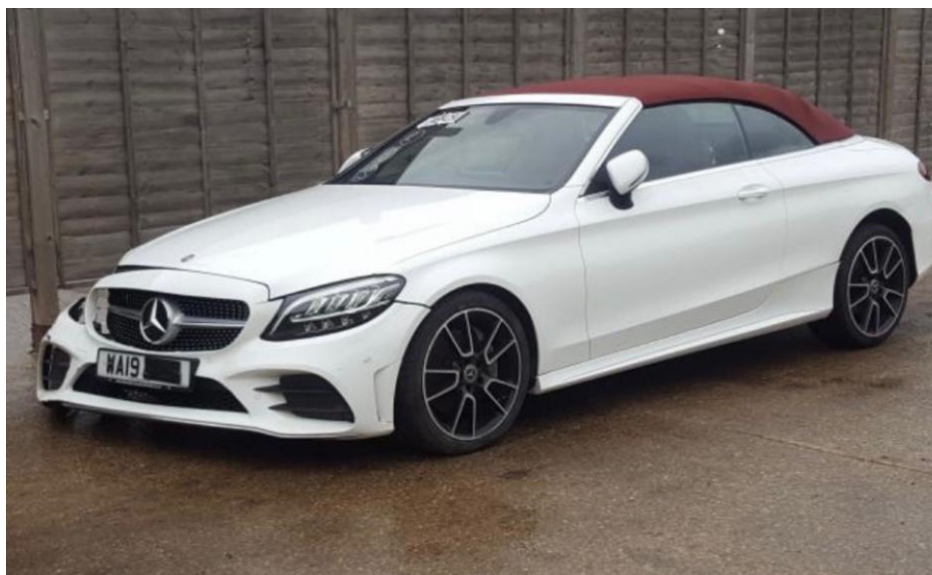
Photo 2 shows the front left body of the Motor Car (photograph provided to me). The front left wheel was orientated straight as compared to the front right wheel, which was orientated slightly to the right (refer to photograph 1 above). This would indicate to me that there was damage to the front right undercarriage parts of the Motor Car, given that the front left portion of the Motor Car was seen to be undamaged.

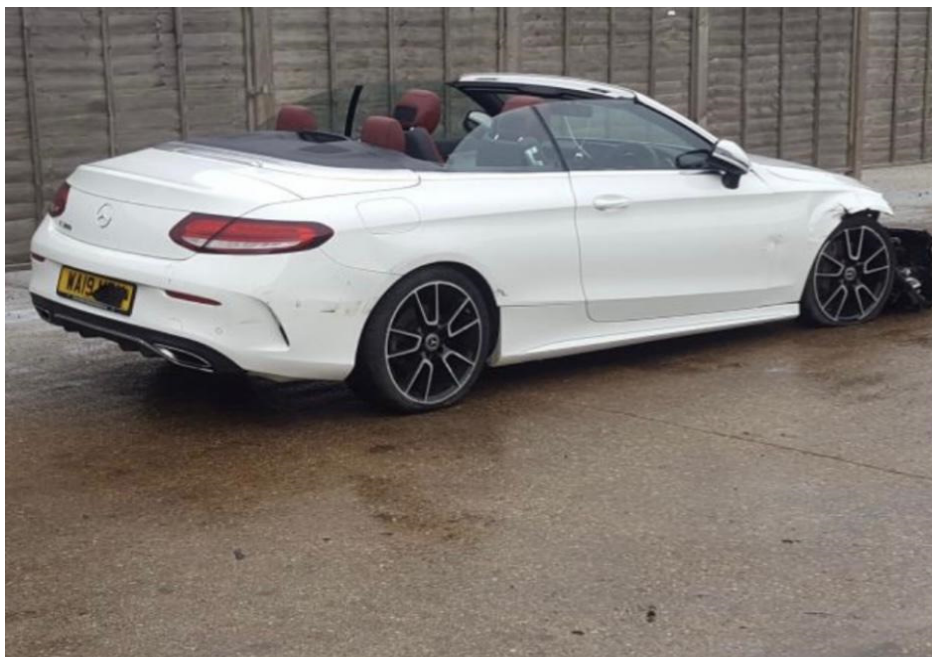
Photo 3 shows the rear right body of the Motor Car (photograph provided to me). Apart for the front right portion, there was no physical damage seen to other areas of the Motor Car. The airbags of the Motor Car were also not activated as seen from the photographs that were provided to me.

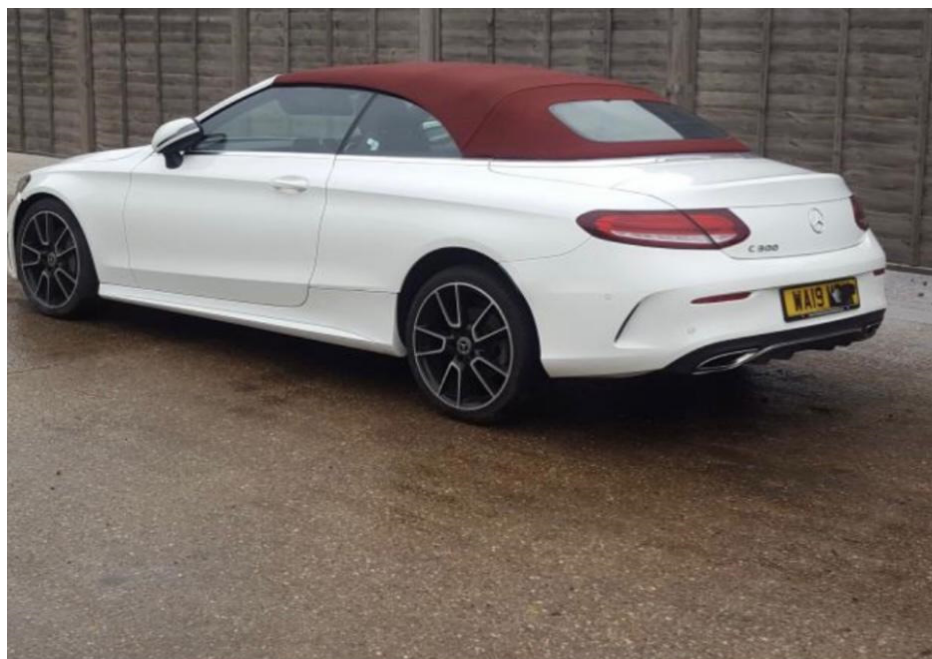
Photo 4 shows the rear left body of the Motor Car (photograph provided to me). Apart for the front right portion, there was no physical damage seen to other areas of the Motor Car.

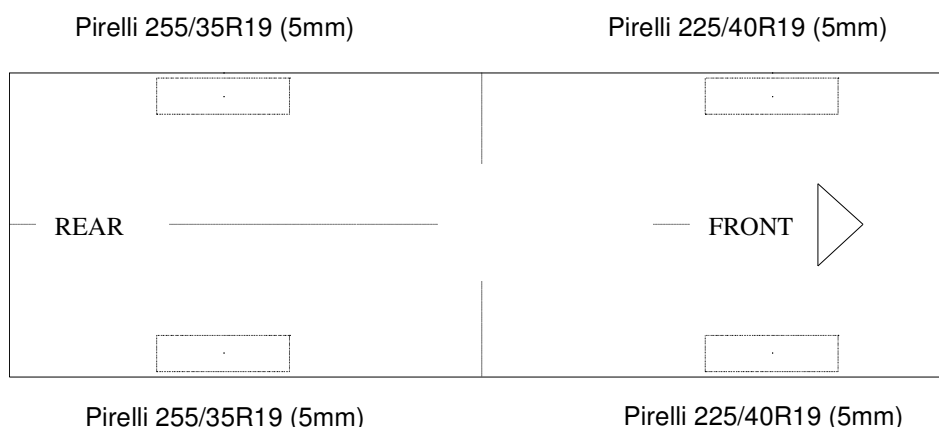
9. It was fitted with 19inch sport wheel rims that were wrapped with tyres that were observed to be of serviceable condition. The tyres were also sufficiently inflated for vehicular operation. The tyre brand, tyre size and approximate remaining tread depth of the 4 tyres of the Motor Car were recorded as follows: -

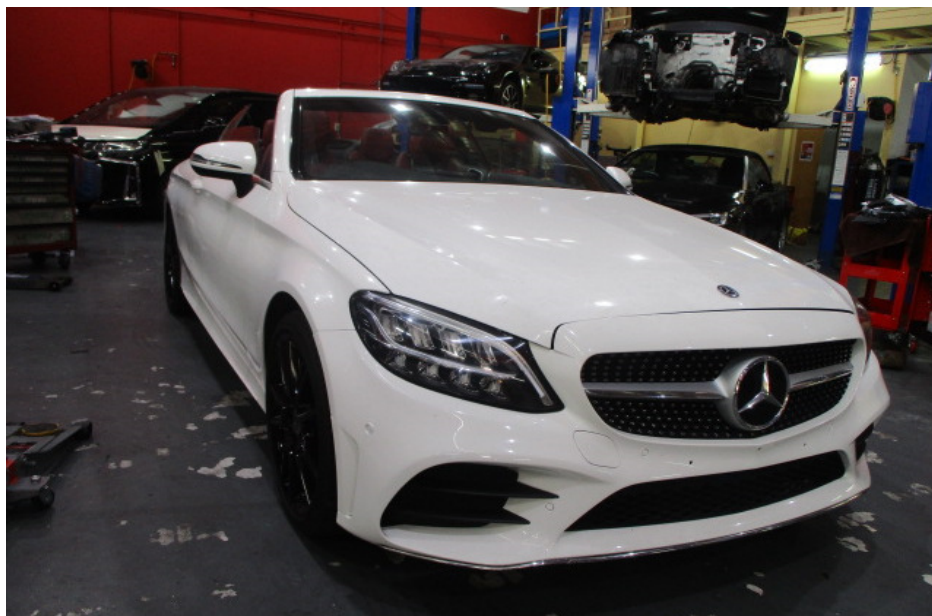
Photo 5 shows a general view of the front right body of the Motor Car at the time of my inspection. The Motor Car was observed to be in a relatively good general condition with no loose exterior fittings observed. The body parts at the front right portion of the Motor Car were visually examined and it was observed that the repair/restoration works carried out to the damaged area of the Motor Car (refer to photograph 1 above) were reasonably adequate and in order.

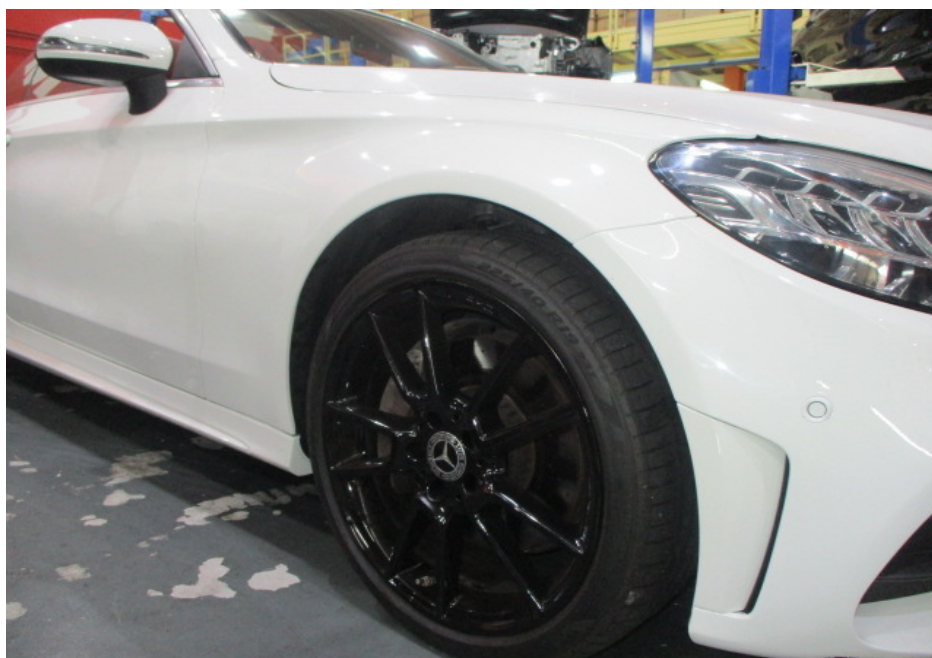
Photo 6 shows a closer view of the front bumper, front right headlamp, front right fender, front right wheel and front right tyre of the Motor Car at the time of my inspection. The body parts at the front right portion of the Motor Car were visually examined and it was observed that the repair/restoration works carried out to the damaged area of the Motor Car (refer to photograph 1 above) were reasonably adequate and in order.

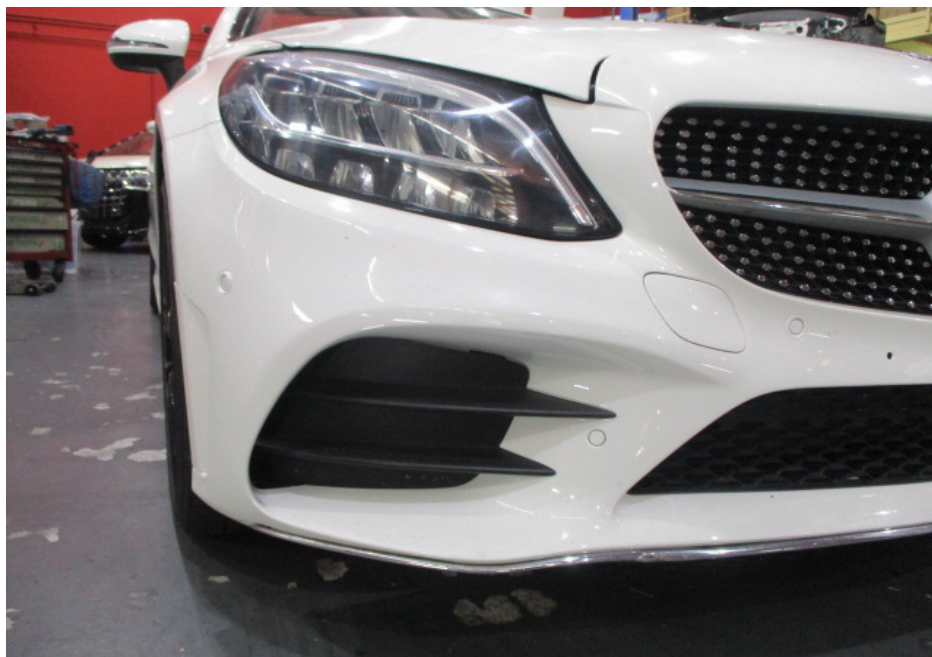
Photo 7 shows a closer view of the front bumper and front right headlamp of the Motor Car at the time of my inspection. The body parts at the front right portion of the Motor Car were visually examined and it was observed that the repair/restoration works carried out to the damaged area of the Motor Car (refer to photograph 1 above) were reasonably adequate and in order.

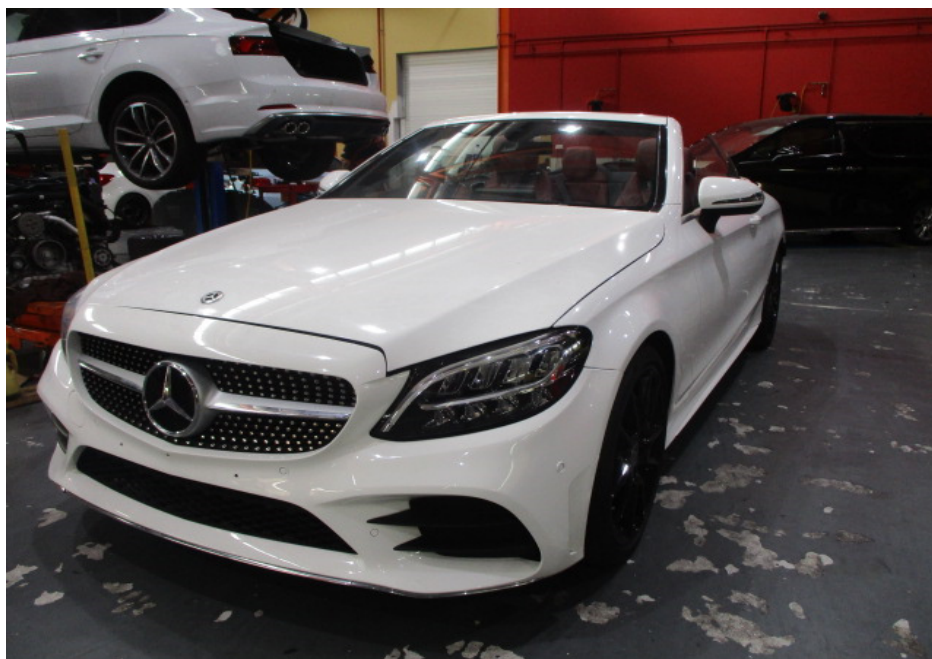
Photo 8 shows a general view of the front left body of the Motor Car at the time of my inspection. The Motor Car was observed to be in a relatively good general condition with no loose exterior fittings observed. The mileage of the Motor Car recorded at the time of my inspection was 8,019km.

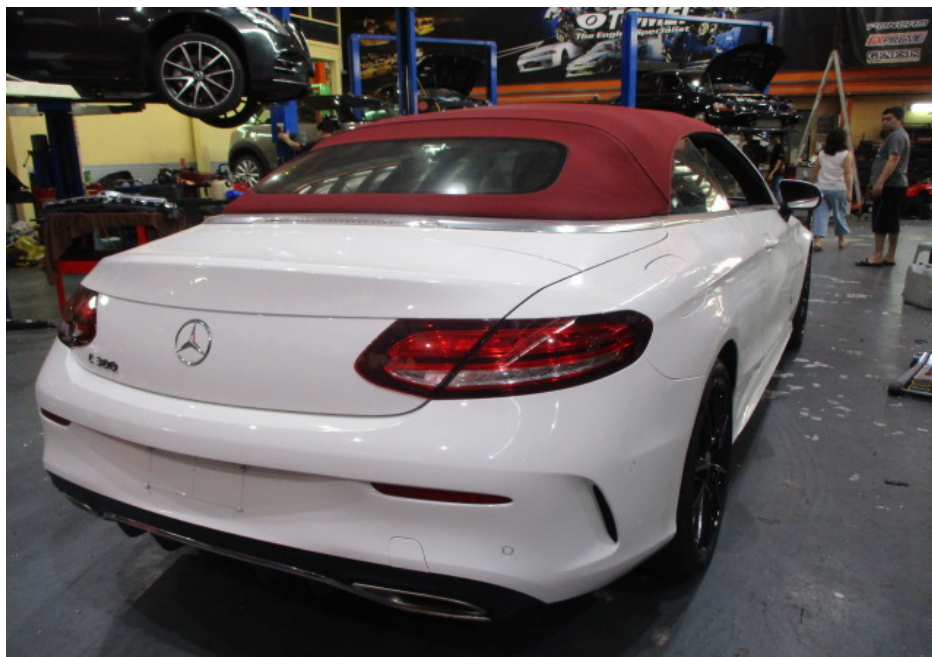
Photo 9 shows a general view of the rear right body of the Motor Car at the time of my inspection. The Motor Car was observed to be in a relatively good general condition with no loose exterior fittings observed. The mileage of the Motor Car recorded at the time of my inspection was 8,019km.

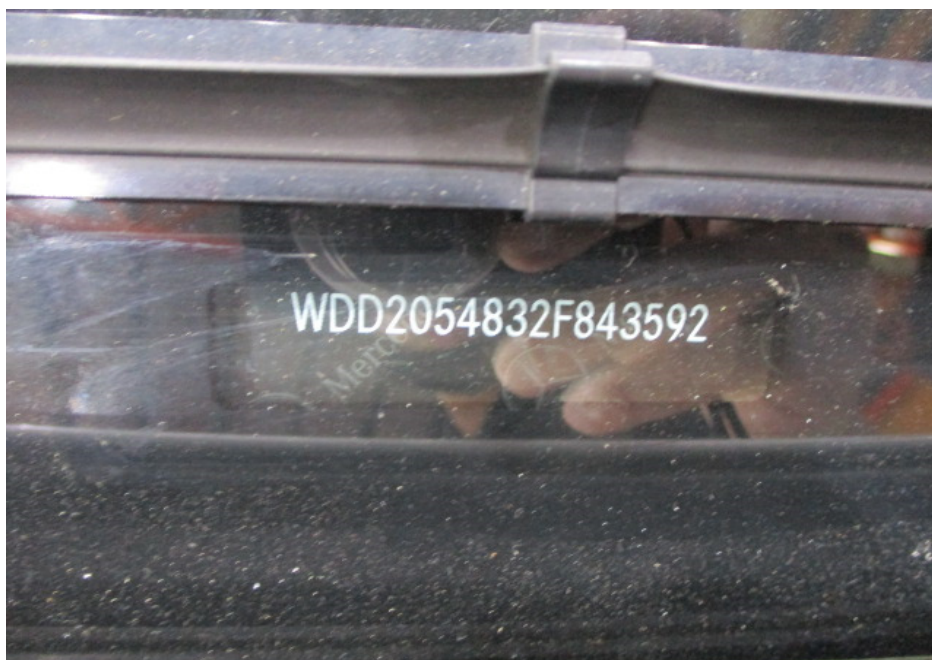
Photo 10 shows the chassis number of the Motor Car. The chassis number recorded was WDD2054832F843592.

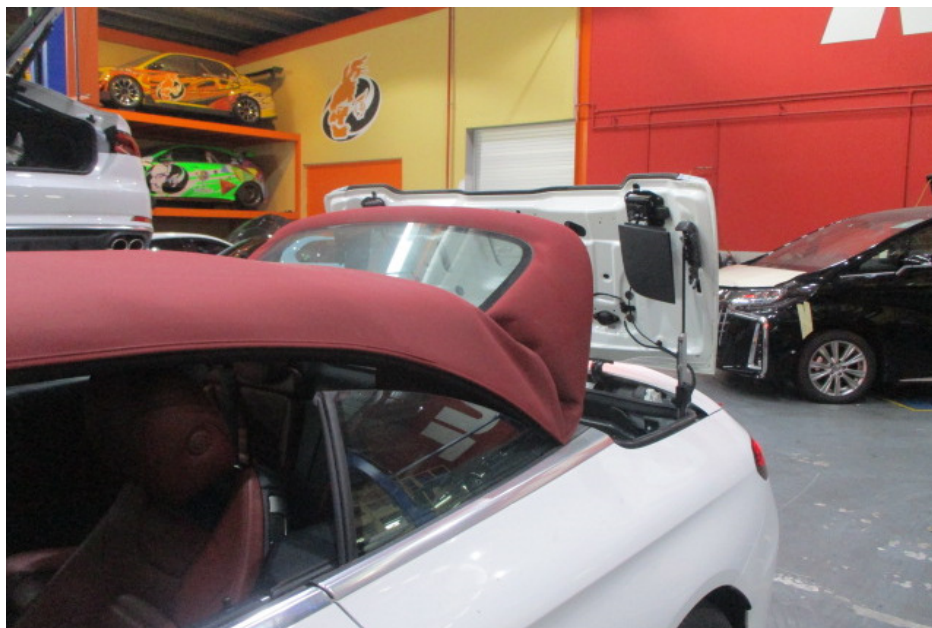
Photo 11 shows the Motor Car's soft top being tested. It was observed that as a safety feature, the soft top could only open and close when the Motor Car was in a stationary position. When opened, the soft top is completely folded into the rear boot compartment with no parts protruding out of the Motor Car's body. The soft top was also found adequately secured to the "A" pillar after closing.

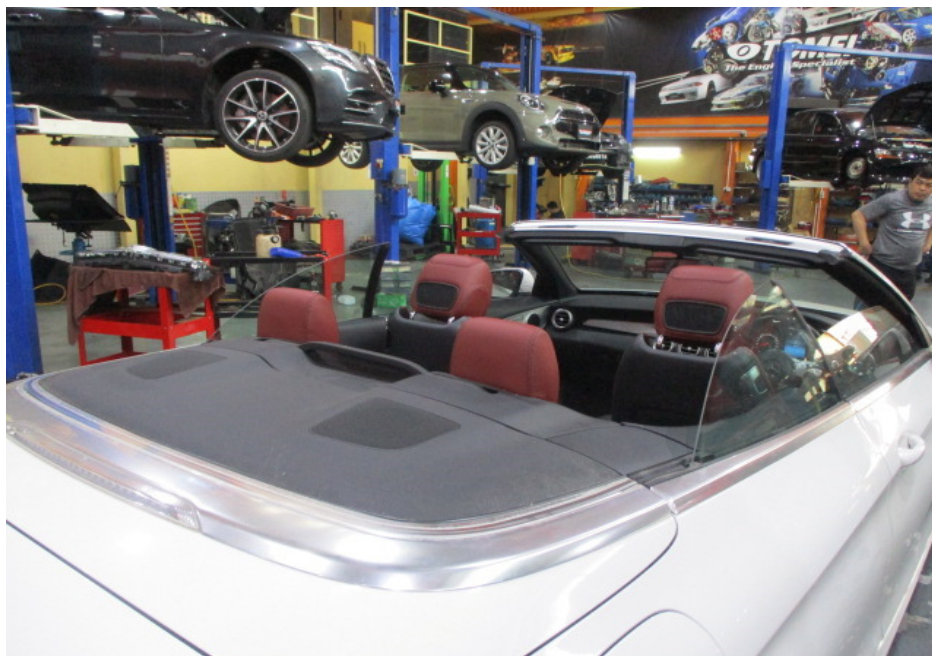
Photo 12 shows the Motor Car's with its soft top completely folded. It was observed that as a safety feature, the soft top could only open and close when the Motor Car was in a stationary position. When opened, the soft top is completely folded into the rear boot compartment with no parts protruding out of the Motor Car's body. The soft top was also found adequately secured to the "A" pillar after closing.

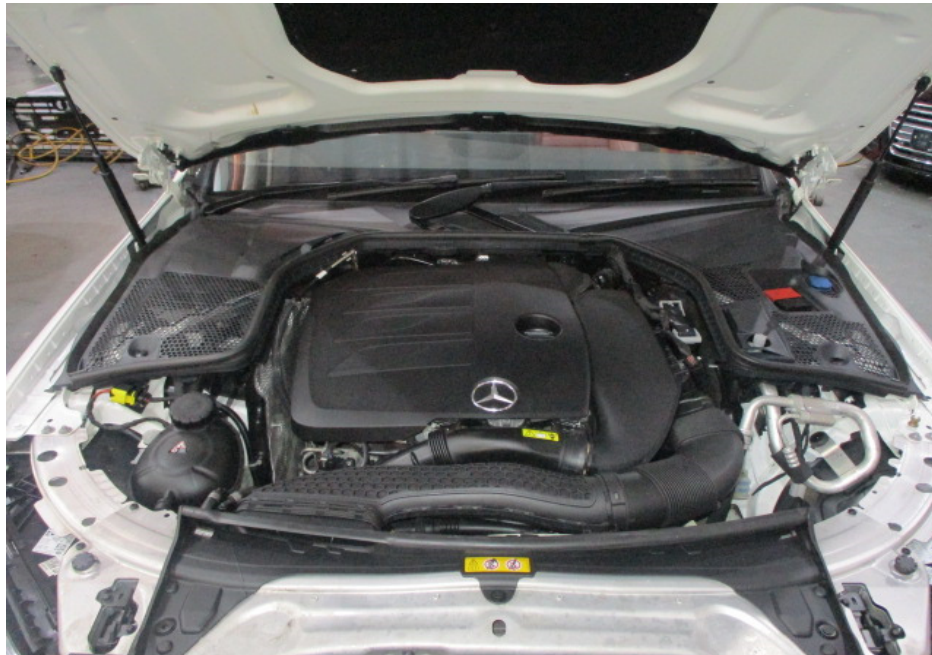
Photo 13 shows a general view of the engine compartment of the Motor Car at the time of my inspection. The various parts and components inside the engine compartment were all observed to be intact and properly fitted. There was also no sign(s) or indication(s) of fluid leak and/or fluid stain found inside the engine compartment.

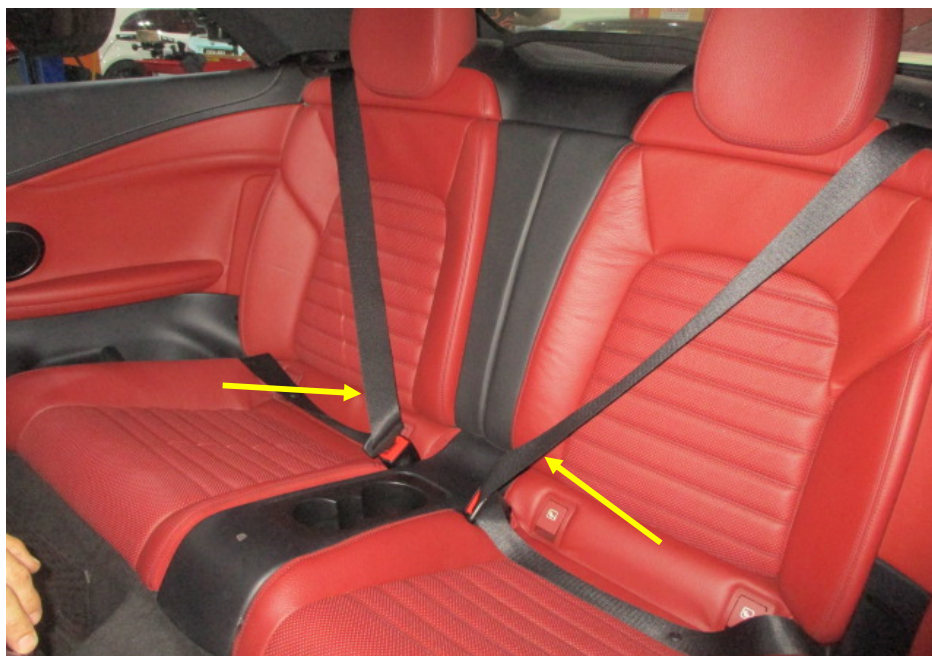
Photo 14 shows the rear seats of the Motor Car. All the seats of the Motor Car were secured via seat rails to the floorboard. They were also fitted with a retractable seat belt reel and a pre-tensioner. The seat belts (arrowed) were tested and were able to be fastened into the respective pre-tensions that were fitted on the side of each individual seat.

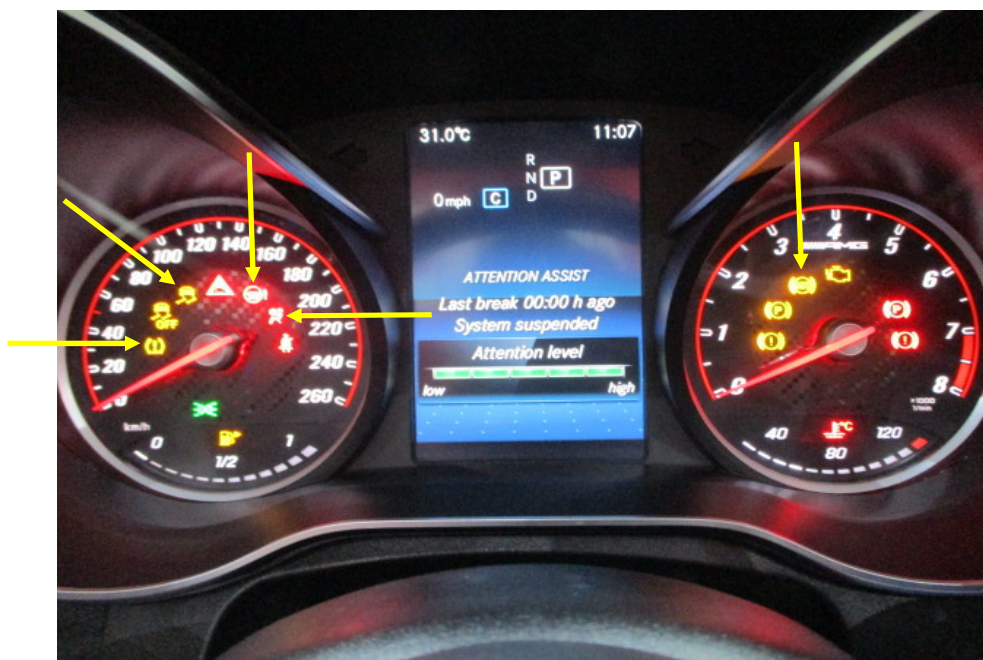
Photo 15 shows the warning lights for the various electronic safety features appearing on the instrument panel of the Motor Car during its self-test when the engine is cranked, in particular the ABS, SRS, EPS, TPM and TCS lights (arrowed).

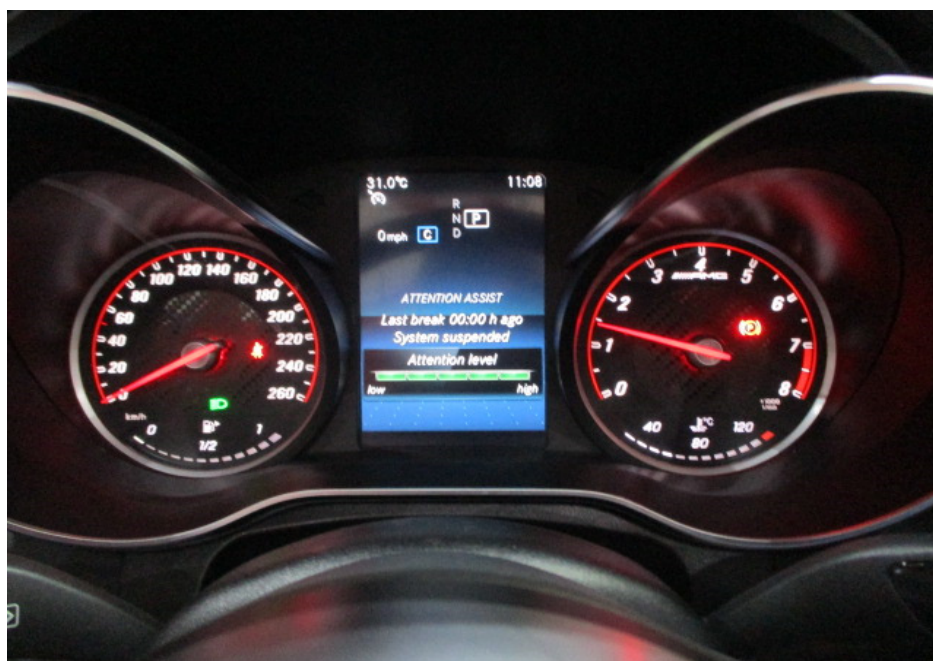
Photo 16 shows the respective warning lights no longer illuminated, indicating that there is no fault detected to the ABS, SRS, EPS, TPM and TCS systems of the Motor Car during the self-test. These electronic systems were hence in working condition at the time of my inspection.

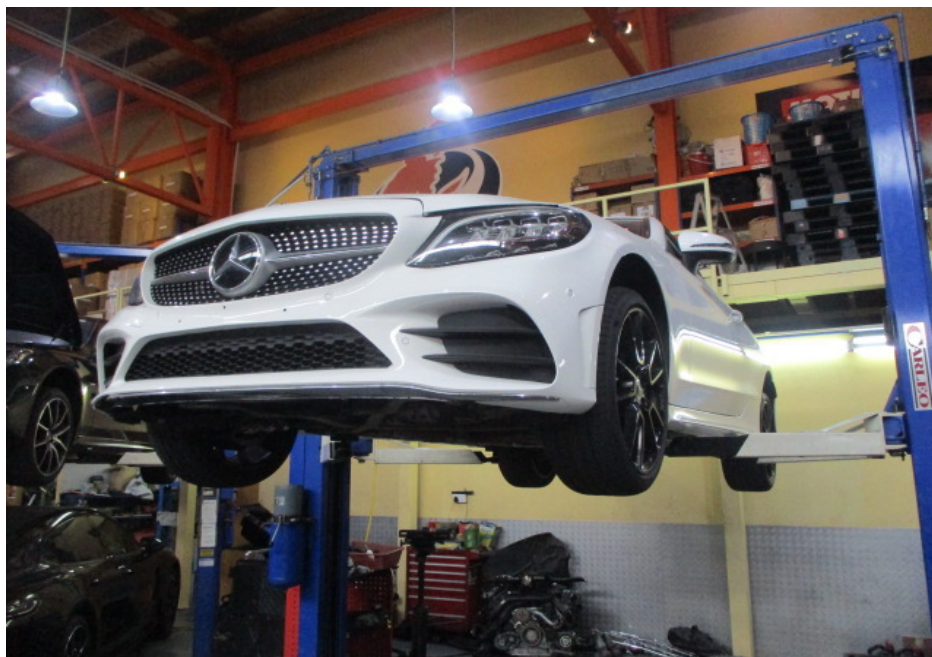
Photo 17 shows the Motor Car hoisted up for checks on its undercarriage. There was no sign(s) or indication(s) of fluid leakage and/or fluid stain(s) on the underside of the Motor Car. The undercarriage components of the Motor Car were also all observed to be intact and secured in an appropriate manner.

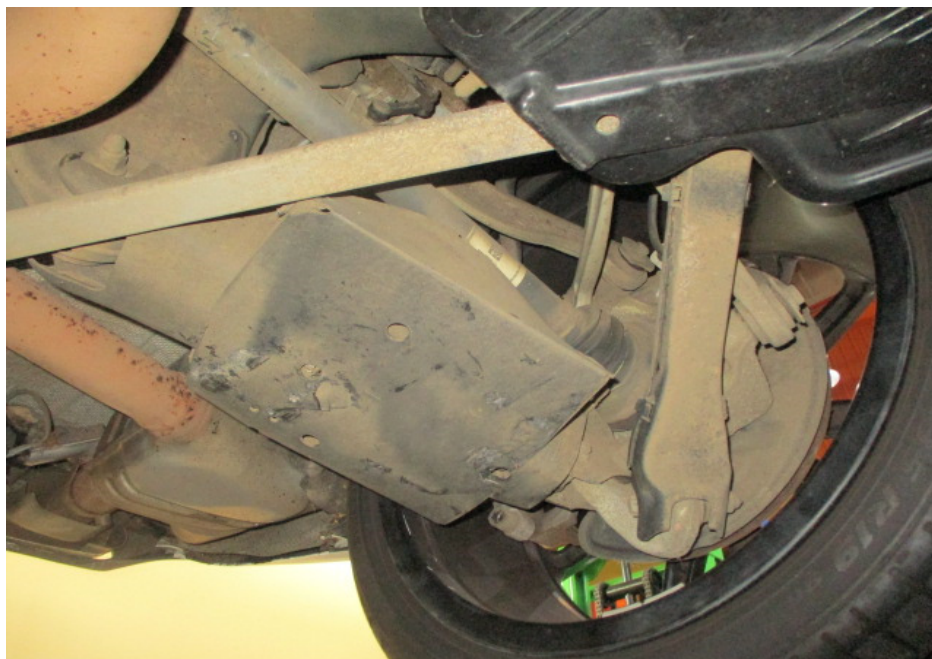
Photo 18 shows a general view of the control arms and linkages at the rear left wheel of the Motor Car. I did not observe any fluid leak and/or fluid stain on the underside of the Motor Car. All of the Motor Car's undercarriage components were observed to be intact and secured in an appropriate manner.

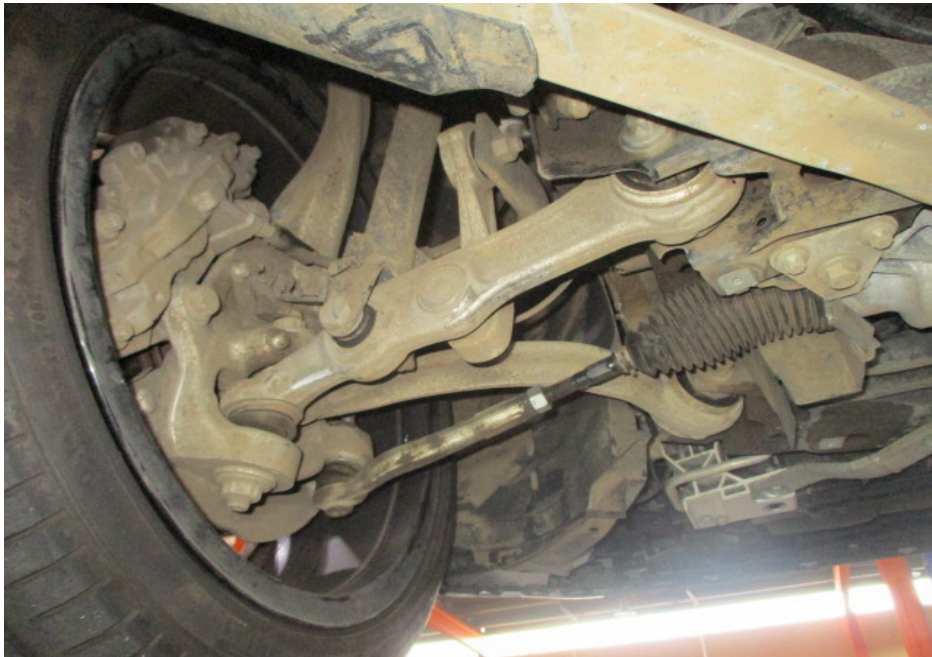
Photo 19 shows the various undercarriage components at the front left wheel of the Motor Car. The mechanical components, control arms and linkages were all found to be intact and secured in an appropriate manner.

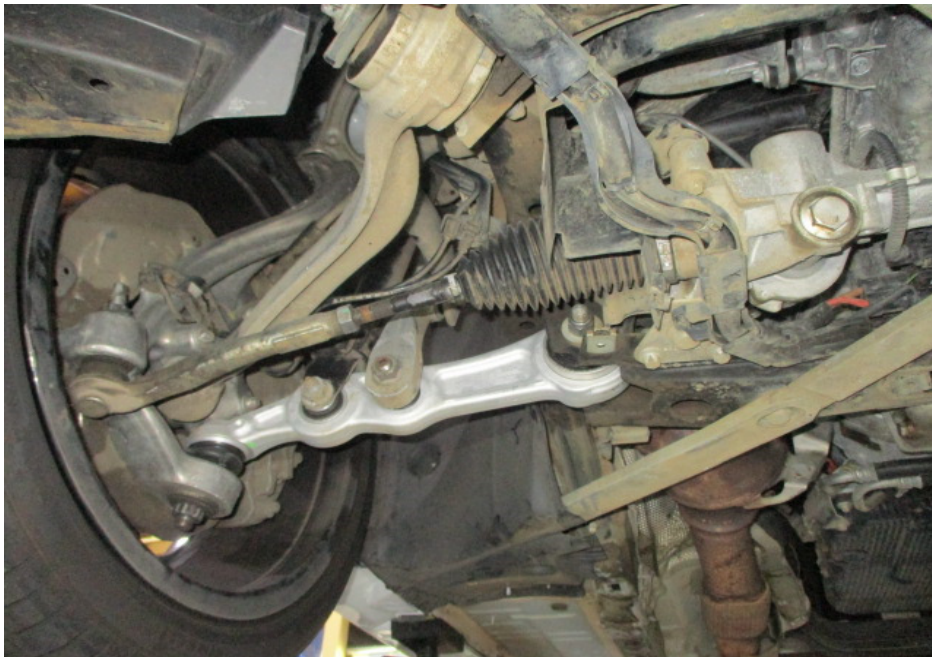
Photo 20 shows the various undercarriage components at the front right wheel of the Motor Car. The mechanical components, control arms and linkages were all found to be intact and secured in an appropriate manner. I also did not observe any fluid leak and/or fluid stain on the underside of the Motor Car.

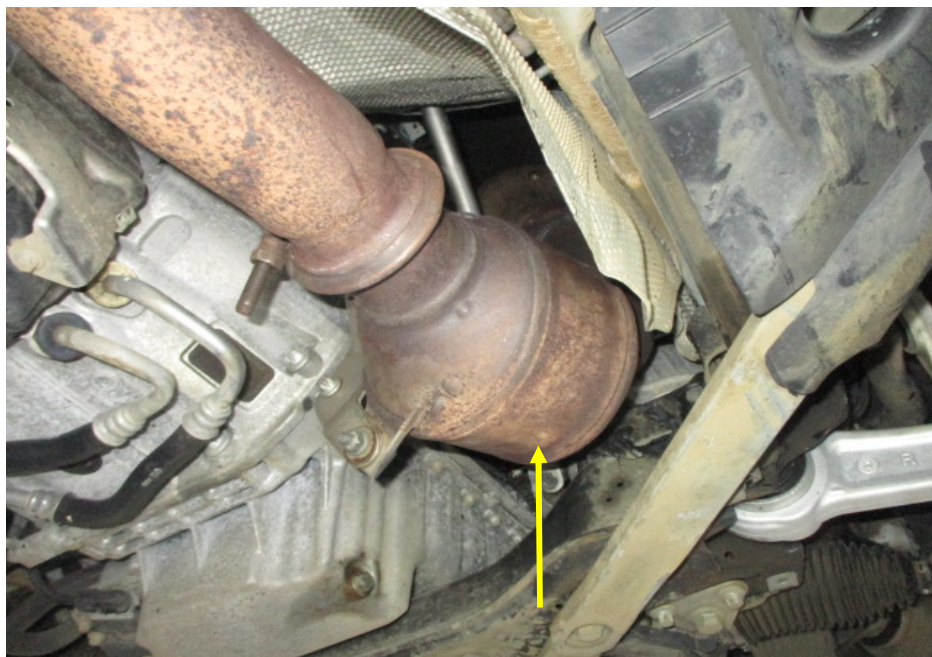
Photo 21 shows the Motor Car's catalytic converter (arrowed). My examination of the Motor Car's exhaust system revealed no sign(s) or indication(s) of any cut or weld marks along its exhaust pipes and on its rear mufflers.

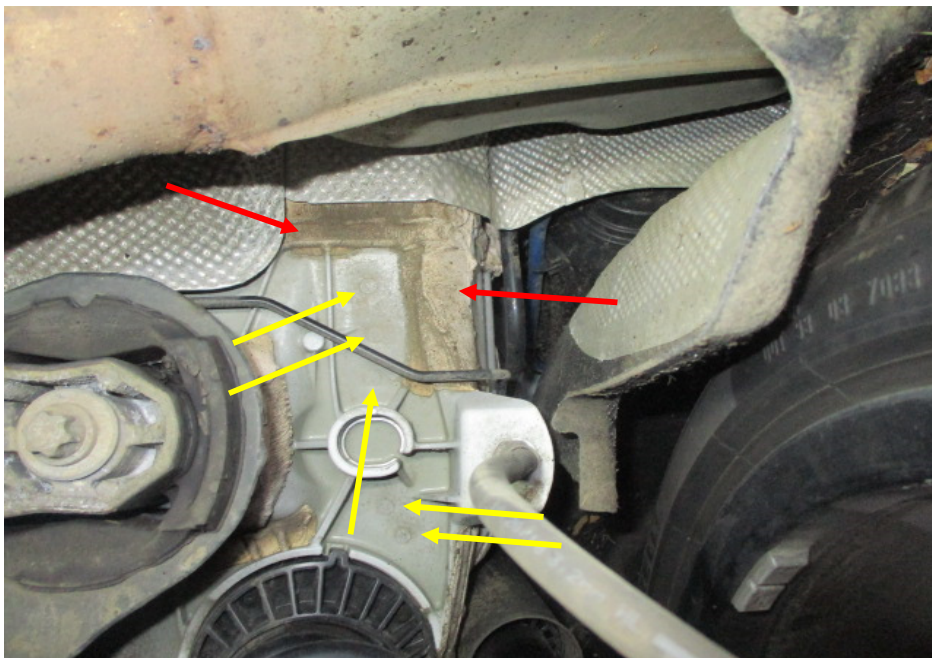
Photo 22 shows the chassis/structural body at the underside rear right of the Motor Car. I did not find any weld marks other than original spot weld marks (yellow arrow) on the chassis/structural body of the Motor Car. The original factory sealant (red arrow) at the joints along the chassis/structural body was untouched, indicating no work was done on the chassis/structural body of the Motor Car and that the chassis/structural body was originally fitted.

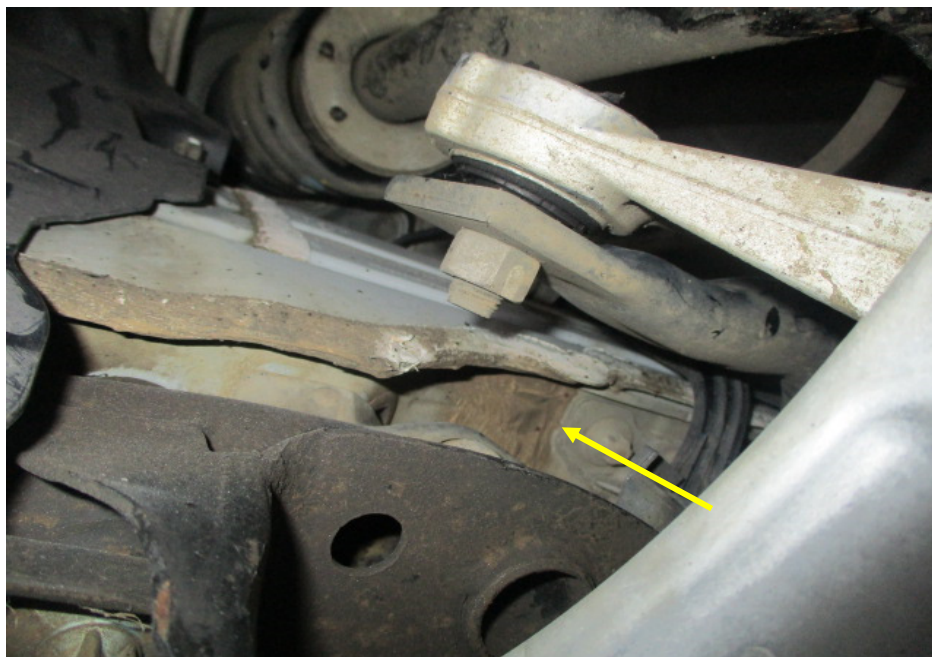
Photo 23 shows the chassis/structural body at the underside front right of the Motor Car. The original factory sealant (arrowed) at the joints along the chassis/structural body was observed to be untouched. In general, I had found no work was carried out on the chassis/structural body of the Motor Car. The chassis/structural body of the Motor Car was originally fitted.

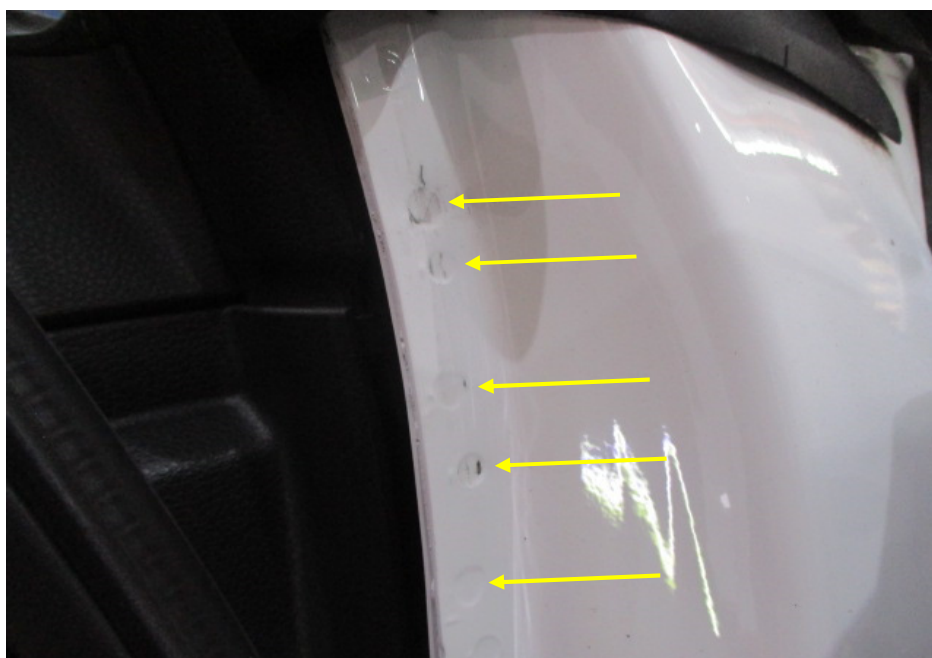
Photo 24 shows the right side "A" pillar of the Motor Car. I did not find any weld marks other than original spot weld marks (arrowed) on the right side "A" pillar of the Motor Car which, indicates that there was no re-welding works carried out. In general, I had found all the non-detachable body panels of the Motor Car to be originally fitted at the time of my inspection.

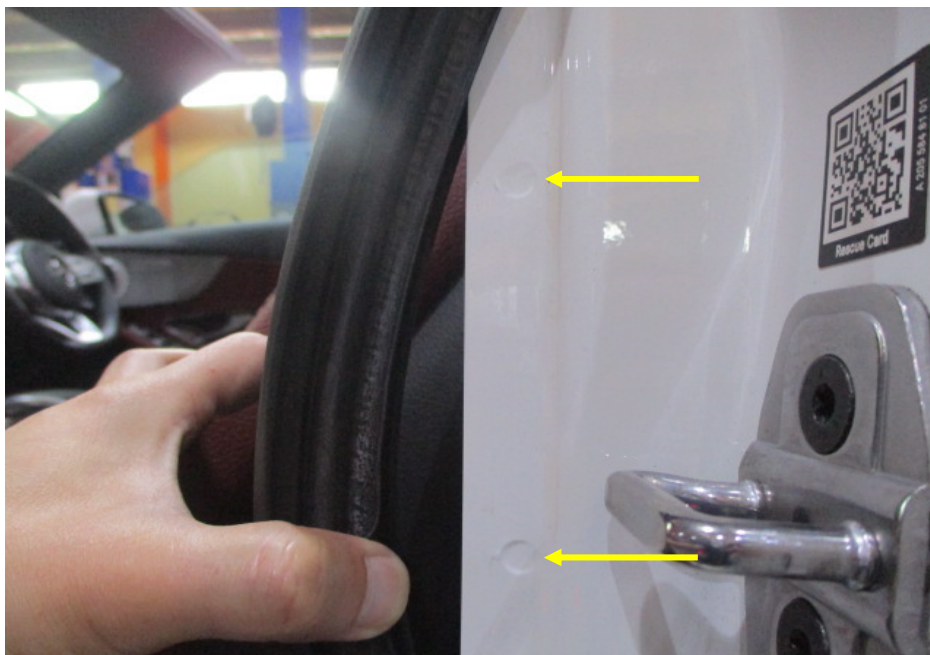
Photo 25 shows the left rear body panel of the Motor Car. I did not find any weld marks other than original spot weld marks (arrowed) on the left rear body panel of the Motor Car which, indicates that there was no re-welding works carried out. In general, I had found all the non-detachable body panels of the Motor Car to be originally fitted at the time of my inspection.
