Our Reference : KAAS/TA/6142/1686/TP/12.20
Date : 14 January 2021

VEHICLE APPRAISAL REPORT

Registration No.	: SME 1686J	Chassis Frame No.	: GB7-1070657
Make / Model	: Honda Freed Hybrid 1.5G (A)	Engine No. (Logcard)	: LEB5604773
Year of Manufacture/Reg	: 2018	Odometer Reading	: 183,803 KM
Colour	: Grey		
Class / Type	: MPV

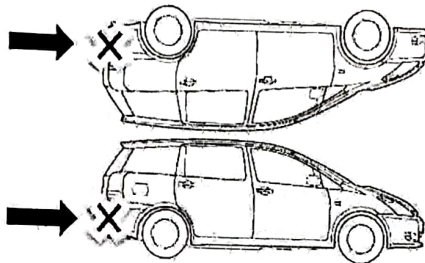
Damages sustained were consistent with the subject vehicle being involved in a collision with another vehicle and the impact was delivered

Squarely to the Rear

portion of the vehicle.

The general area of damages is at the

Rear portion
