Your Ref: BMW 320d  
(chassis number WBA5V72000AE83626)  
Our Ref : CI/TP21002306/D

17 February 2021

**INSPECTION REPORT OF AN UNREGISTERD BMW 320d MOTOR CAR  
WITH CHASSIS NUMBER WBA5V72000AE83626**

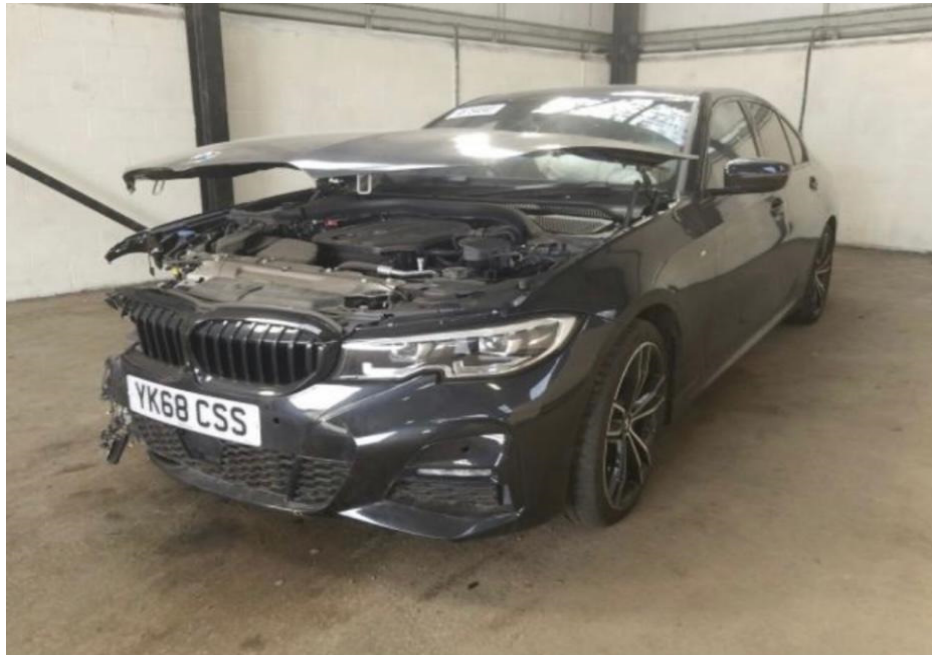
**Photo 1** shows the front left body of the Motor Car (photograph provided to me). The Motor Car was observed to have sustained damage at its front right portion. The front bumper, front bonnet and bonnet hinges were amongst the body parts that were observed to have been damaged.

22. The body parts at the front right portion of the Motor Car were visually examined and it was noted that the repair/restoration works carried out to the damaged area of the Motor Car (refer to photograph 1 & 2 above) were reasonably adequate and in order.

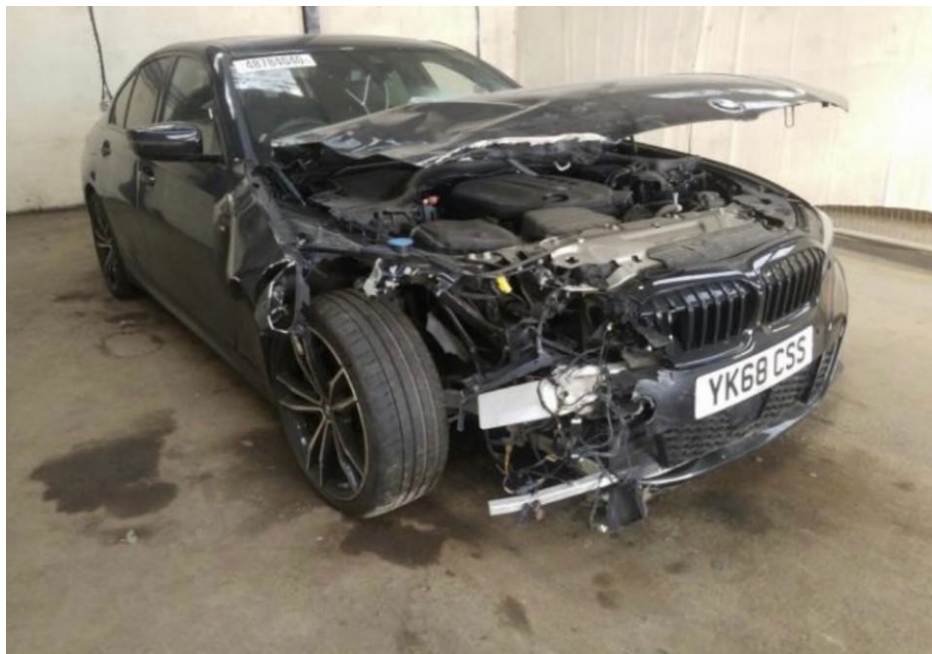
**Photo 2** shows the front right body of the Motor Car (photograph provided to me). The Motor Car was observed to have sustained damage at its front right portion. The front bumper, front bumper right lower grille, front bumper reinforcement, front grilles, front right headlamp, front right headlamp top panel, front bonnet, front bonnet hinges, front support panel, air ducts and front right fender were amongst the body parts that were observed to have been damaged.

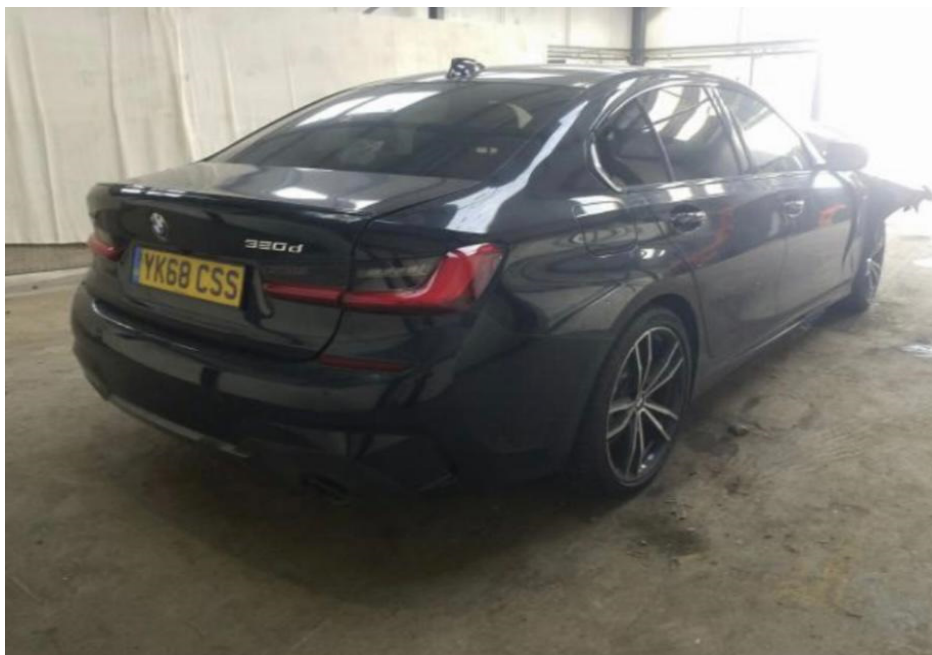
**Photo 3** shows the rear right body of the Motor Car (photograph provided to me). Apart for the front right portion, there was no physical damage seen to other areas of the Motor Car.

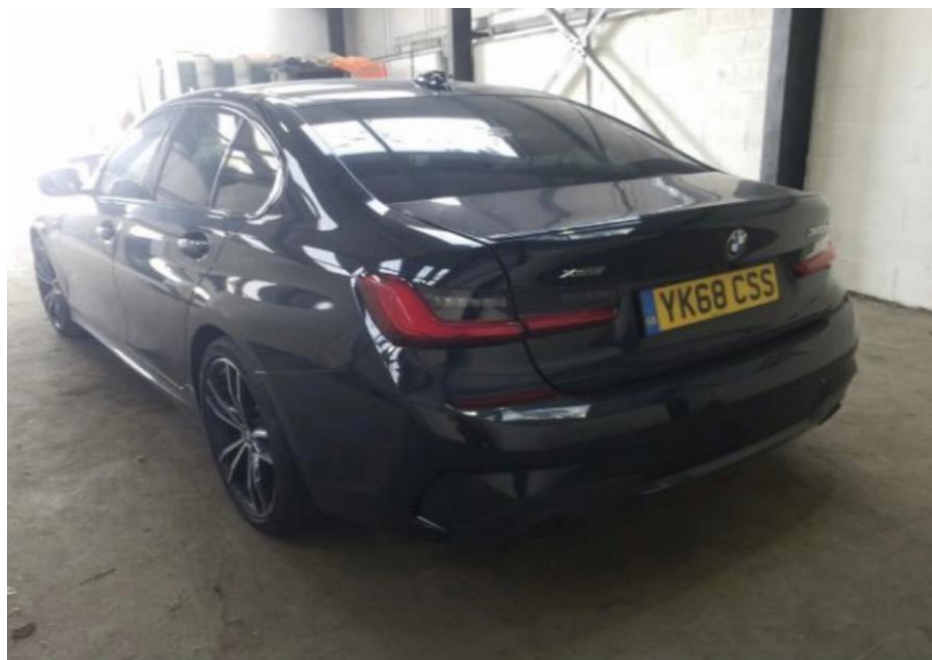
**Photo 4** shows the rear left body of the Motor Car (photograph provided to me). Apart for the front right portion, there was no physical damage seen to other areas of the Motor Car. The airbags of the Motor Car were also not activated as seen from the photographs that were provided to me.

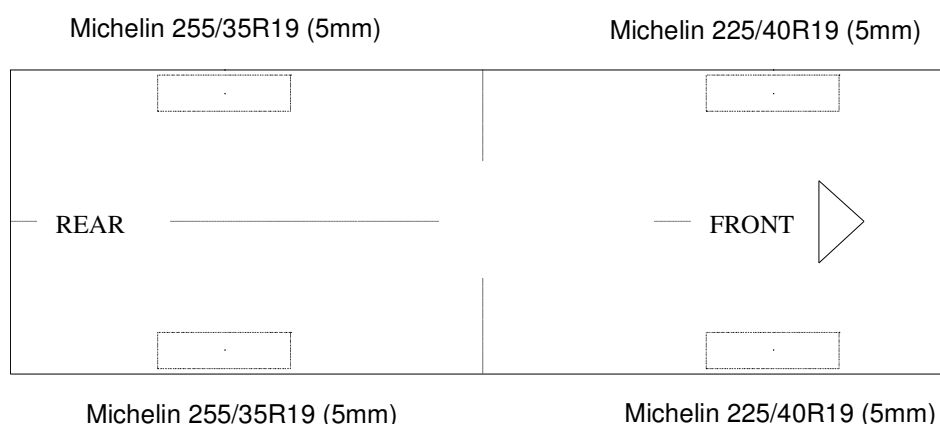
8. It was fitted with 19inch sport wheel rims that were wrapped with tyres that were observed to be of serviceable condition. The tyres were also sufficiently inflated for vehicular operation. The tyre brand, tyre size and approximate remaining tread depth of the 4 tyres of the Motor Car were recorded as follows: -

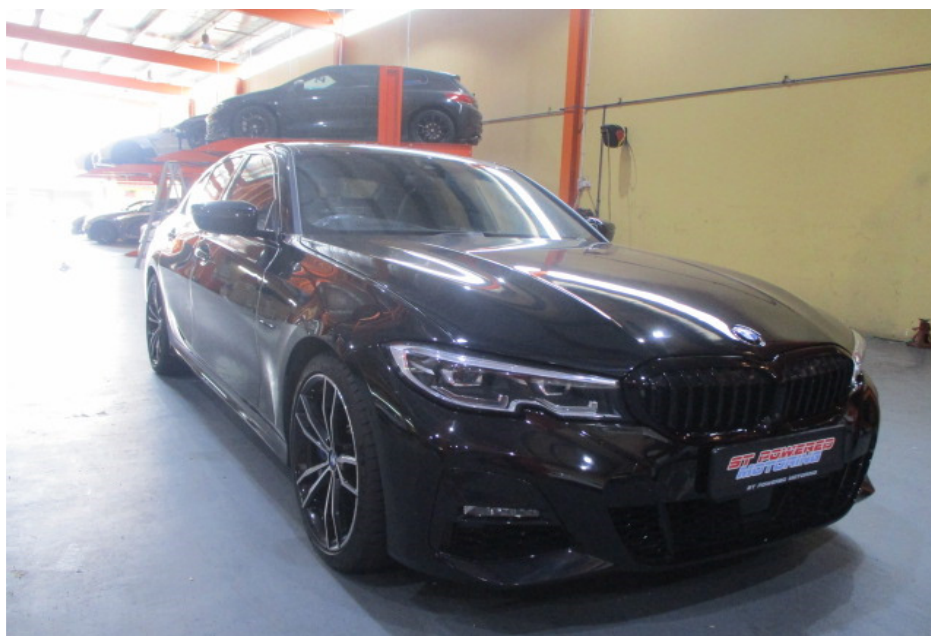
**Photo 5** shows a general view of the front right body of the Motor Car at the time of my inspection. The Motor Car was observed to be in a relatively good general condition with no loose exterior fittings observed. The body parts at the front right portion of the Motor Car were visually examined and it was observed that the repair/restoration works carried out to the damaged area of the Motor Car (refer to photograph 1 & 2 above) were reasonably adequate and in order.

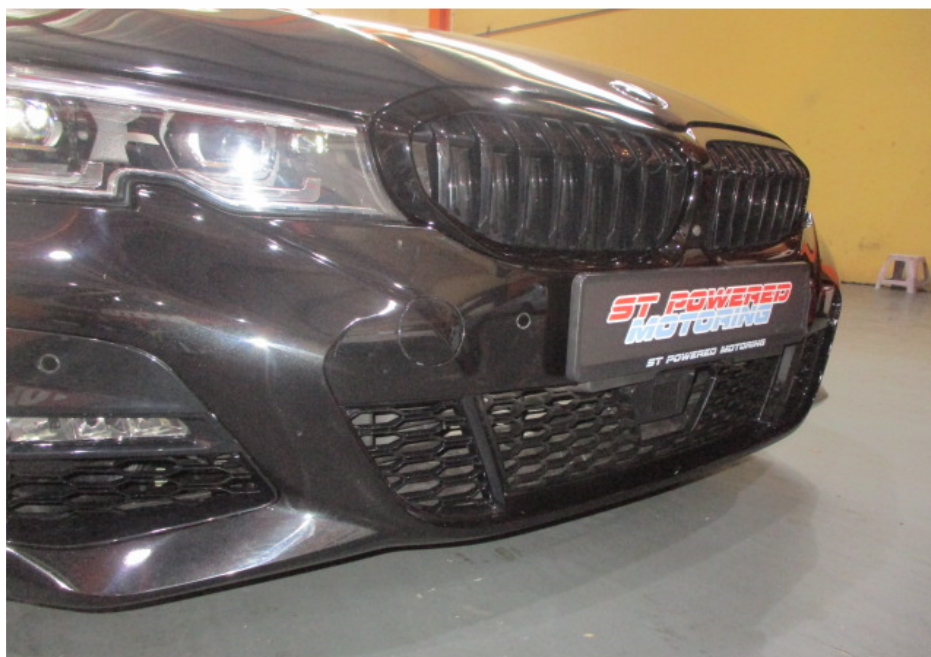
**Photo 6** shows a closer view of the front bumper, front bumper right lower grille, front grilles and front right headlamp of the Motor Car at the time of my inspection. The body parts at the front right portion of the Motor Car were visually examined and it was observed that the repair/restoration works carried out to the damaged area of the Motor Car (refer to photograph 1 & 2 above) were reasonably adequate and in order.

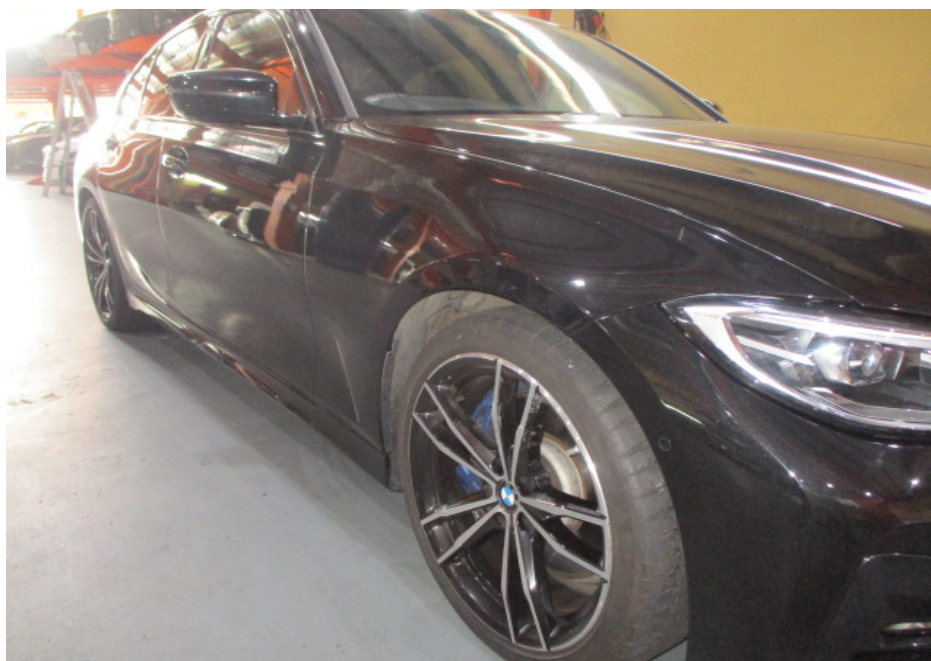
**Photo 7** shows a closer view of the front bumper, front right headlamp and front bonnet of the Motor Car at the time of my inspection. The body parts at the front right portion of the Motor Car were visually examined and it was observed that the repair/restoration works carried out to the damaged area of the Motor Car (refer to photograph 1 & 2 above) were reasonably adequate and in order.

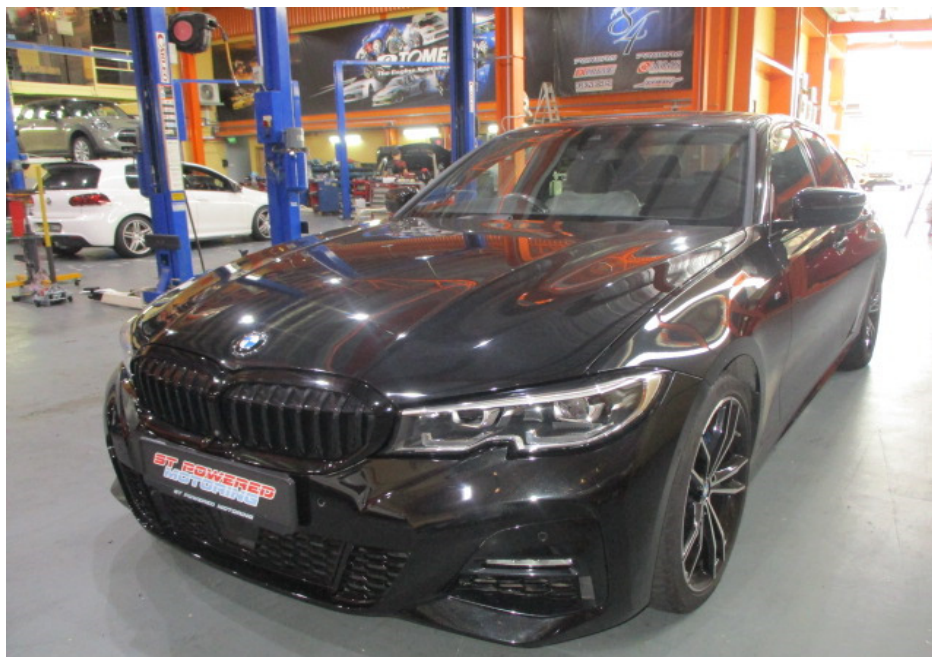
**Photo 8** shows a general view of the front left body of the Motor Car at the time of my inspection. The Motor Car was observed to be in a relatively good general condition with no loose exterior fittings observed. The body parts at the front right portion of the Motor Car were visually examined and it was observed that the repair/restoration works carried out to the damaged area of the Motor Car (refer to photograph 1 & 2 above) were reasonably adequate and in order.

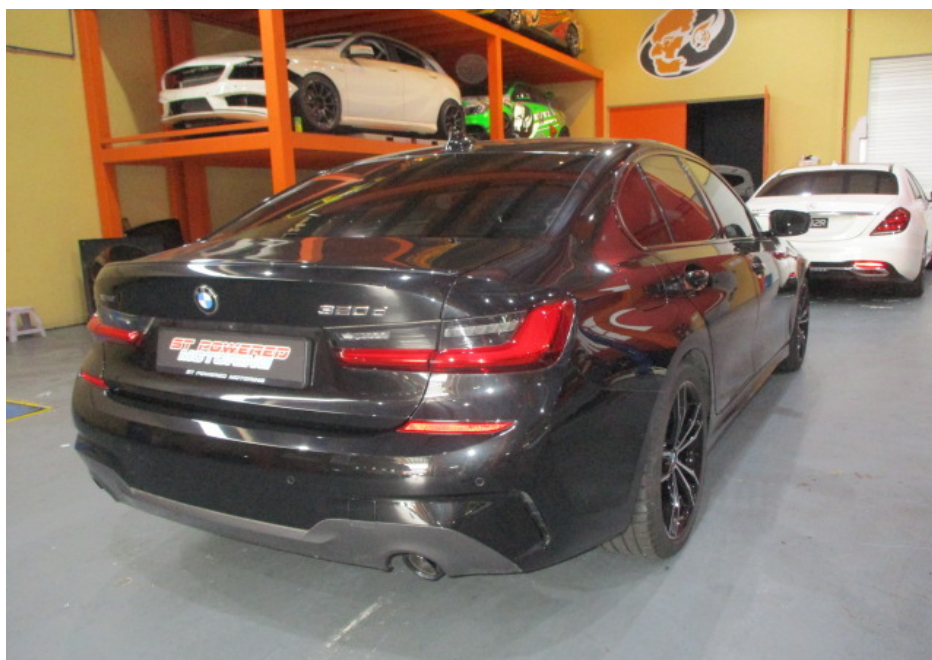
**Photo 9** shows a general view of the rear right body of the Motor Car at the time of my inspection. The Motor Car was observed to be in a relatively good general condition with no loose exterior fittings observed. The mileage of the Motor Car recorded at the time of my inspection was 8,605km.

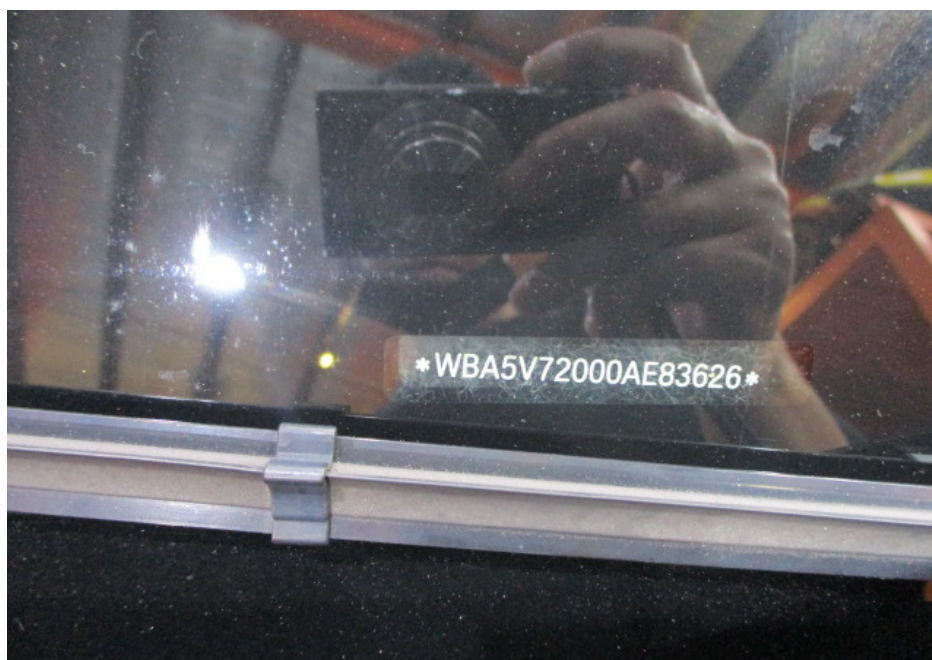
**Photo 10** shows the chassis number of the Motor Car. The chassis number recorded was WBA5V72000AE83626.

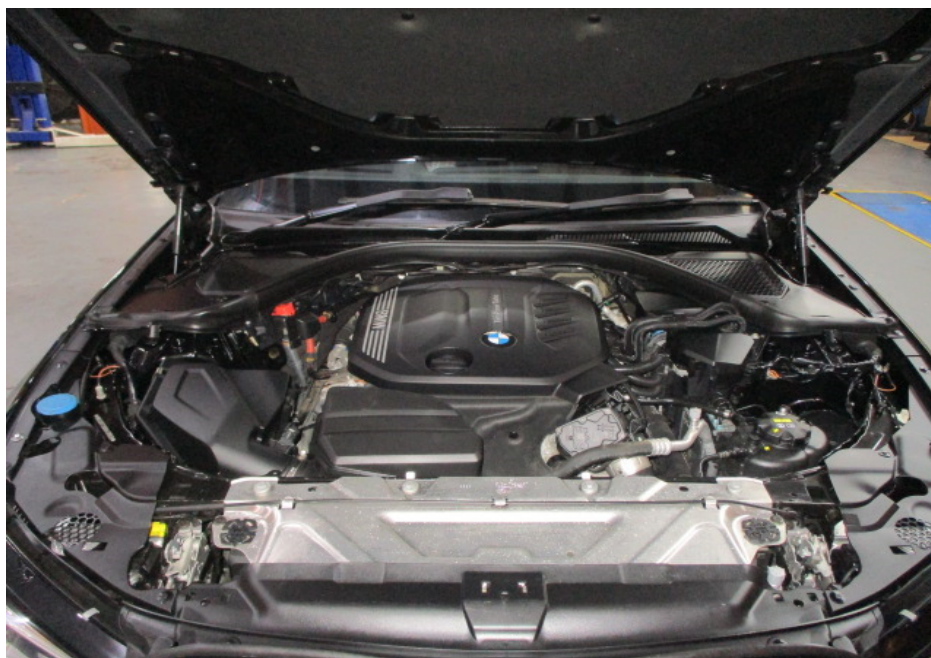
**Photo 11** shows a general view of the engine compartment of the Motor Car at the time of my inspection. The various parts and components inside the engine compartment were all observed to be intact and properly fitted. There was also no sign(s) or indication(s) of fluid leak and/or fluid stain found within the engine compartment.

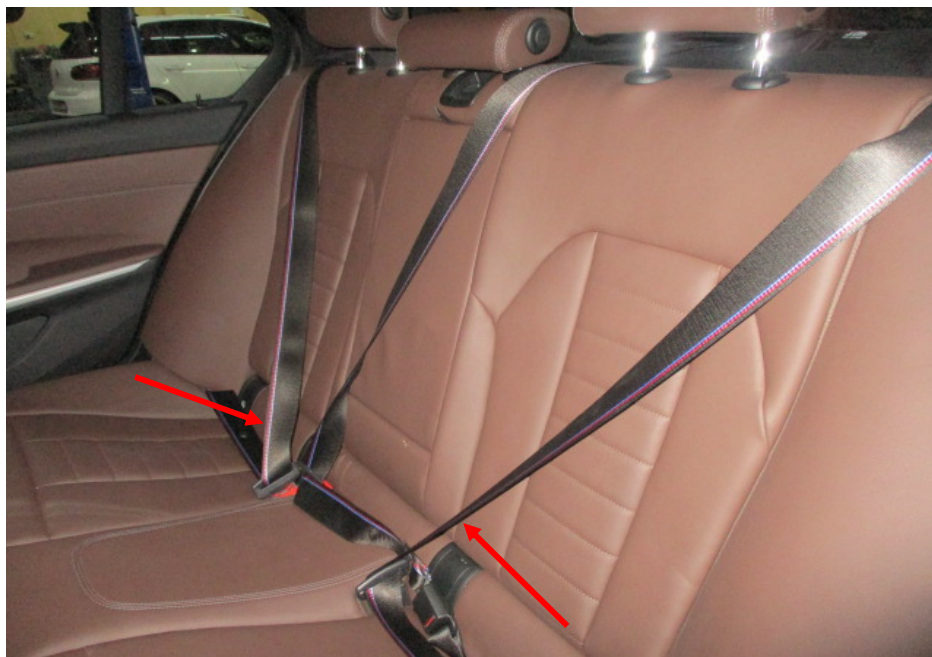
**Photo 12** shows the rear seats of the Motor Car. All the seats of the Motor Car were secured via seat rails to the floorboard. They were also fitted with a retractable seat belt reel and a pre-tensioner. The seat belts (arrowed) were tested and were able to be fastened into the respective pre-tensions that were fitted on the side of each individual seat.

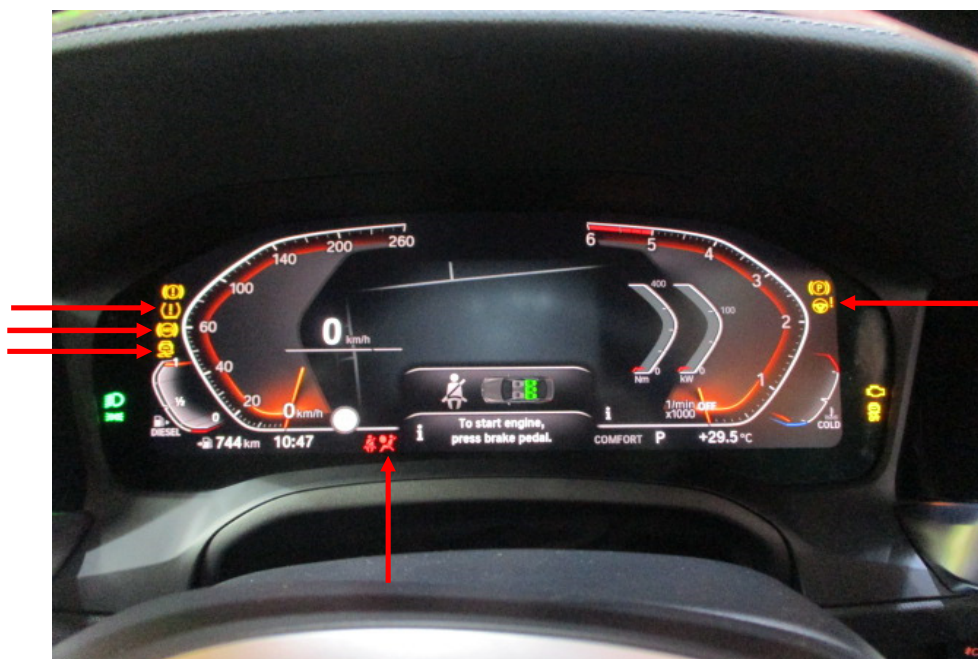
**Photo 13** shows the warning lights for the various electronic safety features appearing on the instrument panel of the Motor Car during its self-test when the engine is cranked, in particular the ABS, SRS, IAS, TPM and DSC lights (arrowed).

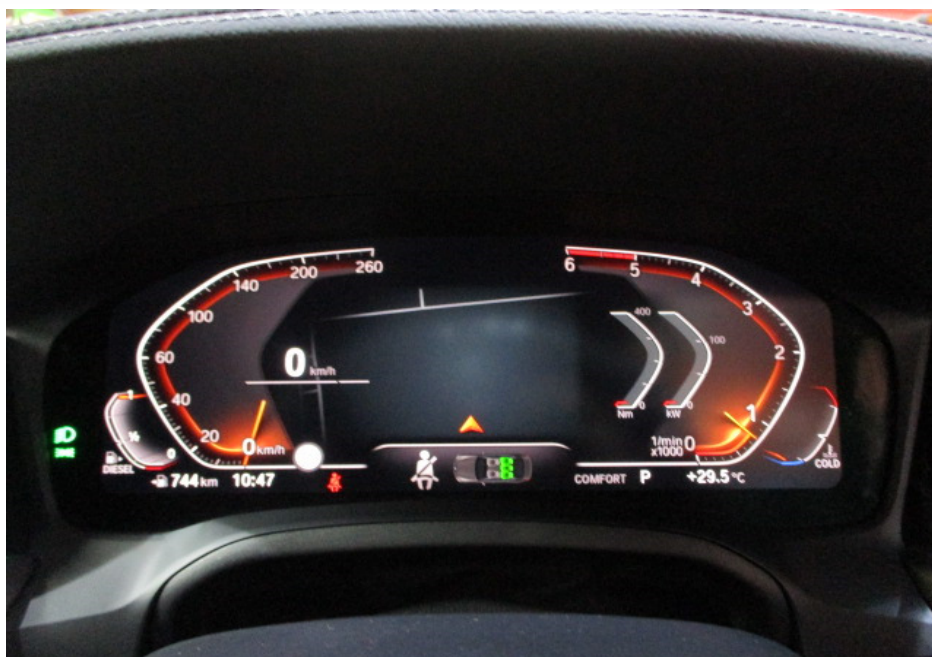
**Photo 14** shows the respective warning lights no longer illuminated, indicating that there is no fault detected to the ABS, SRS, IAS, TPM and DSC systems of the Motor Car during the self-test. These electronic systems were hence in working condition at the time of my inspection.

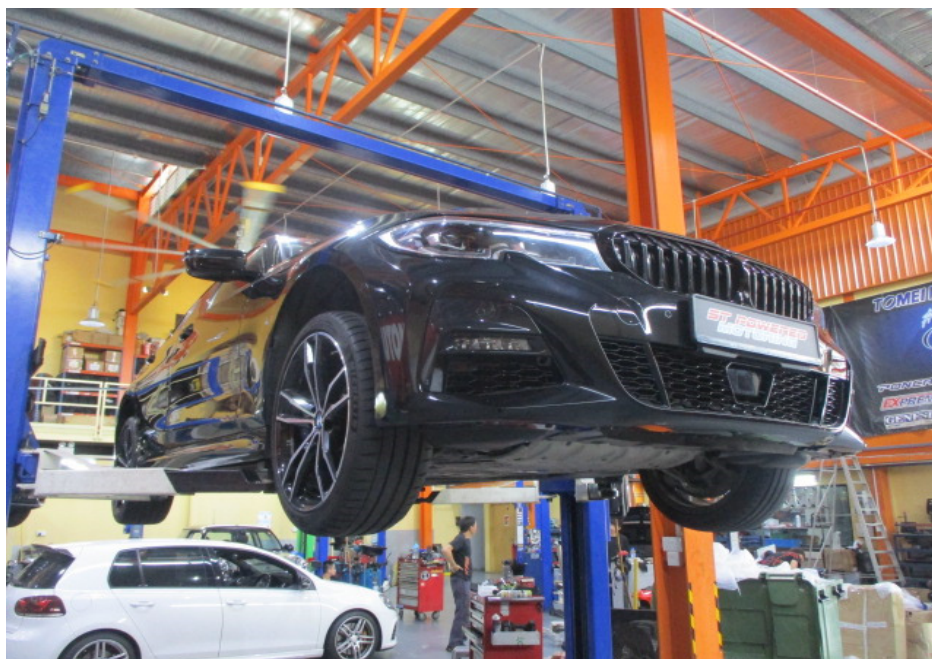
**Photo 15** shows the Motor Car hoisted up for checks on its undercarriage. There was no sign(s) or indication(s) of fluid leakage and/or fluid stain(s) on the underside of the Motor Car. The undercarriage components of the Motor Car were also all observed to be intact and secured in an appropriate manner.

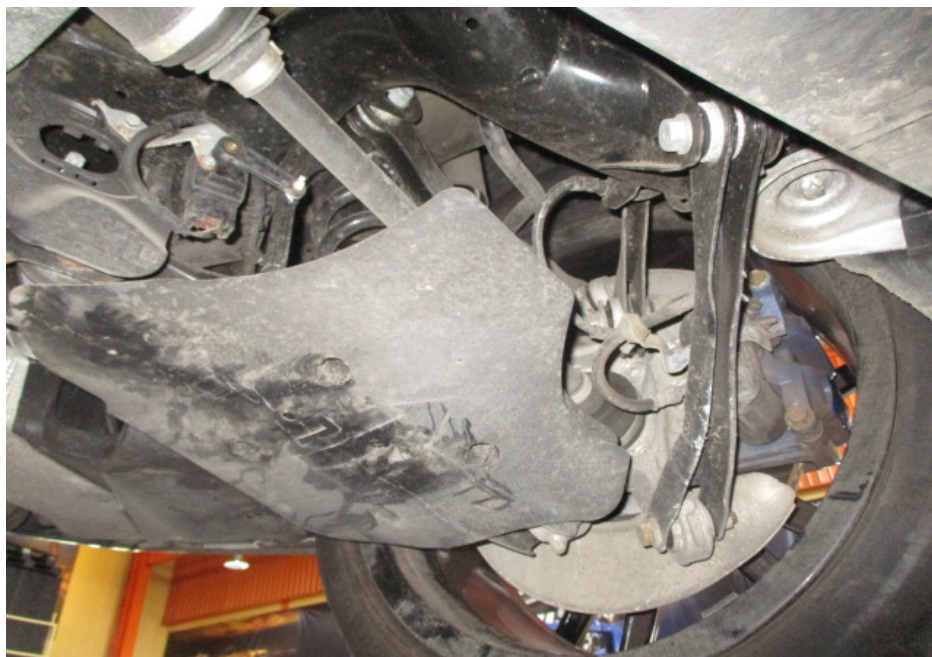
**Photo 16** shows a general view of the control arms and linkages at the rear left wheel of the Motor Car. I did not observe any fluid leak and/or fluid stain on the underside of the Motor Car. All of the Motor Car's undercarriage components were observed to be intact and secured in an appropriate manner.

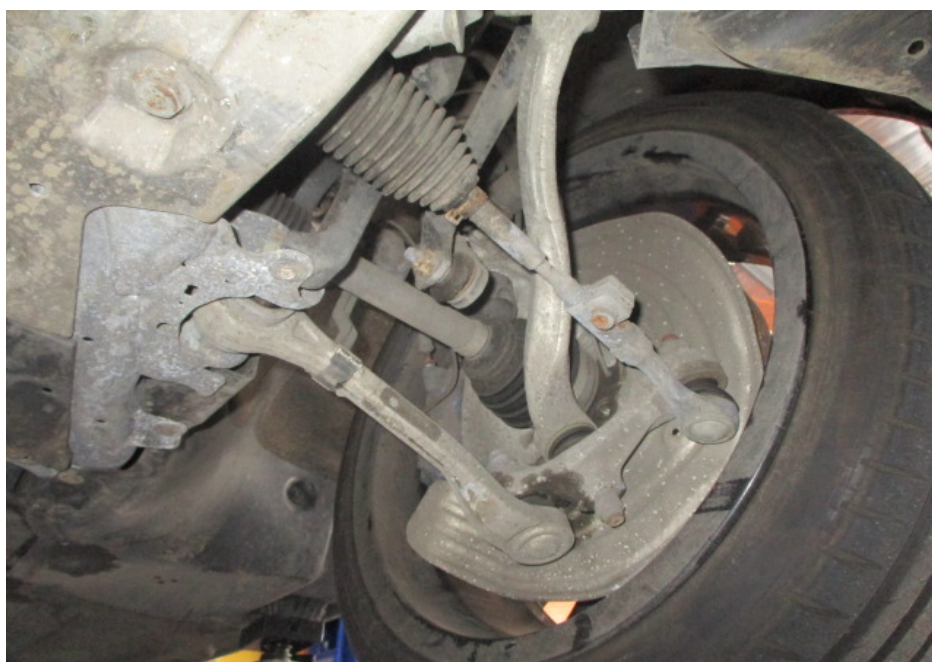
**Photo 17** shows the various undercarriage components at the front left wheel of the Motor Car. The mechanical components, control arms and linkages were all found to be intact and secured in an appropriate manner.

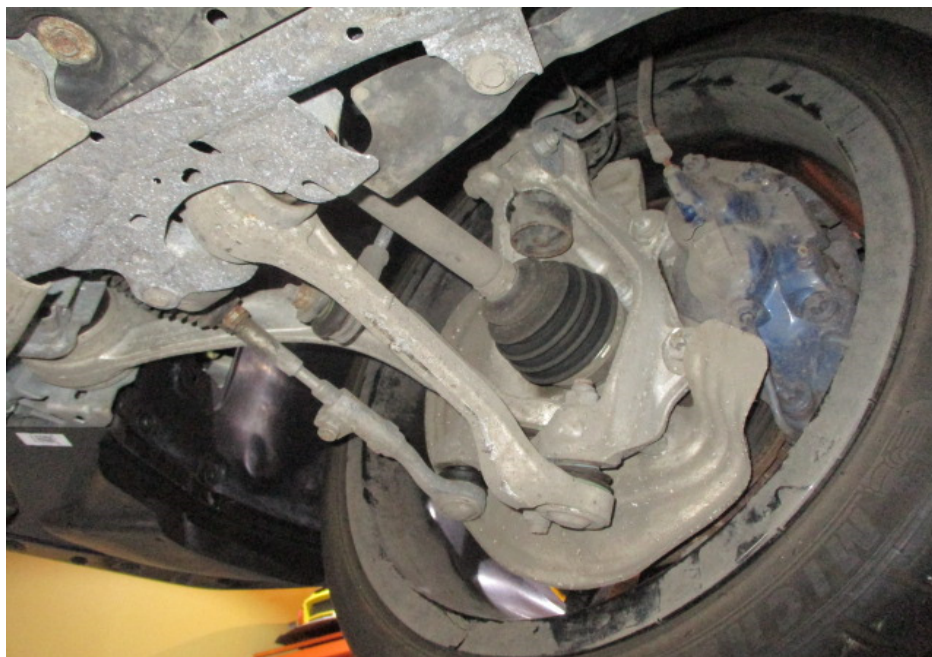
**Photo 18** shows the various undercarriage components at the front right wheel of the Motor Car. The mechanical components, control arms and linkages were all found to be intact and secured in an appropriate manner. I also did not observe any fluid leak and/or fluid stain on the underside of the Motor Car.

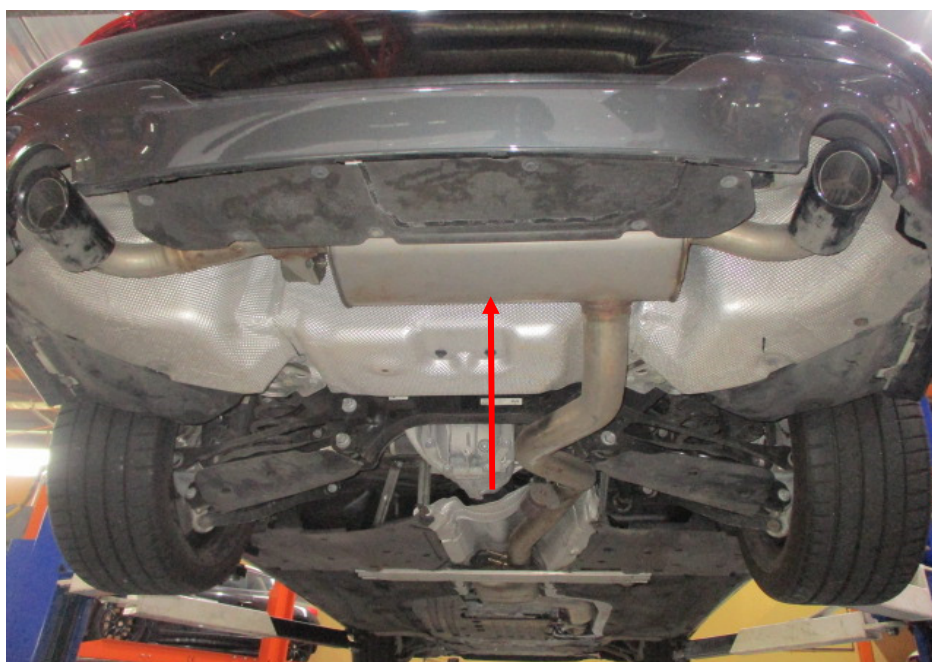
**Photo 19** shows the Motor Car's rear muffler (arrowed). My examination of the Motor Car's exhaust system revealed no sign(s) or indication(s) of any cut or weld marks along its exhaust pipes and on its catalytic converter.

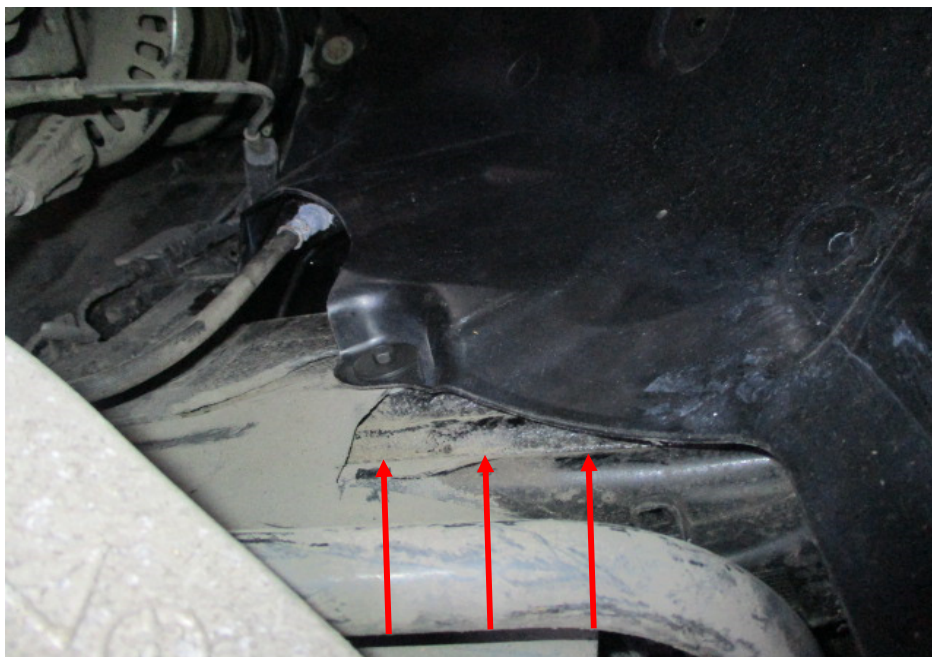
**Photo 20** shows the chassis/structural body at the underside front right of the Motor Car. I did not find any weld marks other than original spot weld marks on the chassis/structural body of the Motor Car. The original factory sealant (arrowed) at the joints along the chassis/structural body was untouched, indicating no work was done on the chassis/structural body of the Motor Car and that the chassis/structural body was originally fitted.

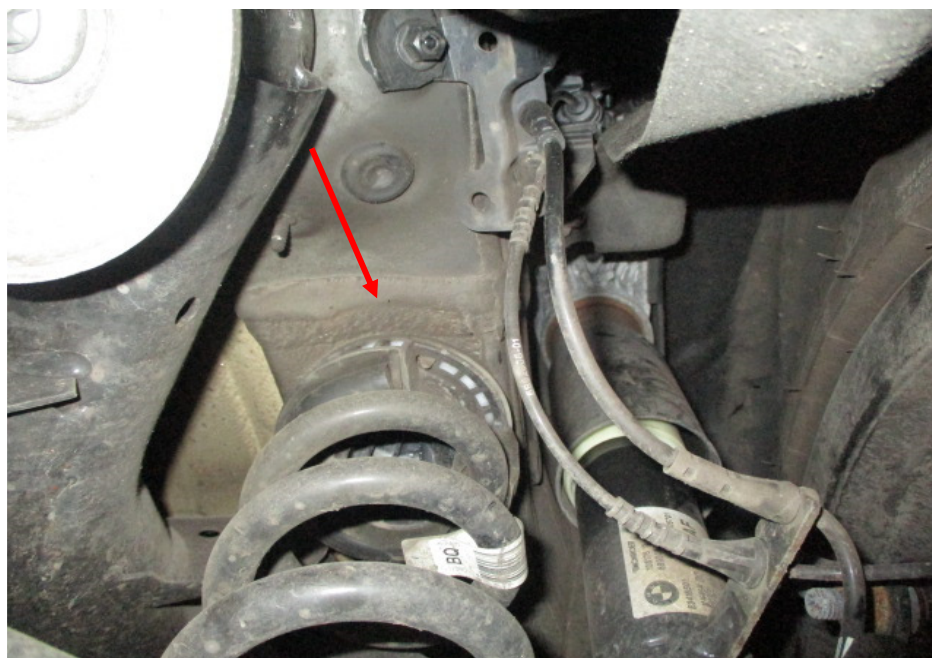
**Photo 21** shows the chassis/structural body at the underside rear right of the Motor Car. The original factory sealant (arrowed) at the joints along the chassis/structural body was observed to be untouched. In general, I had found no work was carried out on the chassis/structural body of the Motor Car. The chassis/structural body of the Motor Car was originally fitted.

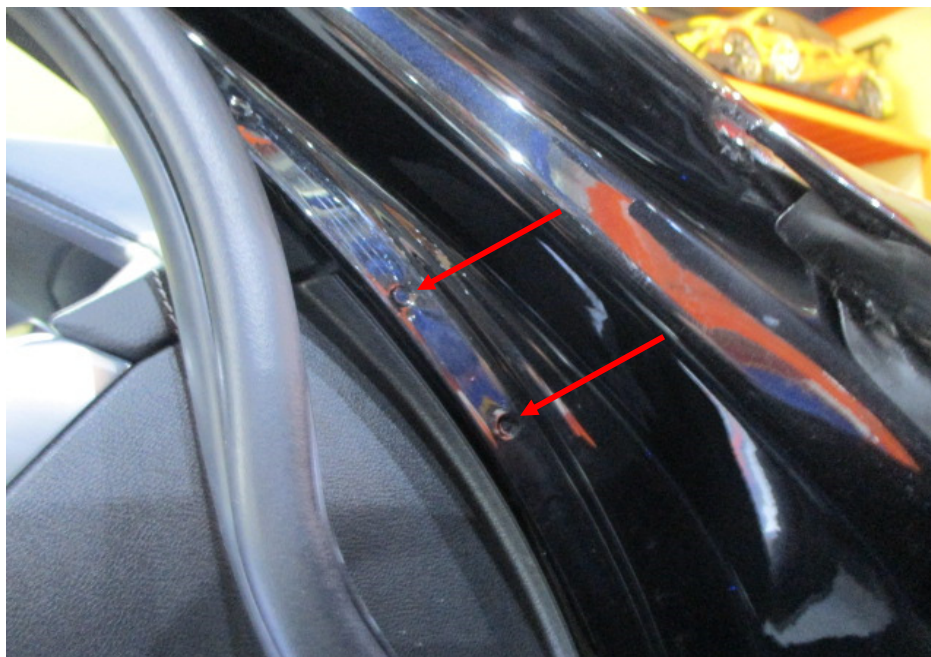
**Photo 22** shows the right side "A" pillar of the Motor Car. I did not find any weld marks other than original spot weld marks (arrowed) on the right side "A" pillar of the Motor Car which, indicates that there was no re-welding works carried out. In general, I had found all the non-detachable body panels of the Motor Car to be originally fitted at the time of my inspection.
