Your Ref: Audi A5 Cabriolet
(chassis number WAUZZZF58KN003283)
Our Ref : CI/TP21002308/D

09 April 2021

INSPECTION REPORT OF AN UNREGISTERD AUDI A5 CABRIOLET MOTOR CAR WITH CHASSIS NUMBER WAUZZZF58KN003283

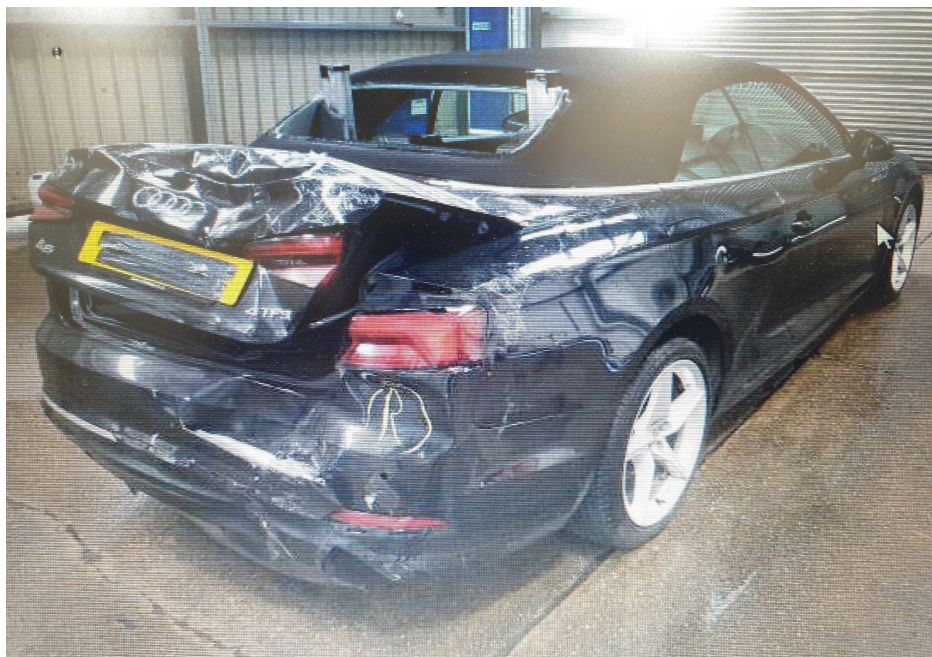
3. From the photographs provided to me, it was observed that the Motor Car had sustained damages at its rear portion. Body parts damaged include the rear bumper, rear bumper lower cover, rear bumper reinforcement, rear taillamps, rear bootlid, rear bootlid lamps, rear left body panel, rear right body panel, rear right exhaust and rear windshield amongst others.
4. No physical damage was observed to other areas of the Motor Car. The airbags of the Motor Car were also not activated as seen from the photographs that were provided to me. See photo 1 – 4 below.

Photo 1 shows the rear right body of the Motor Car (photograph provided to me). The Motor Car was observed to have sustained damage at its rear portion. The rear bumper, rear bumper lower cover, rear bumper reinforcement, rear right taillamp, rear bootlid, rear right bootlid lamp and rear right exhaust were amongst the body parts that were observed to have been damaged.

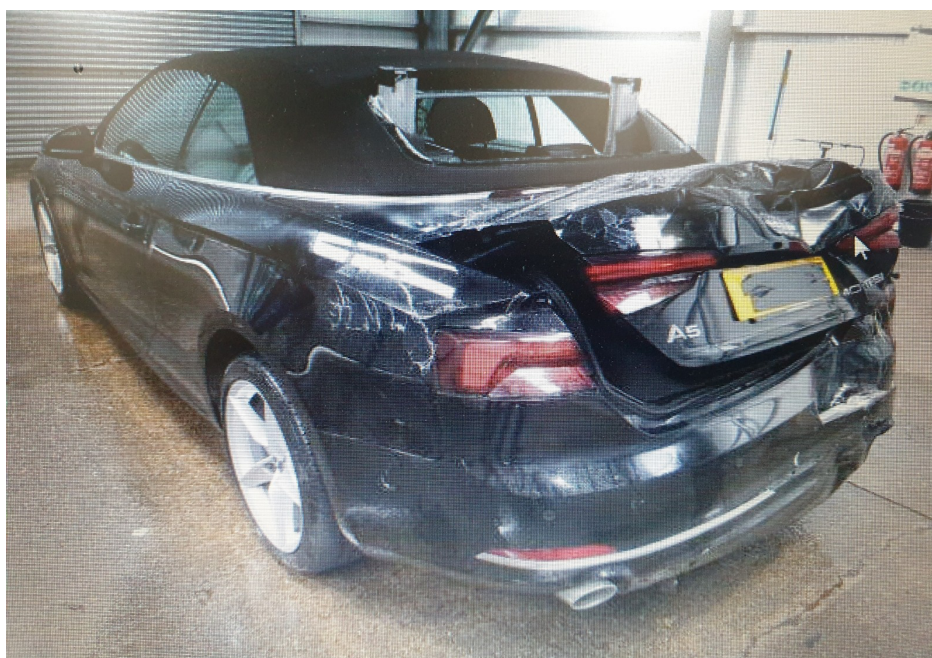
Photo 2 shows the rear left body of the Motor Car (photograph provided to me). The Motor Car was observed to have sustained damage at its rear portion. The rear bumper, rear bumper lower cover, rear left body panel, rear left taillamp, rear bootlid, rear left bootlid lamp and rear windshield were amongst the body parts that were observed to have been damaged.

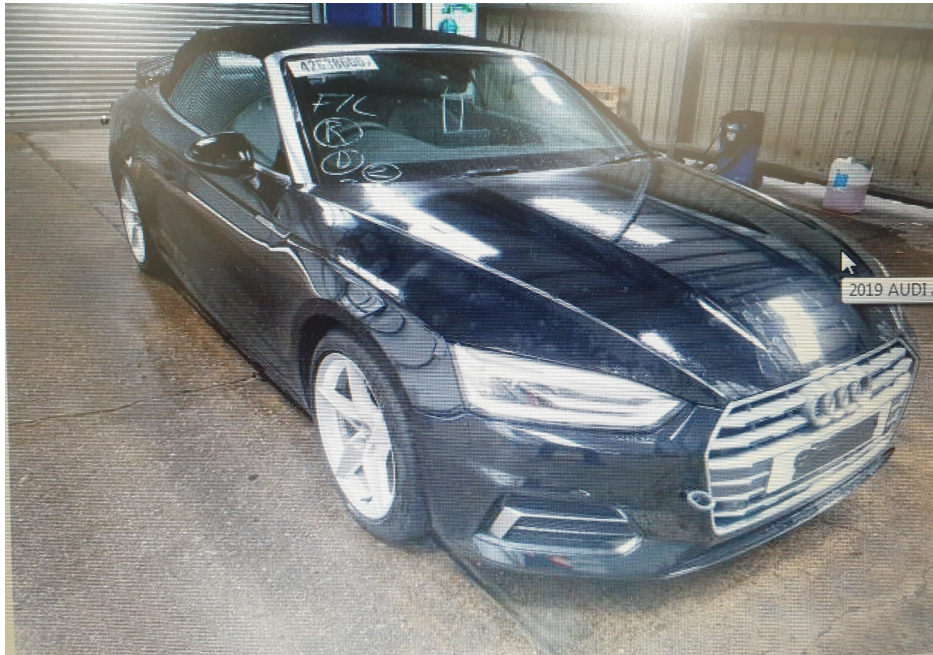
Photo 3 shows the front right body of the Motor Car (photograph provided to me). Apart for the rear portion, there was no physical damage seen to other areas of the Motor Car.

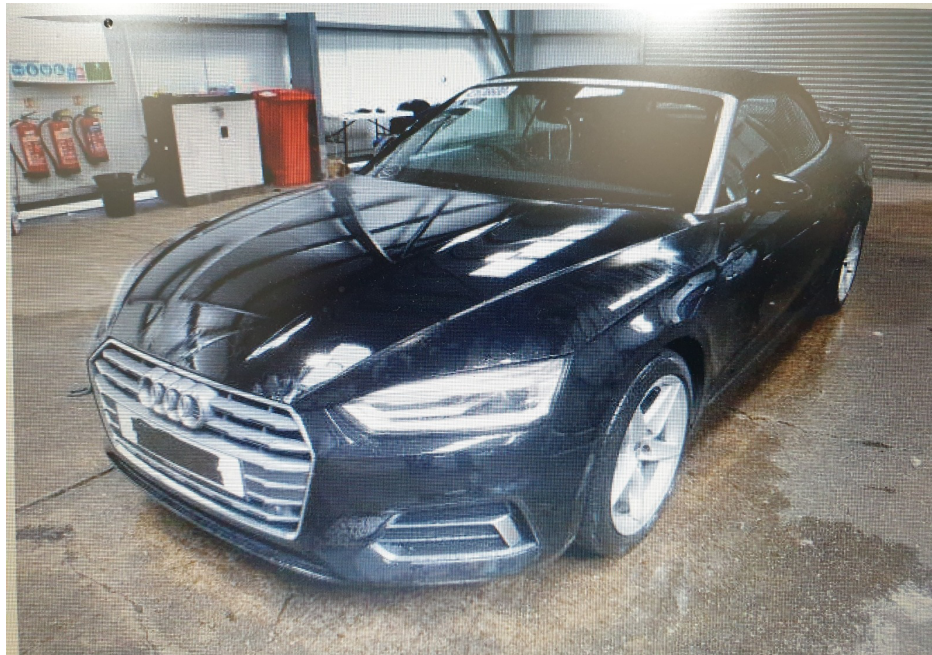
Photo 4 shows the front left body of the Motor Car (photograph provided to me). Apart for the rear portion, there was no physical damage seen to other areas of the Motor Car. The airbags of the Motor Car were also not activated as seen from the photographs that were provided to me.

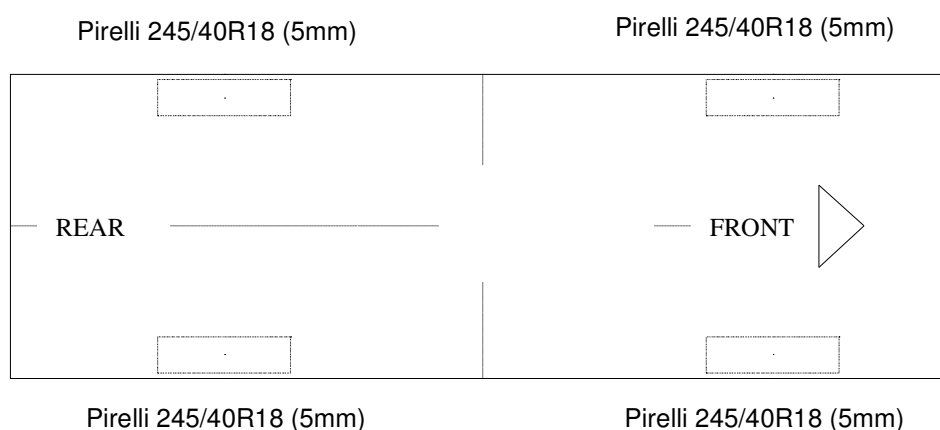
9. It was fitted with 18inch sport wheel rims that were wrapped with tyres that were observed to be of serviceable condition. The tyres were also sufficiently inflated for vehicular operation. The tyre brand, tyre size and approximate remaining tread depth of the 4 tyres of the Motor Car were recorded as follows: -

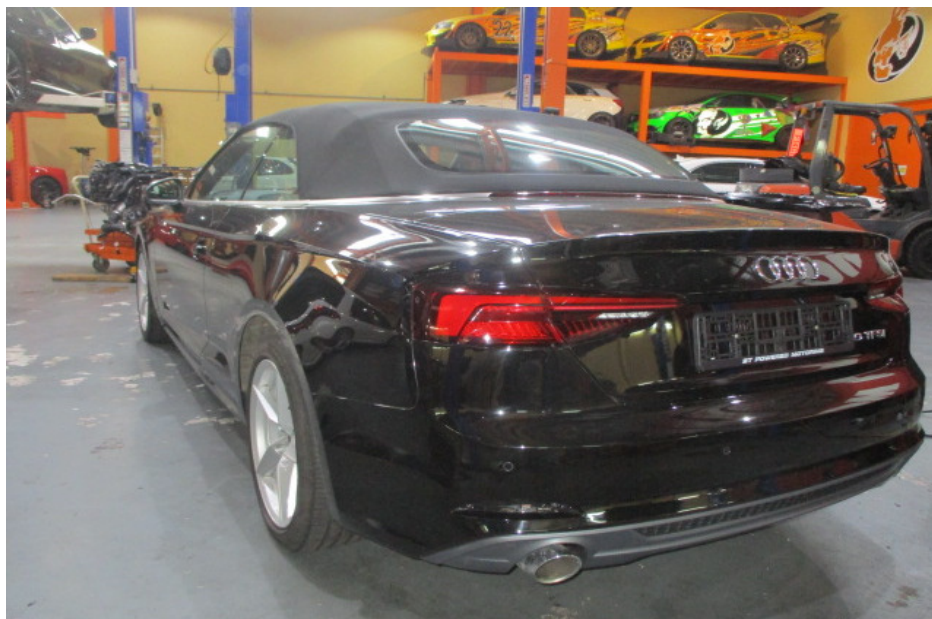
Photo 5 shows a general view of the rear left body of the Motor Car at the time of my inspection. The Motor Car was observed to be in a relatively good general condition with no loose exterior fittings observed. The body parts at the rear portion of the Motor Car were visually examined and it was observed that the repair/restoration works carried out to the damaged area of the Motor Car (refer to photograph 1 & 2 above) were reasonably adequate and in order.

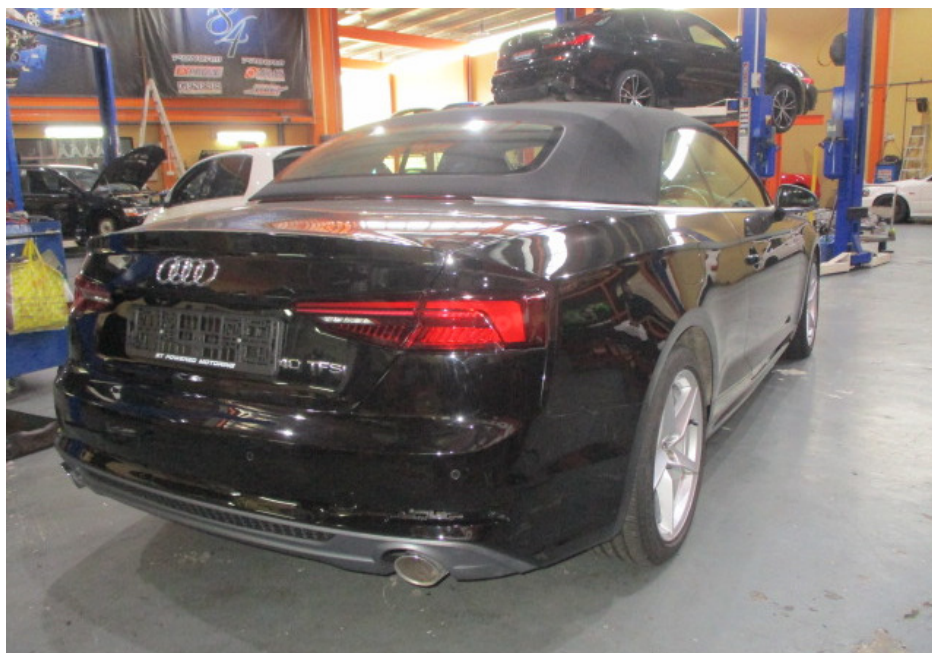
Photo 6 shows a general view of the rear right body of the Motor Car at the time of my inspection. The Motor Car was observed to be in a relatively good general condition with no loose exterior fittings observed. The body parts at the rear portion of the Motor Car were visually examined and it was observed that the repair/restoration works carried out to the damaged area of the Motor Car (refer to photograph 1 & 2 above) were reasonably adequate and in order.

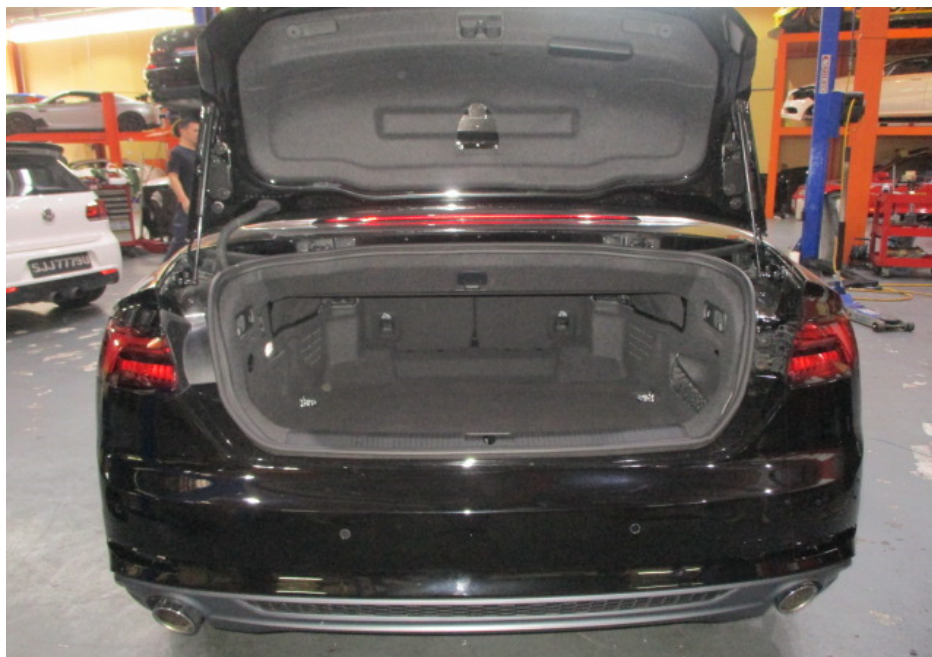
Photo 7 shows a general view of the rear boot compartment of the Motor Car at the time of my inspection. The Motor Car was observed to be in a relatively good general condition with no loose exterior fittings observed. The body parts at the rear portion of the Motor Car were visually examined and it was observed that the repair/restoration works carried out to the damaged area of the Motor Car (refer to photograph 1 & 2 above) were reasonably adequate and in order.

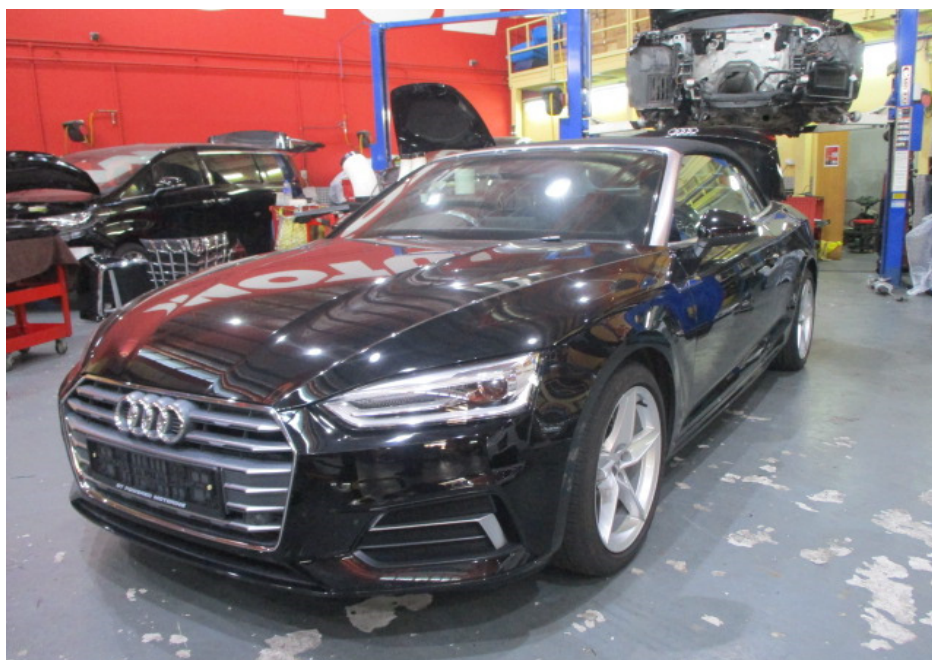
Photo 8 shows a general view of the front left body of the Motor Car at the time of my inspection. The Motor Car was observed to be in a relatively good general condition with no loose exterior fittings observed. The mileage of the Motor Car recorded at the time of my inspection was 8,586km.

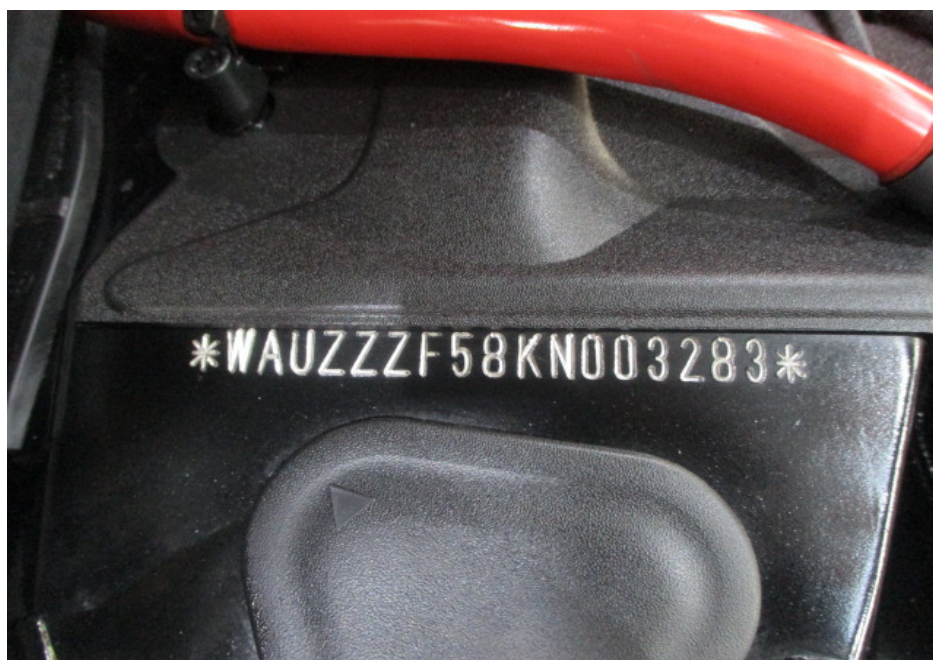
Photo 9 shows the chassis number of the Motor Car. The chassis number recorded was WAUZZZF58KN003283.

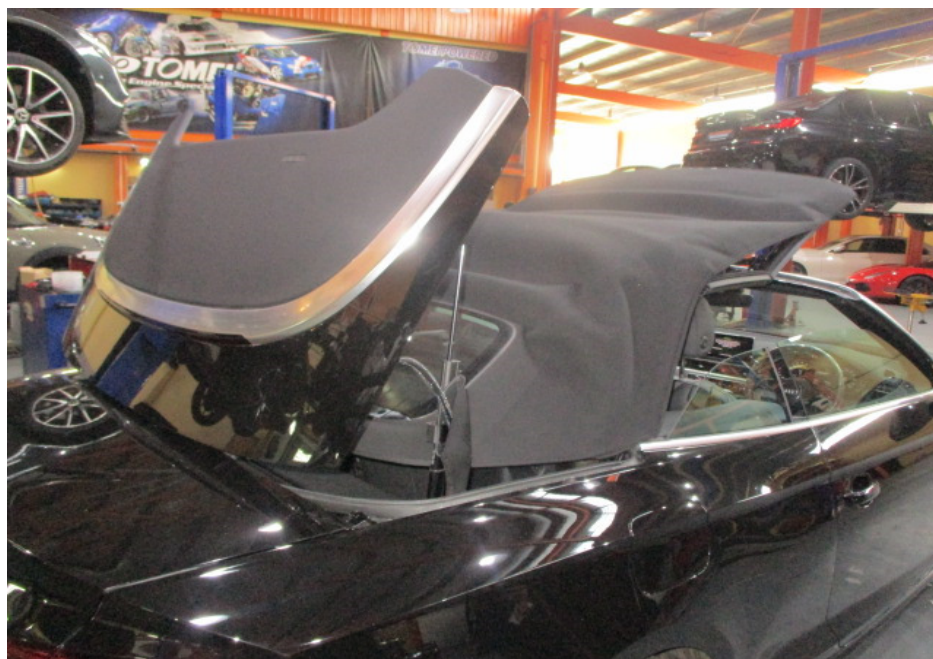
Photo 10 shows the Motor Car's soft top being tested. It was observed that as a safety feature, the soft top could only open and close when the Motor Car was in a stationary position. When opened, the soft top is completely folded into the rear boot compartment with no parts protruding out of the Motor Car's body. It was also observed that during the folding and unfolding process, the soft top roof did not extend laterally beyond the Motor Car's body.

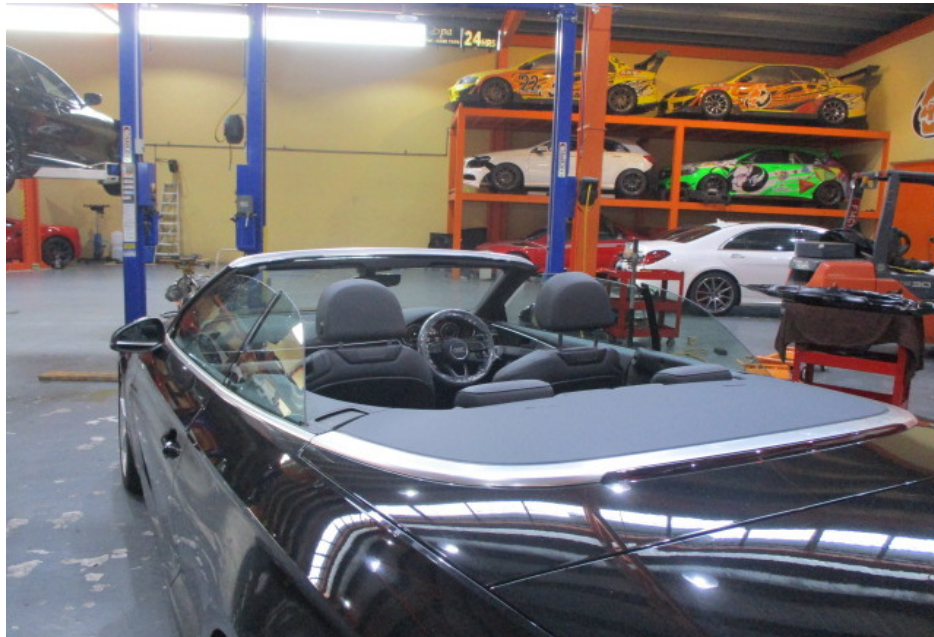
Photo 11 shows the Motor Car with its soft top completely folded. It was observed that as a safety feature, the soft top could only open and close when the Motor Car was in a stationary position. When opened, the soft top is completely folded into the rear boot compartment with no parts protruding out of the Motor Car's body. The soft top was also found adequately secured to the "A" pillar after closing.

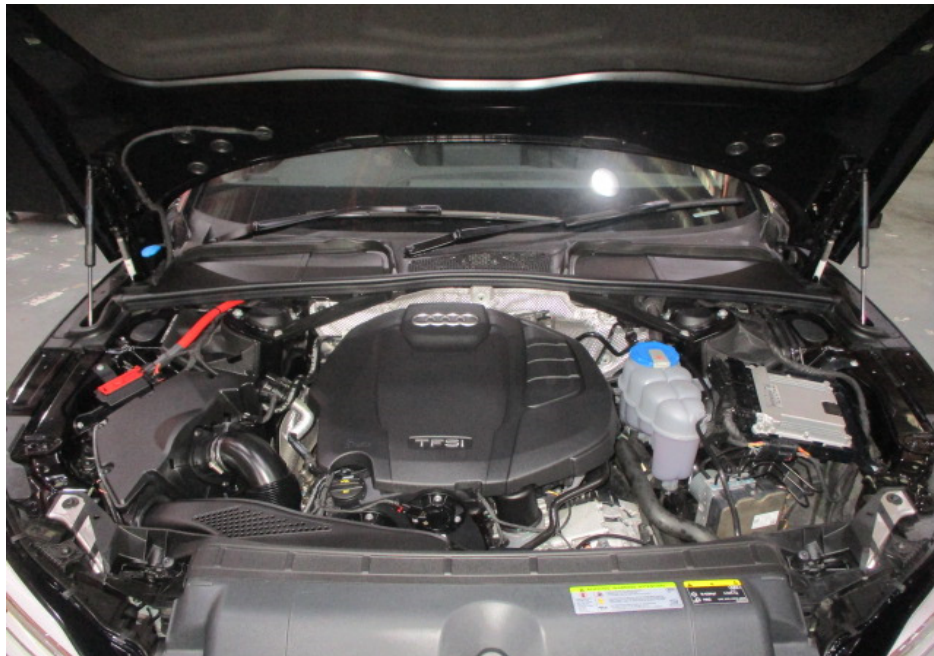
Photo 12 shows a general view of the engine compartment of the Motor Car at the time of my inspection. The various parts and components inside the engine compartment were all observed to be intact and properly fitted. There was also no sign(s) or indication(s) of fluid leak and/or fluid stain found inside the engine compartment.

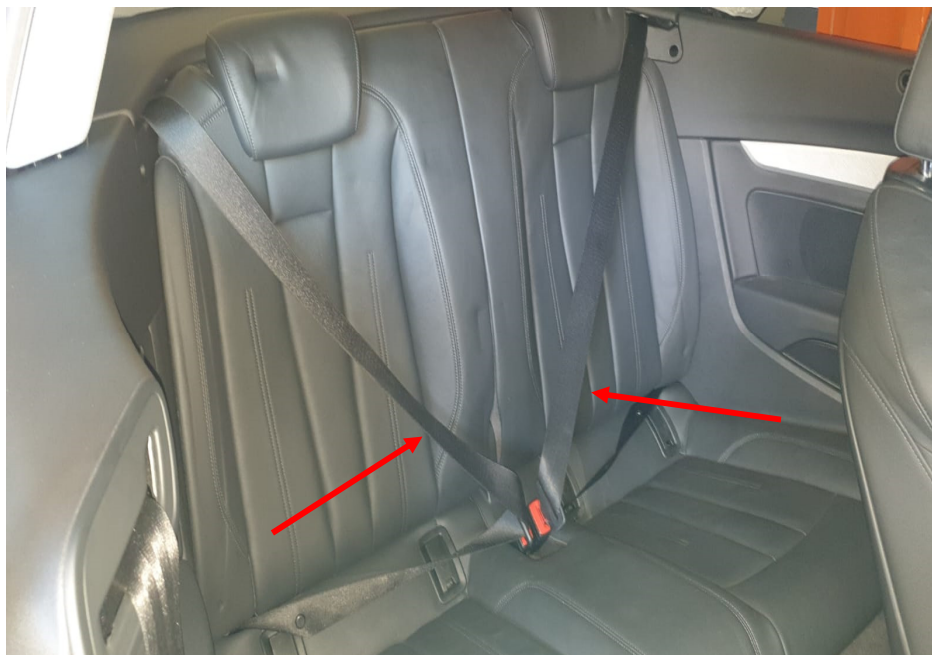
Photo 13 shows the rear seats of the Motor Car. All the seats of the Motor Car were secured via seat rails to the floorboard. They were also fitted with a retractable seat belt reel and a pre-tensioner. The seat belts (arrowed) were tested and were able to be fastened into the respective pre-tensions that were fitted on the side of each individual seat.

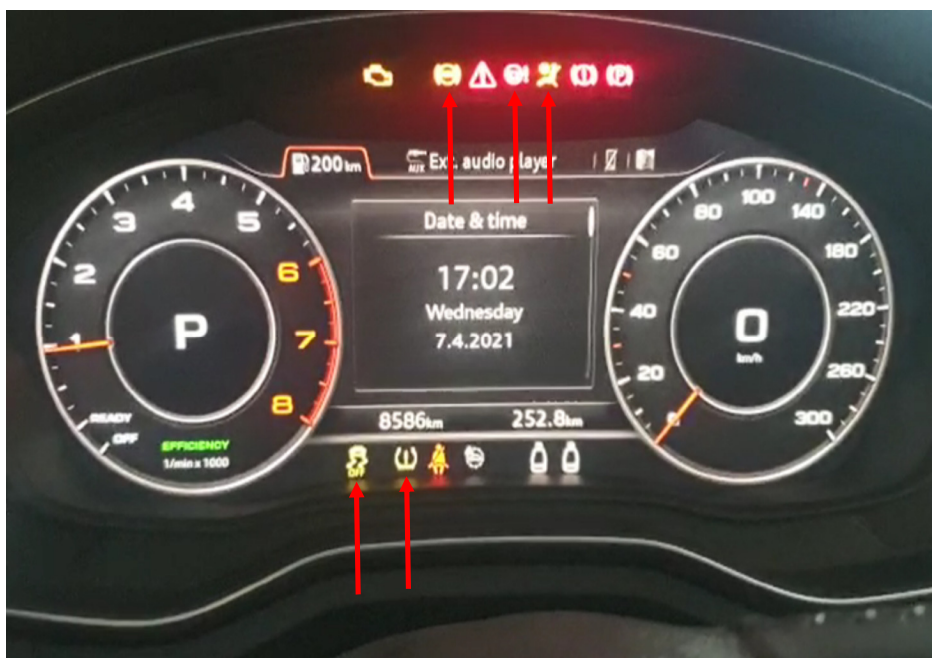
Photo 14 shows the warning lights for the various electronic safety features appearing on the instrument panel of the Motor Car during its self-test when the engine is cranked, in particular the ABS, SRS, EPS, TPM and ESC lights (arrowed).

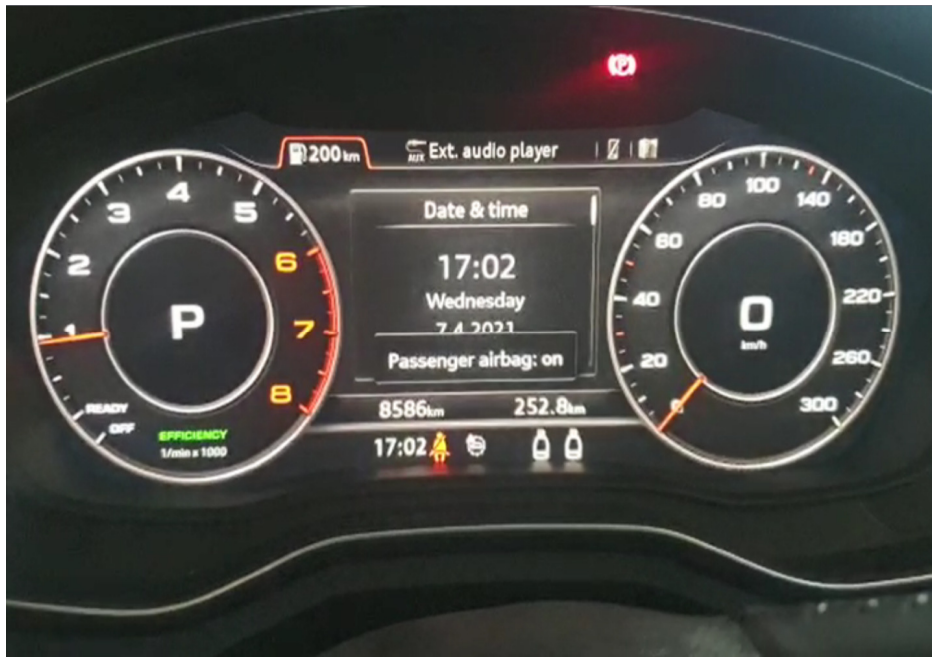
Photo 15 shows the respective warning lights no longer illuminated, indicating that there is no fault detected to the ABS, SRS, EPS, TPM and ESC systems of the Motor Car during the self-test. These electronic systems were hence in working condition at the time of my inspection.

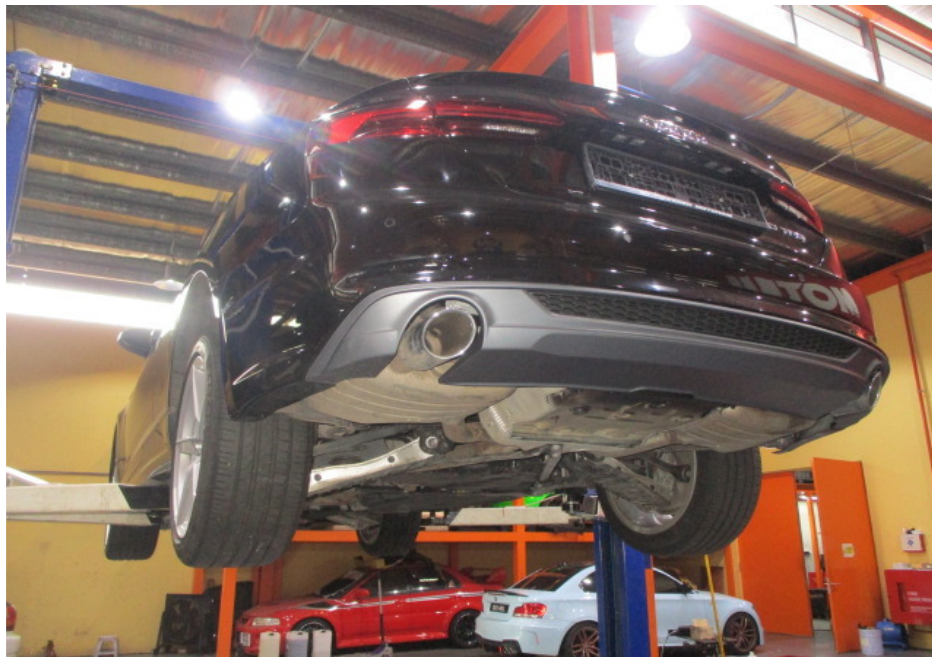
Photo 16 shows the Motor Car hoisted up for checks on its undercarriage. There was no sign(s) or indication(s) of fluid leakage and/or fluid stain(s) on the underside of the Motor Car. The undercarriage components of the Motor Car were also all observed to be intact and secured in an appropriate manner.

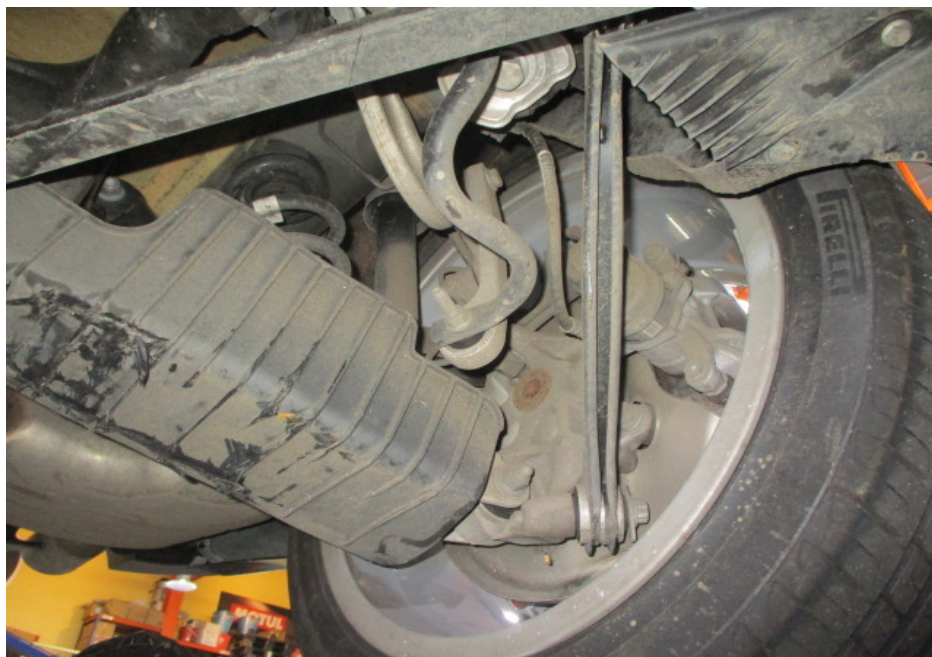
Photo 17 shows a general view of the control arms and linkages at the rear left wheel of the Motor Car. I did not observe any fluid leak and/or fluid stain on the underside of the Motor Car. All of the Motor Car's undercarriage components were observed to be intact and secured in an appropriate manner.

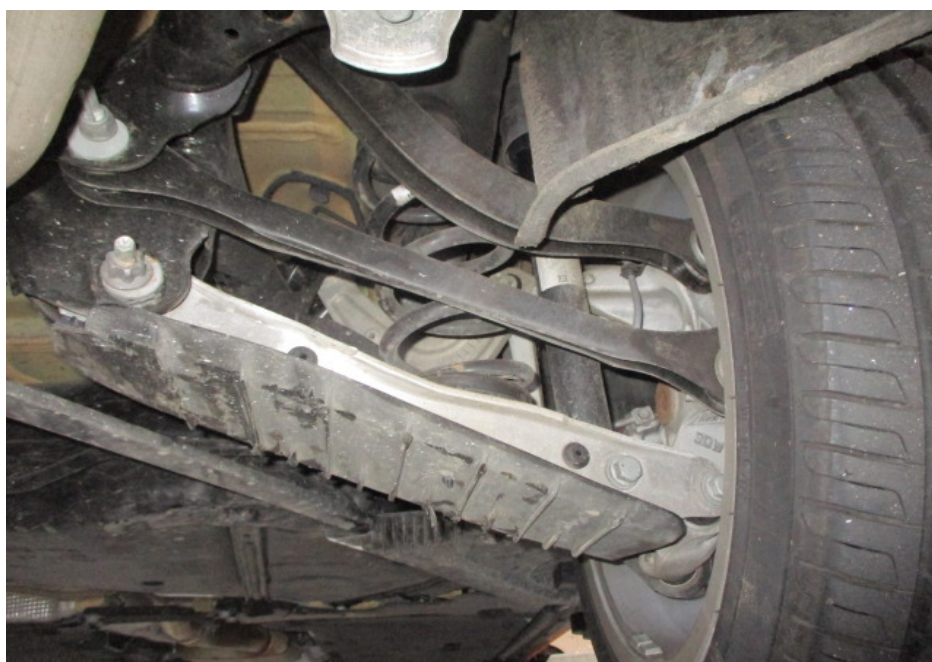
Photo 18 shows the various undercarriage components at the rear right wheel of the Motor Car. The mechanical components, control arms and linkages were all found to be intact and secured in an appropriate manner.

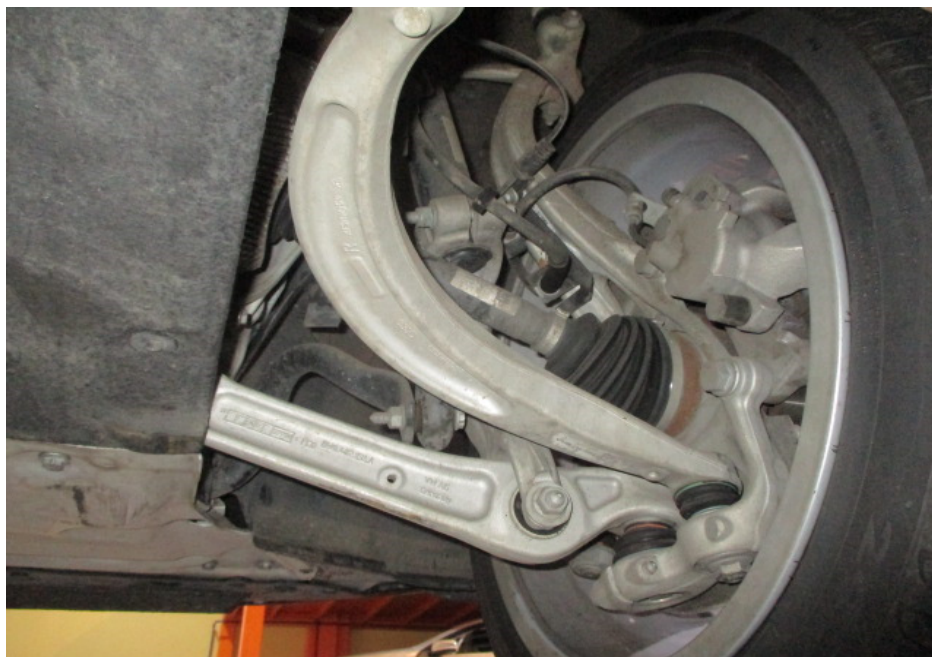
Photo 19 shows the various undercarriage components at the front left wheel of the Motor Car. The mechanical components, control arms and linkages were all found to be intact and secured in an appropriate manner. I also did not observe any fluid leak and/or fluid stain on the underside of the Motor Car.

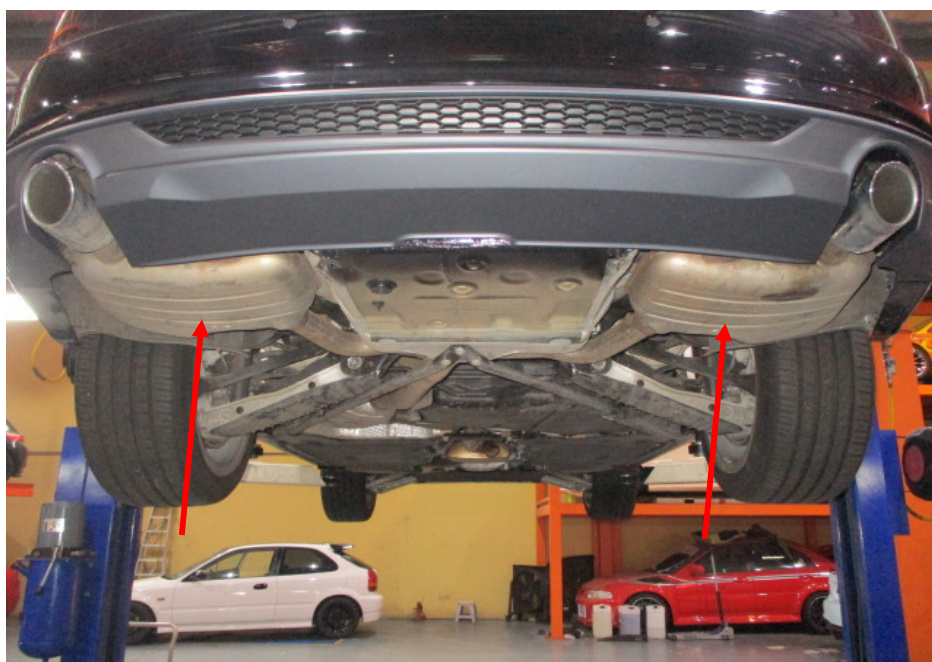
Photo 20 shows the Motor Car's rear mufflers (arrowed). My examination of the Motor Car's exhaust system revealed no sign(s) or indication(s) of any cut or weld marks along its exhaust pipes and on its catalytic converter.

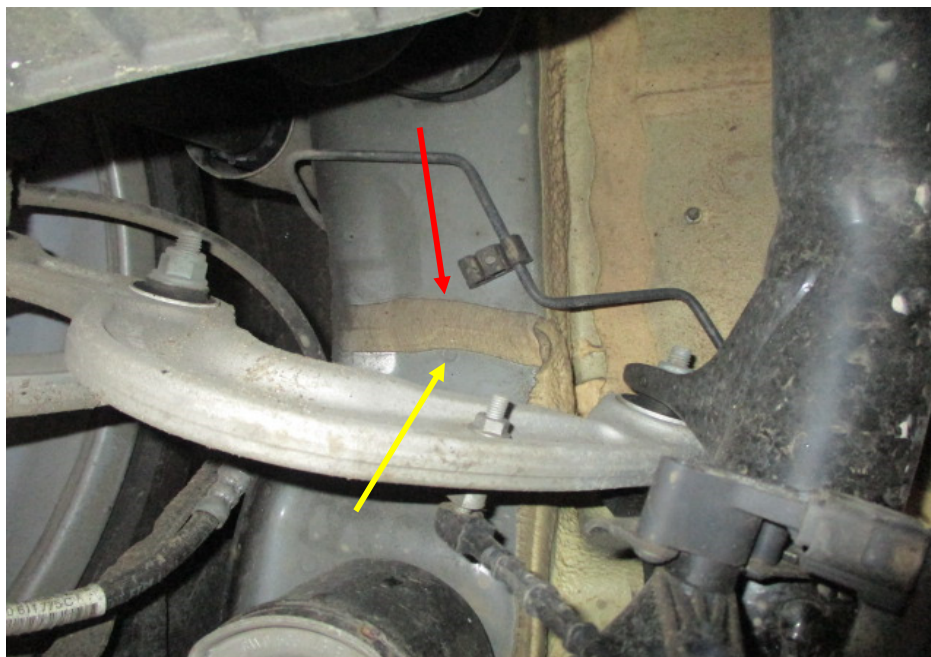
Photo 21 shows the chassis/structural body at the underside rear left of the Motor Car. I did not find any weld marks other than original spot weld marks (yellow arrow) on the chassis/structural body of the Motor Car. The original factory sealant (red arrow) at the joints along the chassis/structural body was untouched, indicating no work was done on the chassis/structural body of the Motor Car and that the chassis/structural body was originally fitted.

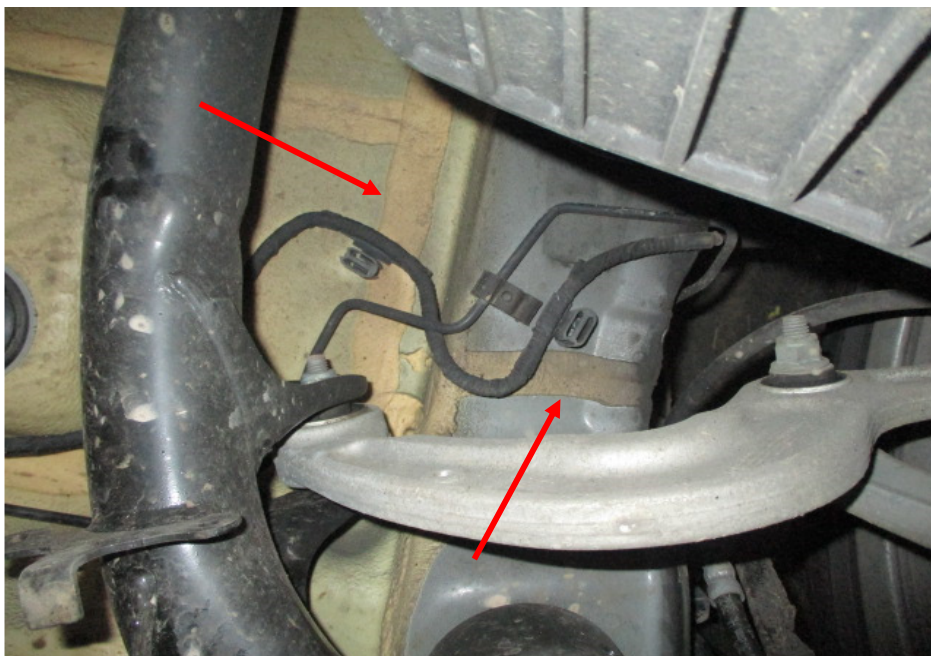
Photo 22 shows the chassis/structural body at the underside rear right of the Motor Car. The original factory sealant (arrowed) at the joints along the chassis/structural body was observed to be untouched. In general, I had found no work was carried out on the chassis/structural body of the Motor Car. The chassis/structural body of the Motor Car was originally fitted.

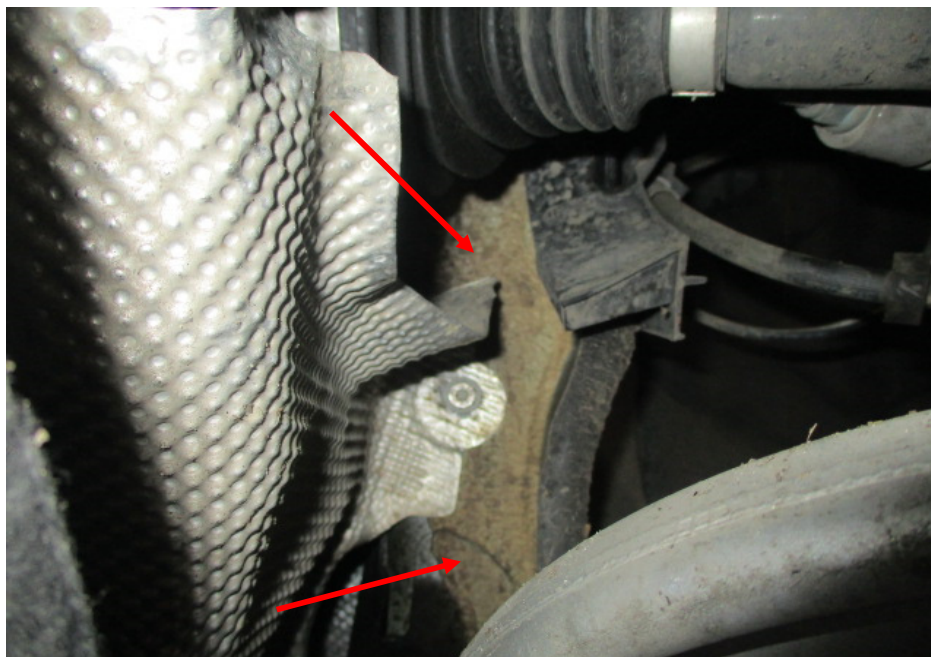
Photo 23 shows the chassis/structural body at the underside front left of the Motor Car. The original factory sealant (arrowed) at the joints along the chassis/structural body was observed to be untouched. In general, I had found no work was carried out on the chassis/structural body of the Motor Car. The chassis/structural body of the Motor Car was originally fitted.
