Your Ref: Honda Civic  
(chassis number SHHFK7760KU001884)  
Our Ref : CI/TP21002372/D

**INSPECTION REPORT OF AN UNREGISTERD HONDA CIVIC MOTOR CAR  
WITH CHASSIS NUMBER SHHFK7760KU001884**

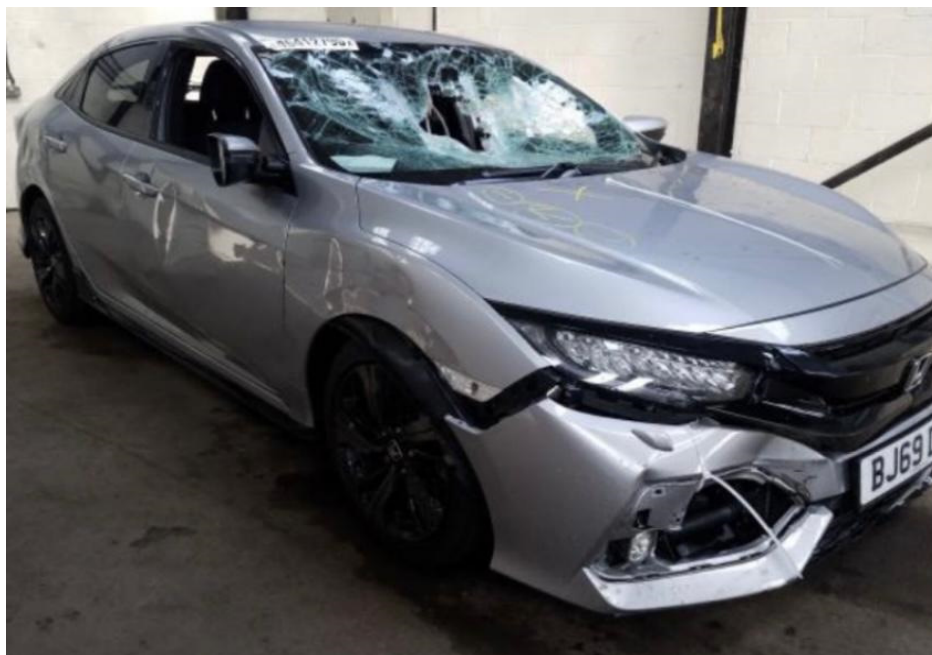
**Photo 1** shows the front right body of the Motor Car (photograph provided to me). The Motor Car was observed to have sustained damage at multiple areas. The front bumper, front right fog lamp, front bumper right lower grille, front right fender, right side wing mirror and front right door were amongst the body parts that were observed to have been damaged. The orientation of the front right wheel and front left wheel (refer to photograph 3 below) indicates to me that there was damage to the front undercarriage part(s) of the Motor Car.

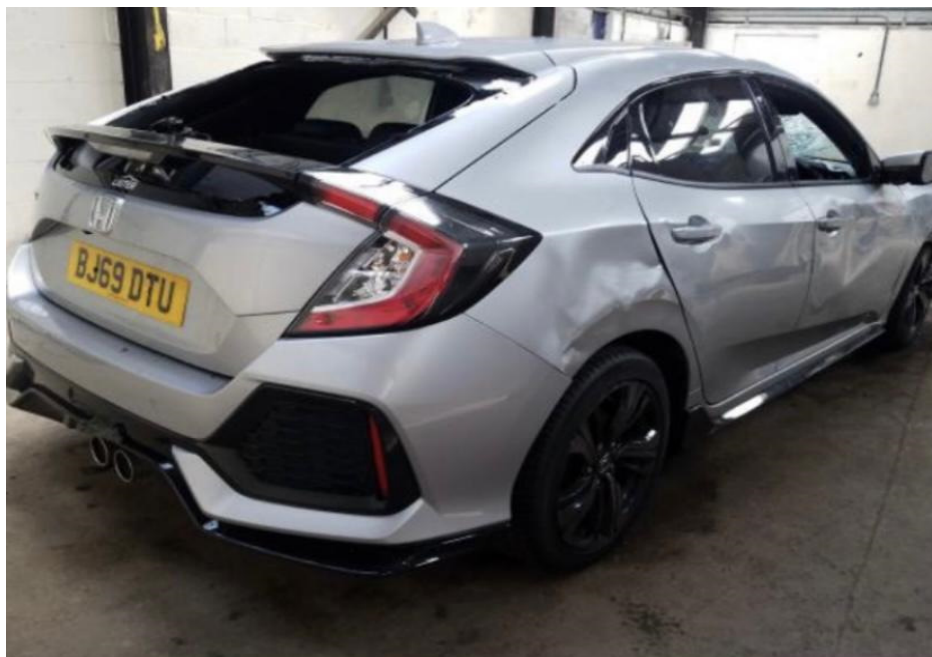
**Photo 2** shows the rear right body of the Motor Car (photograph provided to me). The rear right fender, rear right door and front right door were amongst the body parts that were observed to have been damaged. The rear windscreen was also observed to be shattered.

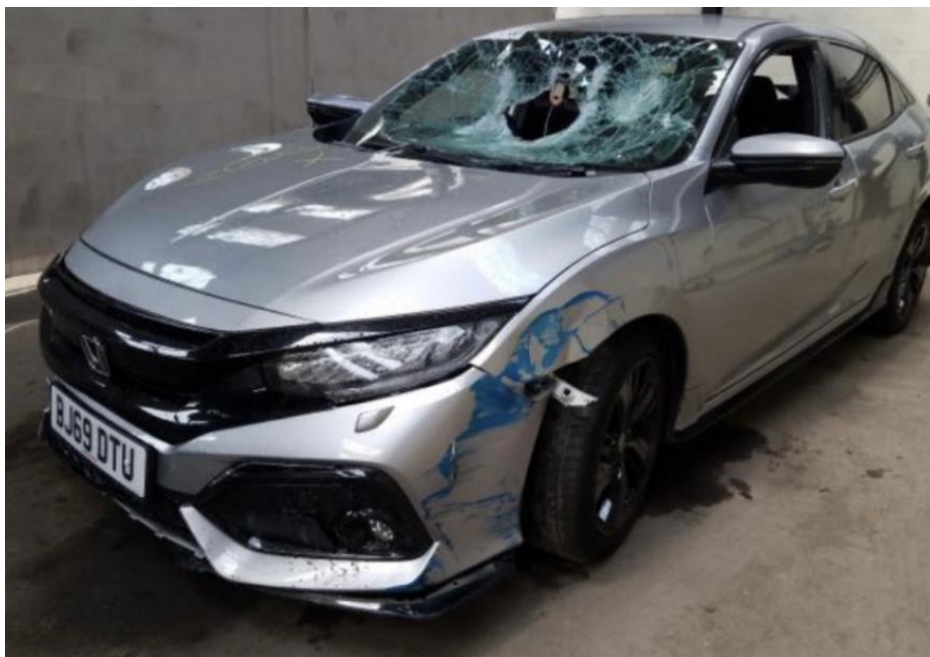
**Photo 3** shows the front left body of the Motor Car (photograph provided to me). The Motor Car was observed to have sustained damage at multiple areas. The front bumper, front bumper left lower grille, front left fender and front windscreen were amongst the body parts that were observed to have been damaged. The orientation of the front left wheel was slightly towards the left while the orientation of the front right wheel was straight (refer to photograph 1 above), which indicates to me that there was damage to the front undercarriage part(s) of the Motor Car.

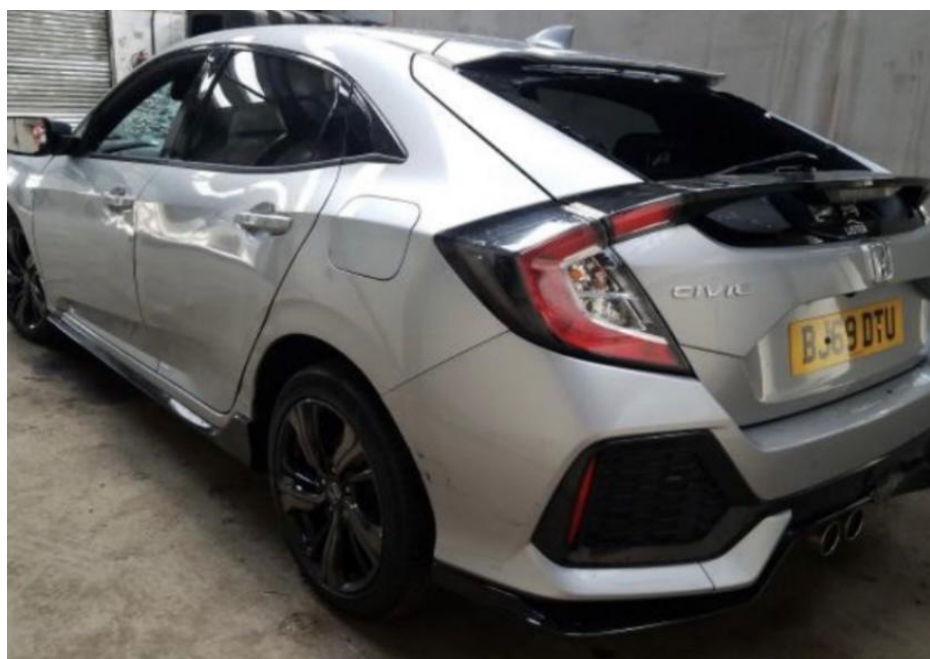
**Photo 4** shows the rear left body of the Motor Car (photograph provided to me). The rear windscreen, rear left door and front left door were amongst the body parts that were observed to have been damaged.

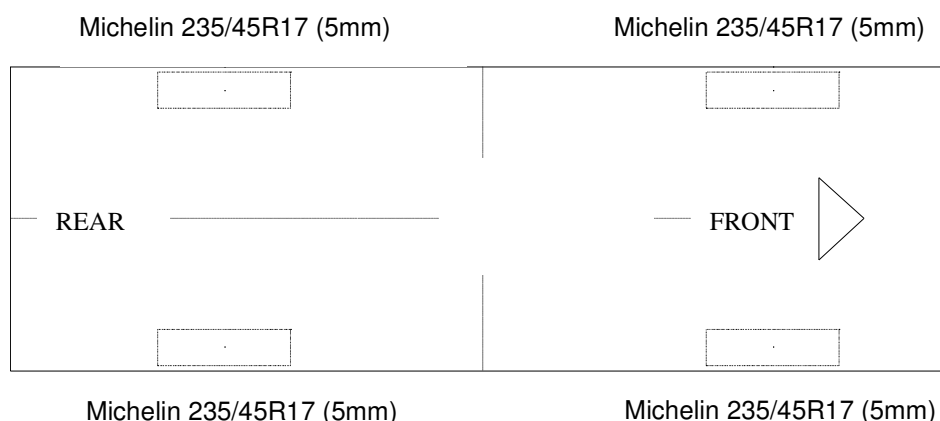
8. It was fitted with 17inch sport wheel rims that were wrapped with tyres that were observed to be of serviceable condition. The tyres were also sufficiently inflated for vehicular operation. The tyre brand, tyre size and approximate remaining tread depth of the 4 tyres of the Motor Car were recorded as follows: -

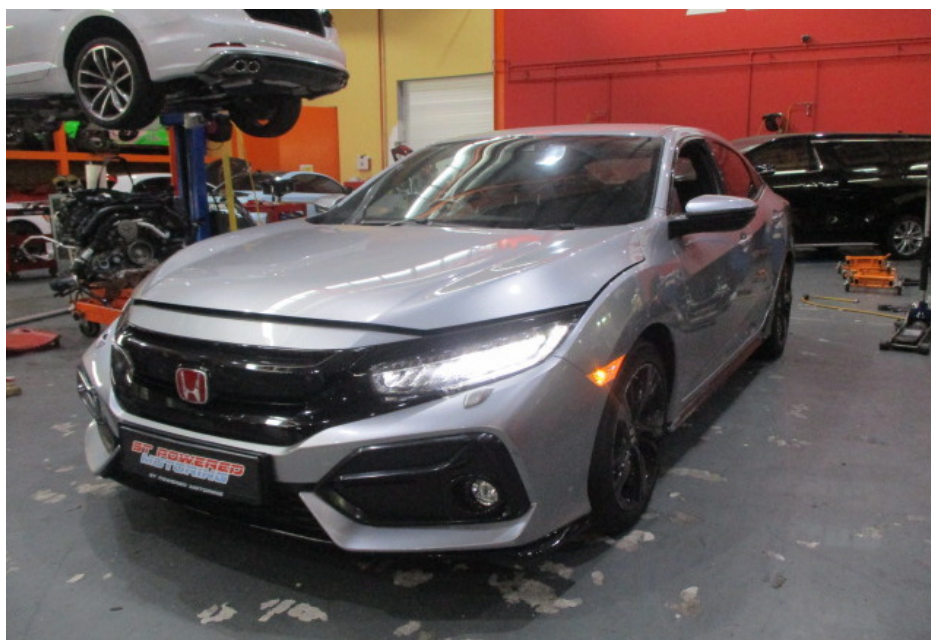
**Photo 5** shows a general view of the front left body of the Motor Car at the time of my inspection. The Motor Car was observed to be in a relatively good general condition with no loose exterior fittings observed. The body parts at the front left portion of the Motor Car were visually examined and it was observed that the repair/restoration works carried out to the damaged area of the Motor Car (refer to photograph 3 above) were reasonably adequate and in order.

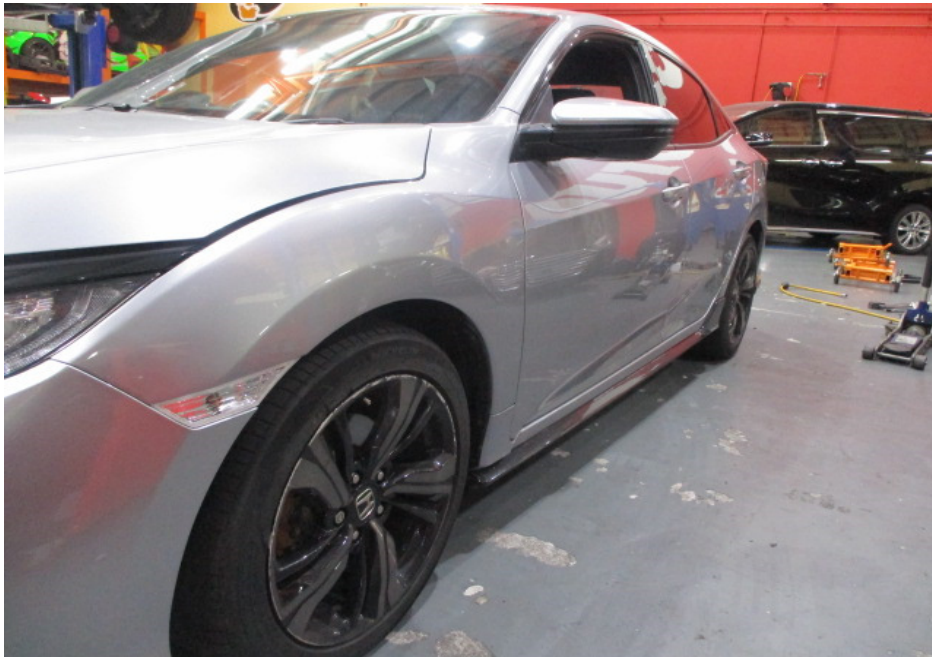
**Photo 6** shows a closer view of the front left fender, front left fender reflector, front left door and front windscreen of the Motor Car at the time of my inspection. The body parts along the left side portion of the Motor Car were visually examined and it was observed that the repair/restoration works carried out to the damaged area of the Motor Car (refer to photograph 3 above) were reasonably adequate and in order.

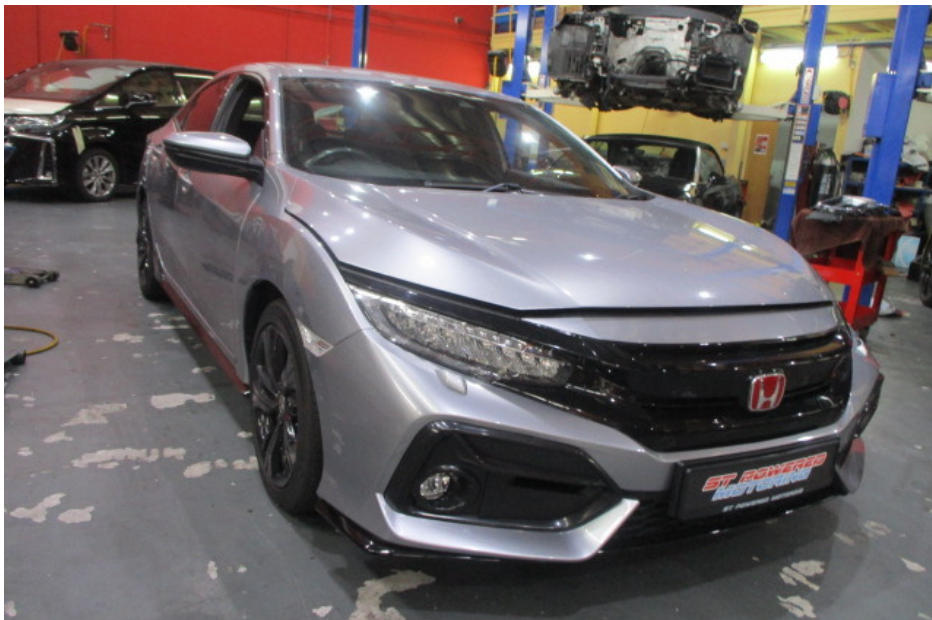
**Photo 7** shows a general view of the front right body of the Motor Car at the time of my inspection. The Motor Car was observed to be in a relatively good general condition with no loose exterior fittings observed. The body parts at the front right portion of the Motor Car were visually examined and it was observed that the repair/restoration works carried out to the damaged area of the Motor Car (refer to photograph 1 above) were reasonably adequate and in order.

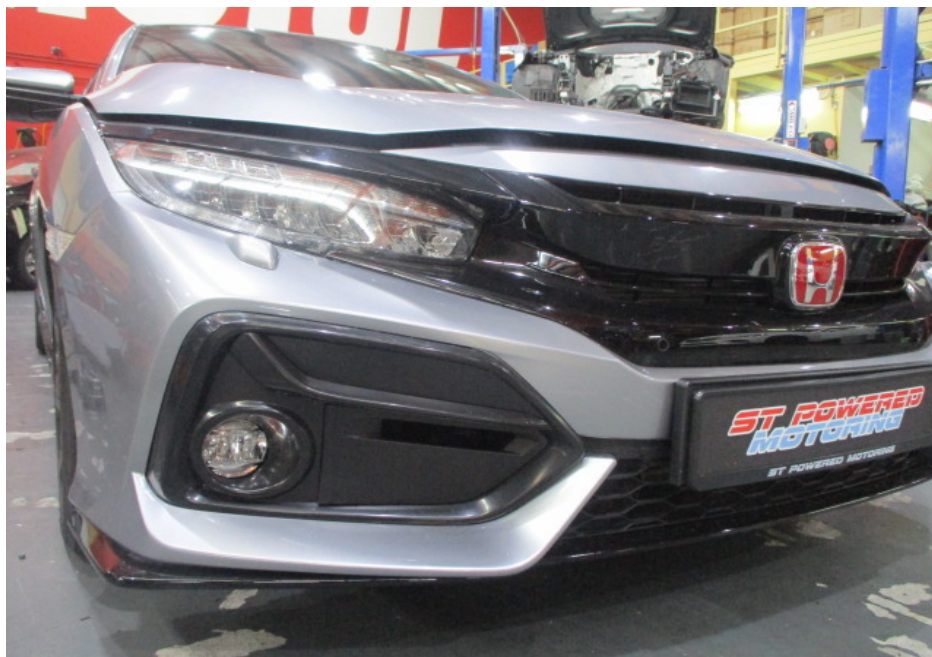
**Photo 8** shows a closer view of the front bumper, front right lower grille, front right fog lamp of the Motor Car at the time of my inspection. The body parts at the front right portion of the Motor Car were visually examined and it was observed that the repair/restoration works carried out to the damaged area of the Motor Car (refer to photograph 1 above) were reasonably adequate and in order.

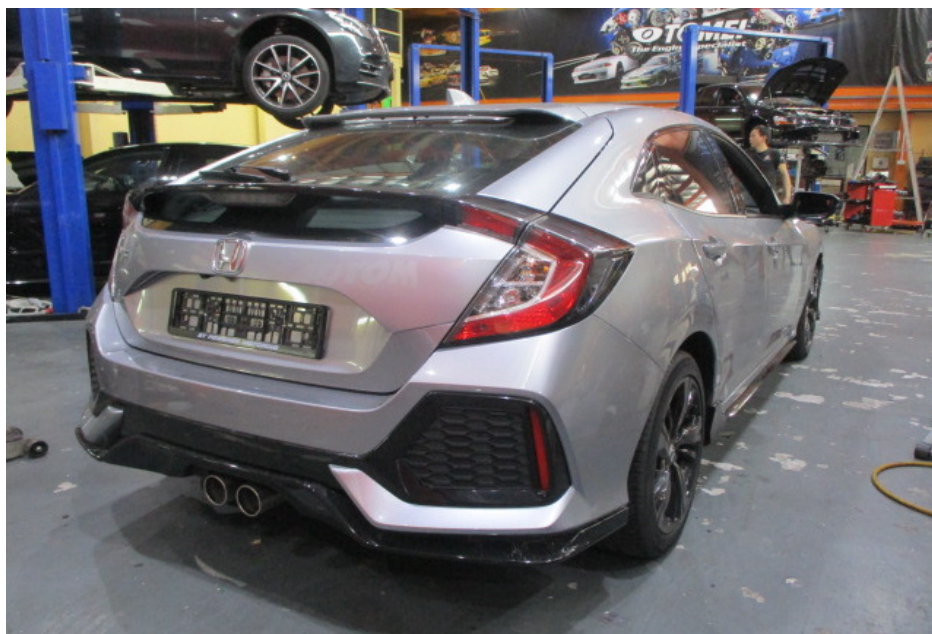
**Photo 9** shows a general view of the rear right body of the Motor Car at the time of my inspection. The Motor Car was observed to be in a relatively good general condition with no loose exterior fittings observed. The body parts at the rear right portion of the Motor Car were visually examined and it was observed that the repair/restoration works carried out to the damaged area of the Motor Car (refer to photograph 2 above) were reasonably adequate and in order.

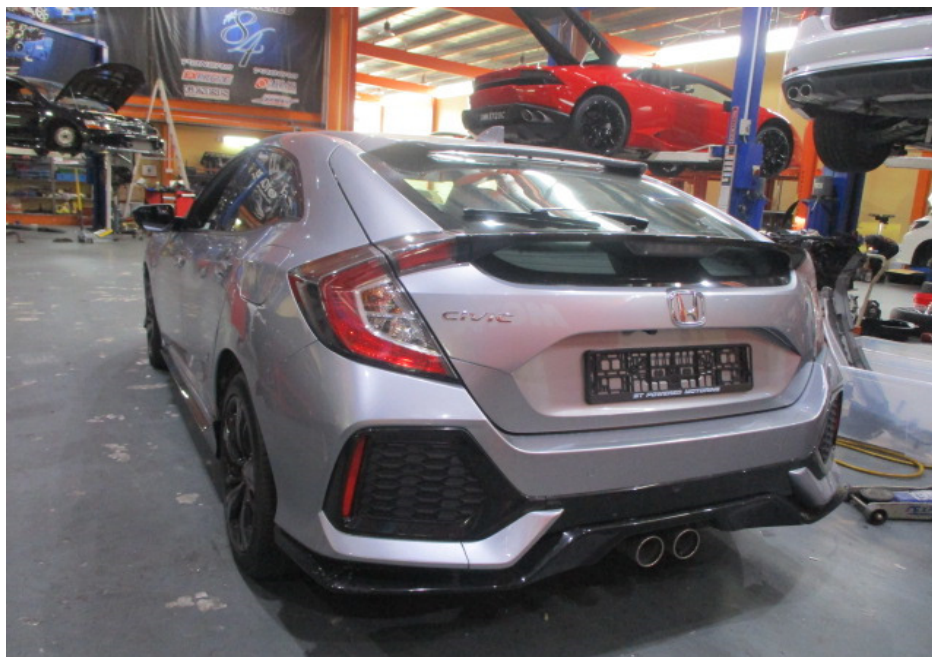
**Photo 10** shows a general view of the rear left body of the Motor Car at the time of my inspection. Overall, the Motor Car was observed to be in a relatively good general condition with no loose exterior fittings observed. The mileage of the Motor Car recorded at the time of my inspection was 11,404km.

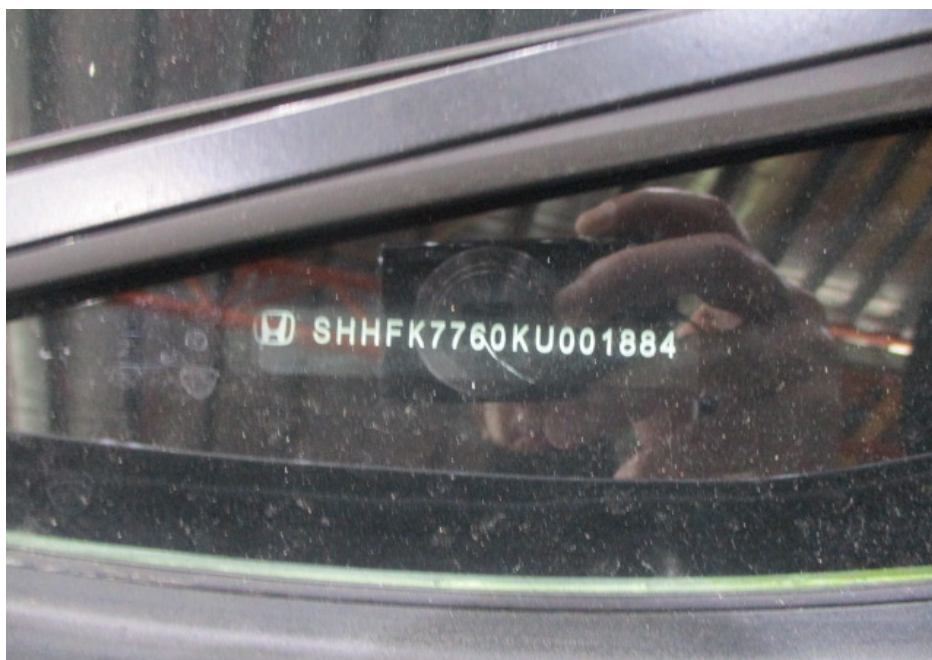
**Photo 11** shows the chassis number of the Motor Car. The chassis number recorded was SHHFK7760KU001884.

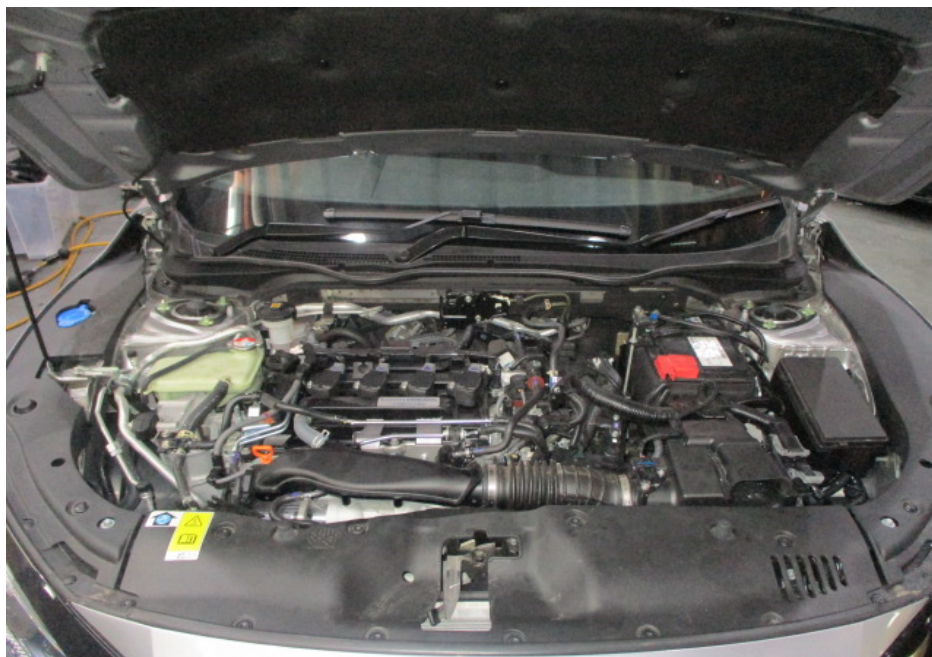
14. My examination of the engine compartment of the Motor Car revealed that the various parts and components inside the engine compartment were all intact and properly fitted. The engine oil, brake fluid and engine coolant were all found to be of sufficient level for operating purposes. Visually, there was also no contamination found to these fluids.

**Photo 12** shows a general view of the engine compartment of the Motor Car at the time of my inspection. The various parts and components inside the engine compartment were all observed to be intact and properly fitted. There was also no sign(s) or indication(s) of fluid leak and/or fluid stain found inside the engine compartment.

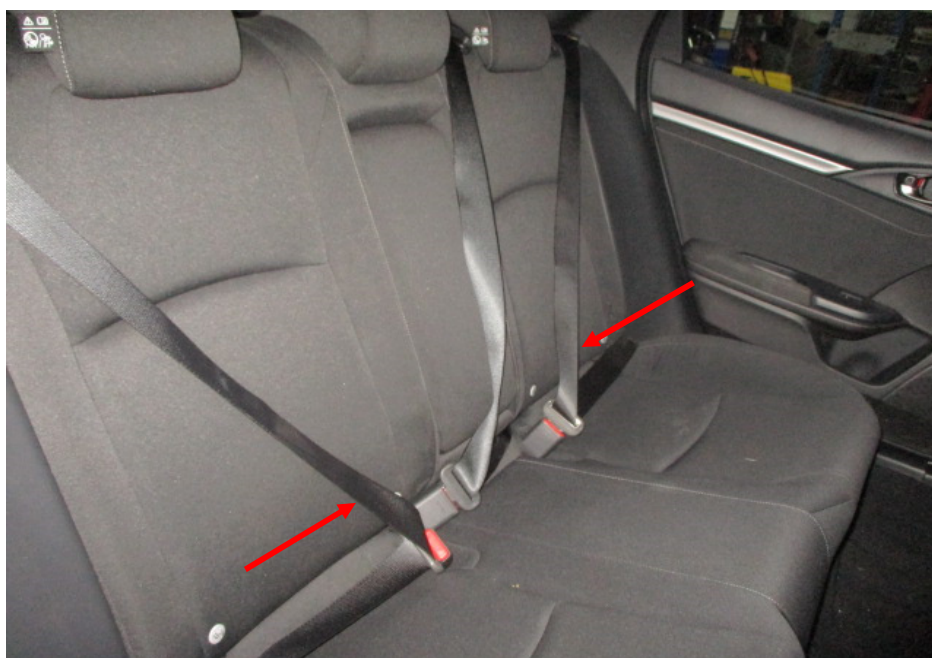
12. The seats of the Motor Car were found to be secured to the floorboard of the Motor Car via seat rails bolted onto the floorboard. Retractable seat belt reels and pre-tensioners were fitted on all seats of the Motor Car. The seat belts were tested and were able to be fastened securely into the respective pre-tensioners that were fixed to the side of all the seats.

**Photo 13** shows the rear seats of the Motor Car. All the seats of the Motor Car were secured via seat rails to the floorboard. They were also fitted with a retractable seat belt reel and a pre-tensioner. The seat belts (arrowed) were tested and were able to be fastened into the respective pre-tensions that were fitted on the side of each individual seat.

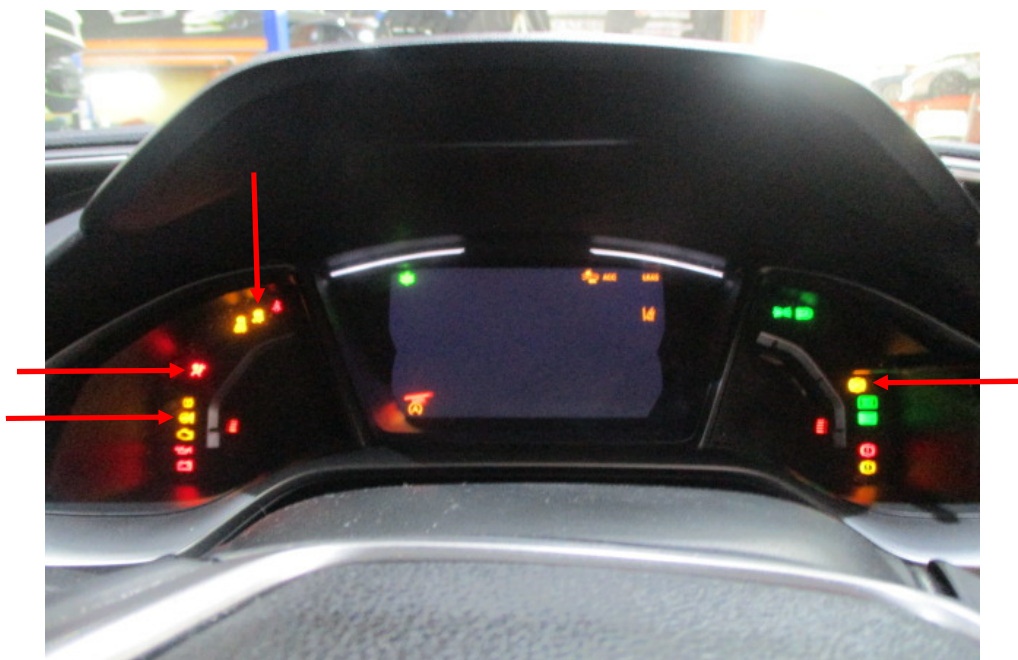
**Photo 14** shows the warning lights for the various electronic safety features appearing on the instrument panel of the Motor Car during its self-test when the engine is cranked, in particular the ABS, SRS, EPS and SC lights (arrowed).

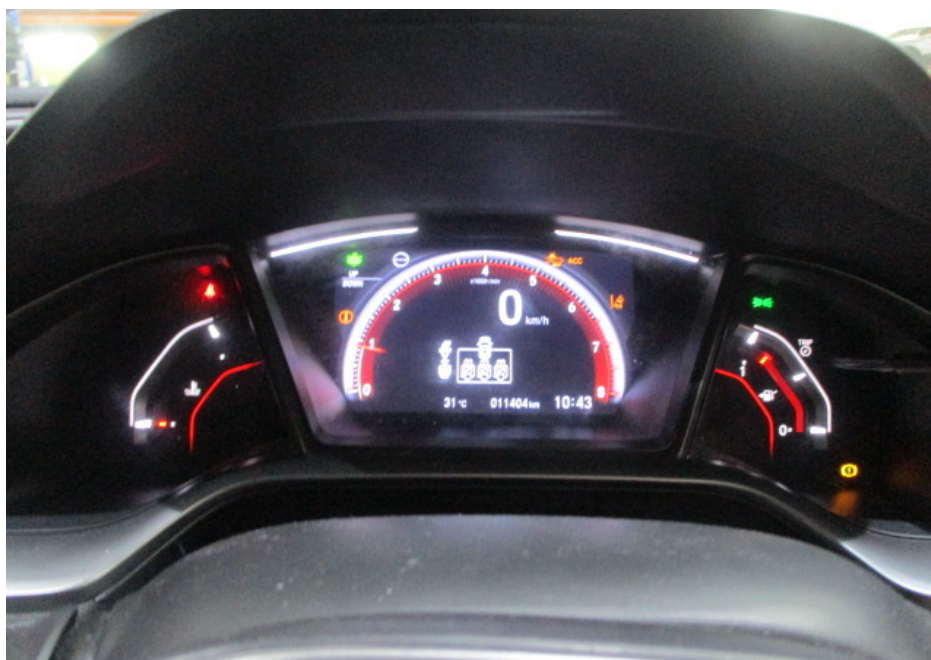
13. The Motor Car's automatic self-test of the functionality of its various electronic safety features like the Anti-Lock Brake System (ABS), Supplemental Restraint System (SRS), Electric Power Steering (EPS) and Stability Control (SC) during cranking of the engine had indicated that these electronic systems were in working condition. This was determined from the respective warning lights disappearing from the instrument panel after the self-test.

**Photo 15** shows the respective warning lights no longer illuminated, indicating that there is no fault detected to the ABS, SRS, EPS and SC systems of the Motor Car during the self-test. These electronic systems were hence in working condition at the time of my inspection.

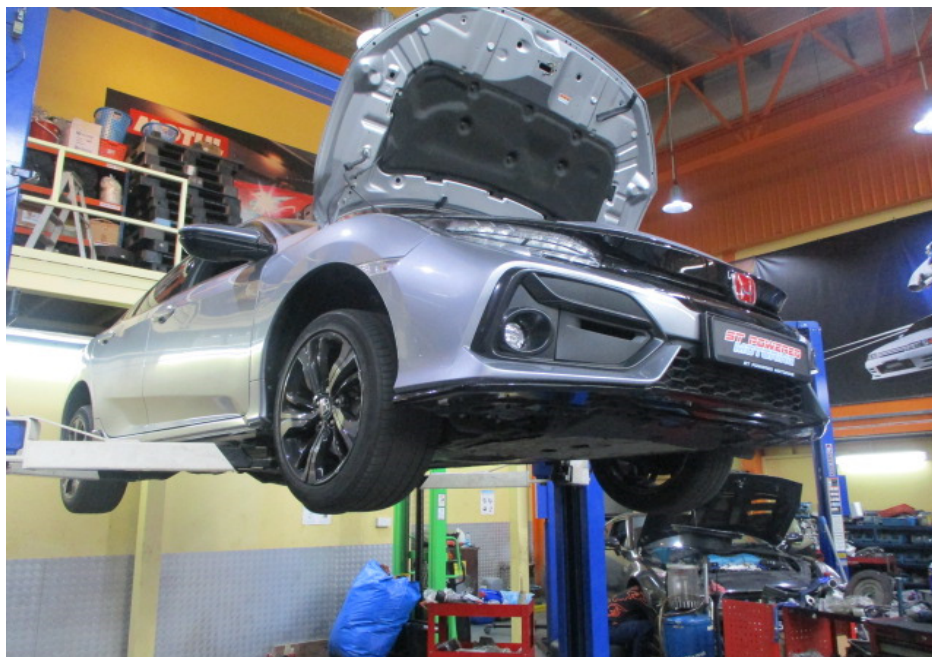
15. My checks on the underside of the Motor Car revealed no sign(s) or indication(s) of fluid leakage and/or fluid stain(s). The engine block and automatic transmission assembly were both secured properly. All undercarriage components of the Motor Car were also observed to be intact and secured in an appropriate manner.

**Photo 16** shows the Motor Car hoisted up for checks on its undercarriage. There was no sign(s) or indication(s) of fluid leakage and/or fluid stain(s) on the underside of the Motor Car. The undercarriage components of the Motor Car were also all observed to be intact and secured in an appropriate manner.

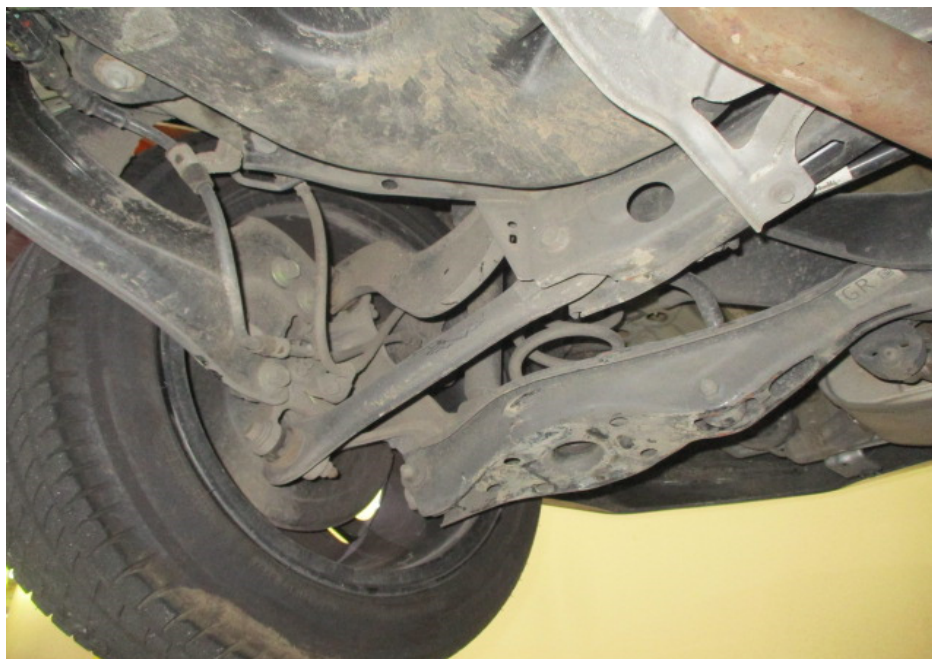
**Photo 17** shows a general view of the control arms and linkages at the rear right wheel of the Motor Car. I did not observe any fluid leak and/or fluid stain on the underside of the Motor Car. All of the Motor Car's undercarriage components were observed to be intact and secured in an appropriate manner.

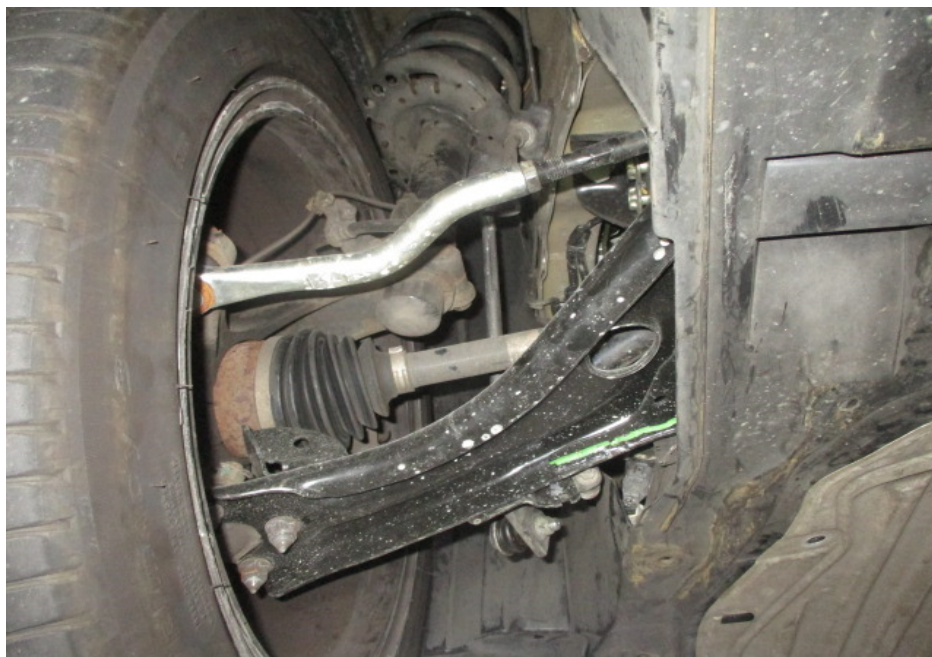
**Photo 18** shows the various undercarriage components at the front left wheel of the Motor Car. The mechanical components, control arms and linkages were all found to be intact and secured in an appropriate manner.

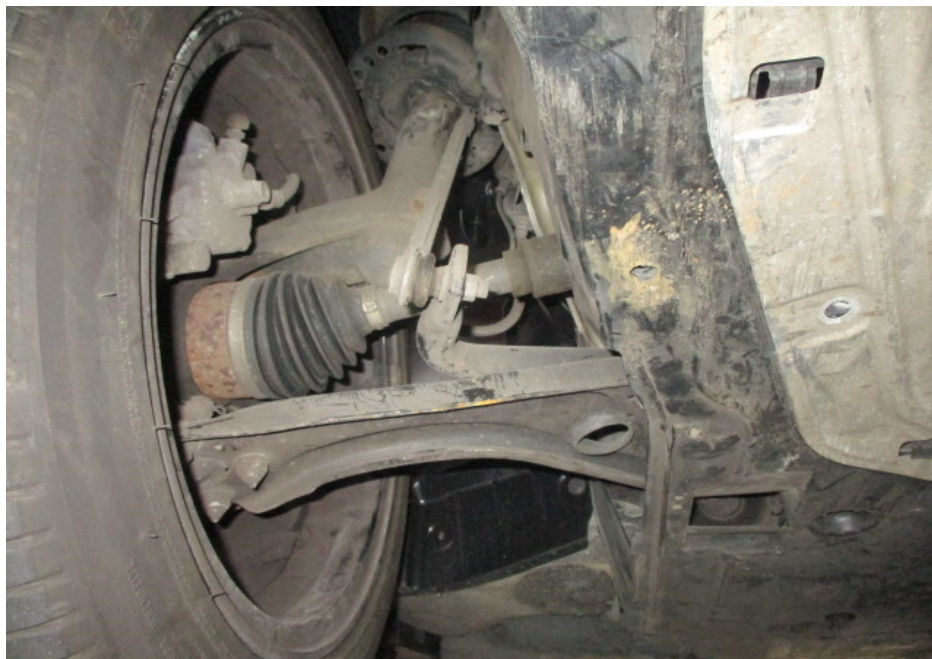
**Photo 19** shows the various undercarriage components at the front right wheel of the Motor Car. The mechanical components, control arms and linkages were all found to be intact and secured in an appropriate manner. I also did not observe any fluid leak and/or fluid stain on the underside of the Motor Car.

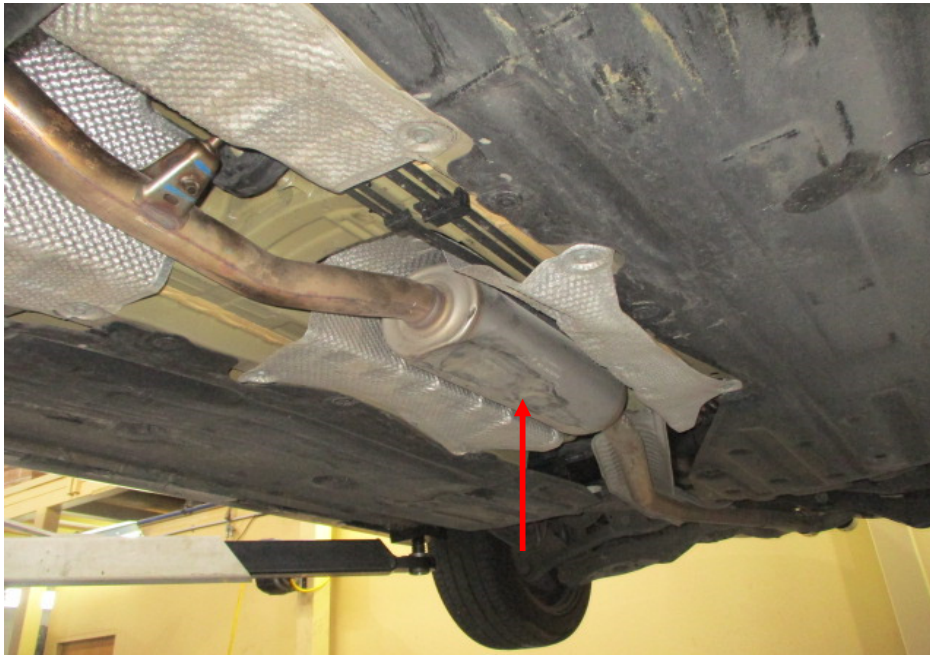
**Photo 20** shows the Motor Car's centre resonator (arrowed). My examination of the Motor Car's exhaust system revealed no sign(s) or indication(s) of any cut or weld marks along its exhaust pipes, on its catalytic converter and on its rear muffler.

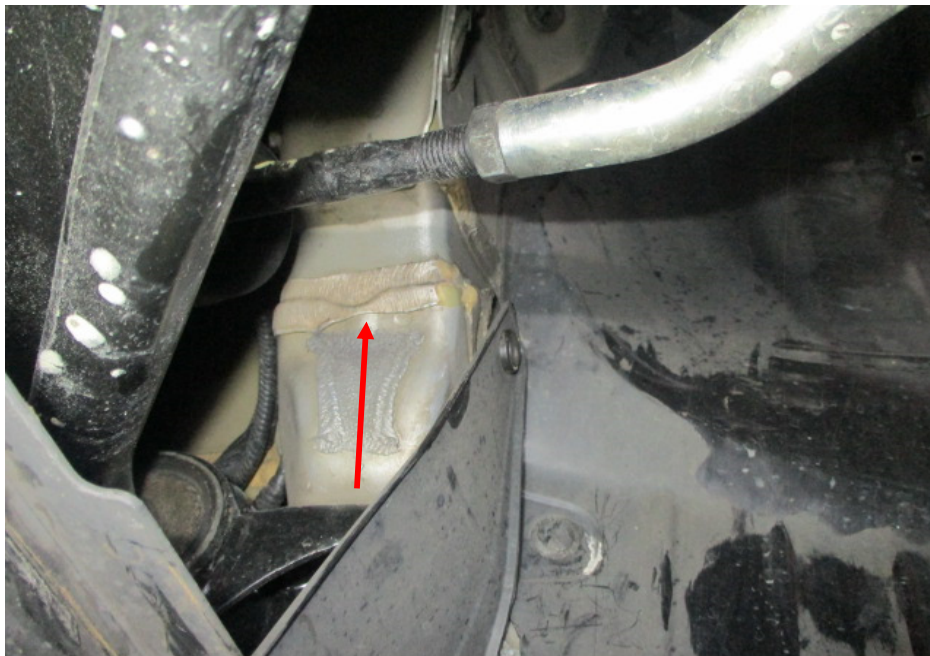
11. Visually, I did not find any weld marks, other than the original spot weld marks, on the chassis/structural body of the Motor Car. The original factory sealant at the joints along the chassis/structural body was also untouched, again indicating that no replacement of the chassis/structural body was carried out; and that the chassis/structural body was originally fitted.

**Photo 21** shows the chassis/structural body at the underside front left of the Motor Car. I did not find any weld marks other than original spot weld marks on the chassis/structural body of the Motor Car. The original factory sealant (arrowed) at the joints along the chassis/structural body was untouched, indicating no work was done on the chassis/structural body of the Motor Car and that the chassis/structural body was originally fitted.

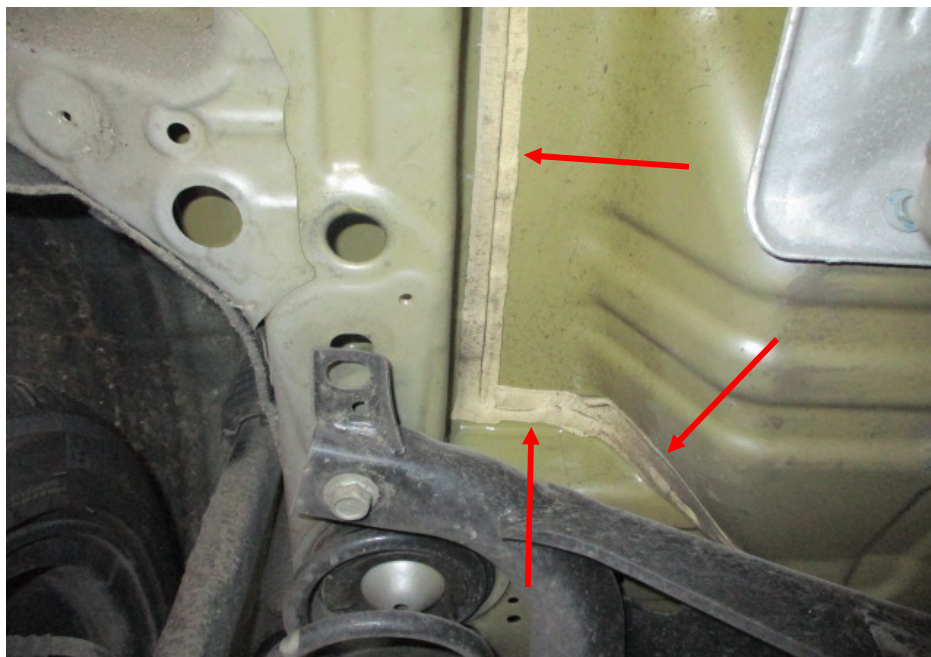
**Photo 22** shows the chassis/structural body at the underside rear left of the Motor Car. The original factory sealant (arrowed) at the joints along the chassis/structural body was observed to be untouched. In general, I had found no work was carried out on the chassis/structural body of the Motor Car. The chassis/structural body of the Motor Car was originally fitted.

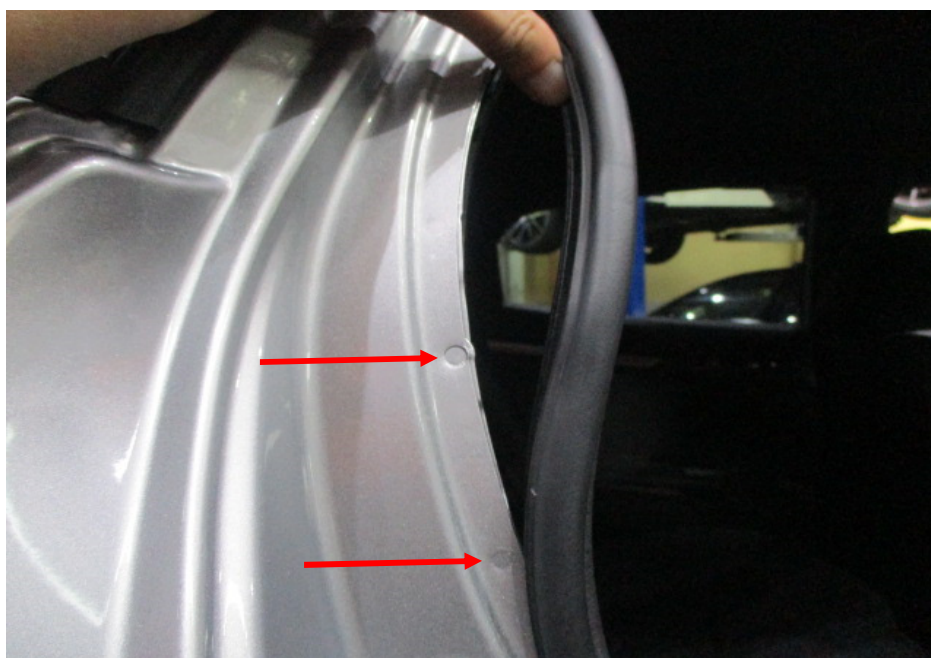
10. Checks on the non-detachable body panels like the rear fenders, floorboard, roof panel, pillars and rocker panels amongst others, revealed that these body panels were spot welded onto the chassis/structural body of the Motor Car. The original factory sealant at the joints of the non-detachable body panels was all untouched indicating no replacement of the non-detachable body panels was carried out; and that these body panels were all originally fitted.

**Photo 23** shows the right side "C" pillar of the Motor Car. I did not find any weld marks other than original spot weld marks (arrowed) on the right side "C" pillar of the Motor Car which, indicates that there was no re-welding works carried out. In general, I had found all the non-detachable body panels of the Motor Car to be originally fitted at the time of my inspection.

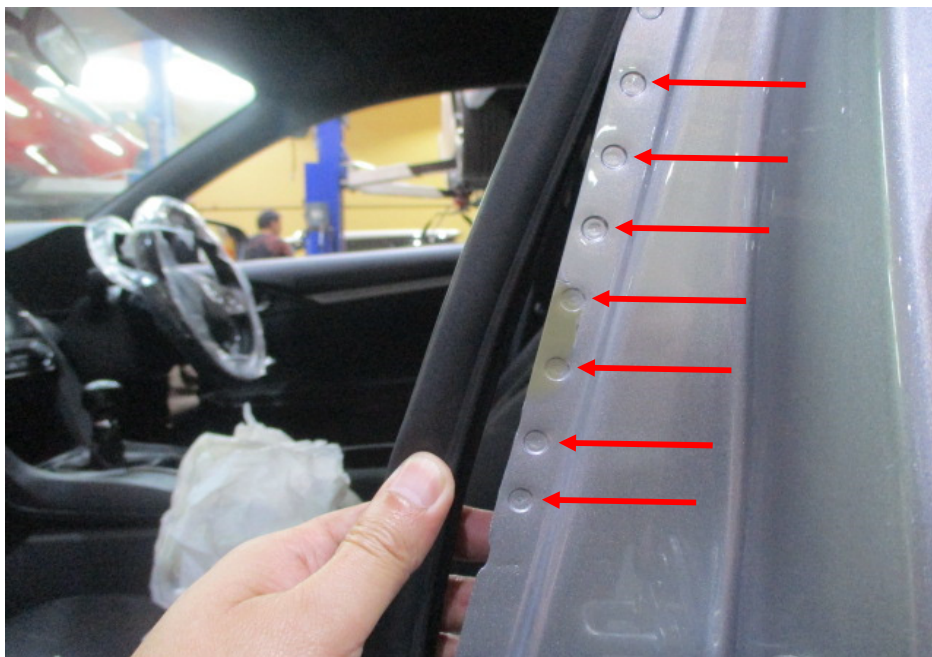
**Photo 24** shows the left side "B" pillar of the Motor Car. I did not find any weld marks other than original spot weld marks (arrowed) on the left side "B" pillar of the Motor Car which, indicates that there was no re-welding works carried out. In general, I had found all the non-detachable body panels of the Motor Car to be originally fitted at the time of my inspection.
