### **INVESTIGATION REPORT:**

Insured : GBE 5165A

Date of Accident : 19 February 2021

Location : Telok Blangah Road near Labrador Park MRT Station

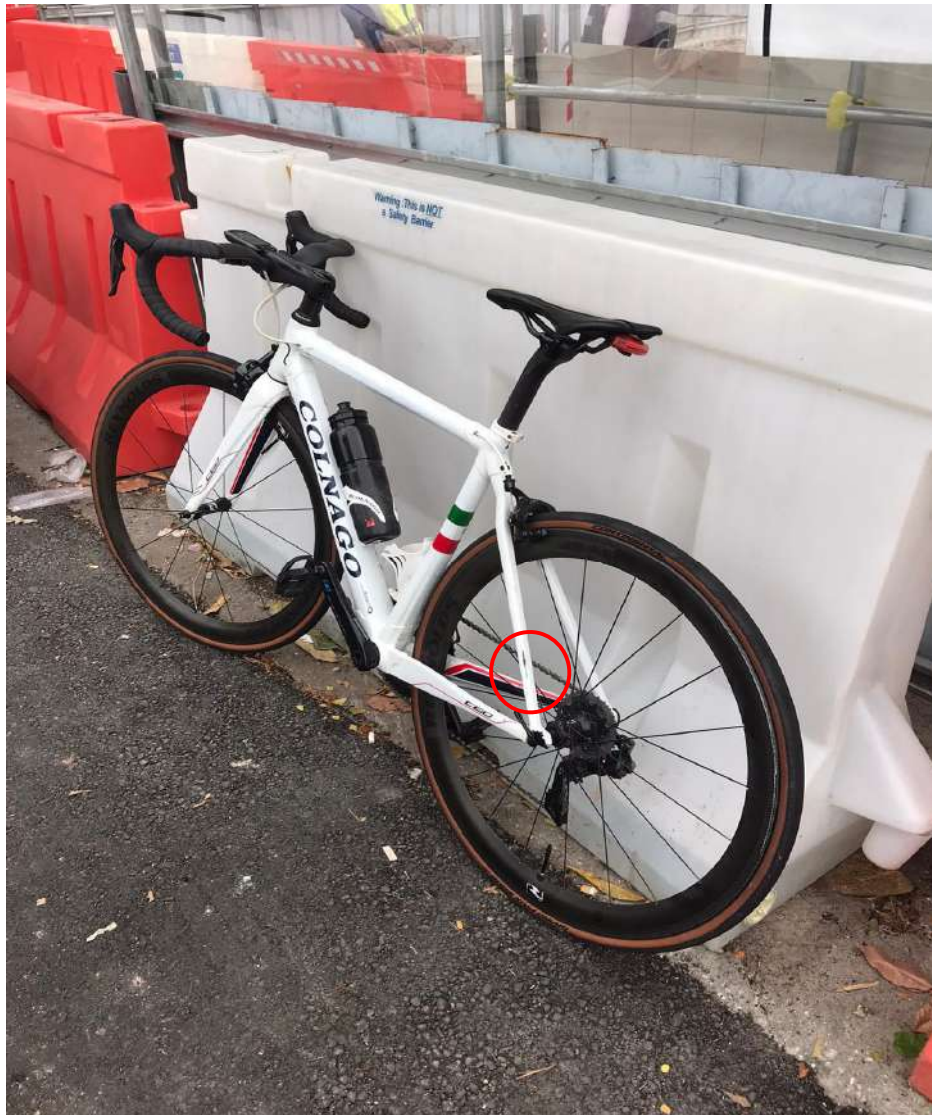
10. We managed to obtain a photograph of the bicycle post- interview from Mr Leow. The photograph had showed damages to the bicycle. Upon closer examination, we observed black marks on the left portion of the rear frame of the bicycle. See photos 7 & 8 below.

**Photo 7** shows the bicycle post- accident which was taken by Mr Leow. The photographs had showed damages to the bicycle at the left portion of the rear frame (circled).

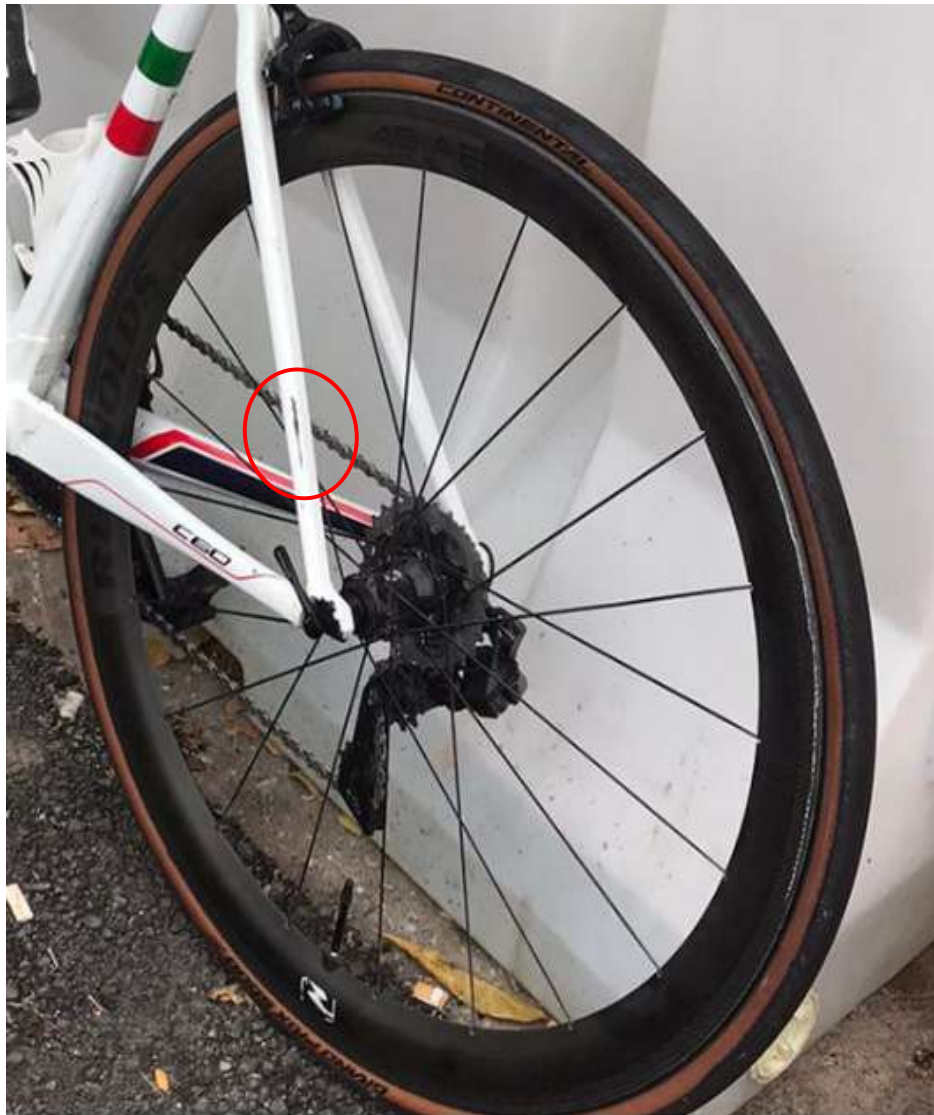
**Photo 8** shows a closer view of the damages to the bicycle at the left portion of the rear frame post- accident. Upon closer examination, we observed black marks on the left portion of the rear frame of the bicycle (circled).

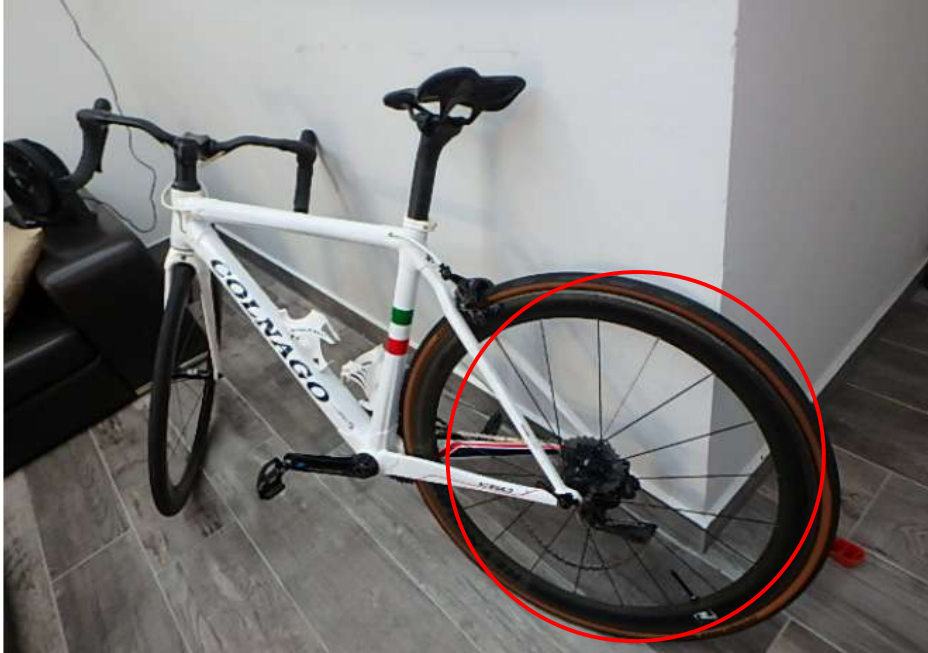
1. From our examination of the photographs taken during the Pre- Repair Survey conducted by LKK Auto Consultants Pte. Ltd., we note that the bicycle had sustained an impact onto its rear portion. The damages were mainly observed to be at or around the rear wheel rim, frame and gear train. See photos 9 - 13 below.

**Photo 9** shows the general view of the left portion of the bicycle at the time of the Pre- Repair Survey conducted by LKK Auto Consultants Pte. Ltd. The damage to the bicycle was observed to be confined around the rear wheel rim and frame (circled).

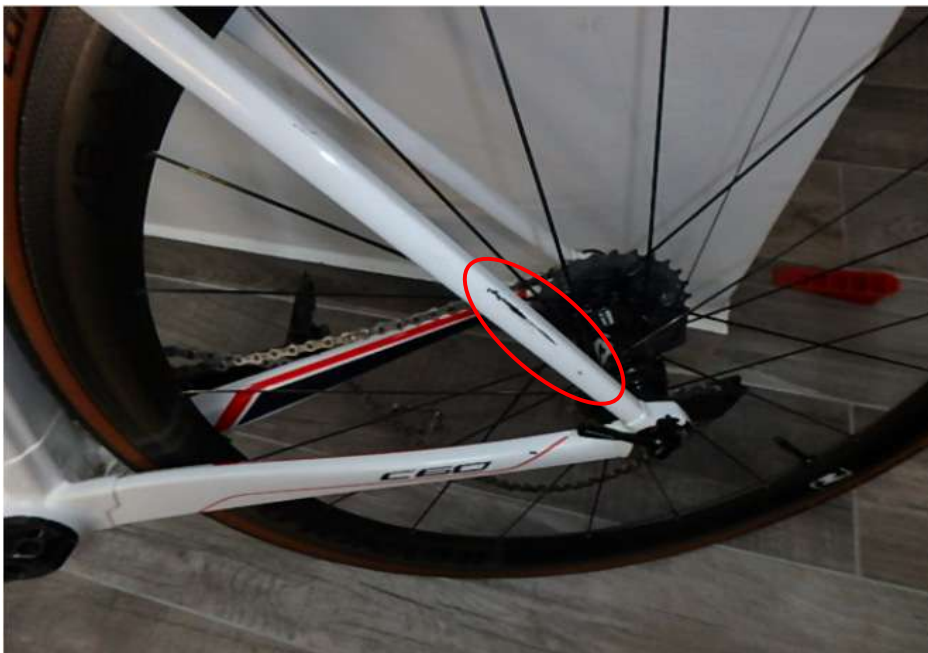
**Photo 10** shows a closer view of the black marks on the left portion of the rear frame of the bicycle (circled).

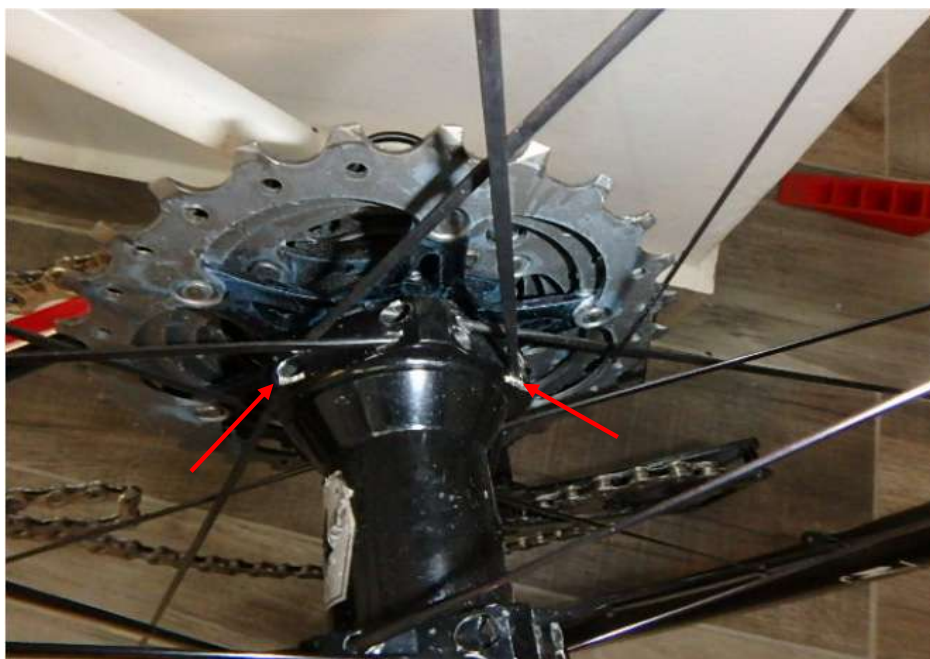
**Photo 11** shows upon closer inspection, the spokes of the rear wheel rim of the bicycle was observed to be slightly deformed (arrowed).

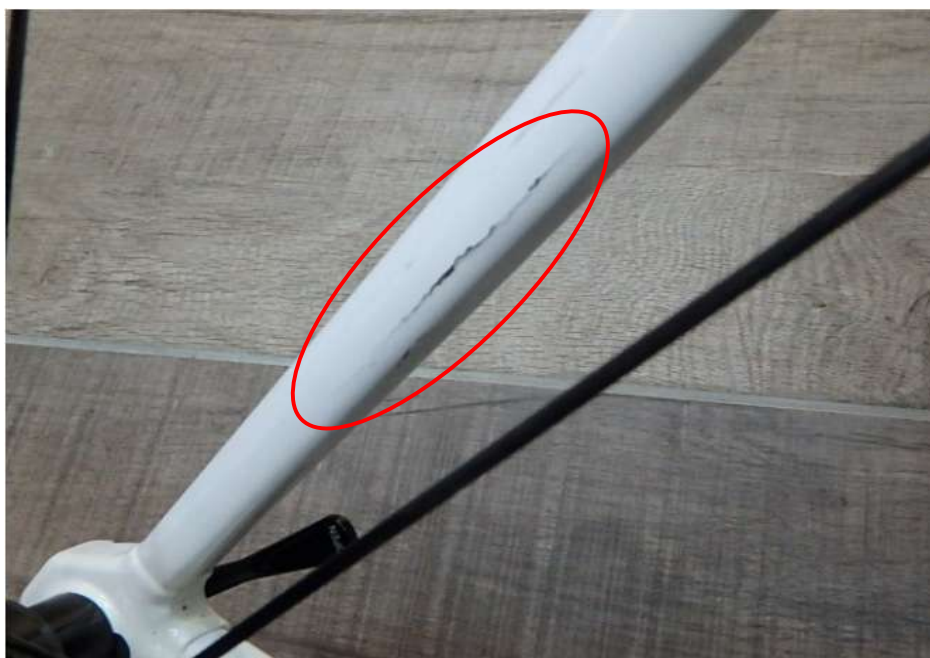
**Photo 12** shows a crack on the right portion of the rear frame of the bicycle (circled).

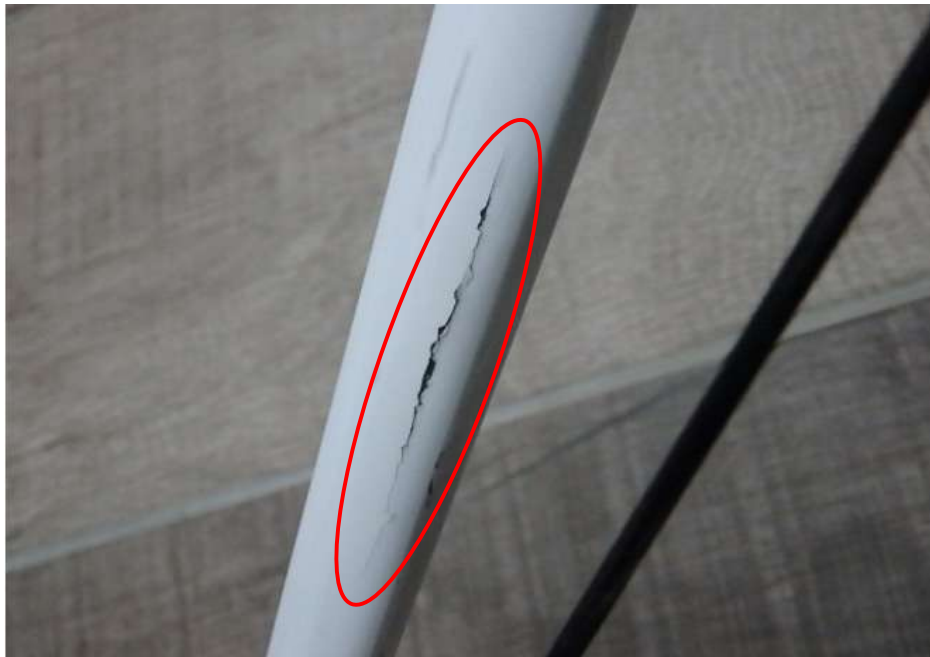
**Photo 13** shows a close up view of the crack on the right portion of the rear frame of the bicycle (circled).

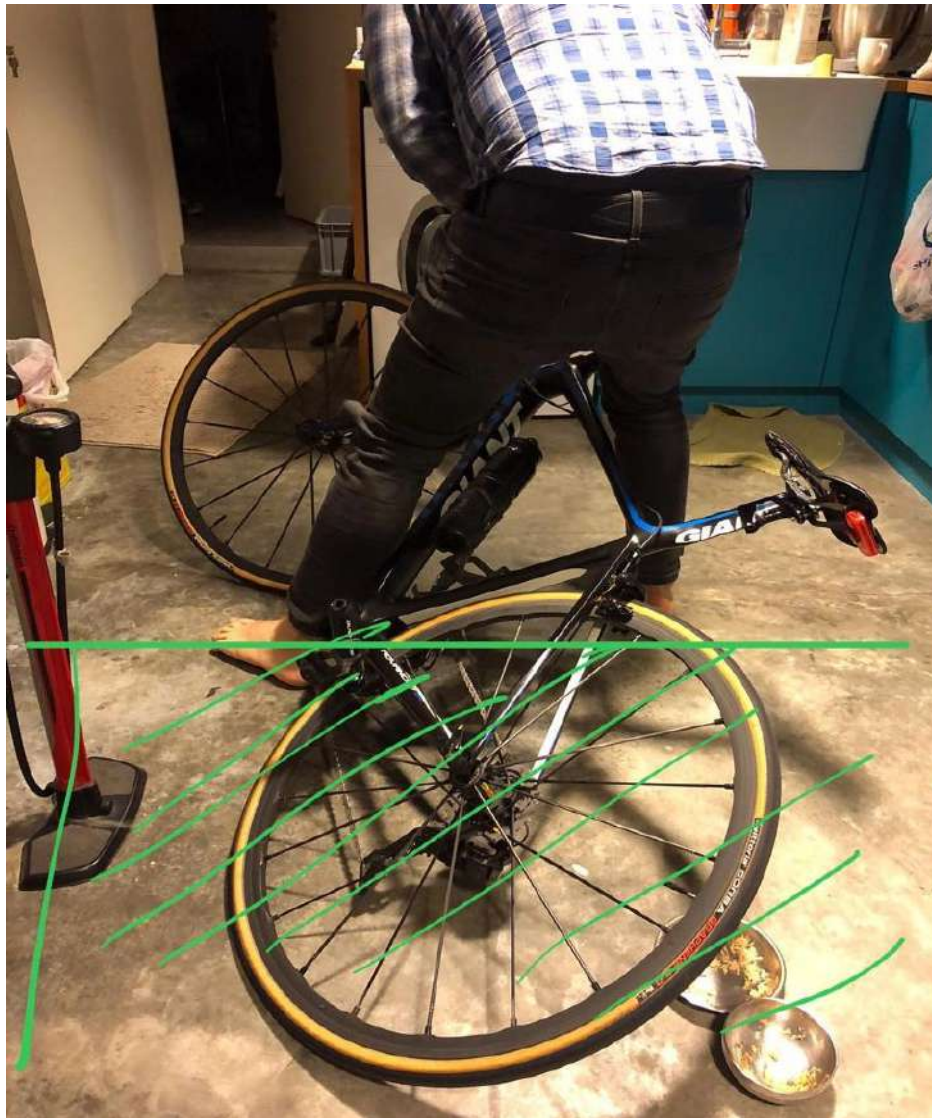
11.A follow up with the cyclist by the LKK surveyor had revealed the circumstances of the accident. He mentioned that the front bumper of the Insured Vehicle had went over the bicycle. The cyclist was able to hold on to the steering handle, preventing the bicycle from falling. The photograph obtain from the cyclist seemed to corroborate with his account of the accident. The damages to the bicycle were also consistent to the cyclist's account. See Screenshot 1 below.

**Screenshot 1** shows the re-enactment of the position of the bicycle post-accident. The cyclist mentioned to the LKK surveyor that the front bumper of the Insured Vehicle had went over the bicycle. The cyclist was able to hold on to the steering handle, preventing the bicycle from falling. The photograph obtained from the cyclist seemed to corroborate with his account of the accident. The damages to the bicycle were also consistent to the cyclist's account (as marked by the green lines).
