Your Ref: S1M033YE
Our Ref : CS4/ASM21002653/P

5th April 2021

**TECHNICAL INVESTIGATION REPORT OF FIRE INCIDENT INVOLVING THE
INSURED VEHICLE SMV 3691R ON 23rd February 2021**

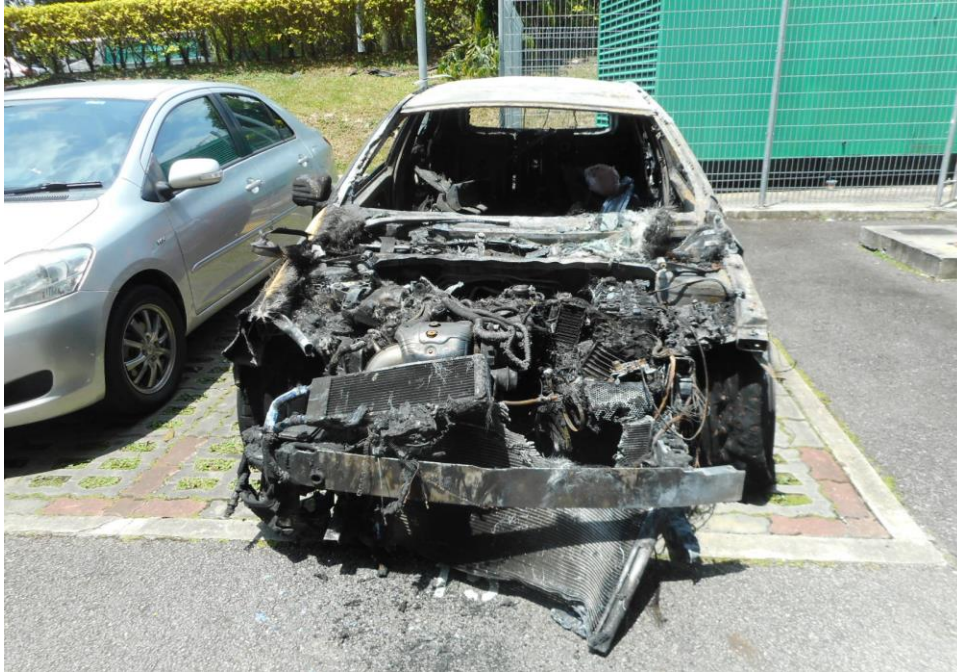
Photo 1 shows the general view of the front portion of the Insured Vehicle at the time of our inspection. The Insured Vehicle was observed to have sustained extensive fire damage all around. Its engine compartment and interior compartment were completely burnt. Rust had accumulated all over the front and centre portion of the Insured Vehicle as a result of exposure to environmental condition for a period of time.

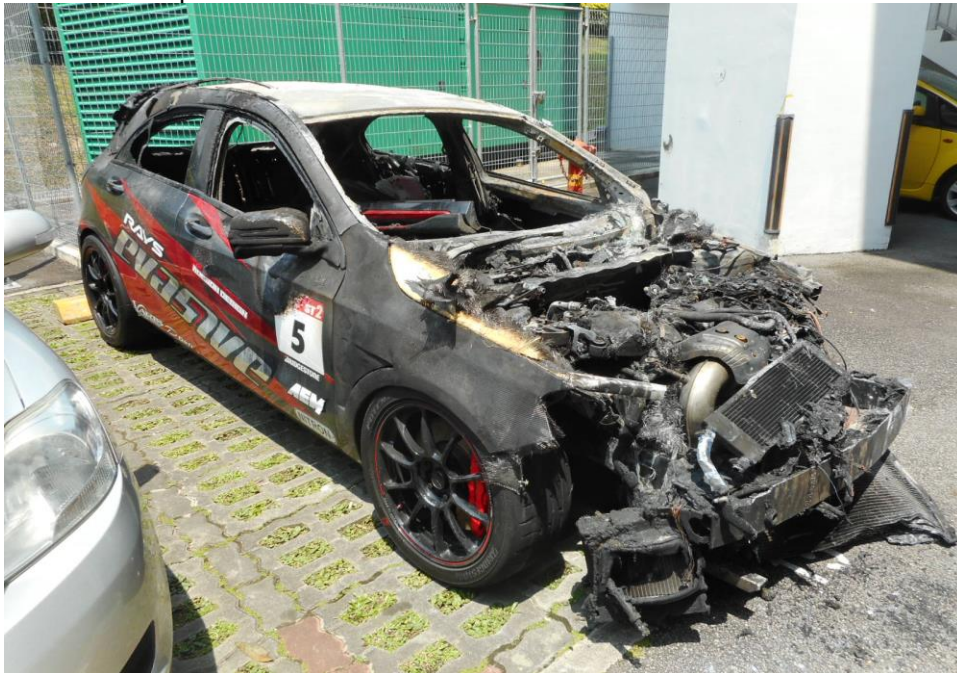
Photo 2 shows the general view of the right body of the Insured Vehicle at the time of our inspection. The Insured Vehicle was observed to have sustained extensive fire damage all around. Rust had accumulated all over the front and interior compartment of the Insured Vehicle as a result of exposure to environmental condition for a period of time.

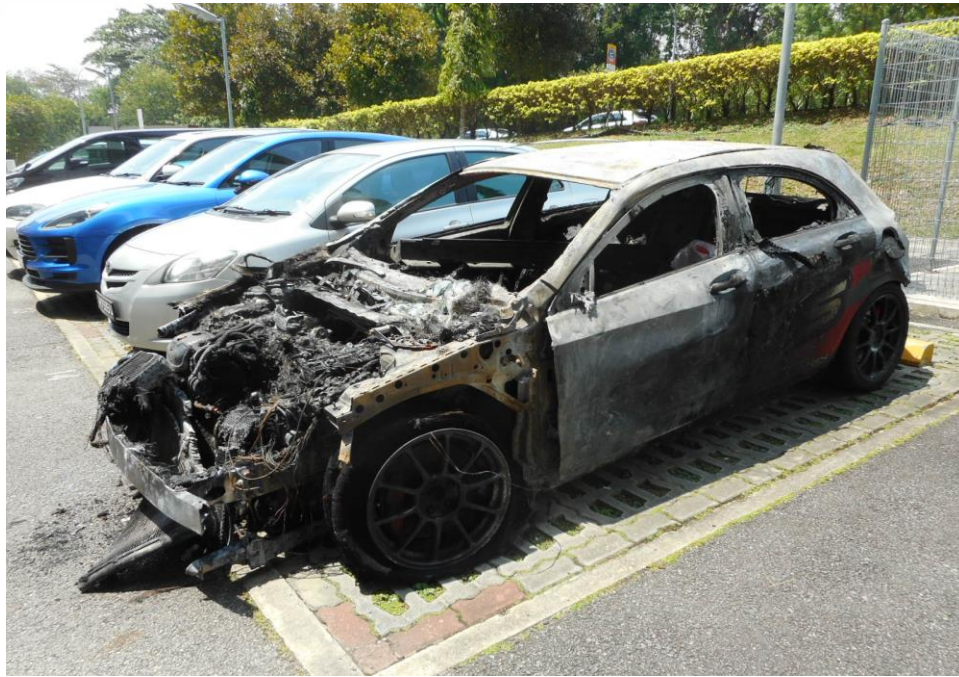
Photo 3 shows the general view of the left body of the Insured Vehicle at the time of our inspection. The Insured Vehicle was observed to have sustained extensive fire damage all around. Rust had accumulated all over the front and centre portion of the Insured Vehicle as a result of exposure to environmental condition for a period of time.

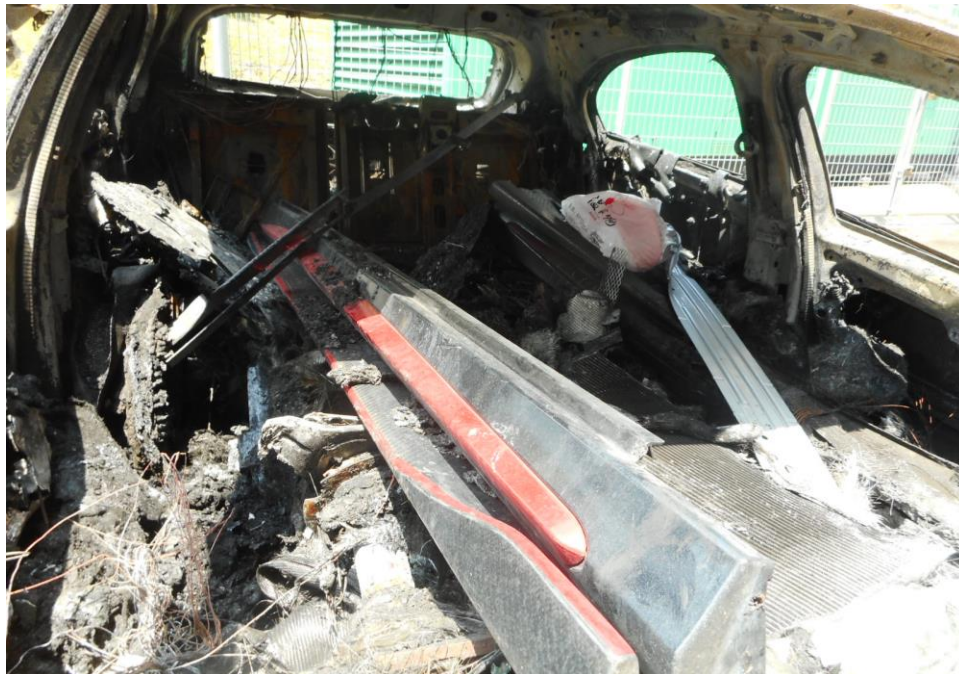
Photo 4 shows the general view of the interior compartment of the Insured Vehicle at the time of our inspection. Its interior compartment was completely burnt as a result of the fire.

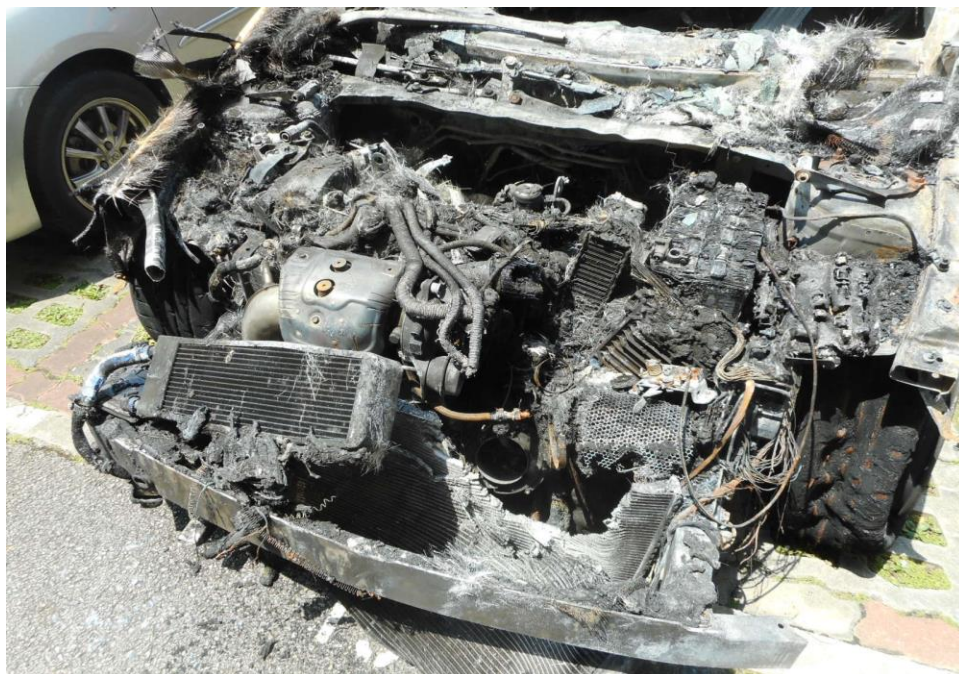
Photo 5 shows the engine compartment of the Insured Vehicle at the time of our inspection. The entire engine compartment of the Insured Vehicle was observed to be severely burnt. Most of the parts inside the engine compartment were found to be burnt and/or melted as a result of the fire.

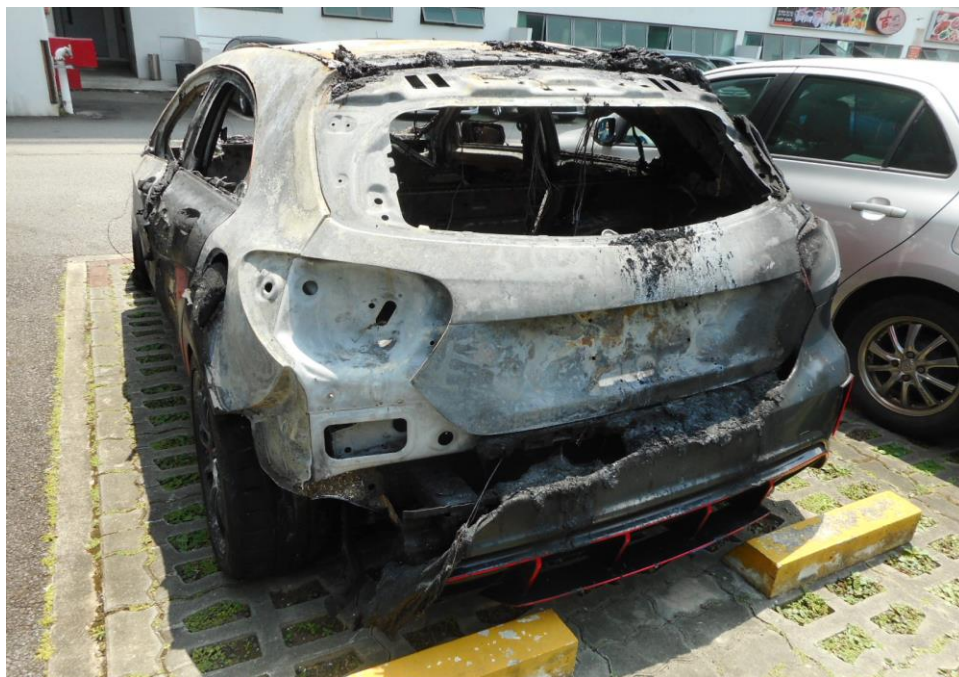
Photo 6 shows the general view of the rear portion of the Insured Vehicle which was observed to be affected heat and smoke damage at the time of our inspection as a result of the fire.

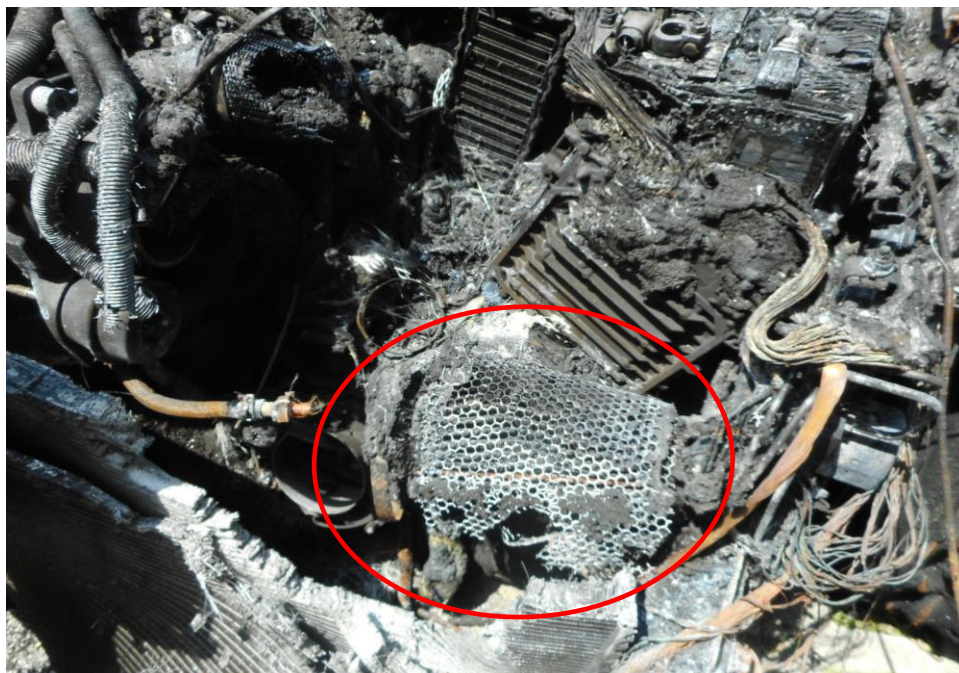
Photo 7 shows a general view an aftermarket air filter (circled) on the Insured Vehicle, which was observed to be affected by the fire.

27. We observed other items such as the aftermarket air filter, sport rims, carbon fibre bonnet, front fenders and an aftermarket subwoofer fitted on the Insured Vehicle at the time of our inspection of the Insured Vehicle. In our opinion, these components did not cause or contribute to the fire incident as the cause of fire was observed to be of short circuit origin on the original wiring harness at the front engine compartment of the Insured Vehicle.

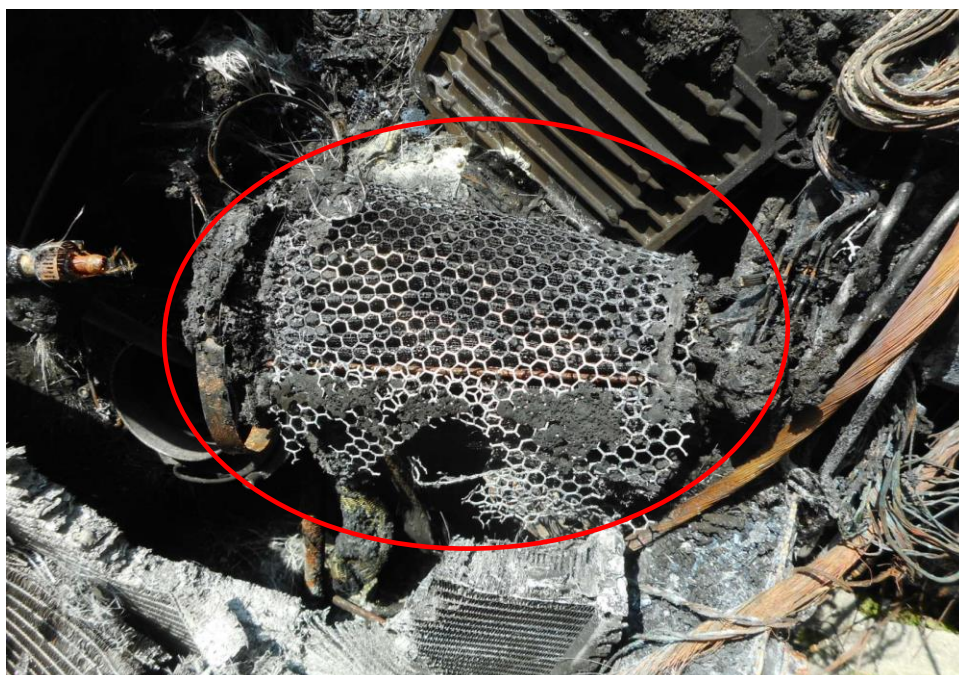
Photo 8 shows a close up view of the aftermarket air filter (circled) on the Insured Vehicle, which was observed to be affected by the fire.

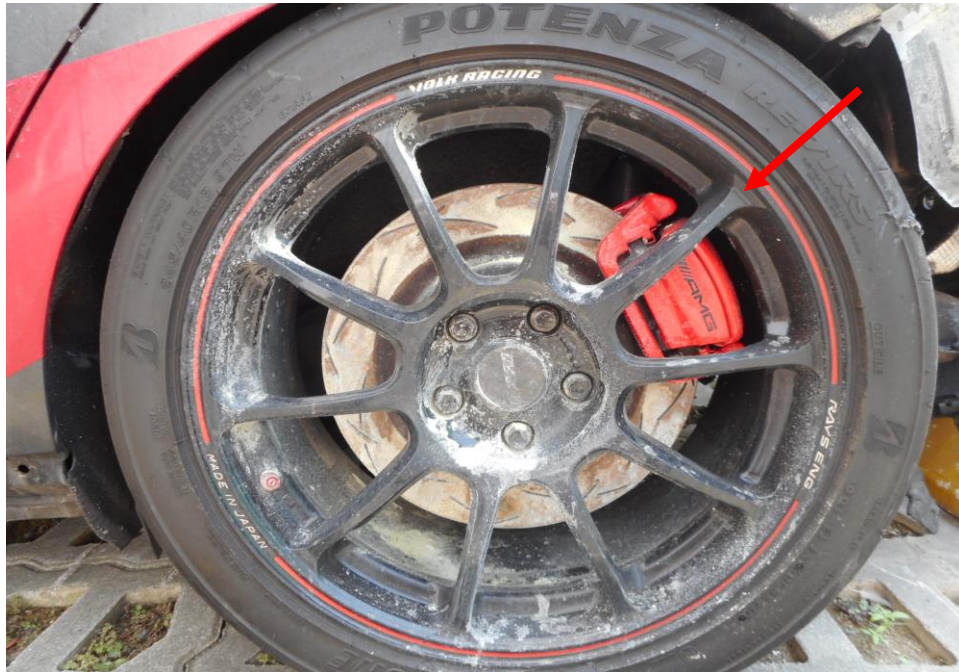
Photo 9 shows an aftermarket rim (arrowed) on the Insured Vehicle, which was observed to be unaffected by the fire.

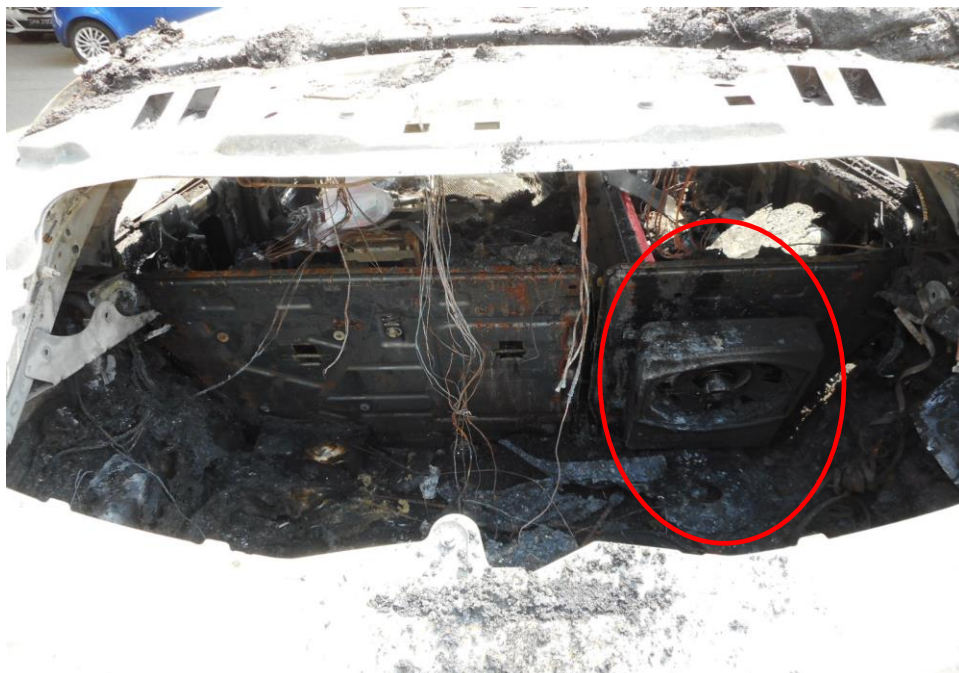
Photo 10 shows a general view of the aftermarket subwoofer (circled) on the Insured Vehicle, which was observed to be damaged by the fire.

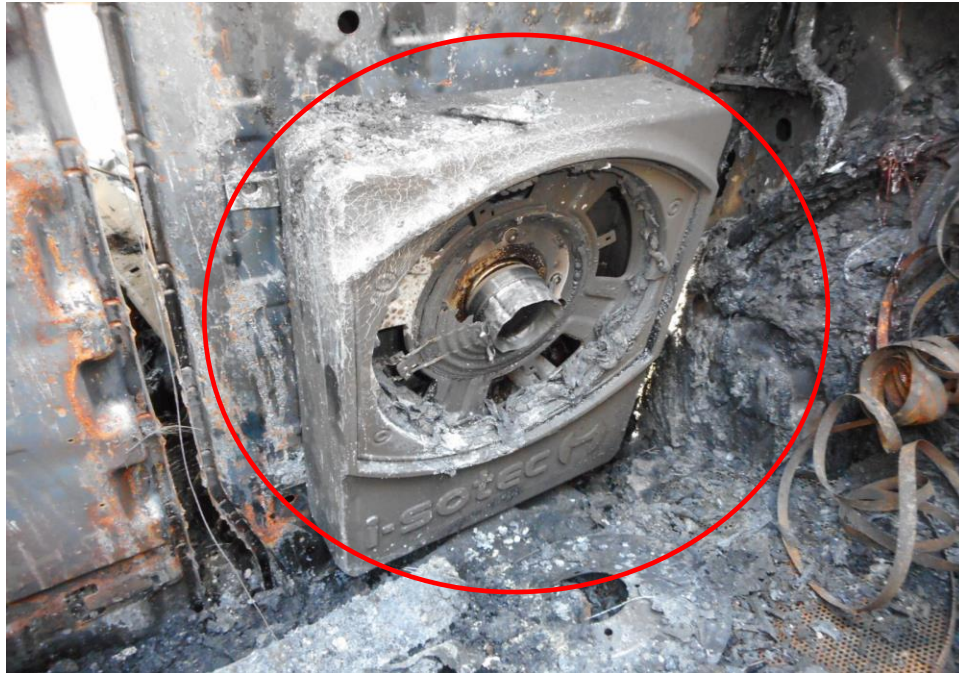
Photo 11 shows the close up view of the aftermarket subwoofer (circled) on the Insured Vehicle, which was observed to be damaged by the fire.

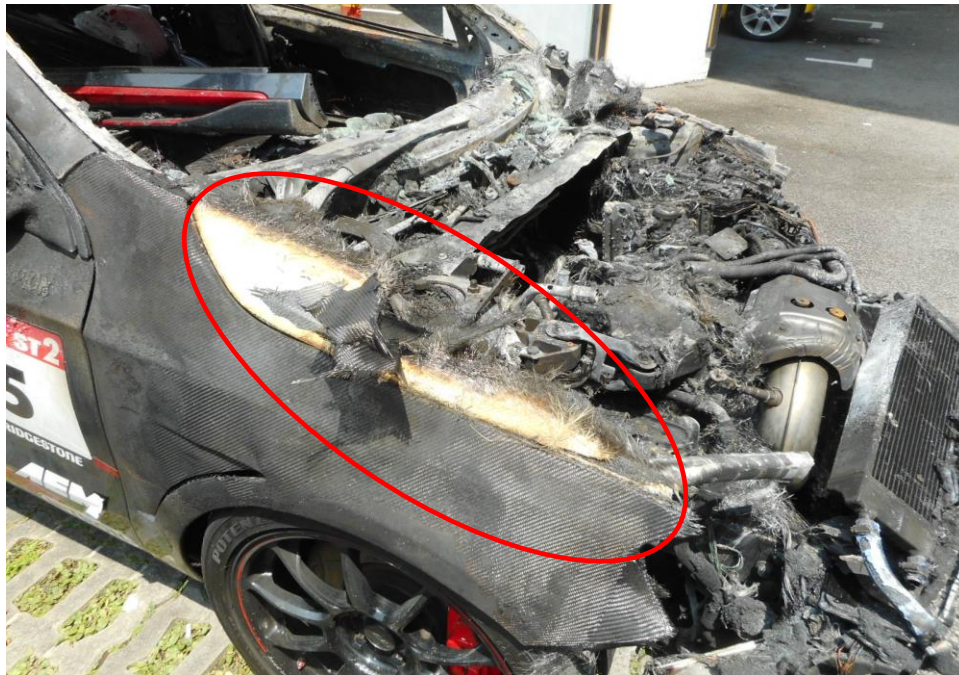
Photo 12 shows the general view of the aftermarket carbon fibre bonnet and fenders (circled) on the Insured Vehicle, which was observed to be damaged by the fire.

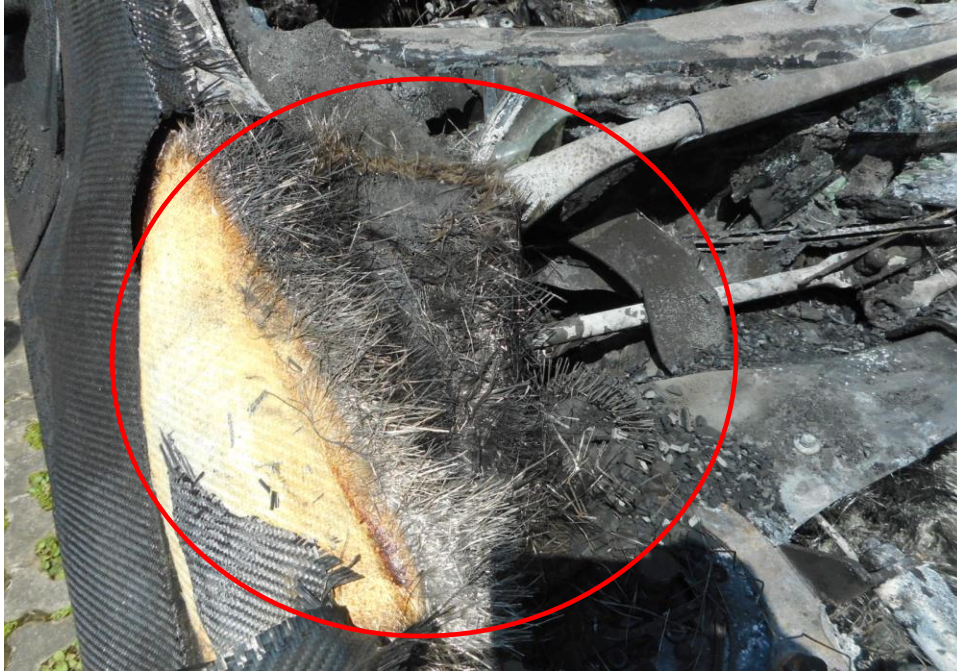
Photo 13 shows the close up view of the aftermarket carbon fibre bonnet and fenders (circled) on the Insured Vehicle, which was observed to be damaged by the fire.

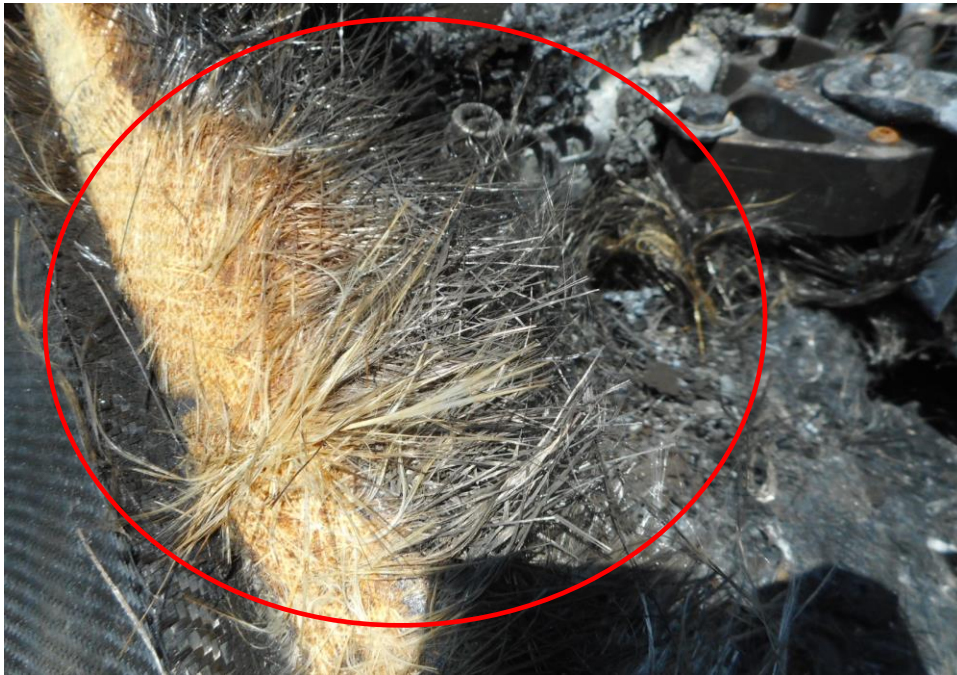
Photo 14 shows the close up view of the aftermarket carbon fibre bonnet and fenders (circled) on the Insured Vehicle, which was observed to be damaged by the fire.

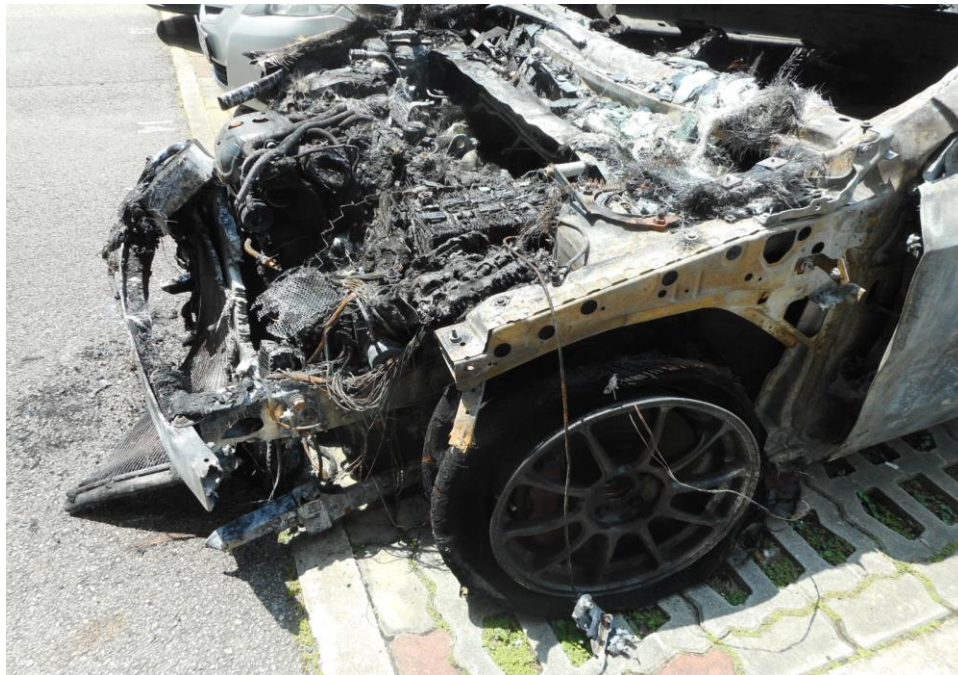
7. Based on the circumstances for this particular case, the fire appears to have originated from the front of the Insured Vehicle, somewhere around the front left and spread to the entire portion of the Insured Vehicle. This can be determined basing on the area where the extent of fire damage was most severe, the circumstances of the fires' origin at the material time of incident and also the high heat intensity burn marks (whitish burn marks) that were found at the front left portion of the Insured Vehicle.

8. These whitish burn marks are a result of exposure to prolong heat intensity. Rust would normally start to develop around these areas soon after a fire as the prolonged exposure to high heat intensity usually causes the bare steel/metal material of the body parts to be exposed to natural environmental condition. The rust that had developed on the front left portion, in the immediate vicinity of where these whitish burn marks were found, would also support our findings of where the fire had affected the Insured Vehicle. See photo 15 and 16 below.

Photo 15 shows the general view of the exterior of the front left fender of the Insured Vehicle at the time of our inspection. The high heat intensity burn marks (whitish burn marks) and rust that had development found on the exterior surface of the bonnet indicates that the fire had originated from the front left portion of the Insured Vehicle.

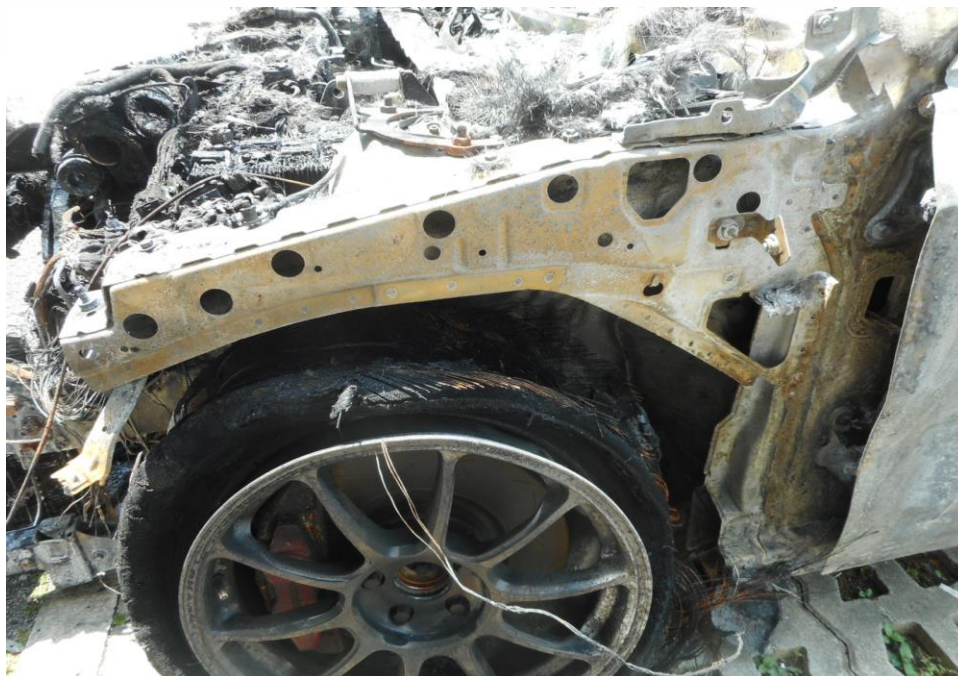
Photo 16 shows the close up view of the exterior of the front left fender of the Insured Vehicle at the time of our inspection. The high heat intensity burn marks (whitish burn marks) and rust that had development found on the exterior surface of the front left fender indicates that the fire had likely originated from the front left portion of the Insured Vehicle.

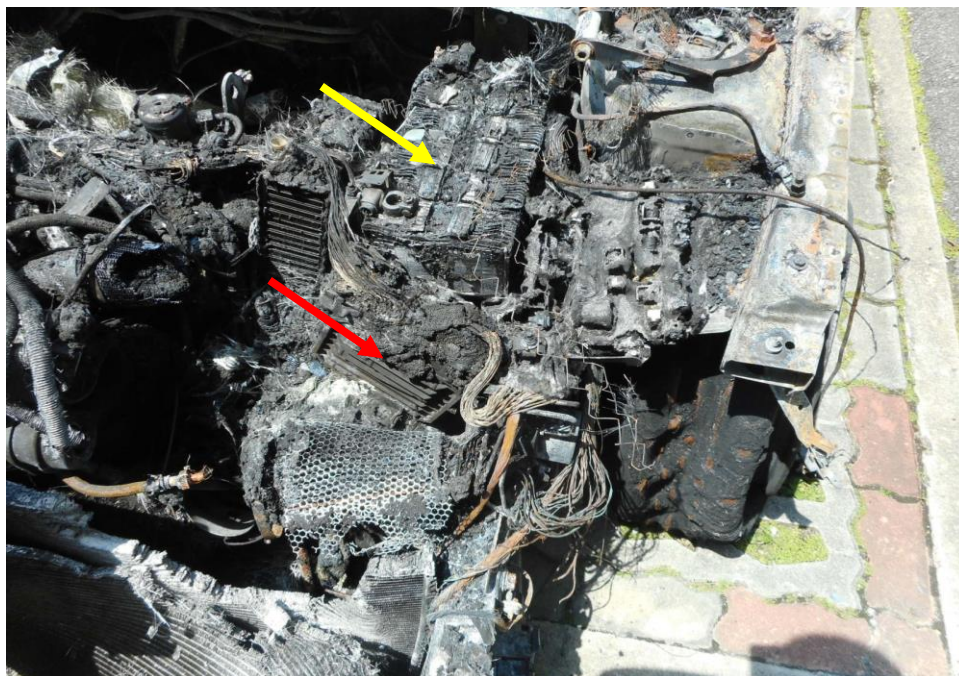
9. Upon closer examination of the front left portion of the Insured Vehicle which was where the fire had likely started, we had found traces of greenish residue on the main wiring's harnesses leading from the engine control unit to the electrical components of the Insured Vehicle. The wirings were original wirings fitted from the manufacturer. The presence of greenish residue indicates internal heating of copper wires, a sign of an electrical short circuit occurring. The greenish residue is normally left behind from the oxidation as a result of chemical reaction involving the copper wires. This physical evidence would then appear to suggest that the cause of fire to the Insured Vehicle could have possibly been due to electrical in nature. See photos 17 - 20 below.

Photo 17 shows the general view of the engine compartment of the Insured Vehicle at the time of our inspection. The fire damage to the Insured Vehicle has affected its engine compartment. Its engine control unit (red arrow), battery (yellow arrow) and various original wiring harnesses was amongst the parts in the compartment that were found to have been affected as a result of the fire.

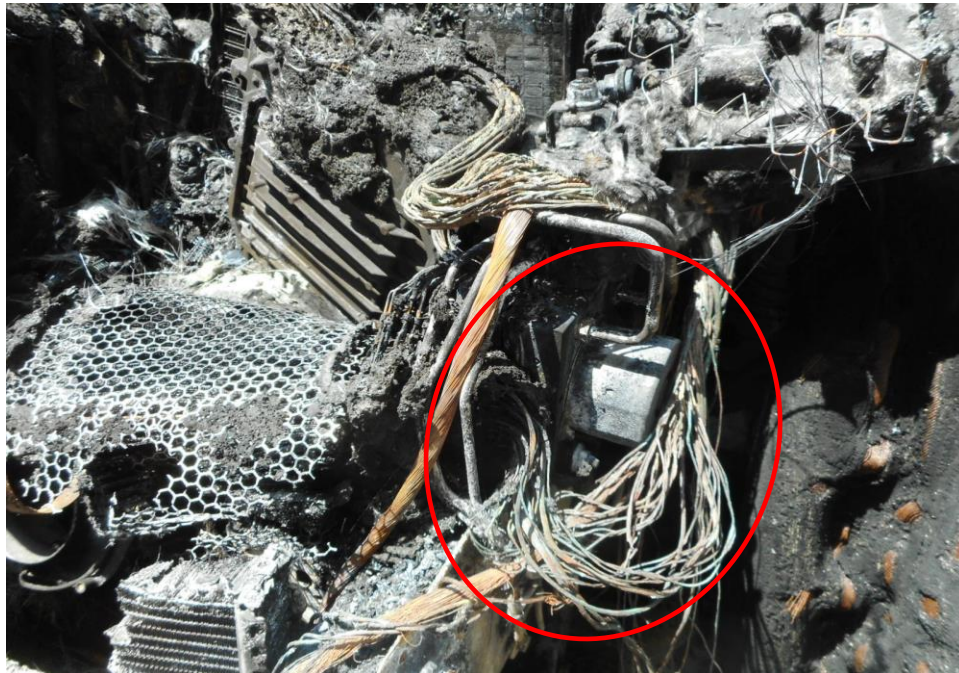
Photo 18 shows a close up view of the original wiring harness in the engine compartment. The original wiring harness from the engine control unit (circled) was observed with greenish residue on the surface. The presence of greenish residue indicates internal heating of copper wires, a sign of an electrical short circuit occurring. The greenish residue is normally left behind from oxidation as a result of chemical reaction involving the copper wires.

26. Having investigated and technically analysed the damages of burnt nature to the Insured Vehicle, we are of the view that the cause of fire to the Insured Vehicle was of electrical nature. The fire had originated along the original wiring harnesses leading from the engine control unit to the electrical components of the Insured Vehicle.

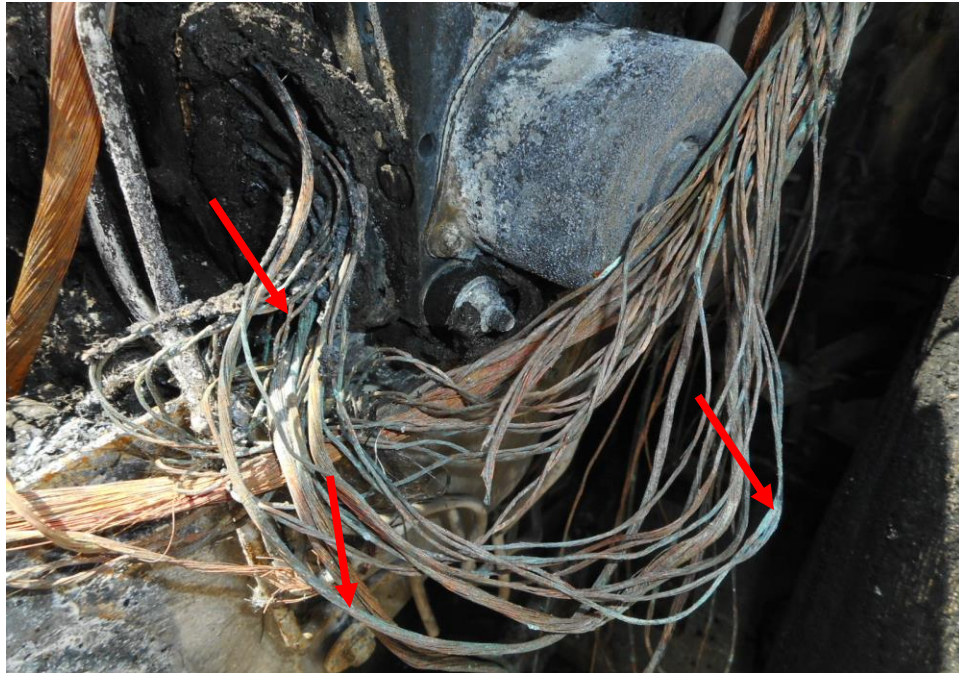
Photo 19 shows a close up view of the original wiring harness from the engine control unit in the engine compartment. The original wiring harness (arrowed) was observed with greenish residue on the surface. The presence of greenish residue indicates internal heating of copper wires, a sign of an electrical short circuit occurring. The greenish residue is normally left behind from oxidation as a result of chemical reaction involving the copper wires.

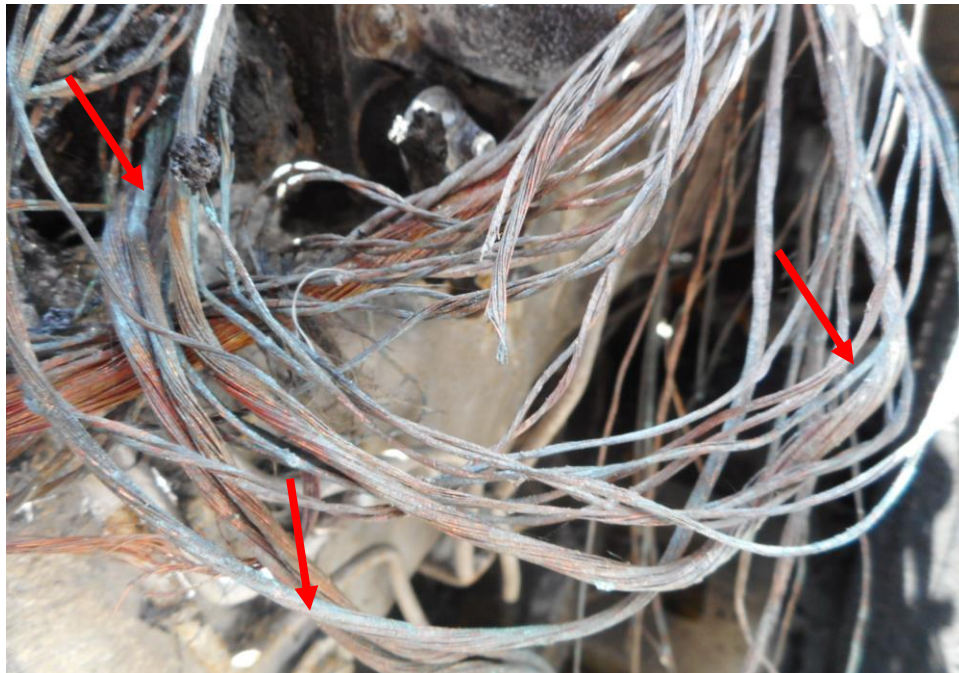
Photo 20 shows a close up view of the original wiring harness from the engine control unit in the engine compartment. The original wiring harness (arrowed) was observed with greenish residue on the surface. The presence of greenish residue indicates internal heating of copper wires, a sign of an electrical short circuit occurring. The greenish residue is normally left behind from oxidation as a result of chemical reaction involving the copper wires.

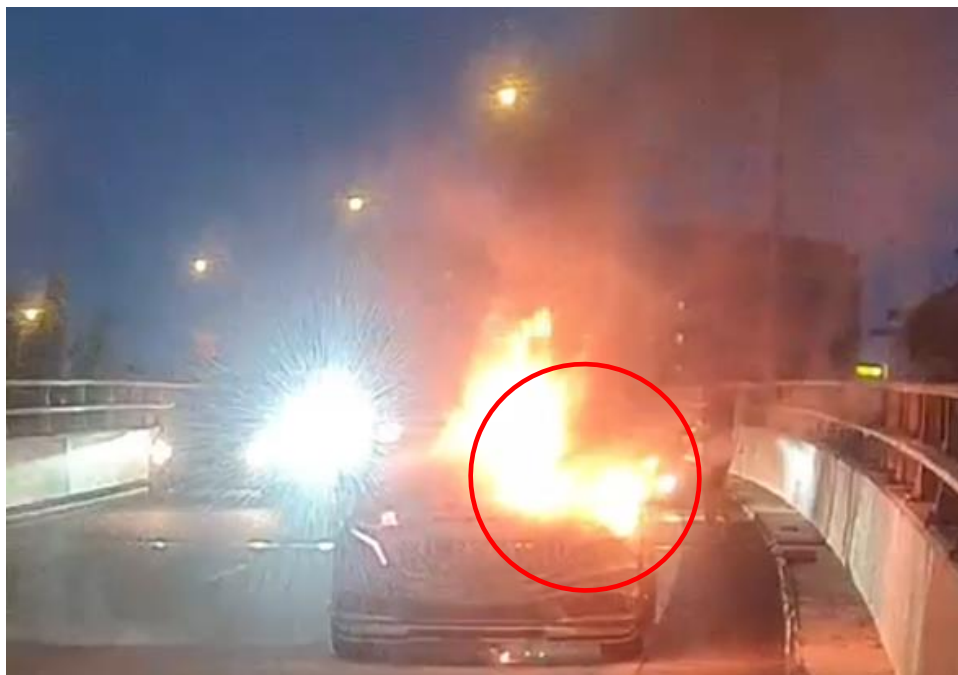
21. Our examination of these photographs revealed that the fire had started from the front of the Insured Vehicle. The photographs had also showed the Insured Vehicle on fire and similar extent of damage and burn pattern to the Insured Vehicle as per what we had observed during our physical inspection of the Insured Vehicle. Apart from the aforesaid; there was no further notable information that could be gathered from these photographs. See photo 21 below which was provided to us by Mr Lim.

Photo 21 shows the fire started burning from the front left side of the engine compartment (circled) of the Insured Vehicle at Bartley flyover. In general, the information that could be gathered from this photograph had corresponded to the events that were related to us by Mr Lim, location when the fire broke out.
