Your Ref: BMW M4  
(chassis number WBS4Y92060AG10423)  
Our Ref : CI/TP21002737/D

08 March 2021

**INSPECTION REPORT OF AN UNREGISTERD BMW M4 MOTOR CAR WITH  
CHASSIS NUMBER WBS4Y92060AG10423**

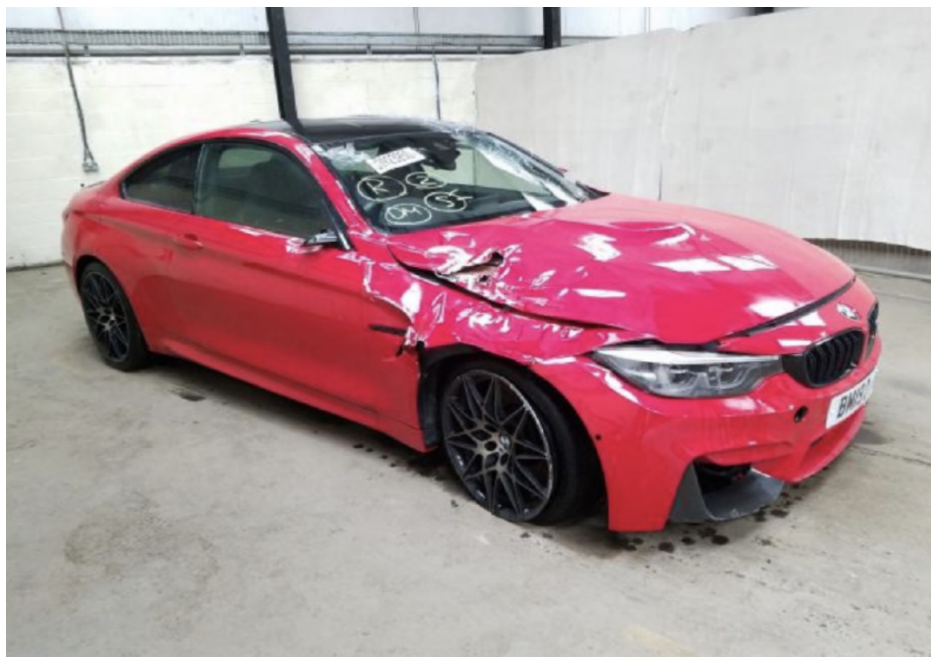
3. From the photographs provided to me, it was observed that the Motor Car had sustained damages at its right front portion. Body parts damaged include the front bumper, front right headlamp, front right fender, front right door, right side "A" pillar outer panel, front right wheel rim, right side wing mirror and front bonnet amongst others. The front right undercarriage part(s) was affected.
4. Apart for the right front portion, there appears to be no visible damage to other areas of the Motor Car. The airbags of the Motor Car were not activated as seen from the photographs that were provided to me. See photo 1 – 4 below.

**Photo 1** shows the front right body of the Motor Car (photograph provided to me). The Motor Car was observed to have sustained damage at its right front portion. The front bumper, front right headlamp, front right fender, front bonnet, front right wheel, right side wing mirror and right side "A" pillar outer panel were amongst the body parts that were observed to have been damaged. The front right undercarriage part(s) was affected.

22. The body parts at the right front portion of the Motor Car were visually examined and it was noted that the repair/restoration works carried out to the damaged area of the Motor Car (refer to photograph 1 above) were reasonably adequate and in order.

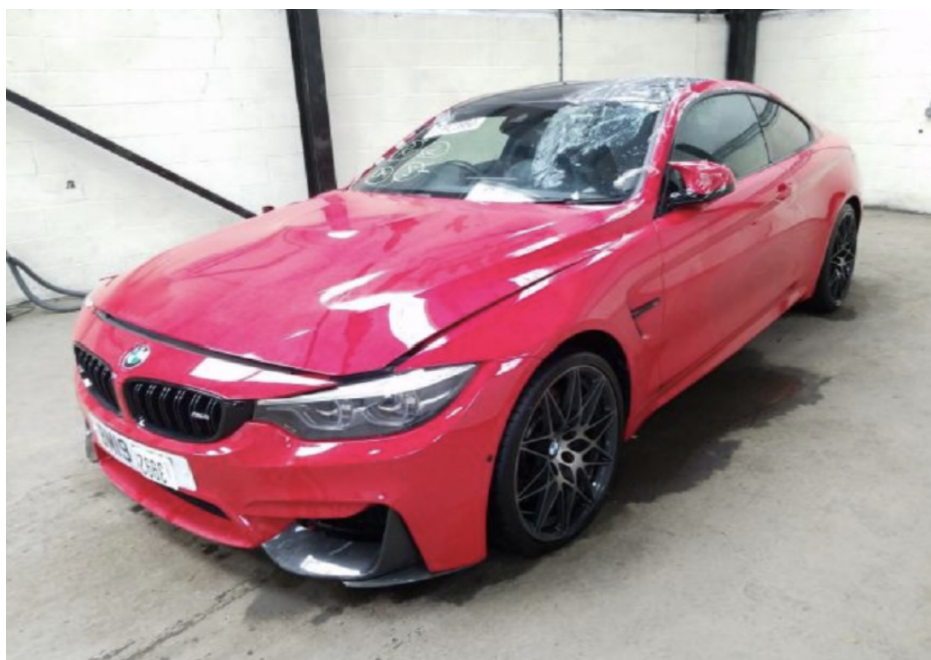
**Photo 2** shows the front left body of the Motor Car (photograph provided to me). Apart for the right front portion, there was no physical damage seen to other areas of the Motor Car.

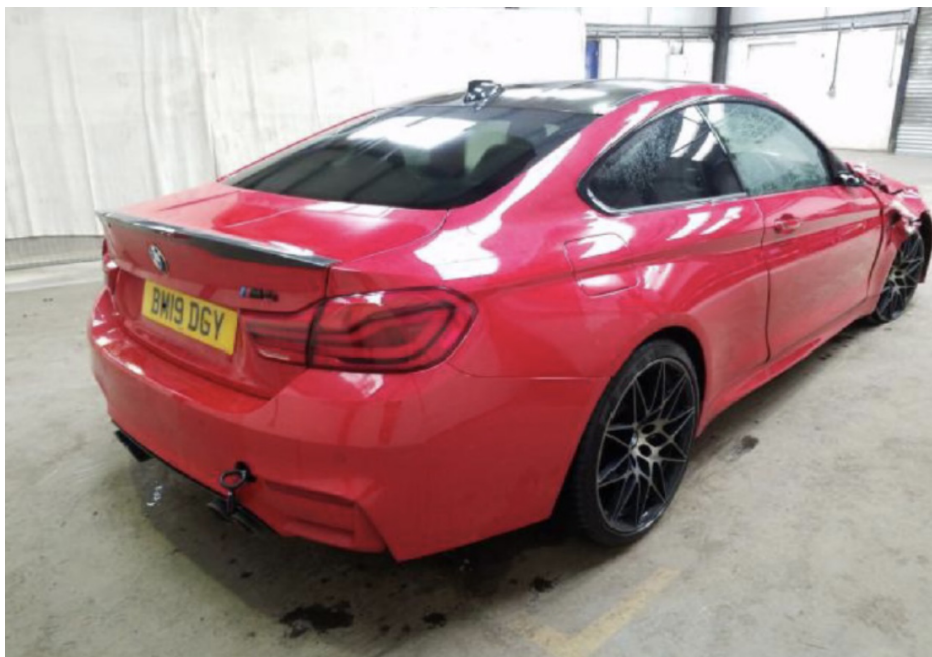
**Photo 3** shows the rear right body of the Motor Car (photograph provided to me). Apart for the right front portion, there was no physical damage seen to other areas of the Motor Car.

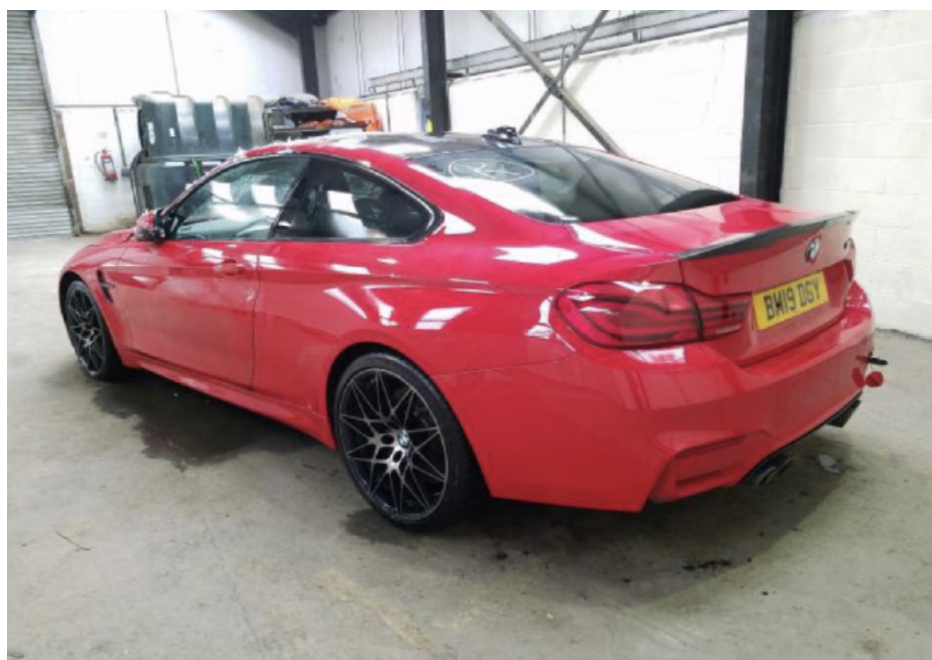
**Photo 4** shows the rear left body of the Motor Car (photograph provided to me). Apart for the right front portion, there was no physical damage seen to other areas of the Motor Car.

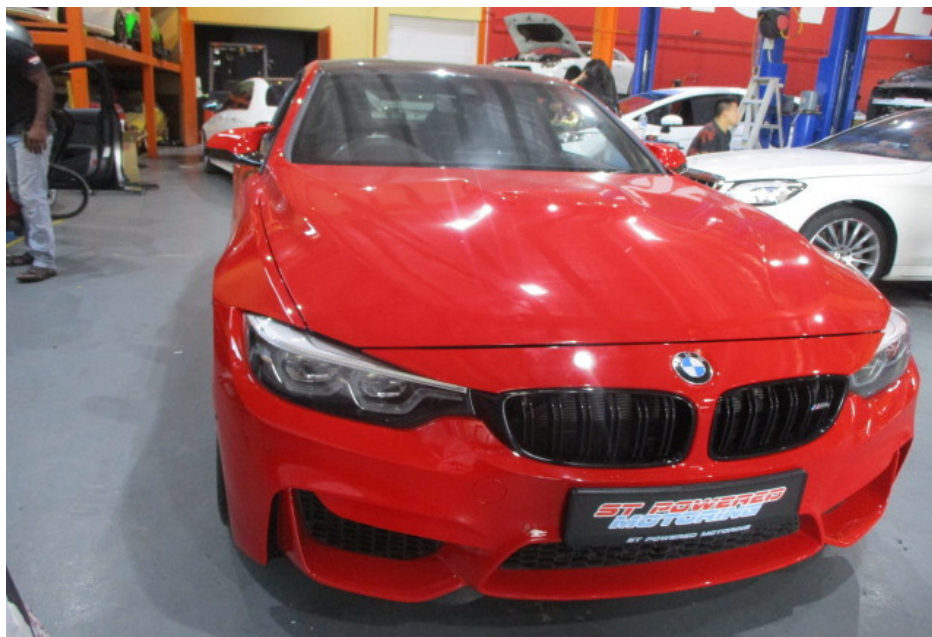
**Photo 5** shows a general view of the front right body of the Motor Car at the time of my inspection. The Motor Car was observed to be in a relatively good general condition with no loose exterior fittings observed. The body parts at the right front portion of the Motor Car were visually examined and it was observed that the repair/restoration works carried out to the damaged area of the Motor Car (refer to photograph 1 above) were reasonably adequate and in order.

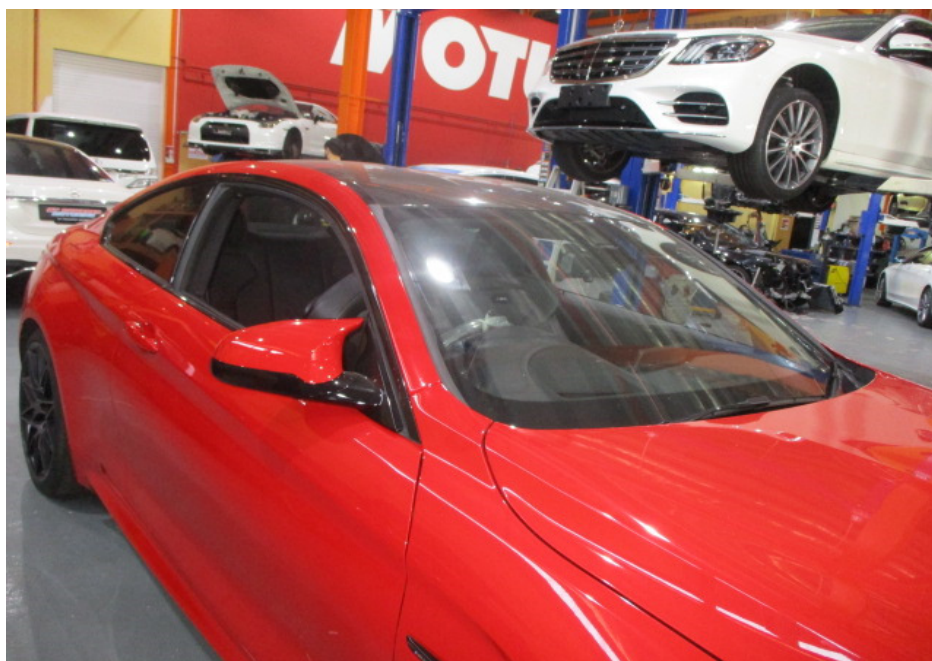
**Photo 6** shows a closer view of the front bonnet, right side "A" pillar outer panel and right side wing mirror of the Motor Car. The body parts at the right front portion of the Motor Car were visually examined and it was observed that the repair/restoration works carried out to the damaged area of the Motor Car (refer to photograph 1 above) were reasonably adequate and in order.

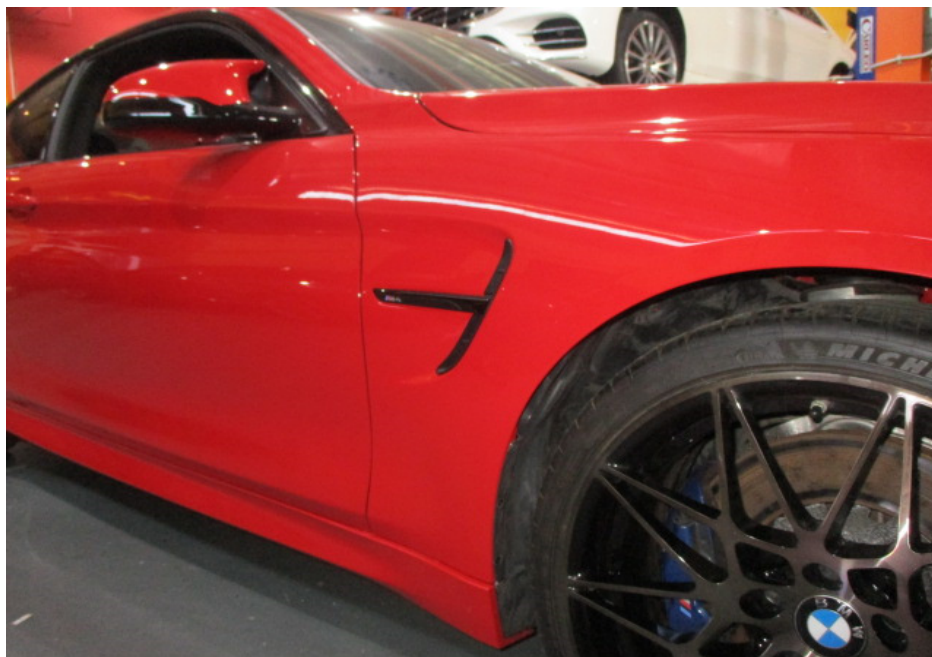
**Photo 7** shows a closer view of the front right fender and front right wheel rim of the Motor Car at the time of my inspection. The body parts at the right front portion of the Motor Car were visually examined and it was observed that the repair/restoration works carried out to the damaged area of the Motor Car (refer to photograph 1 above) were reasonably adequate and in order.

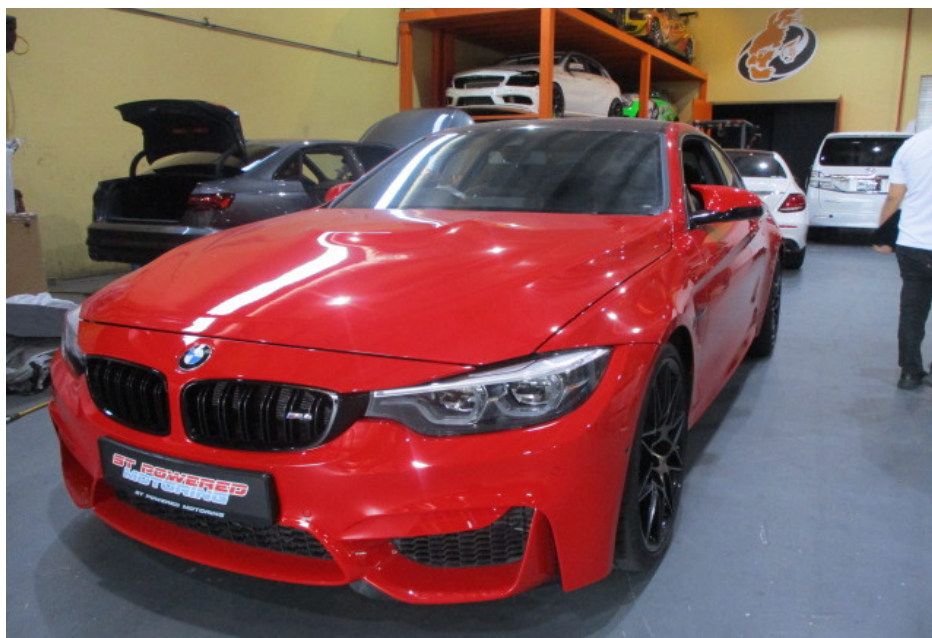
**Photo 8** shows a general view of the front left body of the Motor Car at the time of my inspection. The Motor Car was observed to be in a relatively good general condition with no loose exterior fittings observed. The body parts at the right front portion of the Motor Car were visually examined and it was observed that the repair/restoration works carried out to the damaged area of the Motor Car (refer to photograph 1 above) were reasonably adequate and in order.

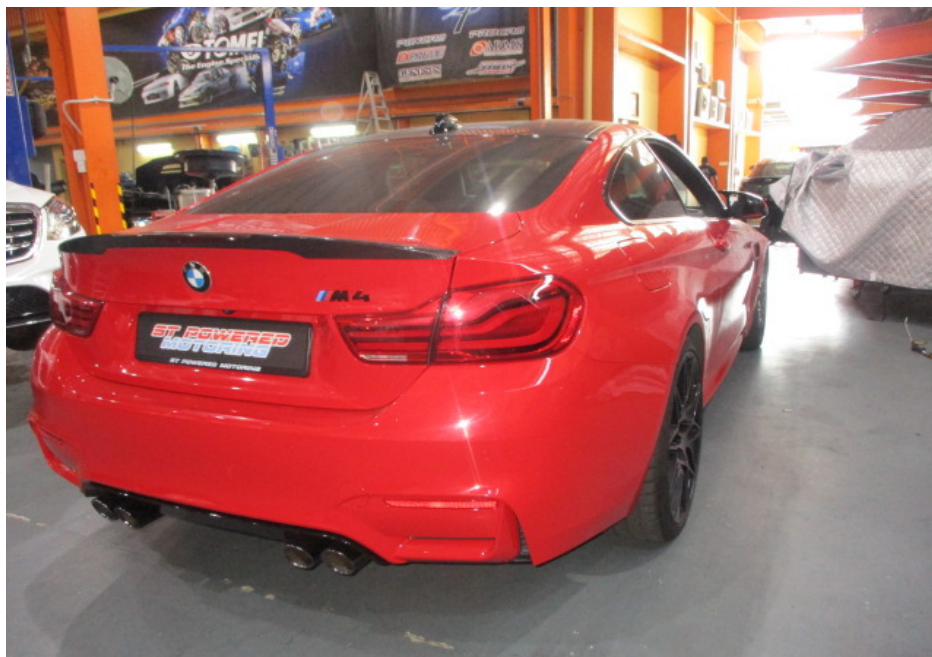
**Photo 9** shows a general view of the rear right body of the Motor Car at the time of my inspection. The Motor Car was observed to be in a relatively good general condition with no loose exterior fittings observed. The mileage of the Motor Car recorded at the time of my inspection was 12,192km.

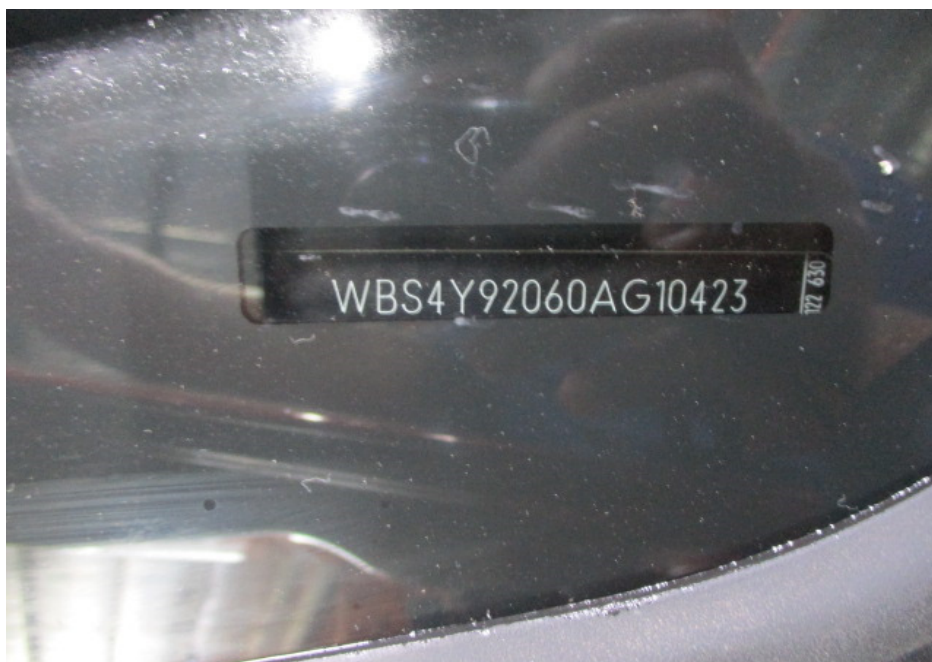
**Photo 10** shows the chassis number of the Motor Car. The chassis number recorded was WBS4Y92060AG10423.

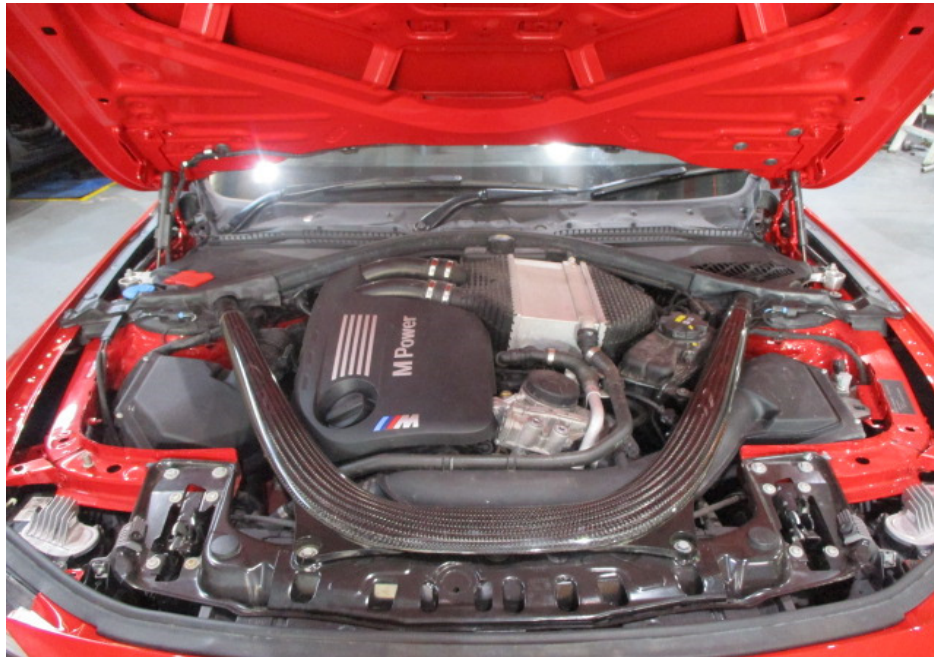
14. My examination of the engine compartment of the Motor Car revealed that the various parts and components inside the engine compartment were all intact and properly fitted. The engine oil, brake fluid and engine coolant were all found to be of sufficient level for operating purposes. Visually, there was also no contamination found to these fluids.
15. My checks on the underside of the Motor Car revealed no sign(s) or indication(s) of fluid leakage and/or fluid stain(s). The engine block and automatic transmission assembly were both secured properly. All undercarriage components of the Motor Car were also observed to be intact and secured in an appropriate manner.

**Photo 11** shows a general view of the engine compartment of the Motor Car at the time of my inspection. The various parts and components inside the engine compartment were all observed to be intact and properly fitted. There was also no sign(s) or indication(s) of fluid leak and/or fluid stain found inside the engine compartment.

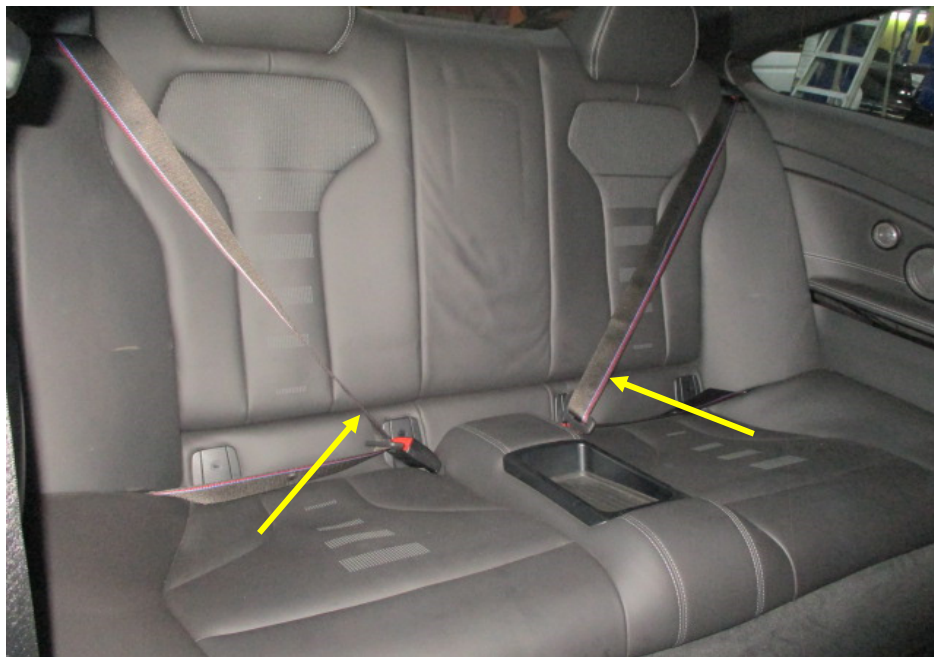
12. The seats of the Motor Car were found to be secured to the floorboard of the Motor Car via seat rails bolted onto the floorboard. Retractable seat belt reels and pre-tensioners were fitted on all seats of the Motor Car. The seat belts were tested and were able to be fastened securely into the respective pre-tensioners that were fixed to the side of all the seats.

**Photo 12** shows the seats of the Motor Car, which were secured via seat rails (arrowed) to the floorboard. All the seats of the Motor Car were fitted with a retractable seat belt reel and pre-tensioner. The seat belts (arrowed) were tested and were able to be fastened into the respective pre-tensions that were fitted on the side of each individual seat.

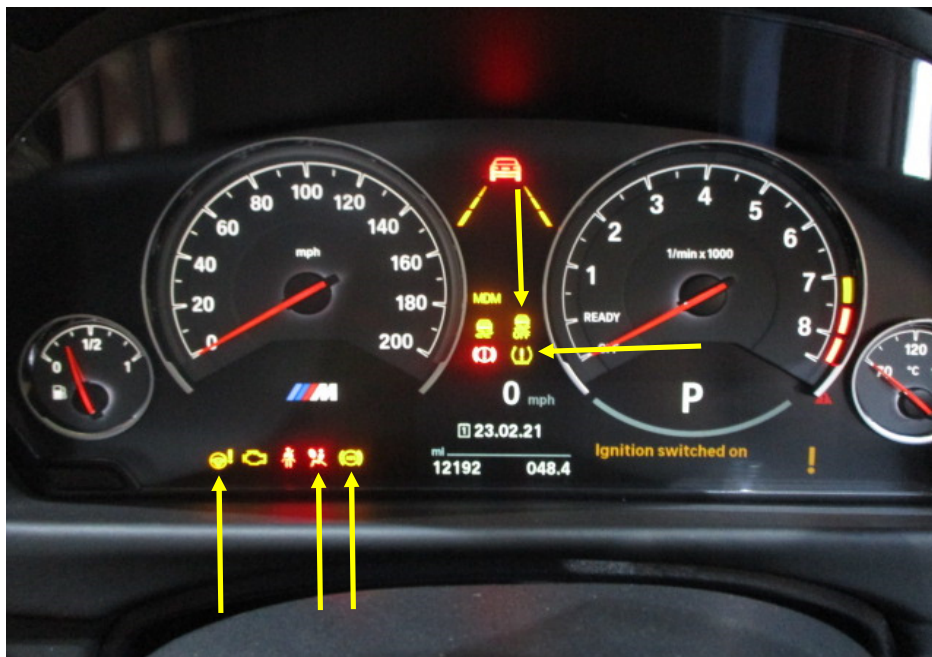
**Photo 13** shows the warning lights for the various electronic safety features appearing on the instrument panel of the Motor Car during its self-test when the engine is cranked, in particular the ABS, SRS, IAS, TPM and DSC lights (arrowed).

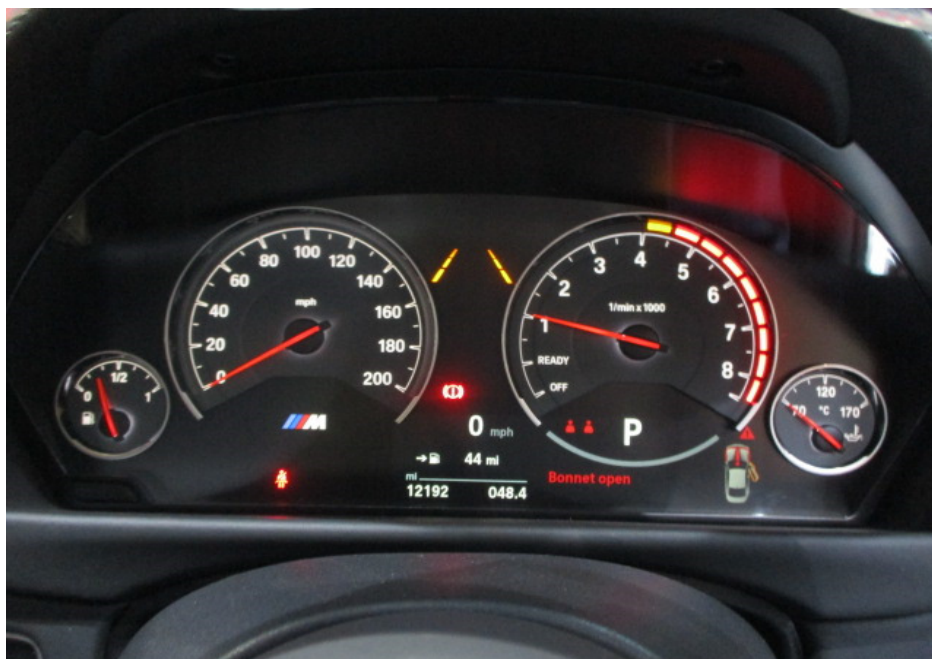
13. The Motor Car's automatic self-test of the functionality of its various electronic safety features like the Anti-Lock Brake System (ABS), Supplemental Restraint System (SRS), Integral Active Steering (IAS), Tyre Pressure Monitor (TPM) and Dynamic Stability Control (DSC) during cranking of the engine had indicated that these electronic systems were in working condition. This was determined from the respective warning lights disappearing from the instrument panel after the self-test.

**Photo 14** shows the respective warning lights no longer illuminated, indicating that there is no fault detected to the ABS, SRS, IAS, TPM and DSC systems of the Motor Car during the self-test. These electronic systems were hence in working condition at the time of my inspection.

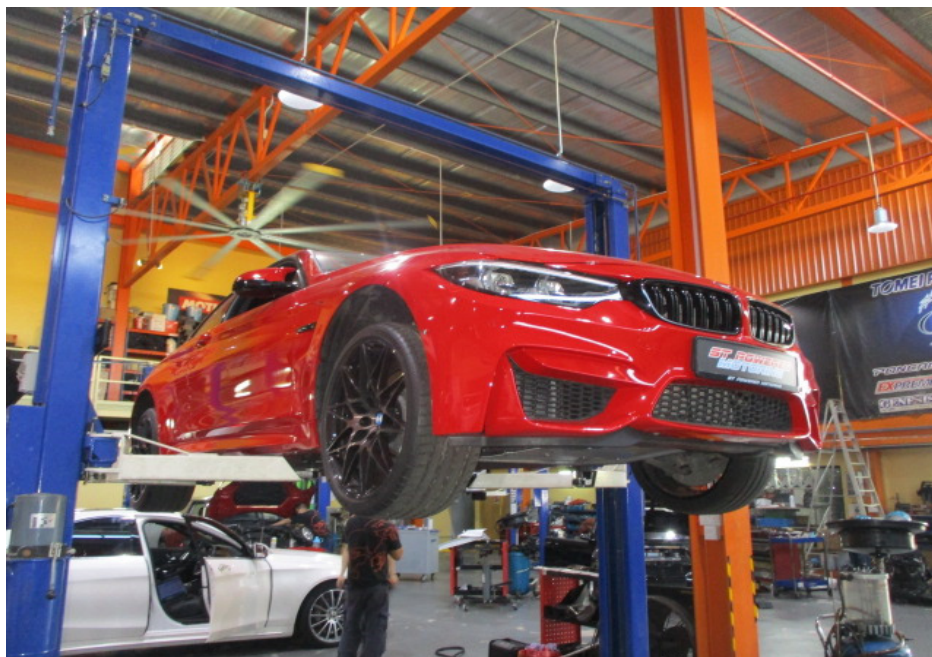
**Photo 15** shows the Motor Car hoisted up for checks on its undercarriage. There was no sign(s) or indication(s) of fluid leakage and/or fluid stain(s) on the underside of the Motor Car. The undercarriage components of the Motor Car were also all observed to be intact and secured in an appropriate manner.

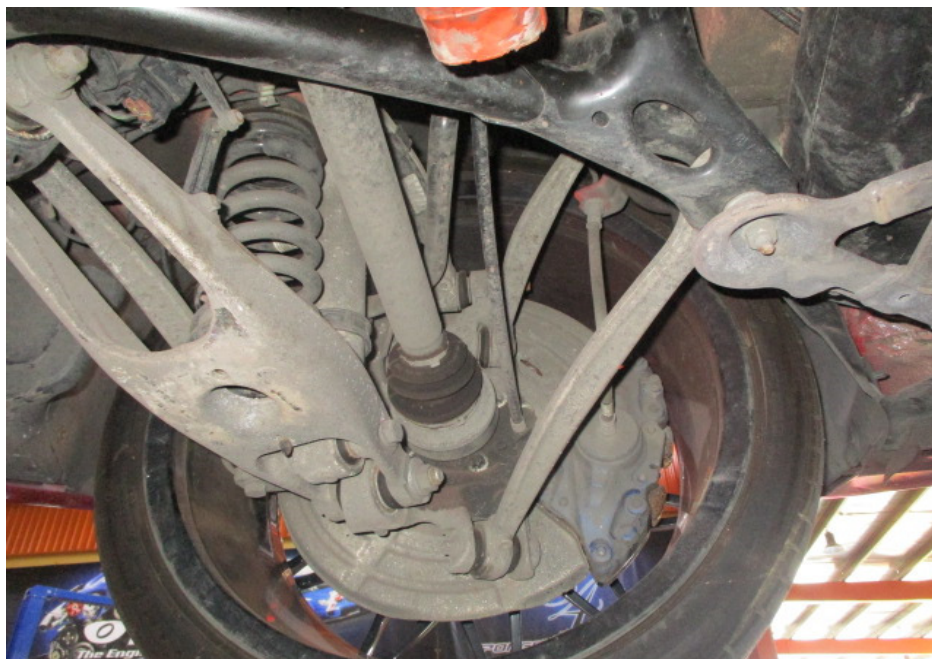
**Photo 16** shows a general view of the control arms and linkages at the rear left wheel of the Motor Car. I did not observe any fluid leak and/or fluid stain on the underside of the Motor Car. All of the Motor Car's undercarriage components were observed to be intact and secured in an appropriate manner.

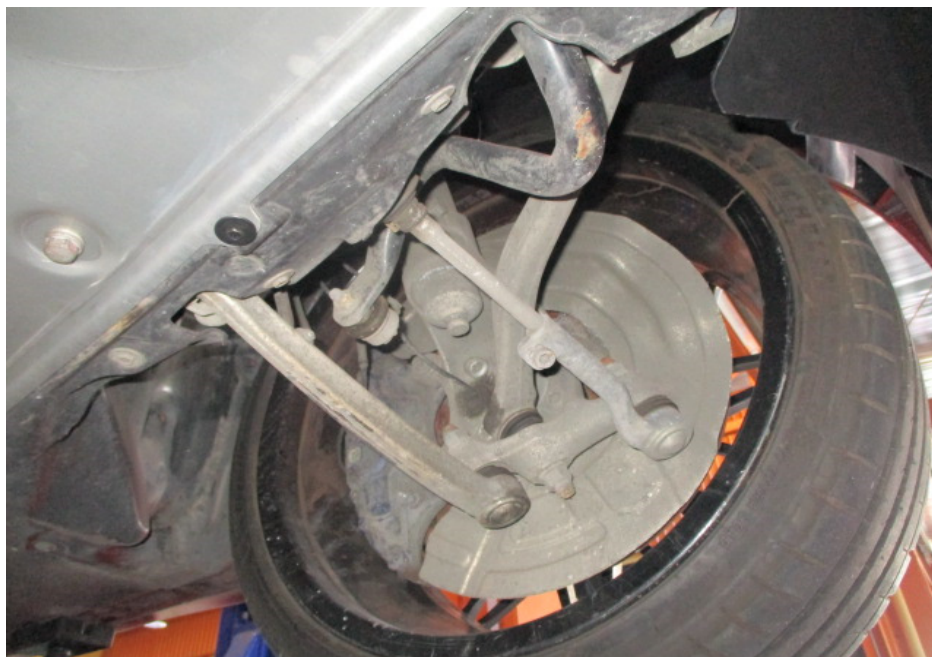
**Photo 17** shows the various undercarriage components at the front left wheel of the Motor Car. The mechanical components, control arms and linkages were all found to be intact and secured in an appropriate manner.

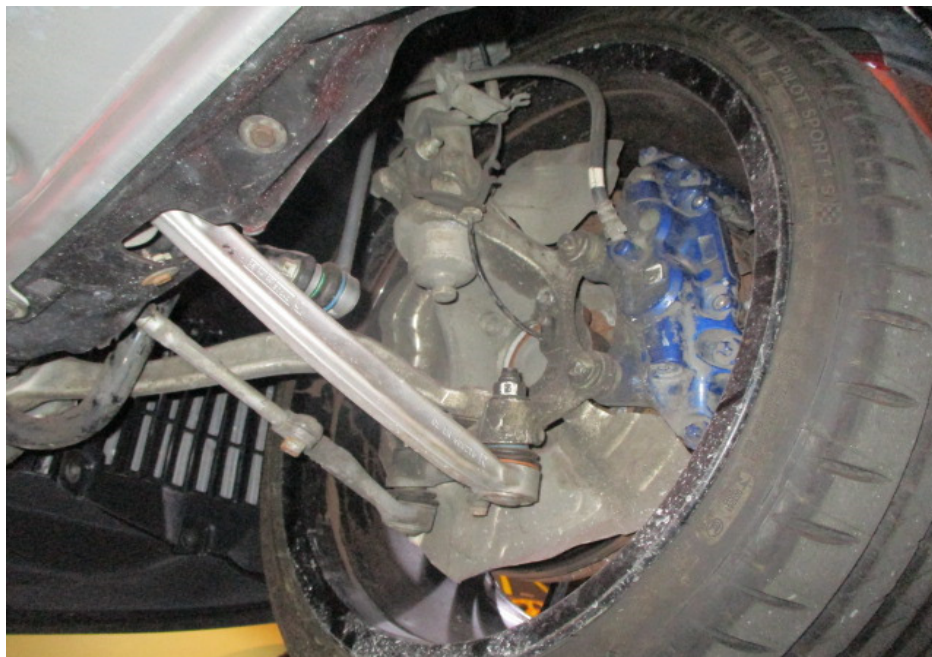
**Photo 18** shows the various undercarriage components at the front right wheel of the Motor Car. The mechanical components, control arms and linkages were all found to be intact and secured in an appropriate manner. I also did not observe any fluid leak and/or fluid stain on the underside of the Motor Car.

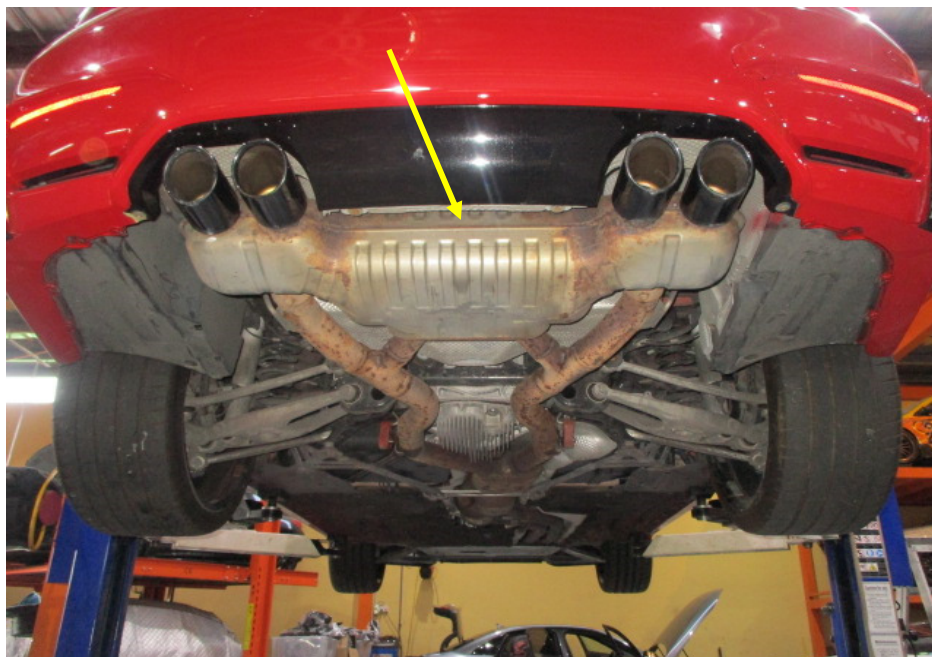
**Photo 19** shows the Motor Car's rear muffler (arrowed). My examination of the Motor Car's exhaust system revealed no sign(s) or indication(s) of any cut or weld marks along its exhaust pipes and on its catalytic converters.

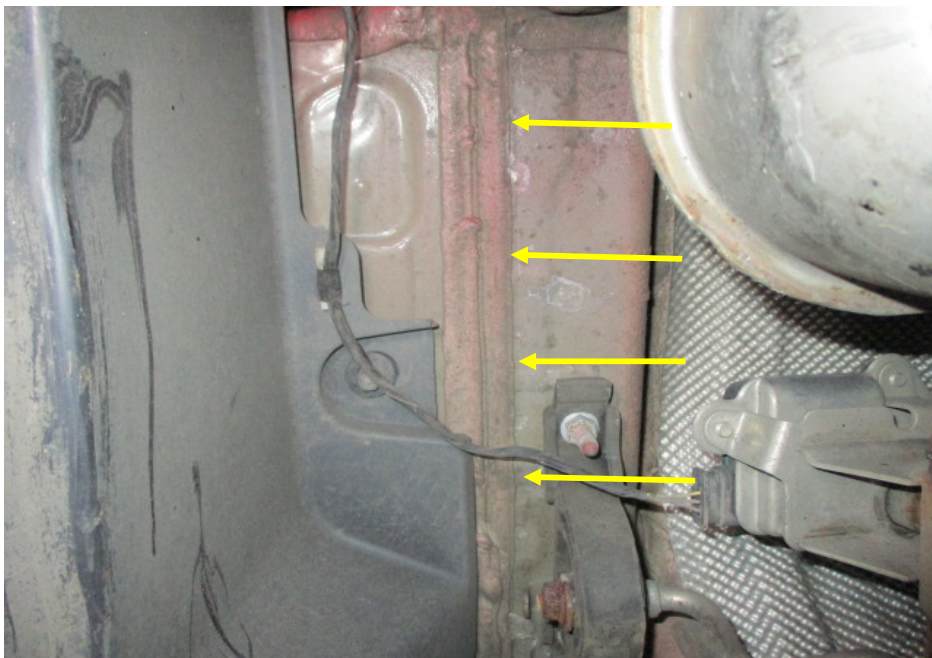
11. Visually, I did not find any weld marks, other than the original spot weld marks, on the chassis/structural body of the Motor Car. The original factory sealant at the joints along the chassis/structural body was also untouched, again indicating that no replacement of the chassis/structural body was carried out; and that the chassis/structural body was originally fitted.

**Photo 20** shows the chassis/structural body at the underside rear left of the Motor Car. I did not find any weld marks other than original spot weld marks on the chassis/structural body of the Motor Car. The original factory sealant (arrowed) at the joints along the chassis/structural body was untouched, indicating no work was done on the chassis/structural body of the Motor Car and that the chassis/structural body was originally fitted.

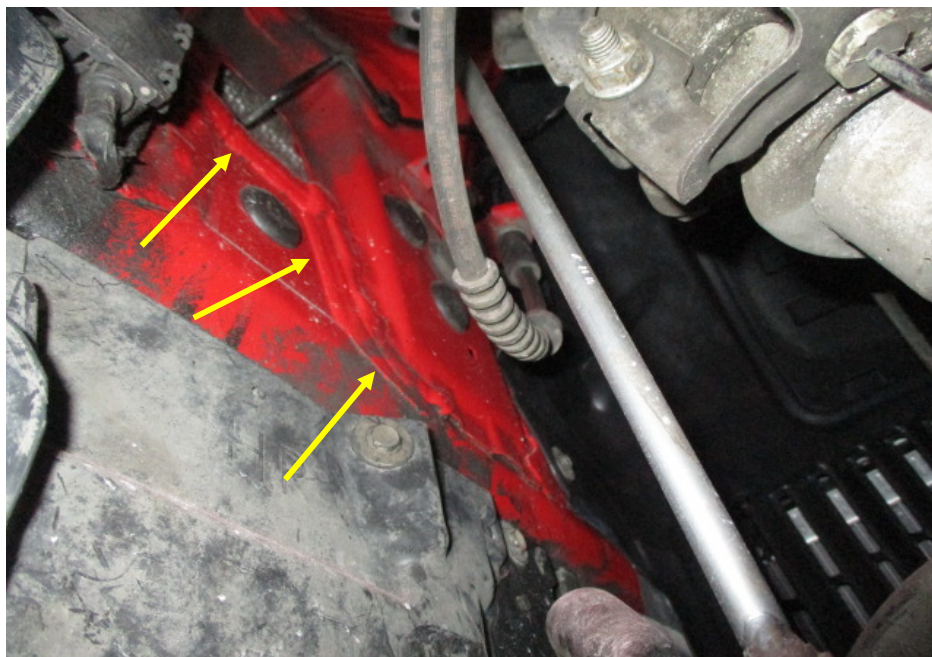
**Photo 21** shows the chassis/structural body at the underside front right of the Motor Car. The original factory sealant (arrowed) at the joints along the chassis/structural body was observed to be untouched. In general, I had found no work was carried out on the chassis/structural body of the Motor Car. The chassis/structural body of the Motor Car was originally fitted.

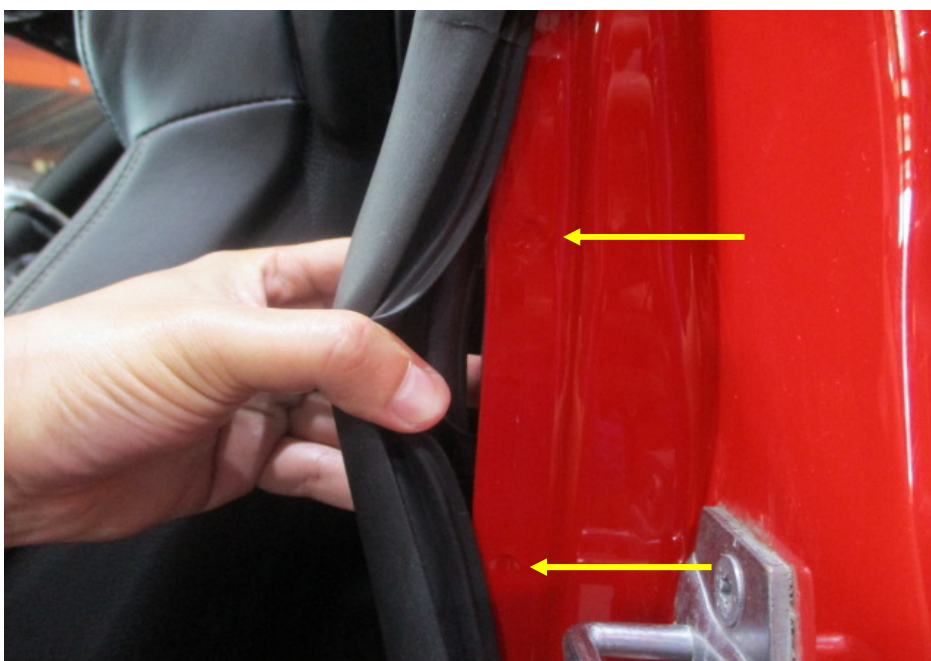
**Photo 22** shows the left side rear body panel of the Motor Car. I did not find any weld marks other than original spot weld marks (arrowed) on the left side rear body panel of the Motor Car which, indicates that there was no re-welding works carried out. In general, I had found all the non-detachable body panels of the Motor Car to be originally fitted at the time of my inspection.

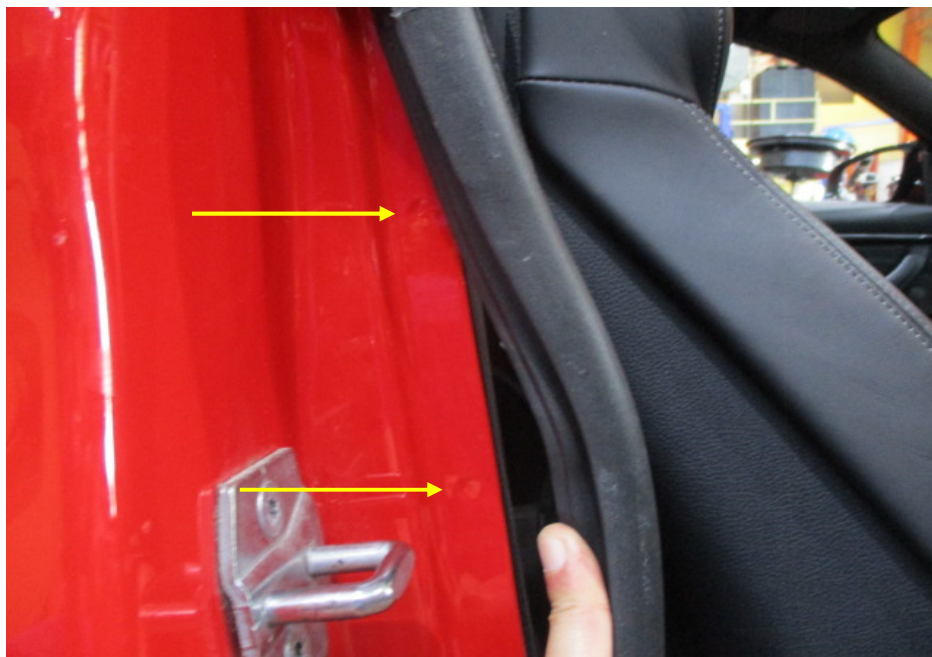
**Photo 23** shows the right side rear body panel of the Motor Car. I did not find any weld marks other than original spot weld marks (arrowed) on the right side rear body panel of the Motor Car which, indicates that there was no re-welding works carried out. In general, I had found all the non-detachable body panels of the Motor Car to be originally fitted at the time of my inspection.
