Your Ref: Mercedes Benz S450
(chassis number WDD2220582A513670)
Our Ref : CI/TP21002739/D

08 March 2021

**INSPECTION REPORT OF AN UNREGISTERD MERCEDES BENZ S450
MOTOR CAR WITH CHASSIS NUMBER WDD2220582A513670**

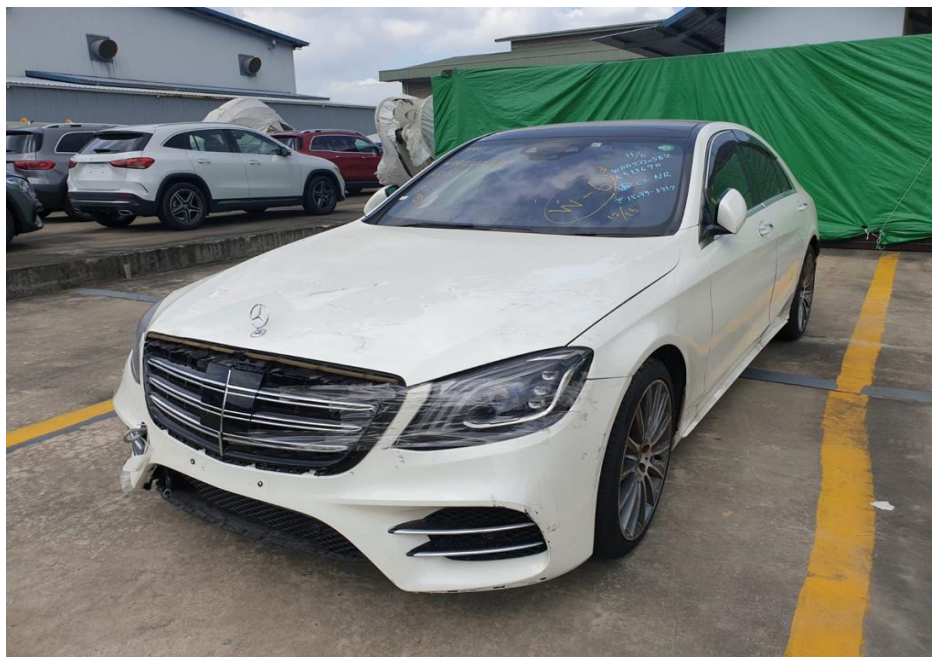
3. From the photographs provided to me, it was observed that the Motor Car had sustained damages at its frontal portion. The front bumper, front bumper lower chrome moulding, front bumper centre lower grille, front bumper number plate garnish, front grille, front bonnet and front undercover were amongst the body parts that were observed to have been damaged.
4. No physical damage was observed to other areas of the Motor Car. The airbags of the Motor Car were also not activated as seen from the photographs that were provided to me. See photo 1 – 4 below.

Photo 1 shows the front left body of the Motor Car (photograph provided to me). The Motor Car was observed to have sustained damage at its frontal portion. The front bumper, front bumper lower chrome moulding, front bumper centre lower grille, front bumper number plate garnish and front undercover were amongst the body parts that were observed to have been damaged.

22. The body parts at the frontal portion of the Motor Car were visually examined and it was noted that the repair/restoration works carried out to the damaged area of the Motor Car (refer to photograph 1 & 2 above) were reasonably adequate and in order.

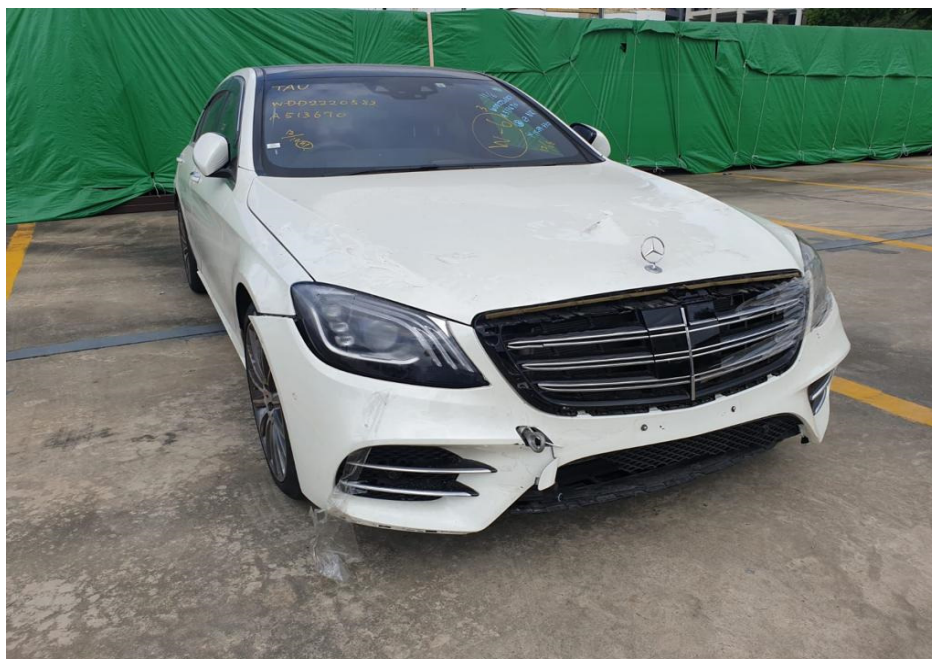
Photo 2 shows the front right body of the Motor Car (photograph provided to me). The Motor Car was observed to have sustained damage at its frontal portion. The front bumper, front bumper lower chrome moulding, front bumper centre lower grille, front grille, front bonnet and front undercover were amongst the body parts that were observed to have been damaged.

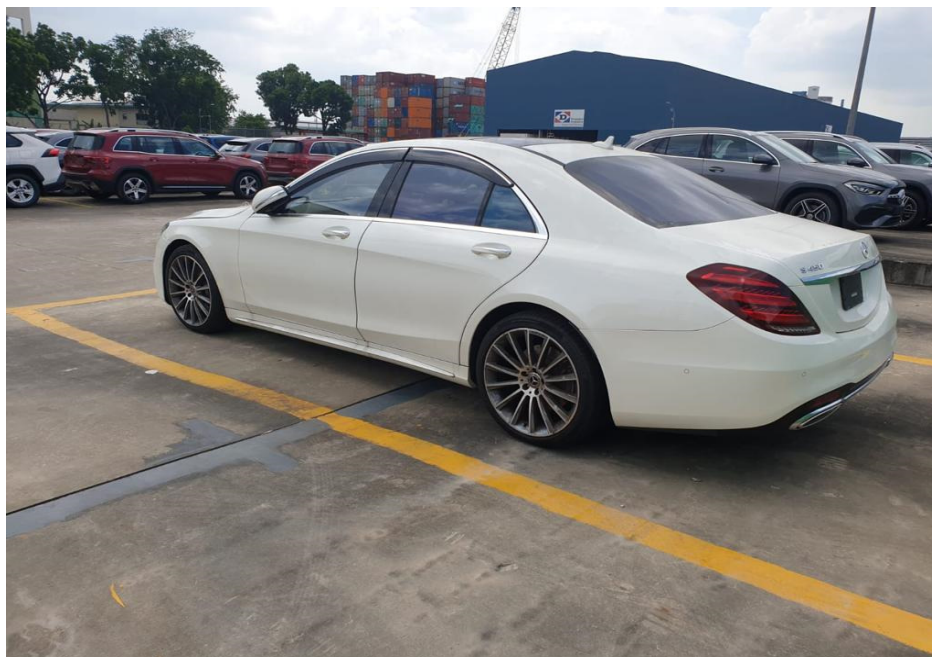
Photo 3 shows the left body of the Motor Car (photograph provided to me). Apart for the frontal portion, there was no physical damage seen to other areas of the Motor Car. The airbags of the Motor Car were also not activated.

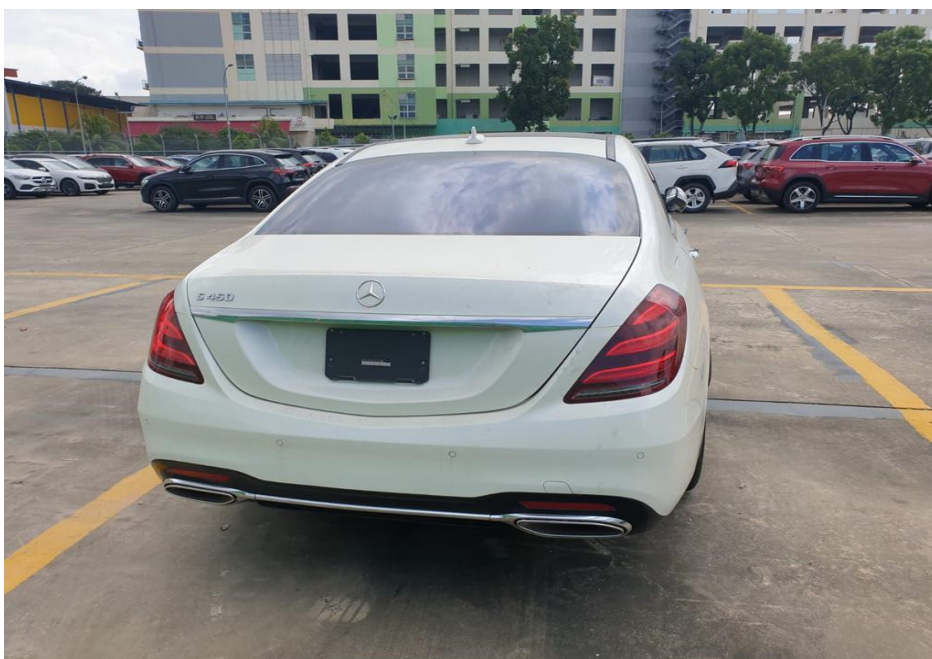
Photo 4 shows the rear body of the Motor Car (photograph provided to me). Apart for the frontal portion, there was no physical damage seen to other areas of the Motor Car. The airbags of the Motor Car were also not activated.

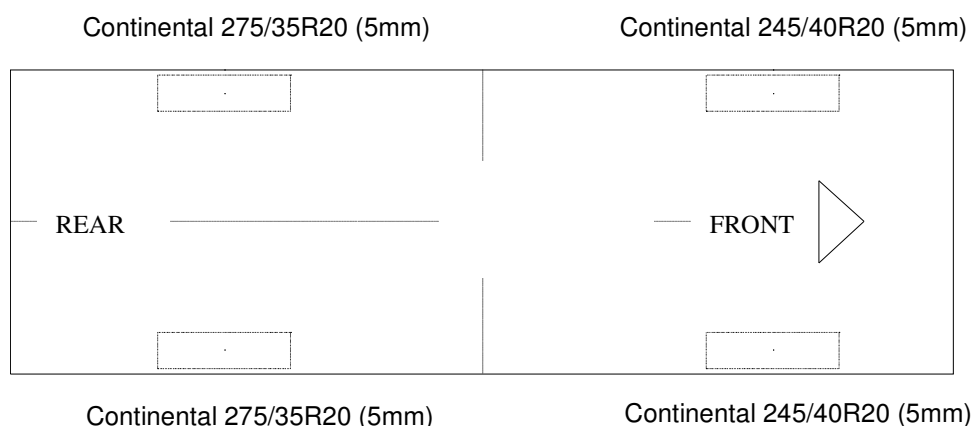
8. It was fitted with 20inch sport wheel rims that were wrapped with tyres that were observed to be of serviceable condition. The tyres were also sufficiently inflated for vehicular operation. The tyre brand, tyre size and approximate remaining tread depth of the 4 tyres of the Motor Car were recorded as follows: -

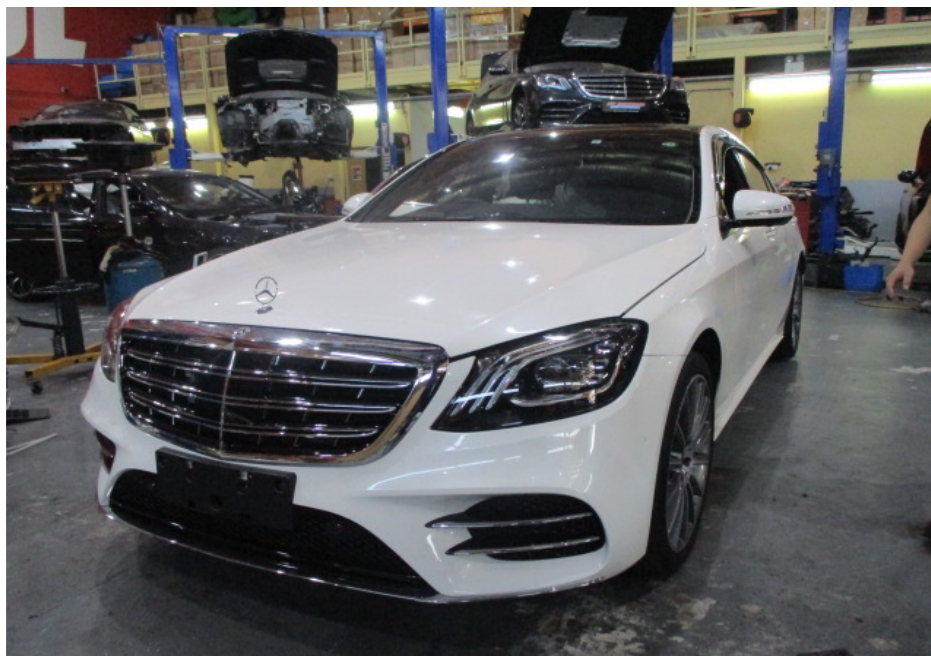
Photo 5 shows a general view of the front left body of the Motor Car at the time of my inspection. The Motor Car was observed to be in a relatively good general condition with no loose exterior fittings observed. The body parts at the frontal portion of the Motor Car were visually examined and it was observed that the repair/restoration works carried out to the damaged area of the Motor Car (refer to photograph 1 & 2 above) were reasonably adequate and in order.

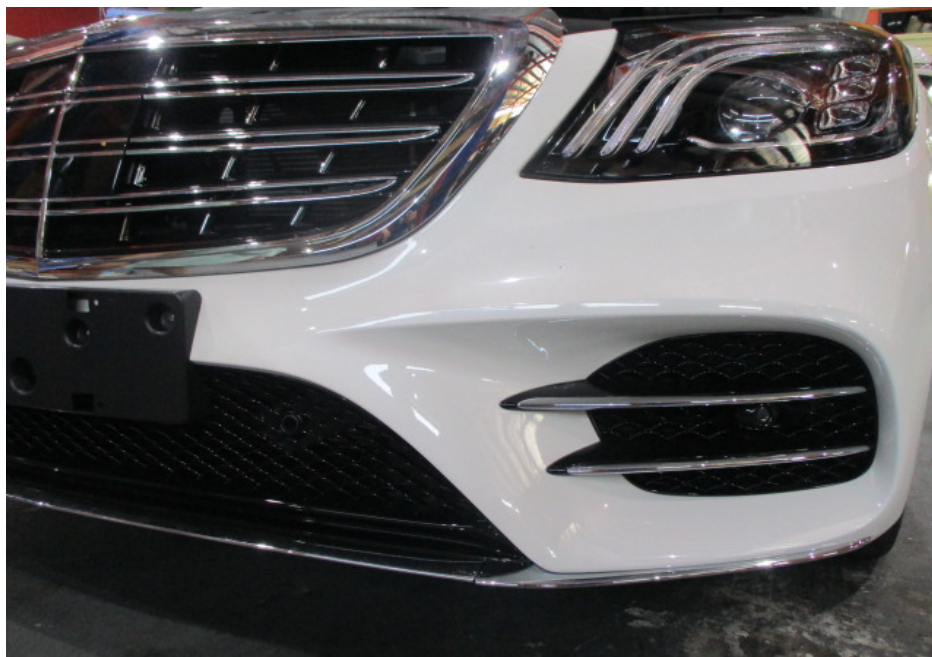
Photo 6 shows a closer view of the front bumper, front bumper lower chrome moulding and front grille of the Motor Car at the time of my inspection. The body parts at the frontal portion of the Motor Car were visually examined and it was observed that the repair/restoration works carried out to the damaged area of the Motor Car (refer to photograph 1 & 2 above) were reasonably adequate and in order.

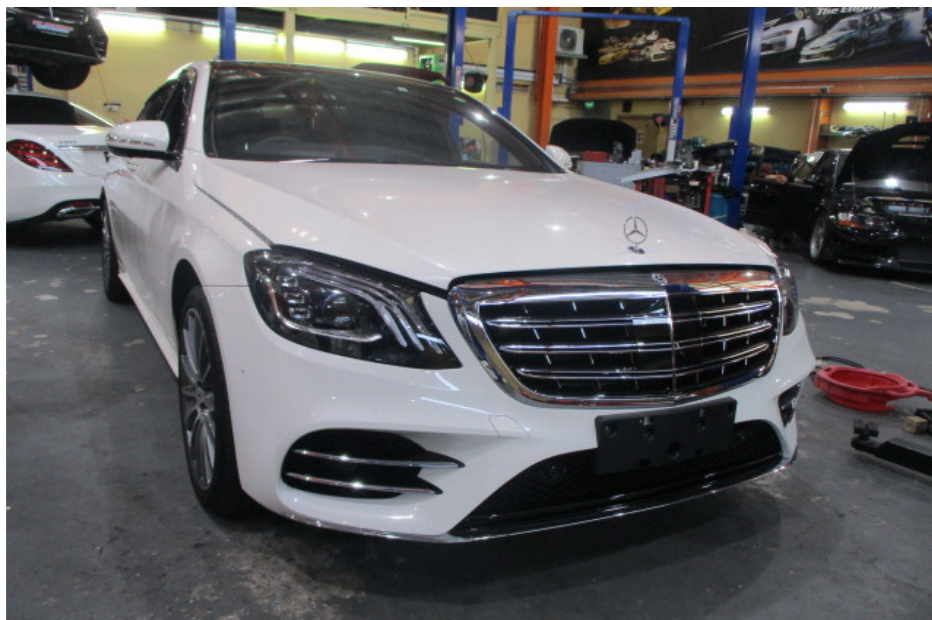
Photo 7 shows a general view of the front right body of the Motor Car at the time of my inspection. The Motor Car was observed to be in a relatively good general condition with no loose exterior fittings observed. The body parts at the frontal portion of the Motor Car were visually examined and it was observed that the repair/restoration works carried out to the damaged area of the Motor Car (refer to photograph 1 & 2 above) were reasonably adequate and in order.

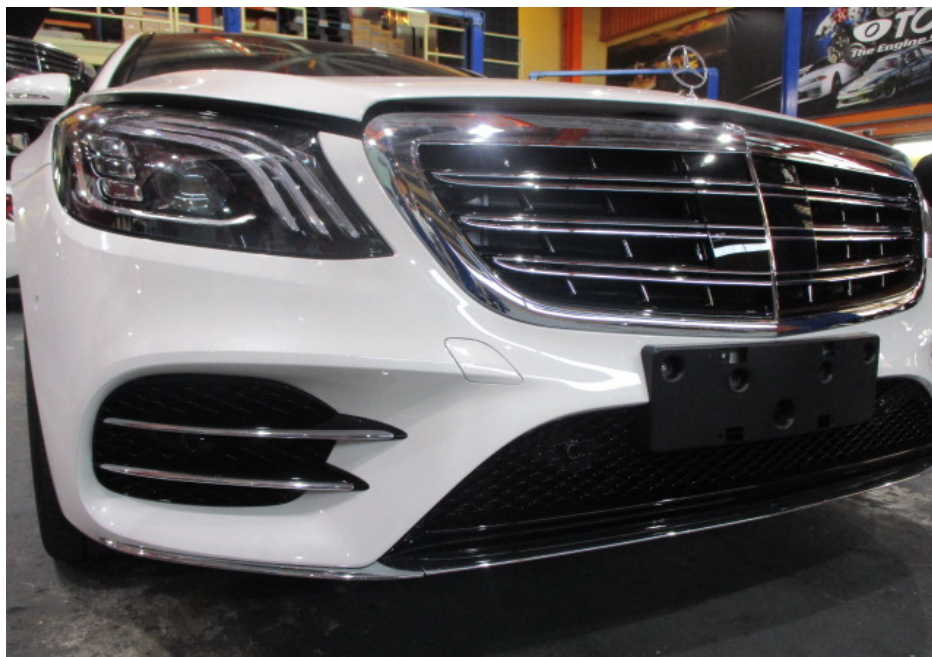
Photo 8 shows a closer view of the front bumper, front bumper lower chrome moulding, front bumper centre lower grille, front bumper number plate garnish and front grille of the Motor Car at the time of my inspection. The body parts at the frontal portion of the Motor Car were visually examined and it was observed that the repair/restoration works carried out to the damaged area of the Motor Car (refer to photograph 1 & 2 above) were reasonably adequate and in order.

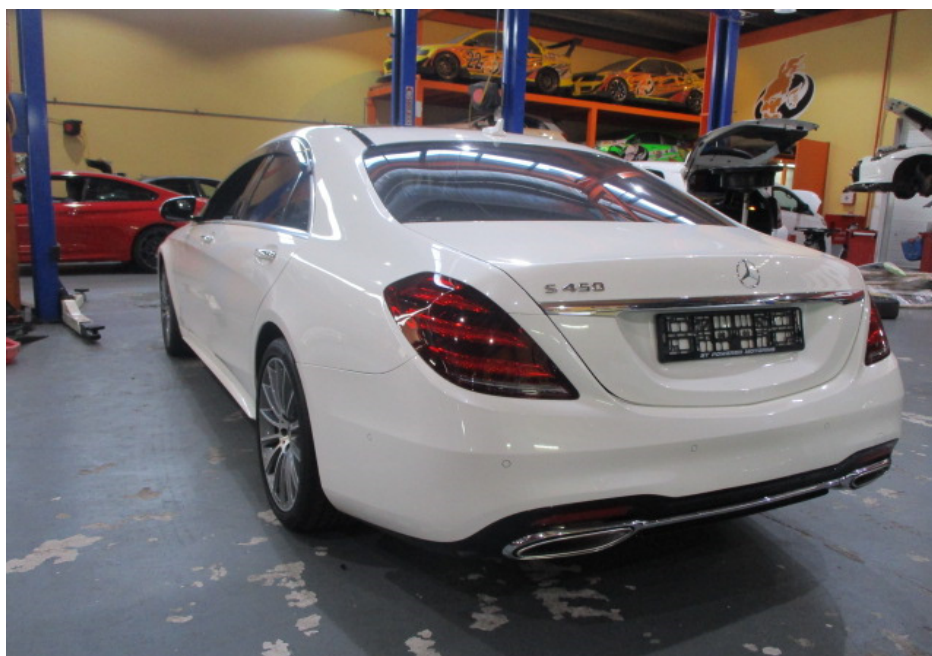
Photo 9 shows a general view of the rear left body of the Motor Car at the time of my inspection. The Motor Car was observed to be in a relatively good general condition with no loose exterior fittings observed. The mileage of the Motor Car recorded at the time of my inspection was 6,125km.

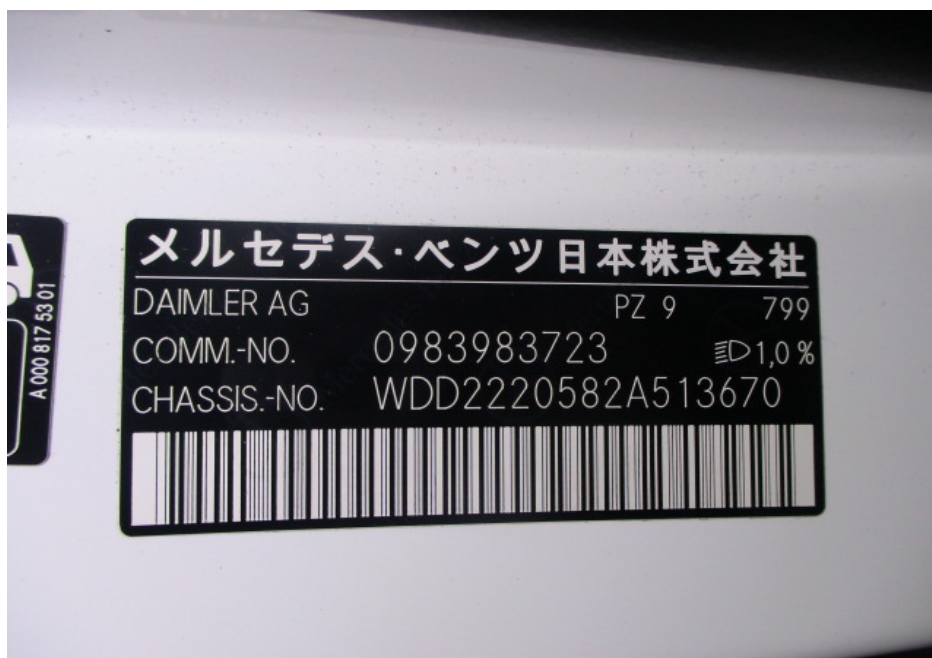
Photo 10 shows the chassis number of the Motor Car. The chassis number recorded was WDD2220582A513670.

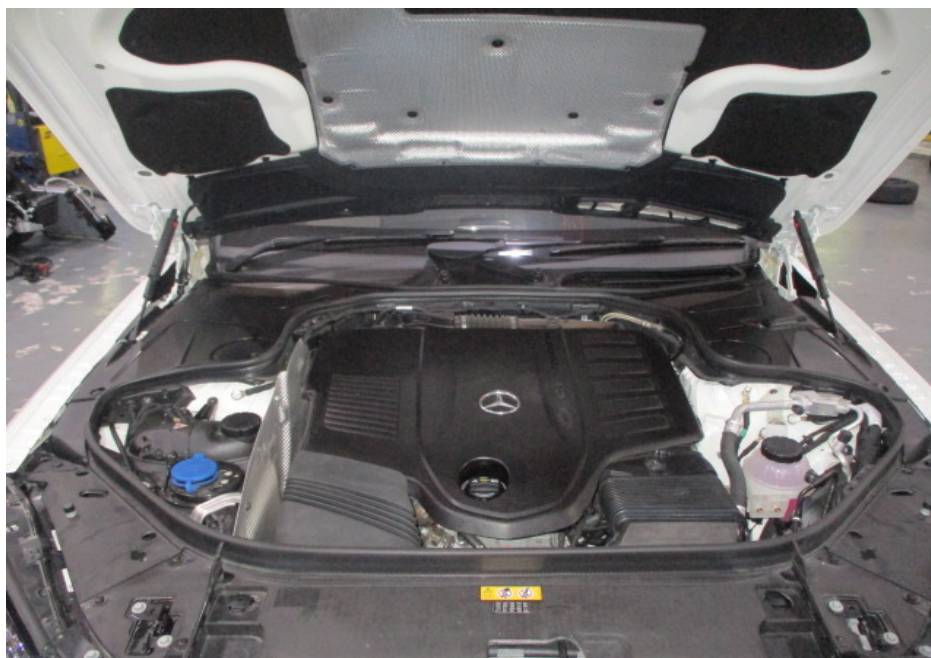
14. My examination of the engine compartment of the Motor Car revealed that the various parts and components inside the engine compartment were all intact and properly fitted. The engine oil, brake fluid and engine coolant were all found to be of sufficient level for operating purposes. Visually, there was also no contamination found to these fluids.

Photo 11 shows a general view of the engine compartment of the Motor Car at the time of my inspection. The various parts and components inside the engine compartment were all observed to be intact and properly fitted. There was also no sign(s) or indication(s) of fluid leak and/or fluid stain found inside the engine compartment.

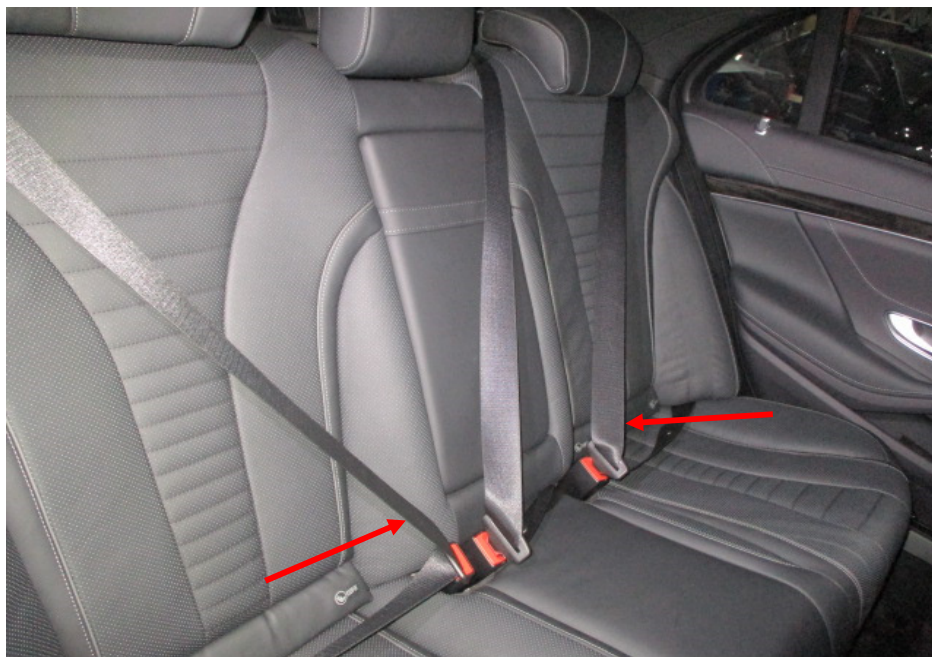
12. The seats of the Motor Car were found to be secured to the floorboard of the Motor Car via seat rails bolted onto the floorboard. Retractable seat belt reels and pre-tensioners were fitted on all seats of the Motor Car. The seat belts were tested and were able to be fastened securely into the respective pre-tensioners that were fixed to the side of all the seats.

Photo 12 shows the rear seats of the Motor Car. All the seats of the Motor Car were secured via seat rails to the floorboard. They were also fitted with a retractable seat belt reel and a pre-tensioner. The seat belts (arrowed) were tested and were able to be fastened into the respective pre-tensions that were fitted on the side of each individual seat.

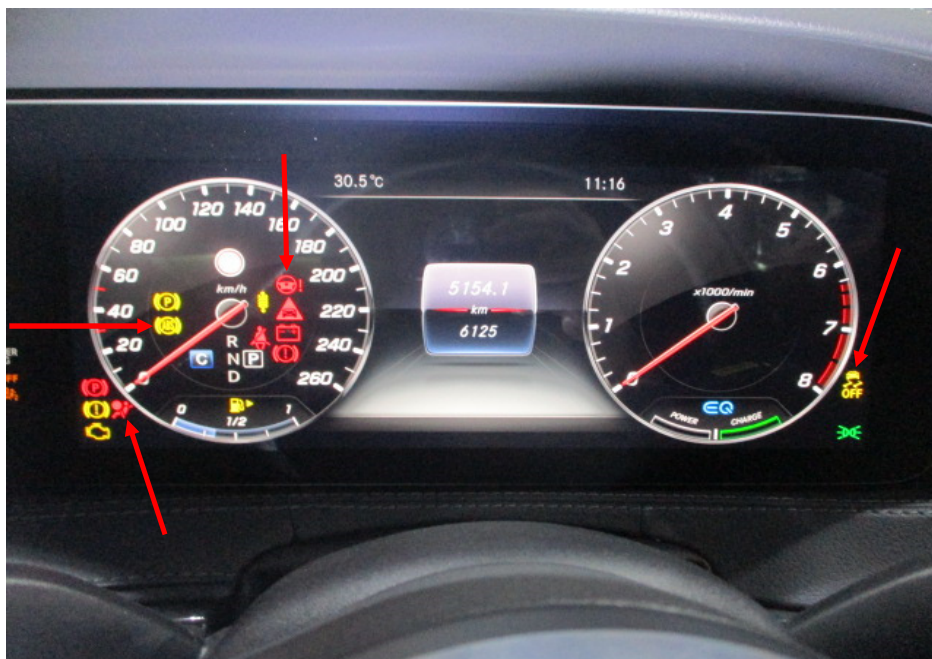
Photo 13 shows the warning lights for the various electronic safety features appearing on the instrument panel of the Motor Car during its self-test when the engine is cranked, in particular the ABS, SRS, EPS and TCS lights (arrowed).

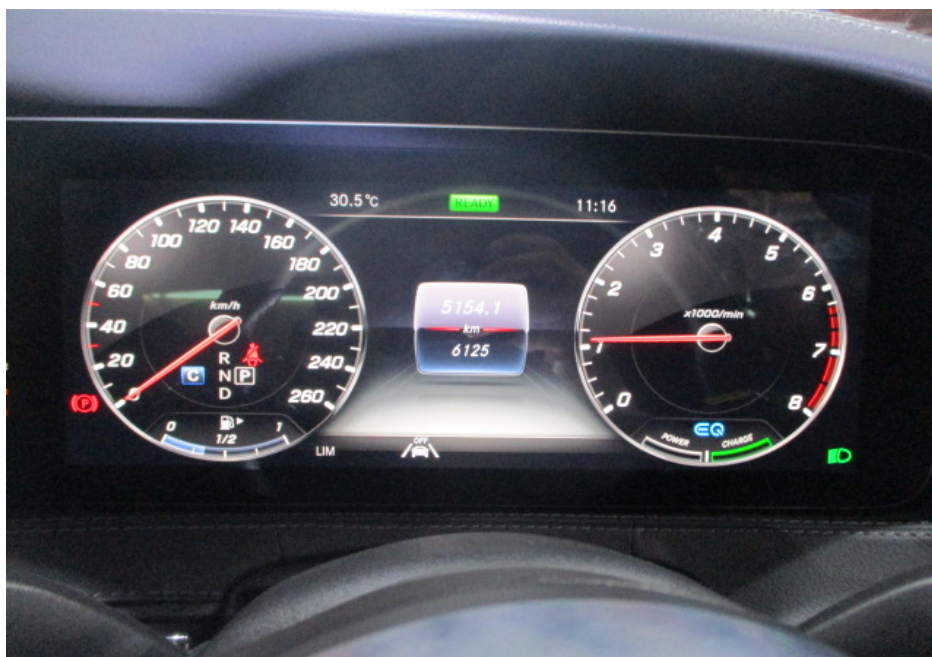
13. The Motor Car's automatic self-test of the functionality of its various electronic safety features like the Anti-Lock Brake System (ABS), Supplemental Restraint System (SRS), Electric Power Steering (EPS) and Traction Control System (TCS) during cranking of the engine had indicated that these electronic systems were in working condition. This was determined from the respective warning lights disappearing from the instrument panel after the self-test.

Photo 14 shows the respective warning lights no longer illuminated, indicating that there is no fault detected to the ABS, SRS, EPS and TCS systems of the Motor Car during the self-test. These electronic systems were hence in working condition at the time of my inspection.

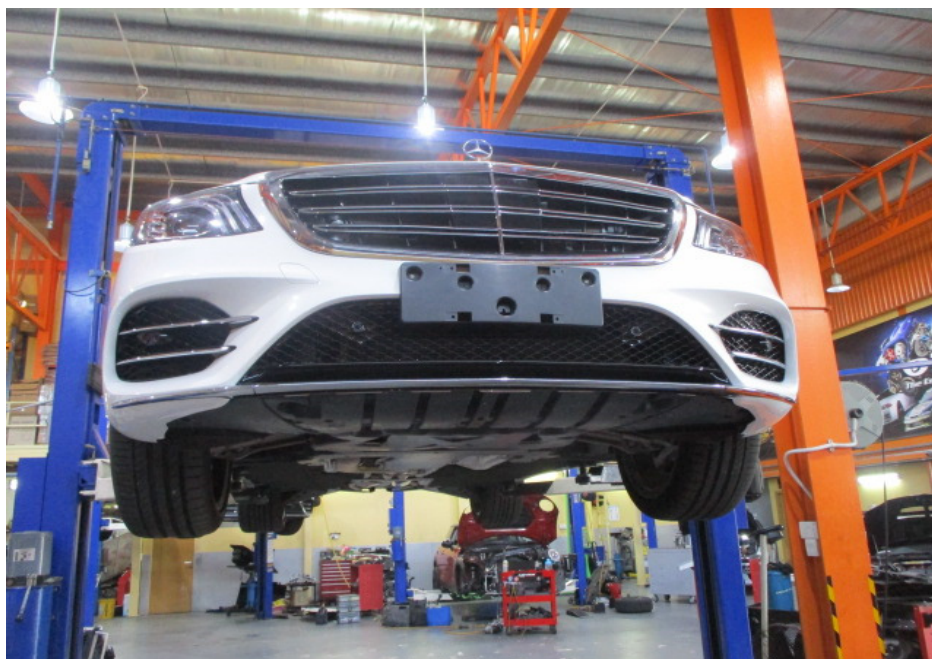
15. My checks on the underside of the Motor Car revealed no sign(s) or indication(s) of fluid leakage and/or fluid stain(s). The engine block and automatic transmission assembly were both secured properly. All undercarriage components of the Motor Car were also observed to be intact and secured in an appropriate manner.

Photo 15 shows the Motor Car hoisted up for checks on its undercarriage. There was no sign(s) or indication(s) of fluid leakage and/or fluid stain(s) on the underside of the Motor Car. The undercarriage components of the Motor Car were also all observed to be intact and secured in an appropriate manner.

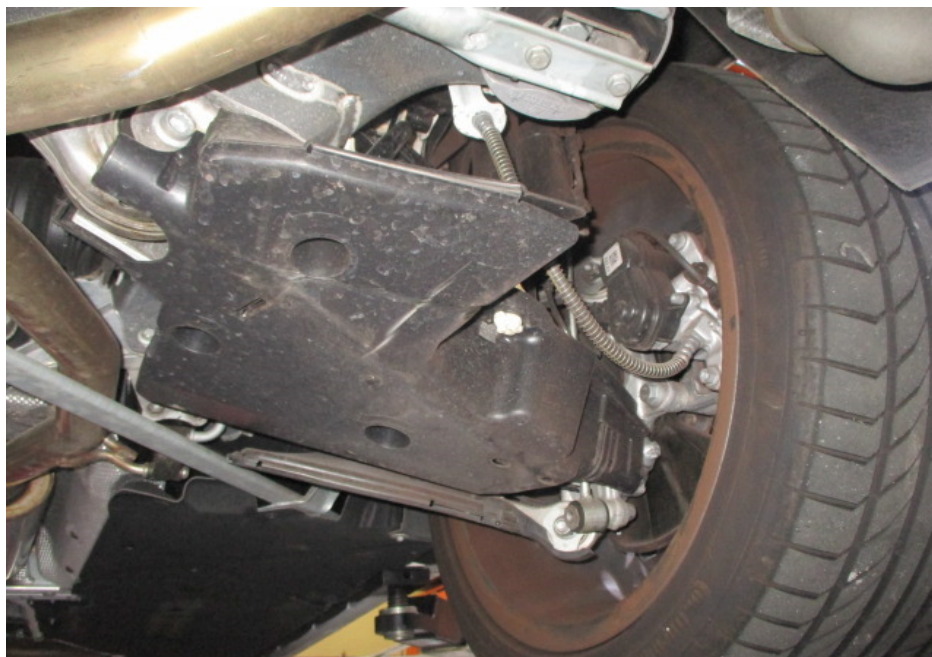
Photo 16 shows a general view of the control arms and linkages at the rear right wheel of the Motor Car. I did not observe any fluid leak and/or fluid stain on the underside of the Motor Car. All of the Motor Car's undercarriage components were observed to be intact and secured in an appropriate manner.

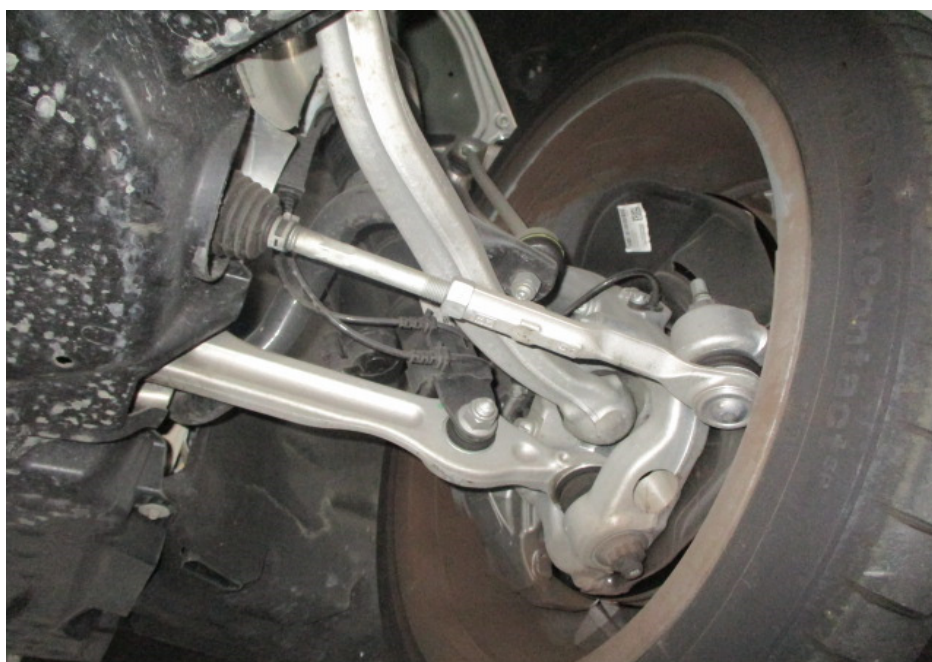
Photo 17 shows the various undercarriage components at the front left wheel of the Motor Car. The mechanical components, control arms and linkages were all found to be intact and secured in an appropriate manner.

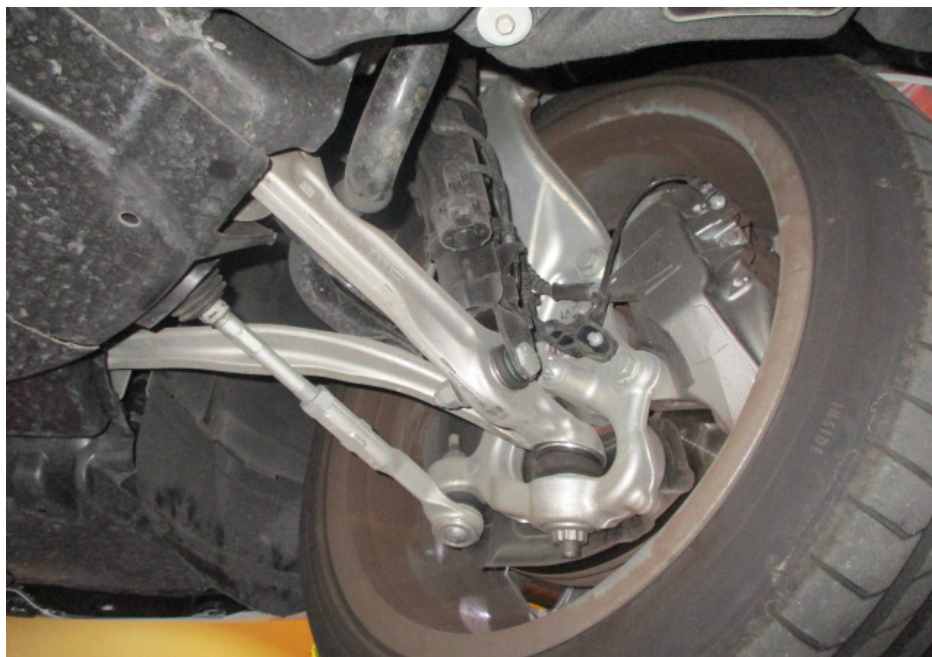
Photo 18 shows the various undercarriage components at the front right wheel of the Motor Car. The mechanical components, control arms and linkages were all found to be intact and secured in an appropriate manner. I also did not observe any fluid leak and/or fluid stain on the underside of the Motor Car.

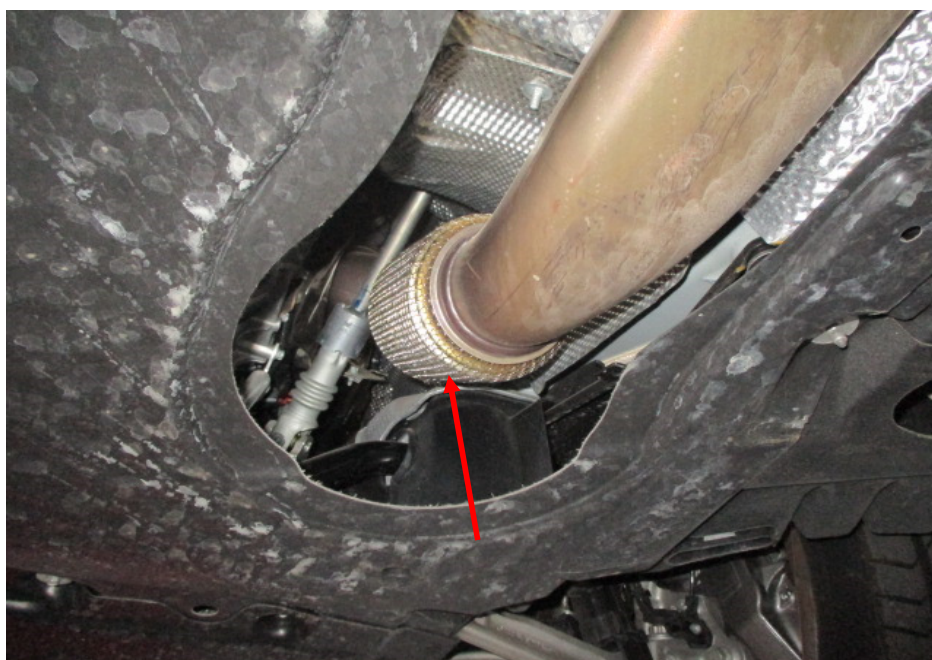
Photo 19 shows the Motor Car's catalytic converter (arrowed). My examination of the Motor Car's exhaust system revealed no sign(s) or indication(s) of any cut or weld marks along its exhaust pipe and on its rear muffler.

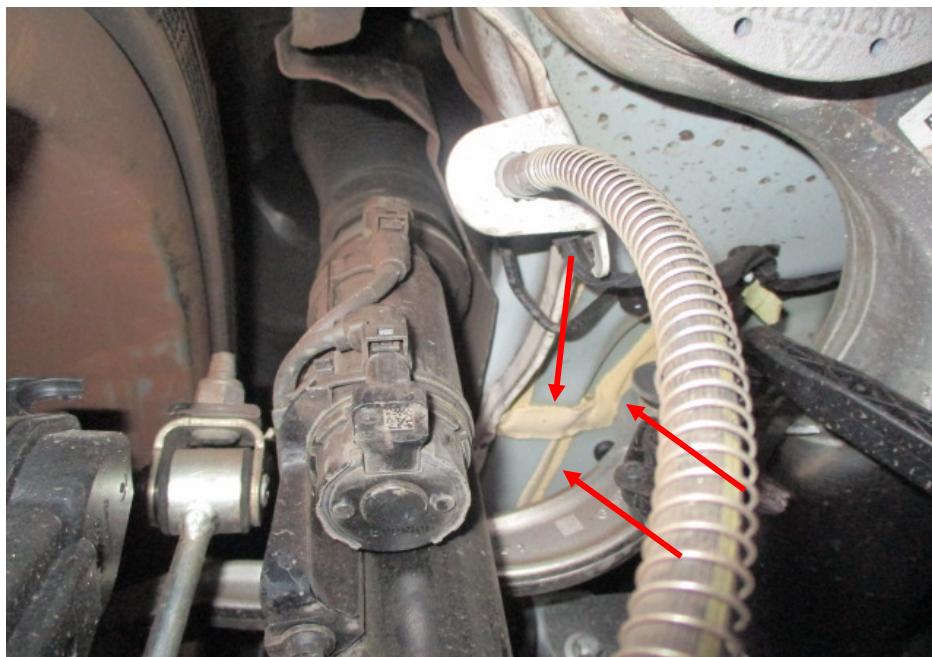
11. Visually, I did not find any weld marks, other than the original spot weld marks, on the chassis/structural body of the Motor Car. The original factory sealant at the joints along the chassis/structural body was also untouched, again indicating that no replacement of the chassis/structural body was carried out; and that the chassis/structural body was originally fitted.

Photo 20 shows the chassis/structural body at the underside rear left of the Motor Car. I did not find any weld marks other than original spot weld marks on the chassis/structural body of the Motor Car. The original factory sealant (arrowed) at the joints along the chassis/structural body was untouched, indicating no work was done on the chassis/structural body of the Motor Car and that the chassis/structural body was originally fitted.

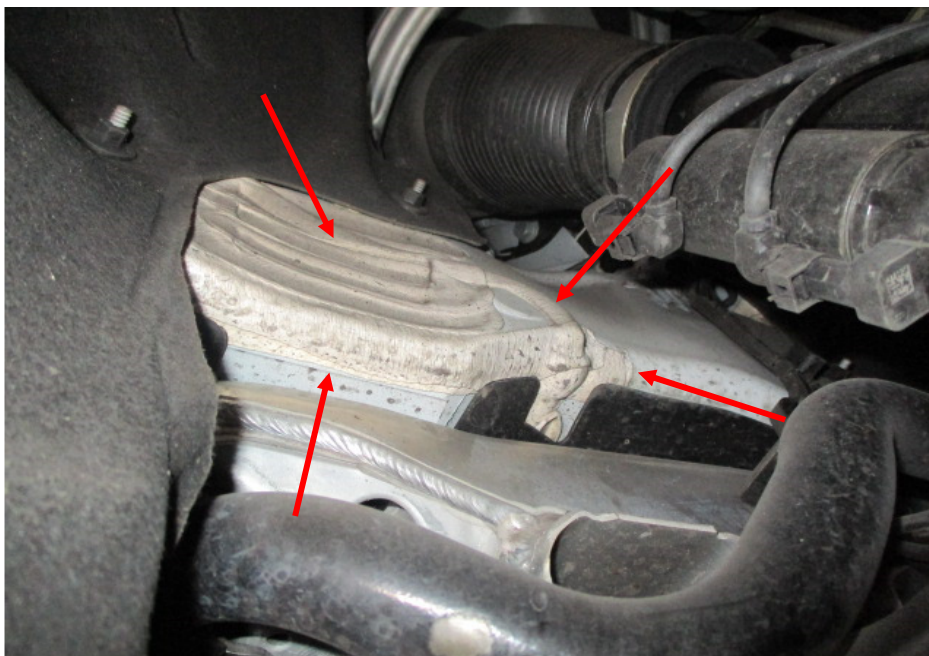
Photo 21 shows the chassis/structural body at the underside front right of the Motor Car. The original factory sealant (arrowed) at the joints along the chassis/structural body was observed to be untouched. In general, I had found no work was carried out on the chassis/structural body of the Motor Car. The chassis/structural body of the Motor Car was originally fitted.

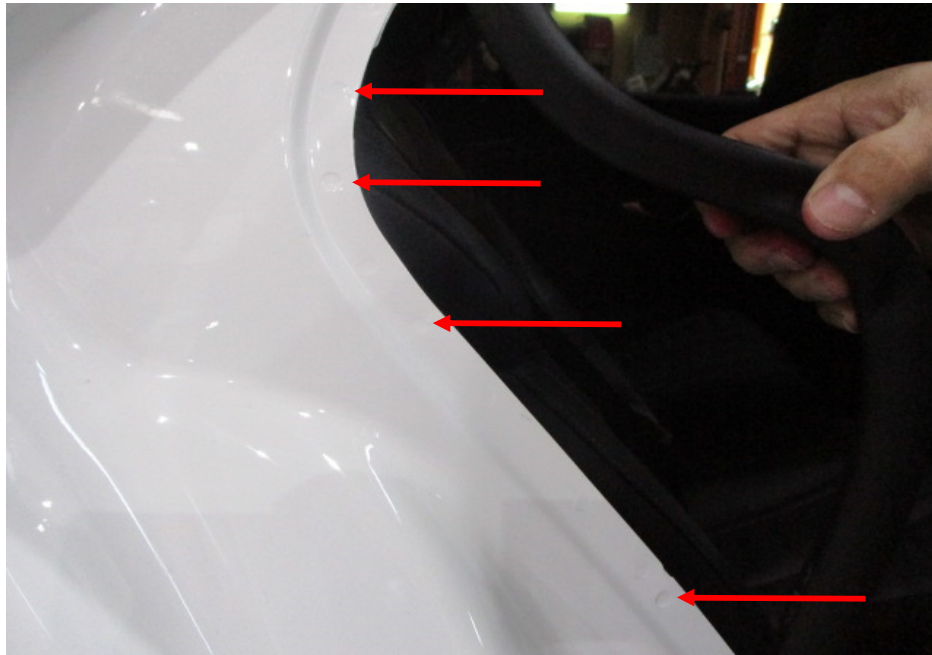
10. Checks on the non-detachable body panels like the rear fenders, floorboard, roof panel, pillars and rocker panels amongst others, revealed that these body panels were spot welded onto the chassis/structural body of the Motor Car. The original factory sealant at the joints of the non-detachable body panels was all untouched indicating no replacement of the non-detachable body panels was carried out; and that these body panels were all originally fitted.

Photo 22 shows the right side "C" pillar of the Motor Car. I did not find any weld marks other than original spot weld marks (arrowed) on the right side "C" pillar of the Motor Car, which indicates that there was no re-welding works carried out. In general, I had found all the non-detachable body panels of the Motor Car to be originally fitted at the time of my inspection.
