Your Ref: Toyota Alphard  
(chassis number AGH300326661)  
Our Ref : CI/TP21002740/D

08 March 2021

**INSPECTION REPORT OF AN UNREGISTERD TOYOTA ALPHARD MOTOR CAR WITH CHASSIS NUMBER AGH300326661**

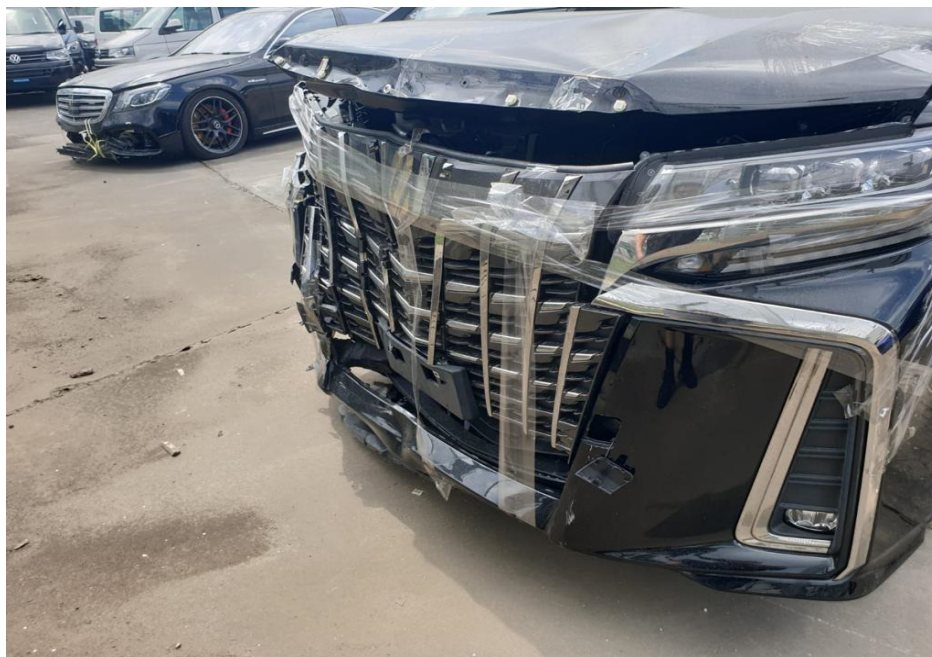
**Photo 1** shows the front left body of the Motor Car (photograph provided to me). The Motor Car was observed to have sustained damage at its frontal portion. The front bumper, front bumper number plate garnish, front grille, front bonnet and front bonnet chrome moulding were amongst the body parts that were observed to have been damaged.

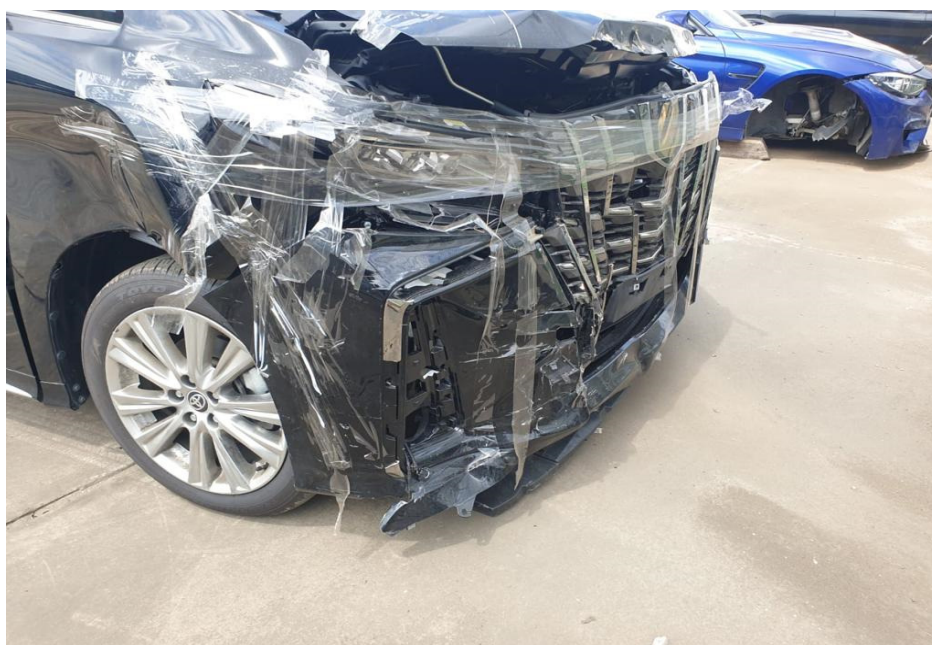
**Photo 2** shows the front right body of the Motor Car (photograph provided to me). The Motor Car was observed to have sustained damage at its frontal portion. The front bumper, front bumper right lower chrome moulding, front right fog lamp, front right fog lamp garnish, front grille, front bonnet, front right fender and front right headlamp were amongst the body parts that were observed to have been damaged.

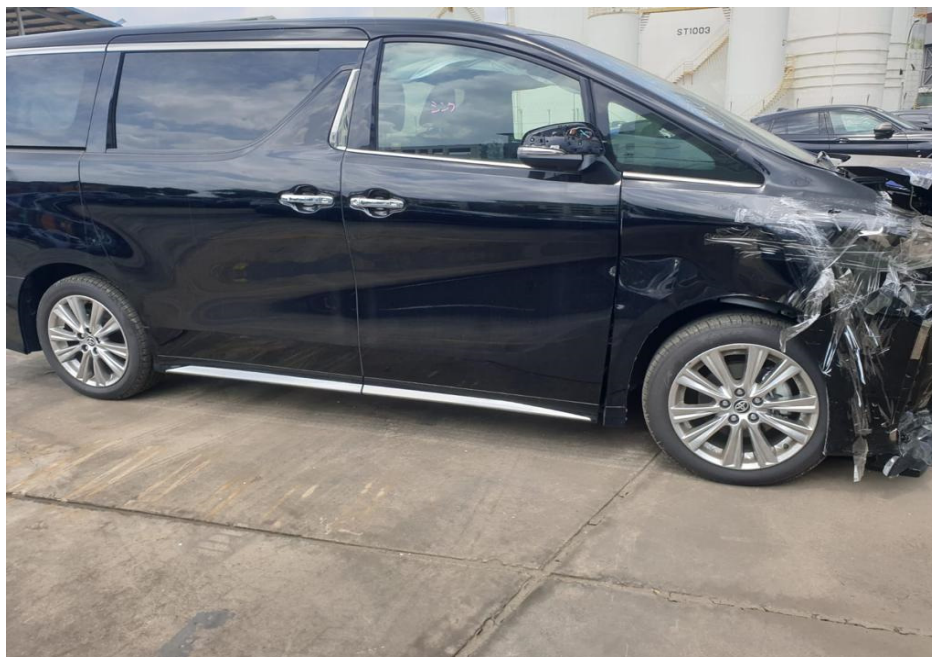
**Photo 3** shows the right body of the Motor Car (photograph provided to me). The front right fender, front right fender inner shield, right side wing mirror and front right door were amongst the parts at the right front portion of the Motor Car that were observed to have been damaged. Apart for the frontal portion and right front portion, there was no physical damage seen to other areas of the Motor Car. The airbags of the Motor Car were also not activated.

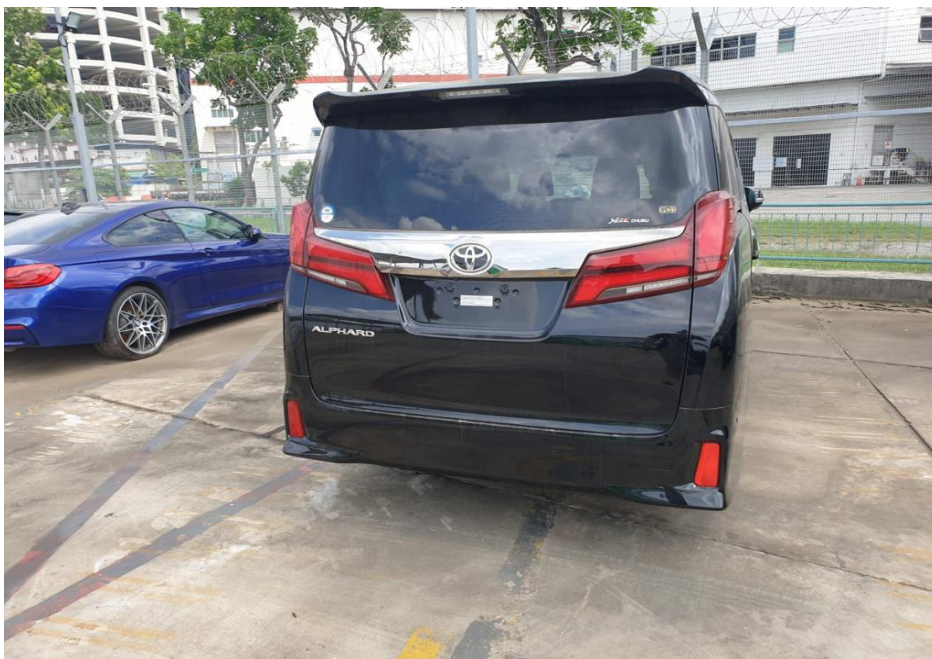
**Photo 4** shows the rear body of the Motor Car (photograph provided to me). Apart for the frontal and right front portion, there was no physical damage seen to other areas of the Motor Car. The airbags of the Motor Car were also not activated.

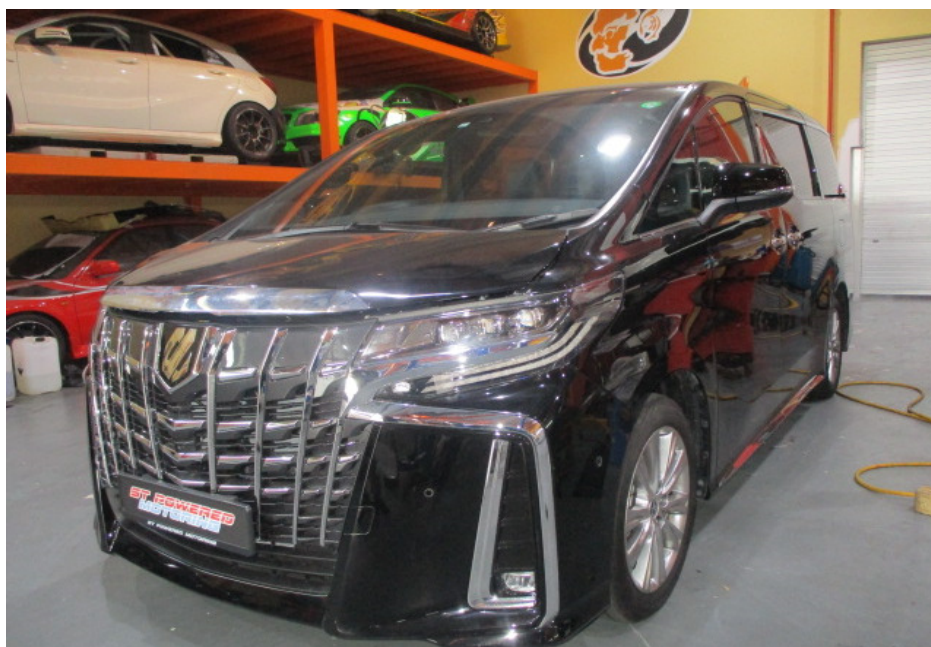
**Photo 5** shows a general view of the front left body of the Motor Car at the time of my inspection. The Motor Car was observed to be in a relatively good general condition with no loose exterior fittings observed. The body parts at the frontal portion of the Motor Car were visually examined and it was observed that the repair/restoration works carried out to the damaged area of the Motor Car (refer to photograph 1 & 2 above) were reasonably adequate and in order.

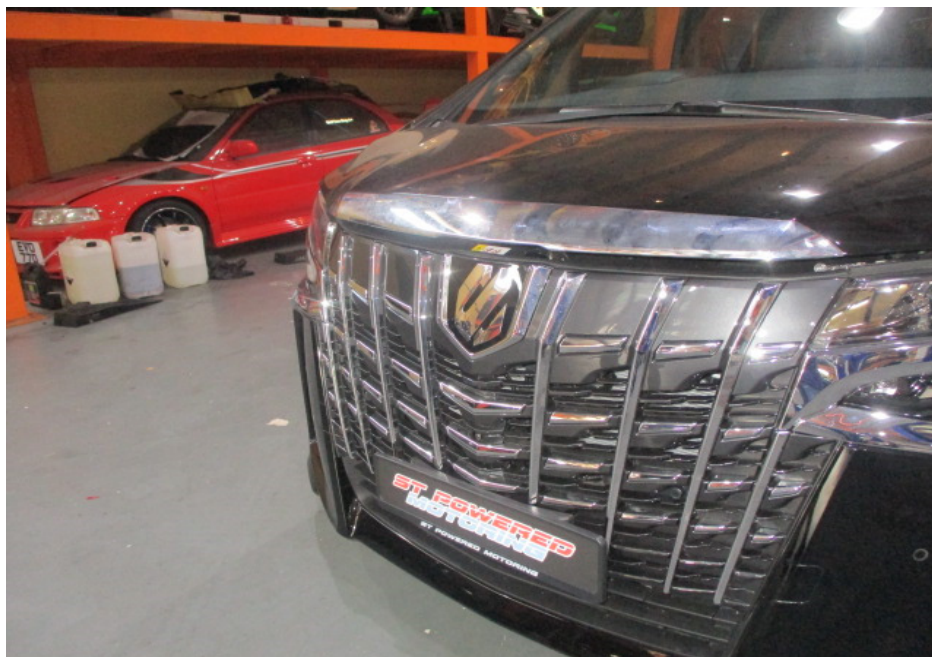
**Photo 6** shows a closer view of the front bumper, front bonnet, front bonnet chrome moulding, front grille and front left headlamp of the Motor Car at the time of my inspection. The body parts at the frontal portion of the Motor Car were visually examined and it was observed that the repair/restoration works carried out to the damaged area of the Motor Car (refer to photograph 1 & 2 above) were reasonably adequate and in order.

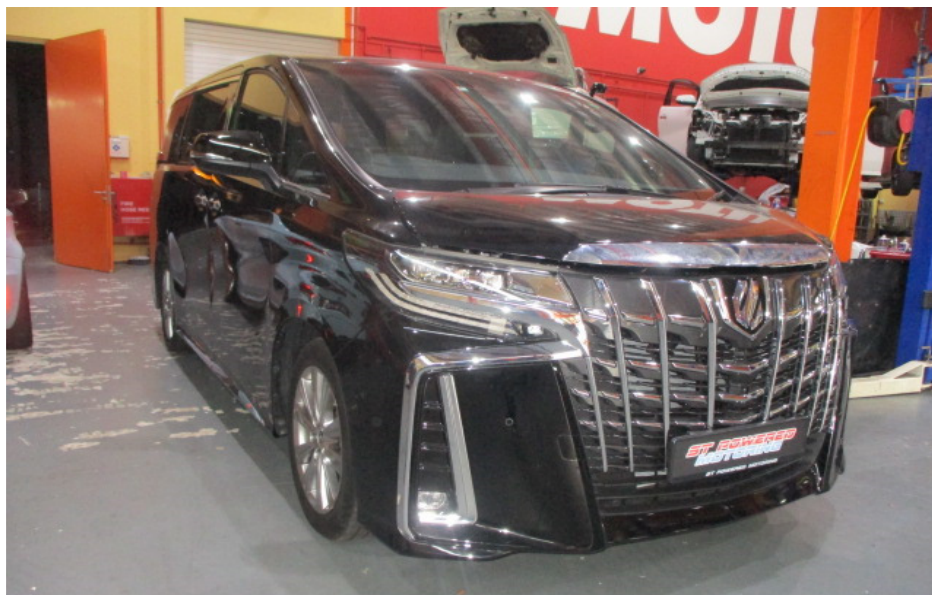
**Photo 7** shows a general view of the front right body of the Motor Car at the time of my inspection. The Motor Car was observed to be in a relatively good general condition with no loose exterior fittings observed. The body parts at the frontal portion and right front portion of the Motor Car were visually examined and it was observed that the repair/restoration works carried out to the damaged area of the Motor Car (refer to photograph 1 - 3 above) were reasonably adequate and in order.

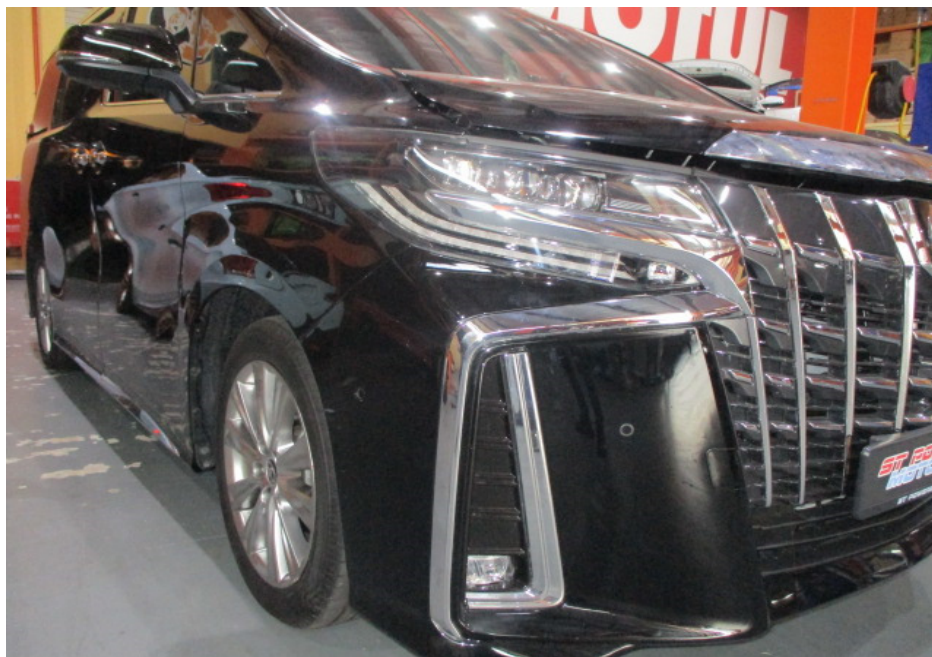
**Photo 8** shows a closer view of the front bumper, front bumper right lower chrome moulding, front right fog lamp, front right fog lamp garnish, front right fender and front right headlamp of the Motor Car at the time of my inspection. The body parts at the frontal portion and right front portion of the Motor Car were visually examined and it was observed that the repair/restoration works carried out to the damaged area of the Motor Car (refer to photograph 1 - 3 above) were reasonably adequate and in order.

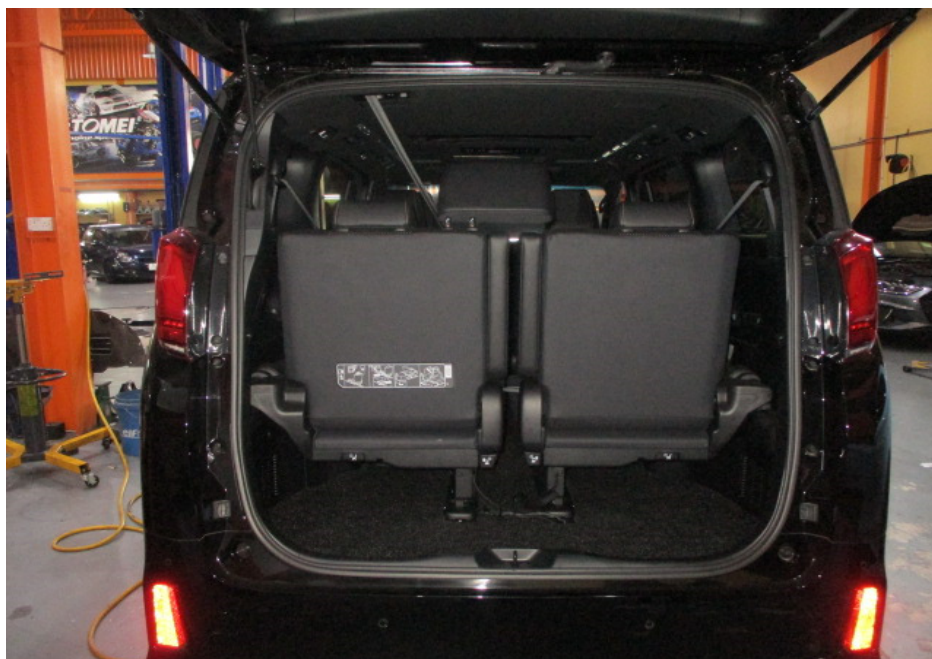
**Photo 9** shows a general view of the Motor Car's rear body at the time of my inspection. The Motor Car was observed to be in a relatively good general condition with no loose exterior fittings observed. The mileage of the Motor Car recorded at the time of my inspection was 2,834km.

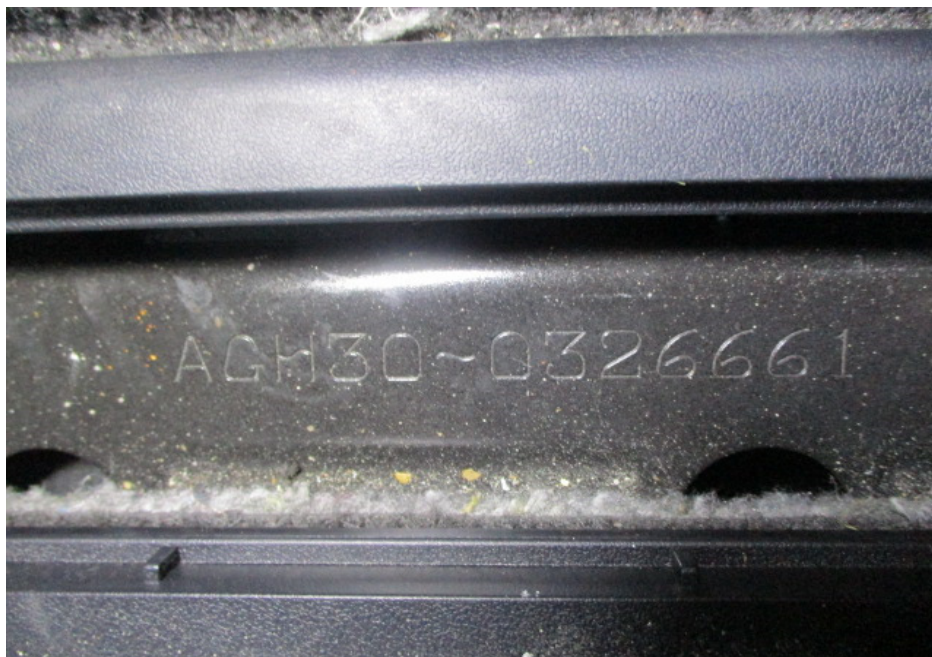
**Photo 10** shows the chassis number of the Motor Car. The chassis number recorded was AGH300326661.

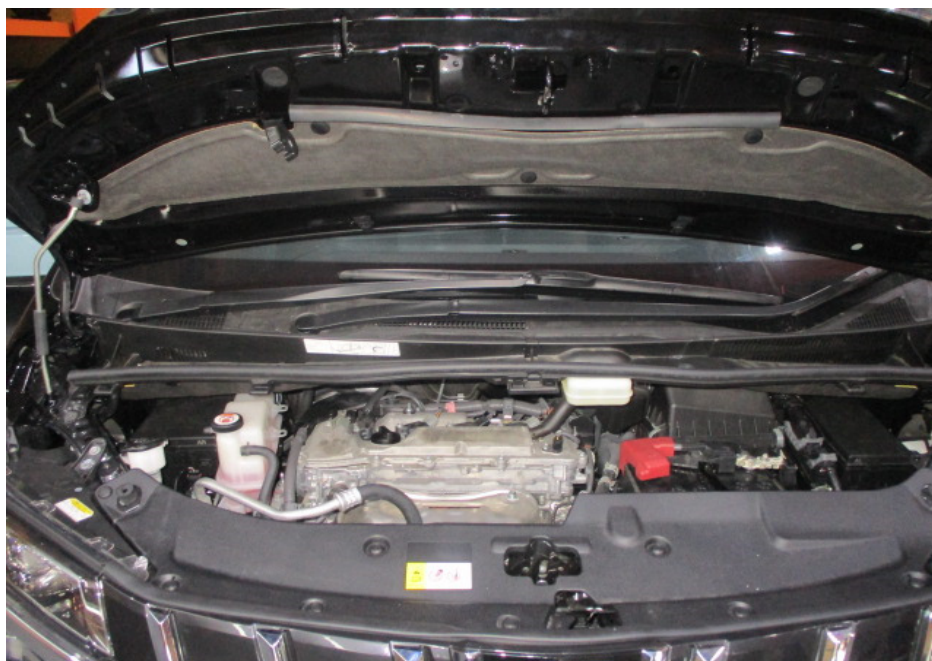
**Photo 11** shows a general view of the engine compartment of the Motor Car at the time of my inspection. The various parts and components inside the engine compartment were all observed to be intact and properly fitted. There was also no sign(s) or indication(s) of fluid leak and/or fluid stain found inside the engine compartment.

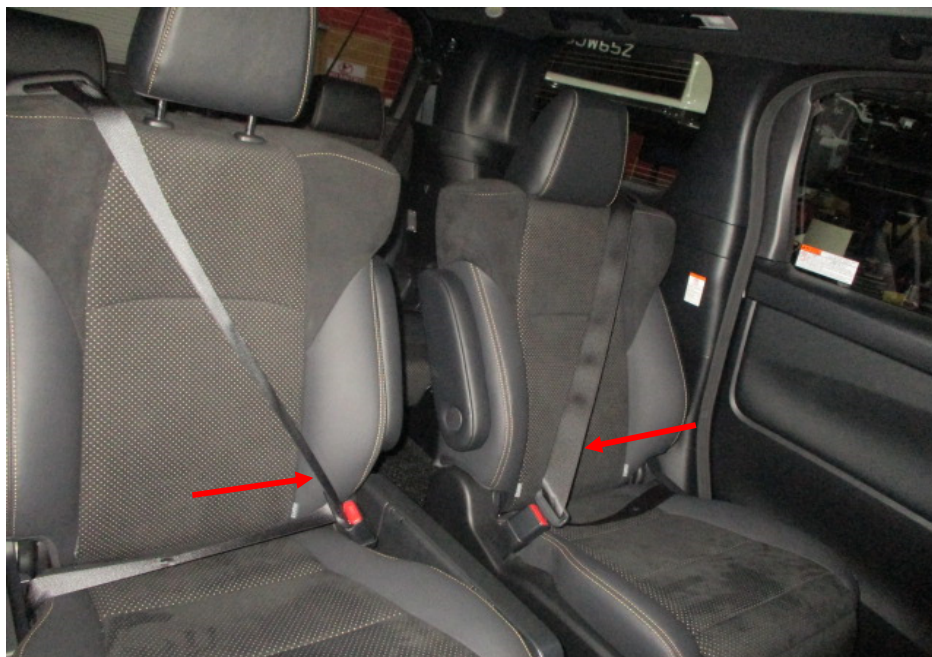
**Photo 12** shows the rear seats at the 1<sup>st</sup> row of the Motor Car. All the seats of the Motor Car were secured via seat rails to the floorboard. They were also fitted with a retractable seat belt reel and a pre-tensioner. The seat belts (arrowed) were tested and were able to be fastened into the respective pre-tensions that were fitted on the side of each individual seat.

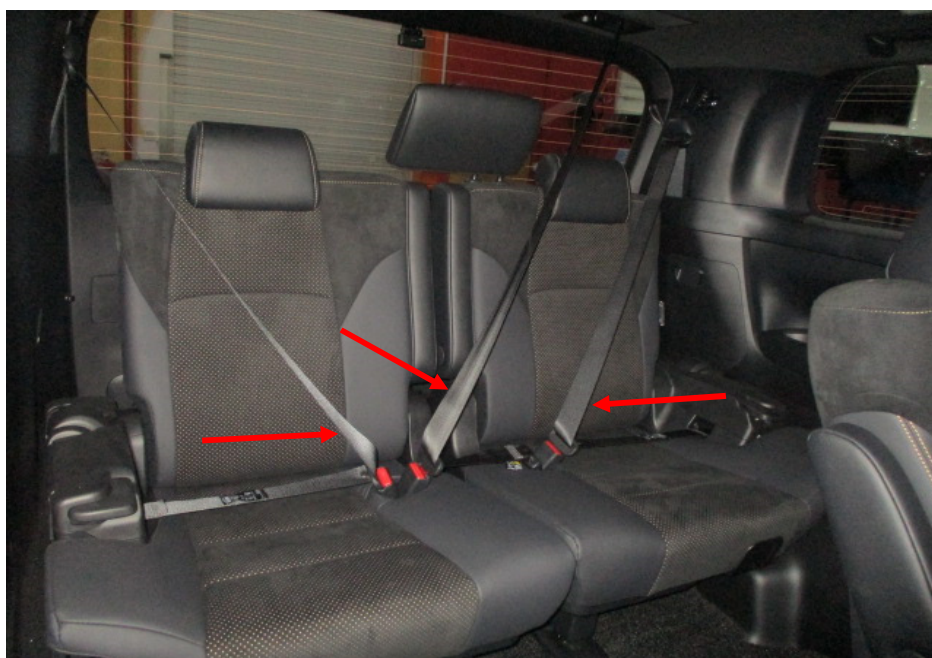
**Photo 13** shows the rear seats at the 2<sup>nd</sup> row of the Motor Car. All the seats of the Motor Car were secured via seat rails to the floorboard. They were also fitted with a retractable seat belt reel and a pre-tensioner. The seat belts (arrowed) were tested and were able to be fastened into the respective pre-tensions that were fitted on the side of each individual seat.

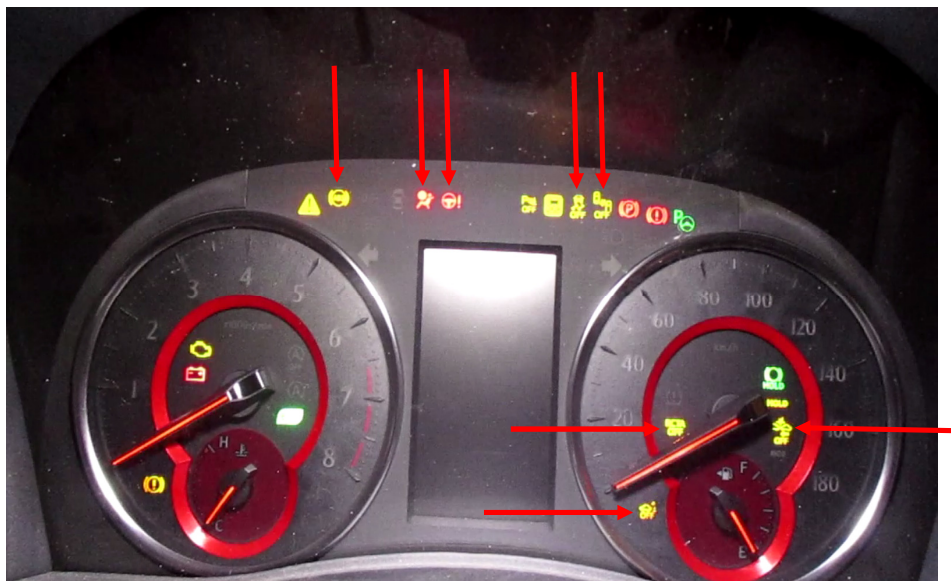
**Photo 14** shows the warning lights for the various electronic safety features appearing on the instrument panel of the Motor Car during its self-test when the engine is cranked, in particular the lights for the ABS, SRS, EPS, VSC and various pre-collision systems (arrowed).

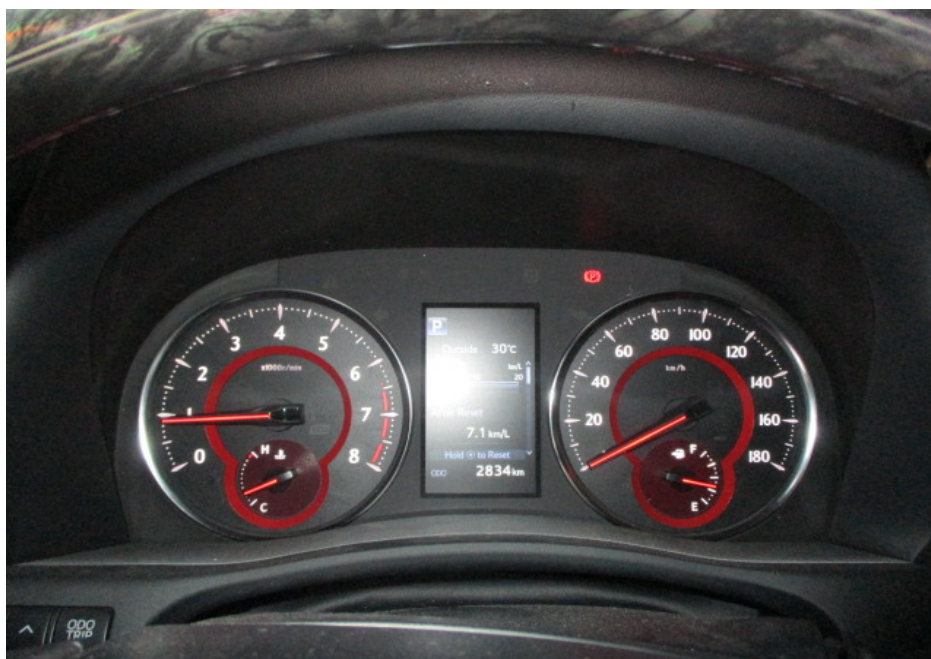
**Photo 15** shows the respective warning lights no longer illuminated, indicating that there is no fault detected to the ABS, SRS, EPS, VSC and various pre-collision systems of the Motor Car during the self-test. These electronic systems were hence in working condition at the time of my inspection.

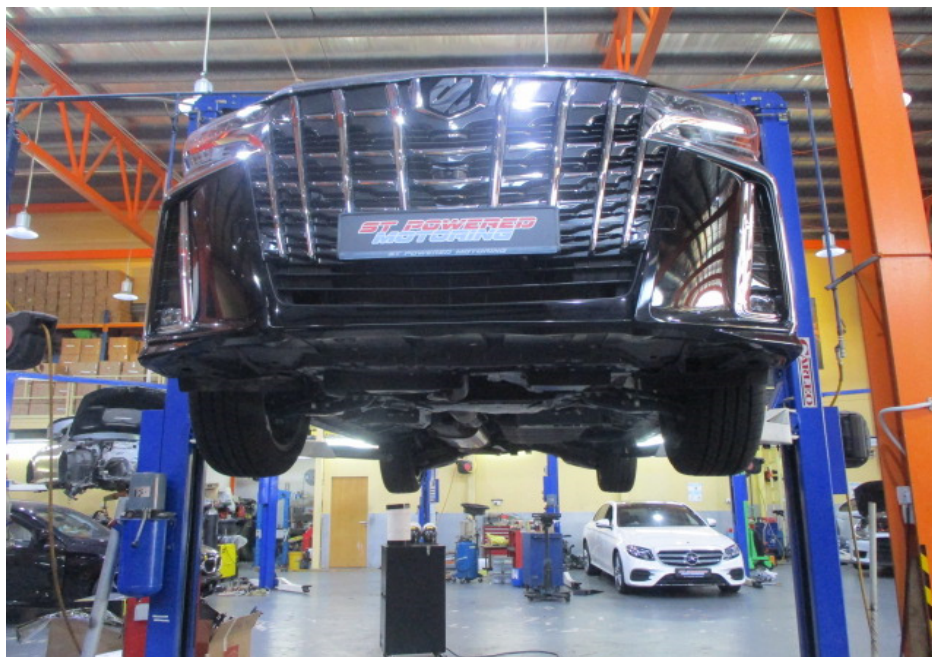
**Photo 16** shows the Motor Car hoisted up for checks on its undercarriage. There was no sign(s) or indication(s) of fluid leakage and/or fluid stain(s) on the underside of the Motor Car. The undercarriage components of the Motor Car were also all observed to be intact and secured in an appropriate manner.

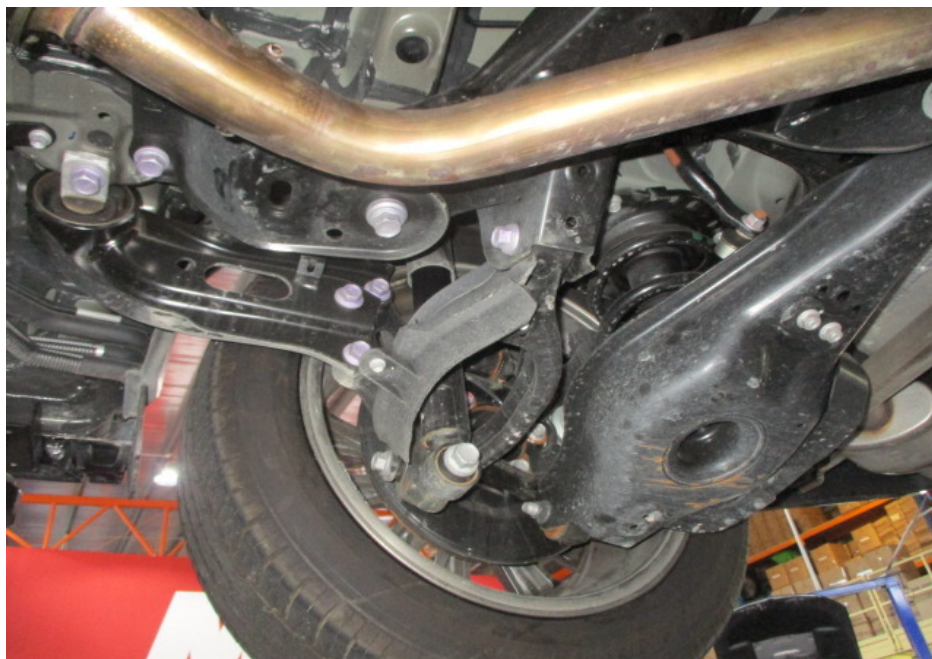
**Photo 17** shows a general view of the control arms and linkages at the rear right wheel of the Motor Car. I did not observe any fluid leak and/or fluid stain on the underside of the Motor Car. All of the Motor Car's undercarriage components were observed to be intact and secured in an appropriate manner.

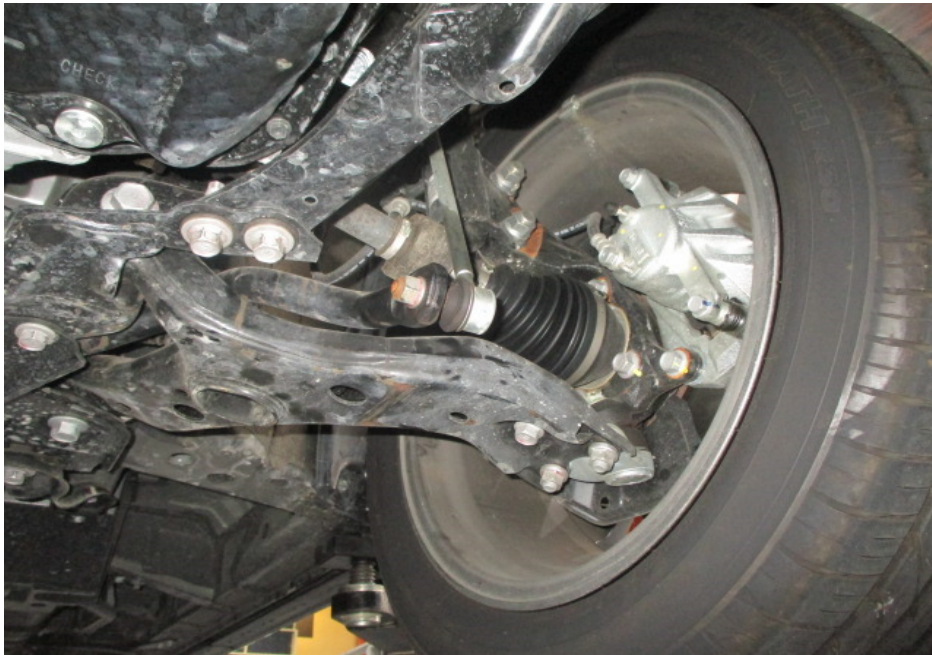
**Photo 18** shows the various undercarriage components at the front left wheel of the Motor Car. The mechanical components, control arms and linkages were all found to be intact and secured in an appropriate manner.

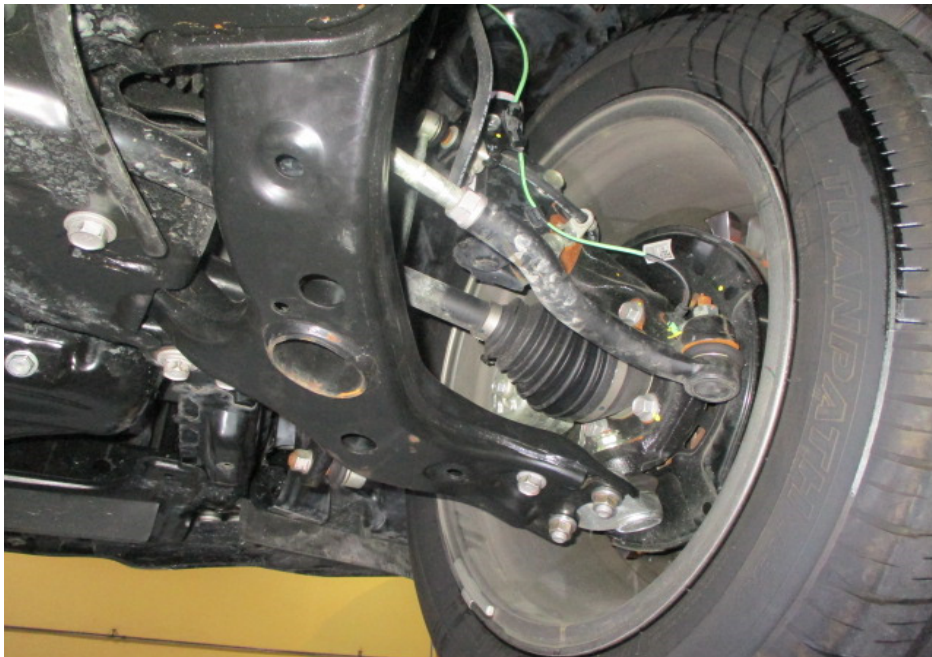
**Photo 19** shows the various undercarriage components at the front right wheel of the Motor Car. The mechanical components, control arms and linkages were all found to be intact and secured in an appropriate manner. I also did not observe any fluid leak and/or fluid stain on the underside of the Motor Car.

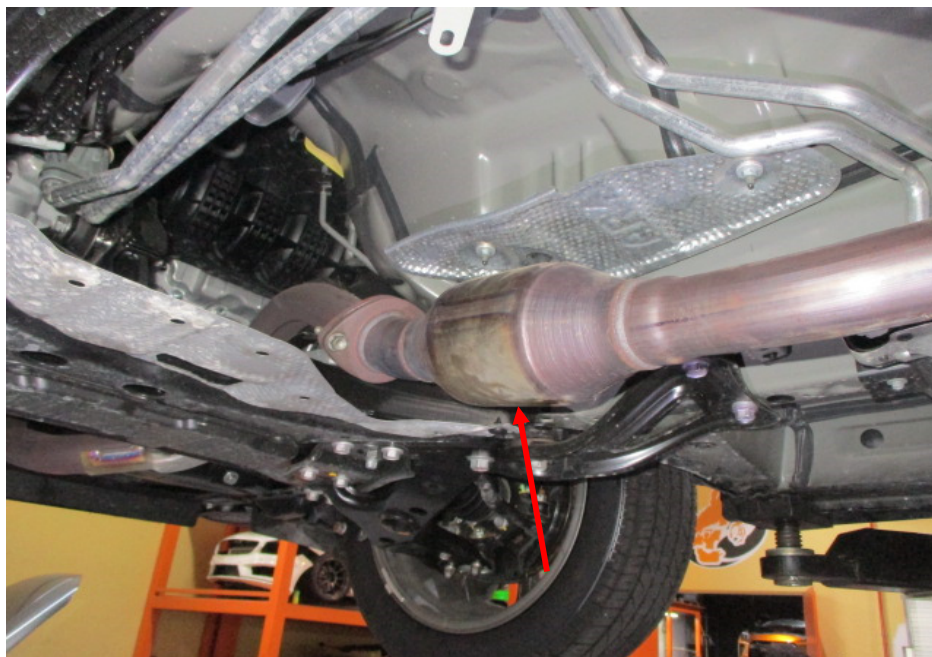
**Photo 20** shows the Motor Car's catalytic converter (arrowed). My examination of the Motor Car's exhaust system revealed no sign(s) or indication(s) of any cut or weld marks along its exhaust pipe and on its rear muffler.

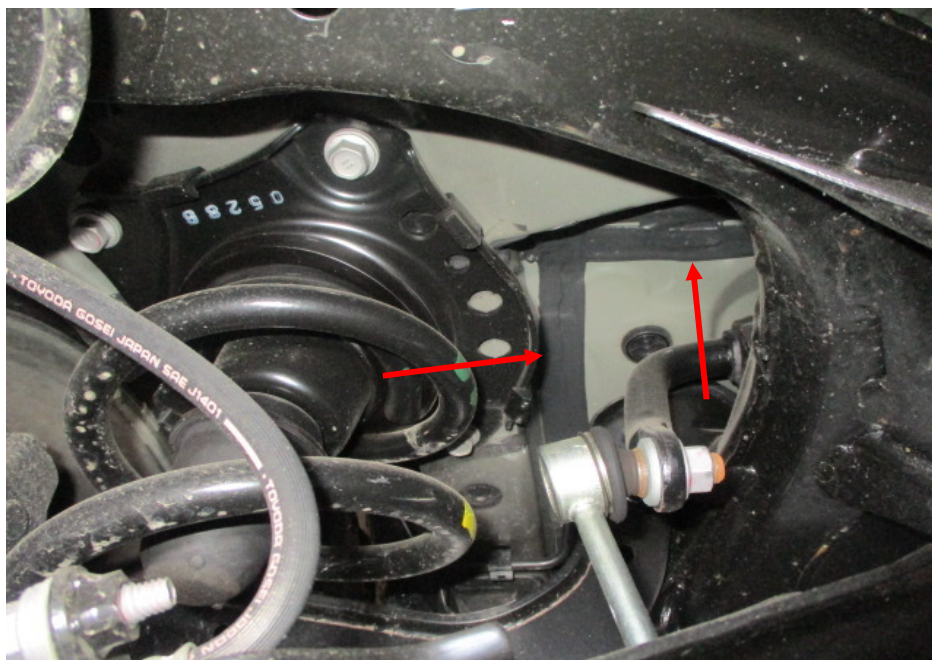
**Photo 21** shows the chassis/structural body at the underside rear left of the Motor Car. I did not find any weld marks other than original spot weld marks on the chassis/structural body of the Motor Car. The original factory sealant (arrowed) at the joints along the chassis/structural body was untouched, indicating no work was done on the chassis/structural body of the Motor Car and that the chassis/structural body was originally fitted.

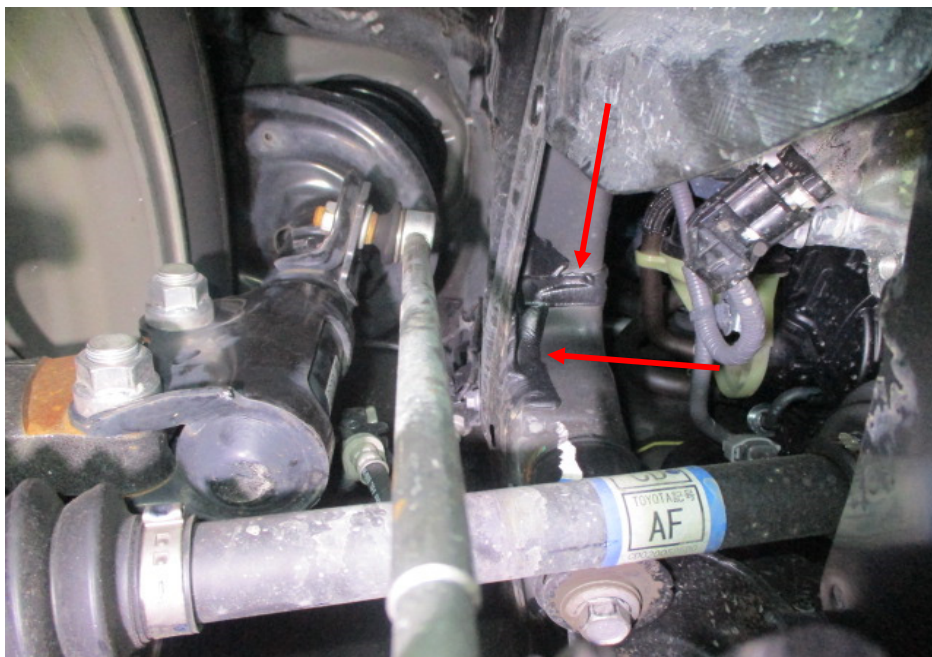
**Photo 22** shows the chassis/structural body at the underside front right of the Motor Car. The original factory sealant (arrowed) at the joints along the chassis/structural body was observed to be untouched. In general, I had found no work was carried out on the chassis/structural body of the Motor Car. The chassis/structural body of the Motor Car was originally fitted.

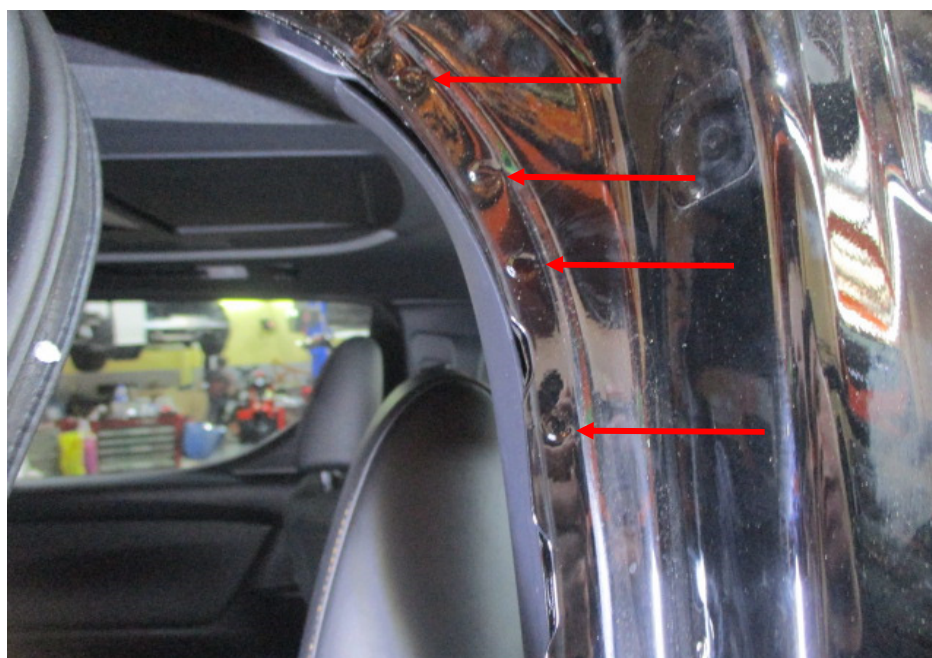
**Photo 23** shows the right side centre pillar of the Motor Car. I did not find any weld marks other than original spot weld marks (arrowed) on the right side centre pillar of the Motor Car, which indicates that there was no re-welding works carried out. In general, I had found all the non-detachable body panels of the Motor Car to be originally fitted at the time of my inspection.

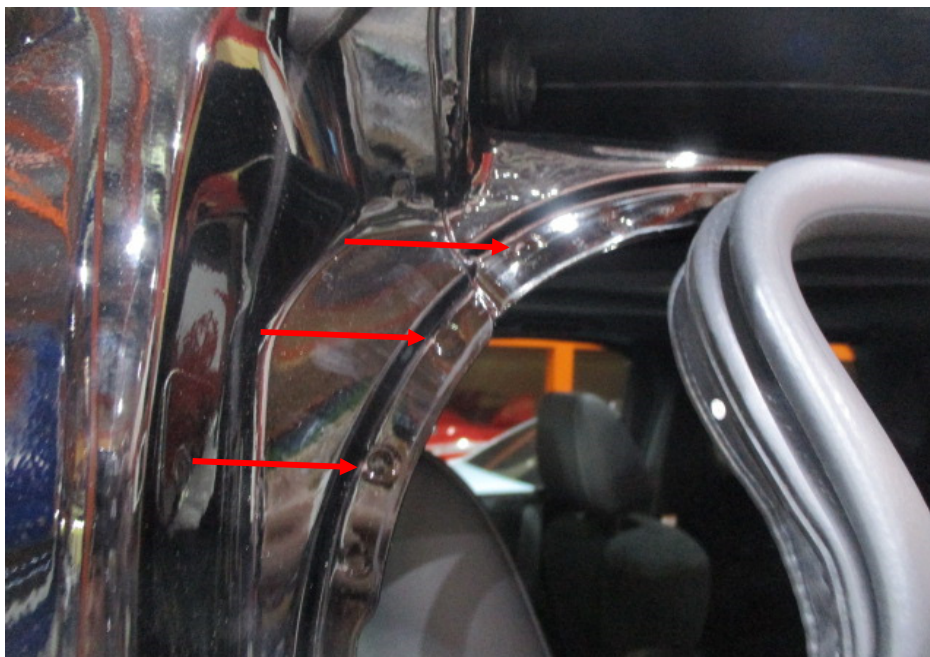
**Photo 24** shows the left side centre pillar of the Motor Car. I did not find any weld marks other than original spot weld marks (arrowed) on the left side centre pillar of the Motor Car, which indicates that there was no re-welding works carried out. In general, I had found all the non-detachable body panels of the Motor Car to be originally fitted at the time of my inspection.
