From: Denise Tay (LKKAuto)
Sent: Monday, 3 May 2021 5:26 PM
To: Reports (LKKAuto); 'Gnoh, Pau Loong'
Cc: SUR; Huey Yon (LKKAuto)
Subject: RE: Please reconfirm damage parts ; RE: Survey Report & Invoice of Vehicle SMW 1313R Ref: CMTD2100207/GPL
Attachments: SMW 1313R Damage photo2.pdf

Subject: Please reconfirm damage parts ; RE: Survey Report & Invoice of Vehicle SMW 1313R Ref: CMTD2100207/GPL

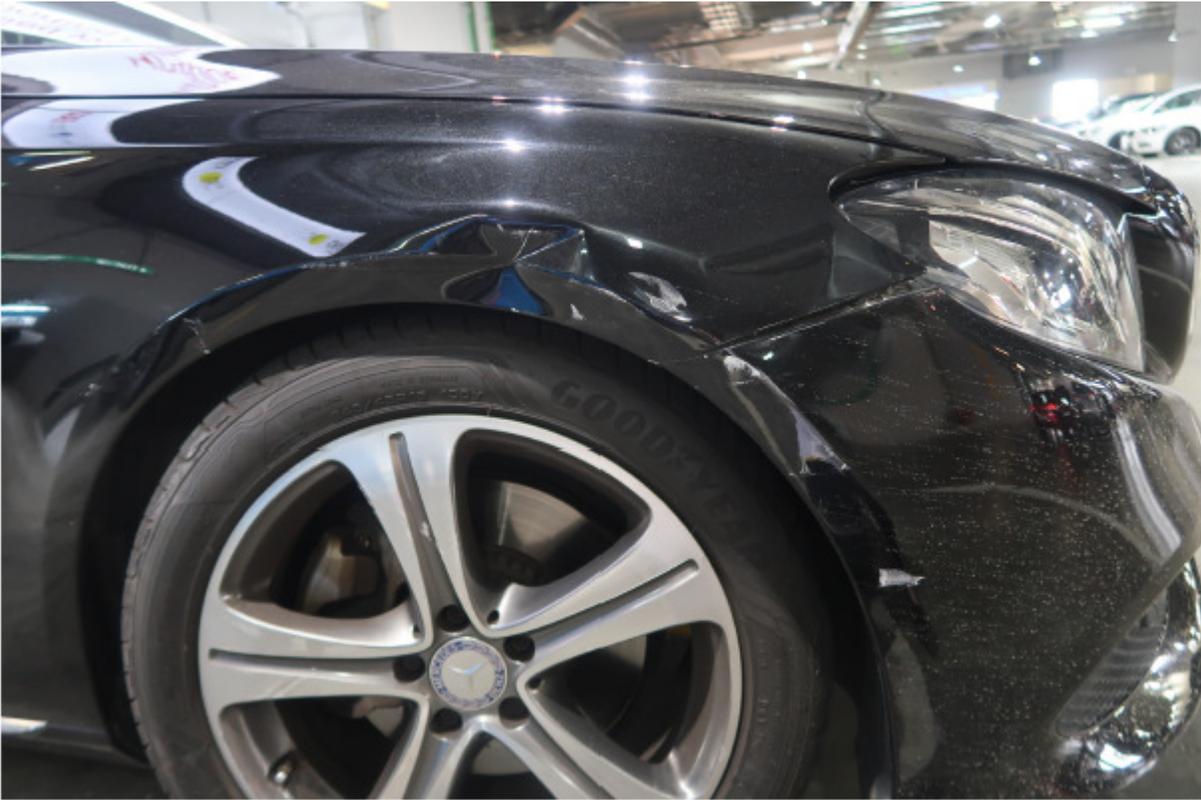
With reference to your email below dated 13/04/21, please recheck with your surveyor, based from attached footage and damage photo below,

we need verification and with your surveyor proof of photo that the following parts need to replace, [highlighted in pink lines](#) :
